**REPORT NUMBER: SINCAP-MGA-2016-054**

**NEW CAR ASSESSMENT PROGRAM (NCAP)  
Moving Deformable Barrier Side Impact Test**

**HONDA OF CANADA MFG.  
2016 Honda Civic LX 2-Door Coupe  
NHTSA No.: O20165315**

**FINAL REPORT**

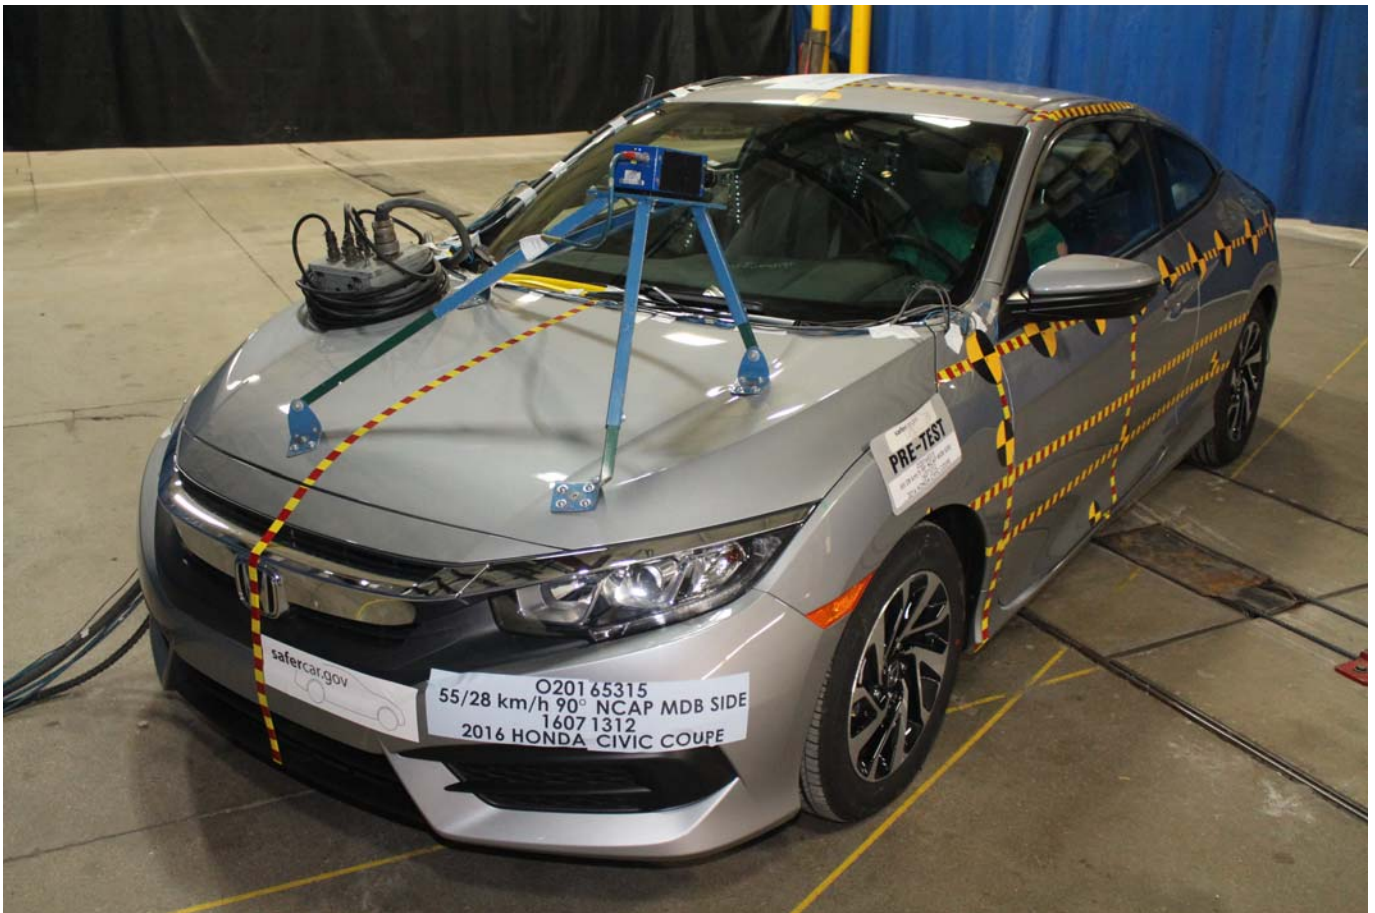
Photo No. 005 - Pre-Test Left Front Three-Quarter View of Test Vehicle

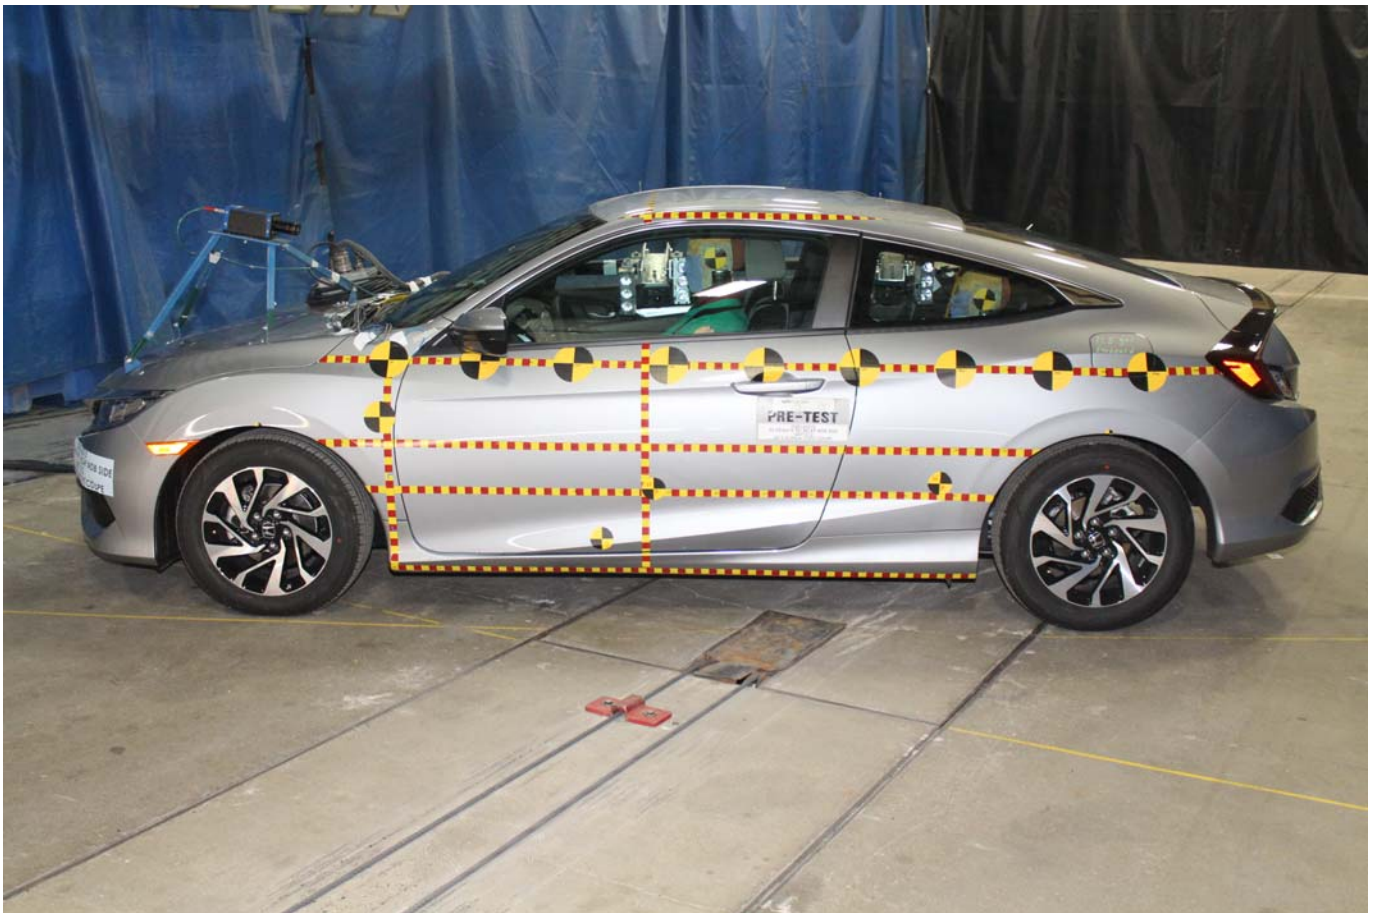
Photo No. 007 - Pre-Test Left Side View of Test Vehicle

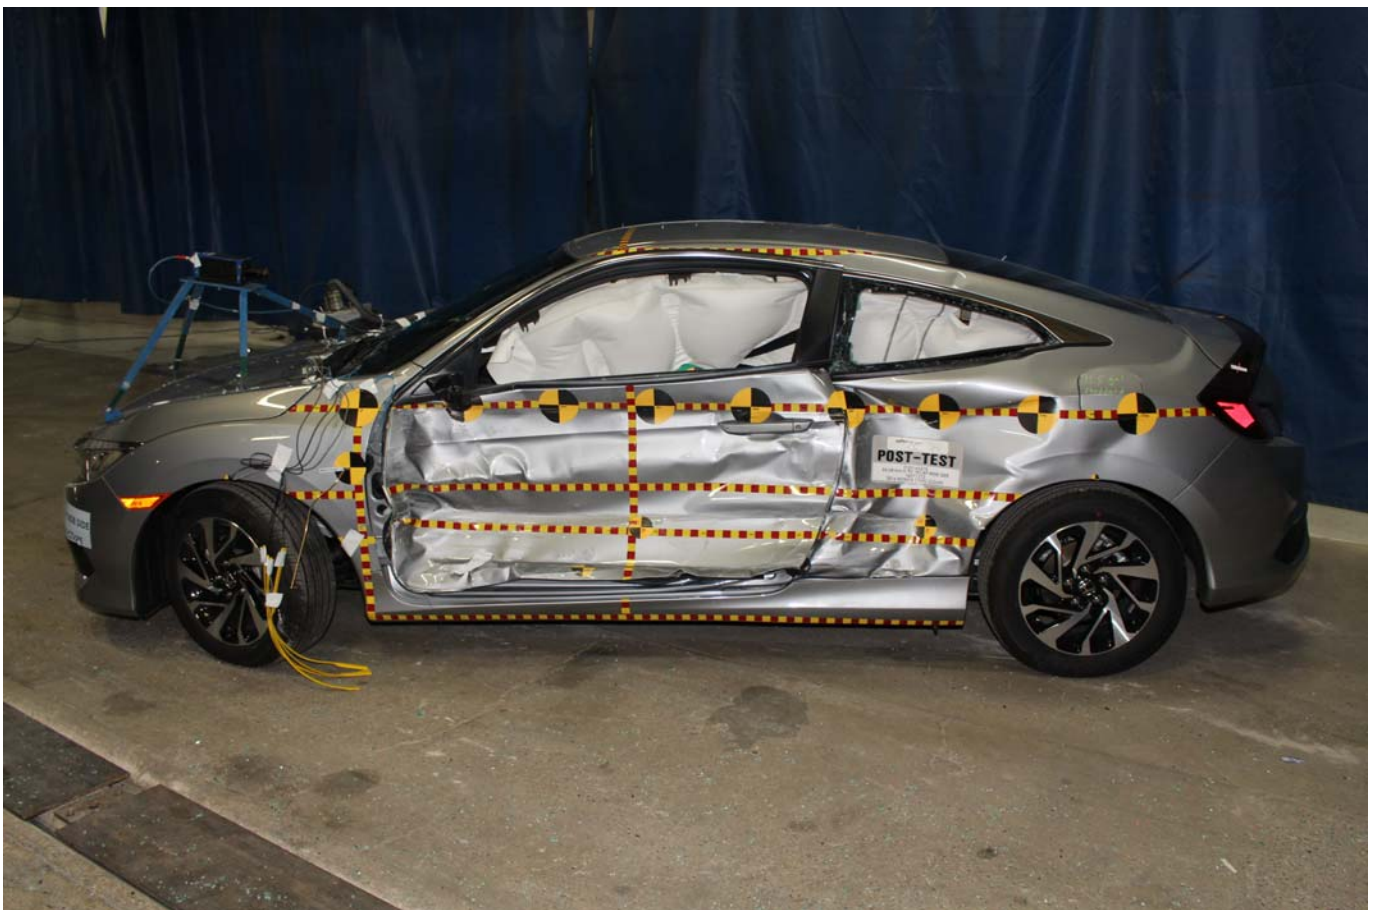
Photo No. 008 - Post-Test Left Side View of Test Vehicle

| Critical Areas of Performance | Observations and Conclusions |
|---|---|
| Side Window Damage | LF, LR Window Broken |

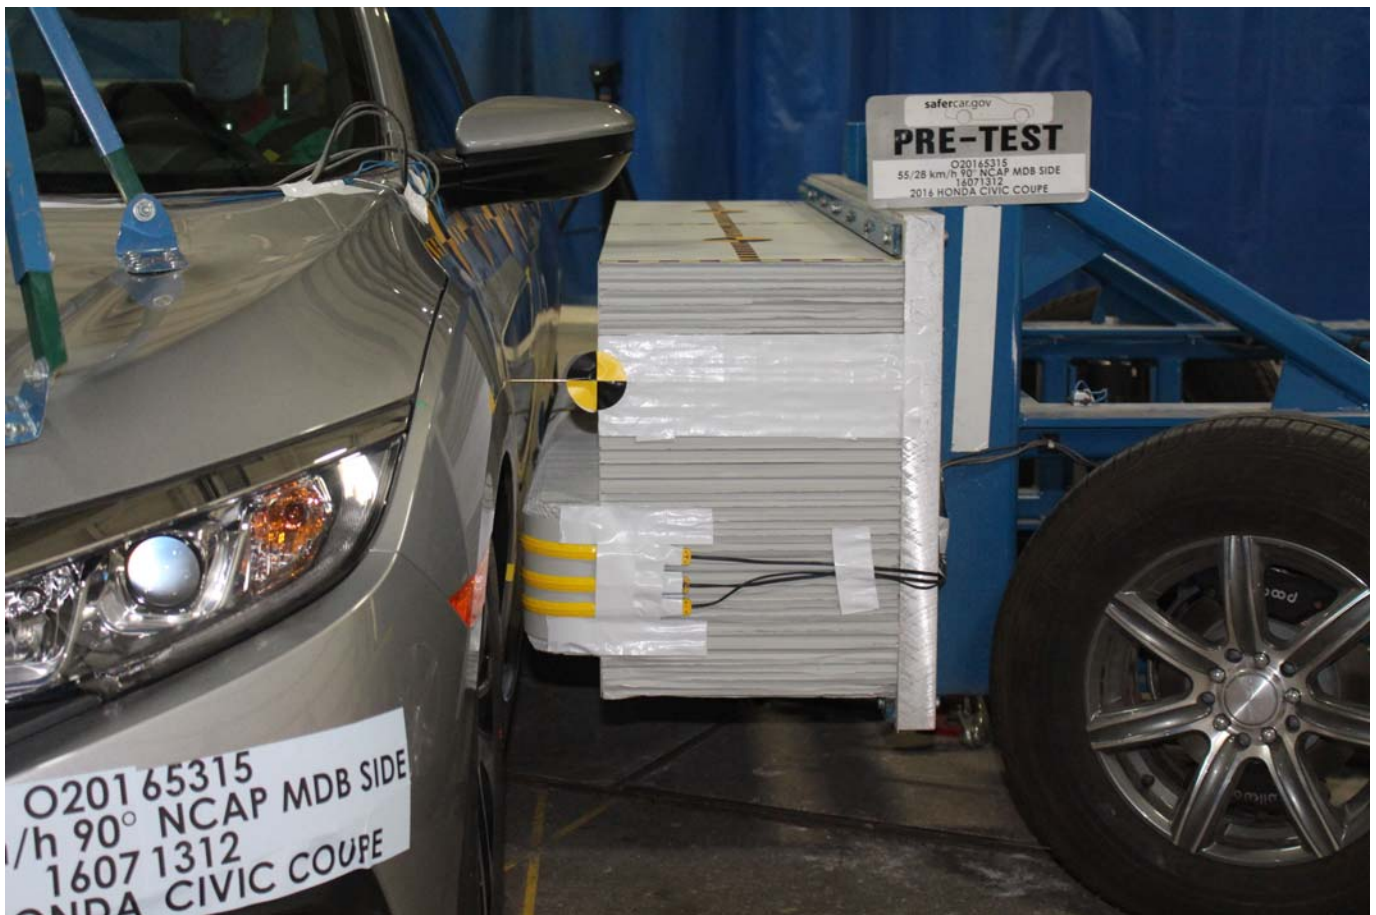
Photo No. 017 - Pre-Test Left Side View of MDB Positioned Against Side of Test Vehicle

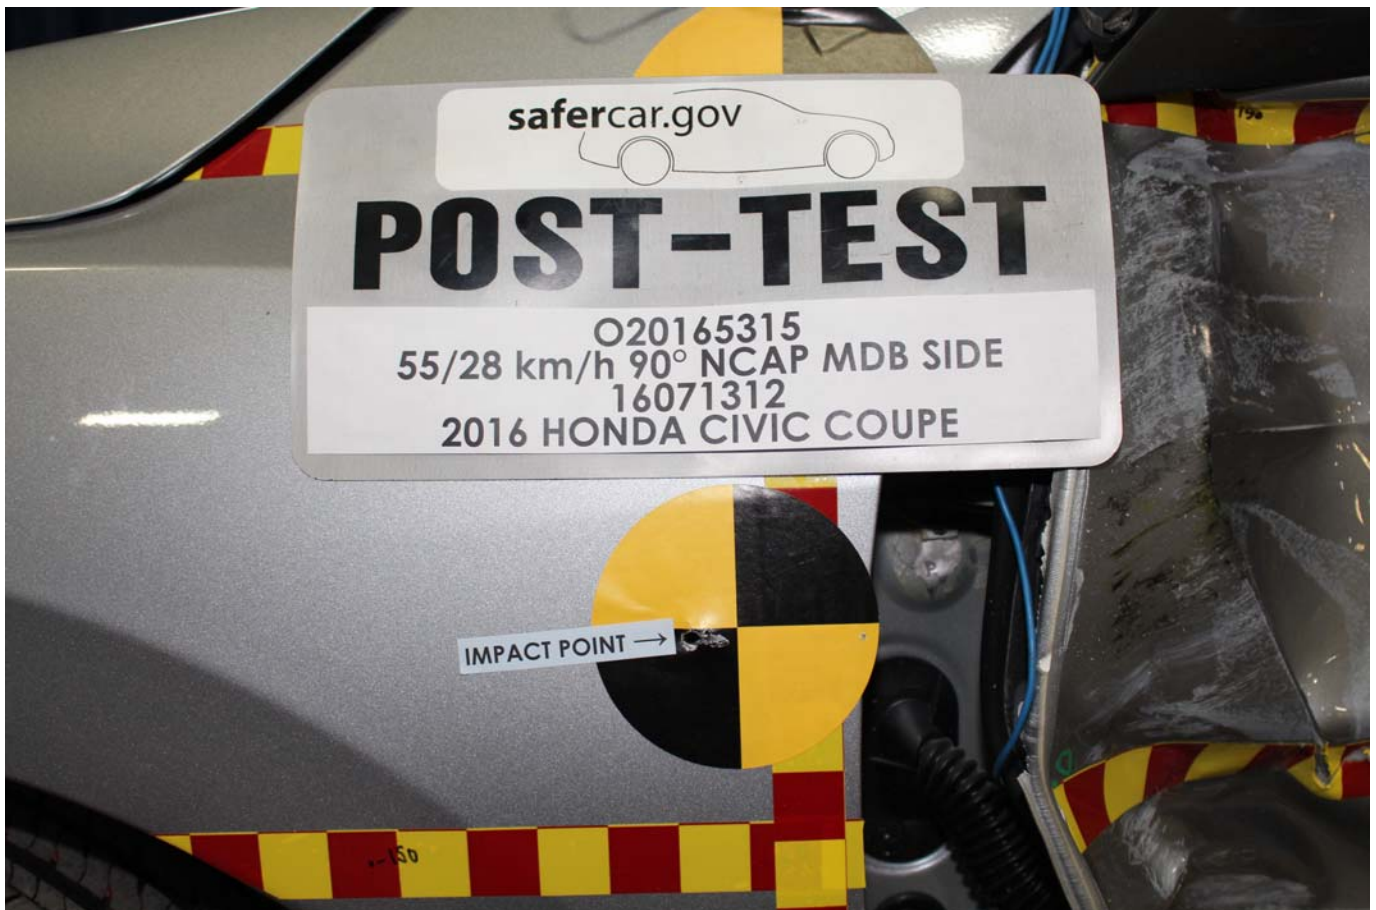
Photo No. 020 - Post-Test Close-Up View of Impact Point Target

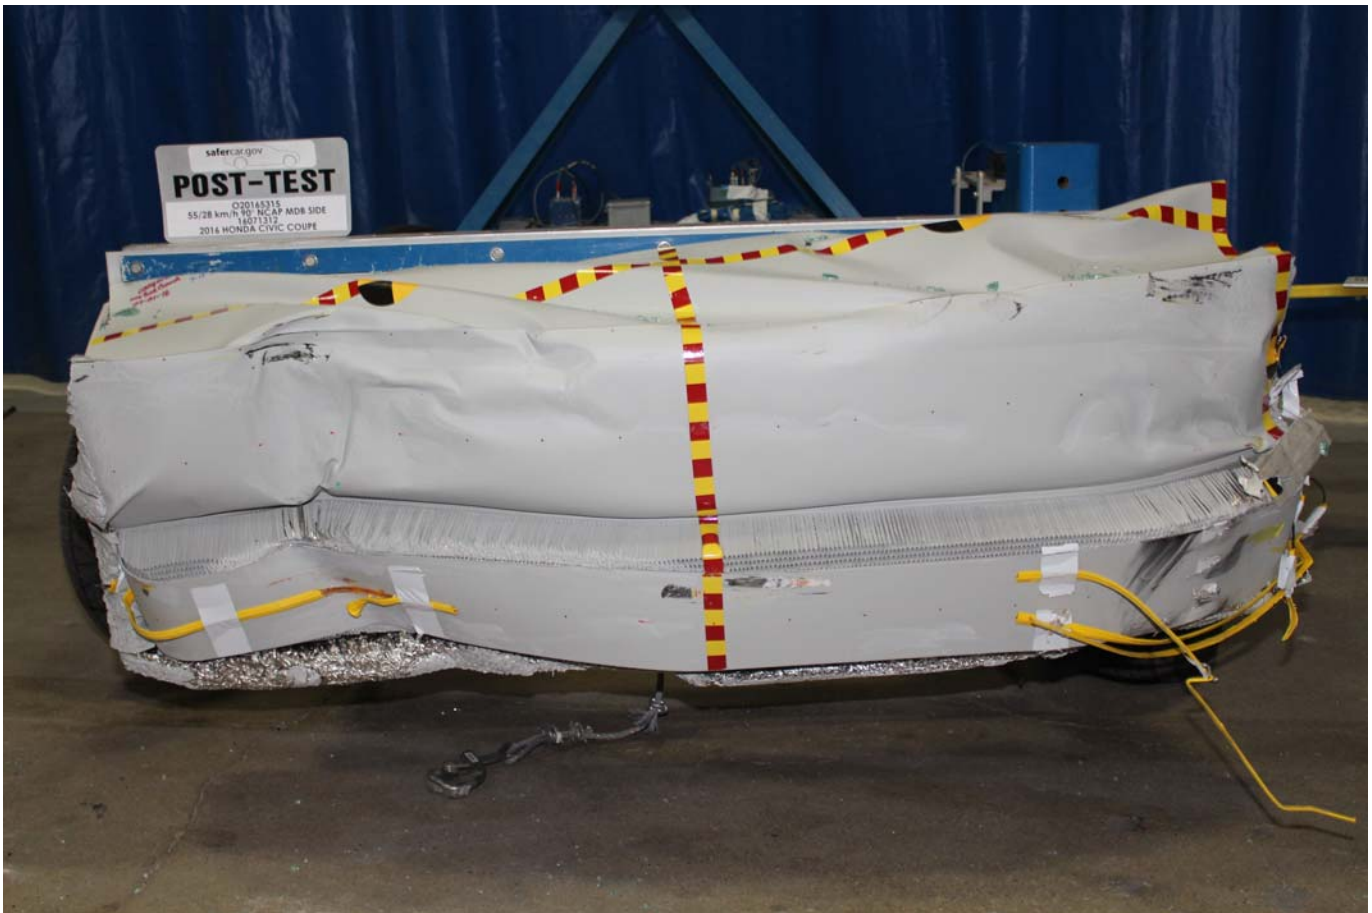
Photo No. 085 - Post-Test Front View of MDB Impactor Face
