REPORT NUMBER: 301-CAL-10-3

**SAFETY COMPLIANCE TESTING FOR FMVSS 301  
FUEL SYSTEM INTEGRITY – REAR IMPACT**

Toyota Motor Corporation  
2010 Lexus HS250h  
Sedan

NHTSA NUMBER: CA5102

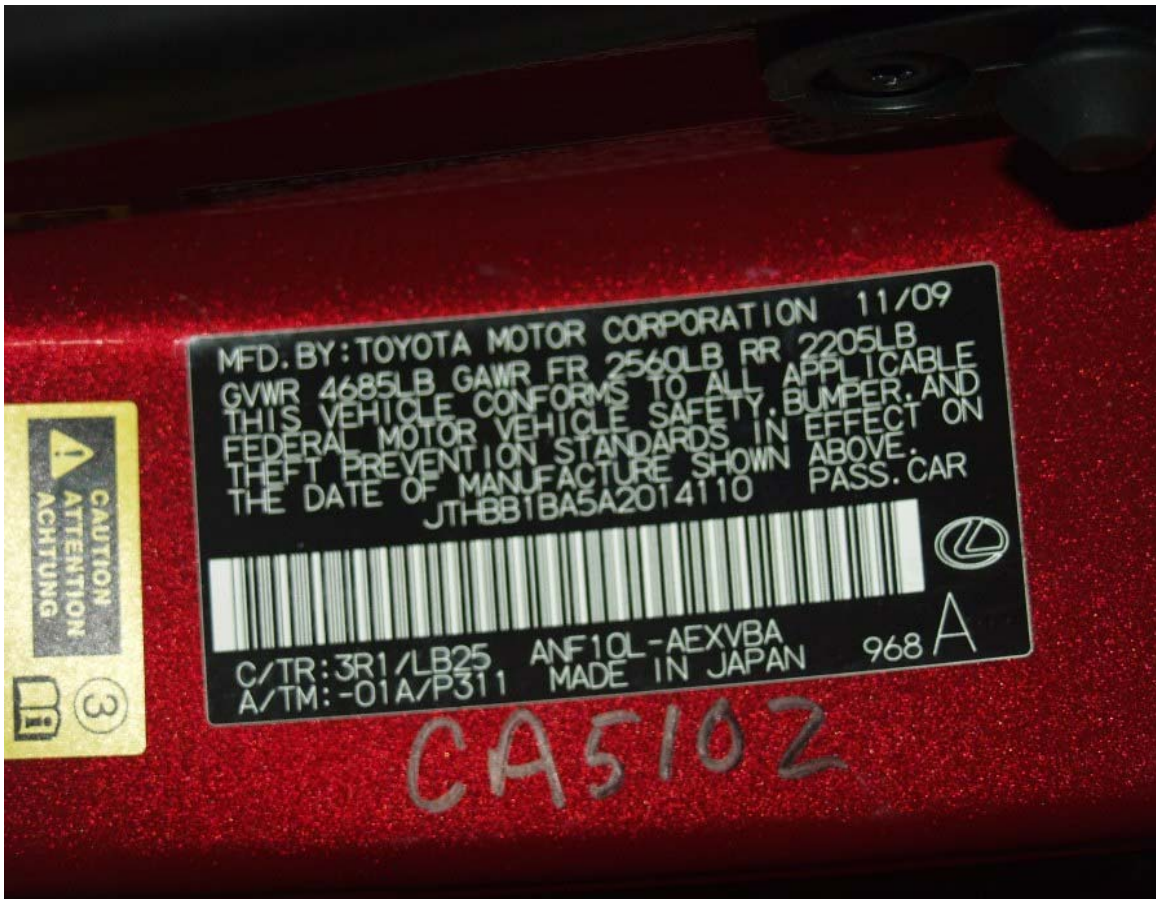
Vehicle Manufacturer: Toyota Motor Corporation  
 Vehicle Build Date: 11/09  
 VIN:: JTHBB1BA5A2014110  
 GVWR: 2125 kg; GAWR: 1160 kg FRONT; 1000 kg REAR

Figure A-1: Vehicle Certification Placard

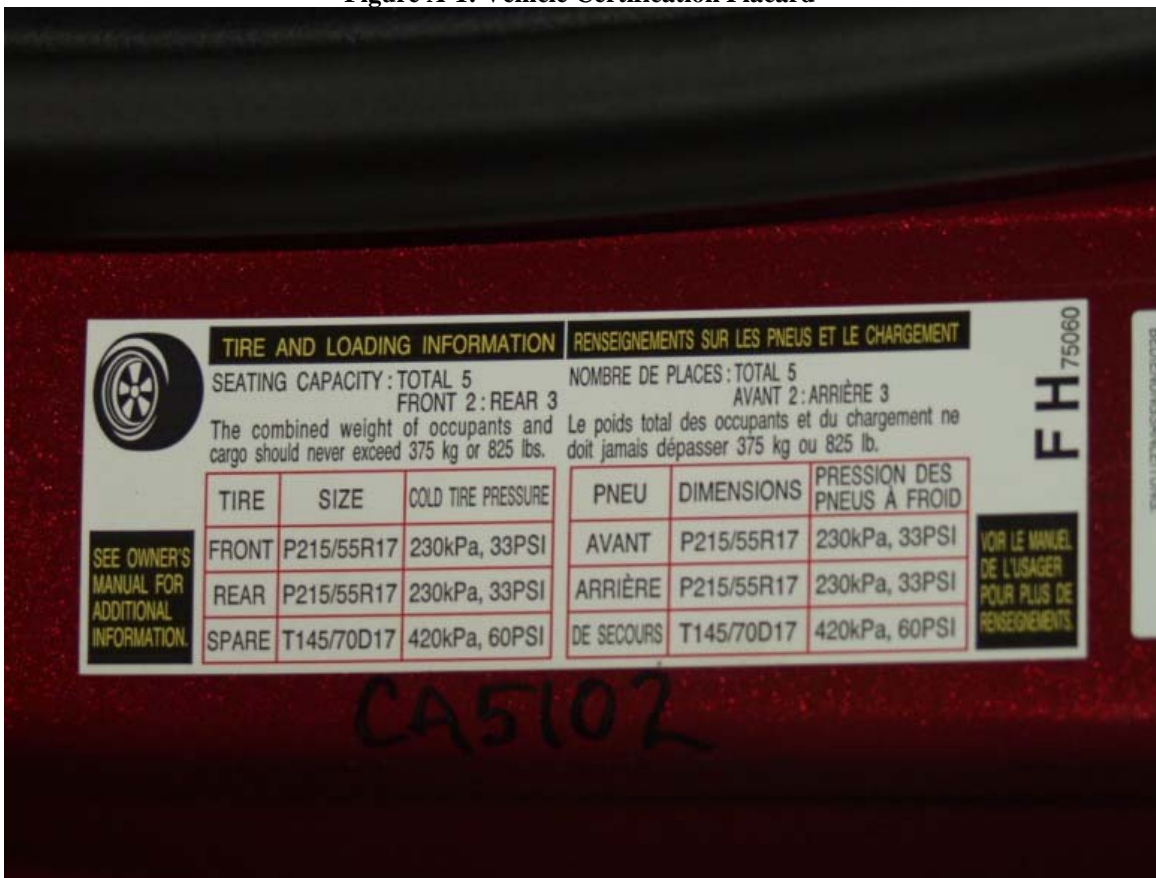
<u>Front</u>	<u>Rear</u>
Maximum Tire Pressure (sidewall - kPa)	300	300
Cold Pressure (tire placard - kPa) – test pressure	230	230
Recommended Tire Size (tire placard)	P215/55R17	P215/55R17
Vehicle Tire Size with load index & speed symbol	P215/55R17	P215/55R17
Tire Manufacturer	Michelin	Michelin
Tire Name	Energy MXV4	Energy MXV4
Treadwear, Traction, Temperature	440, A, A	440, A, A

Figure A-2: Vehicle Tire Placard

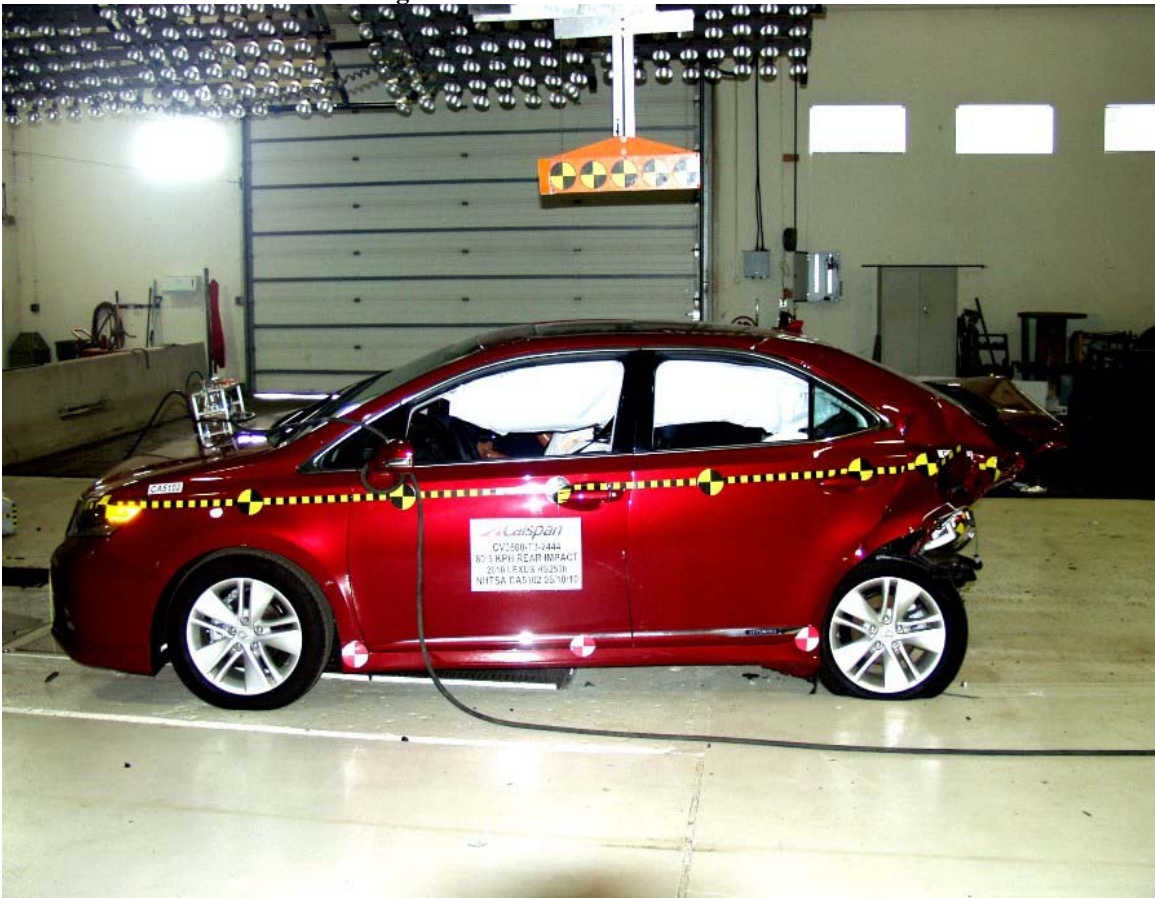
Figure A-6: Post-Test Left Side View

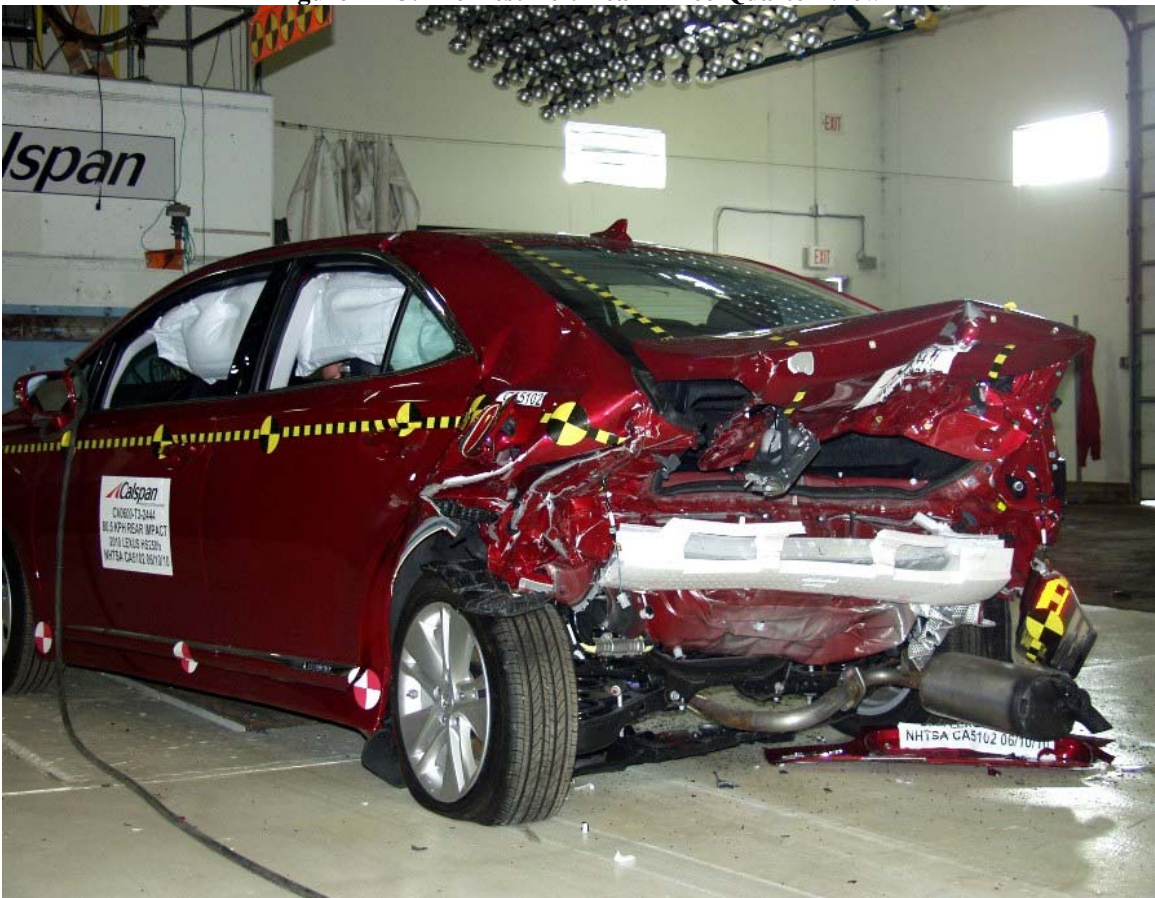
Rollover Stage	Spillage Location
0° - 90°	Stoddard appeared to leak from the fuel filler neck area that was pulled from the left rear fender area during the impact.
90° - 180°	Not collected – stage 1 exceeded
180°-270°	Not collected – stage 1 exceeded
270°-360°	Not collected – stage 1 exceeded

Figure A-14: Post-Test Left Rear Three-Quarter View

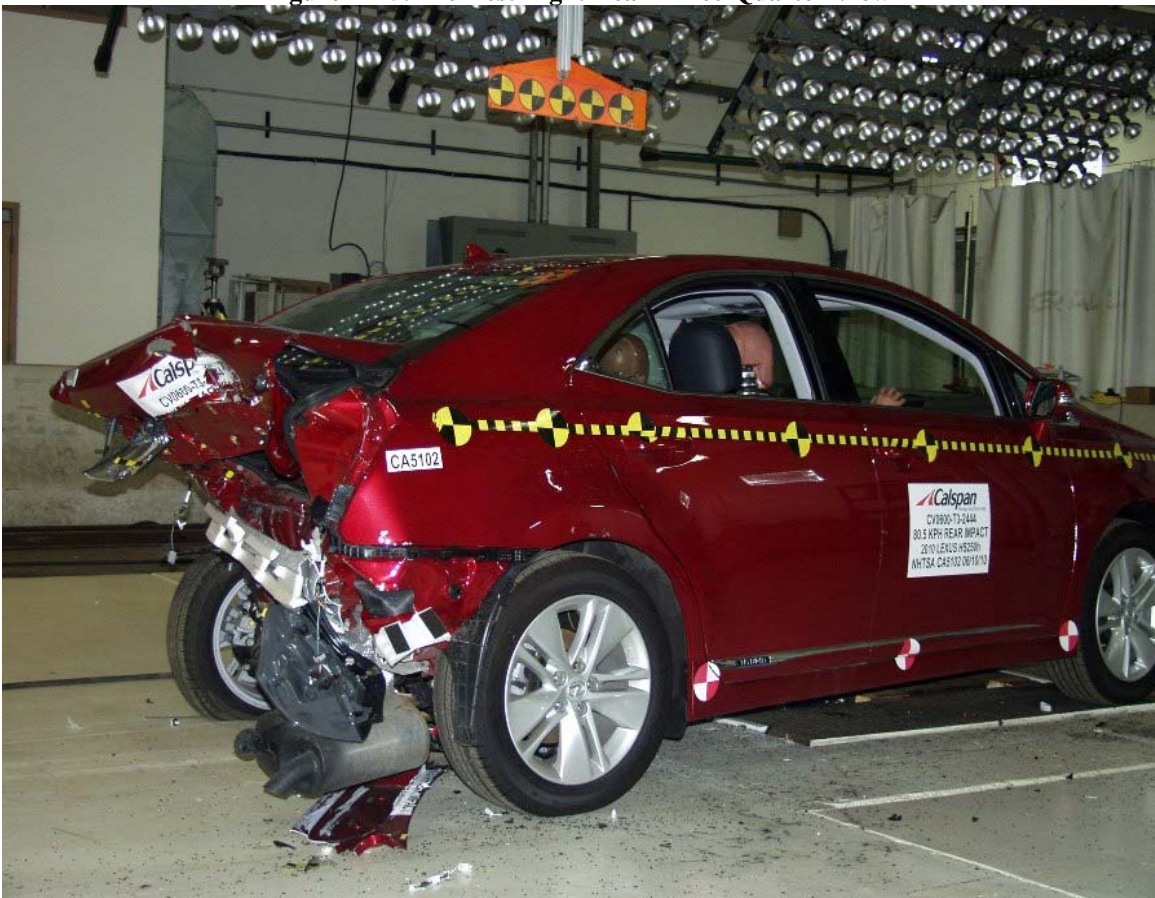
**Figure A-16: Post-Test Right Rear Three-Quarter View**

Post-impact, 1463 grams of fuel leakage was collected during the first 5 minutes of the 0 to 90 degree static roll performed after the impact. The FMVSS 301 standard allows a maximum of 142 grams to leak during this time period. The fuel leakage rate was also exceeded during the 6<sup>th</sup> and 7<sup>th</sup> minute of the collection period. Based on this data, the vehicle does not appear to comply with all the requirements of FMVSS No. 301 "Fuel System Integrity." The average vehicle longitudinal crush was 599 millimeters.

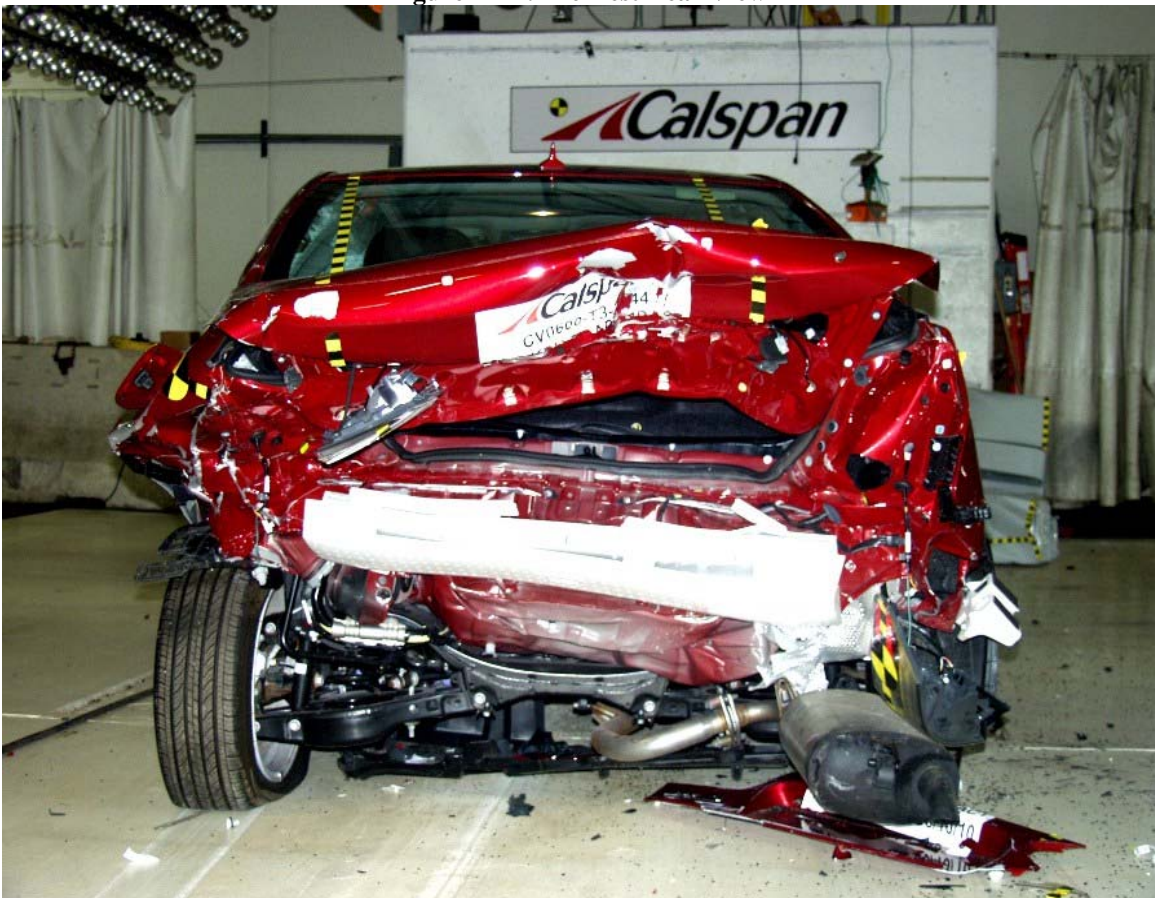
Left Side	Centerline	Right Side
Pre-Test	4632	4700	4630
Post-Test	3878	4105	4181
Crush	754	595	449

**Figure A-18: Post-Test Rear View**

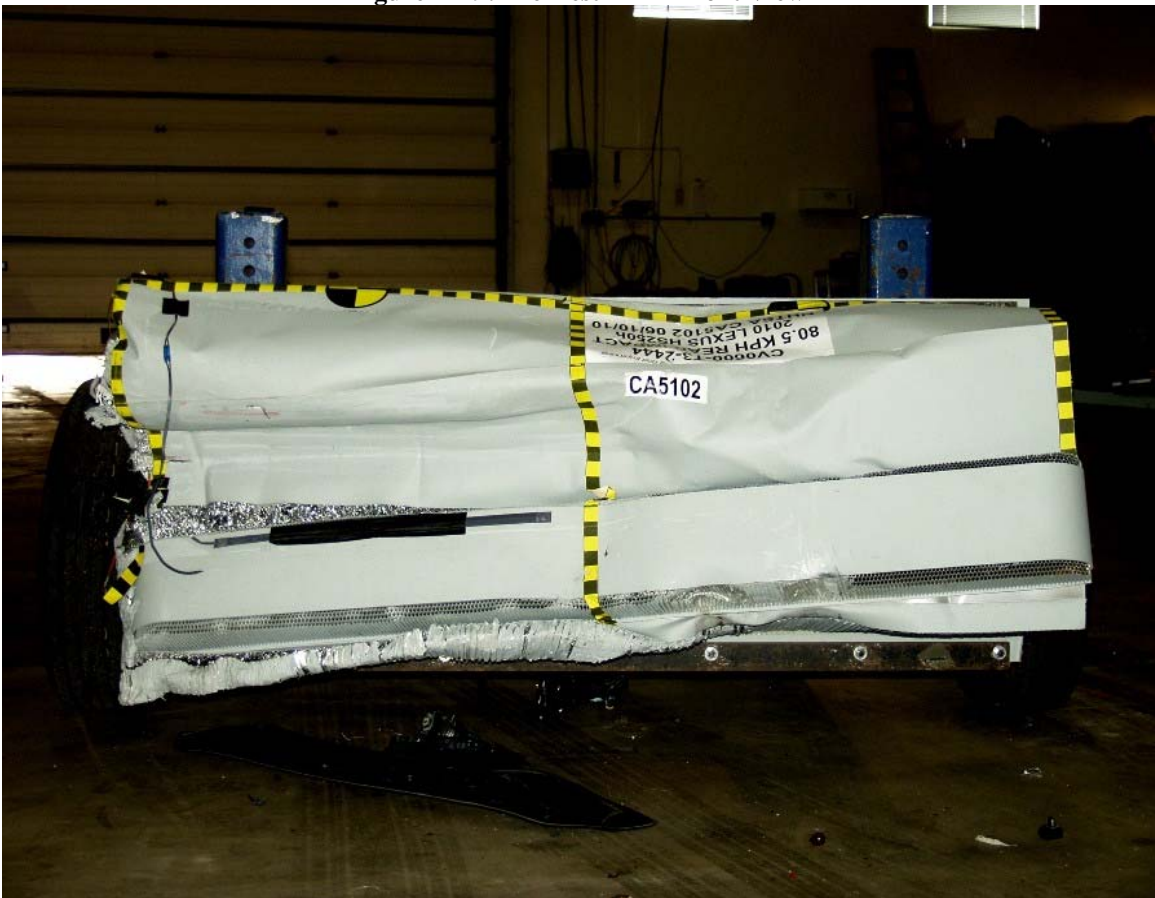
**Figure A-20: Post-Test MDB Front View**

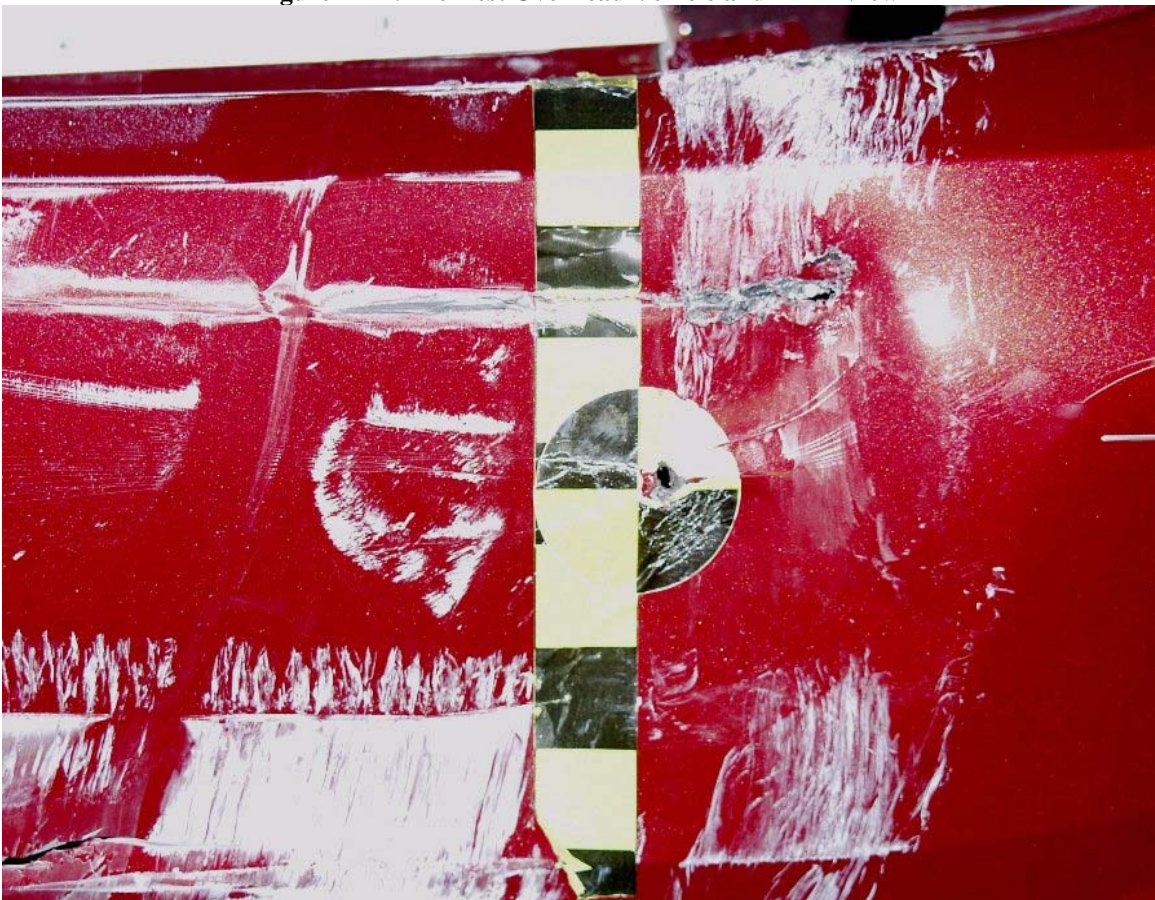
3    Vertical distance from target center (+ is above) Tolerance: ±40 mm

5    Horizontal distance from target center (+ is right) Tolerance: ±50 mm

Figure A-28: Post-Test Impact Target View

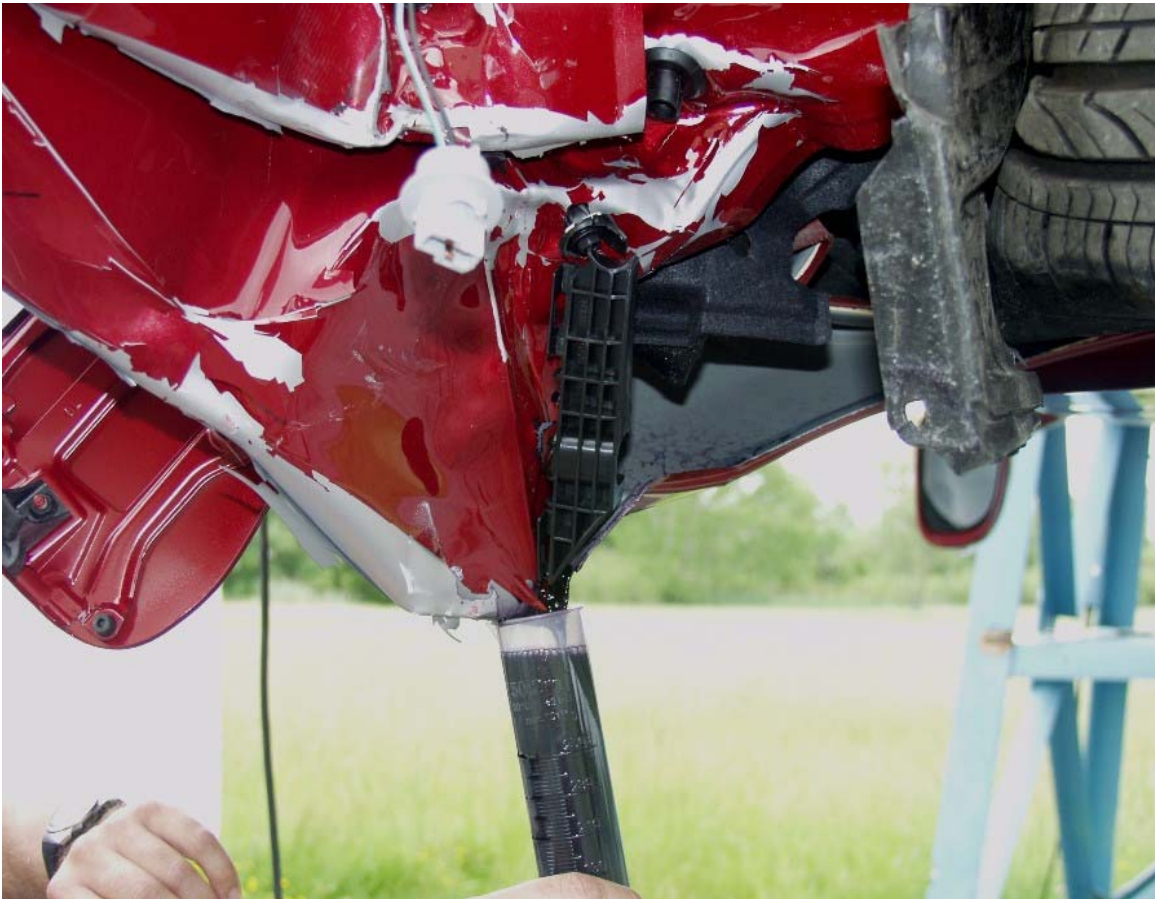
Rollover Stage	First 5 minutes from onset of rotation (g)	6th min. (g)	7th min. (g)	8th min. (if required) (g)
0° - 90°	1463	340	335	N/A
90° - 180°	Not collected – stage 1 exceeded			N/A
180°-270°	Not collected – stage 1 exceeded			N/A
270°-360°	Not collected – stage 1 exceeded			N/A

**Figure A-42: leak collection at 90°**
