**REPORT NUMBER: 301R/305-CAL-12-004**

**SAFETY COMPLIANCE TESTING FOR FMVSS 301 & 305  
Fuel System Integrity – Rear Impact  
Electric Powered Vehicles: Electrolyte Spillage and Electrical Shock Protection**

**General Motors LLC  
2012 Chevrolet Volt  
Four Door Sedan**

**NHTSA No: CC0108**

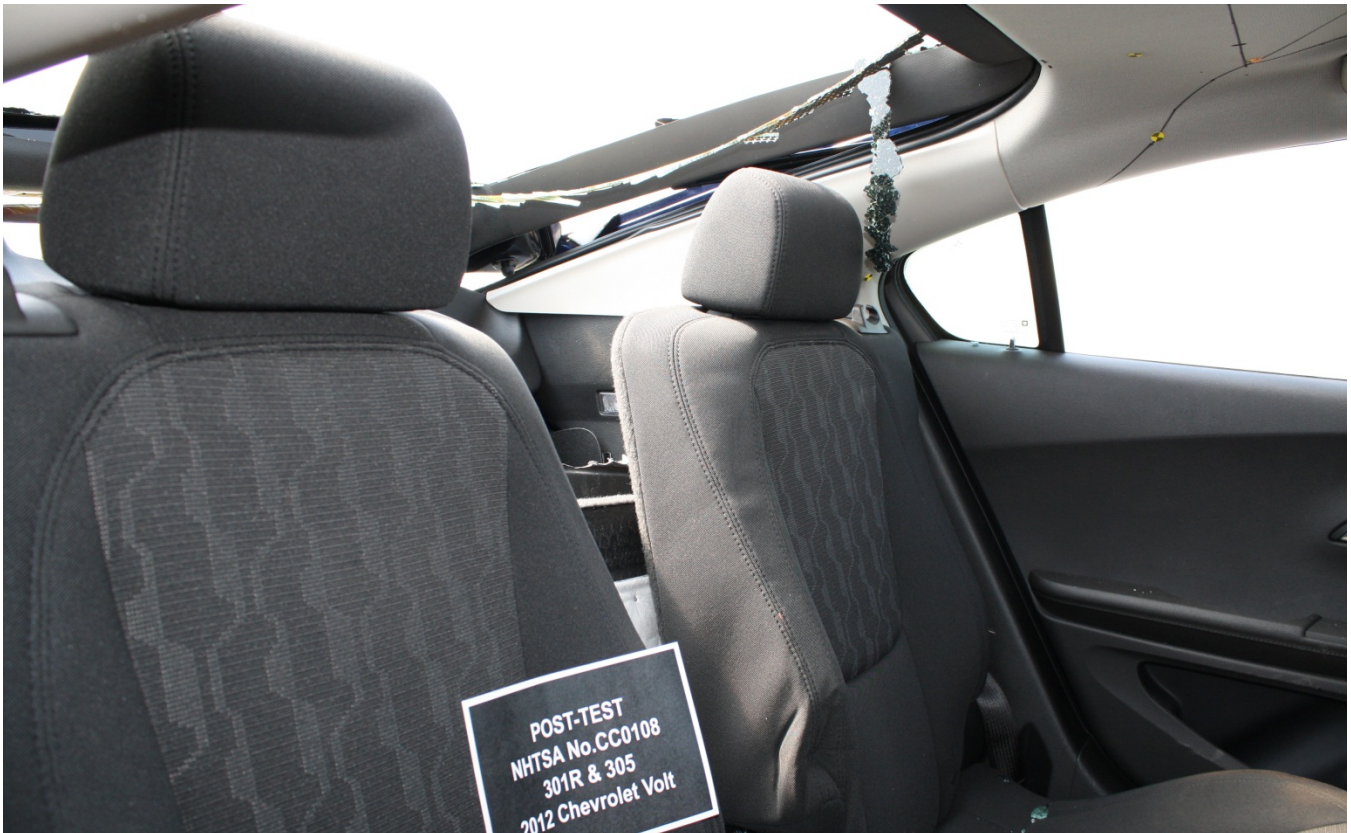
**Figure A-77: Post-Impact View of the Vehicle Passenger Compartment Adjacent to Propulsion Battery**

Measured Parameter	Comments	Passed	Failed
Propulsion Battery Module movement within the passenger compartment	No Movement	X	
Intrusion of an outside Propulsion Battery Component into the passenger compartment	No Intrusion	X	
Is propulsion battery electrolyte spillage visible in the passenger compartment?		X
