REPORT NUMBER: 301R/305-CAL-13-014

**SAFETY COMPLIANCE TESTING FOR FMVSS 301 & 305
Fuel System Integrity – Rear Impact
Electric Powered Vehicles: Electrolyte Spillage and Electrical Shock Protection**

**Honda MFG of Indiana, LLC
2013 Acura ILX Tech Hybrid
Four Door Sedan**

NHTSA No: CD5301

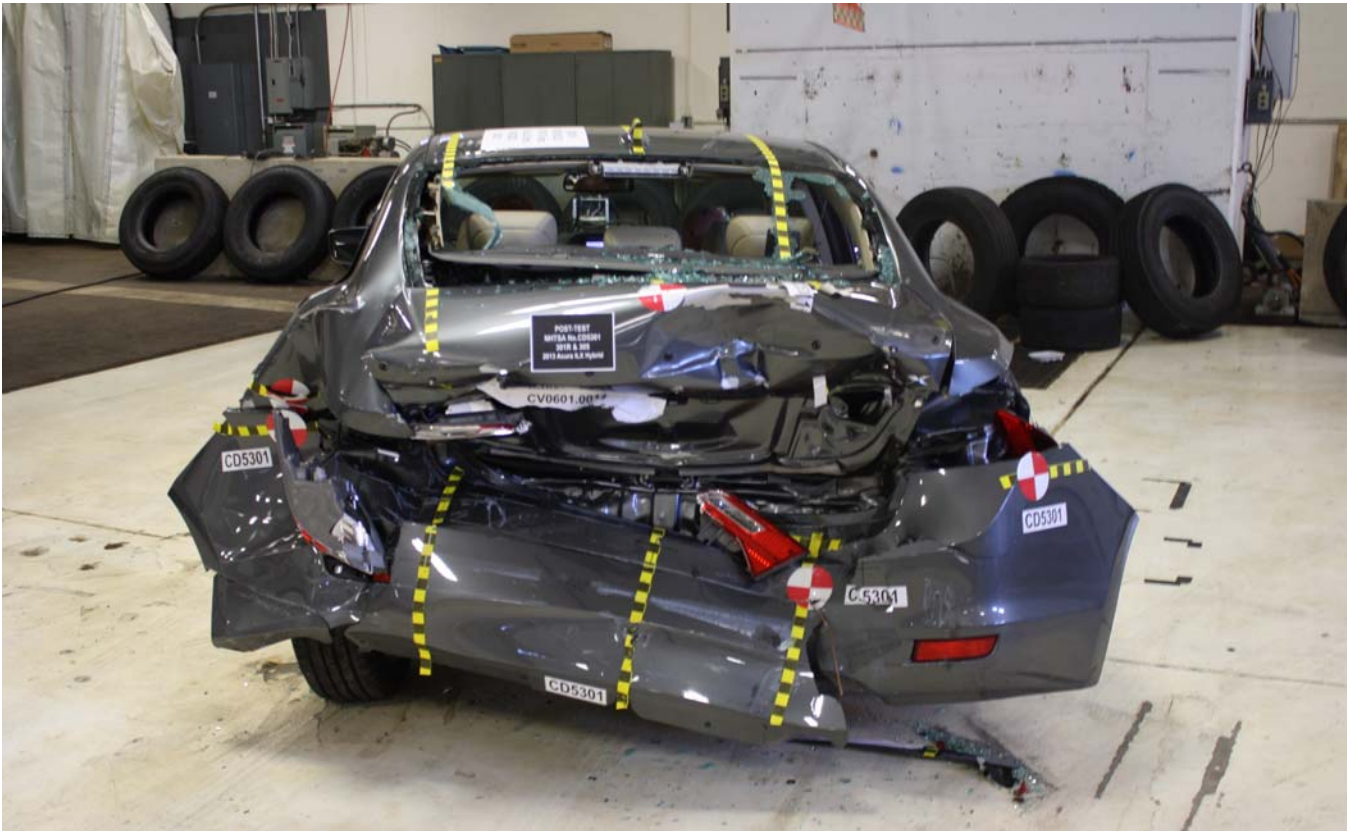
Figure A-20: Post-Test Rear View

Critical Areas of Performance	Observations and Conclusions
Windshield Damage	None
Window Damage	None
Other Notable Effects	Rear windshield shattered

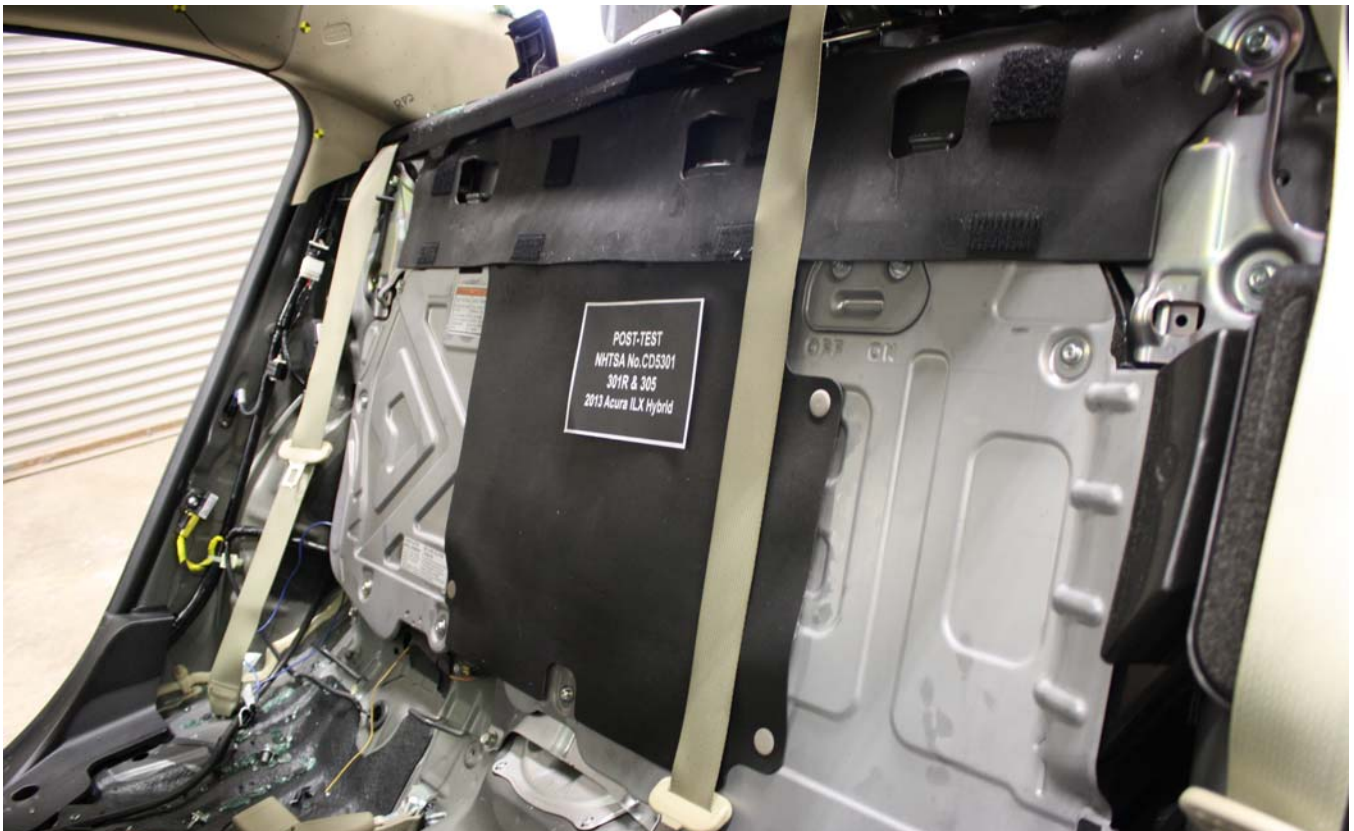
Figure A-50: Post-Impact Front View of Propulsion Battery

Measured Parameter	Comments	Passed	Failed
Propulsion Battery Module movement within the passenger compartment	No Movement	X	
Intrusion of an outside Propulsion Battery Component into the passenger compartment	No Intrusion	X	
Is propulsion battery electrolyte spillage visible in the passenger compartment?		X

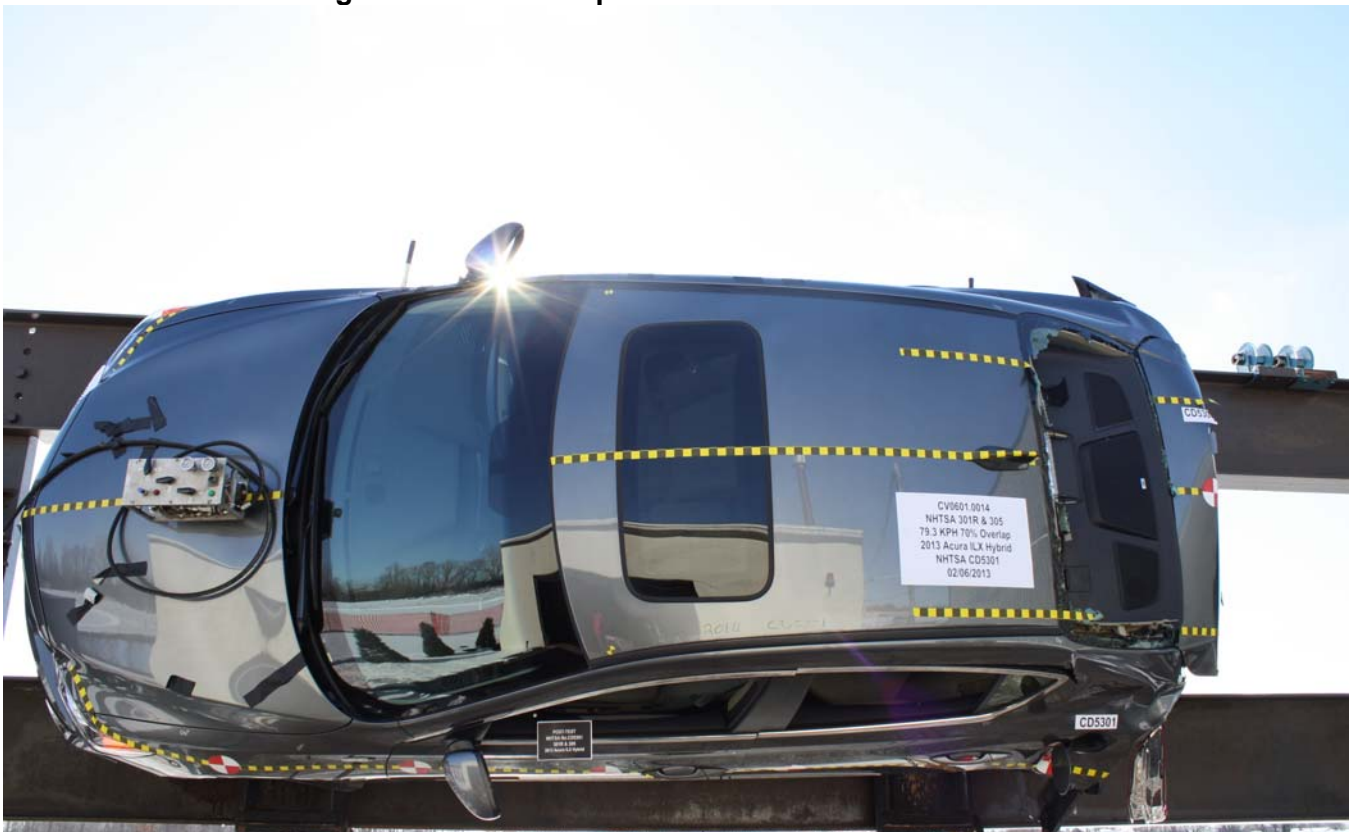
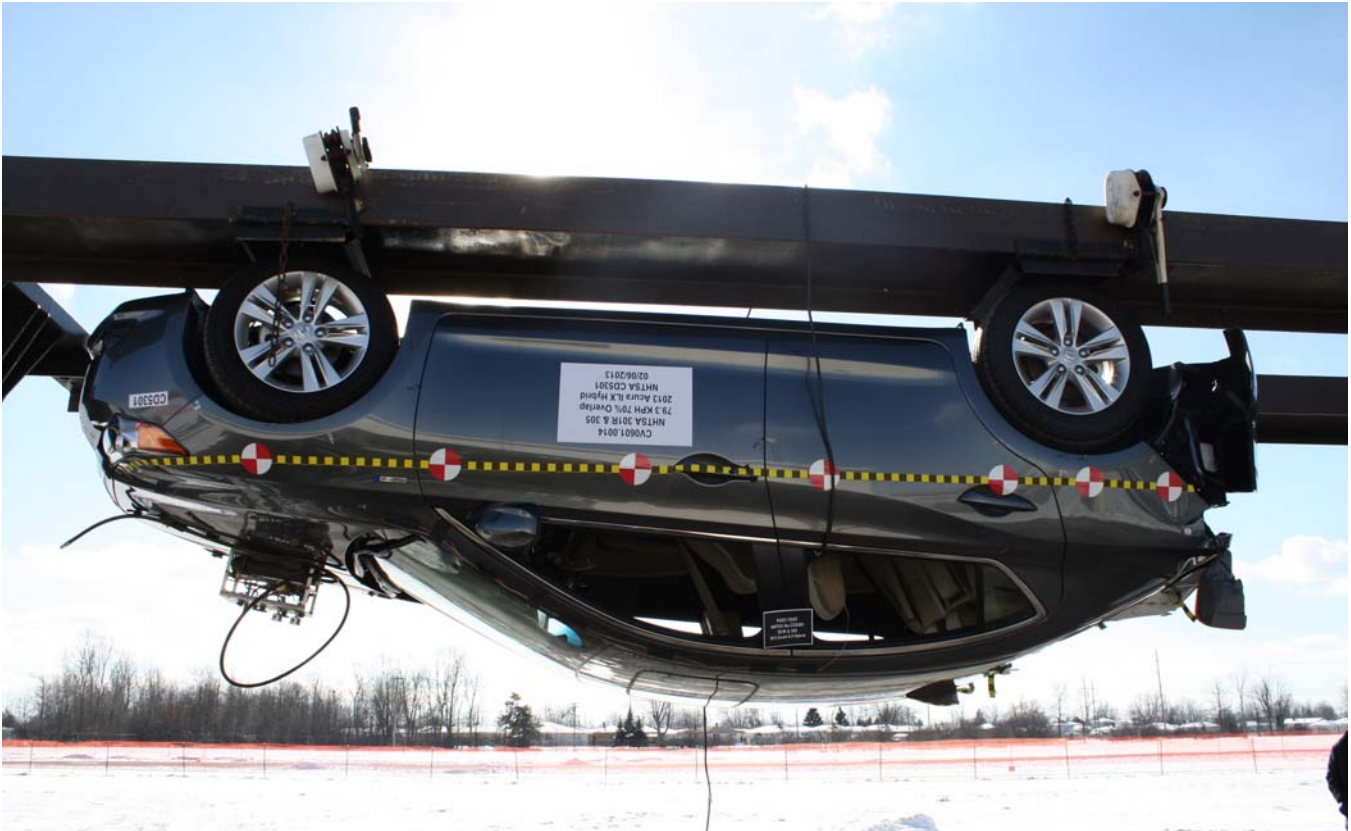
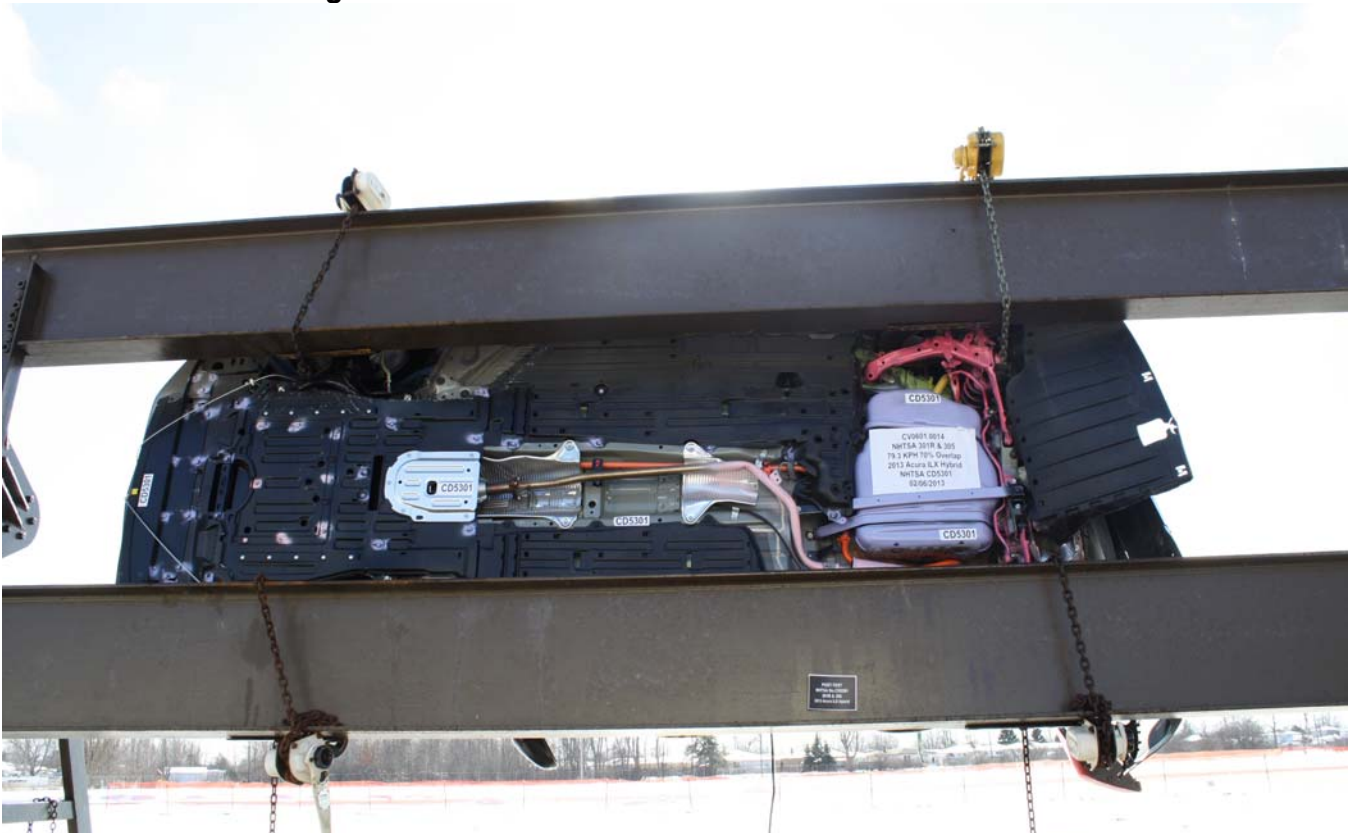
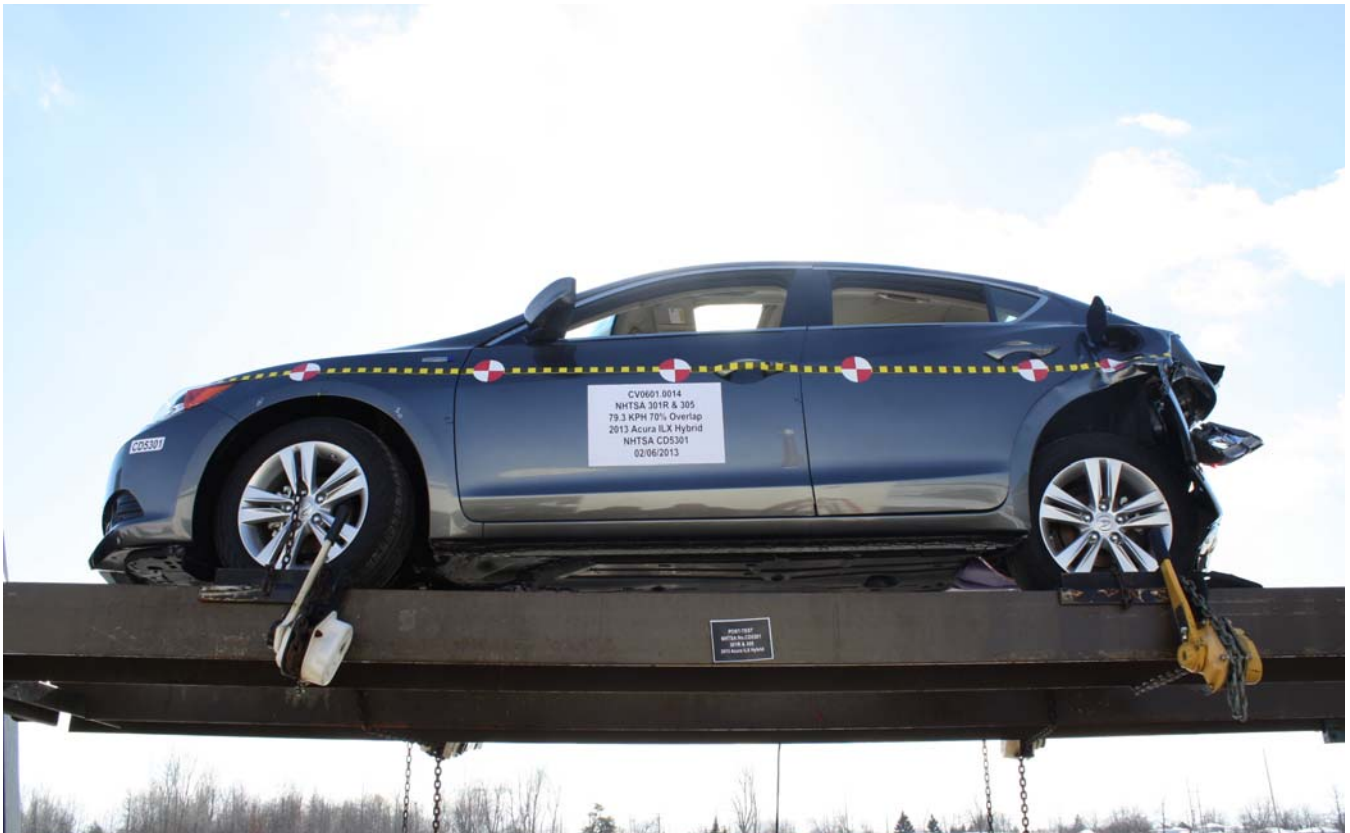
There was no fuel system fluid spillage following the impact and including all portions of the static rollover test. The maximum vehicle longitudinal crush was 450 millimeters of which the average was 325 millimeters. The vehicle appeared to comply with all the requirements of FMVSS No. 301 "Fuel System Integrity."

Figure A-68: FMVSS No. 301 Static Rollover 90° View

Figure A-69: FMVSS No. 301 Static Rollover 180° View

Figure A-70: FMVSS No. 301 Static Rollover 270° View

Figure A-71: FMVSS No. 301 Static Rollover 360° View

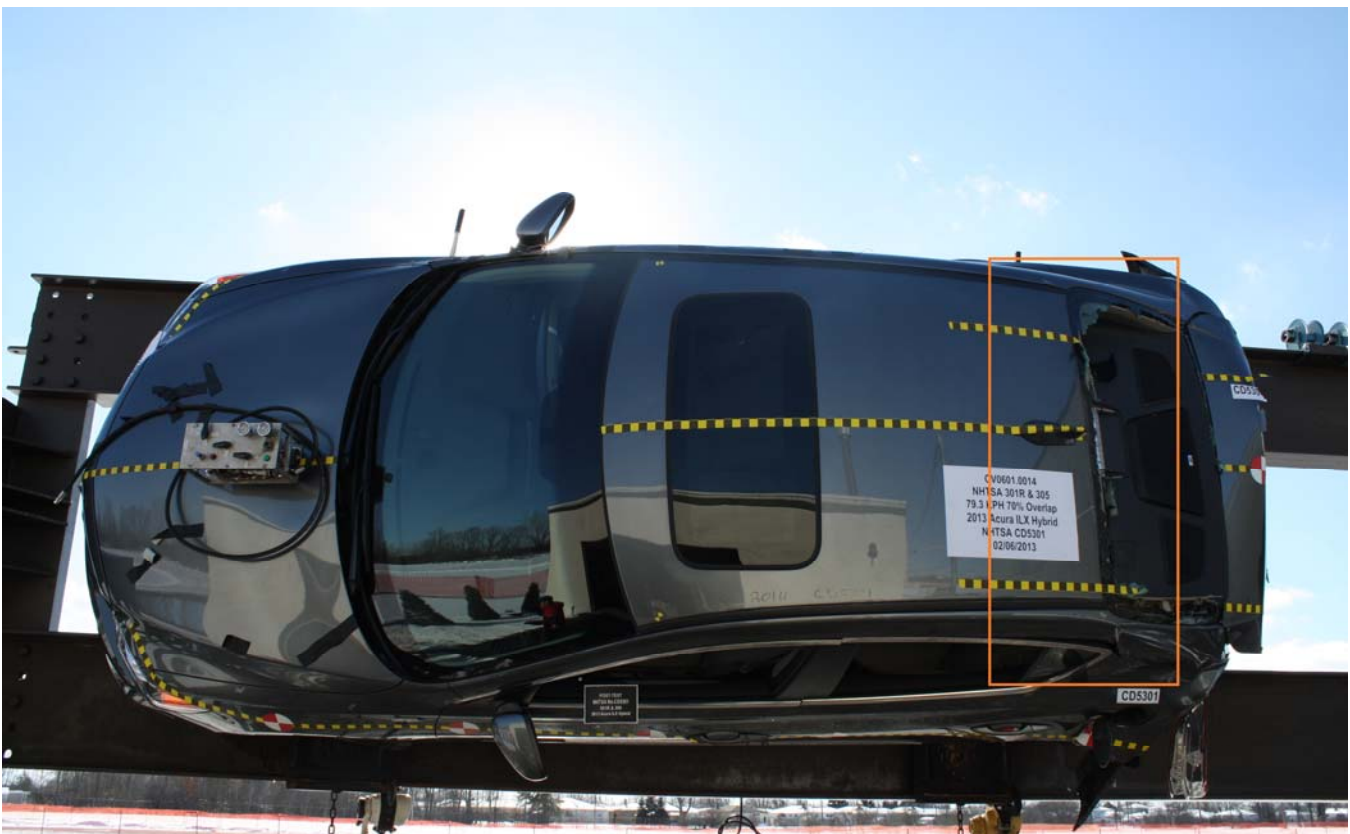
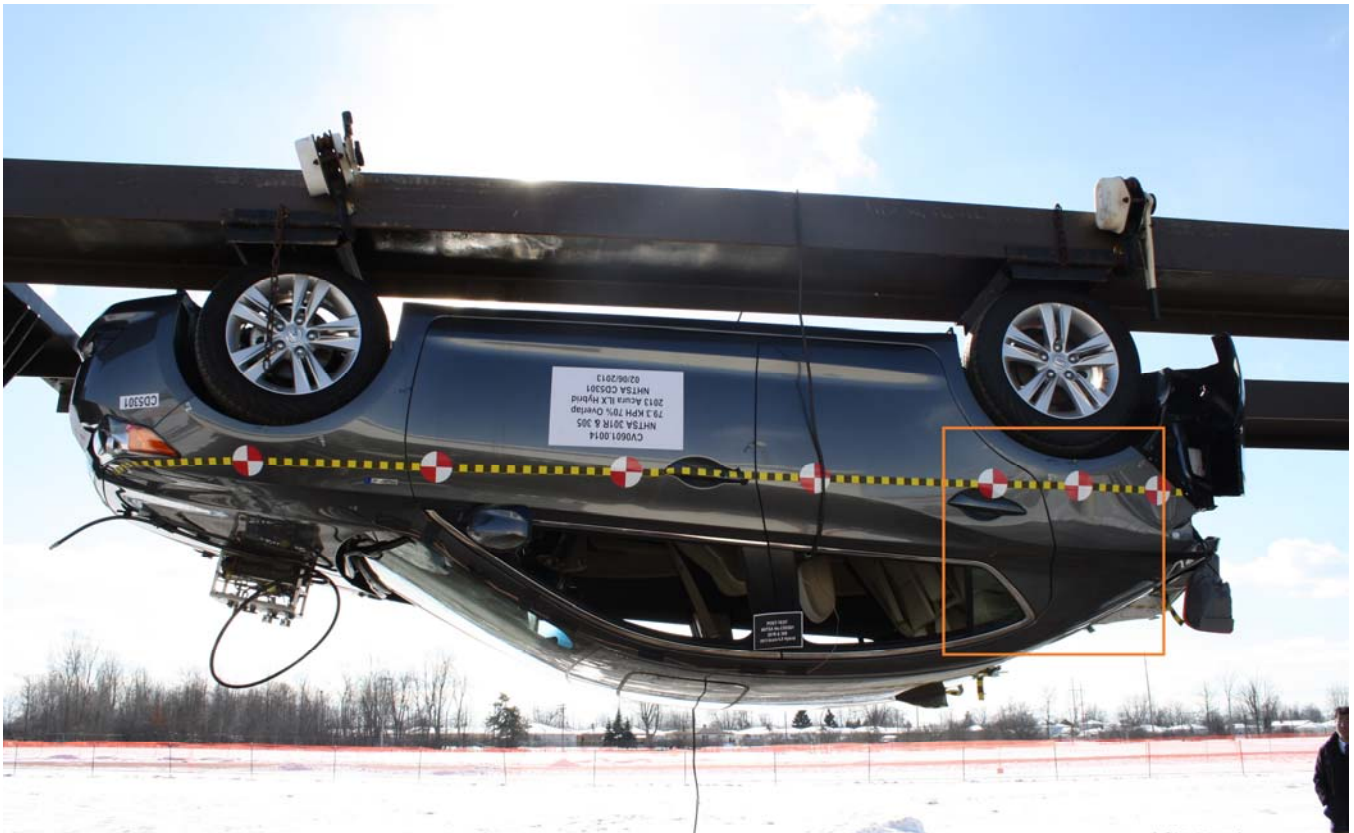
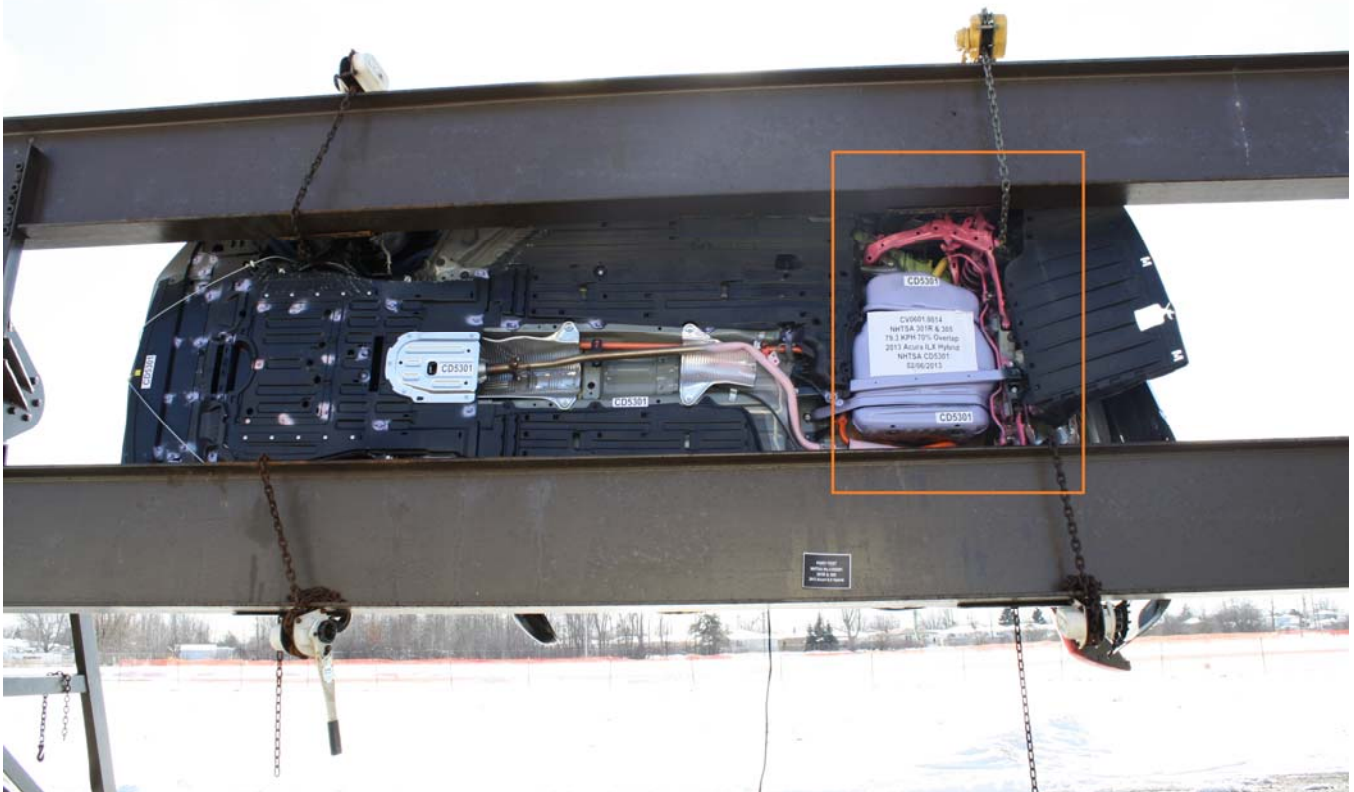
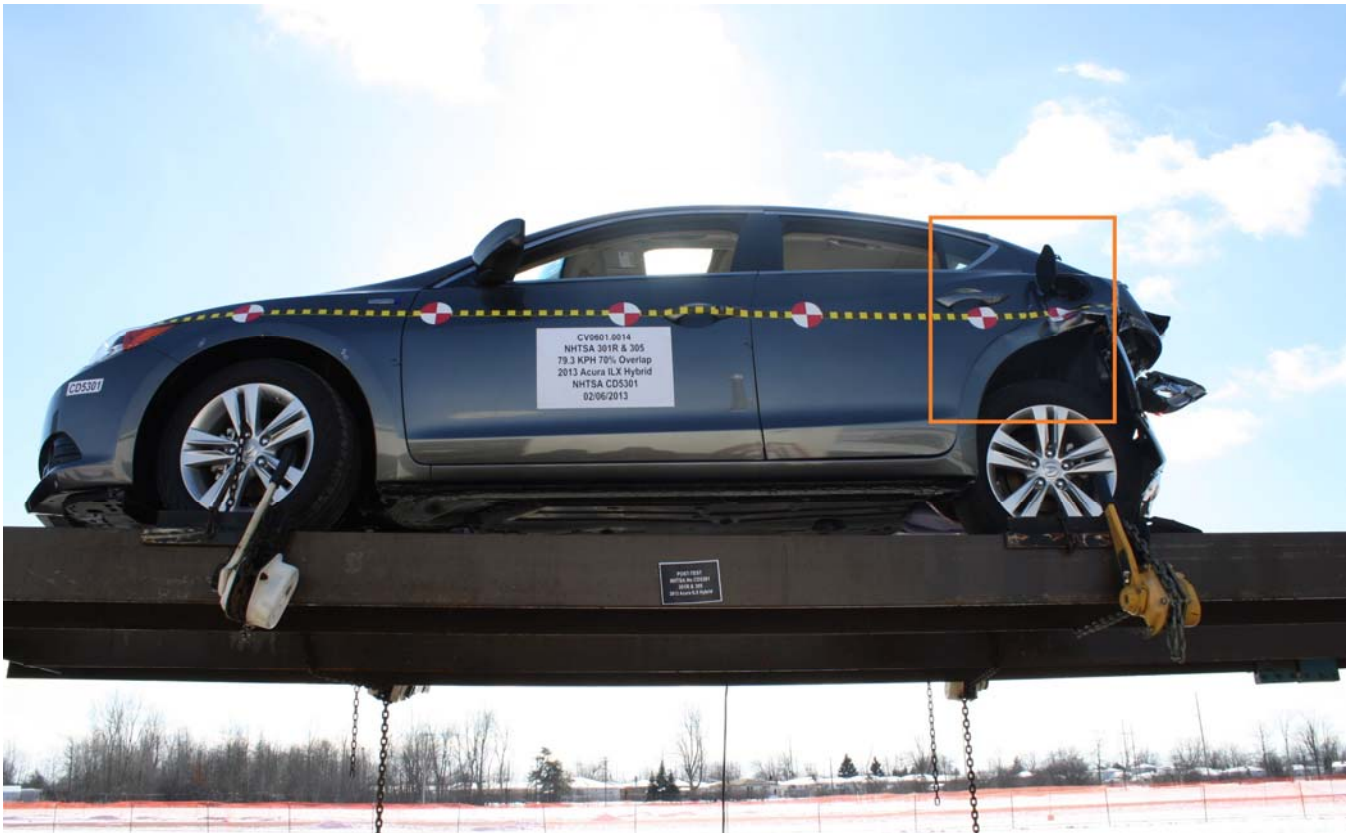
Figure A-72: FMVSS No. 305 Static Rollover at 90° Highlighting Propulsion Battery Location

Figure A-73: FMVSS No. 305 Static Rollover at 180° Highlighting Propulsion Battery Location

Figure A-74: FMVSS No. 305 Static Rollover at 270° Highlighting Propulsion Battery Location

Figure A-75: FMVSS No. 305 Static Rollover at 360° Highlighting Propulsion Battery Location
