REPORT NUMBER: 301R-CAL-13-003

**SAFETY COMPLIANCE TESTING FOR FMVSS 301R
FUEL SYSTEM INTEGRITY – REAR IMPACT**

**GM Korea Company
2013 Chevrolet Spark
Four Door Hatchback**

NHTSA NUMBER: C20130101

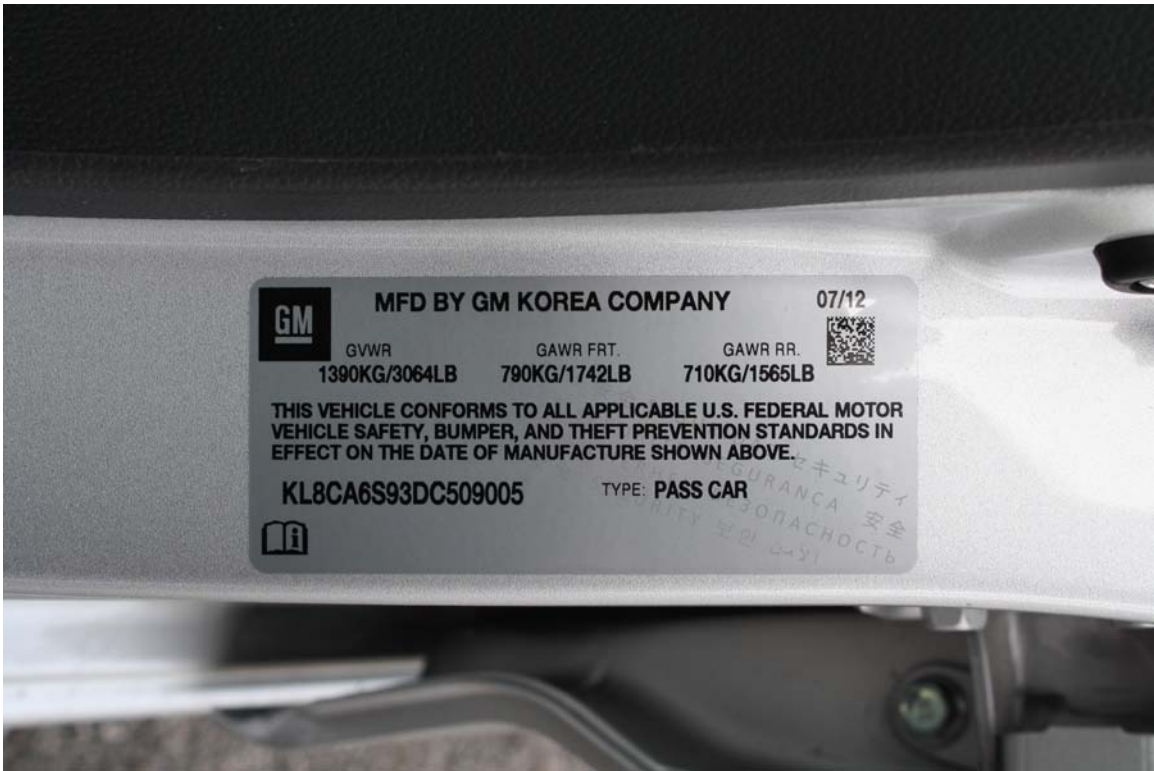
Figure A-1: Vehicle Certification Placard

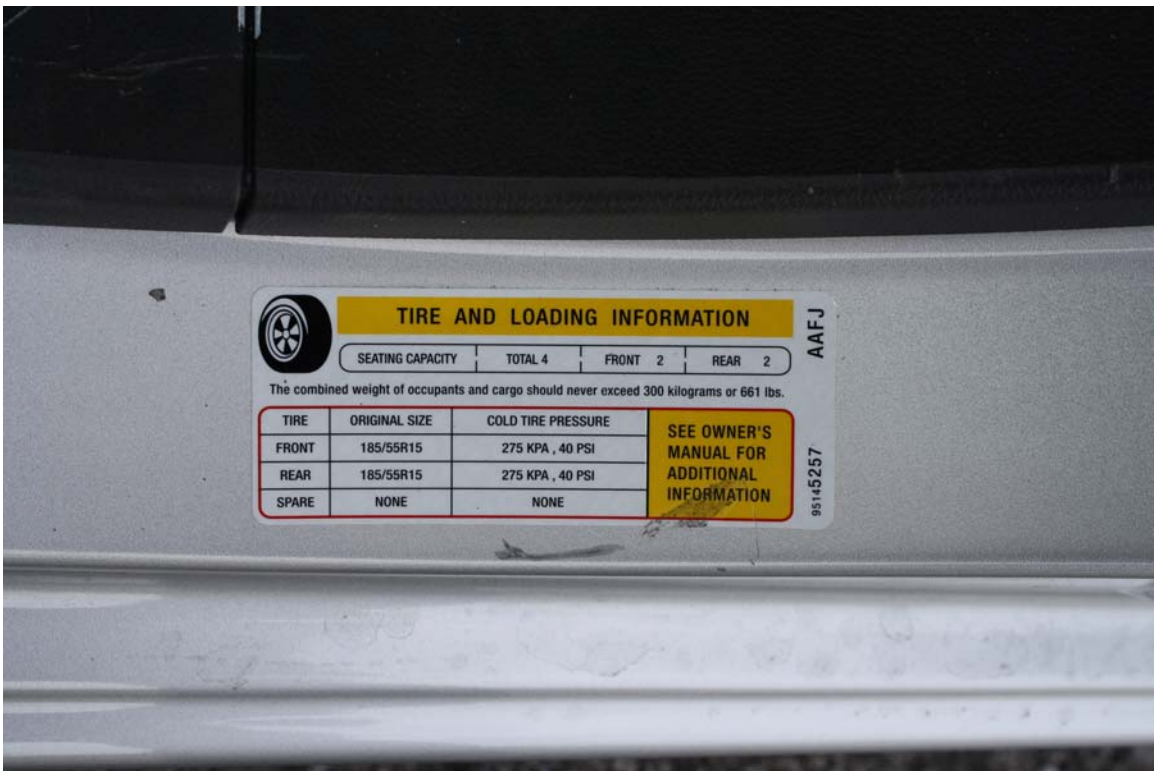
Figure A-2: Vehicle Tire Placard

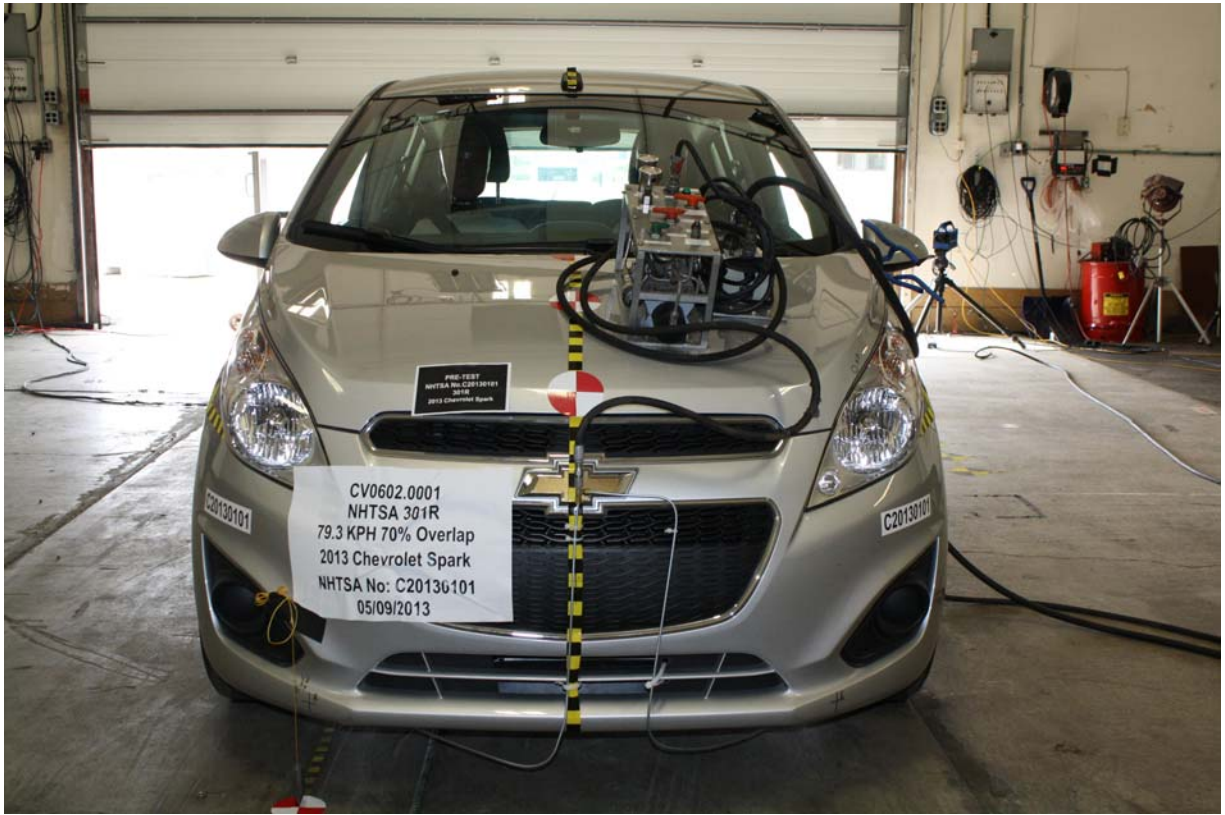
Figure A-3: Pre-Test Front View

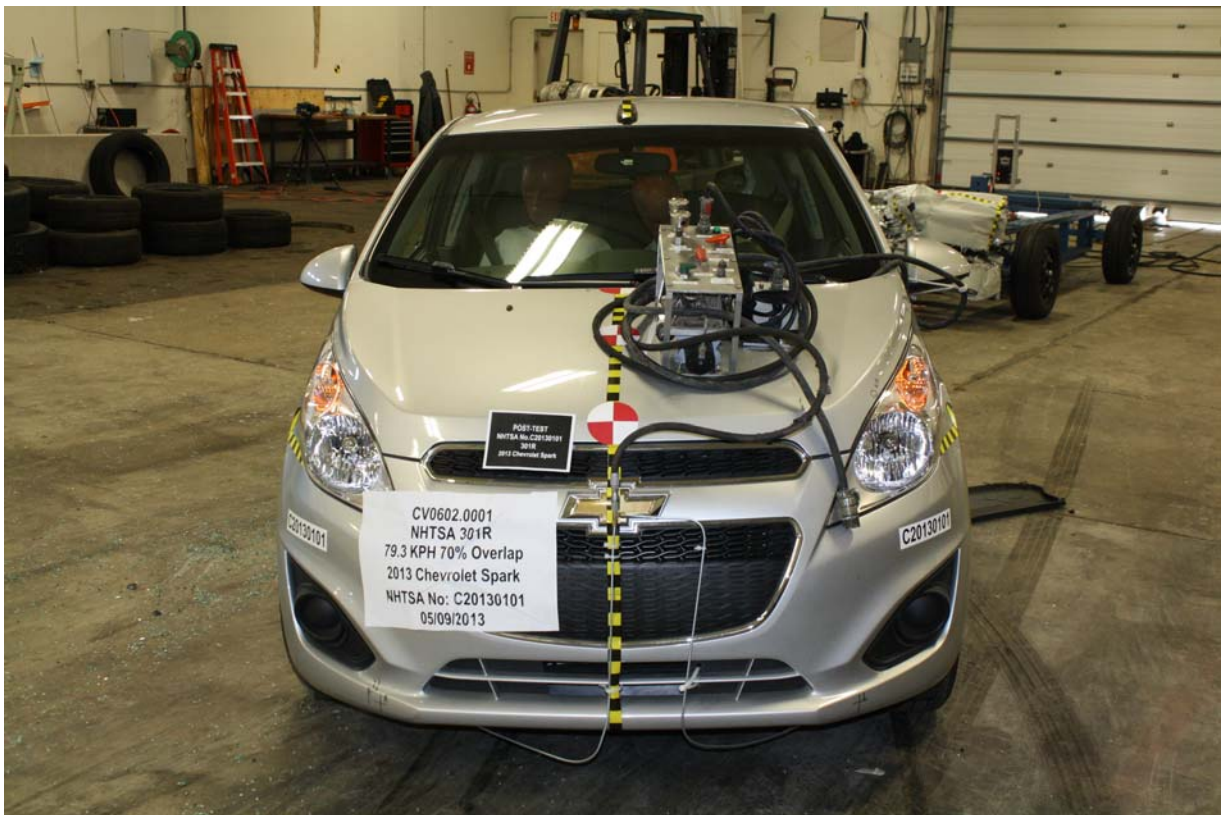
Figure A-4: Post-Test Front View

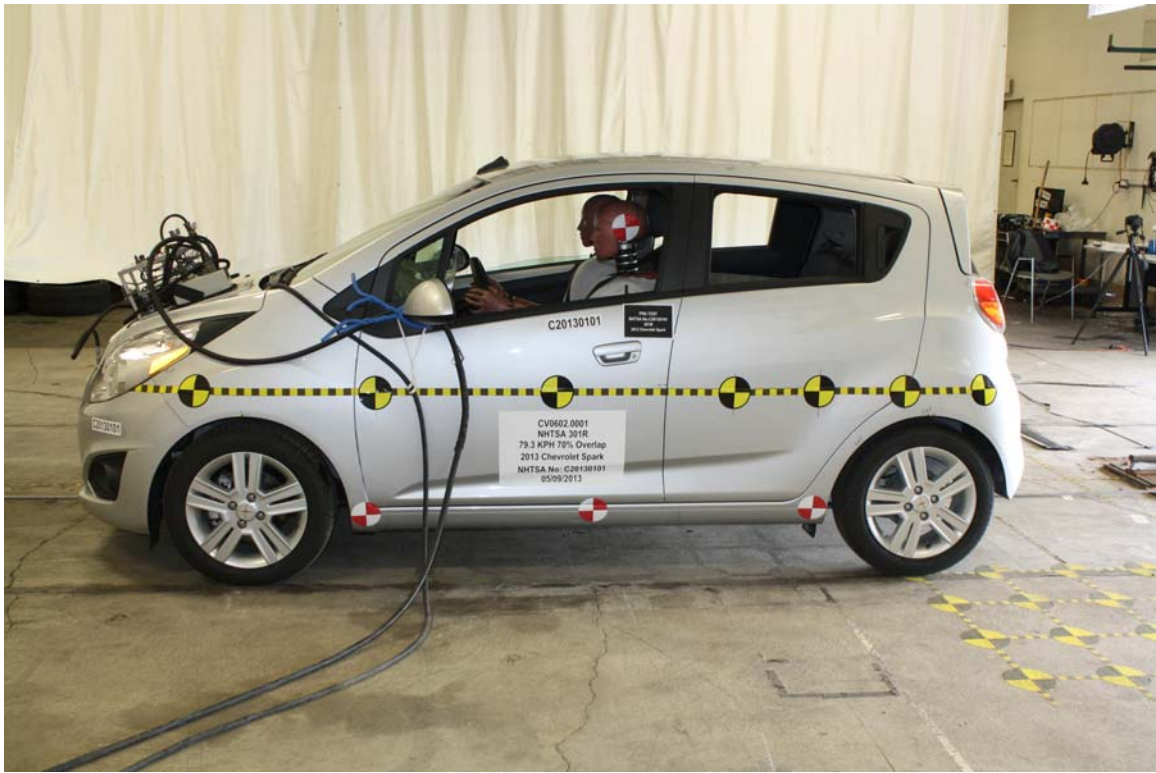
Figure A-5: Pre-Test Left Side View

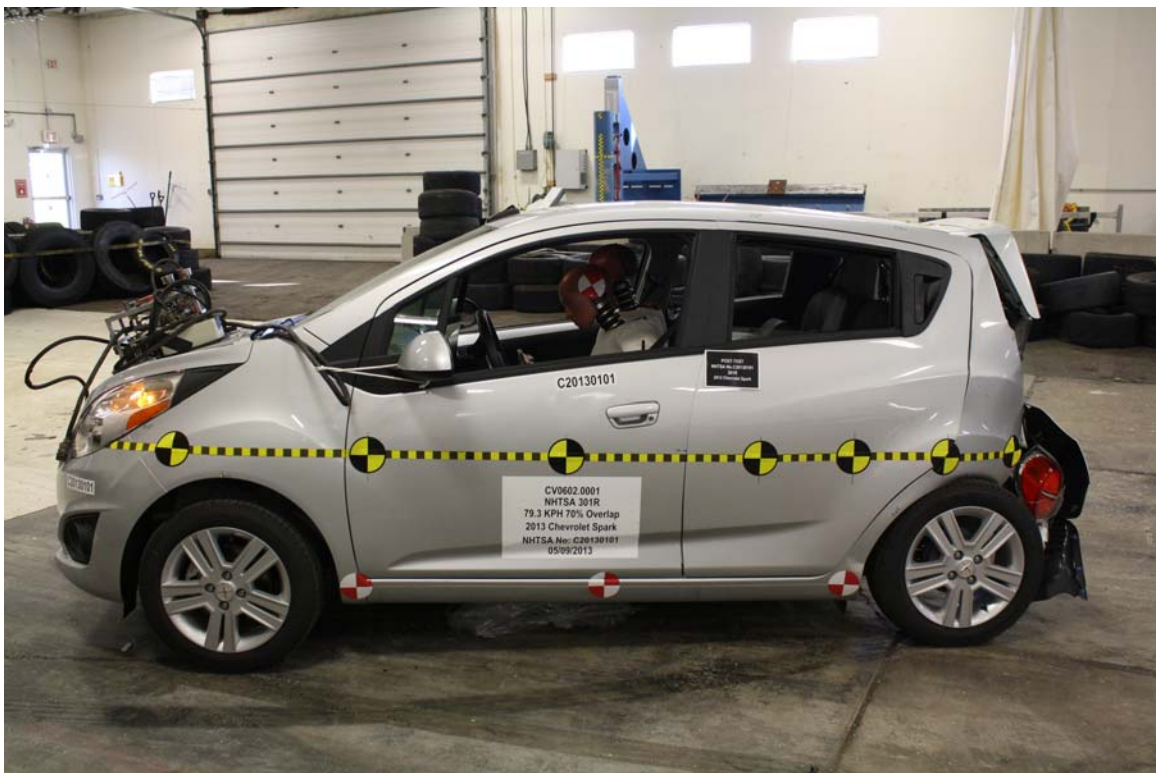
Figure A-6: Post-Test Left Side View

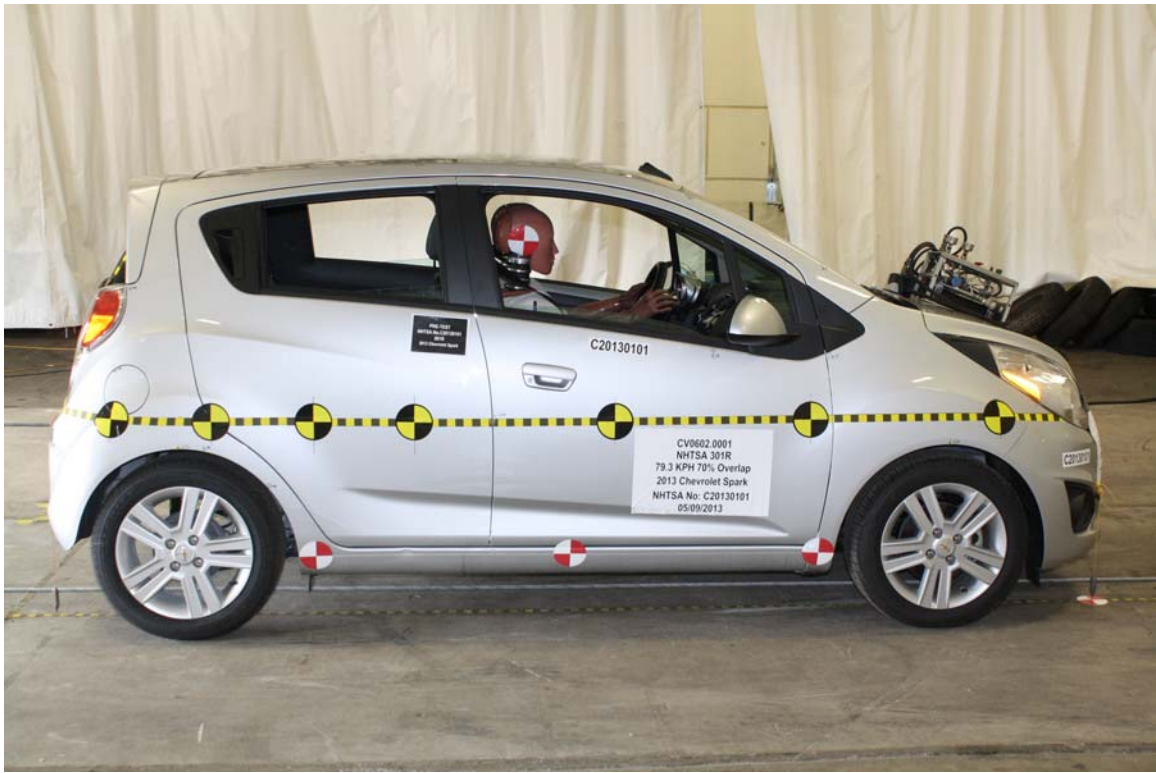
Figure A-7: Pre-Test Right Side View

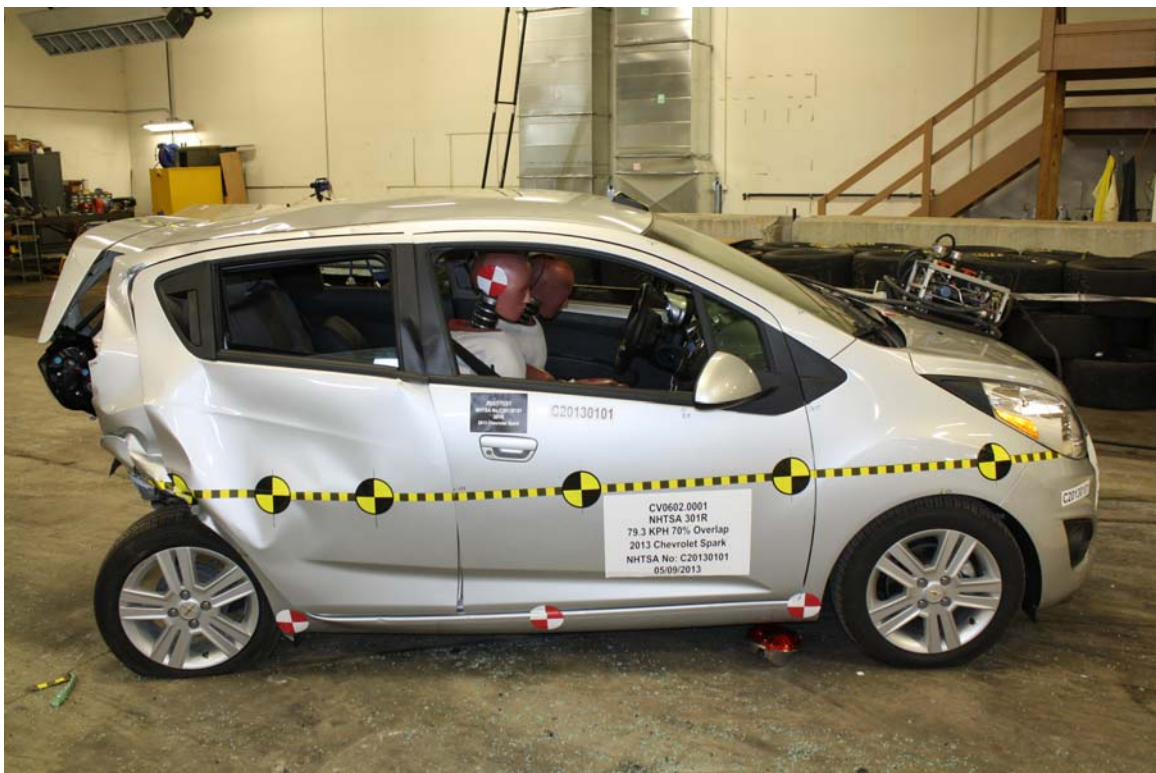
Figure A-8: Post-Test Right Side View

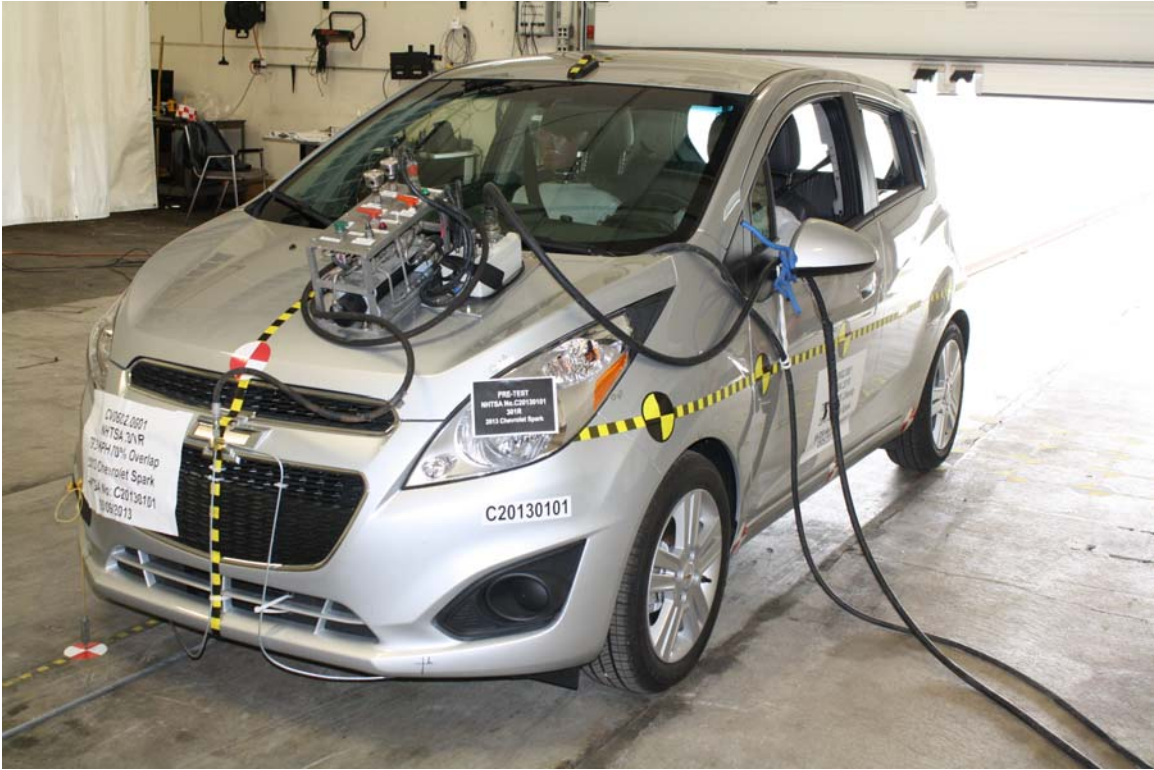
Figure A-9: Pre-Test Left Front 3/4 View

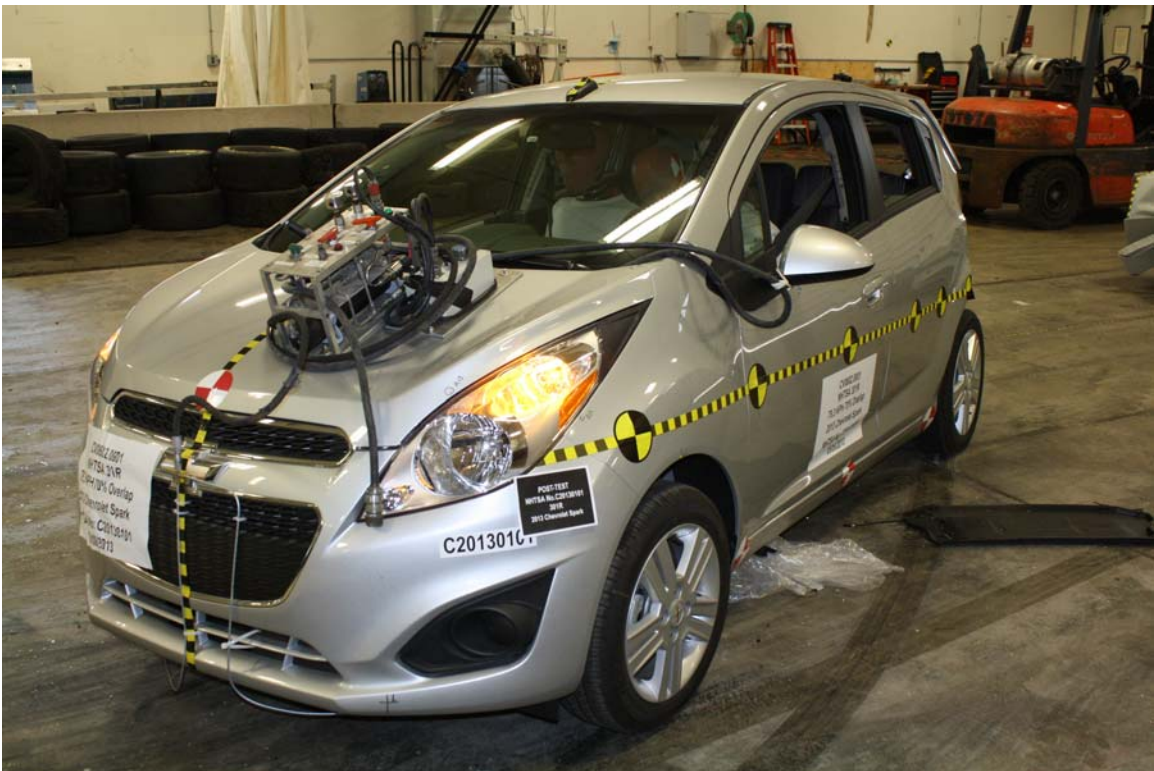
Figure A-10: Post-Test Left Front 3/4 View

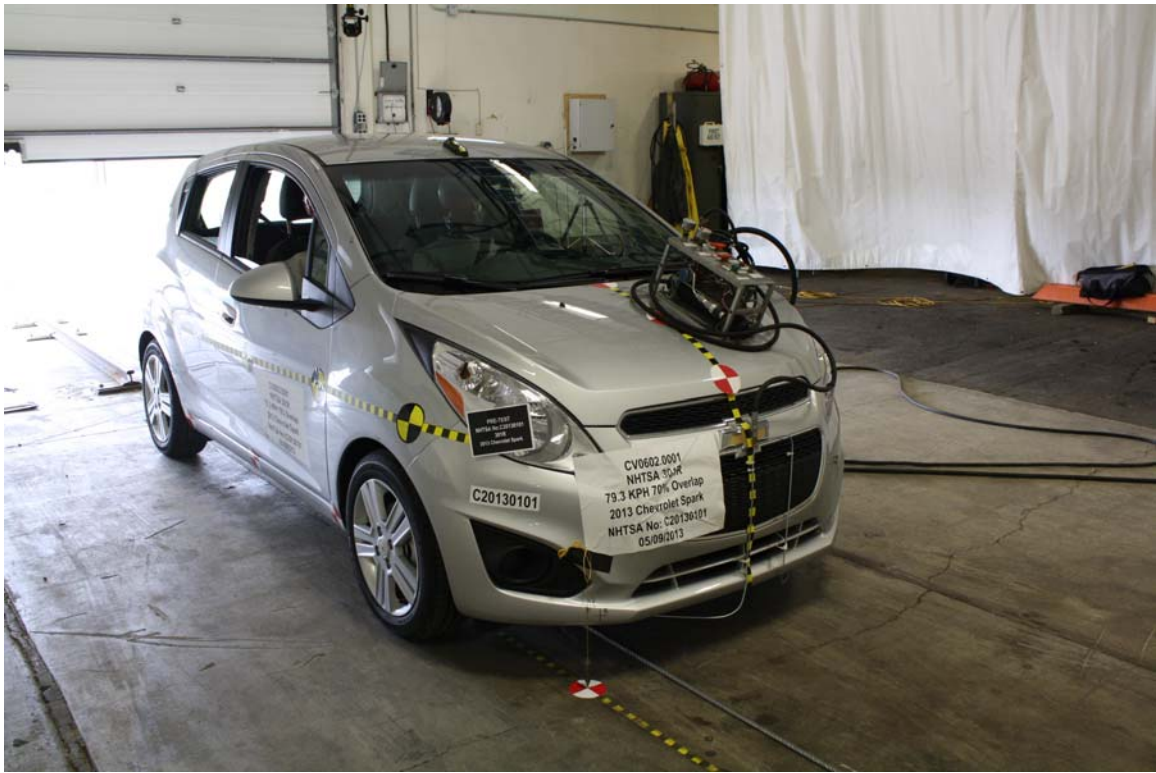
Figure A-11: Pre-Test Right Front 3/4 View

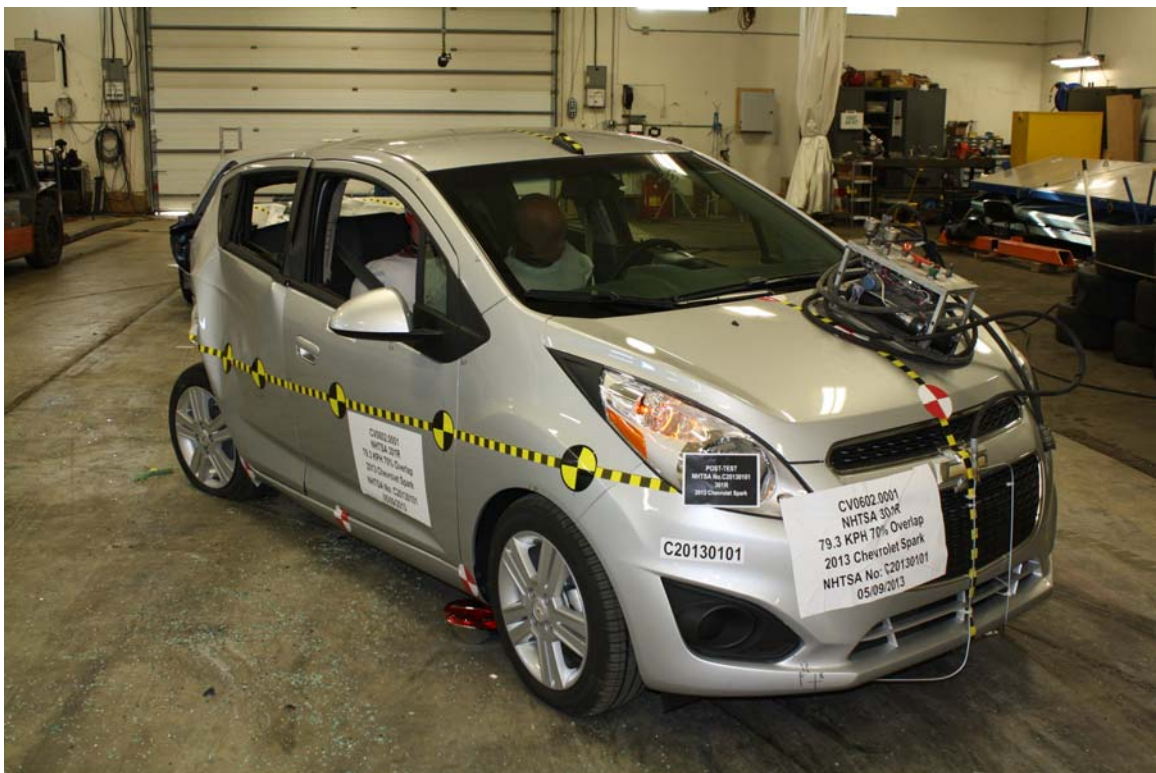
Figure A-12: Post-Test Right Front 3/4 View

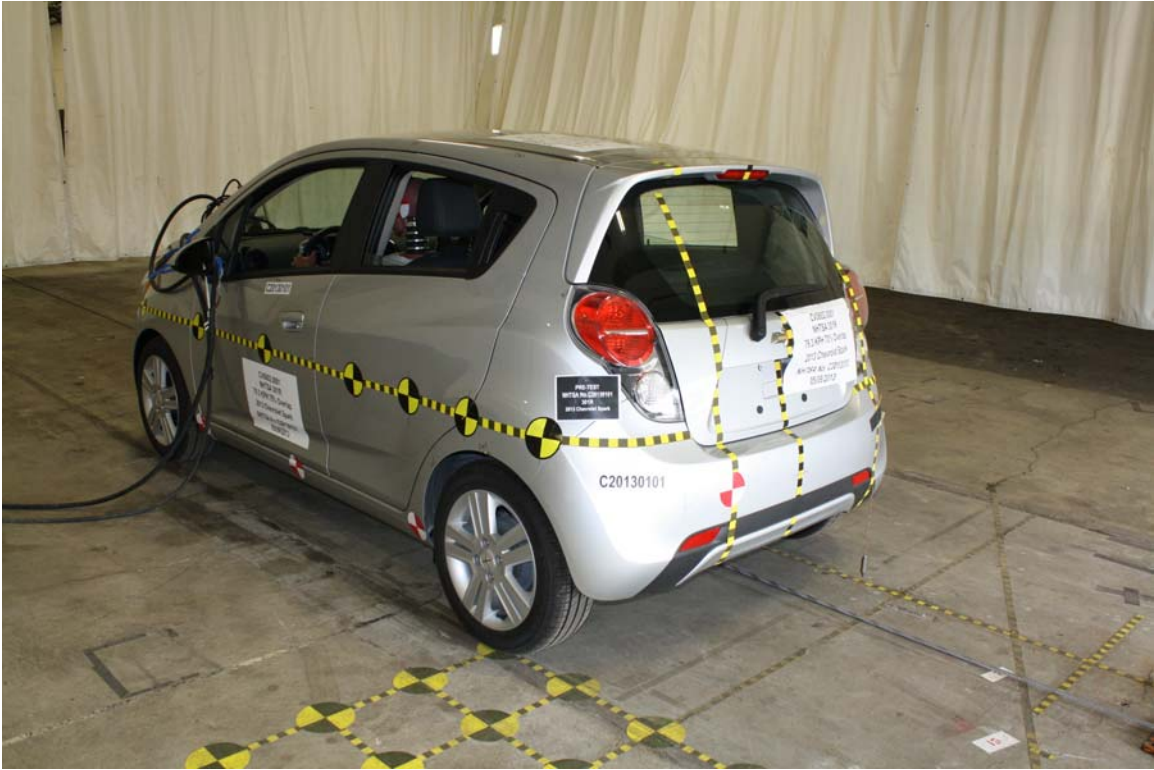
Figure A-13: Pre-Test Left Rear 3/4 View

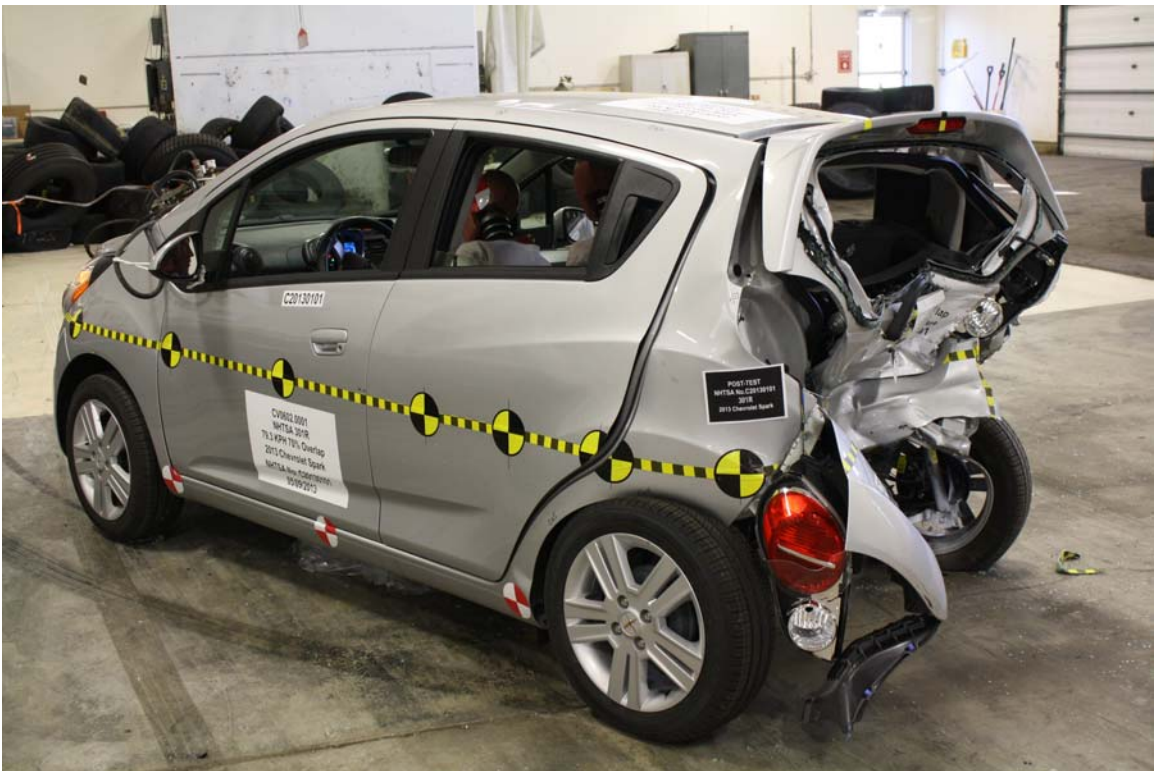
Figure A-14: Post-Test Left Rear 3/4 View

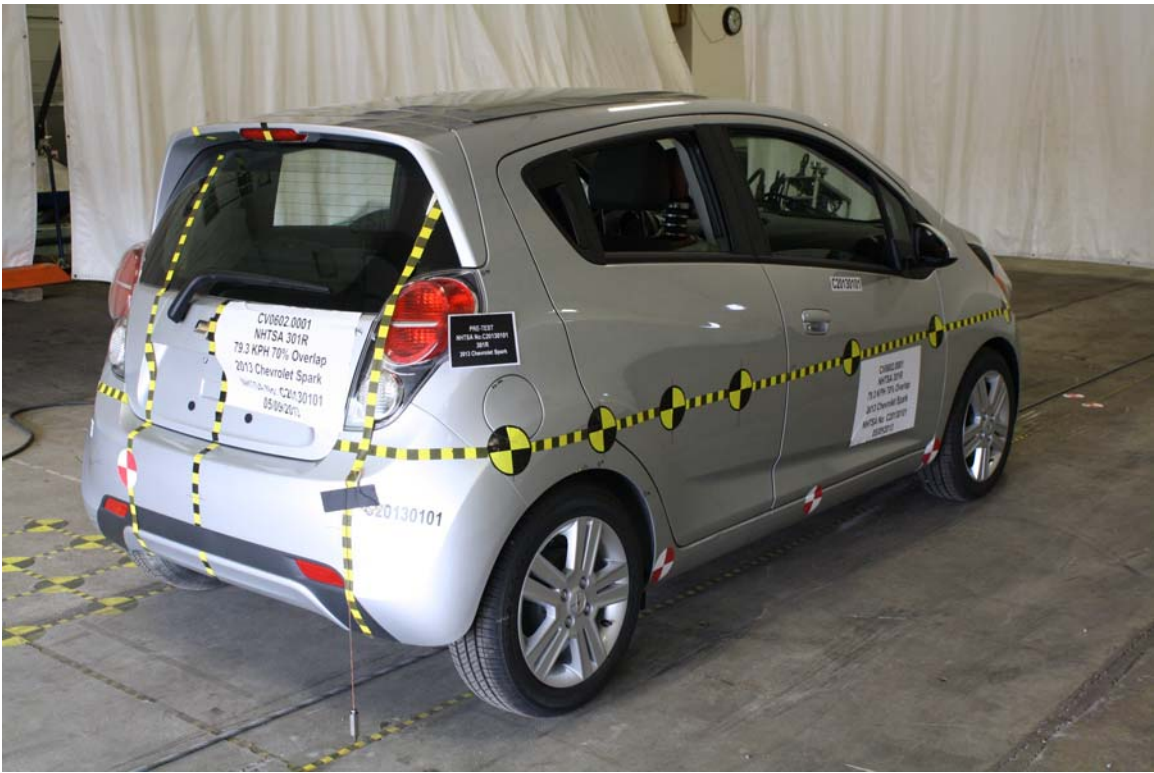
Figure A-15: Pre-Test Right Rear 3/4 View

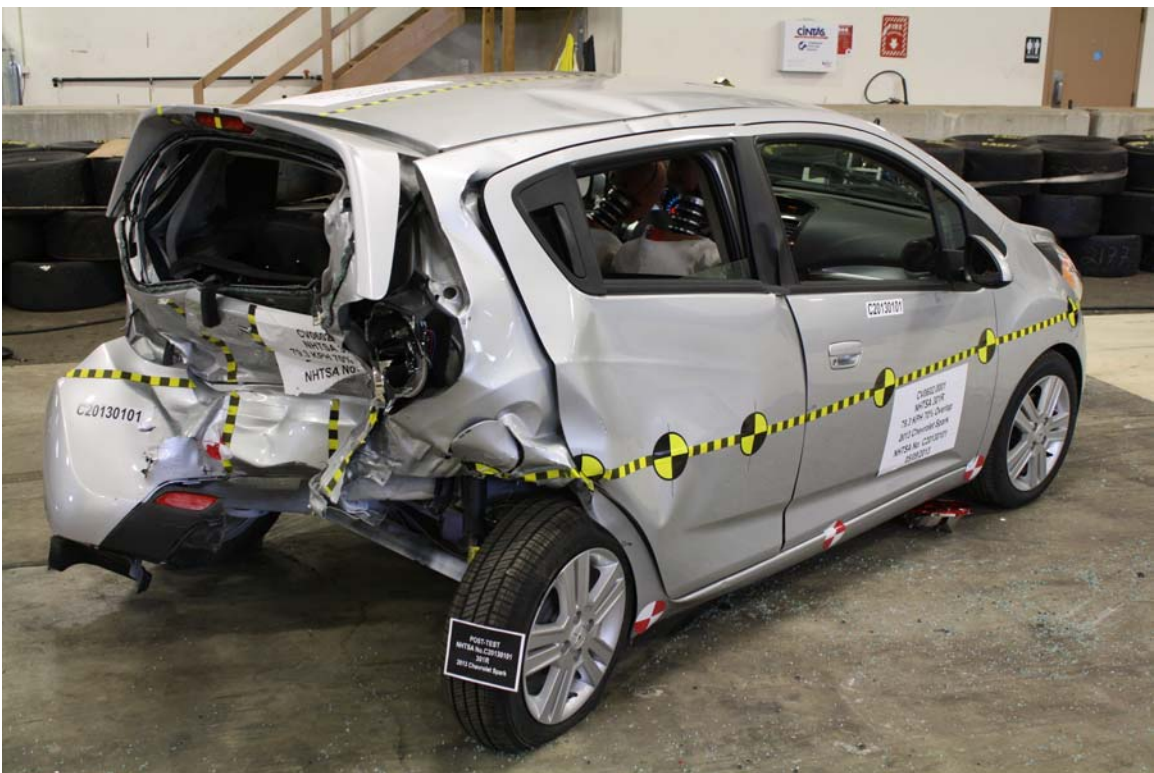
Figure A-16: Post-Test Right Rear 3/4 View

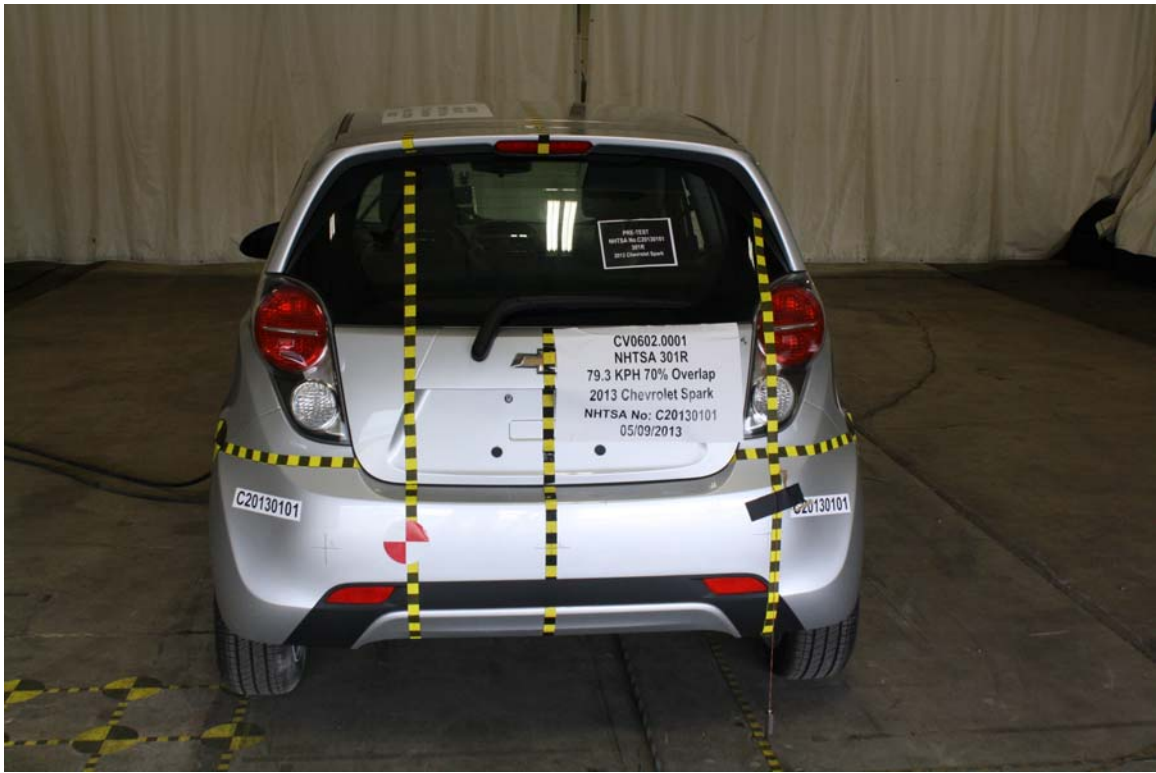
Figure A-17: Pre-Test Rear View

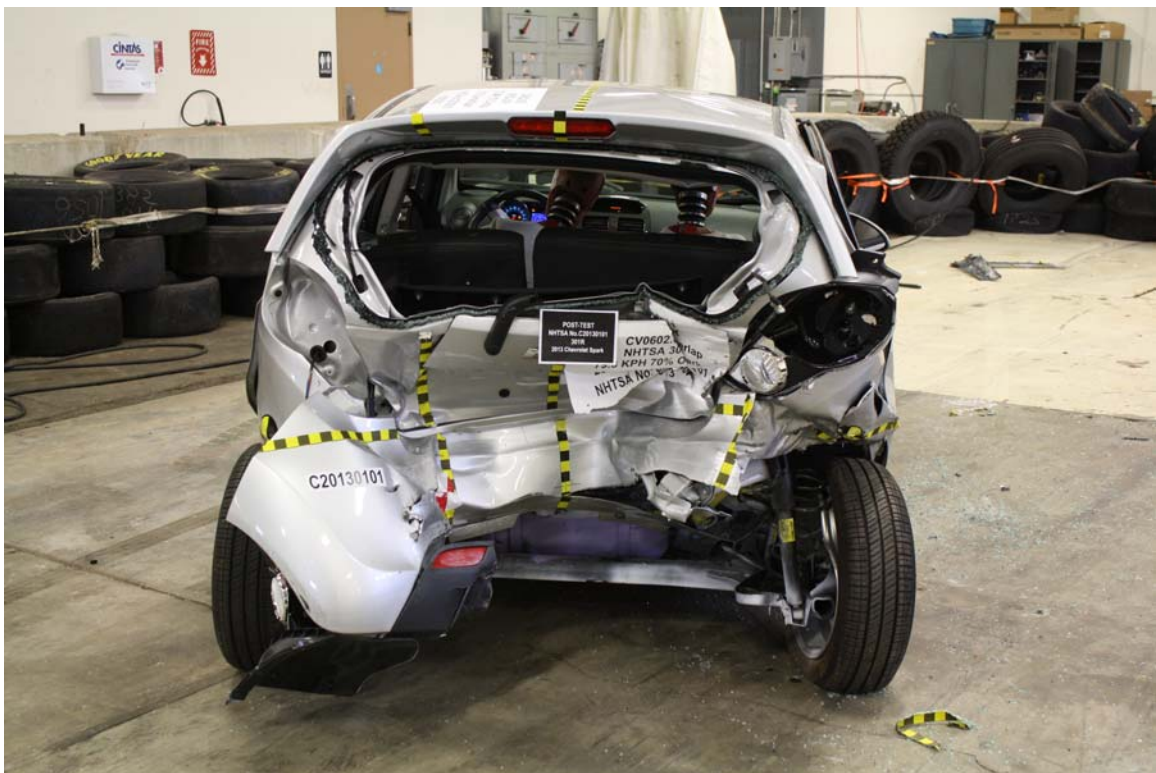
Figure A-18: Post-Test Rear View

| Critical Areas of Performance | Observations and Conclusions |
|---|---|
| Other Notable Effects | Rear Windshield shattered during impact event |

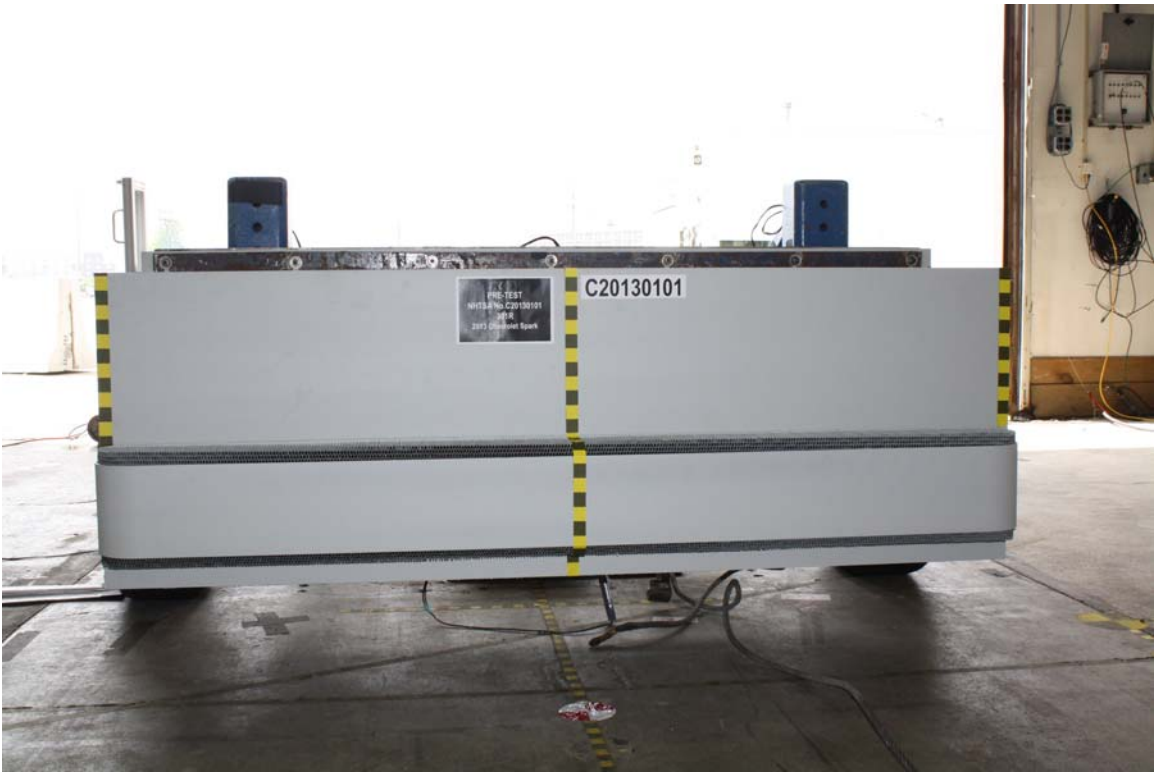
Figure A-19: Pre-Test MDB Front View

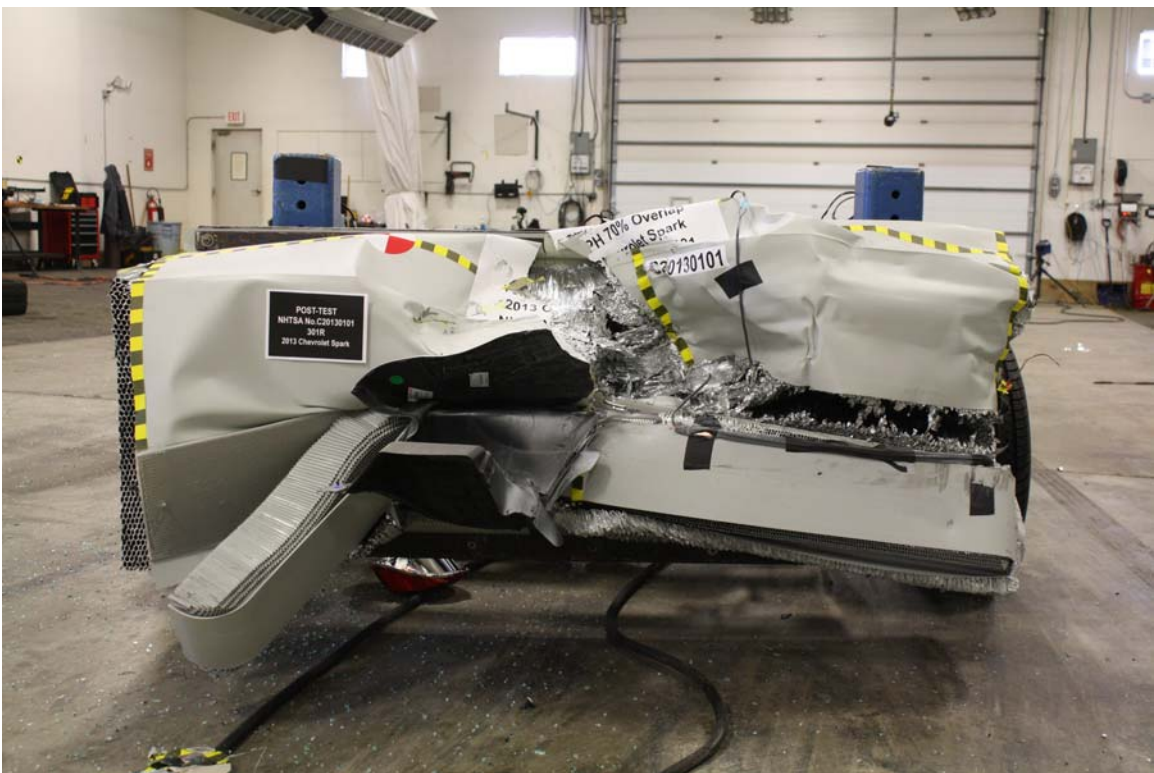
Figure A-20: Post-Test MDB Front View

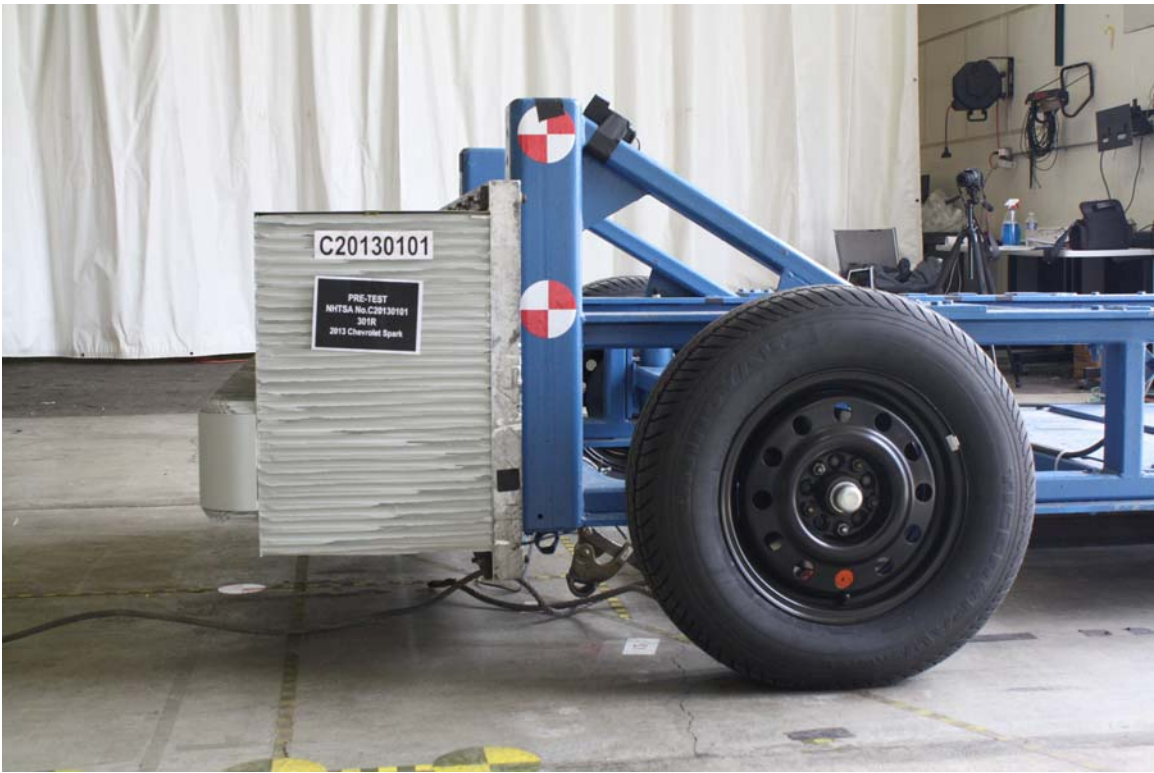
Figure A-21: Pre-Test MDB Left Side View

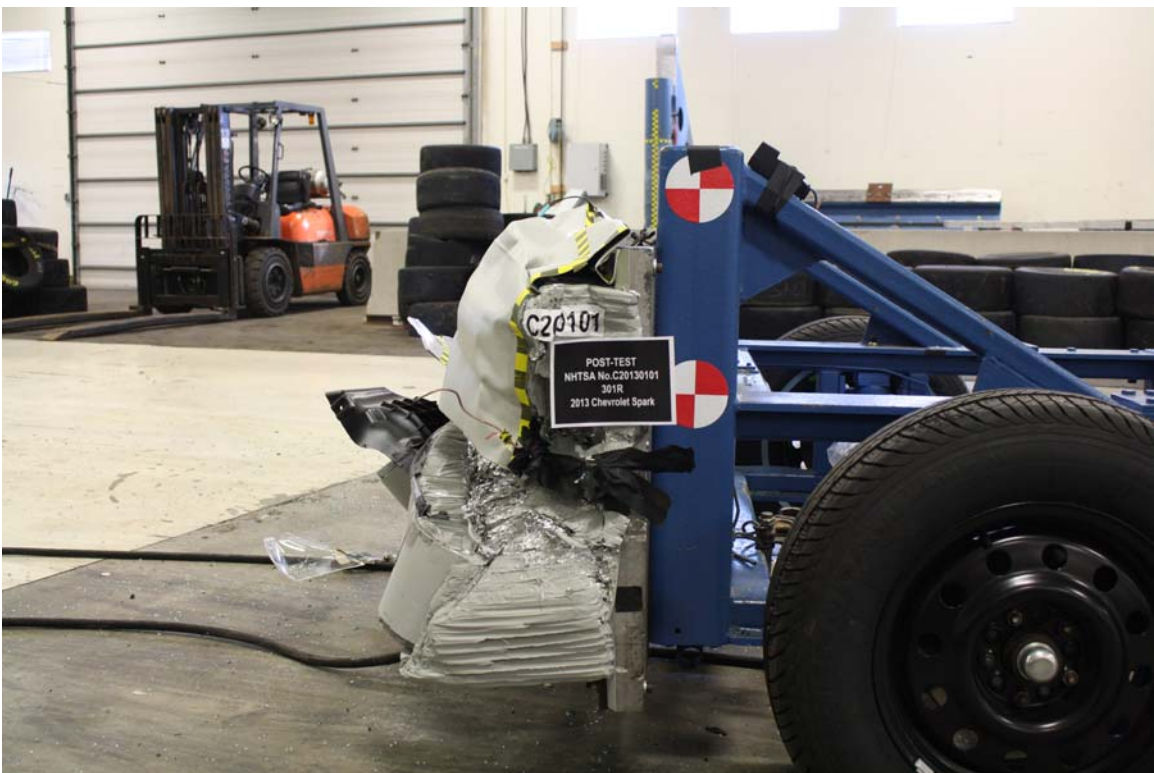
Figure A-22: Post-Test MDB Left Side View

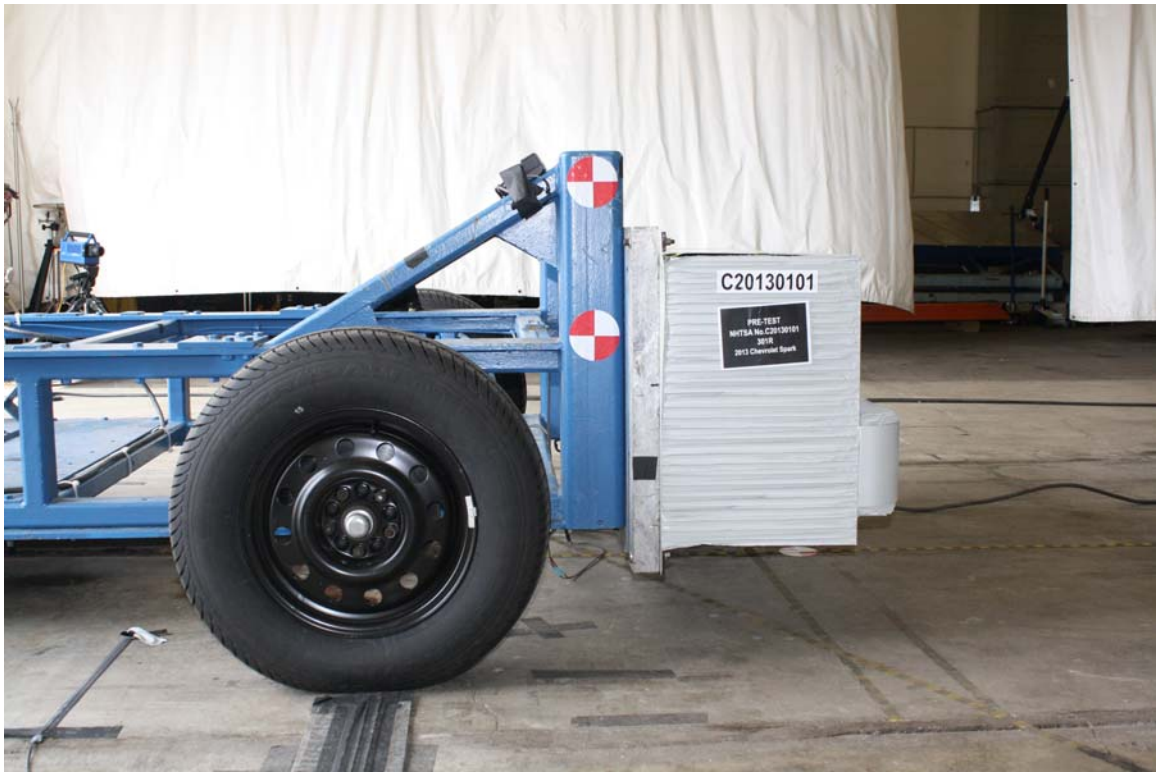
Figure A-23: Pre-Test MDB Right Side View

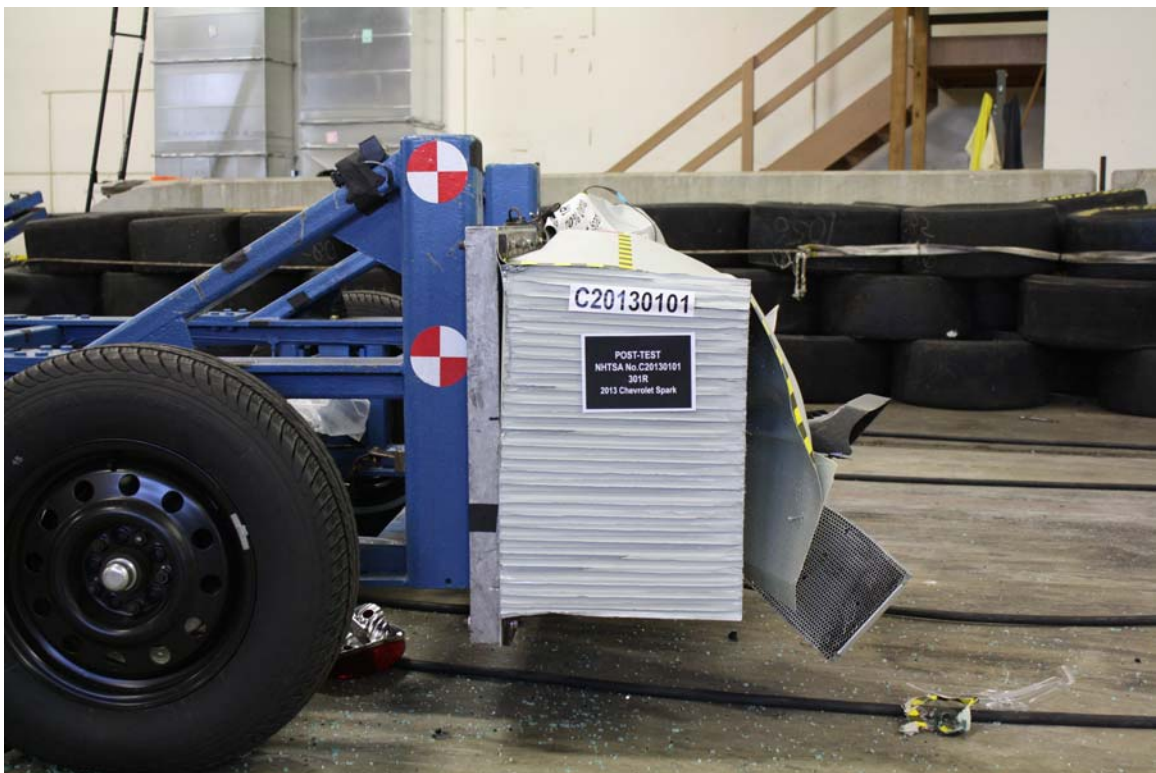
Figure A-24: Post-Test MDB Right Side View

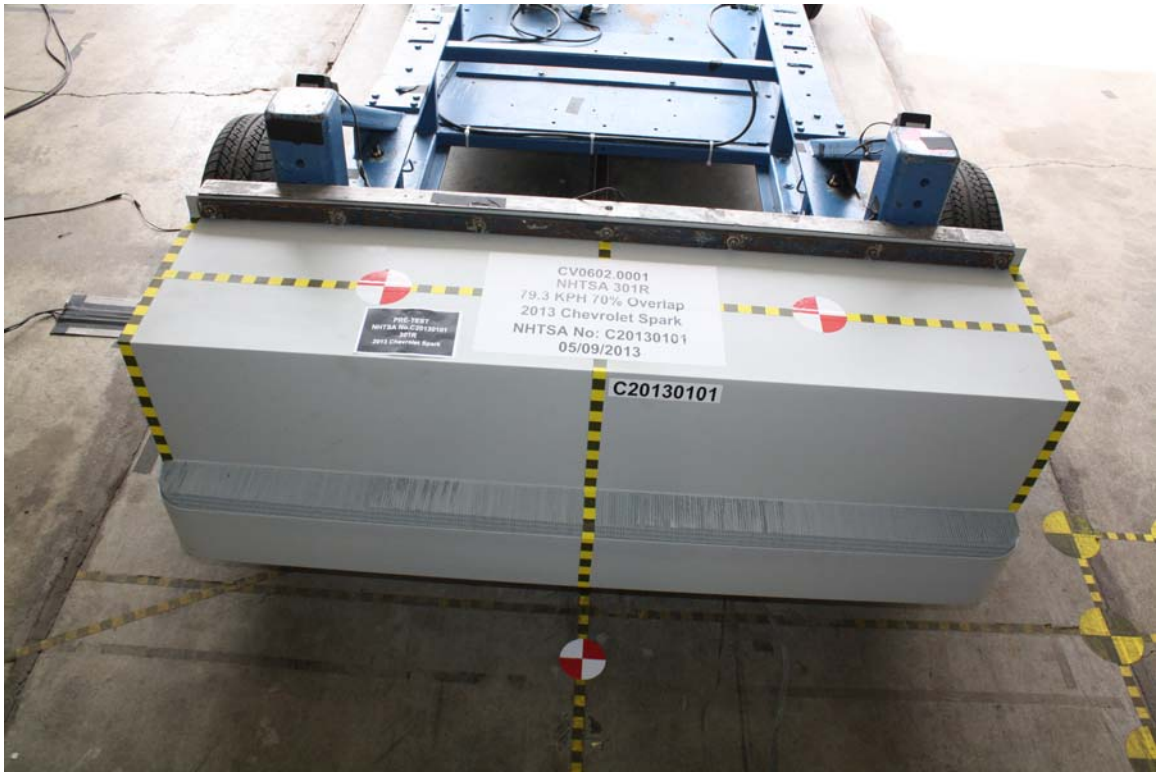
Figure A-25: Pre-Test MDB Top View
