REPORT NUMBER: 301R-CAL-13-003

**SAFETY COMPLIANCE TESTING FOR FMVSS 301R
FUEL SYSTEM INTEGRITY – REAR IMPACT**

**GM Korea Company
2013 Chevrolet Spark
Four Door Hatchback**

NHTSA NUMBER: C20130101

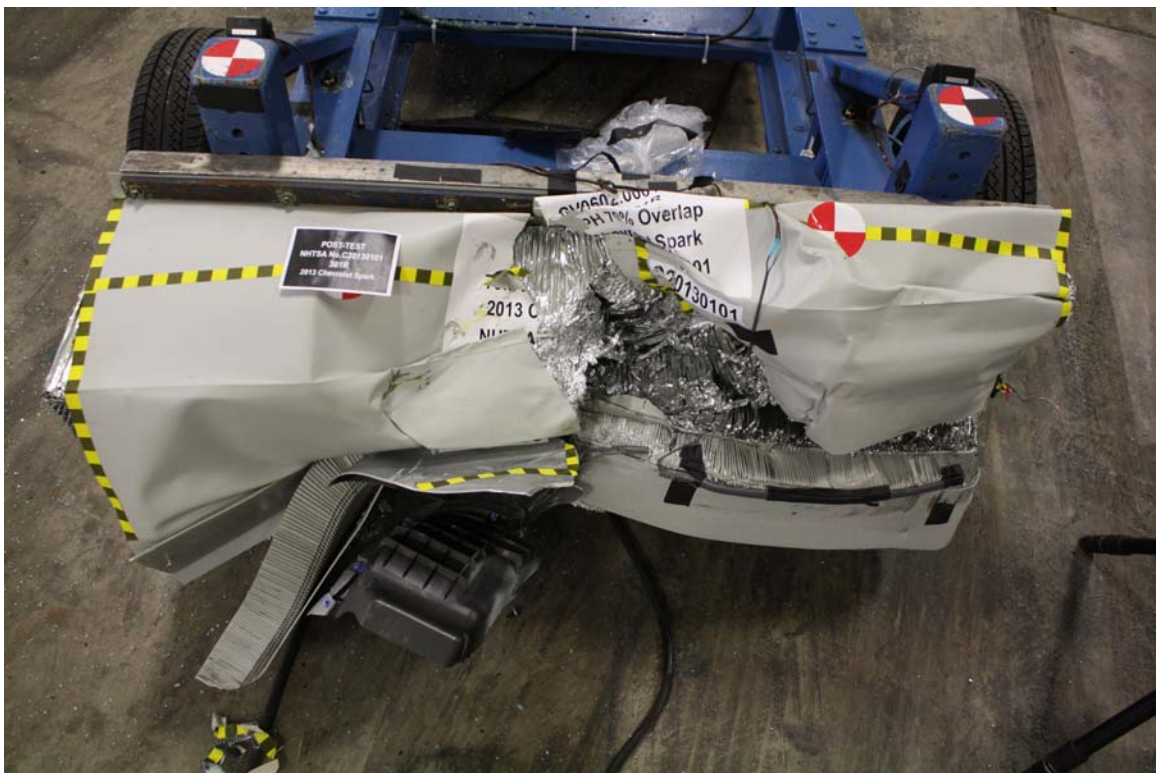
Figure A-26: Post-Test MDB Top View

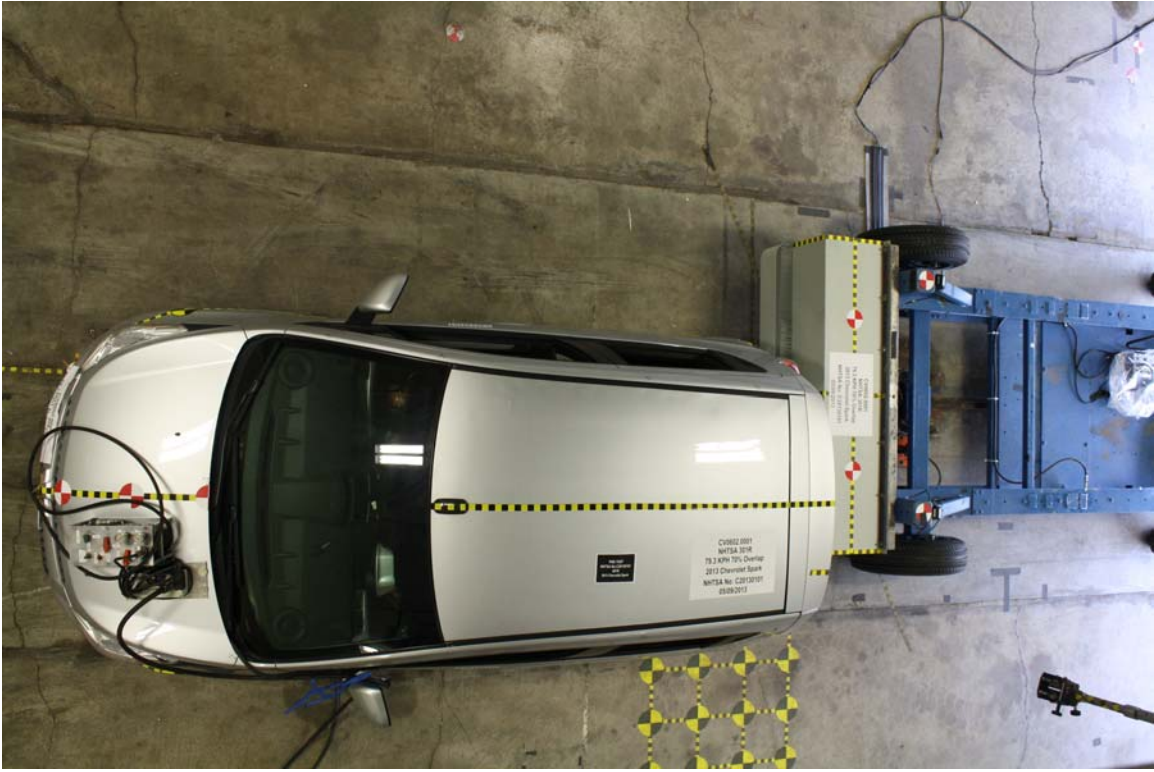
Figure A-27: Pre-Test Overhead Vehicle and MDB View

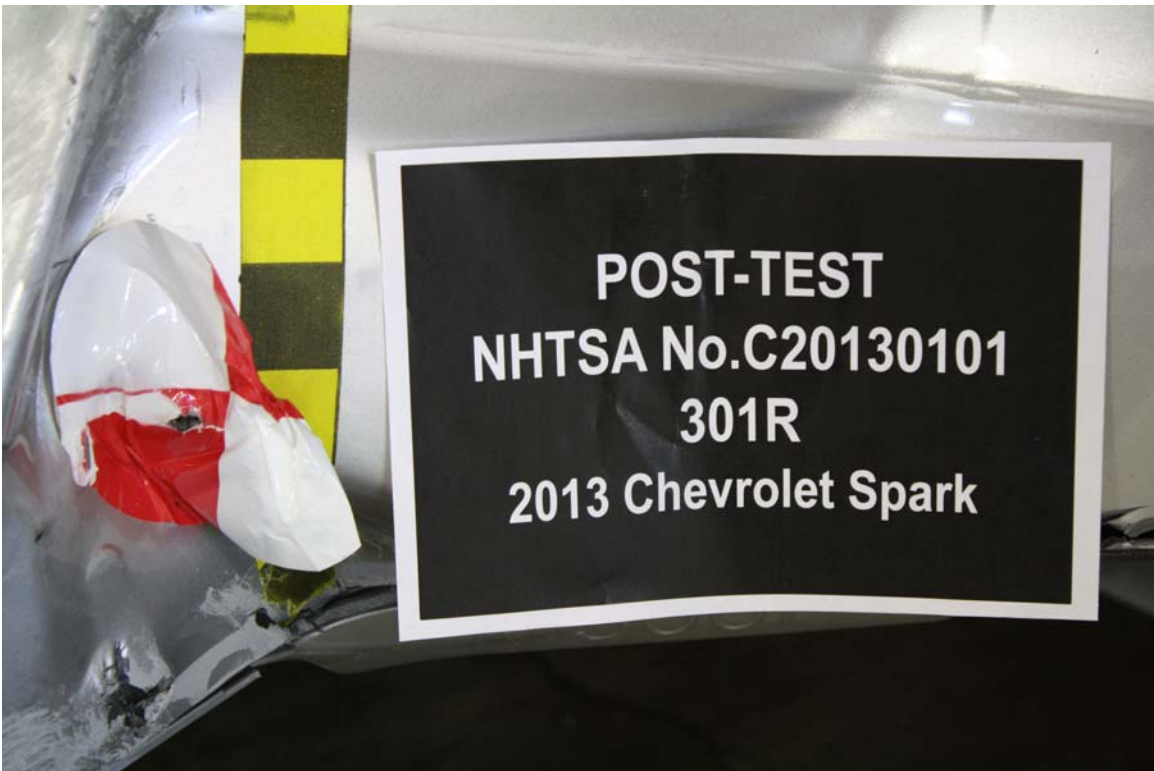
Figure A-28: Post-Test Impact Target View

| Measurement Description | Tolerance | Units | Value |
|--|---|---|---|
| Vertical distance from target center (+ is above) | ±40 mm | mm | -7 |
| Horizontal distance from target center (+ is right) | ±50 mm | mm | -8 |

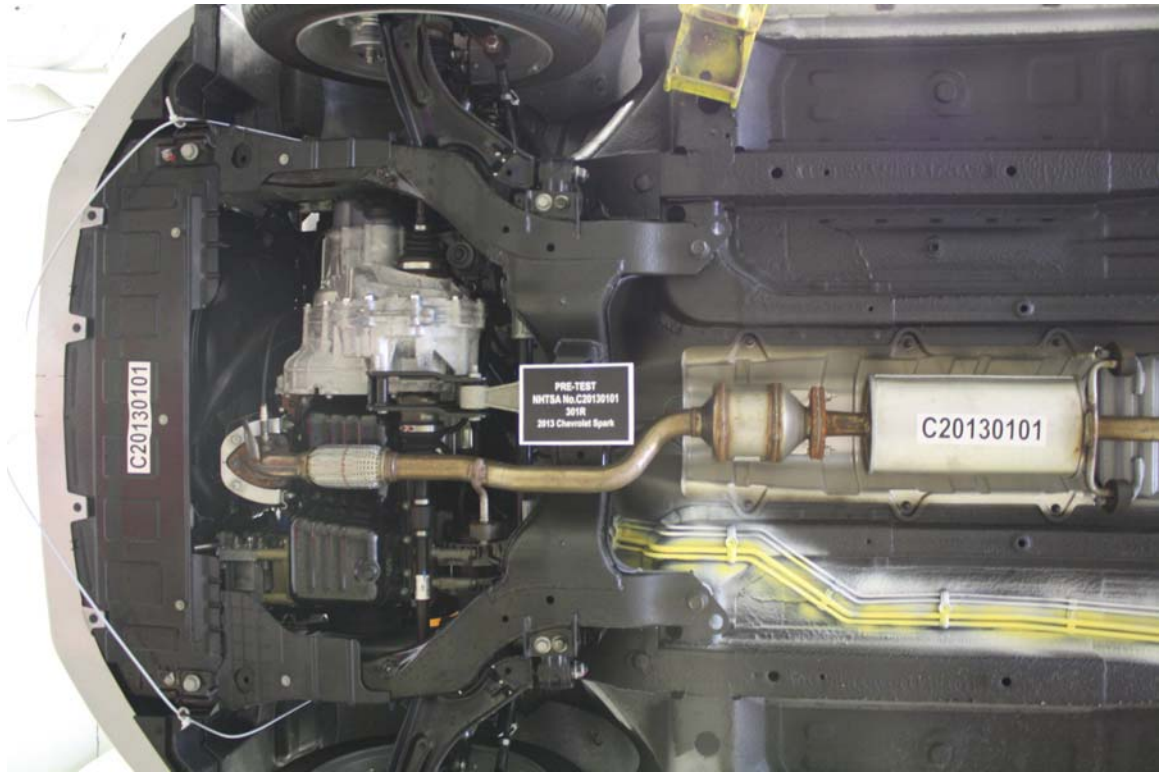
Figure A-29: Pre-Test Front Underbody View

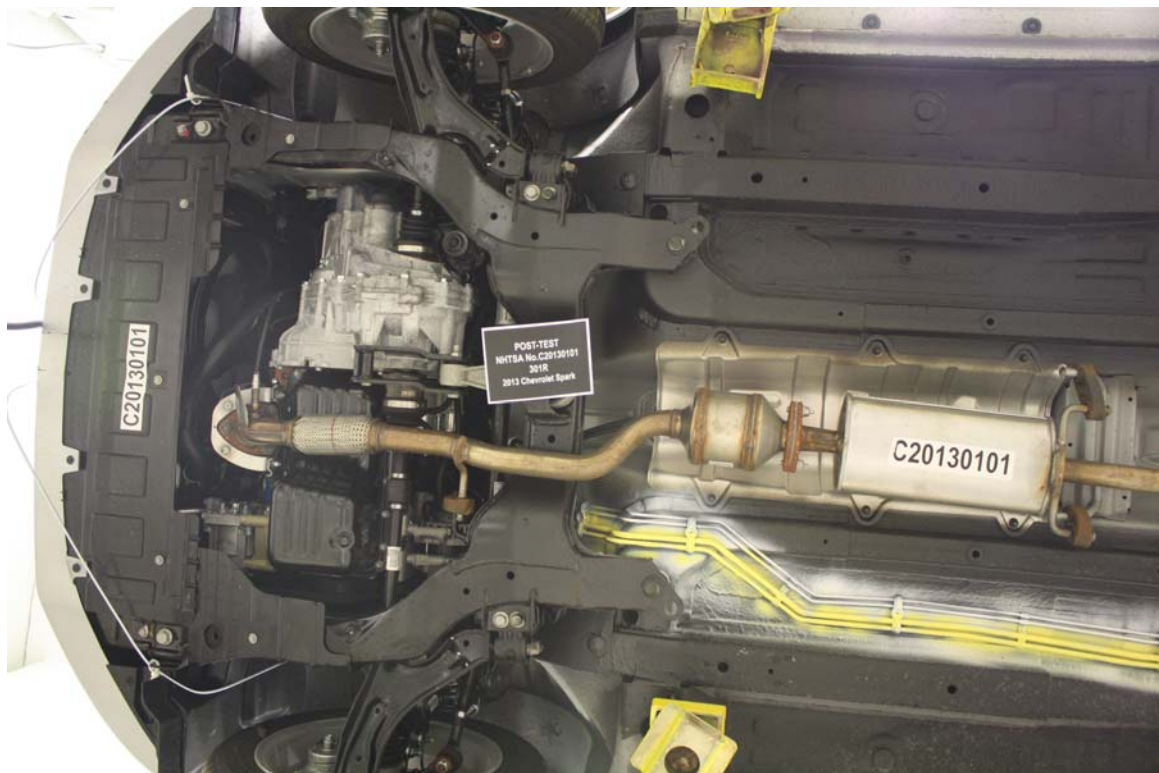
Figure A-30: Post-Test Front Underbody View

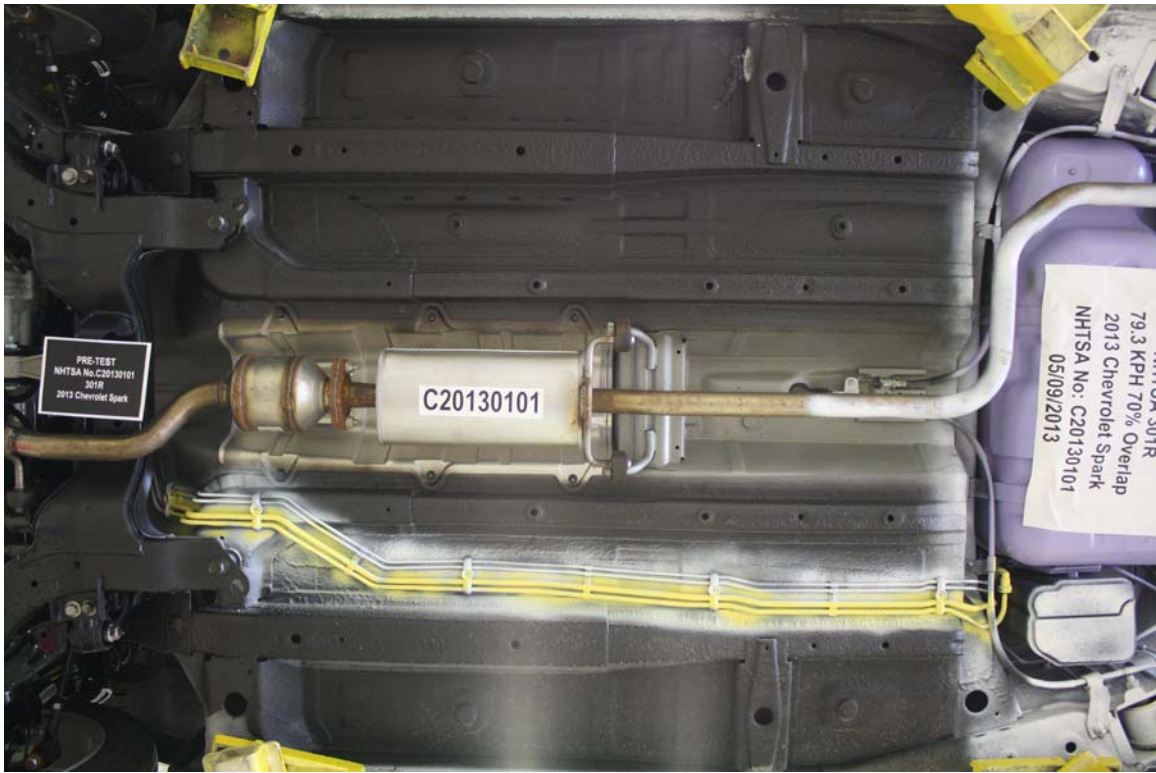
Figure A-31: Pre-Test Mid Underbody View

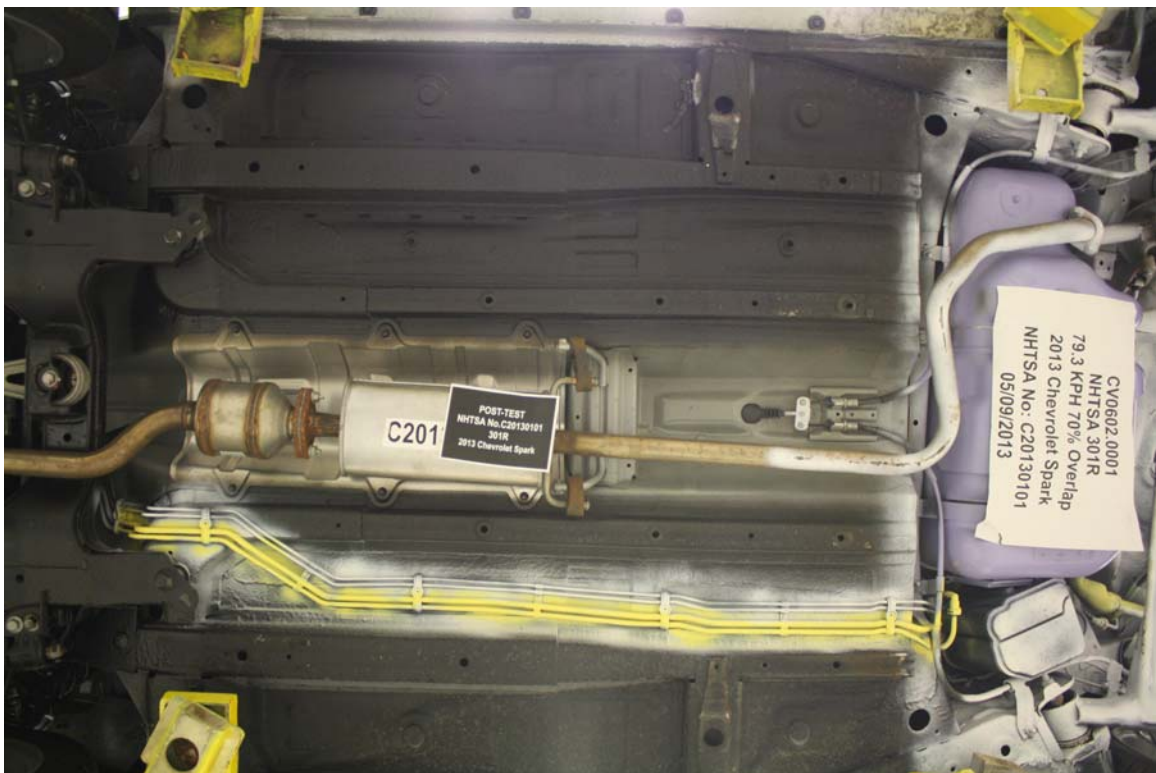
Figure A-32: Post-Test Mid Underbody View

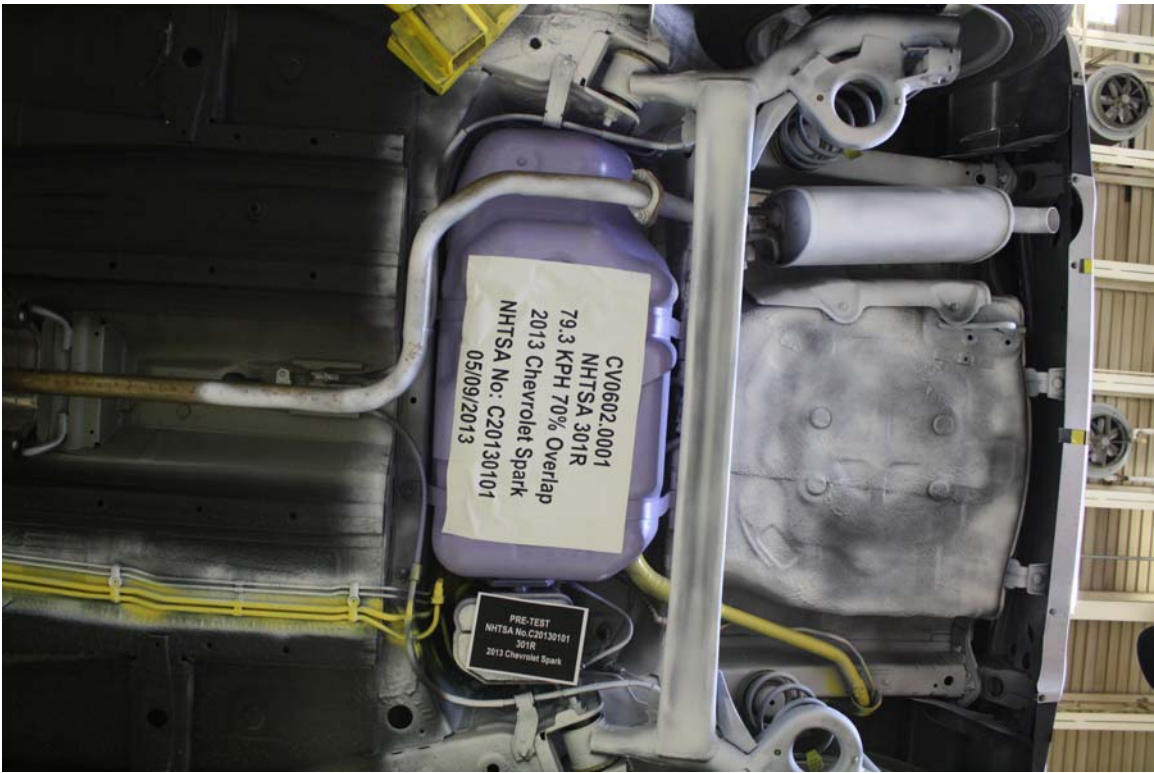
Figure A-33: Pre-Test Rear Underbody View

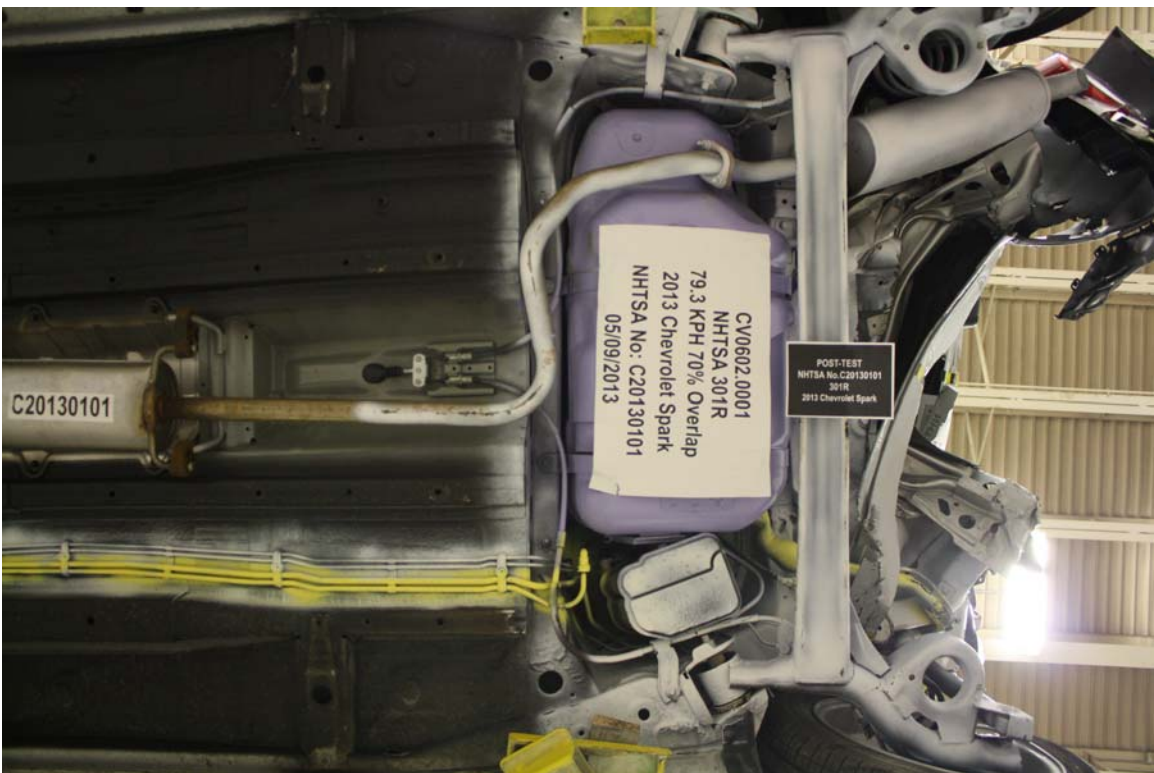
Figure A-34: Post-Test Rear Underbody View

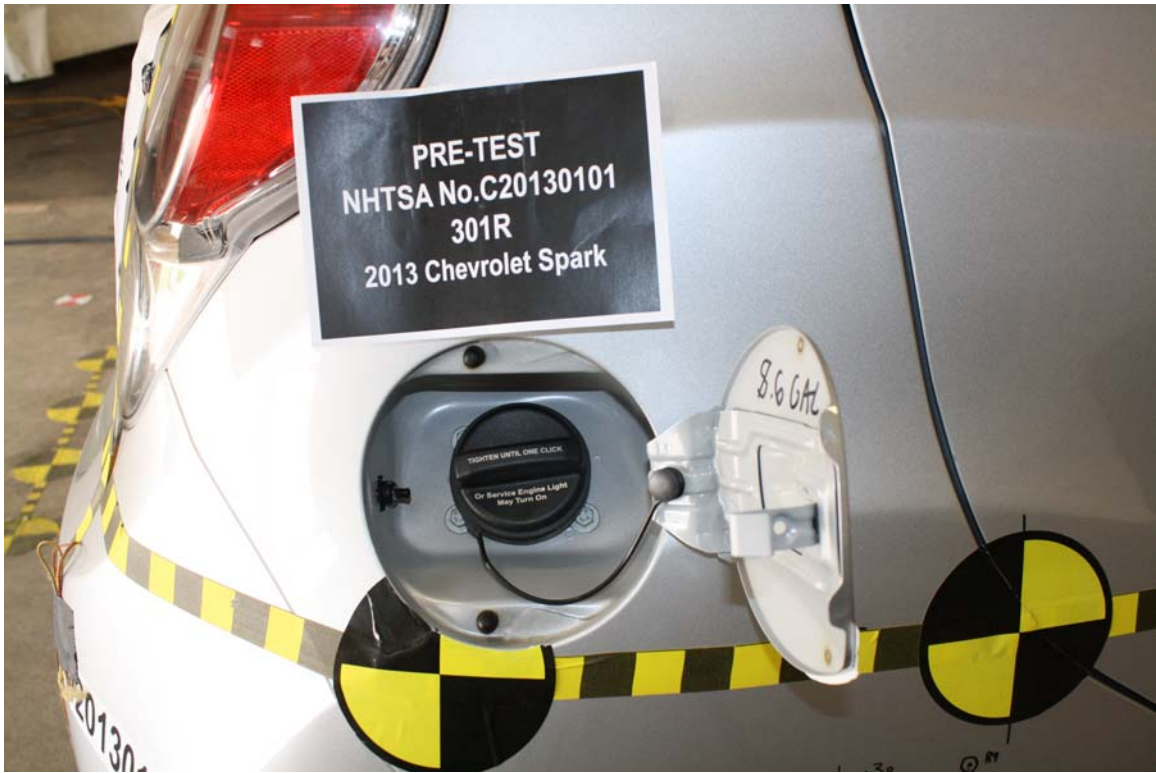
Figure A-35: Pre-Test Fuel Filler Cap View

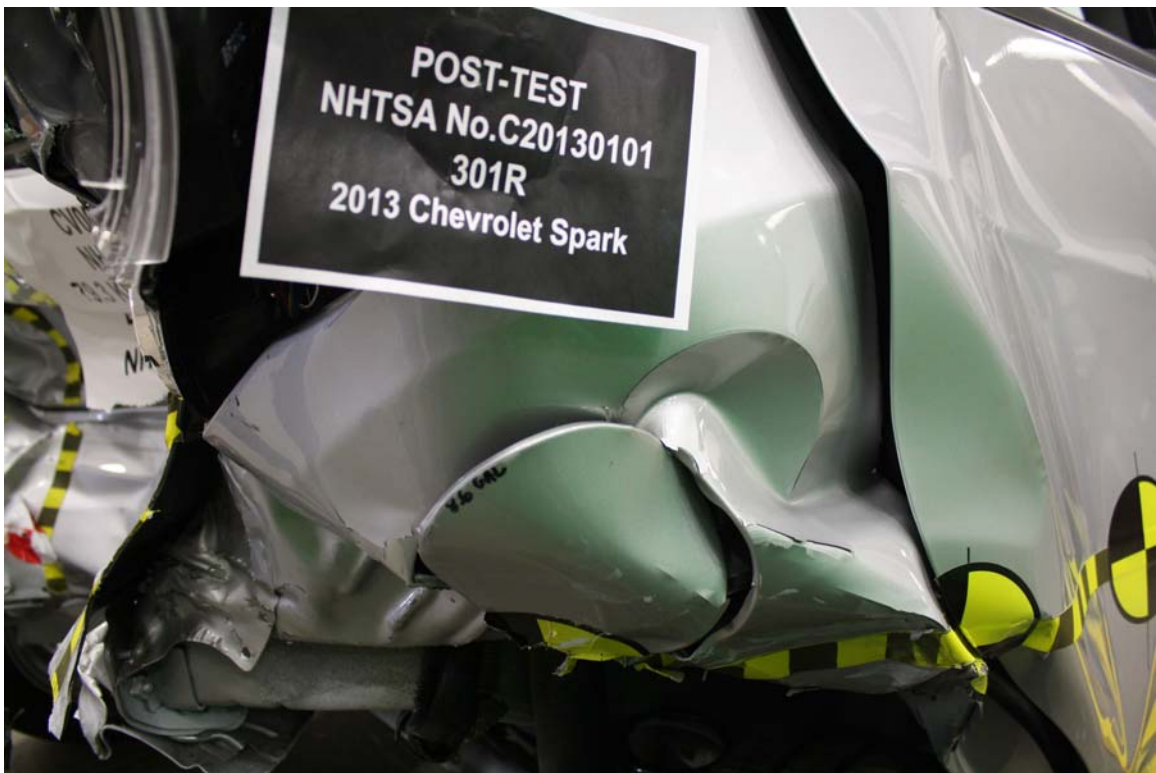
Figure A-36: Post-Test Fuel Filler Cap View

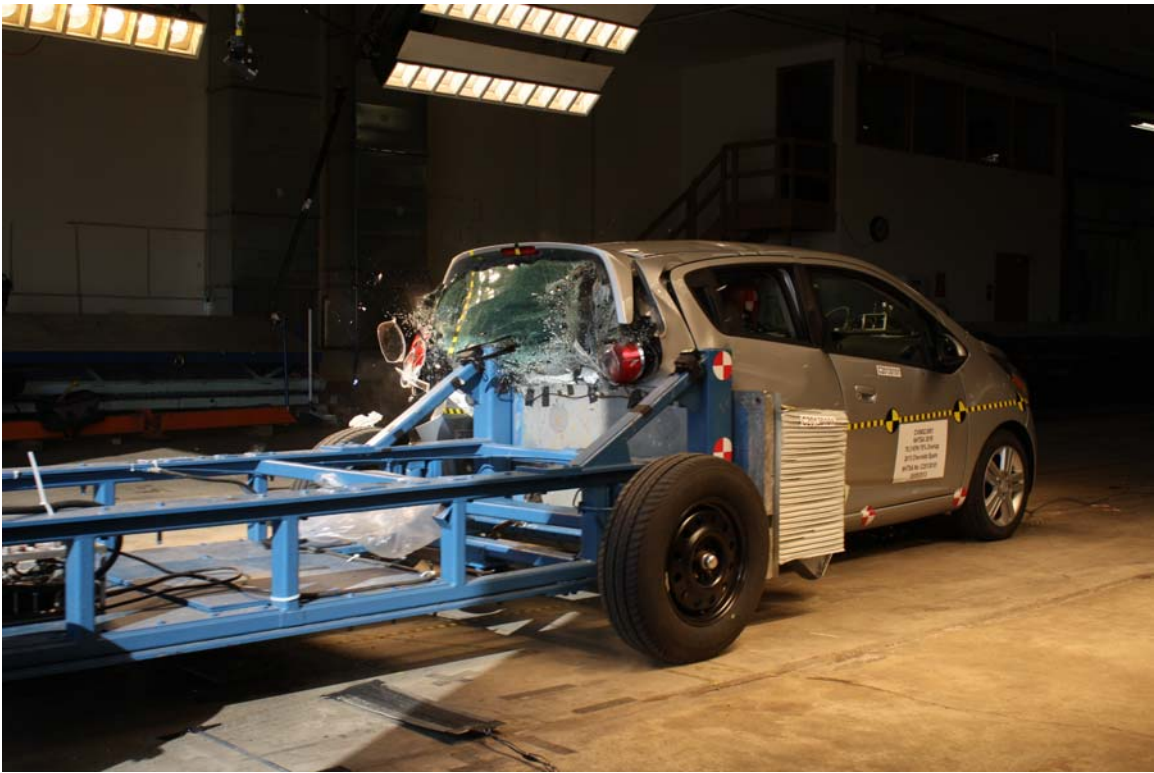
Figure A-37: Impact View

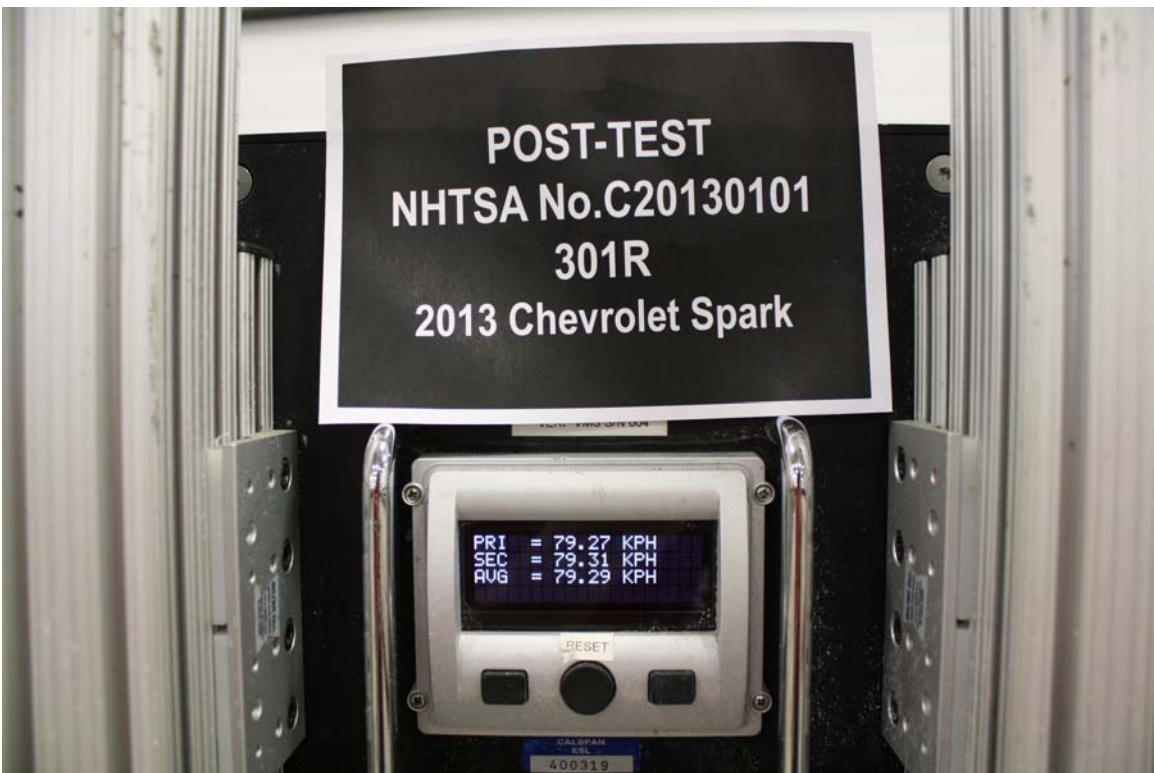
Figure A-38: Speed Trap View

| Measurement Description | Units | Speed |
|---|---|---|
| Trap No. 1 | km/h | 79.27 |
| Trap No. 2 | km/h | 79.31 |
| Average Impact Speed | km/h | 79.29 |

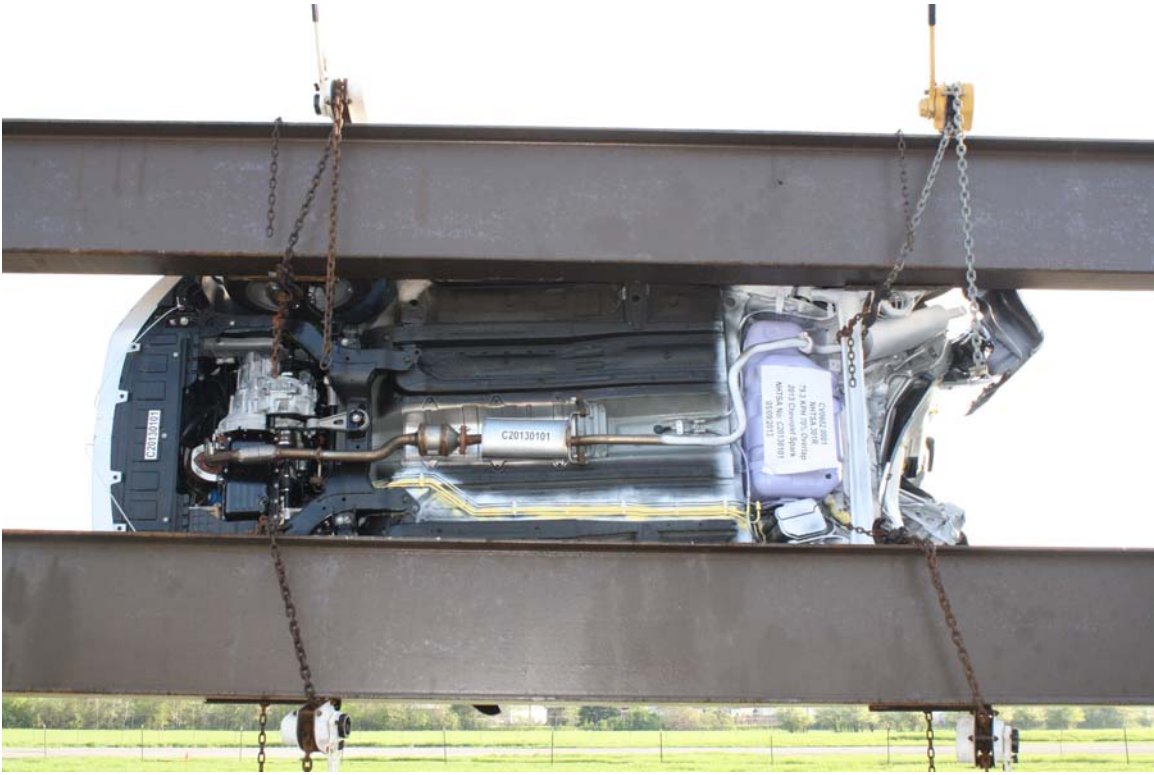
Figure A-39: Rollover 90° View

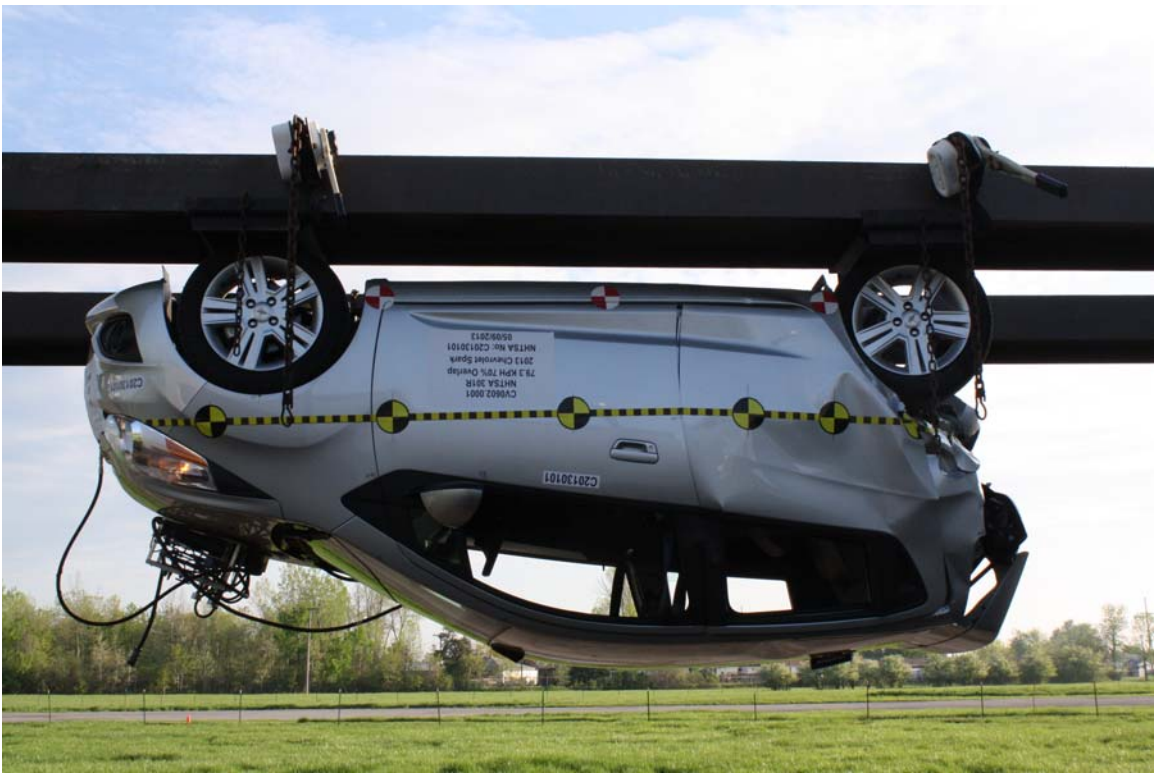
Figure A-40: Rollover 180° View

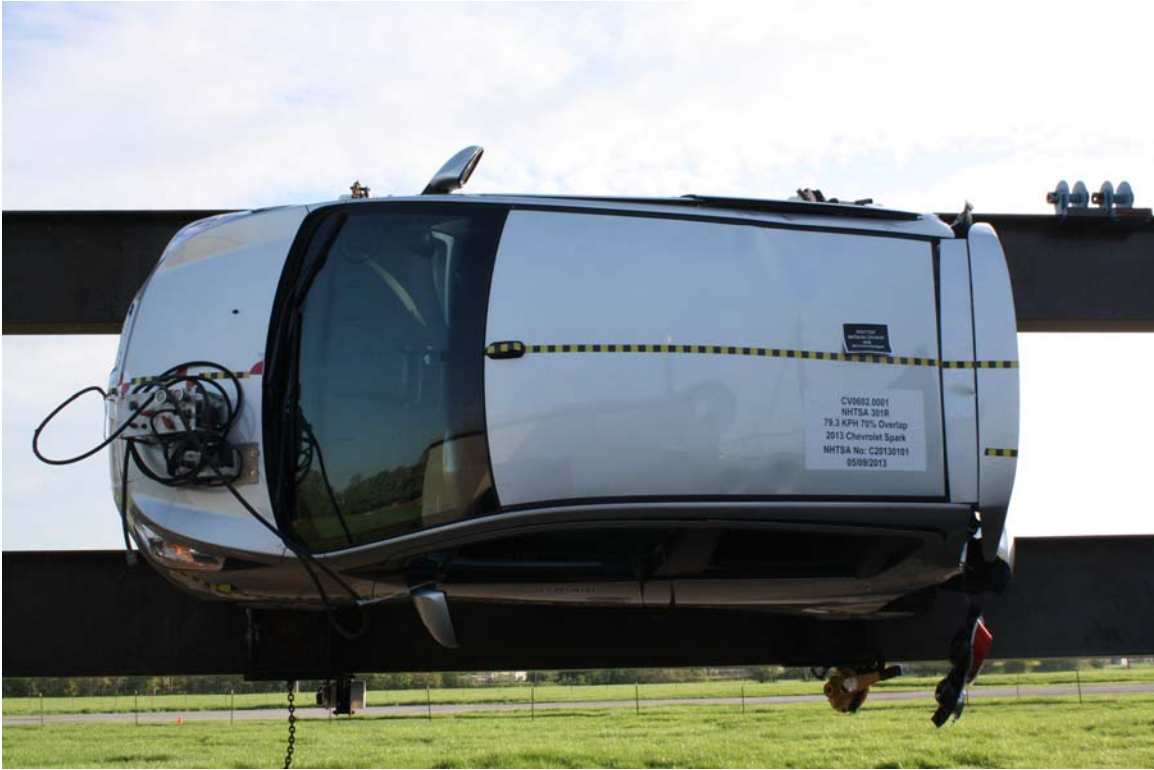
Figure A-41: Rollover 270° View

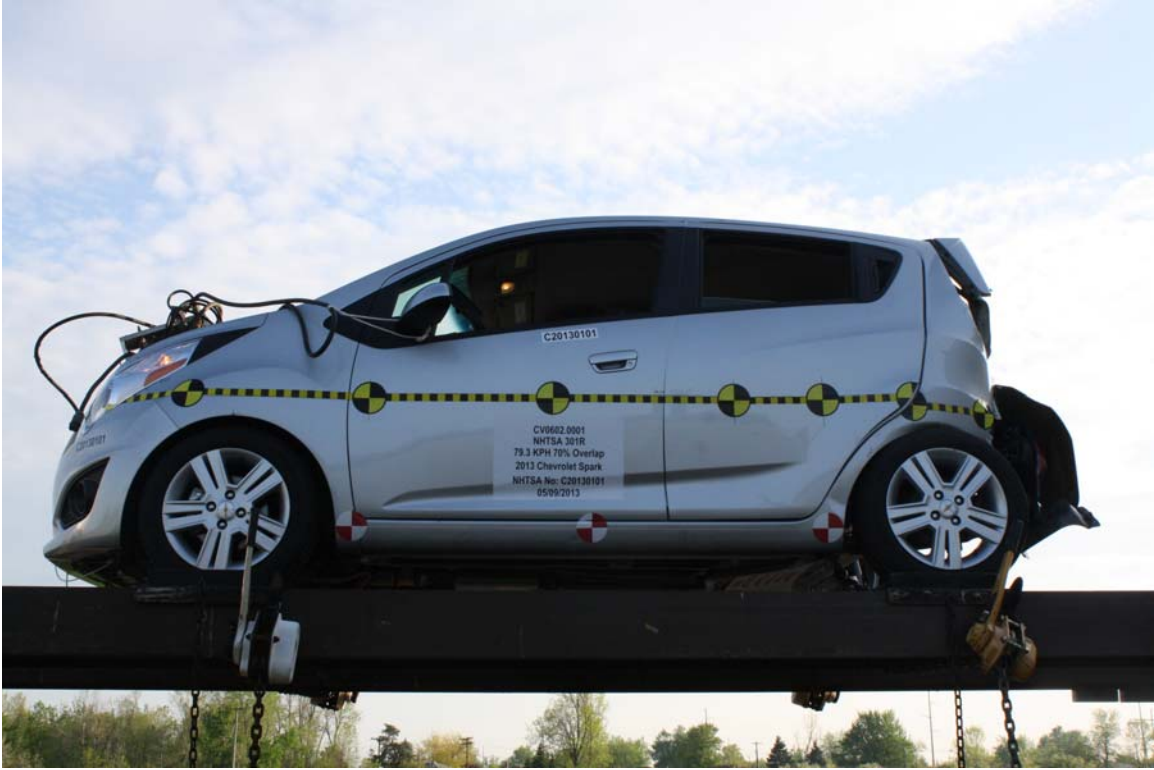
Figure A-42: Rollover 360° View
