**REPORT NUMBER: 301R/305-CAL-13-007**

**SAFETY COMPLIANCE TESTING FOR FMVSS 301 & 305  
Fuel System Integrity – Rear Impact  
Electric Powered Vehicles: Electrolyte Spillage and Electrical Shock Protection**

**Ford Motor Co.  
2013 Ford C-Max Energi  
Five Door Hatchback**

**NHTSA No: C20130201**

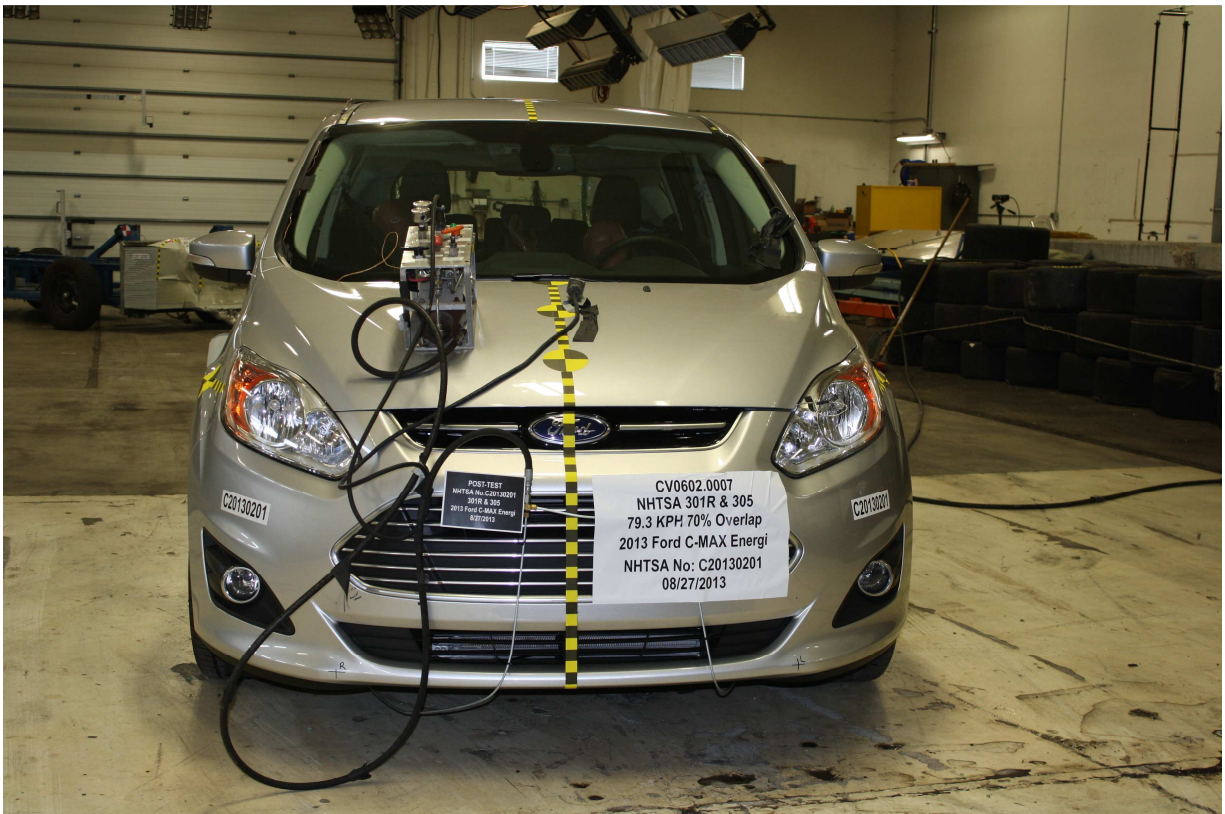
**Figure A-6: Post-Test Front View**

Critical Areas of Performance	Observations and Conclusions
Windshield Damage	None
Window Damage	None
Other Notable Effects	Rear Windshield shattered during impact event.
