**REPORT NUMBER: TR-P34135-02-NC  
SAFETY COMPLIANCE TESTING FOR FMVSS 301R  
FUEL SYSTEM INTEGRITY – REAR IMPACT  
79.3 KM/H 70% OVERLAP REAR IMPACT**

**HONDA OF CANADA MFG.  
2014 HONDA CR-V 5-DOOR MPV**

**NHTSA NUMBER: C20145303**

**PREPARED BY:  
KARCO ENGINEERING, LLC.  
9270 HOLLY ROAD  
ADELANTO, CA 92301**

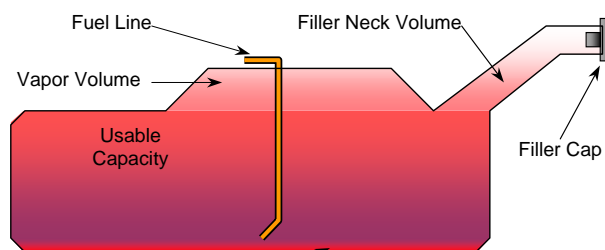
VEHICLE FUEL TANK ASSEMBLY

The vehicle is equipped with an electric fuel pump. The fuel pump is activated on the ignition key is set to the 'ON' position. The pump is filled for two seconds after which pressure is maintained.

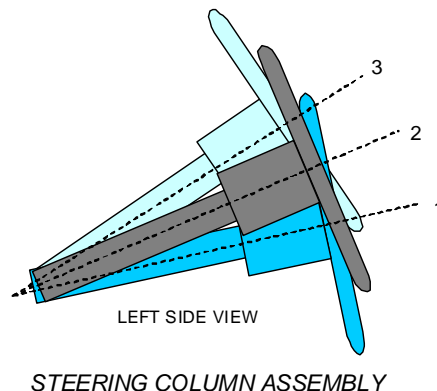
Steering wheel and column adjustments are made so that the steering wheel hub is at the geometric center of the locus it describes when moved through its full range of motion. A digital inclinometer is used to measure a plate which is placed across the rim of the steering wheel for angular measurements. A tape measure is used to measure telescoping steering wheel travel.

Degrees	Fore-Aft Position (mm)
Lowermost Position, No. 1	25.5	132
Geometric Center Position, No. 2	27.9	111
Uppermost Position, No. 3	30.4	89
Telescoping Steering Wheel Travel	4.9	43
Test Position	27.9	111

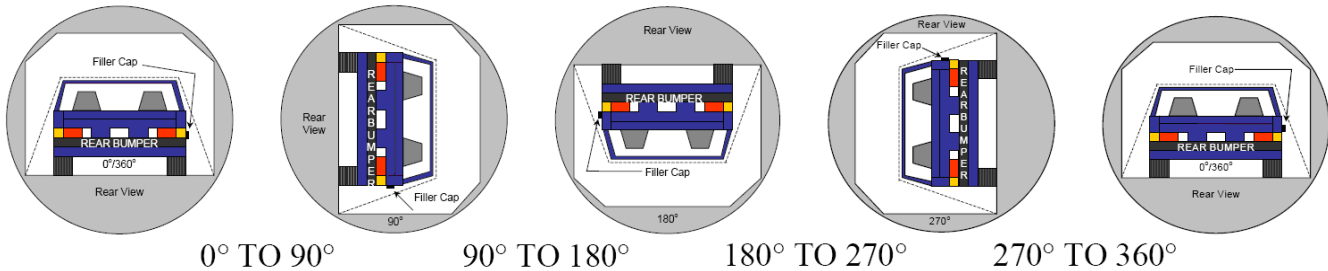
1. The specified fixture rollover rate for each 90° of rotation is 60 to 180 seconds.

2. The position hold time at each position is 300 seconds (minimum).

Details of Stoddard solvent spillage: No Stoddard solvent spillage

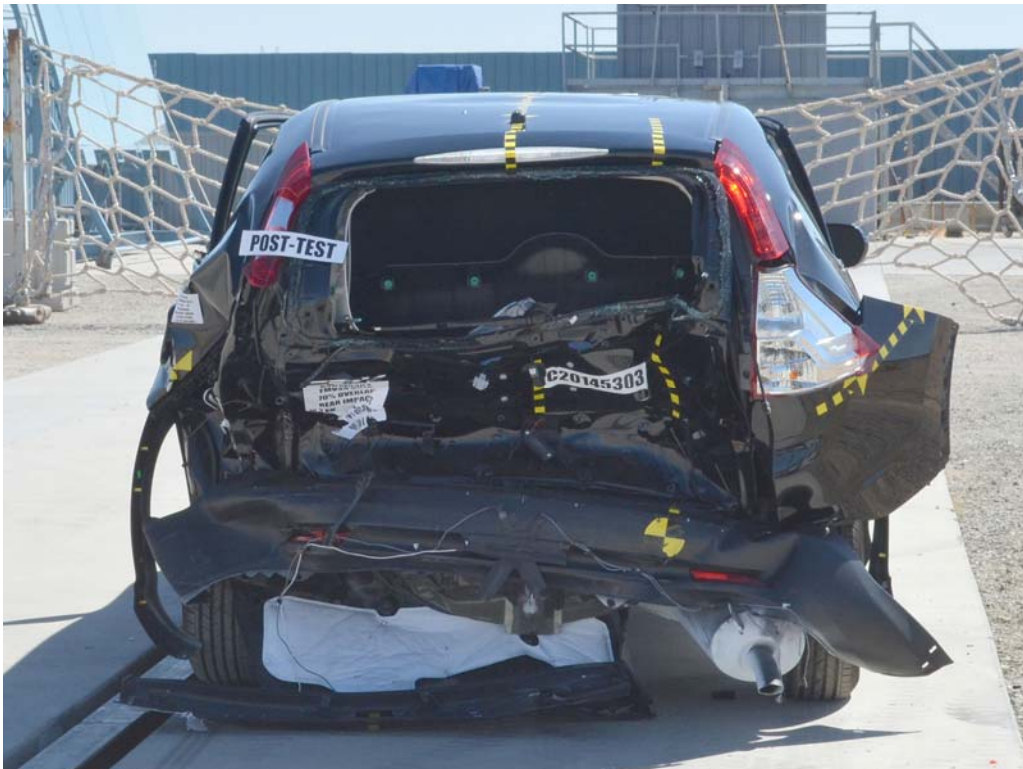
No.	Description	Pre-Test	Post-Test	Difference
1	Total Length at Centerline	4510	4224	286
2	Total Length	4510	4270	240
3	Total Width	1820	2096	276
4	Left Side Wheelbase	2626	2505	121
5	Right Side Wheelbase	2626	2620	6

FIGURE 14. Post-Test Rear View of Test Vehicle

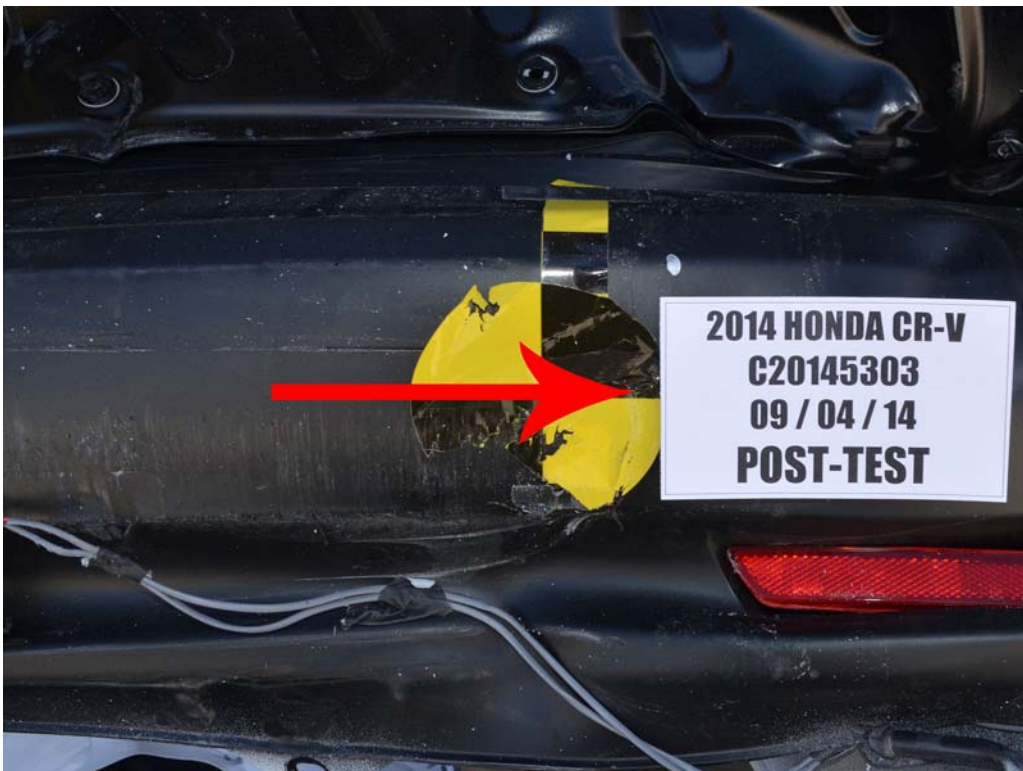
Measured Parameter	Units	Tolerance	Value
Vehicle Width	mm		1820
Vertical Impact Reference Line (Right of Vehicle Center Line)	mm		364
Actual Impact Point (Right of Vehicle Center Line)	mm		378
Horizontal Offset (+ right / - left)	mm	± 50 of Intended Impact Point	-14
Vertical Offset (+ down / - up)	mm	± 40 of Intended Impact Point	4

FIGURE 22. Post-Test Close-Up View of Impact Point Target

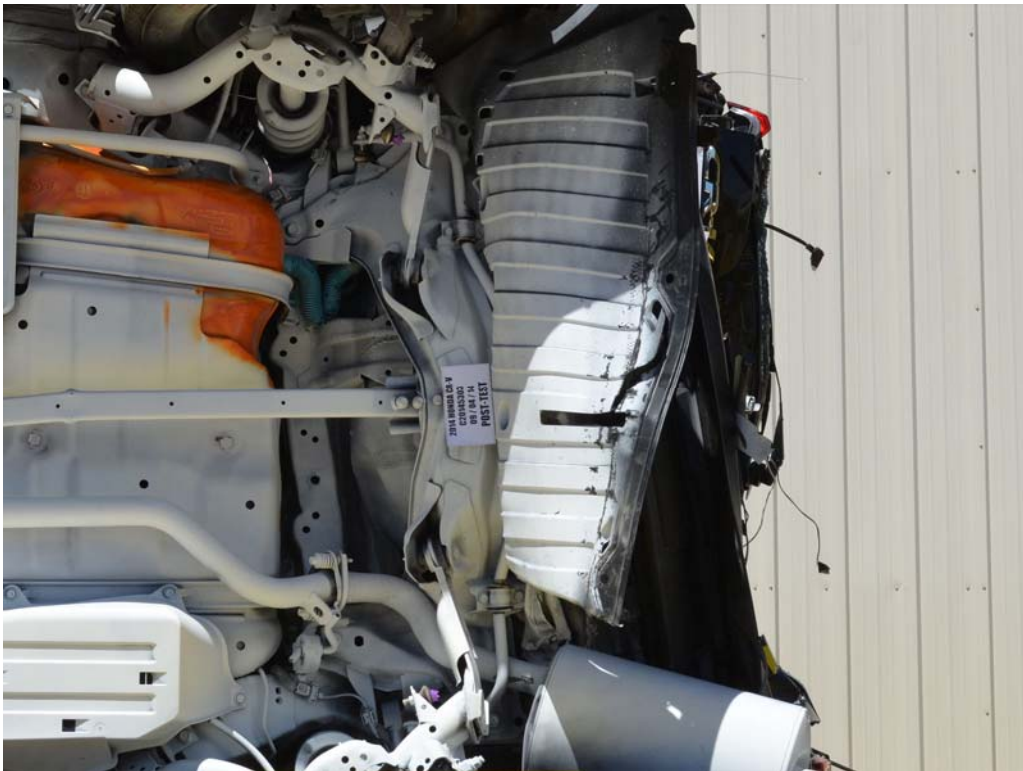
FIGURE 26. Post-Test Rear Underbody View of Test Vehicle

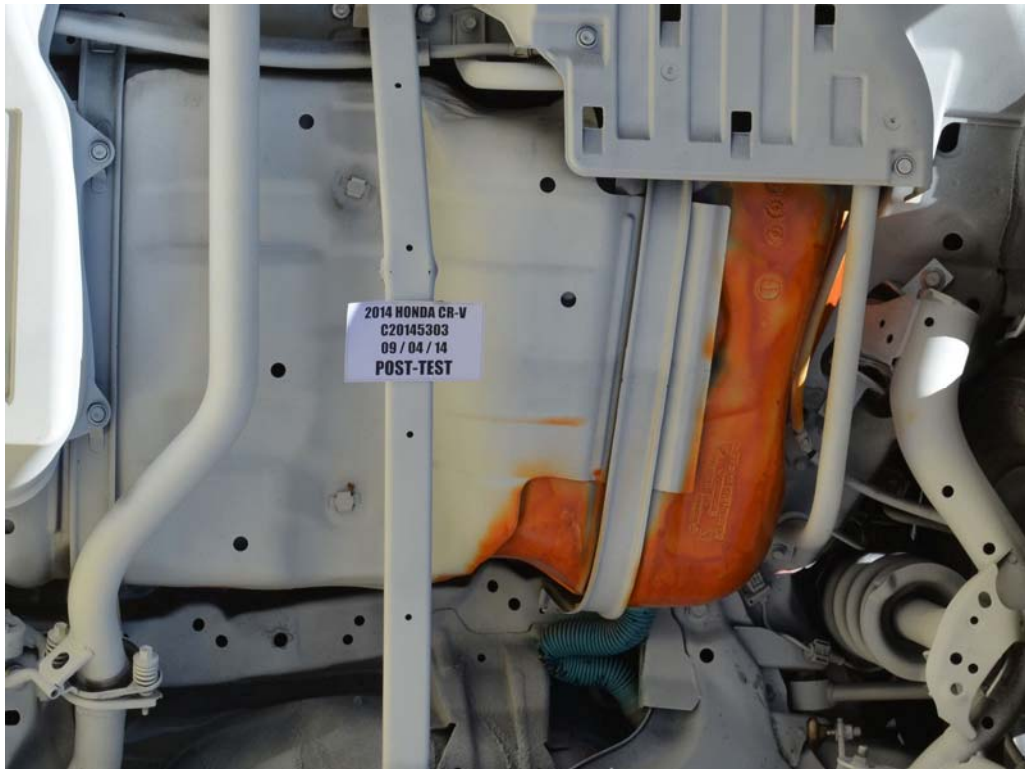
- A. From impact until vehicle motion ceases: 0 g  
(Maximum allowable = 28 g)
- B. For the 5 minute period after motion ceases: 0 g  
(Maximum allowable = 28 g)
- C. For the following 25 minutes: 0 g  
(Maximum allowable = 28 g/minute)
- D. Spillage: No Stoddard Solvent leakage  
\_\_\_\_\_  
\_\_\_\_\_  
\_\_\_\_\_

FIGURE 28. Post-Test Underbody View of Fuel Tank

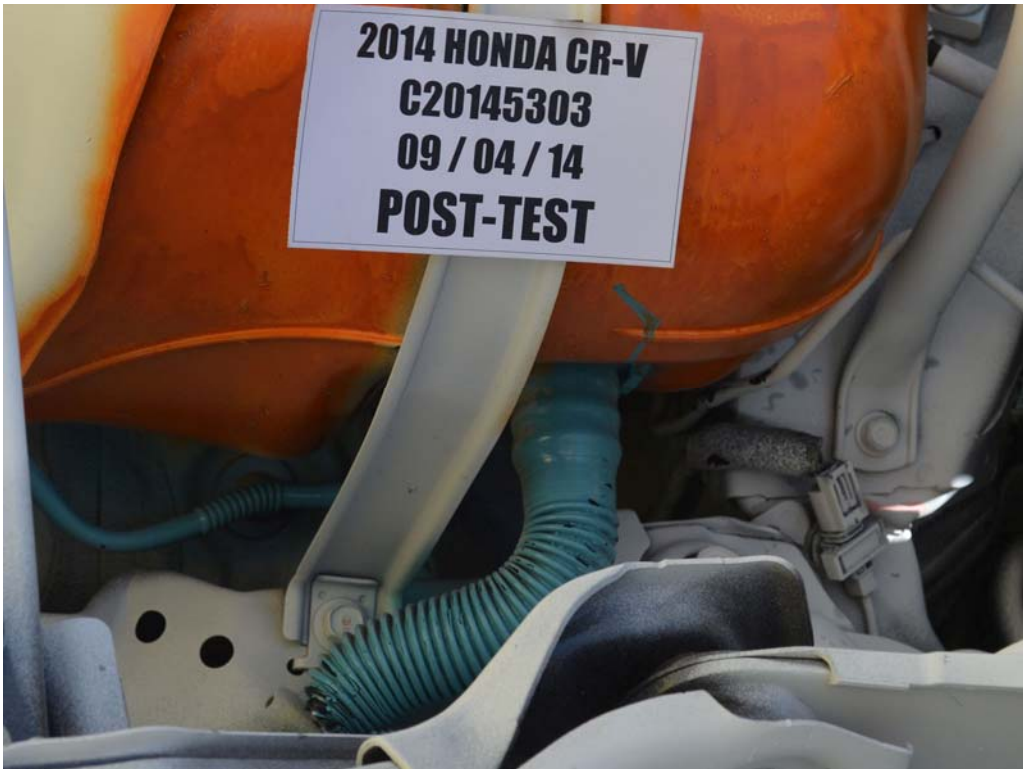
FIGURE 30. Post-Test Underbody View of Fuel Filler Neck

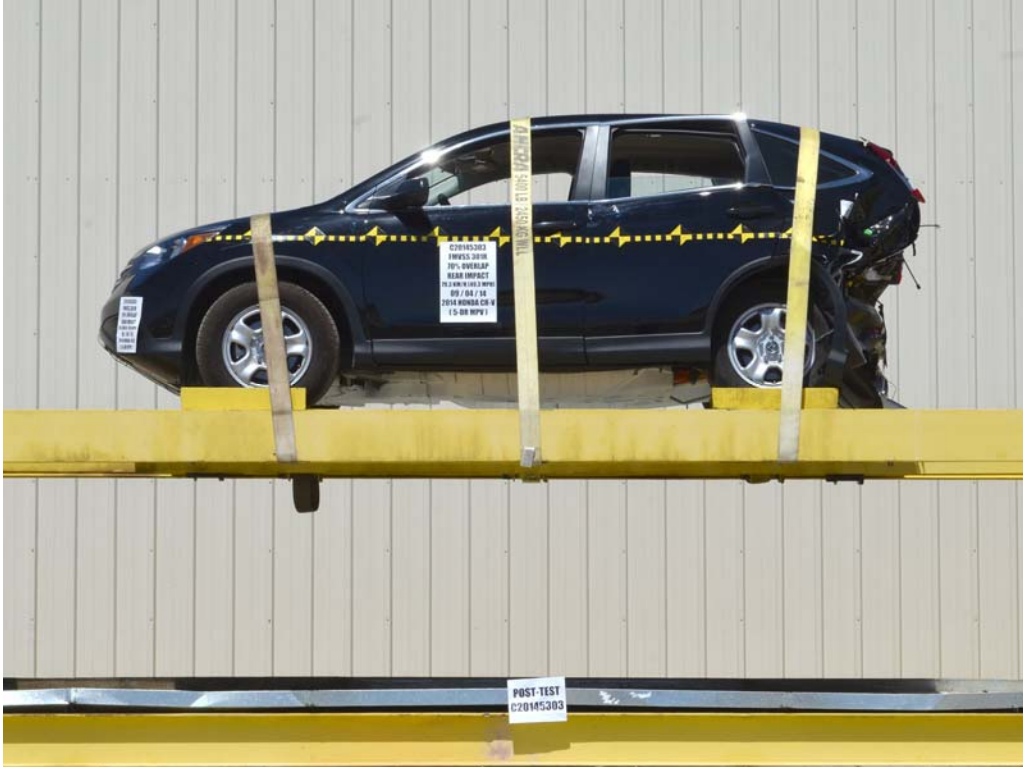
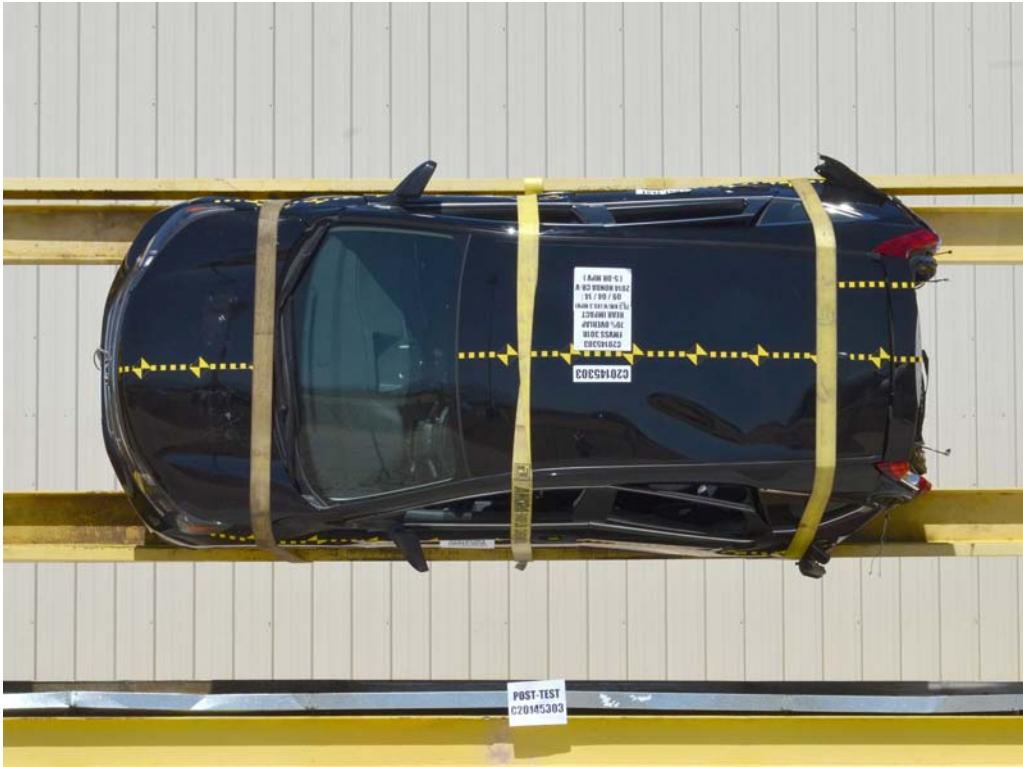
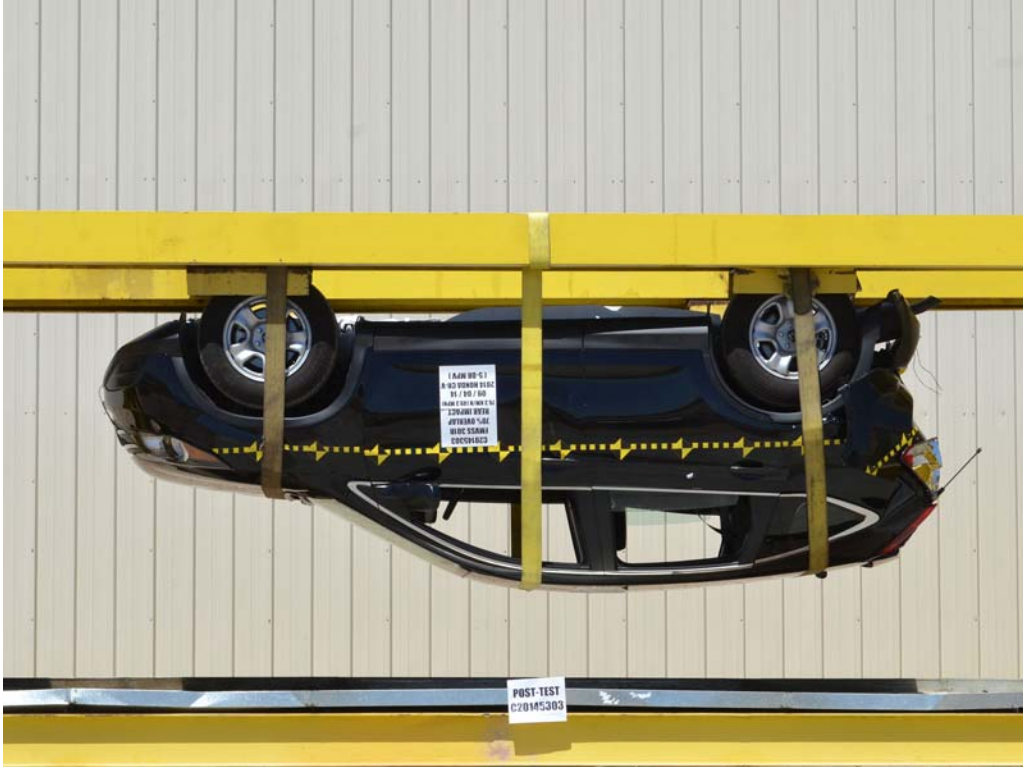
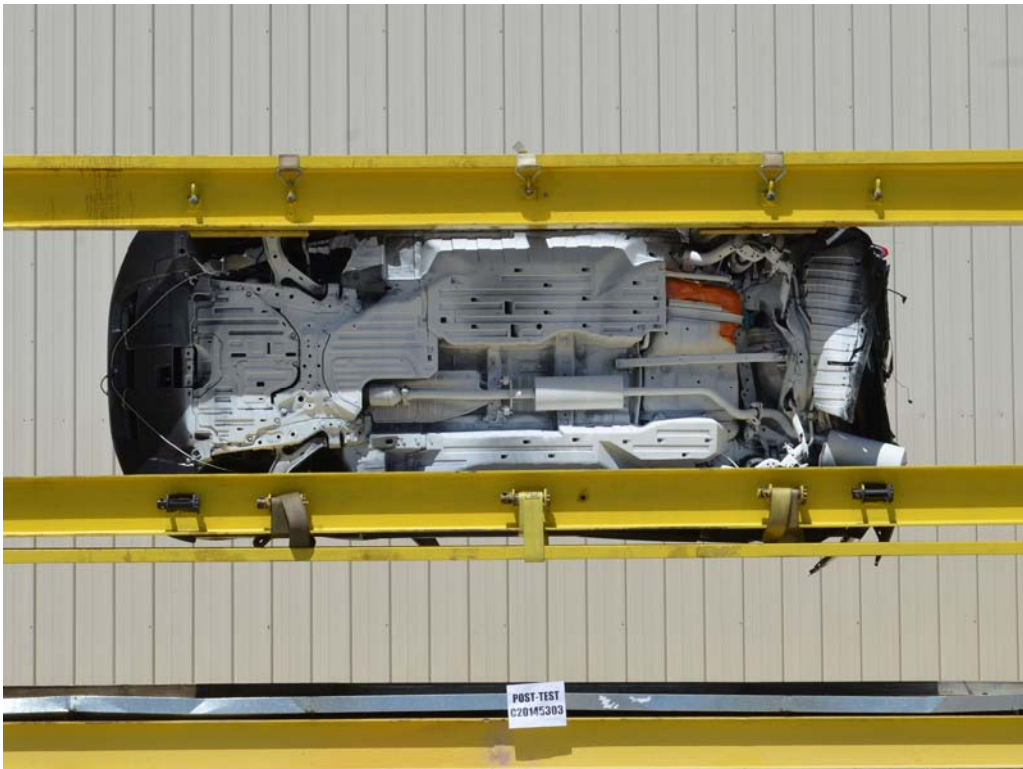
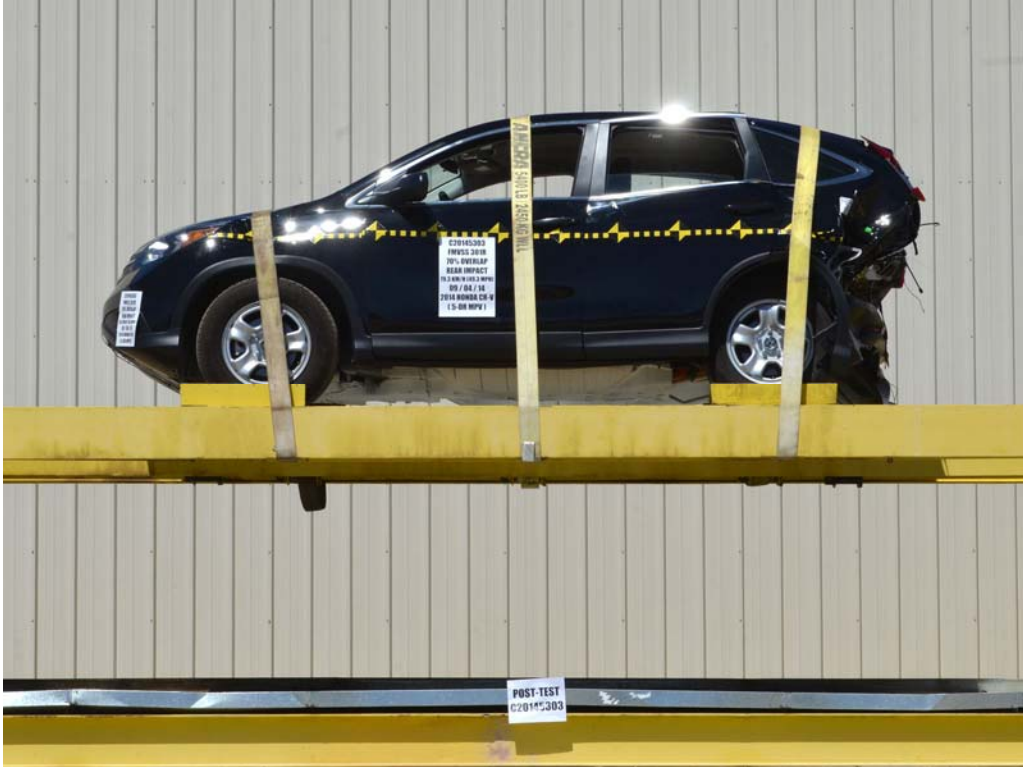
Test Phase	Spillage Location
0° To 90°	No Spillage
90° To 180°	No Spillage
180° To 270°	No Spillage
270° To 360°	No Spillage

FIGURE 31. Test Vehicle at 0° on FMVSS 301 Static Rollover Device

FIGURE 32. Test Vehicle at 90° on FMVSS 301 Static Rollover Device

FIGURE 33. Test Vehicle at 180° on FMVSS 301 Static Rollover Device

FIGURE 34. Test Vehicle at 270° on FMVSS 301 Static Rollover Device

FIGURE 35. Test Vehicle at 360° on FMVSS 301 Static Rollover Device

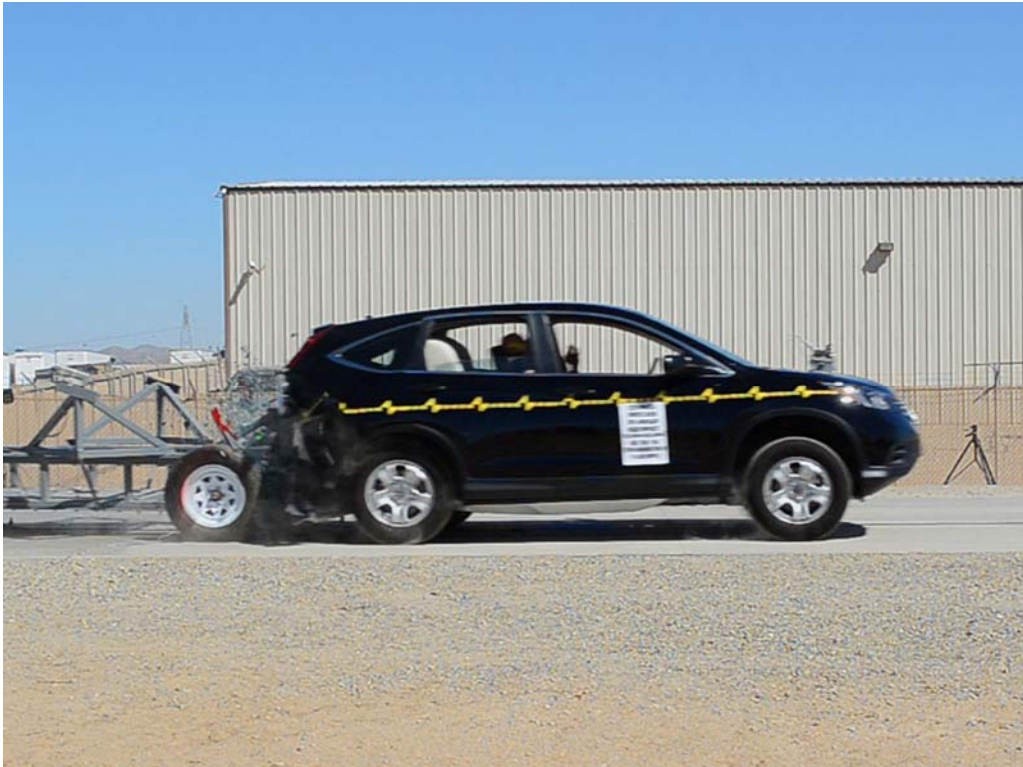
FIGURE 36. Impact Event
