**REPORT NUMBER: 301R-CAL-14-008**

**SAFETY COMPLIANCE TESTING FOR FMVSS 301R  
FUEL SYSTEM INTEGRITY – REAR IMPACT**

**Toyota Motor Corporation  
2014 Toyota 4-Runner  
SUV**

**NHTSA NUMBER: C20145103**

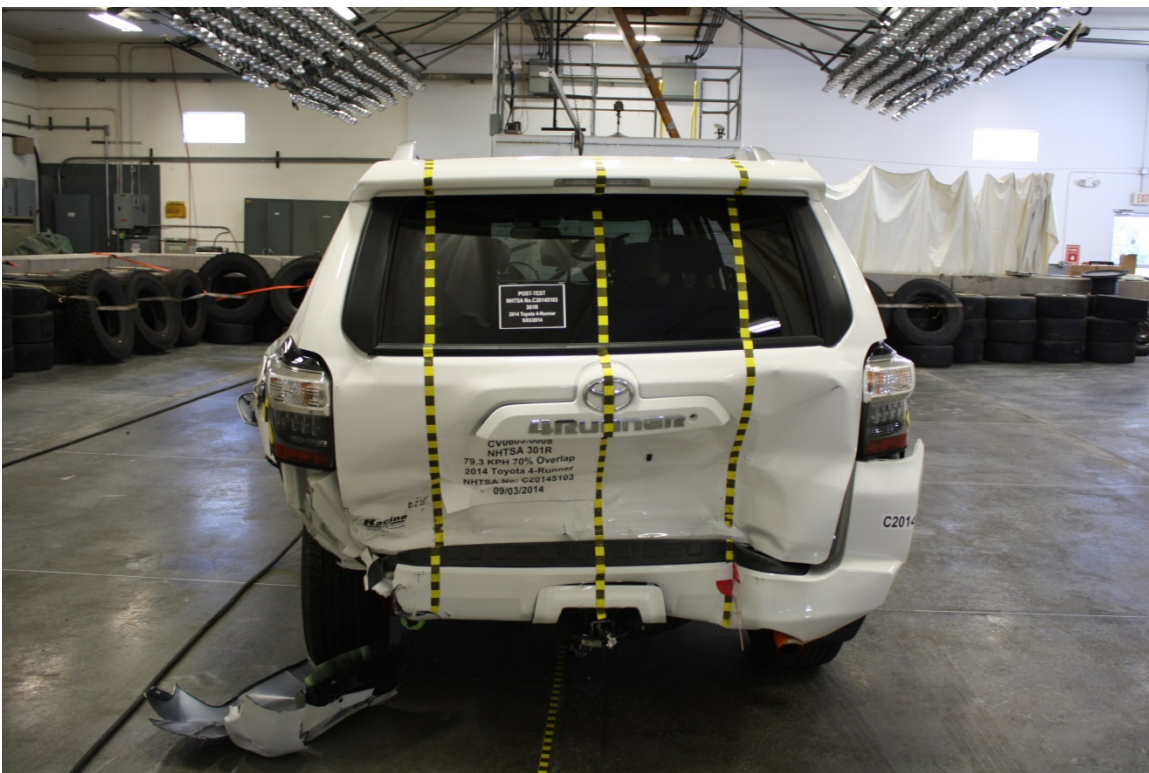
Figure A-18: Post-Test Rear View

| Measurement | Left Side | Centerline | Right Side |
|---|---|---|---|
| Crush | -268 | -332 | -178 |

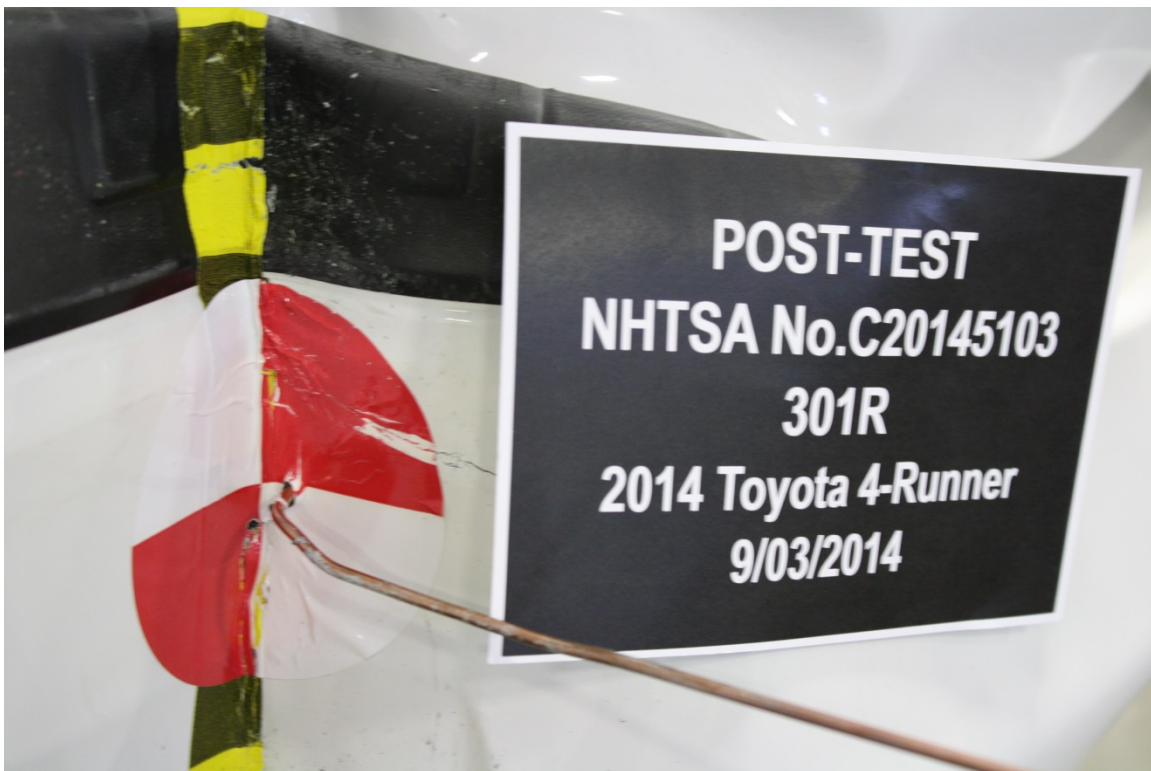
**Figure A-28: Post-Test Impact Target View**

| Measurement Description | Tolerance | Units | Value |
|---|---|---|---|
| Vertical distance from target center<br>(+ is above) | ±40 mm | mm | 0 |
| Horizontal distance from target center<br>(+ is right) | ±50 mm | mm | +6 |
