**REPORT NUMBER: TR-P34135-05-NC**  
**SAFETY COMPLIANCE TESTING FOR FMVSS 301R**  
**FUEL SYSTEM INTEGRITY – REAR IMPACT**  
**79.3 KM/H 70% OVERLAP REAR IMPACT**

**VOLKSWAGEN DE MEXICO S.A. DE C.V.**  
**2014 VOLKSWAGEN BEETLE 3-DOOR HATCHBACK**

**NHTSA NUMBER: C20145801**

**PREPARED BY:**  
**KARCO ENGINEERING, LLC.**  
**9270 HOLLY ROAD**  
**ADELANTO, CA 92301**

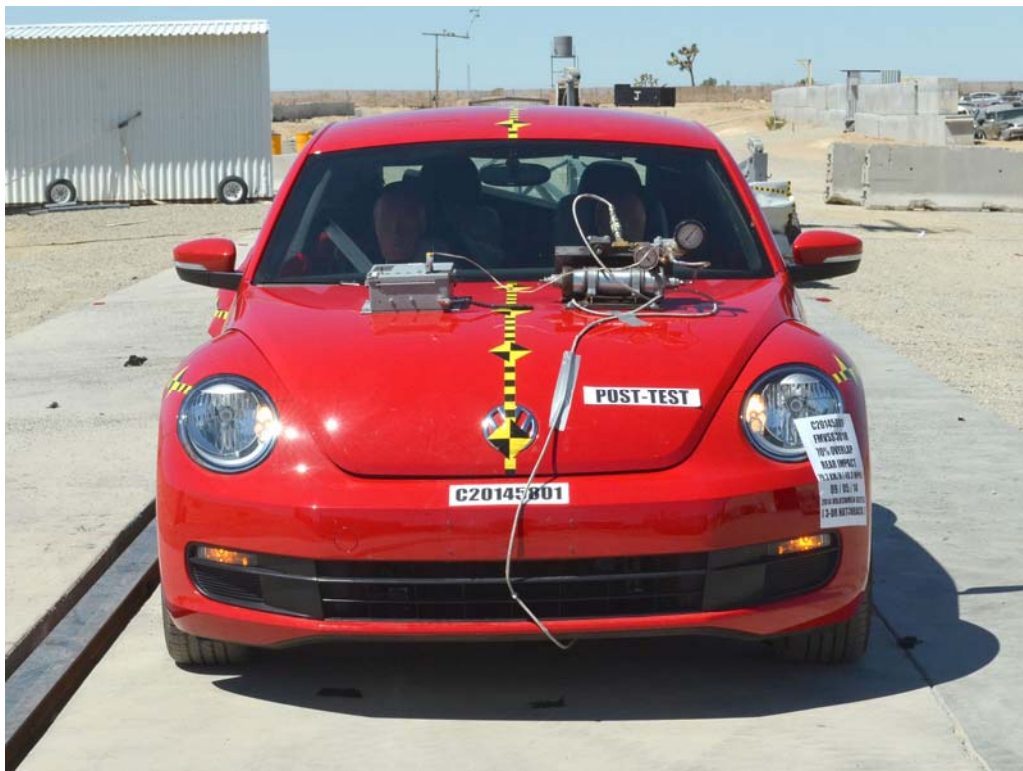
FIGURE 6. Post-Test Front View of Test Vehicle

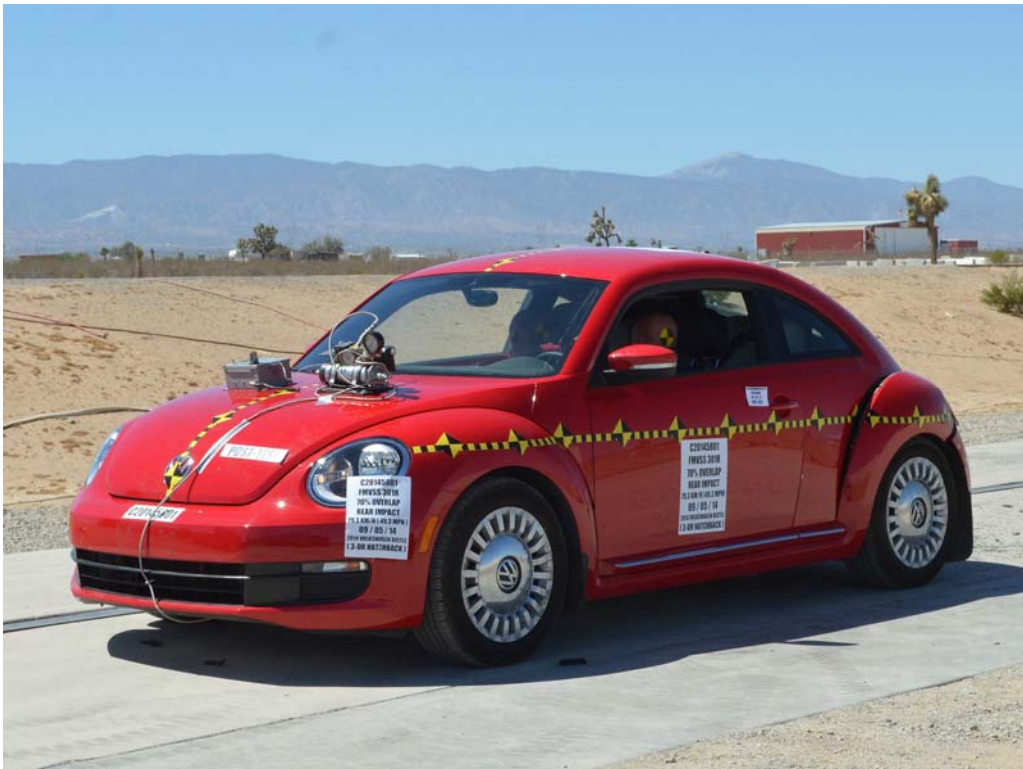
FIGURE 8. Post-Test Left Front  $\frac{3}{4}$  View of Test Vehicle

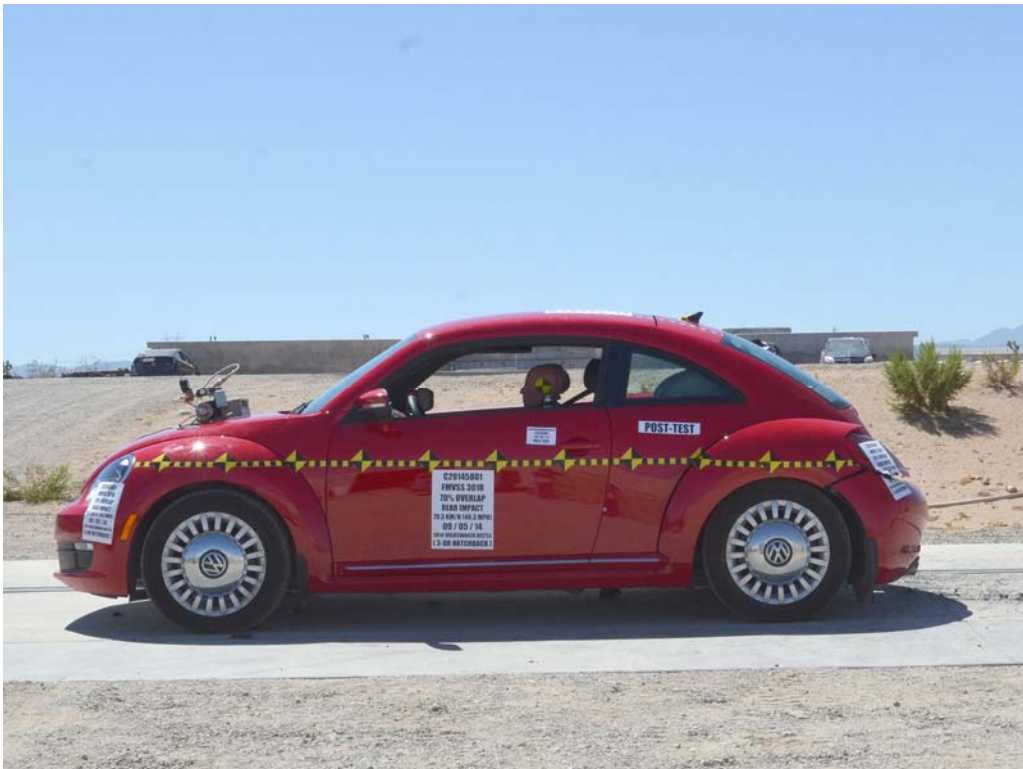
FIGURE 10. Post-Test Left Side View of Test Vehicle

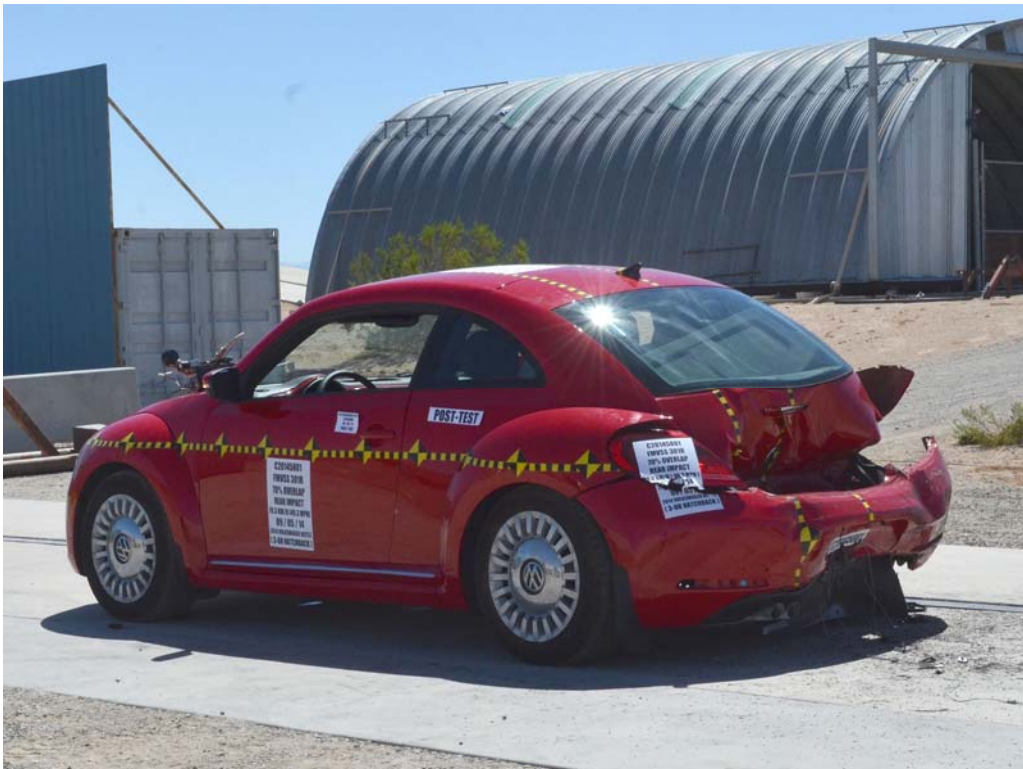
FIGURE 12. Post-Test Left Rear  $\frac{3}{4}$  View of Test Vehicle

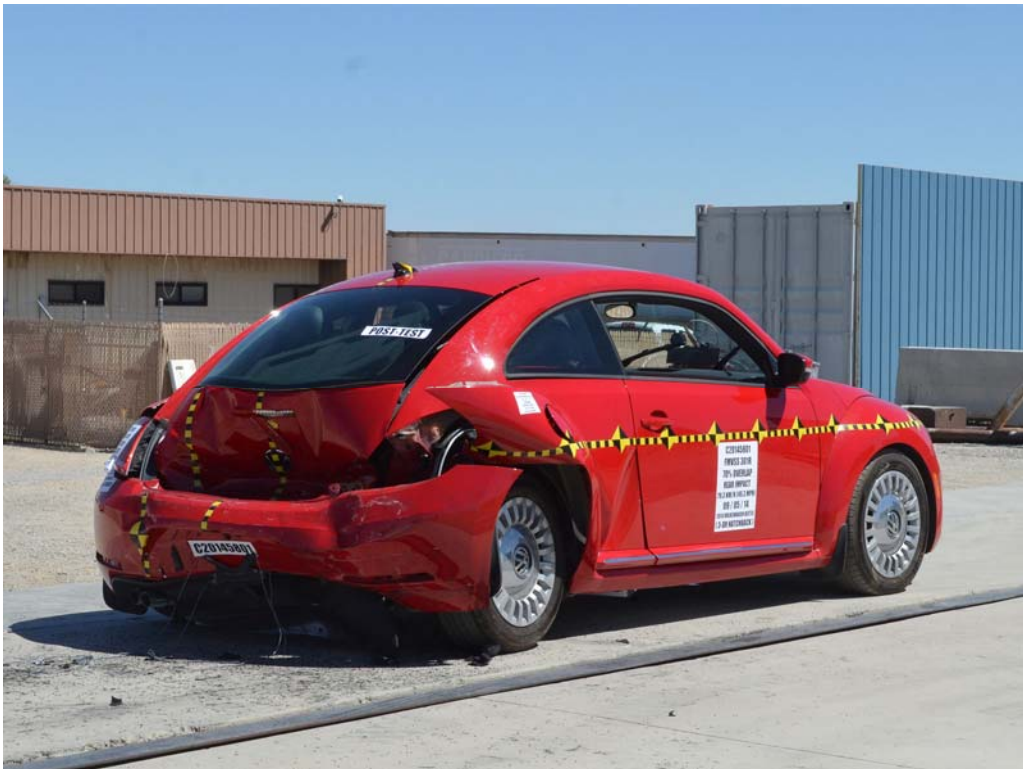
FIGURE 16. Post-Test Right Rear  $\frac{3}{4}$  View of Test Vehicle

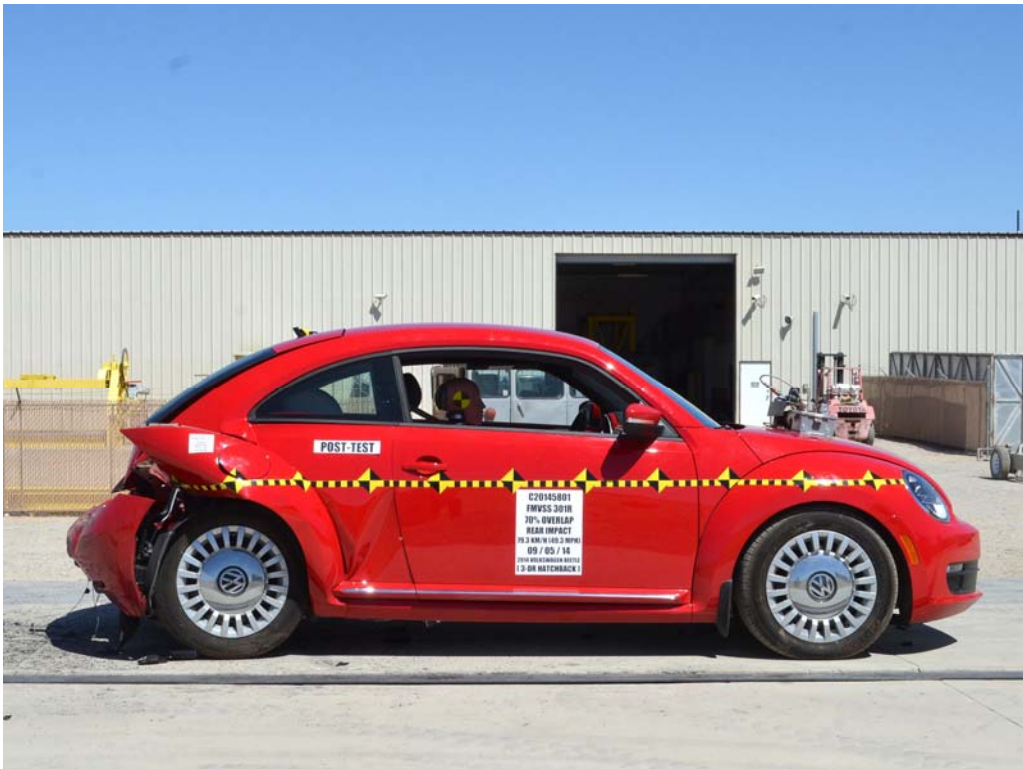
FIGURE 18. Post-Test Right Side View of Test Vehicle

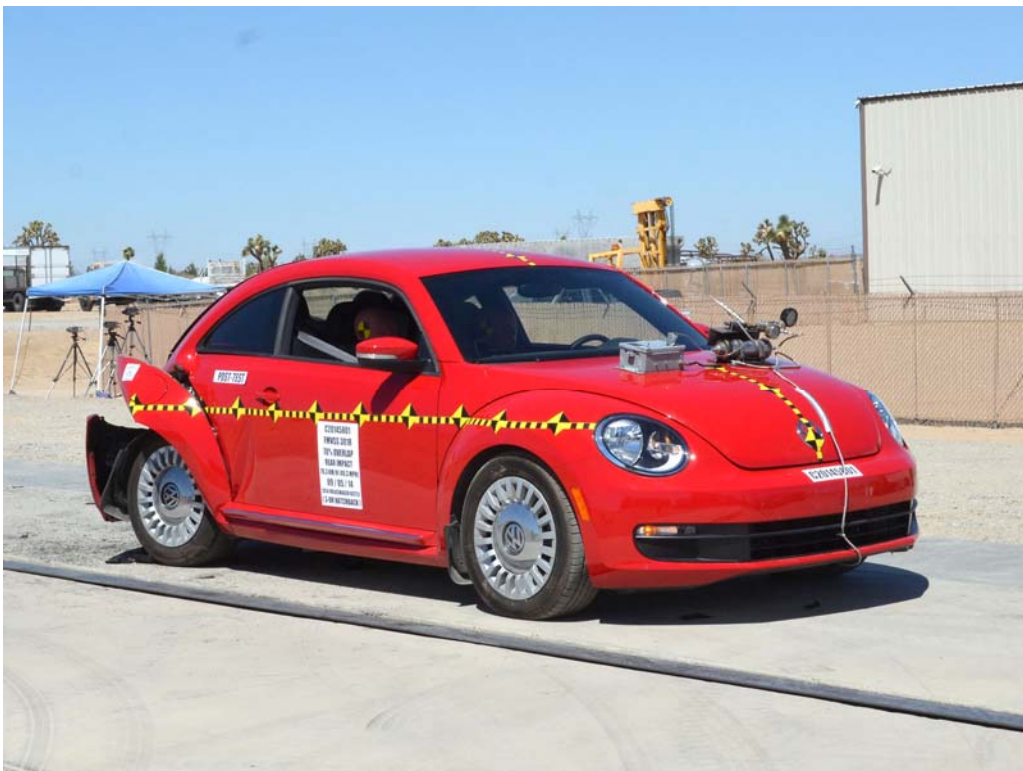
FIGURE 20. Post-Test Right Front  $\frac{3}{4}$  View of Test Vehicle

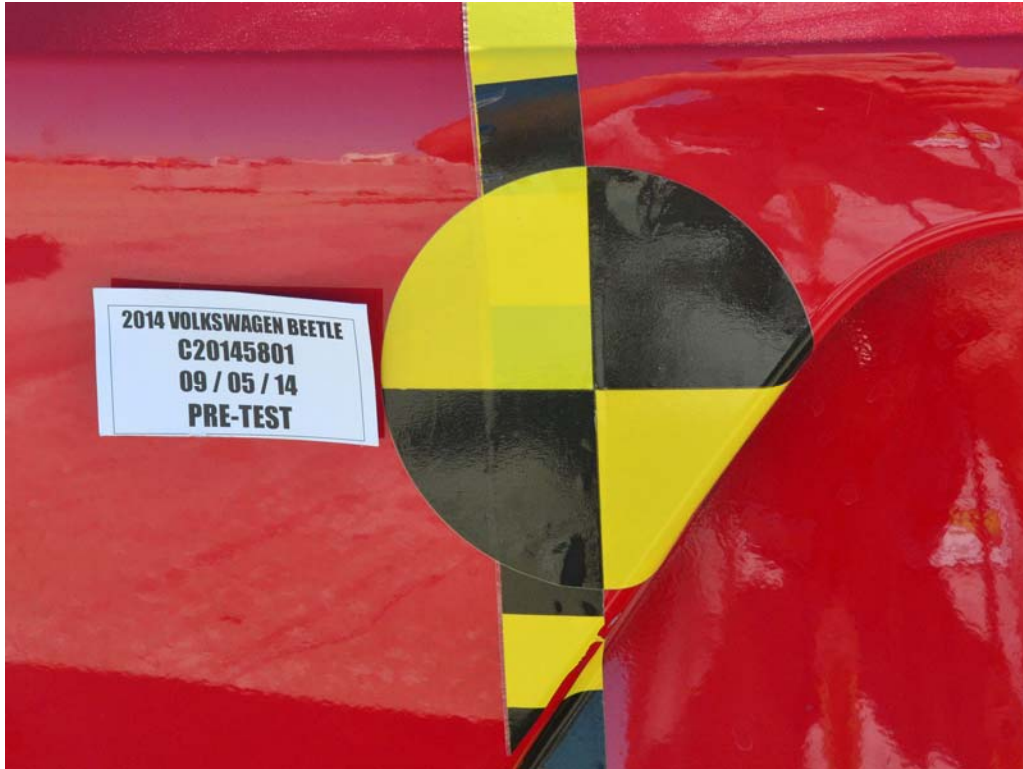
FIGURE 21. Pre-Test Close-Up View of Impact Point Target

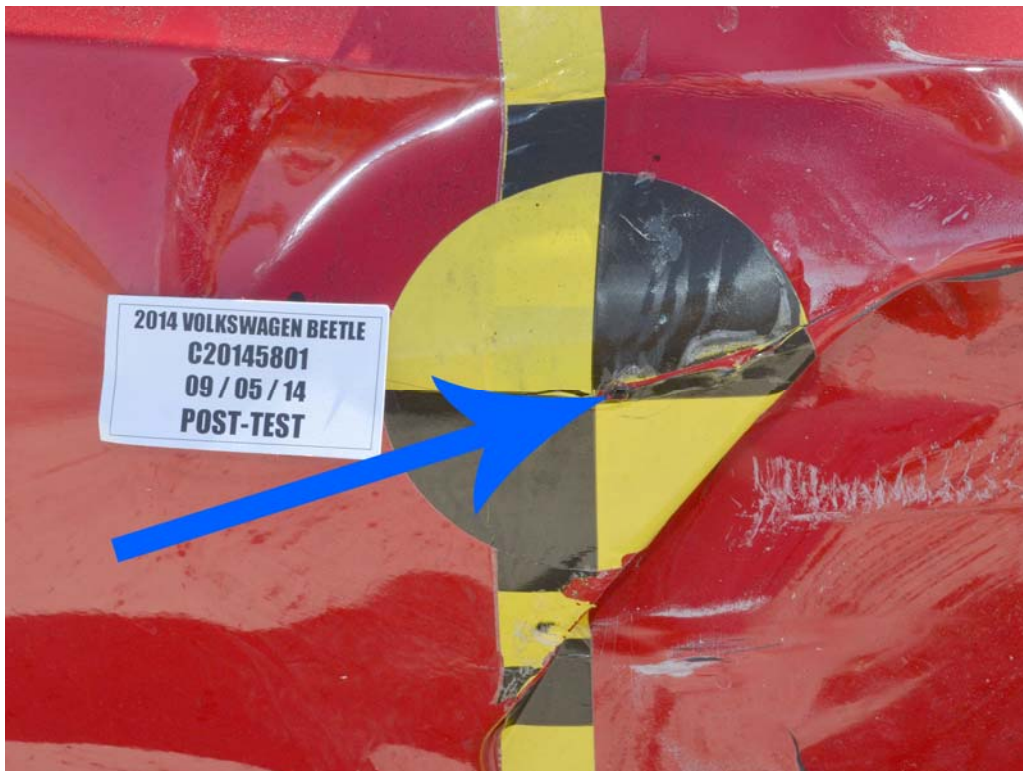
FIGURE 22. Post-Test Close-Up View of Impact Point Target

| Measured Parameter | Units | Tolerance | Value |
|---|---|---|---|
| Actual Impact Point (Left of Vehicle Center Line) | mm | | 351 |

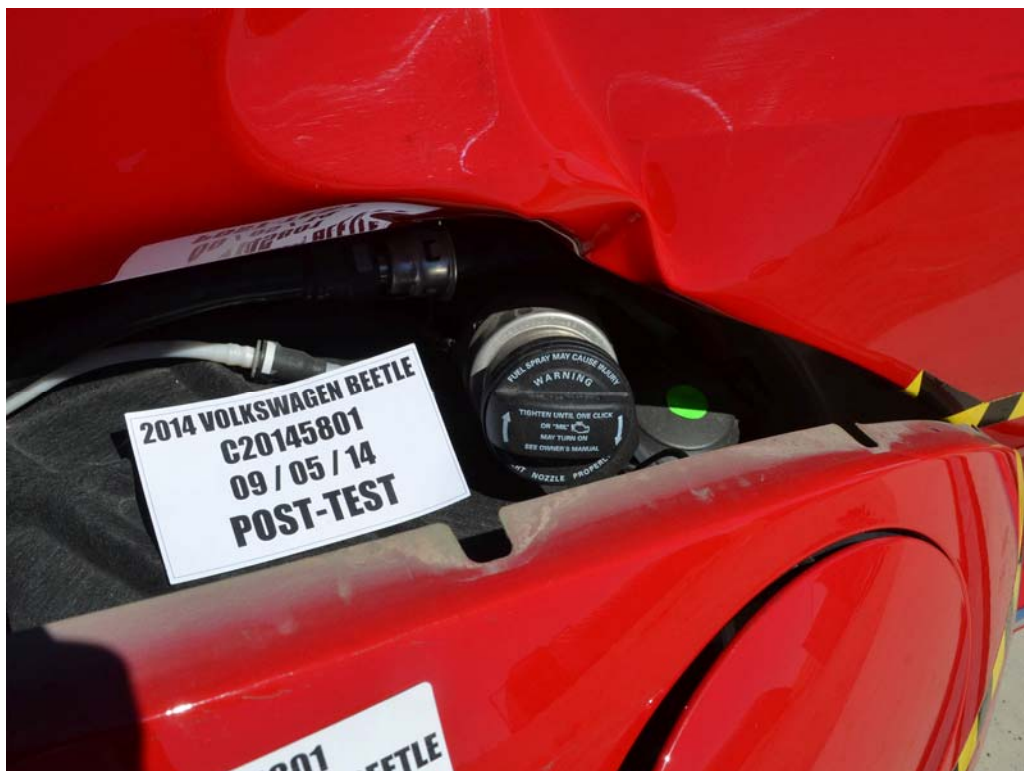
FIGURE 24. Post-Test View of Fuel Filler Cap

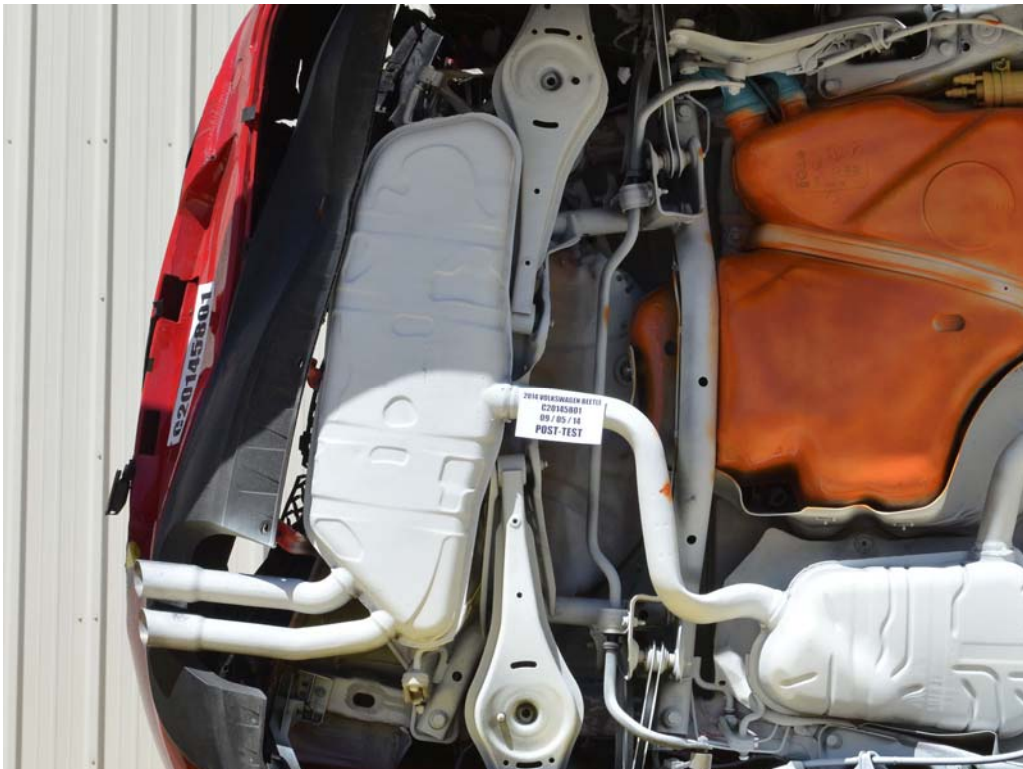
FIGURE 26. Post-Test Rear Underbody View of Test Vehicle

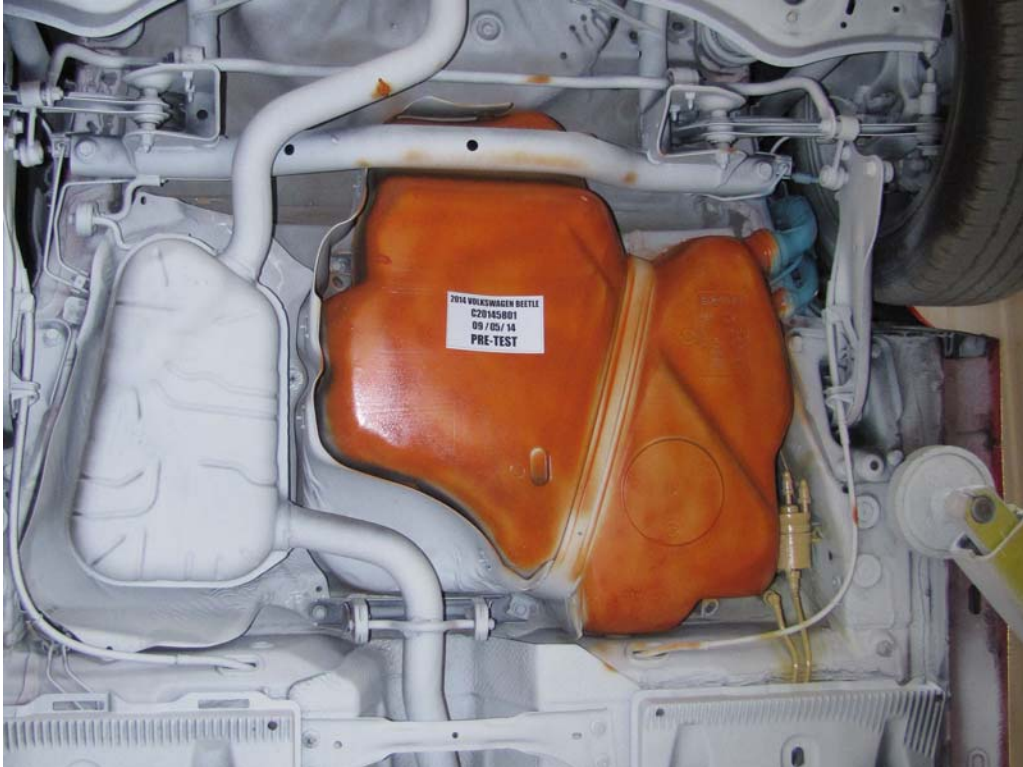
FIGURE 27. Pre-Test Underbody View of Fuel Tank

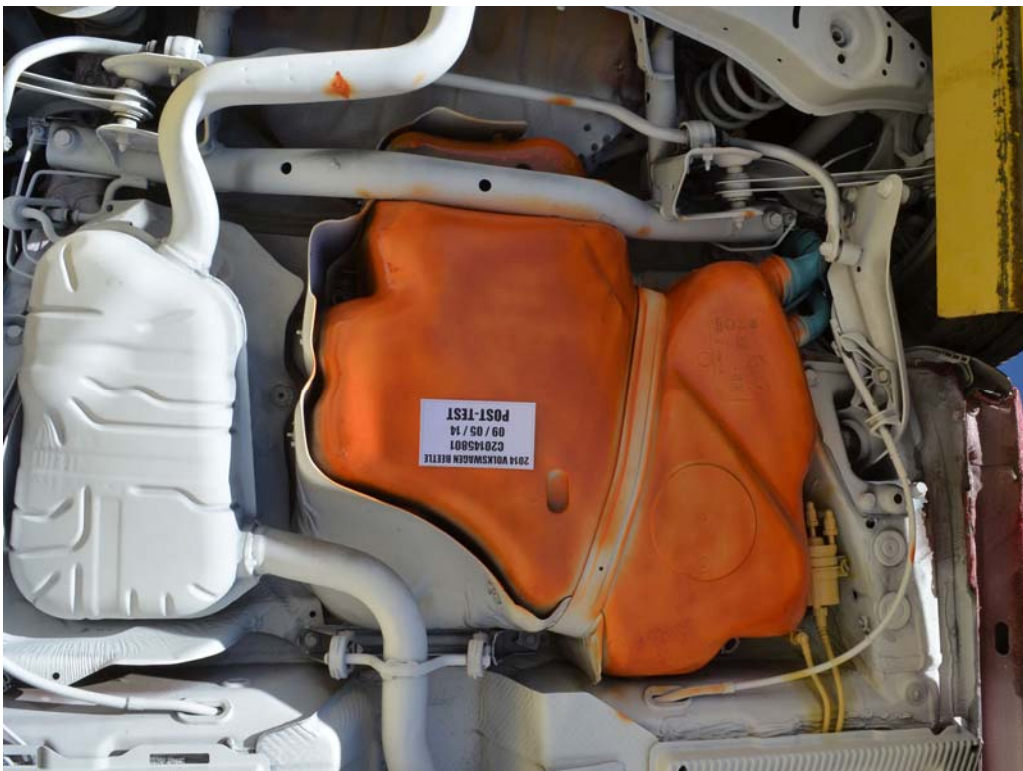
FIGURE 28. Post-Test Underbody View of Fuel Tank

- A. From impact until vehicle motion ceases: 0 g  
(Maximum allowable = 28 g)
- B. For the 5 minute period after motion ceases: 0 g  
(Maximum allowable = 28 g)
- C. For the following 25 minutes: 0 g  
(Maximum allowable = 28 g/minute)
- D. Spillage: No Stoddard Solvent leakage  
\_\_\_\_\_  
\_\_\_\_\_  
\_\_\_\_\_

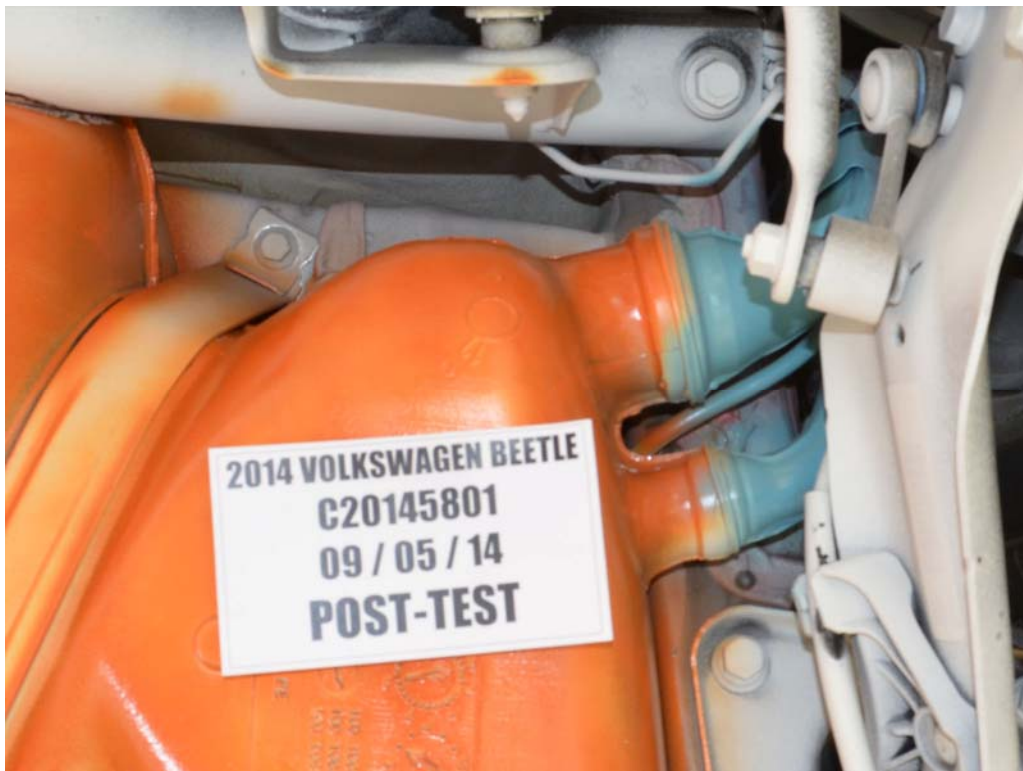
FIGURE 30. Post-Test Underbody View of Fuel Filler Neck

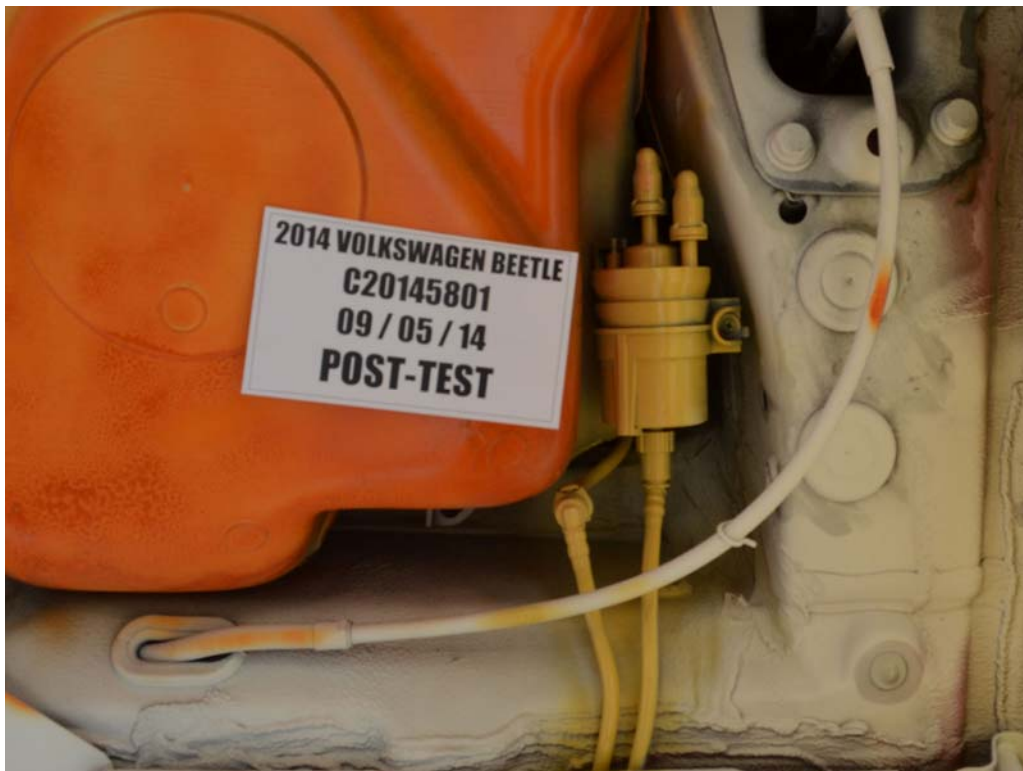
FIGURE 32. Post-Test Underbody View of Fuel Lines

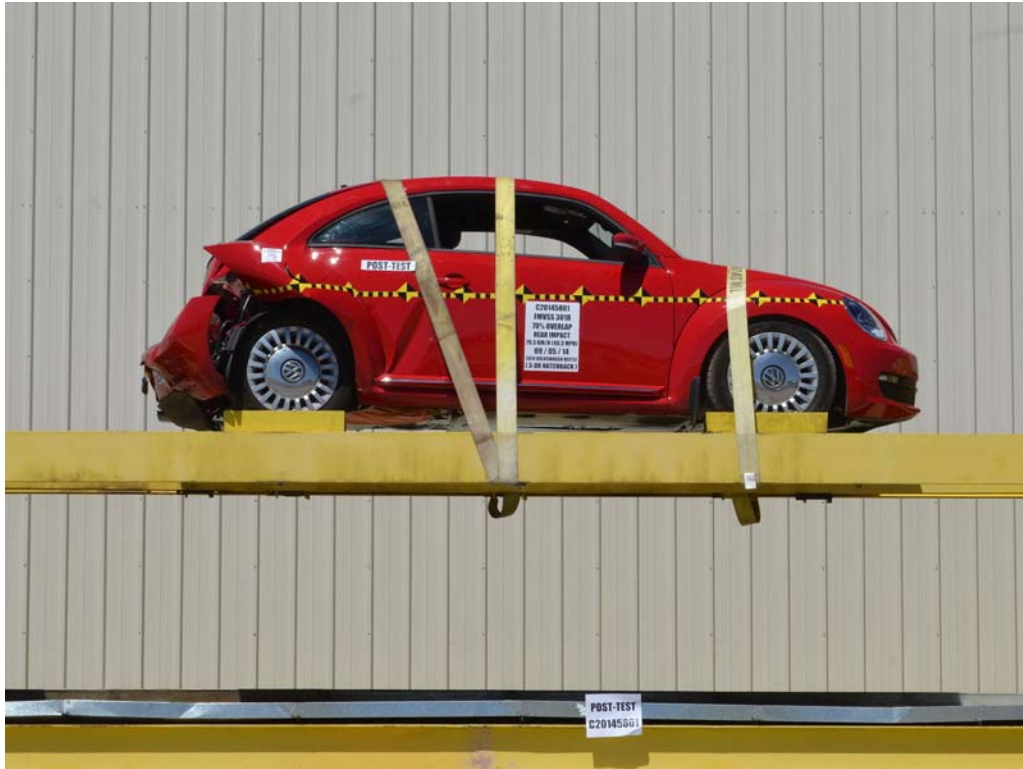
FIGURE 33. Test Vehicle at 0° on FMVSS 301 Static Rollover Device

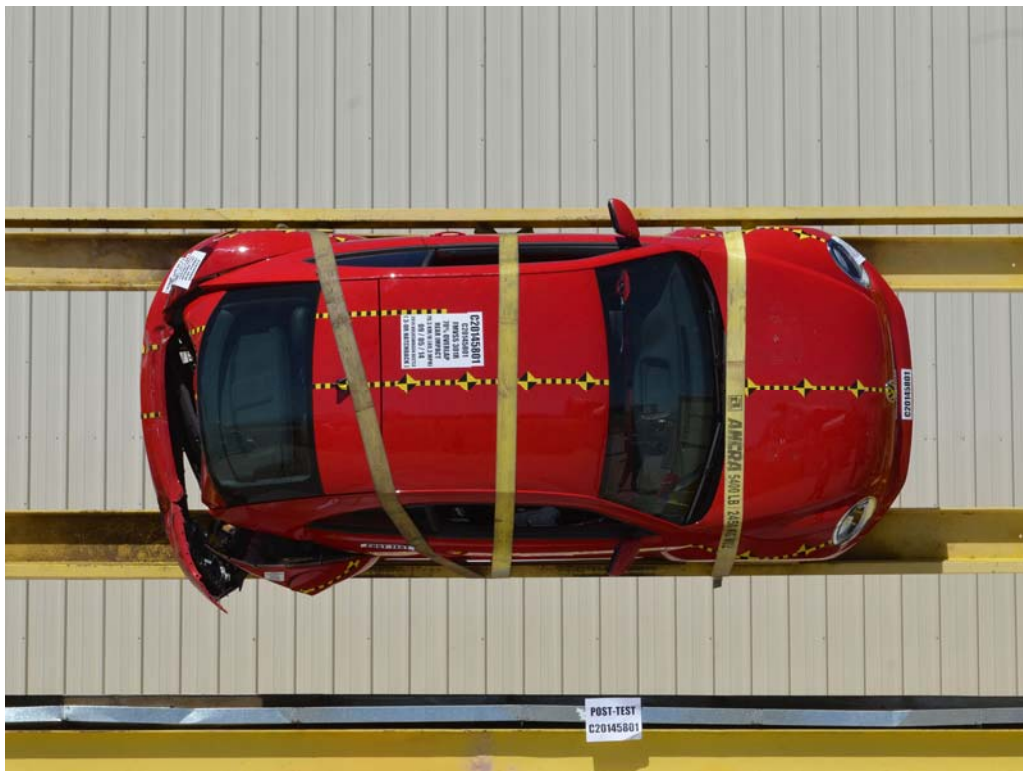
FIGURE 34. Test Vehicle at 90° on FMVSS 301 Static Rollover Device

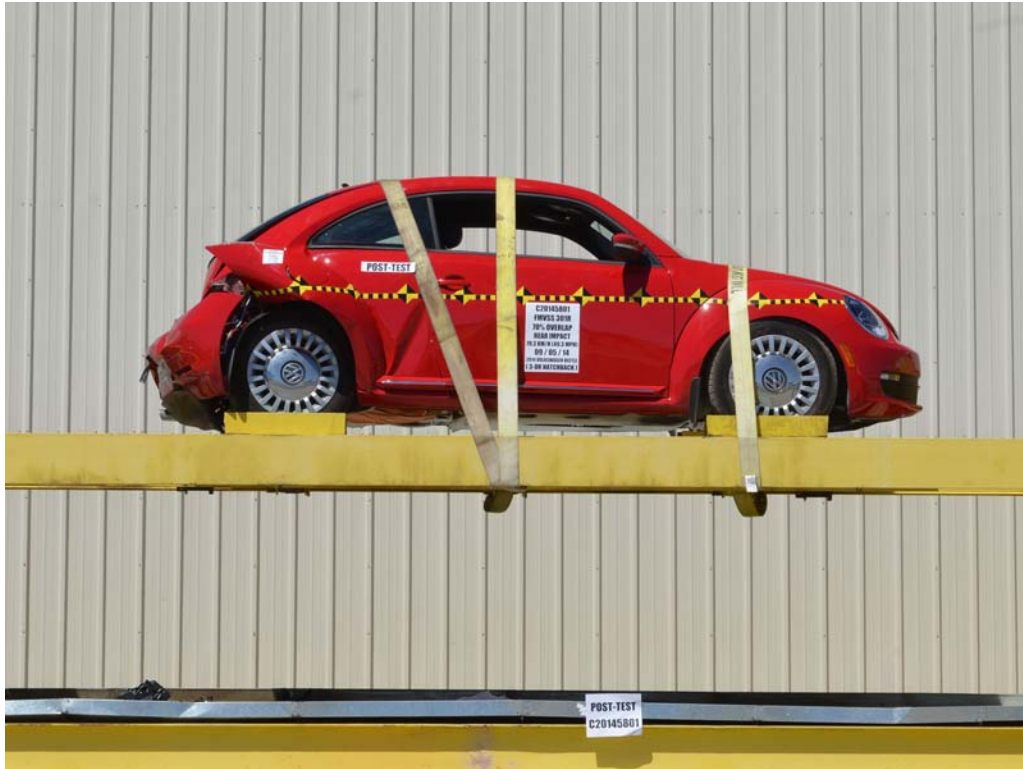
FIGURE 37. Test Vehicle at 360° on FMVSS 301 Static Rollover Device

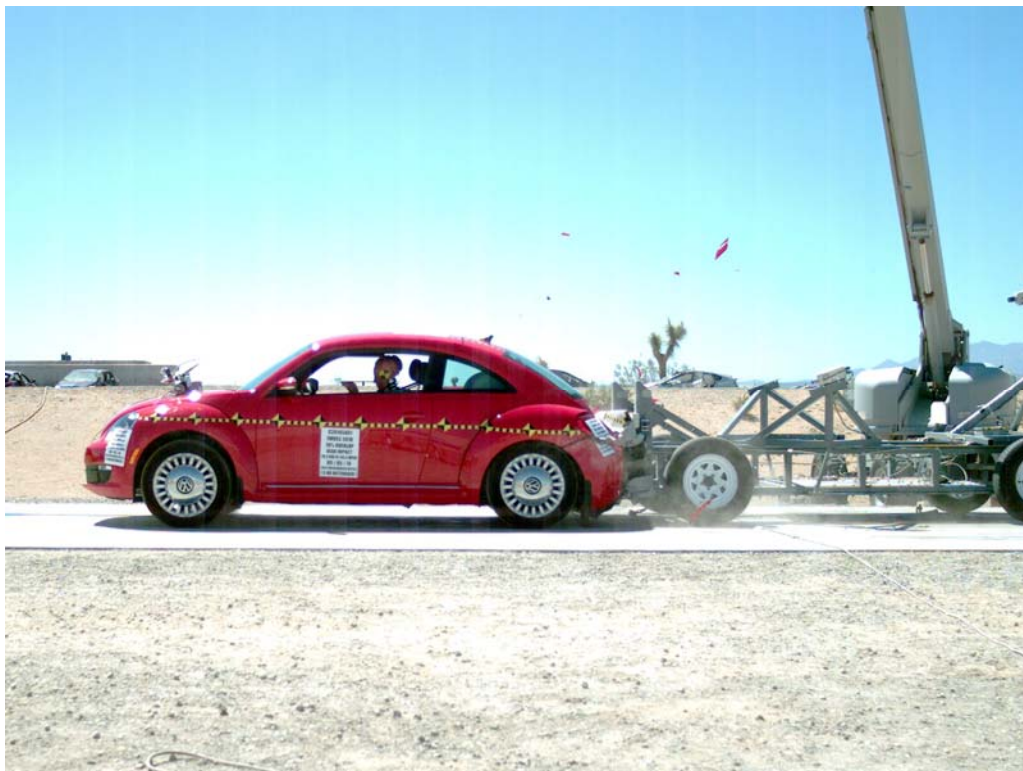
FIGURE 38. Impact Event
