**REPORT NUMBER: 301R-CAL-15-007**

**SAFETY COMPLIANCE TESTING FOR FMVSS 301R  
FUEL SYSTEM INTEGRITY – REAR IMPACT**

**Ford Motor Co.  
2015 Ford Transit**

**NHTSA NUMBER: C20150204**

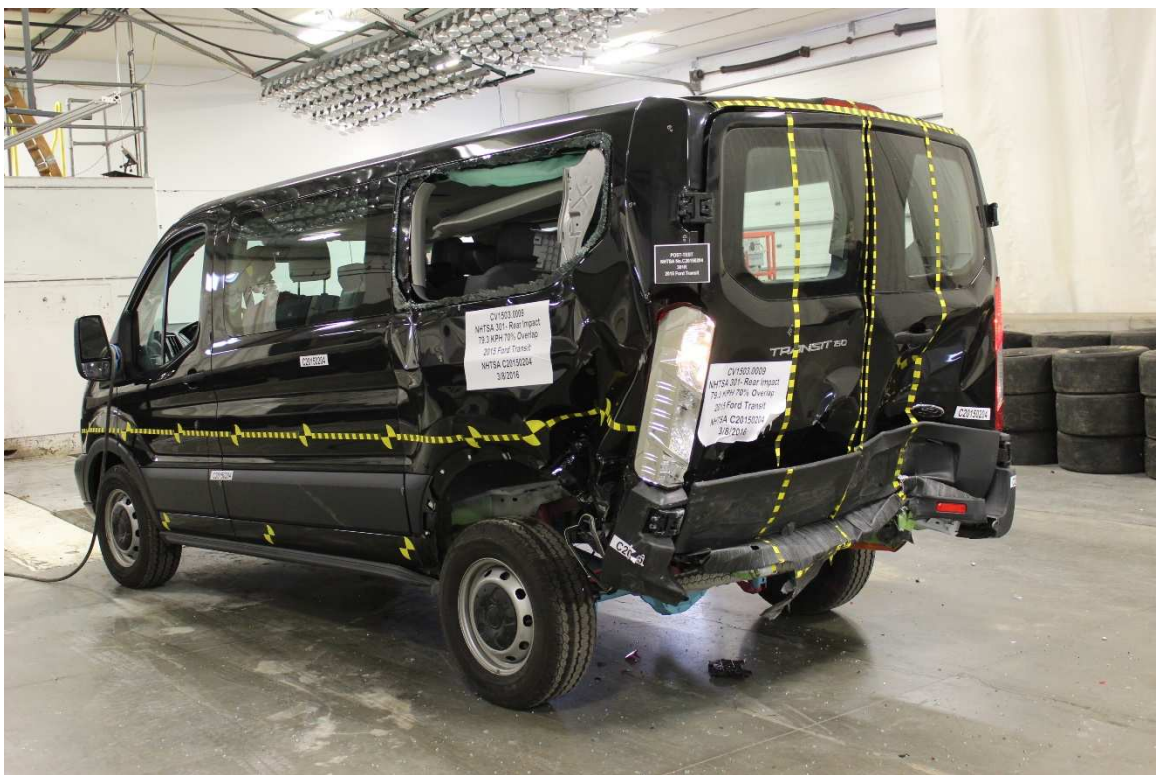
**Figure A-14: Post-Test Left Rear 3/4 View**

| Critical Areas of Performance | Observations and Conclusions |
|---|---|
| Window Damage | Left Rear side window shattered during impact |

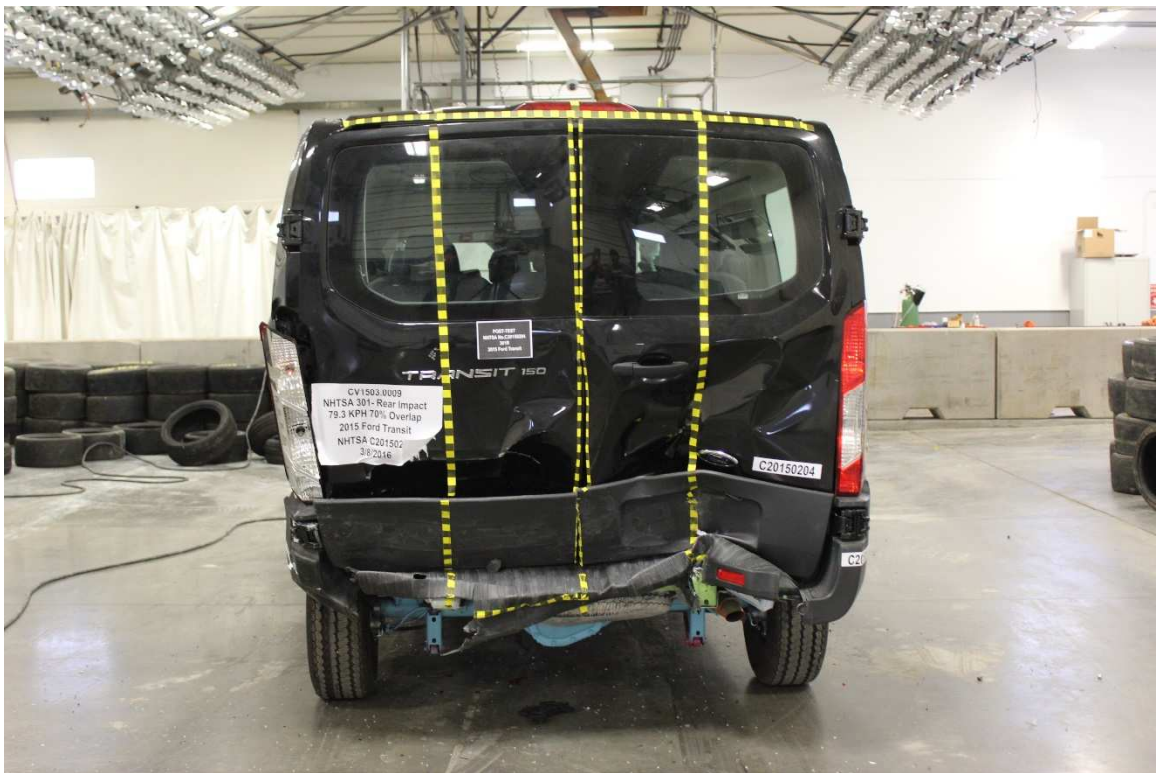
**Figure A-18: Post-Test Rear View**

| Measurement | Units | Left Side | Centerline | Right Side |
|---|---|---|---|---|
| Crush | mm | -392 | -357 | -361 |

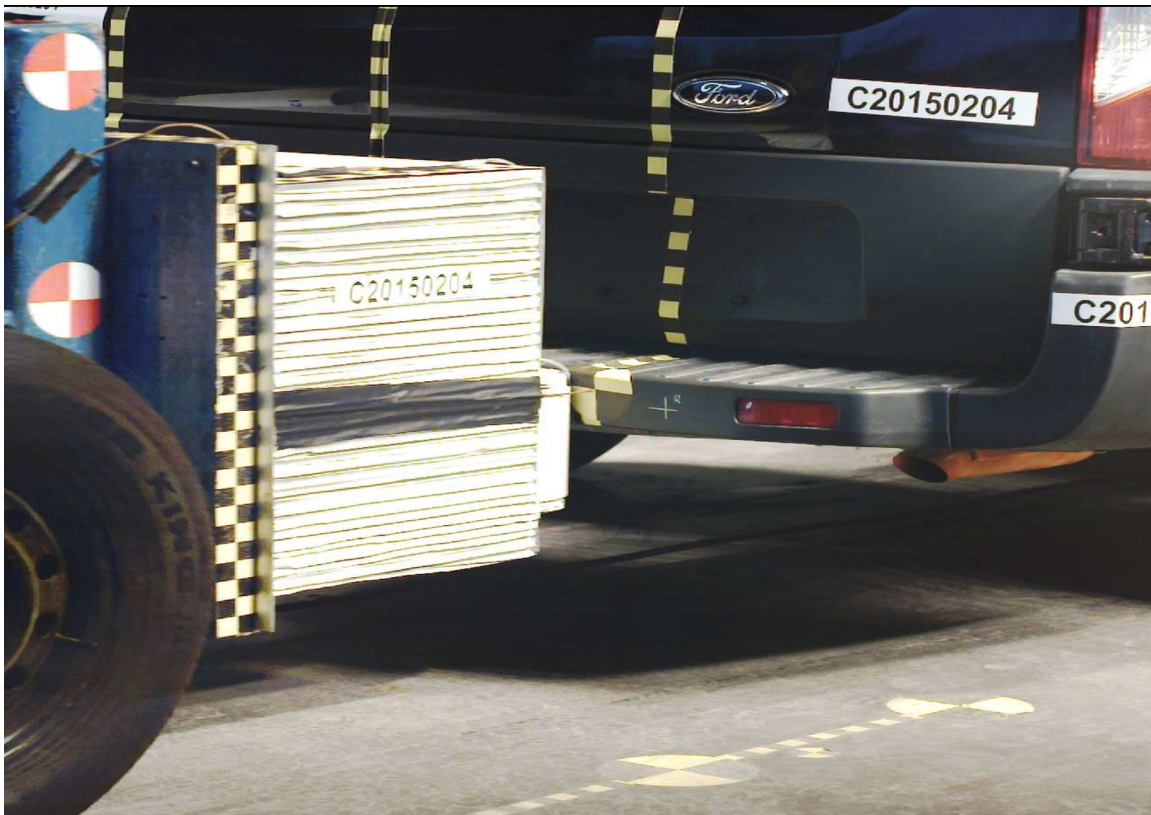
**Figure A-28: Post-Test Impact Target View**

| Measurement Description | Tolerance | Units | Value |
|---|---|---|---|
| Vertical distance from target center<br>(+ is above) | ±40 mm | mm | -3 |
| Horizontal distance from target center<br>(+ is right) | ±50 mm | mm | -3 |

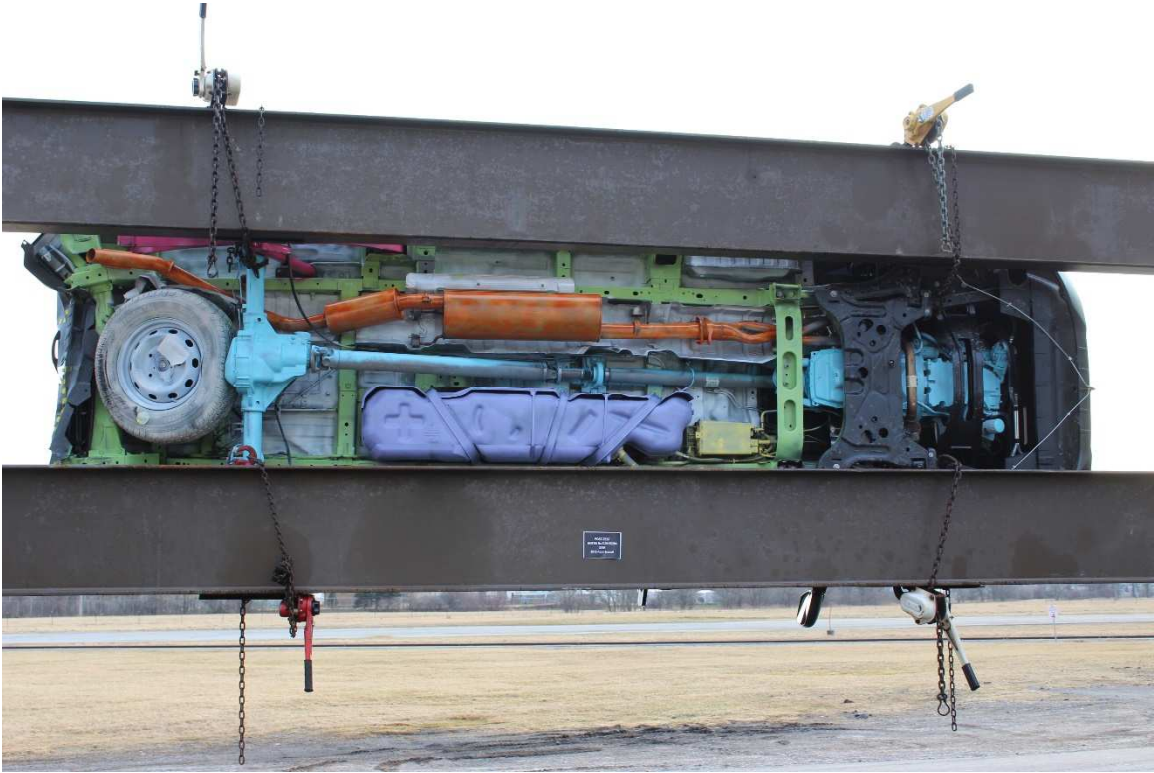
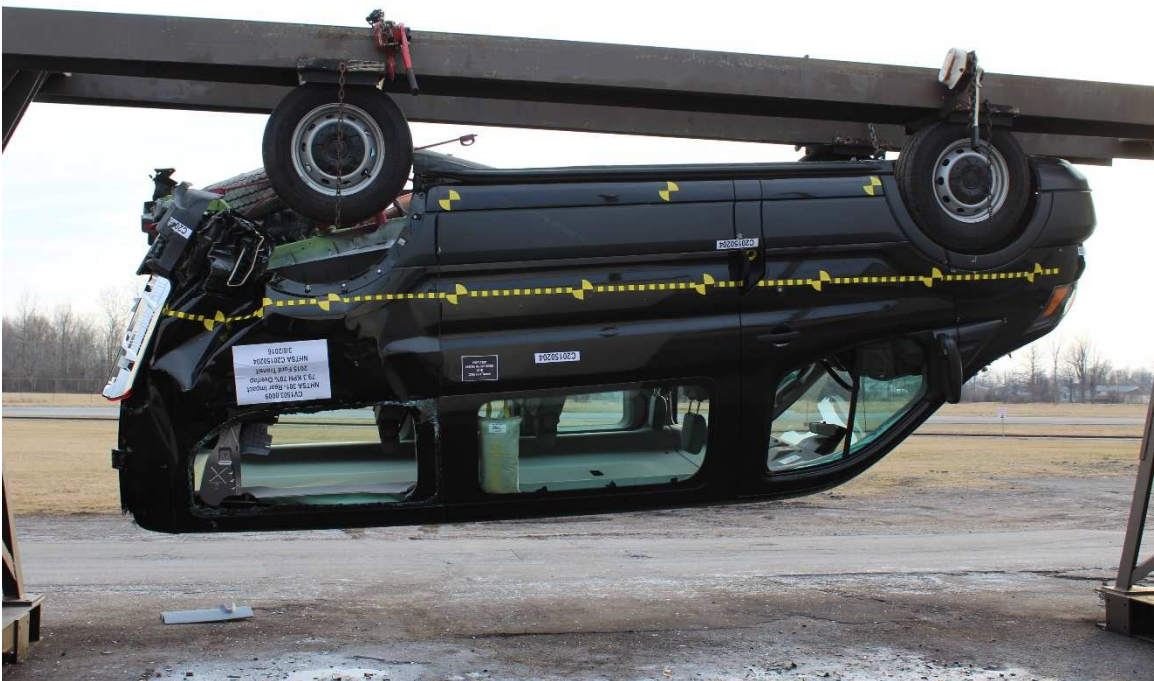
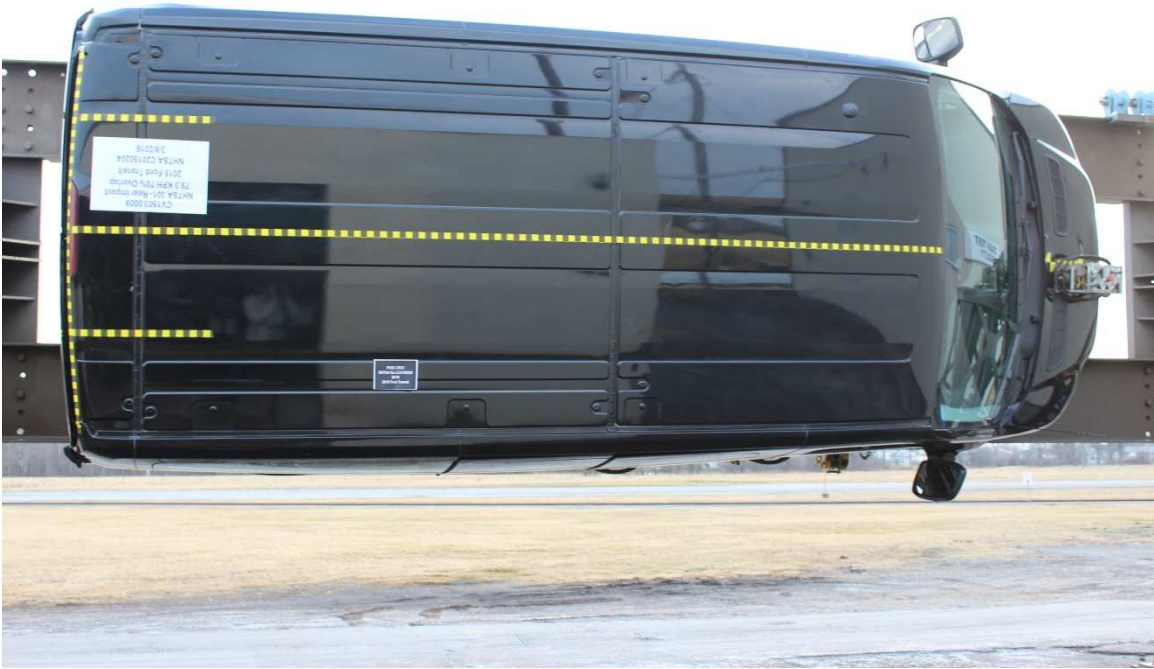
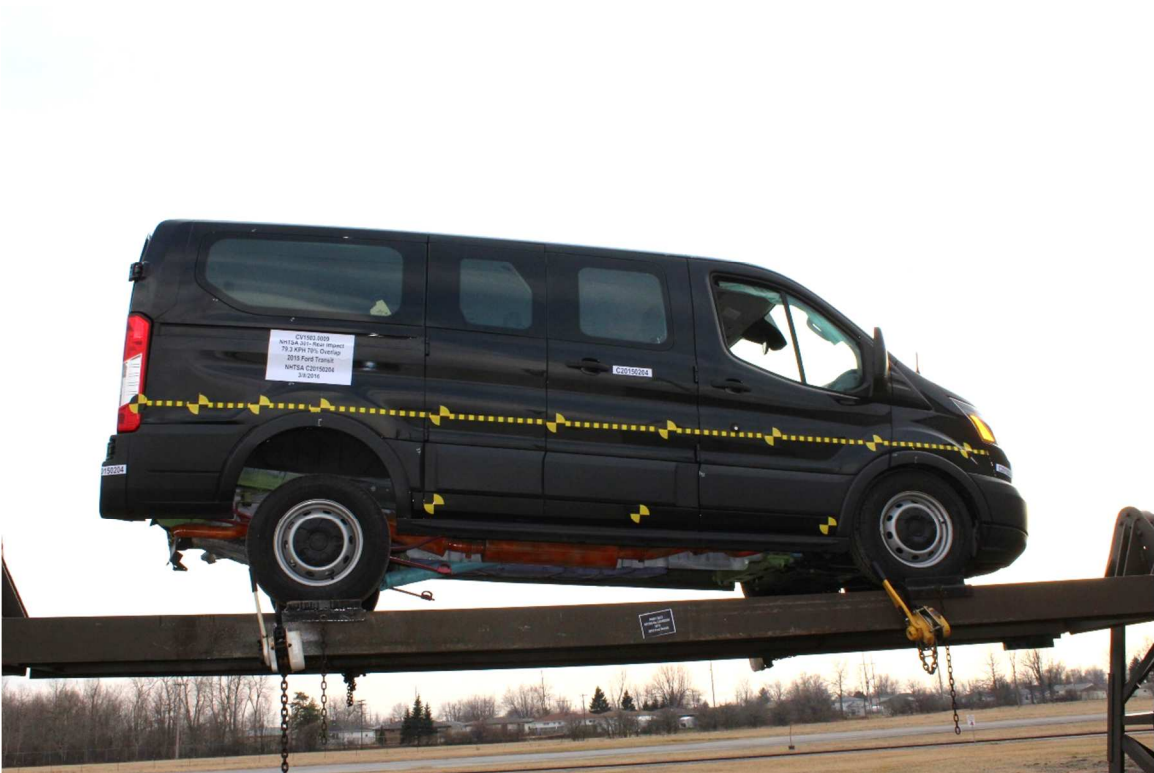
**ACTUAL TEST VEHICLE STODDARD SOLVENT SPILLAGE TABLE**

**ROLLOVER STODDARD SOLVENT SPILLAGE LOCATION TABLE**
