**REPORT NUMBER: 301R-CAL-15-009**

**SAFETY COMPLIANCE TESTING FOR FMVSS 301R  
FUEL SYSTEM INTEGRITY – REAR IMPACT**

**Toyota Motor Manufacturing, Northern Kentucky, INC  
2015 Toyota Camry**

**NHTSA NUMBER: C20155105**

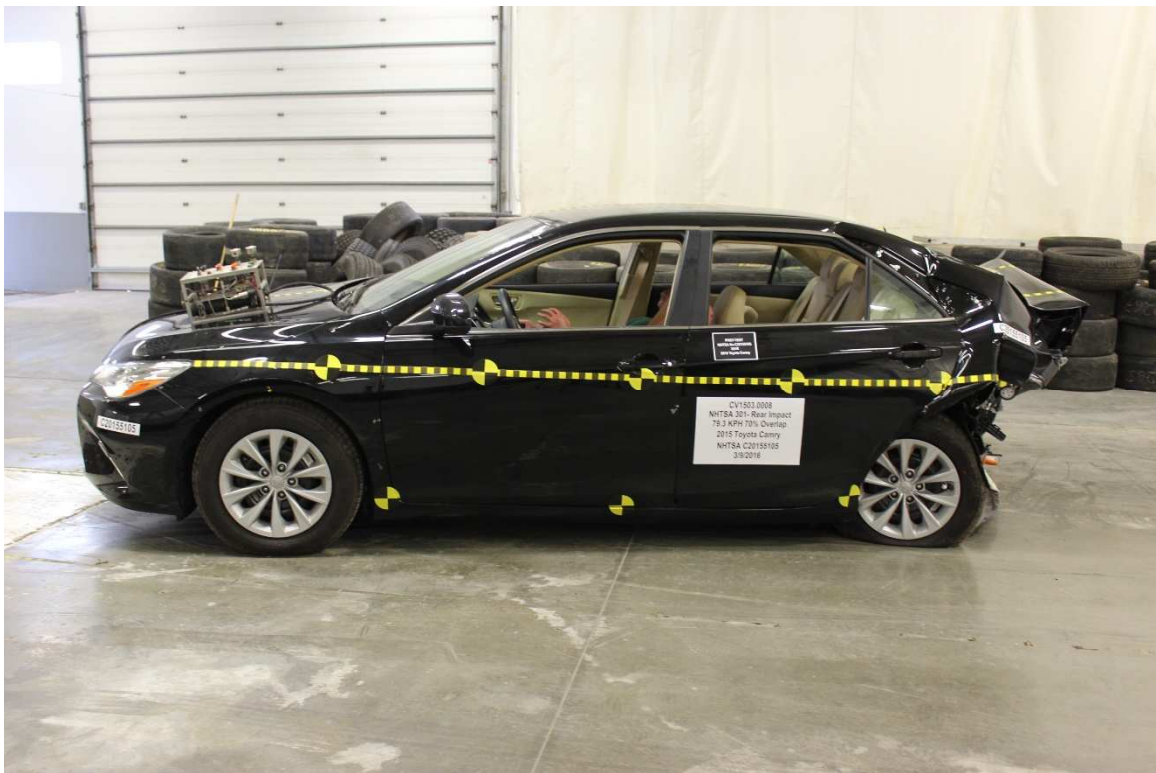
**Figure A-6: Post-Test Left Side View**

| Description | Driver | Passenger |
|---|---|---|
| Rear Door Opening | Jammed | Closed & Operational |

| Measurement | Left Side | Centerline | Right Side |
|---|---|---|---|
| Crush | -814 | -711 | -401 |

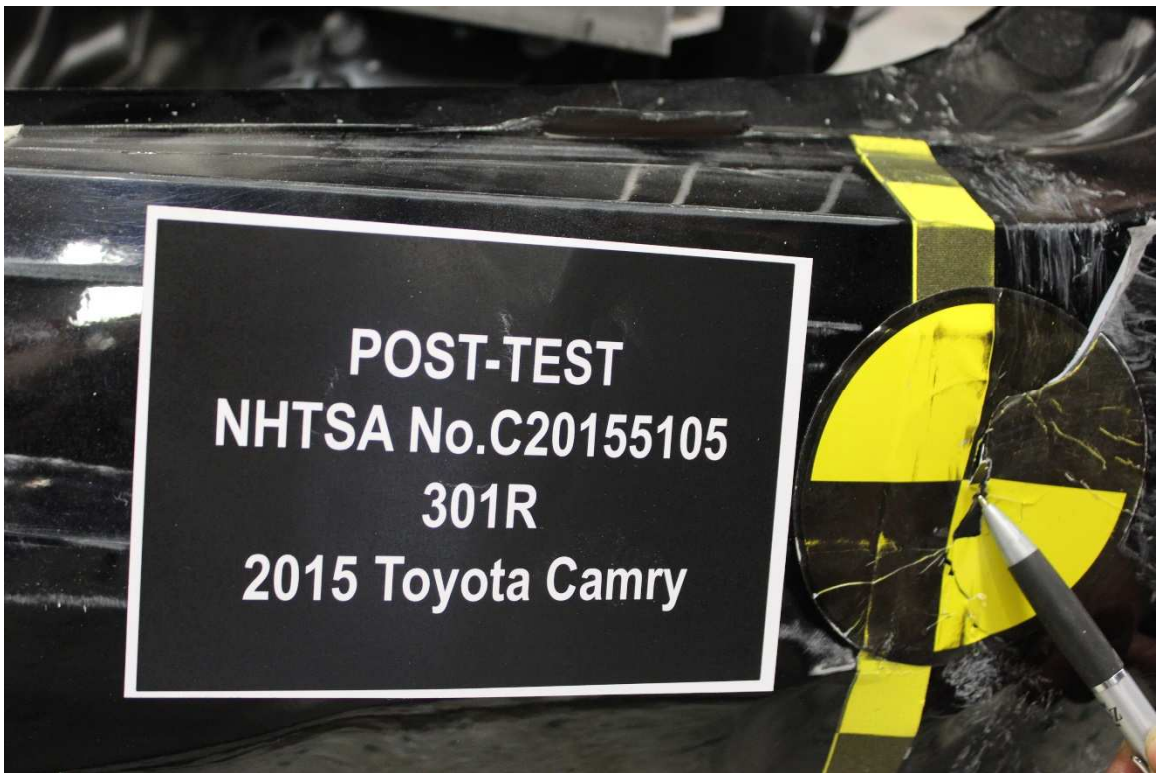
**Figure A-28: Post-Test Impact Target View**

| Measurement Description | Tolerance | Units | Value |
|---|---|---|---|
| Vertical distance from target center<br>(+ is above) | ±40 mm | mm | -4 |
| Horizontal distance from target center<br>(+ is right) | ±50 mm | mm | 6 |

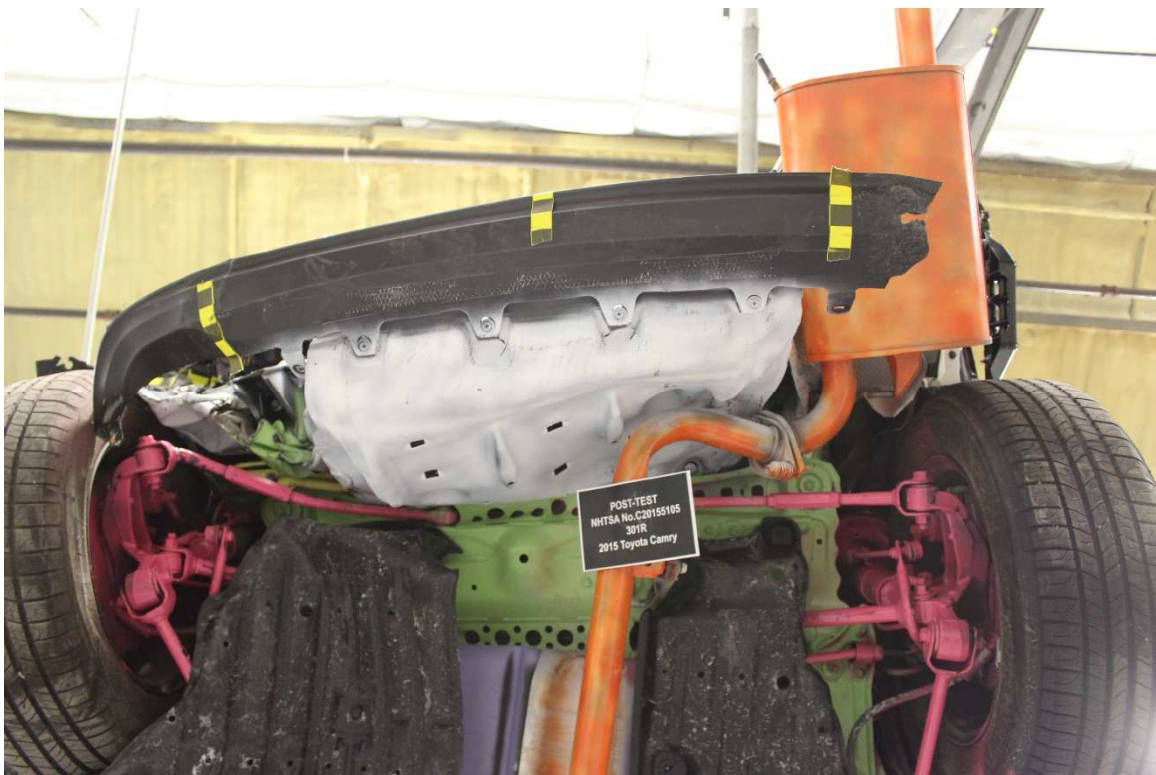
**Figure A-34: Post-Test Rear Underbody View**

- A. From impact until vehicle motion ceases:  
(Maximum allowable is 28 grams) 0 grams
- B. For the 5-minute period after motion ceases:  
(Maximum allowable is 28 grams) 0 grams
- C. For the next 25 minutes:  
(Maximum allowable is 28 grams/minute) 0 grams
- D. Spillage Details: No Spillage Occurred

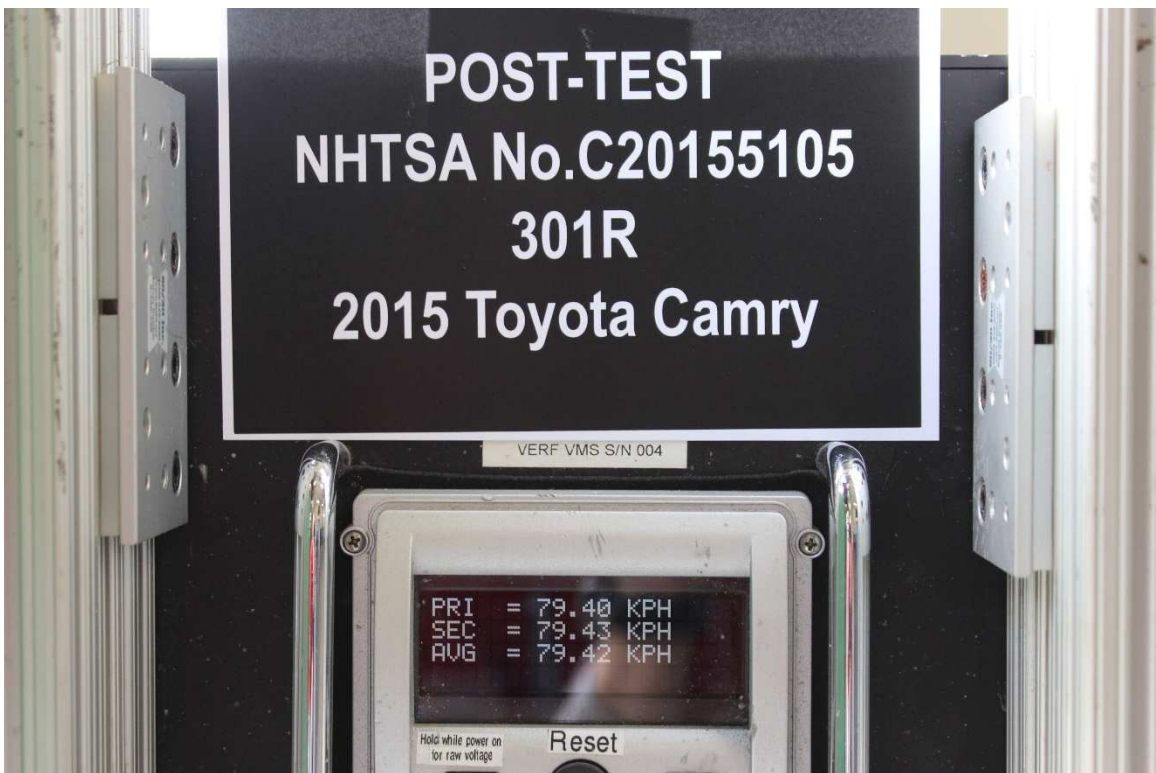
**Figure A-38: Speed Trap View\***

| Measurement Description | Units | Speed |
|---|---|---|
| Trap No. 1 | km/h | 79.40 |
| Trap No. 2 | km/h | 79.43 |

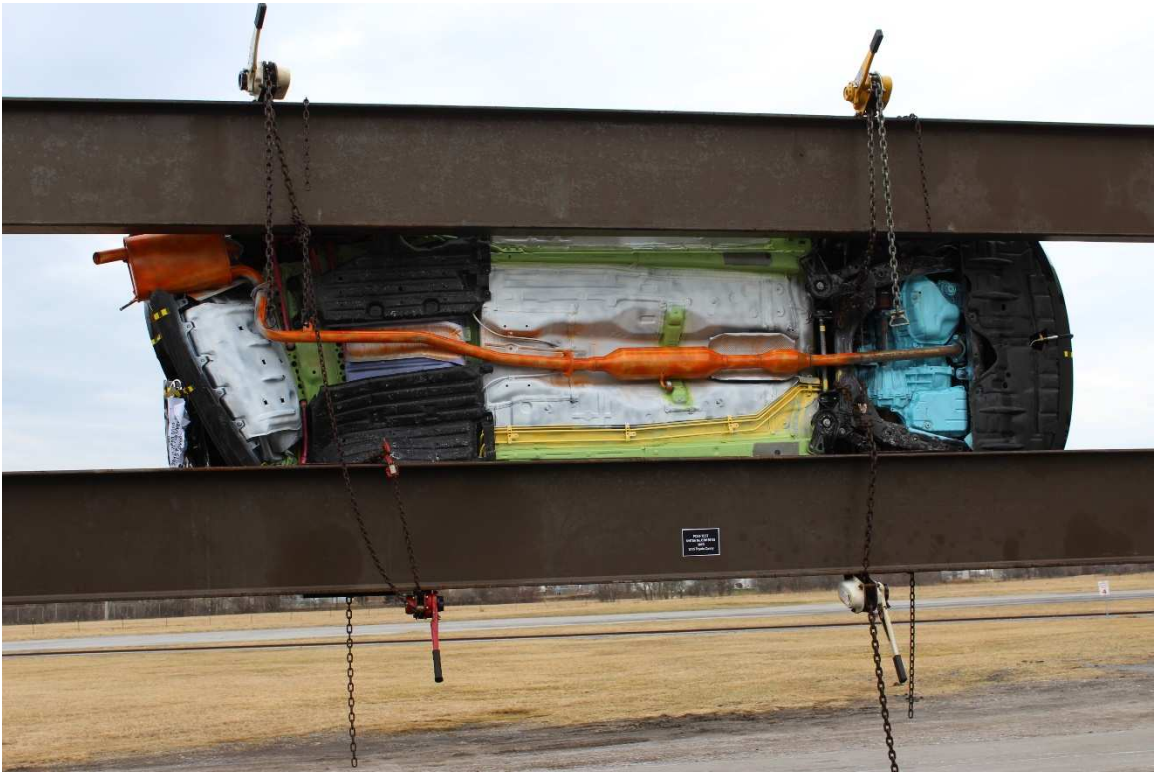
**Figure A-39: Rollover 90° View**

| Test Phase | Spillage Location |
|---|---|
| 0° to 90° | None |

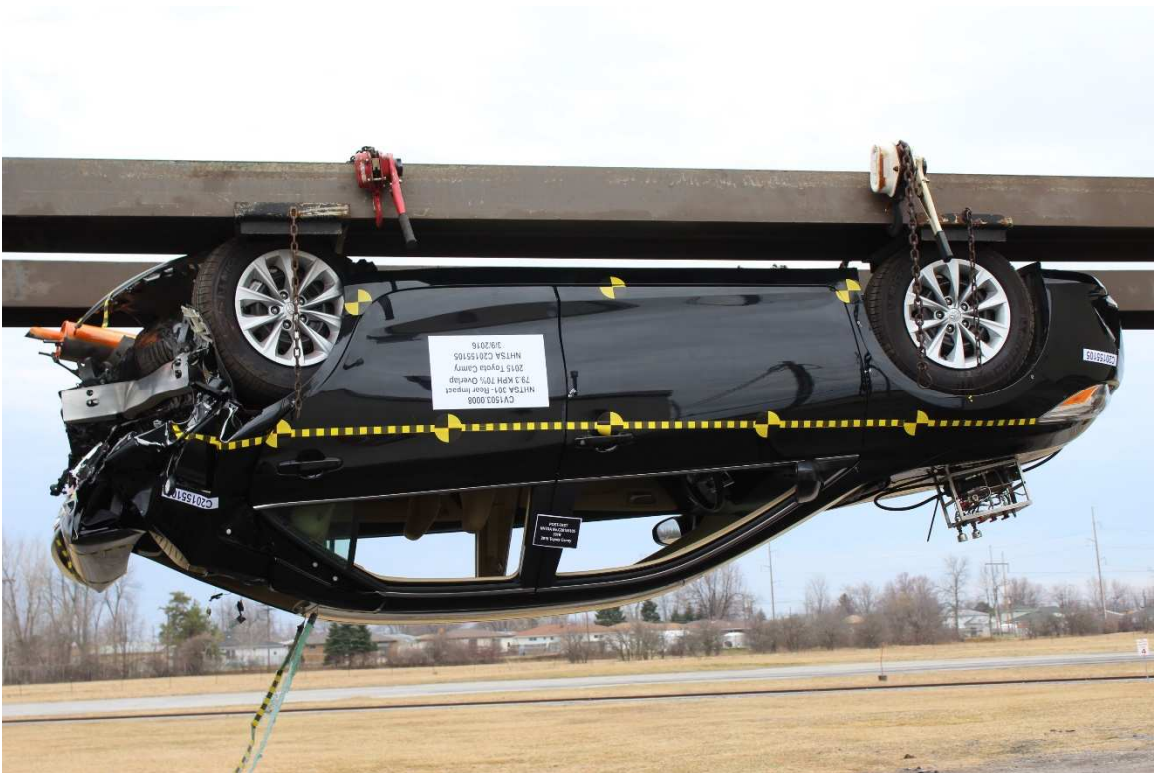
**Figure A-40: Rollover 180° View**

| Test Phase | Spillage Location |
|---|---|
| 90° to 180° | None |

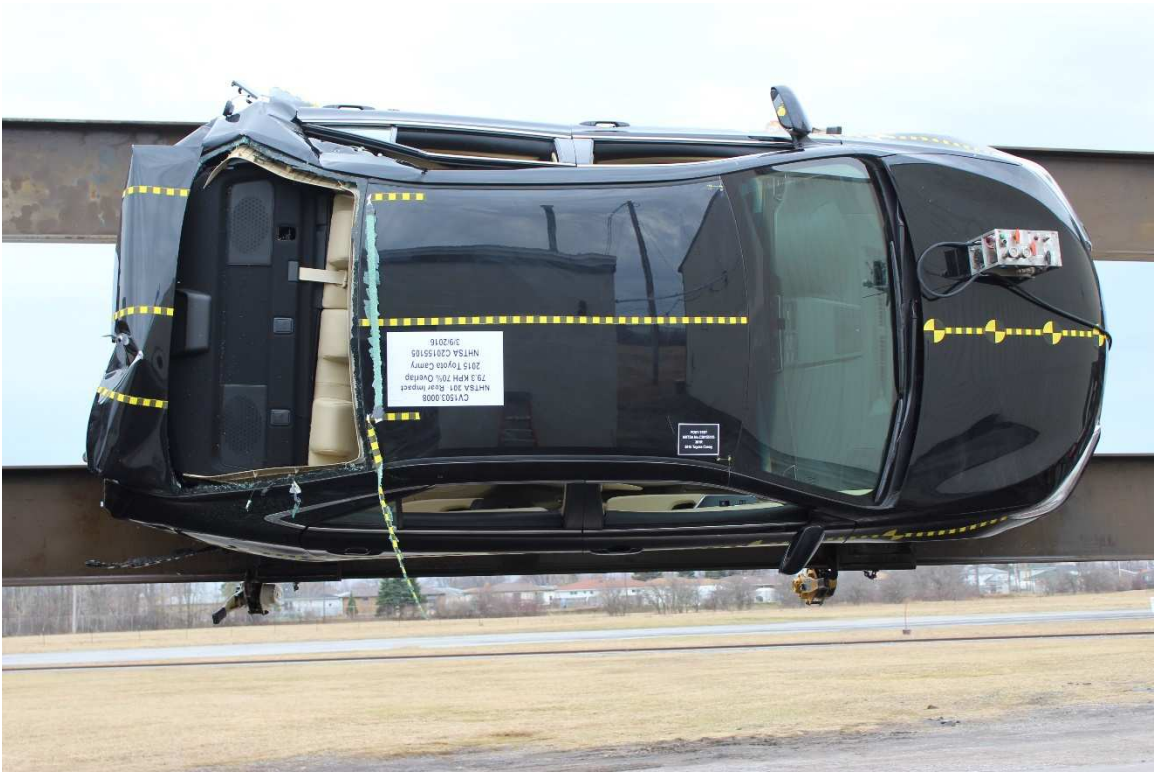
**Figure A-41: Rollover 270° View**

| Test Phase | Spillage Location |
|---|---|
| 180° to 270° | None |

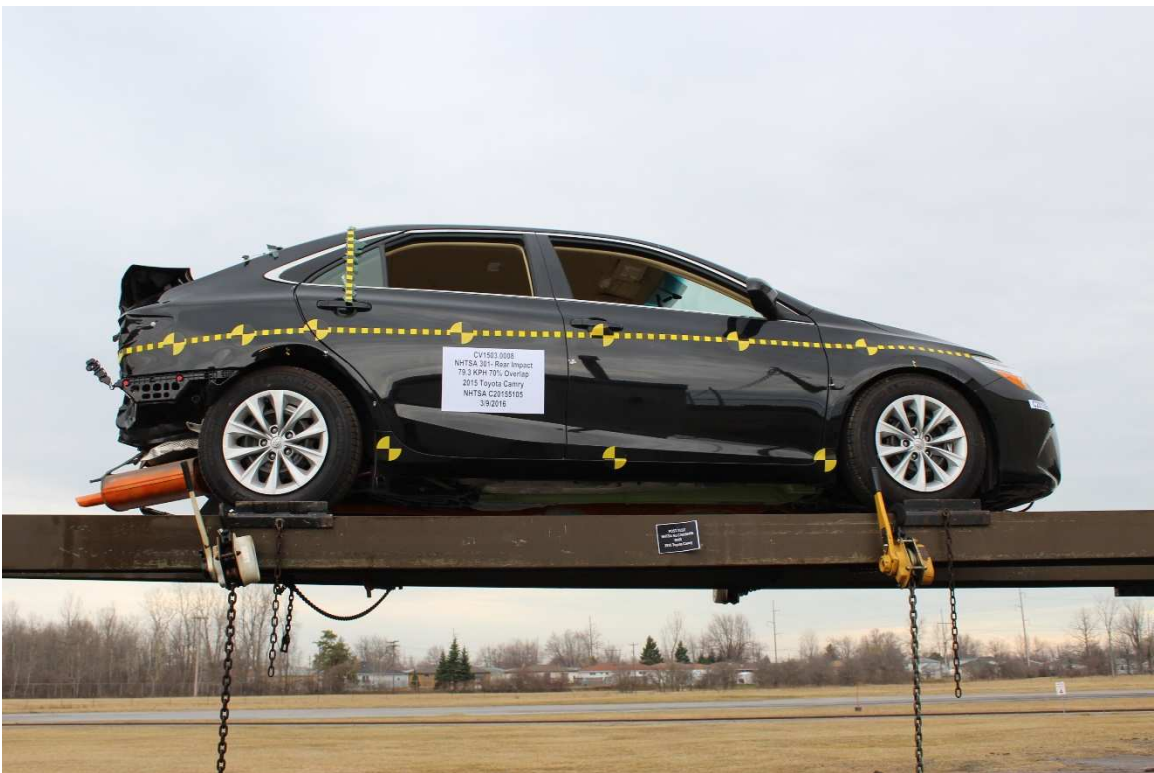
**Figure A-42: Rollover 360° View**

| Test Phase | Spillage Location |
|---|---|
| 270° to 360° | None |
