**REPORT NUMBER: TR-P36135-03-NC**  
**SAFETY COMPLIANCE TESTING FOR FMVSS 301R**  
**FUEL SYSTEM INTEGRITY – REAR IMPACT**  
**79.3 KM/H 70% OVERLAP REAR IMPACT**

**KIA MOTORS MANUFACTURING GEORGIA, INC.**  
**2016 KIA SORENTO 5-DOOR MPV**

**NHTSA NUMBER: C20164200**

**PREPARED BY:**  
**KARCO ENGINEERING, LLC.**  
**9270 HOLLY ROAD**  
**ADELANTO, CA 92301**

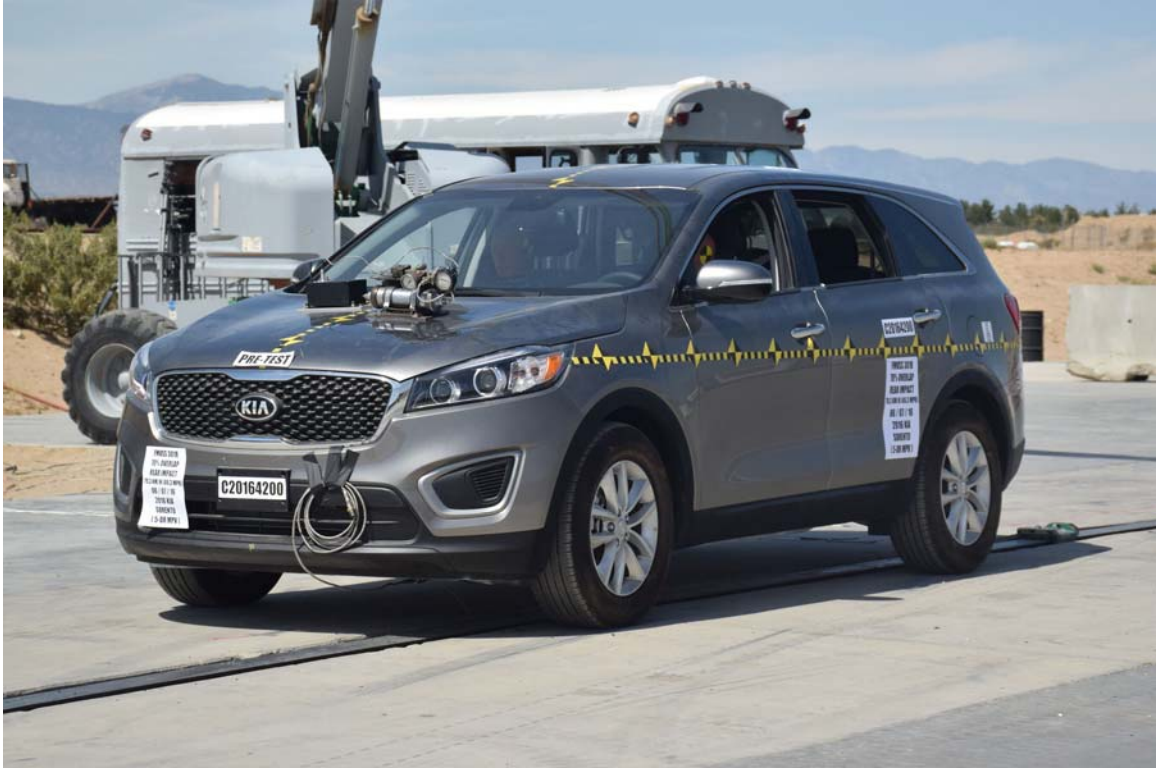
FIGURE 7. Pre-Test Left Front  $\frac{3}{4}$  View of Test Vehicle

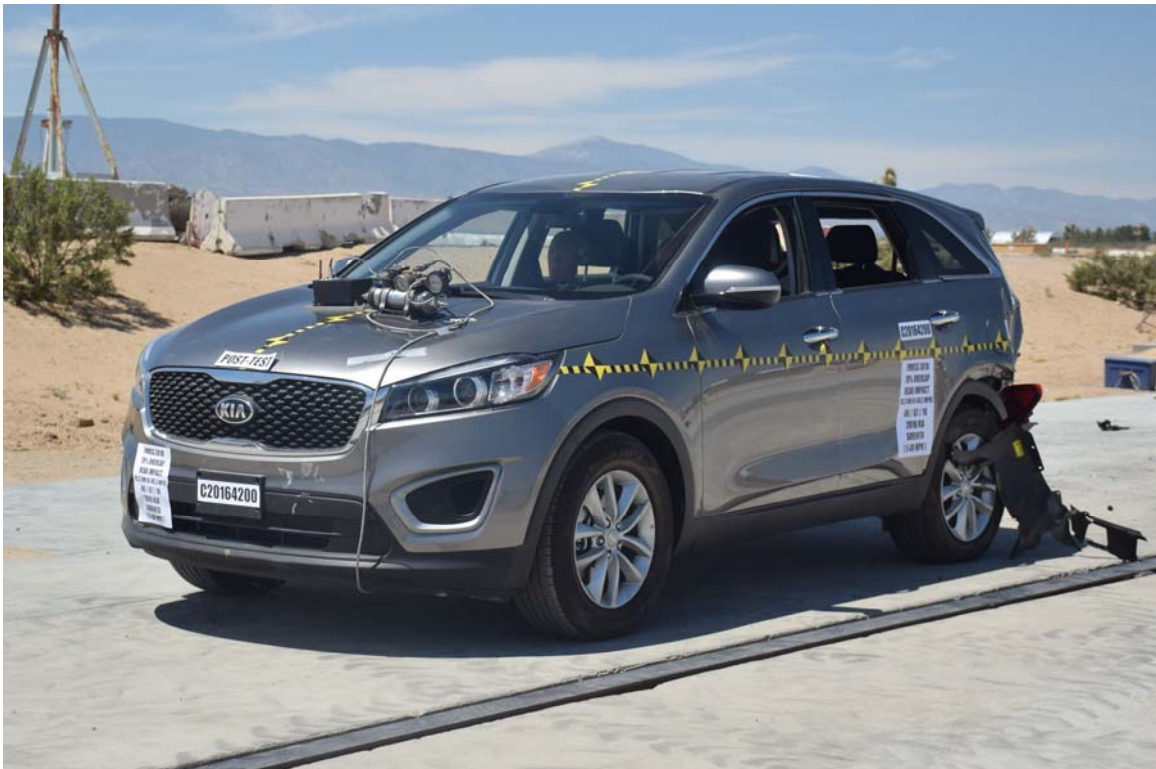
FIGURE 8. Post-Test Left Front  $\frac{3}{4}$  View of Test Vehicle

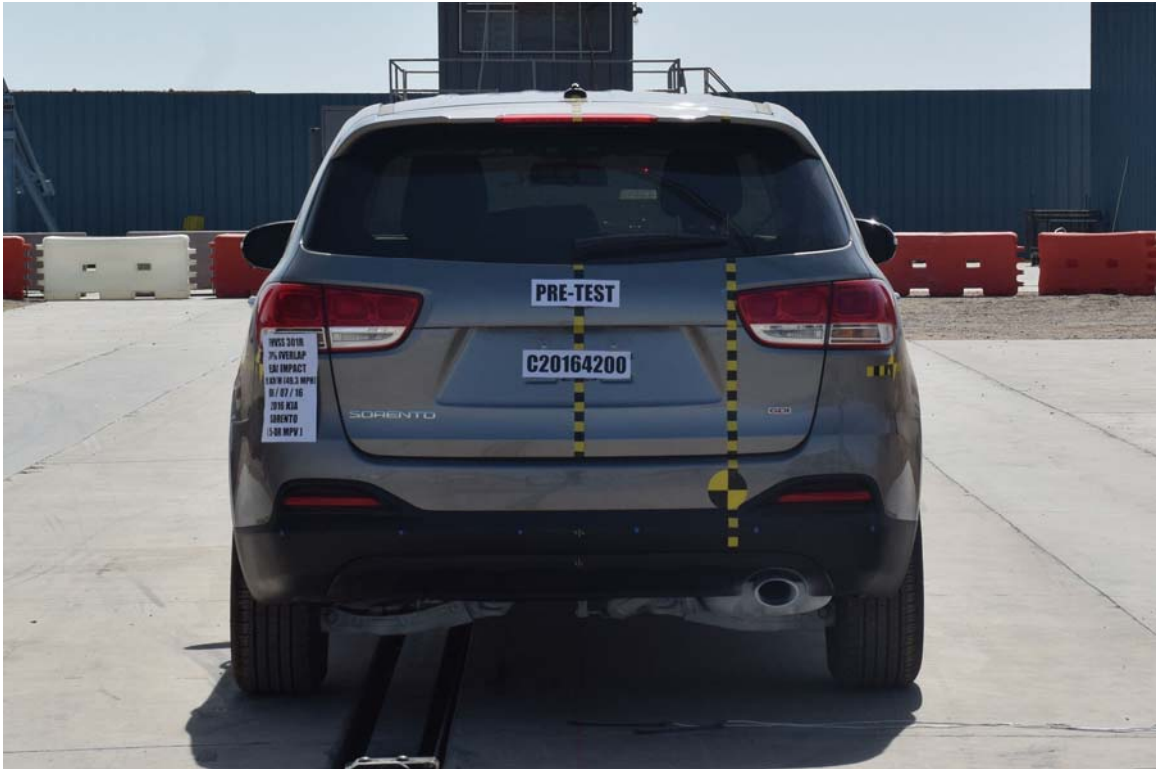
FIGURE 13. Pre-Test Rear View of Test Vehicle

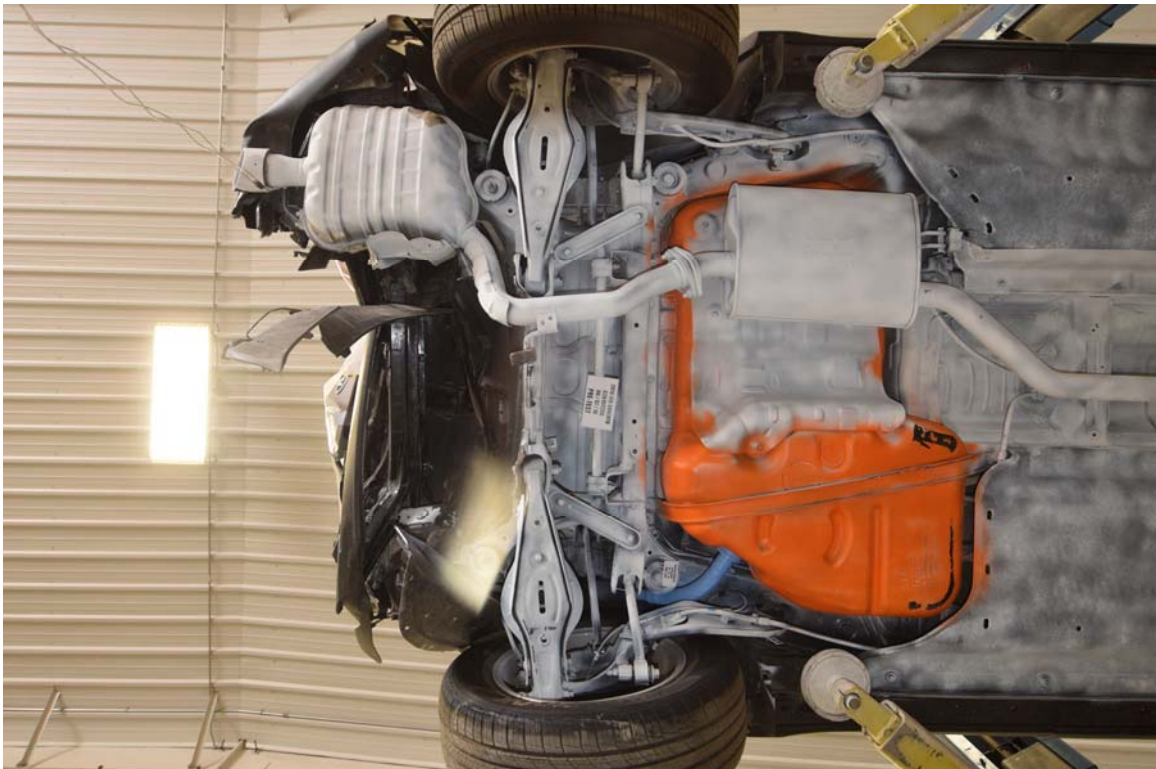
FIGURE 26. Post-Test Rear Underbody View of Test Vehicle

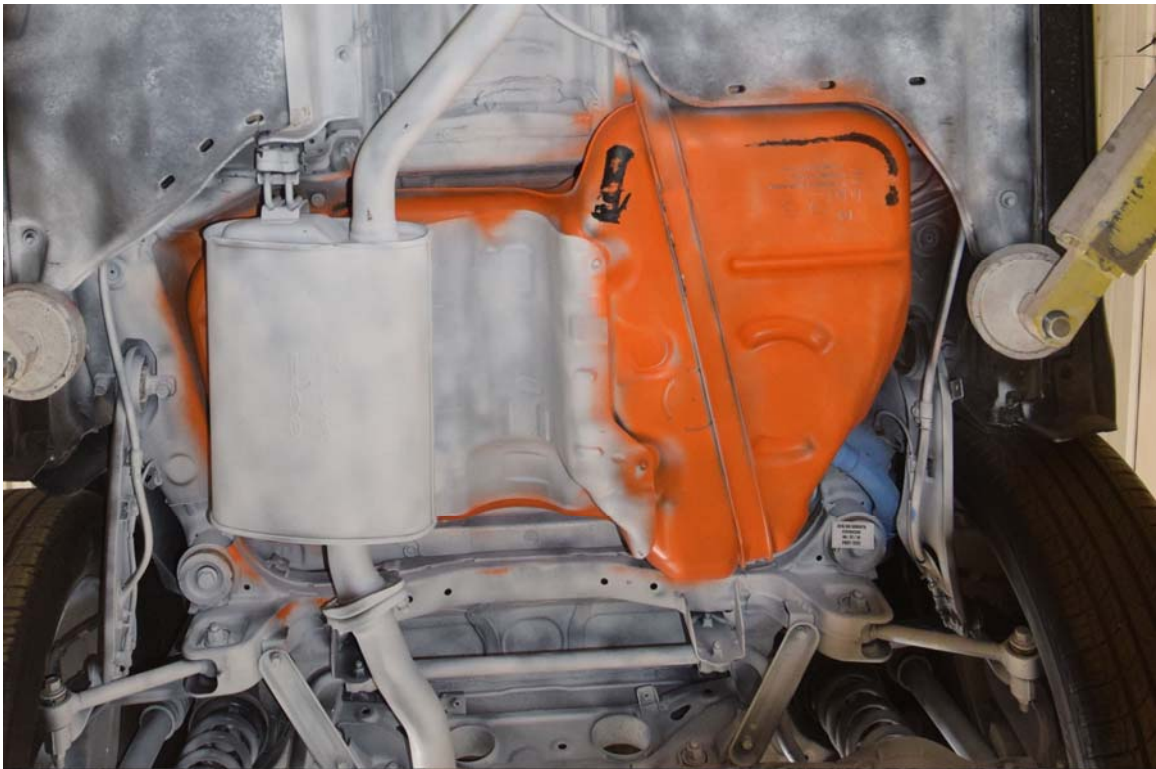
FIGURE 28. Post-Test Underbody View of Fuel Tank

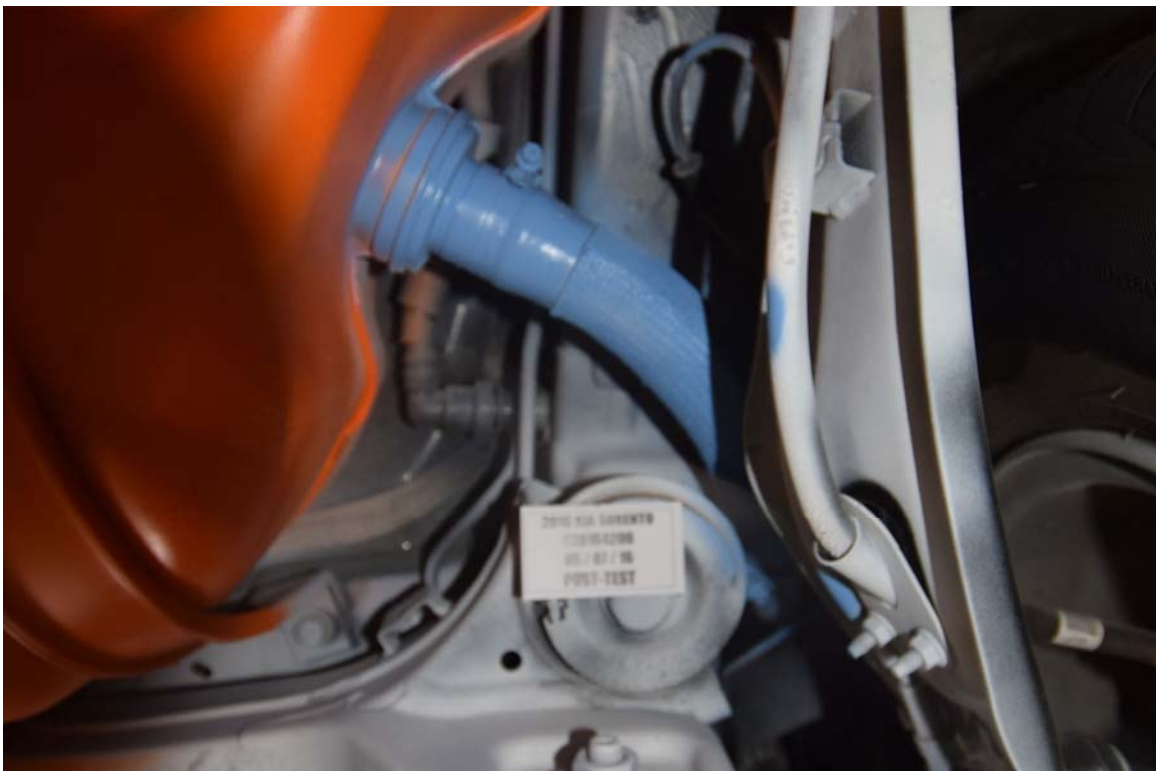
FIGURE 30. Post-Test Underbody View of Fuel Lines

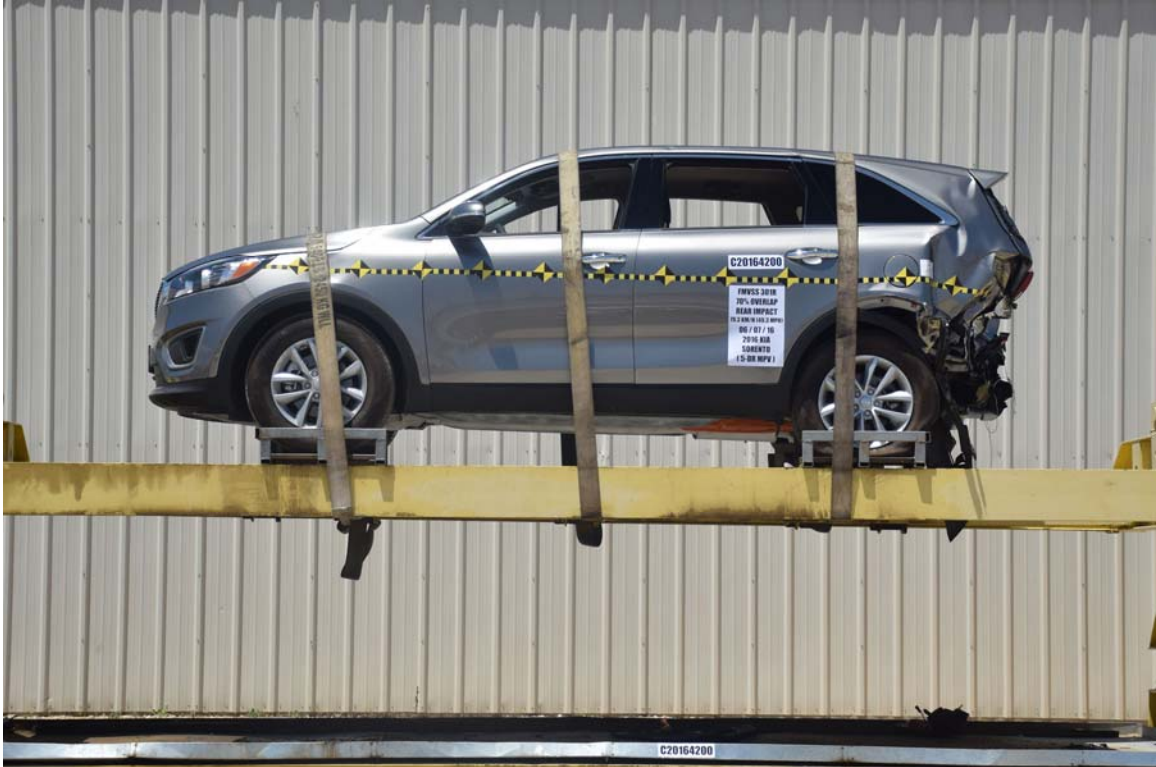
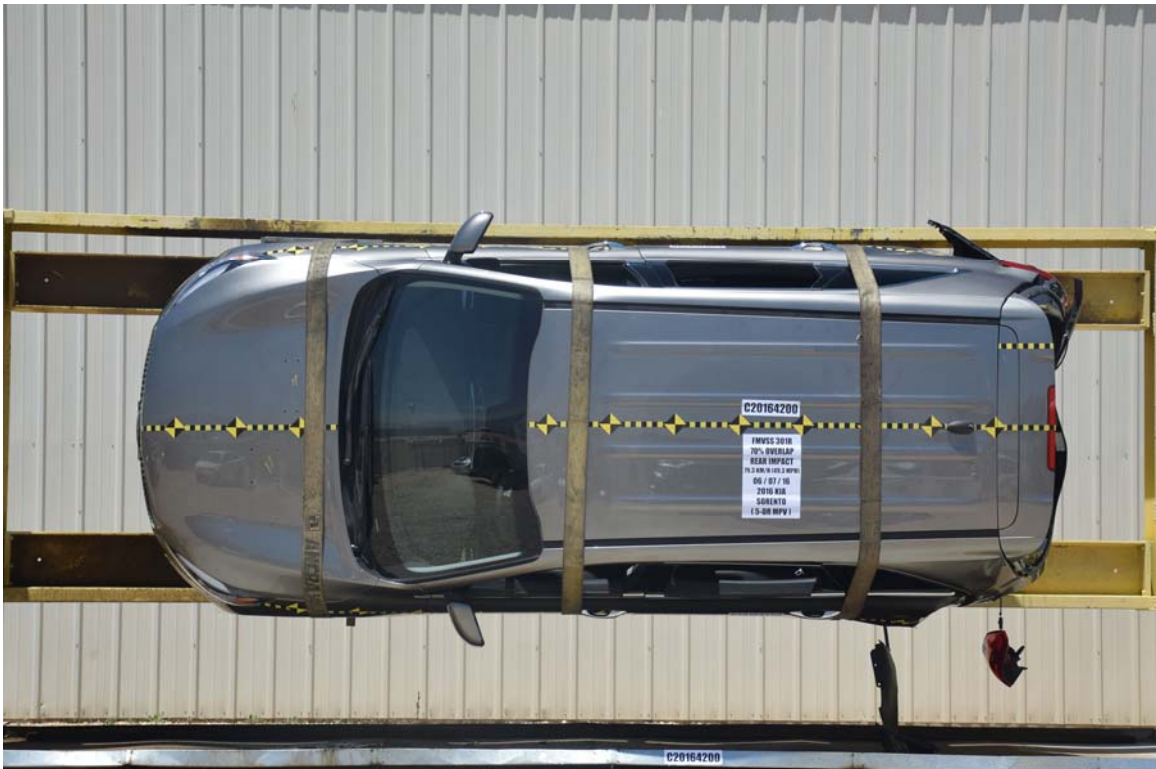
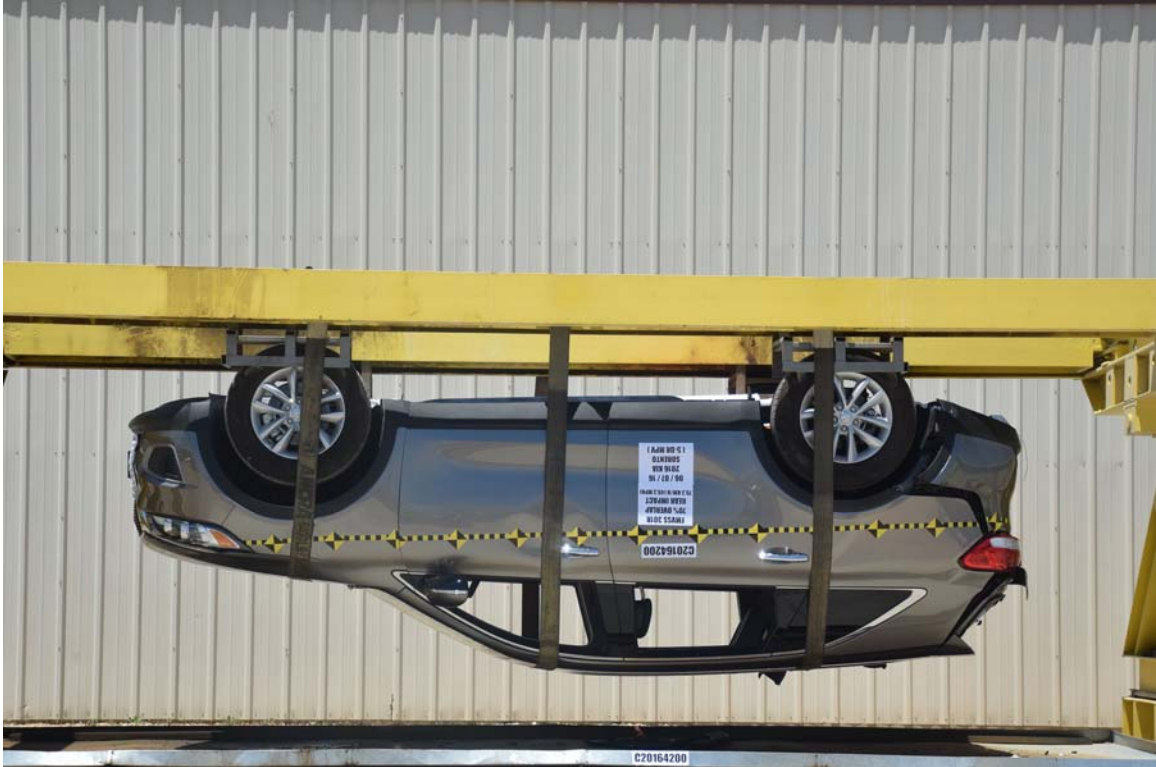
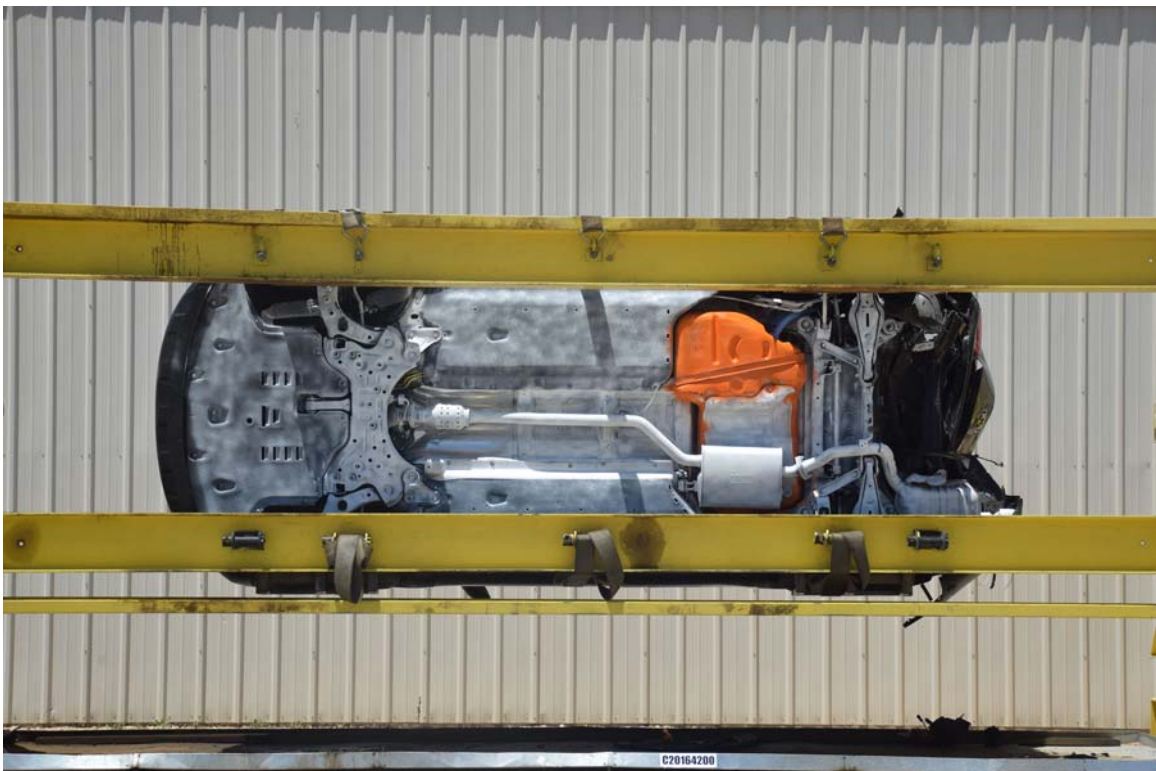
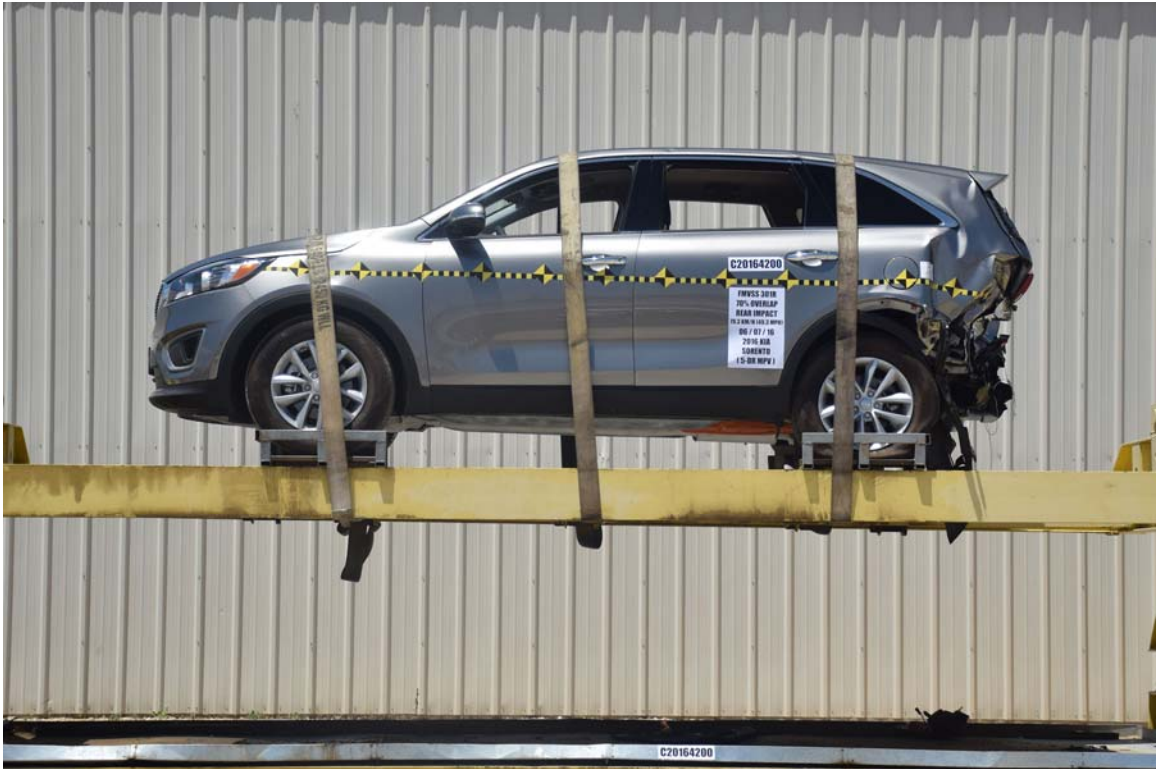
FIGURE 31. Test Vehicle at 0° on FMVSS 301 Static Rollover Device

FIGURE 32. Test Vehicle at 90° on FMVSS 301 Static Rollover Device

FIGURE 33. Test Vehicle at 180° on FMVSS 301 Static Rollover Device

FIGURE 34. Test Vehicle at 270° on FMVSS 301 Static Rollover Device

FIGURE 35. Test Vehicle at 360° on FMVSS 301 Static Rollover Device

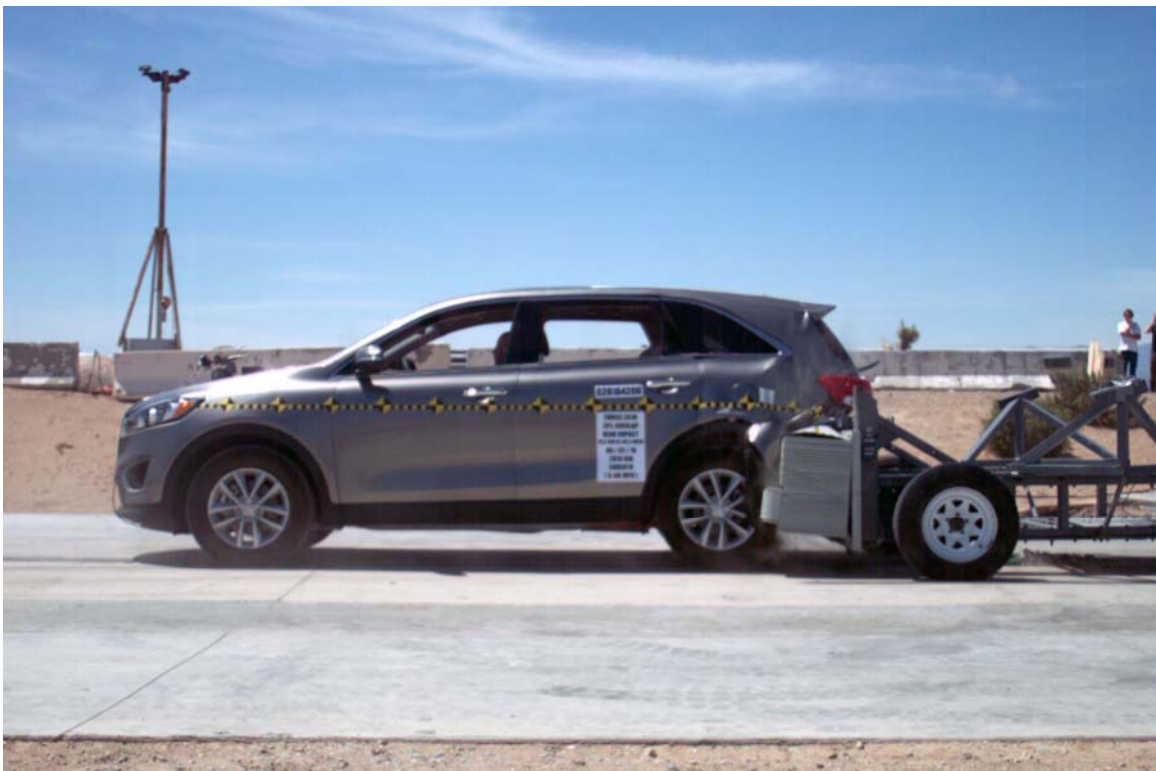
FIGURE 36. Impact Event
