**REPORT NUMBER: SPNCAP-MGA-2017-007**

**NEW CAR ASSESSMENT PROGRAM (NCAP)  
Side Impact Pole Test**

**MITSUBISHI MOTORS (THAILAND) CO., LTD.  
2017 Mitsubishi Mirage ES 5-Door Hatchback  
NHTSA No.: O20175600**

**FINAL REPORT**

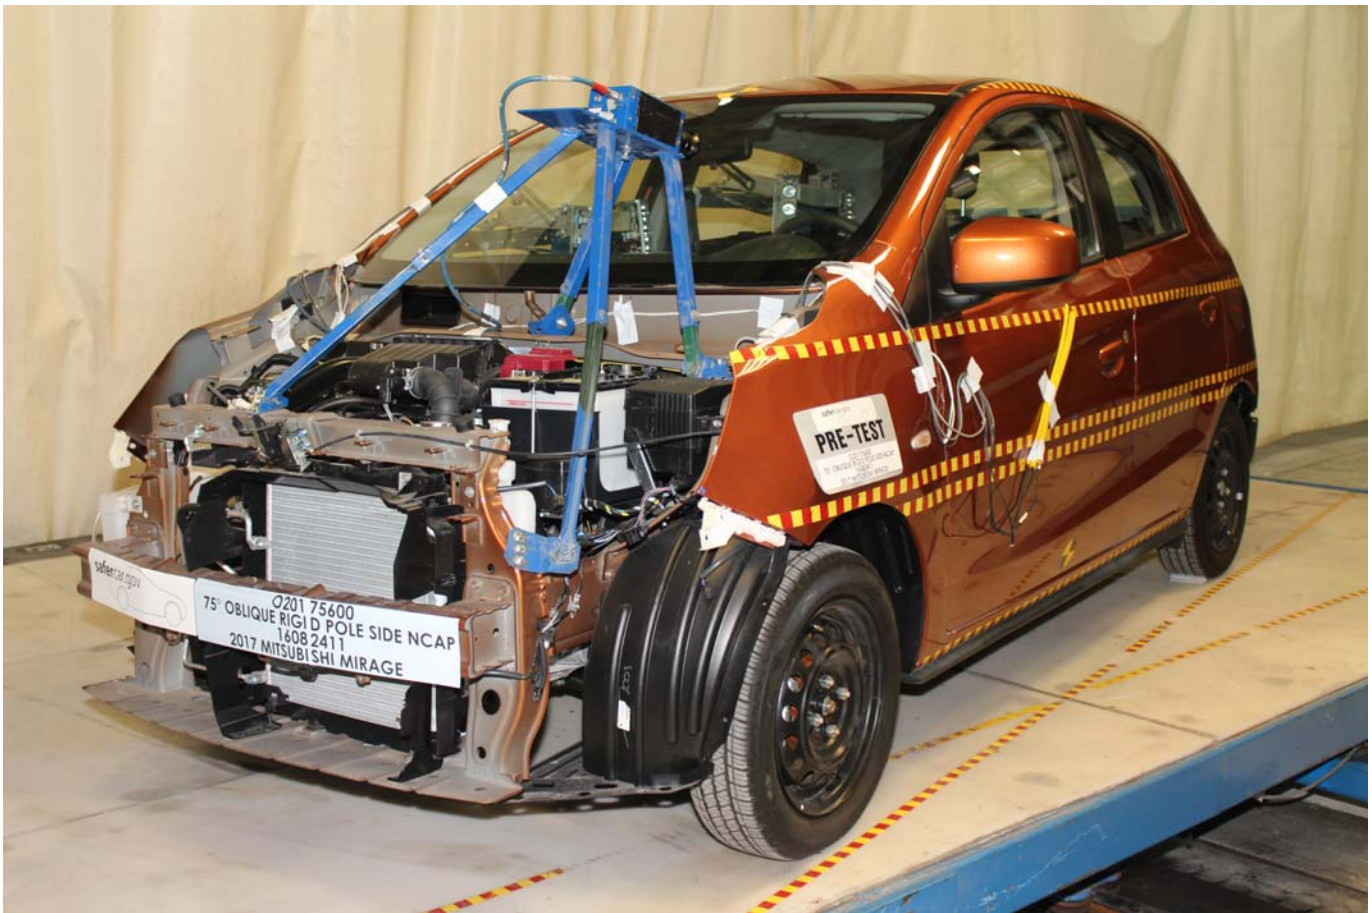
Photo No. 005 - Pre-Test Left Front  $\frac{3}{4}$  View of Test Vehicle

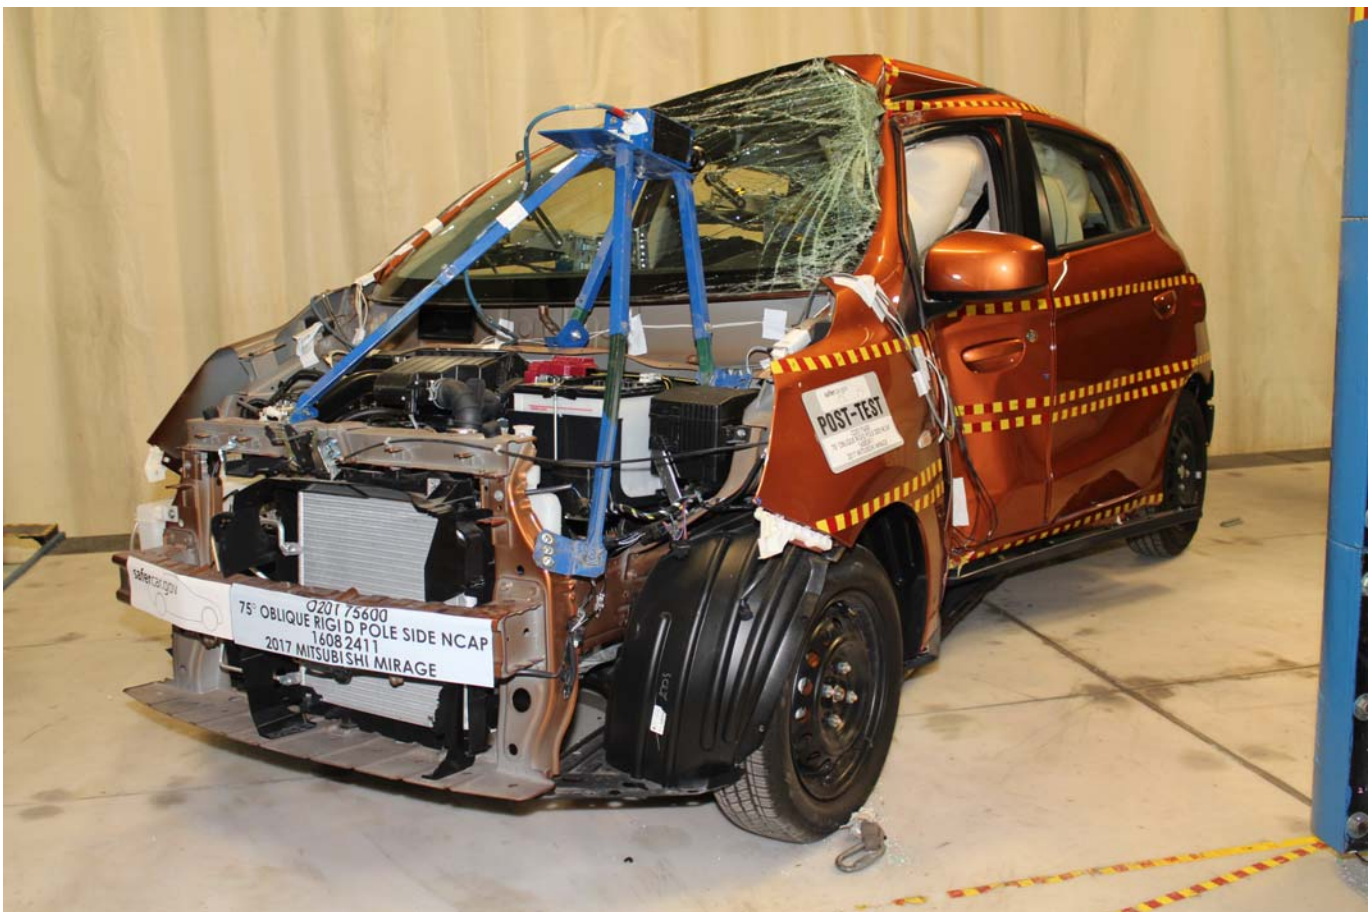
Photo No. 006 - Post-Test Left Front  $\frac{3}{4}$  View of Test Vehicle

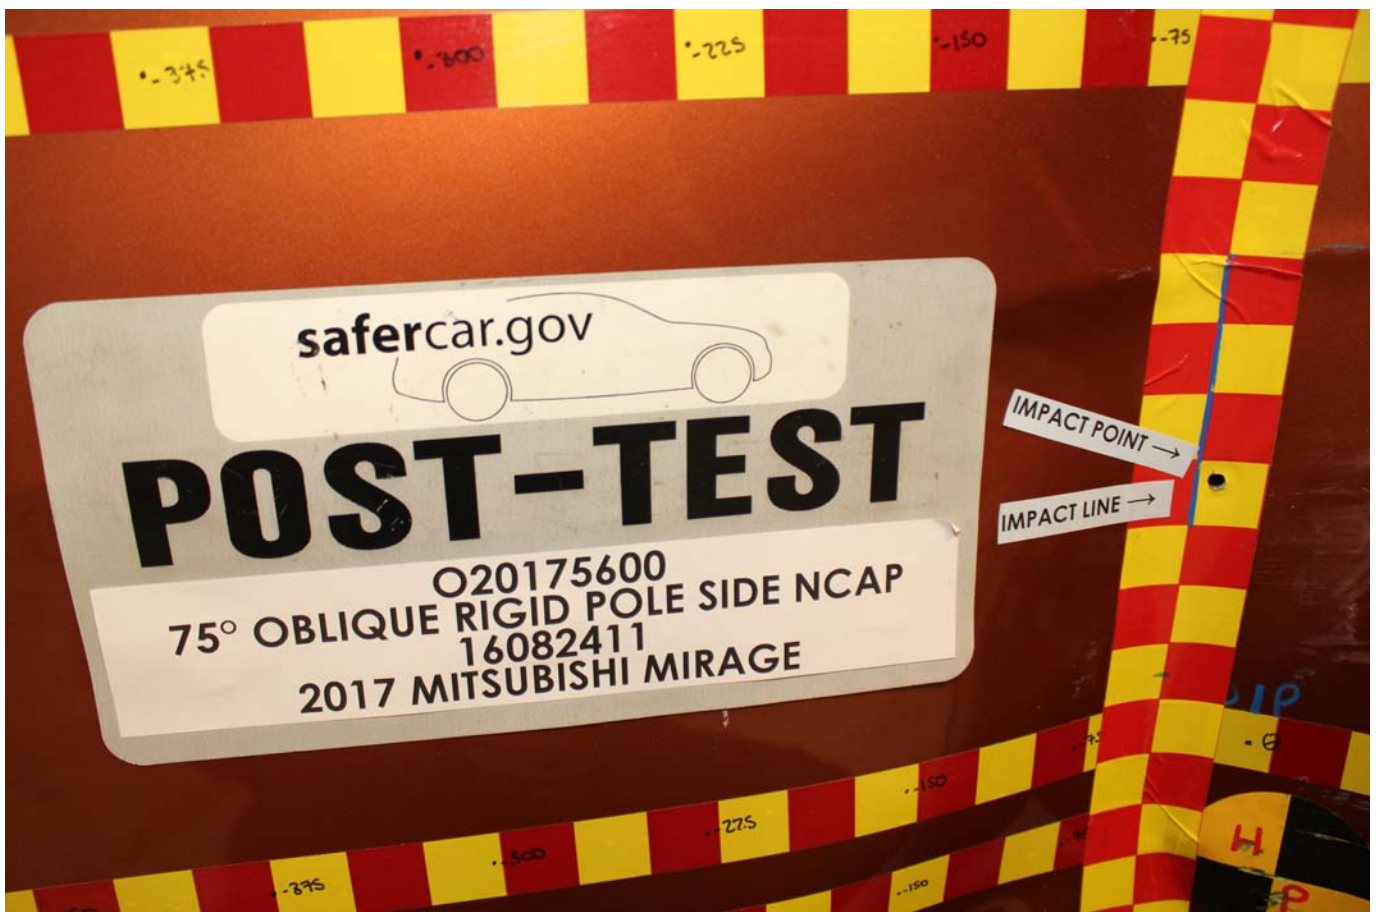
Photo No. 020 - Post-Test Close-Up View of Impact Point Target Showing Impact Location

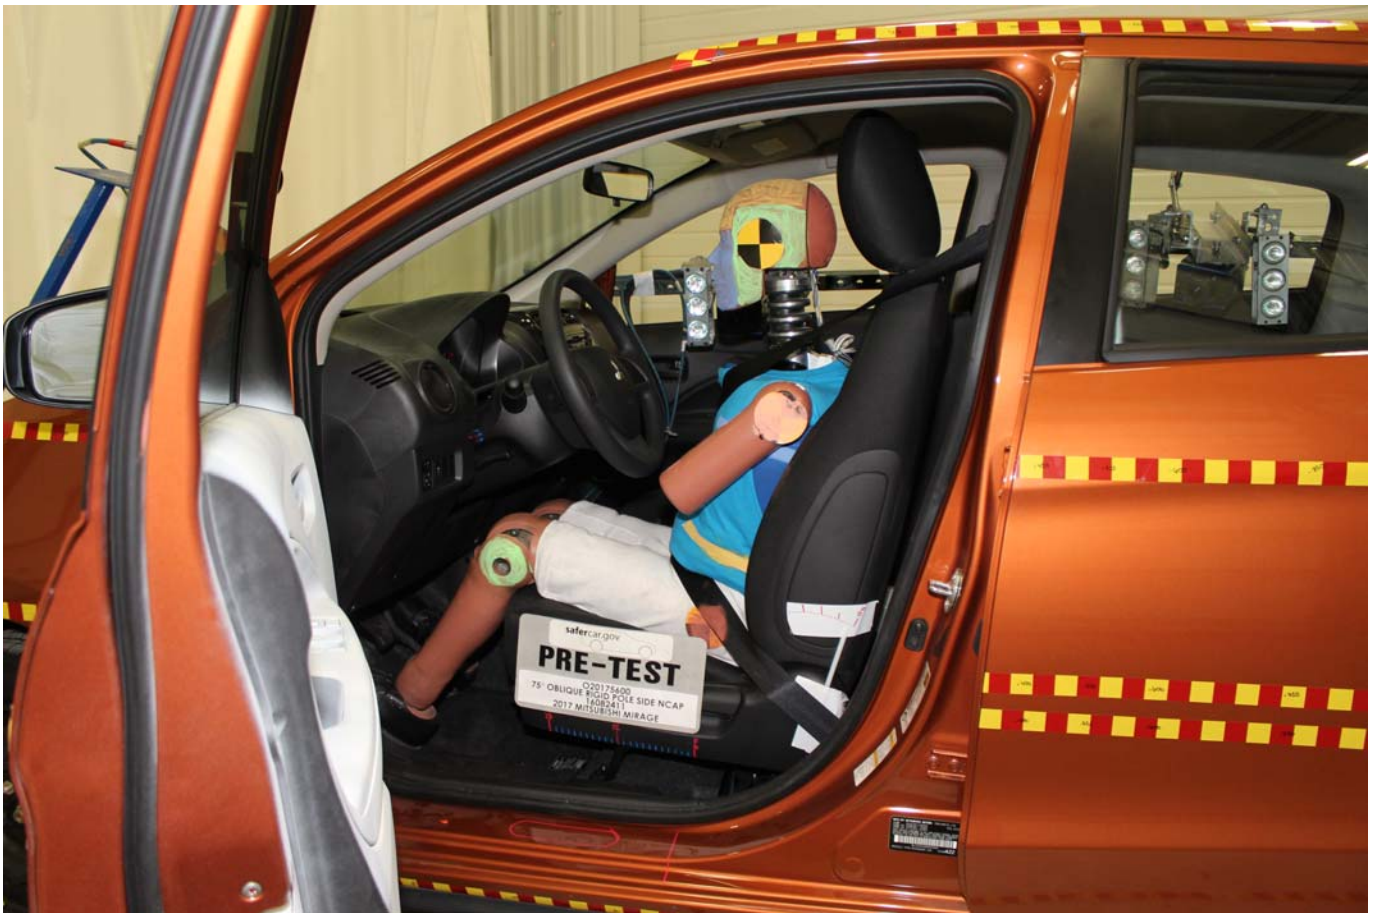
Photo No. 023 - Pre-Test Left Side View of Dummy Showing Belt and Chalking

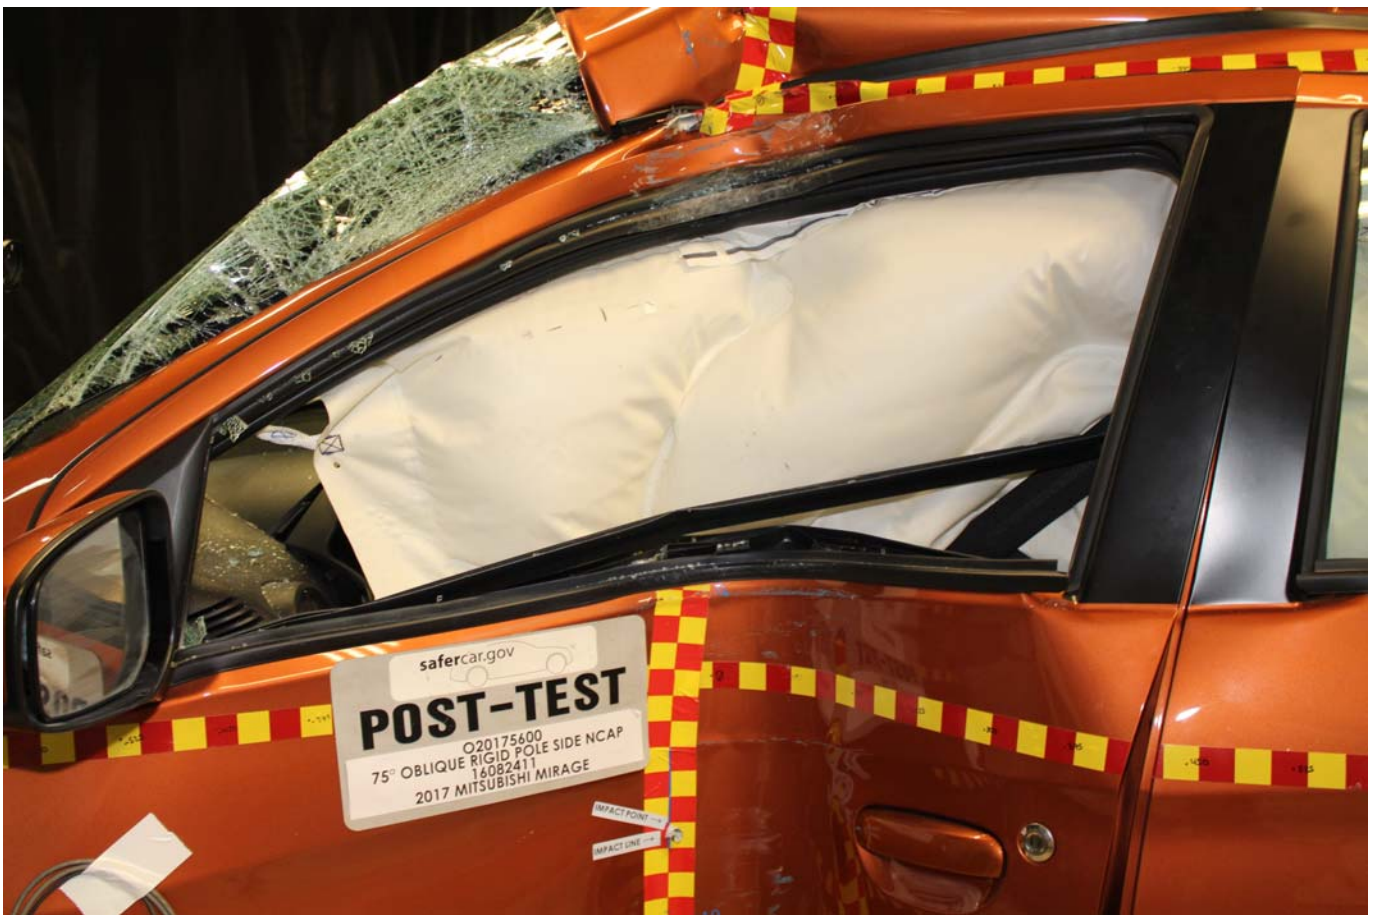
Photo No. 025 - Post-Test Left Side View of Dummy Shoulder and Door Top View

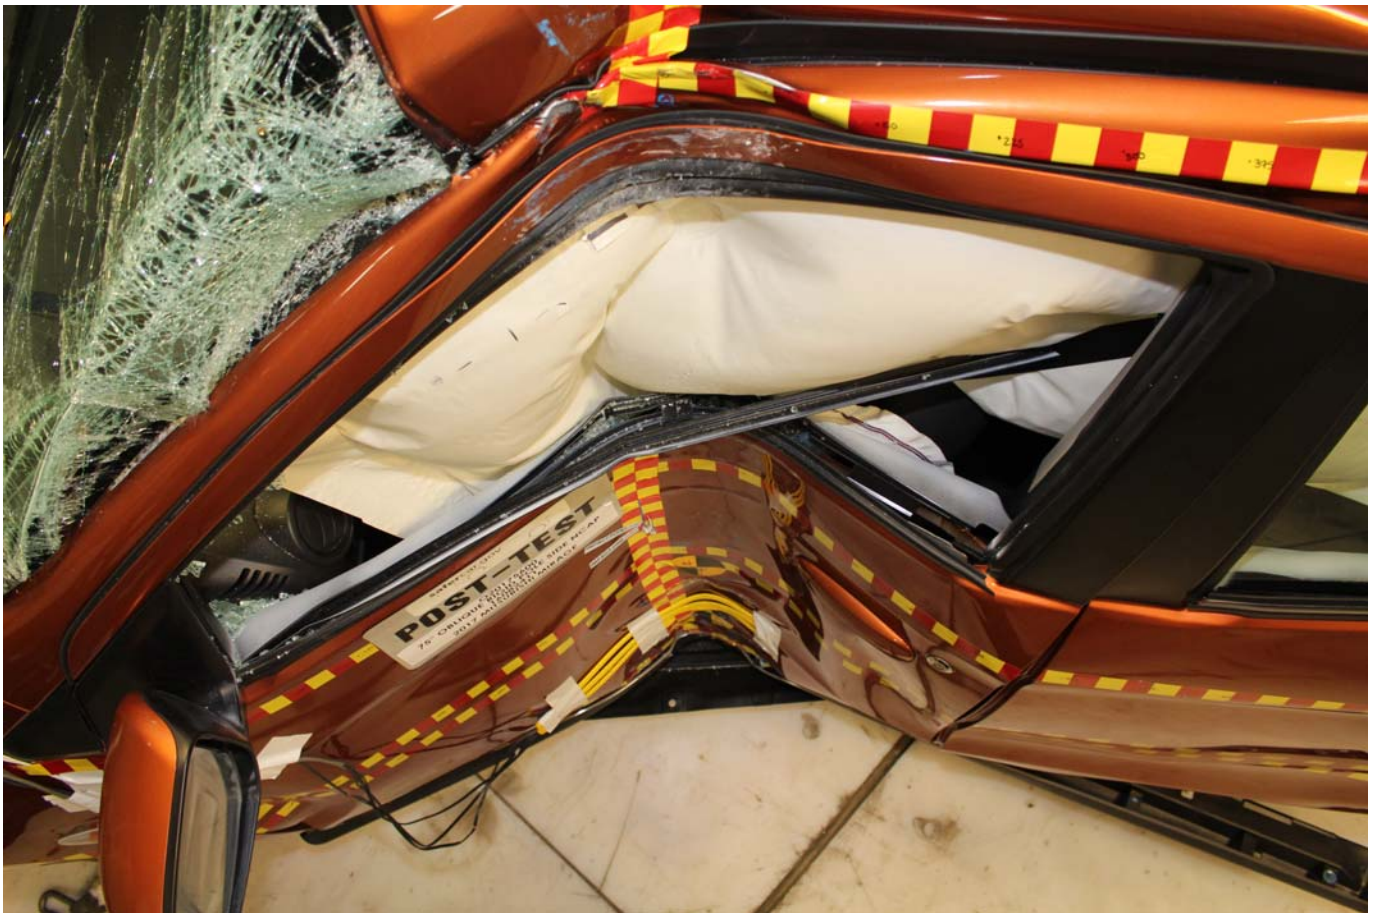
Photo No. 041 - Post-Test Dummy and Door Clearance View

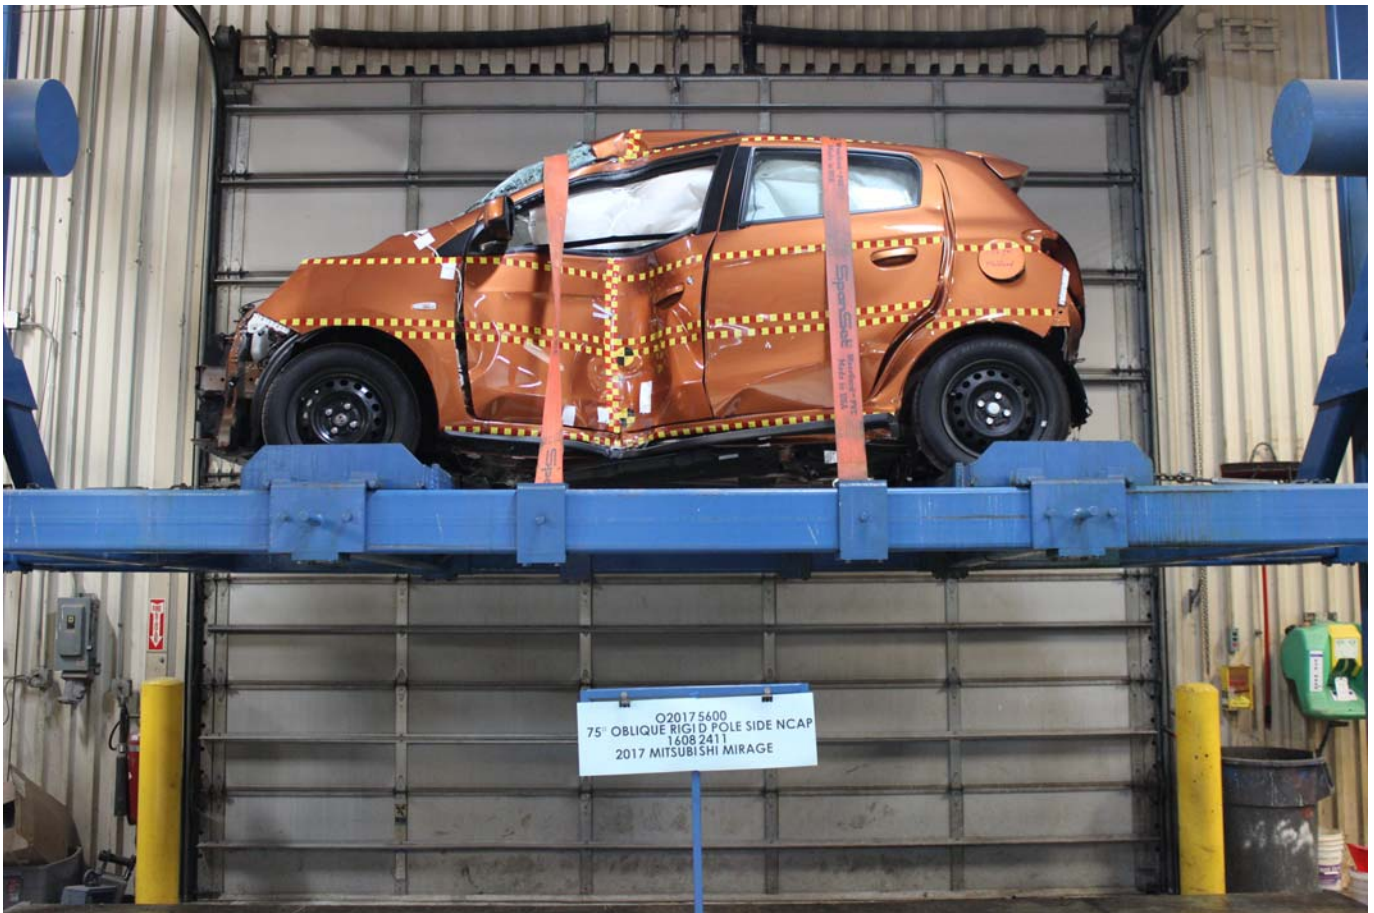
Photo No. 063 - FMVSS No. 301 Static Rollover 0 Degrees

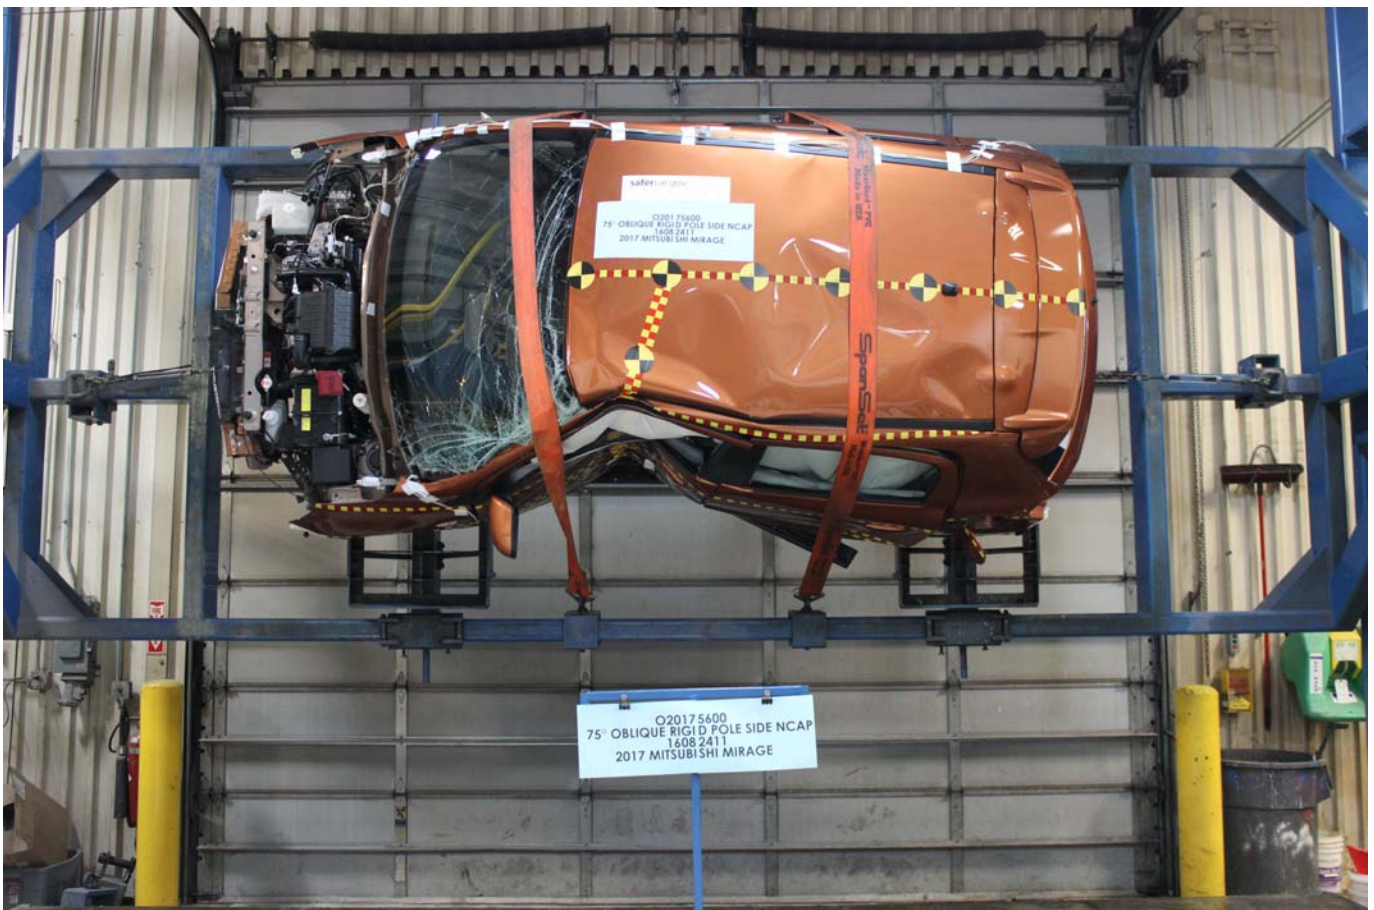
Photo No. 064 - FMVSS No. 301 Static Rollover 90 Degrees

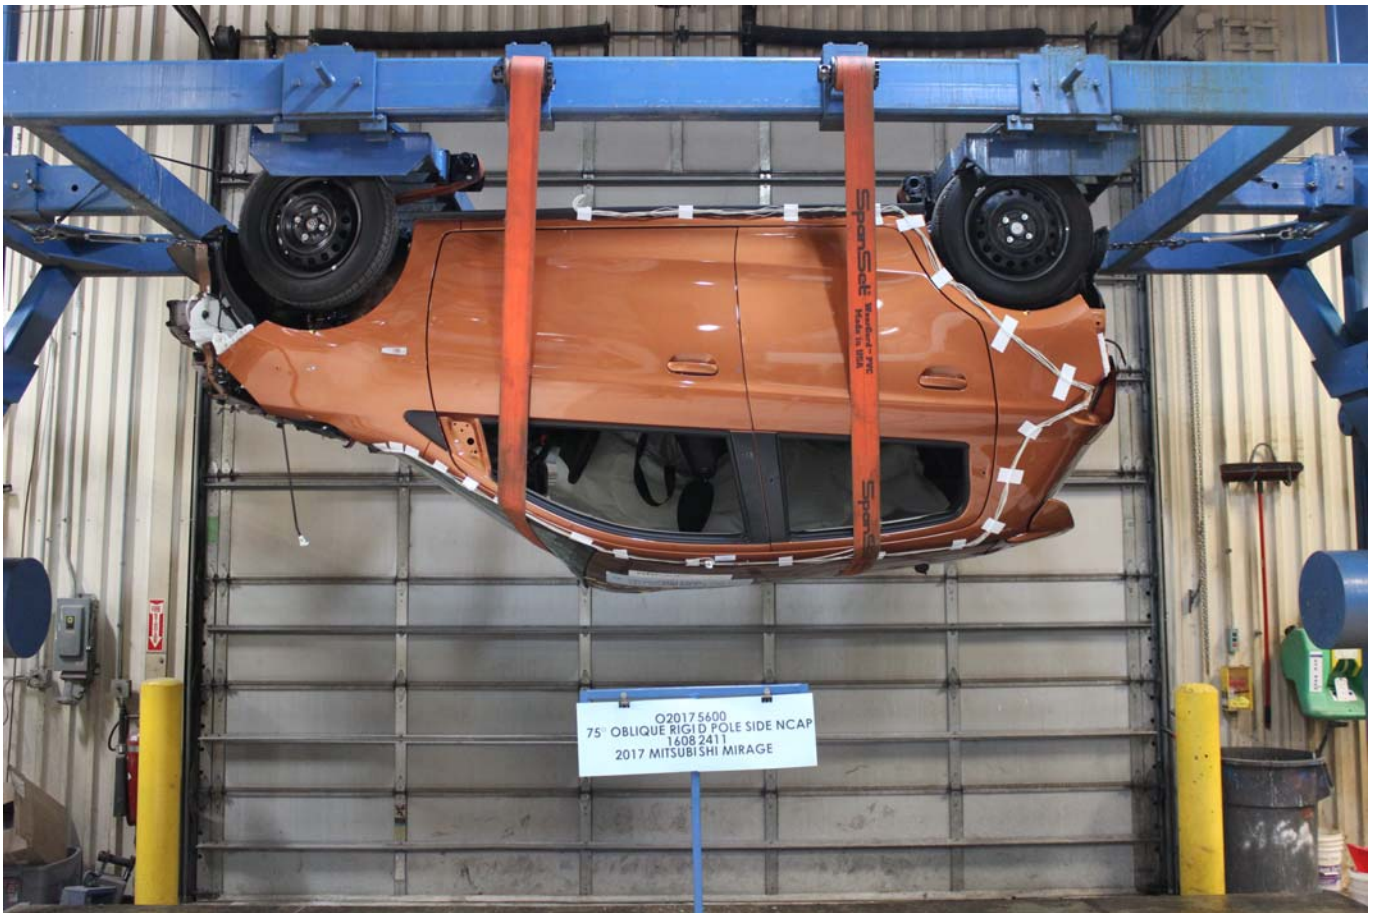
Photo No. 065 - FMVSS No. 301 Static Rollover 180 Degrees

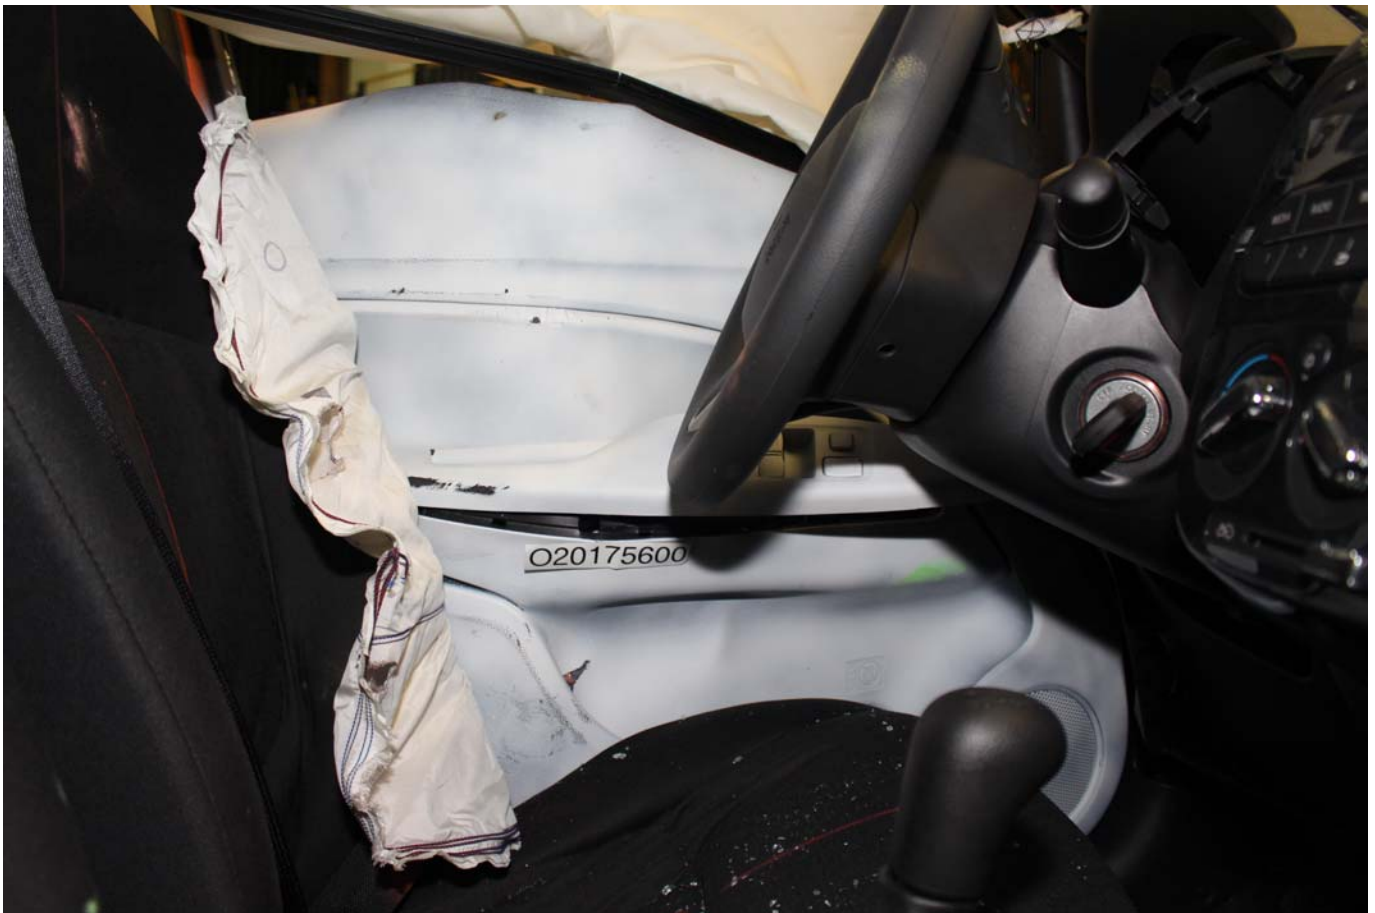
Photo No. 071 - Post-Test View of Shattered Vehicle Inner Door Panel
