**REPORT NUMBER: SINCAP-MGA-2016-059**

**NEW CAR ASSESSMENT PROGRAM (NCAP)  
Moving Deformable Barrier Side Impact Test**

**SAIC GENERAL MOTORS CORPORATION LIMITED  
2016 Buick Envision AWD Premium II 5-Door SUV  
NHTSA No.: O20160107**

**FINAL REPORT**

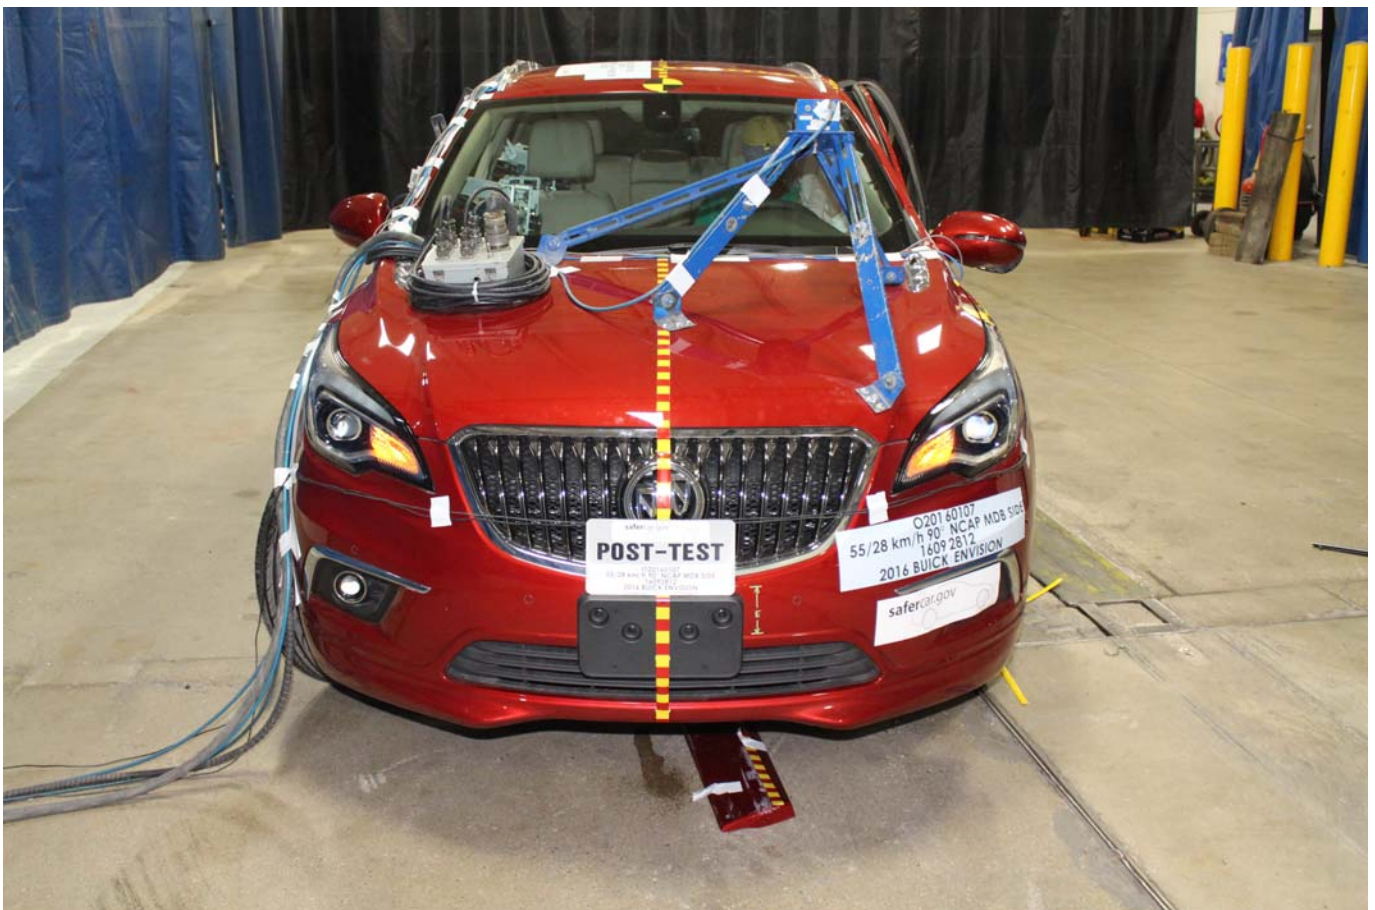
Photo No. 004 - Post-Test Frontal View of Test Vehicle

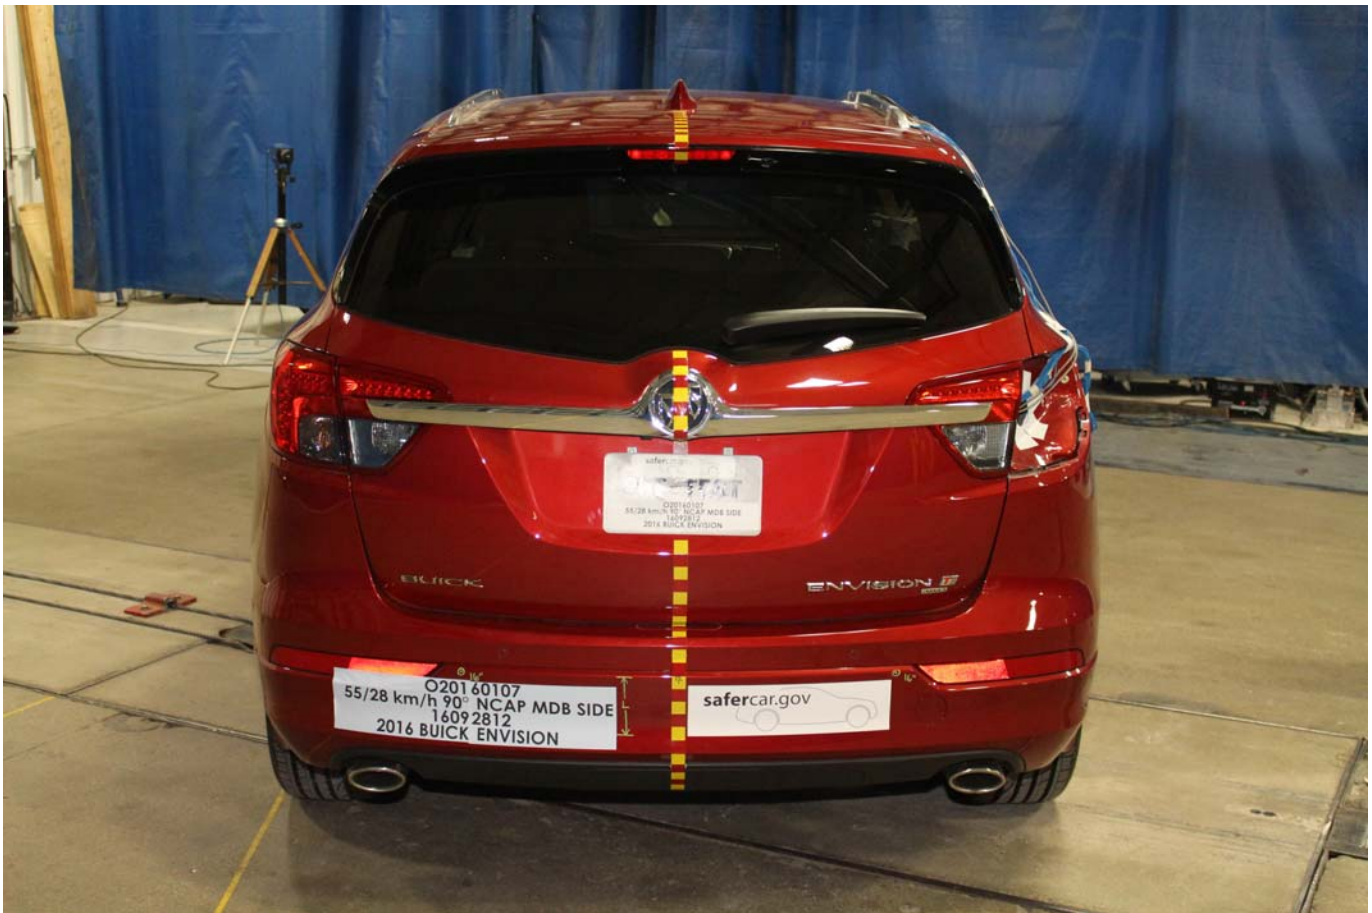
Photo No. 012 - Post-Test Rear View of Test Vehicle

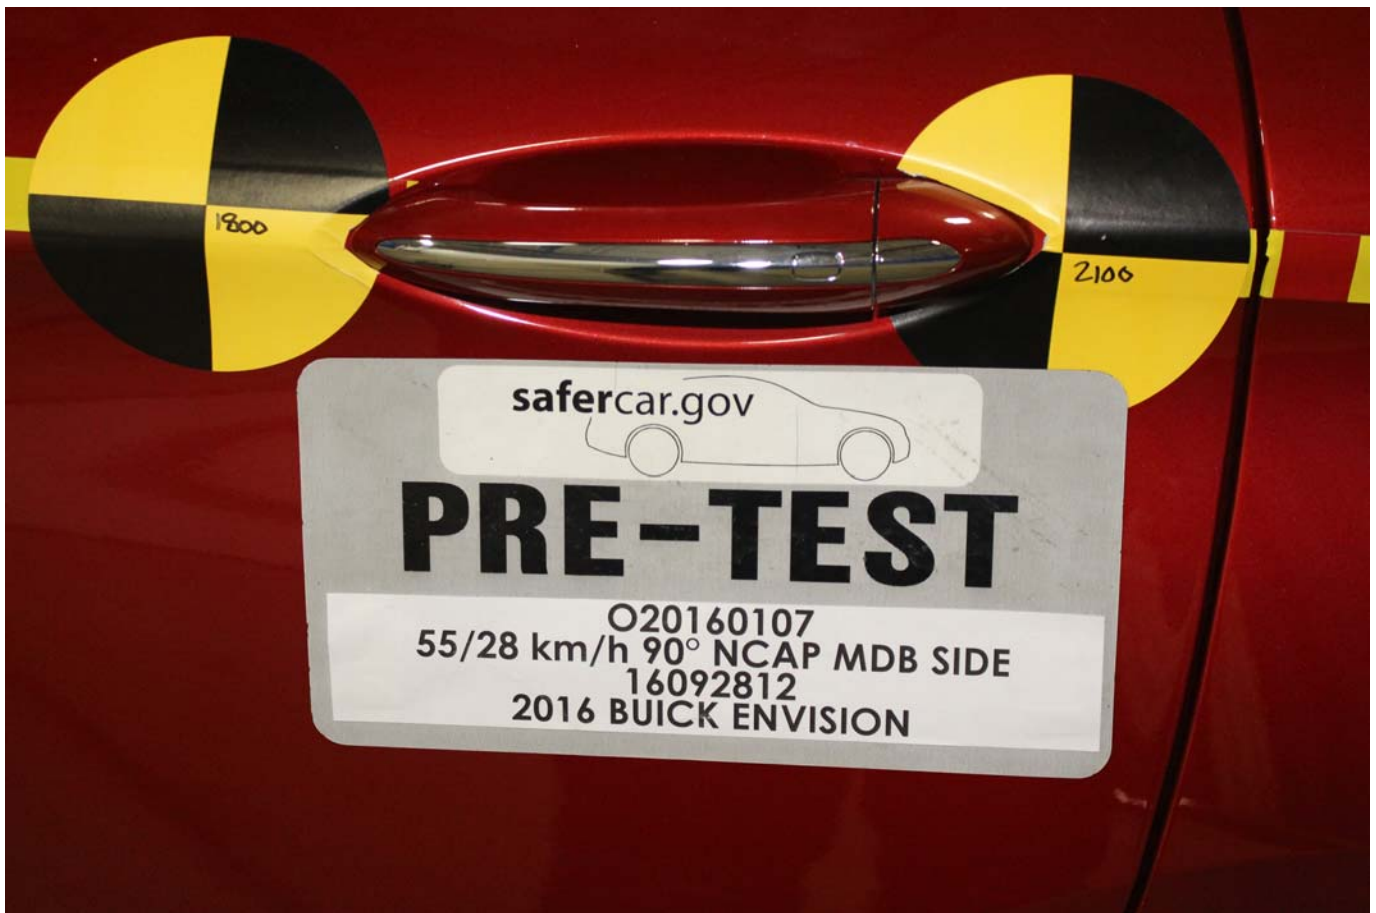
Photo No. 023 - Pre-Test Left Rear Door Latch Close-Up

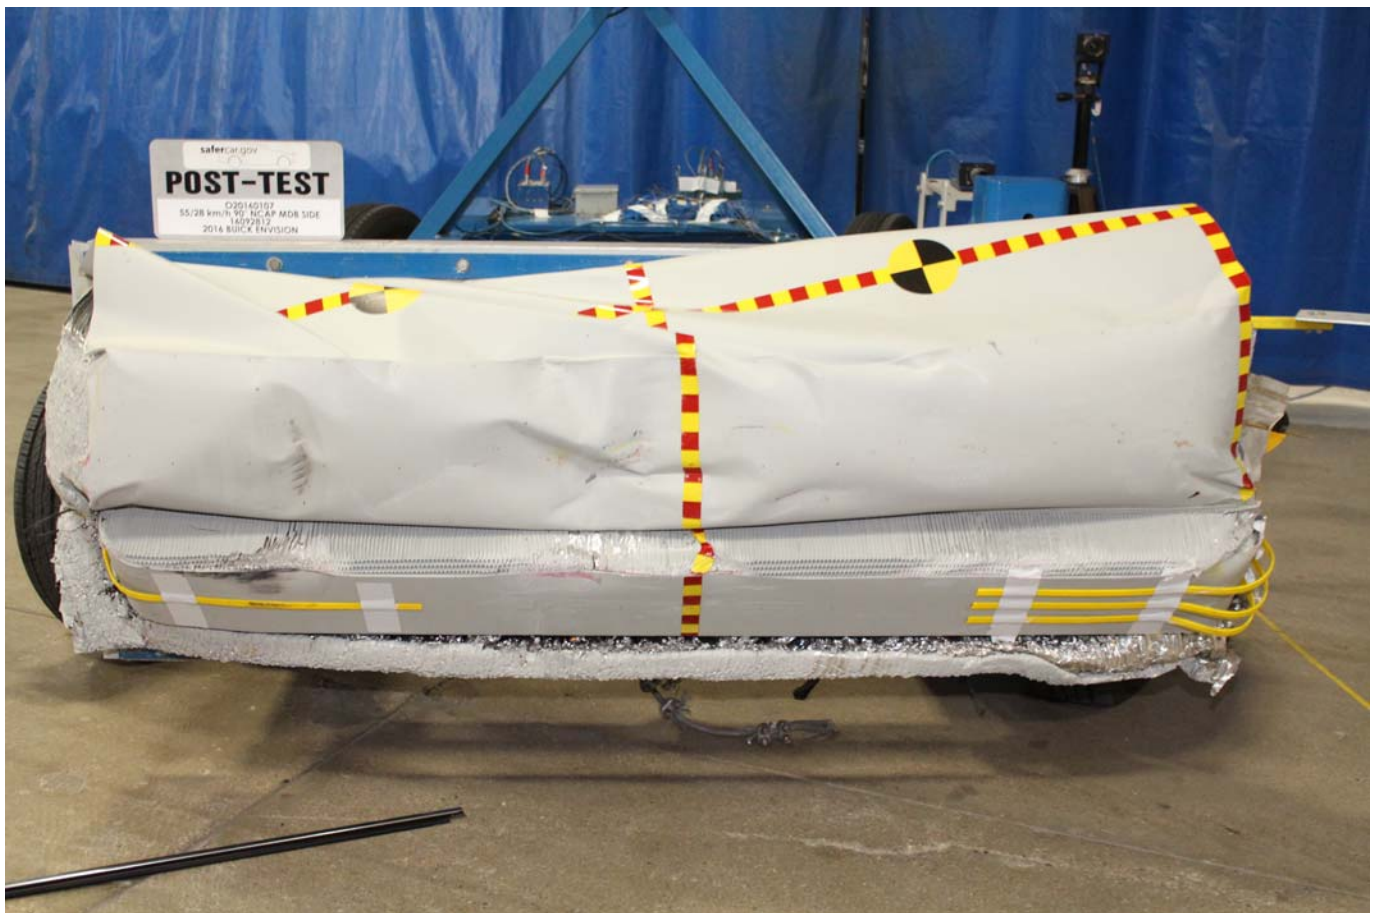
Photo No. 085 - Post-Test Front View of MDB Impactor Face

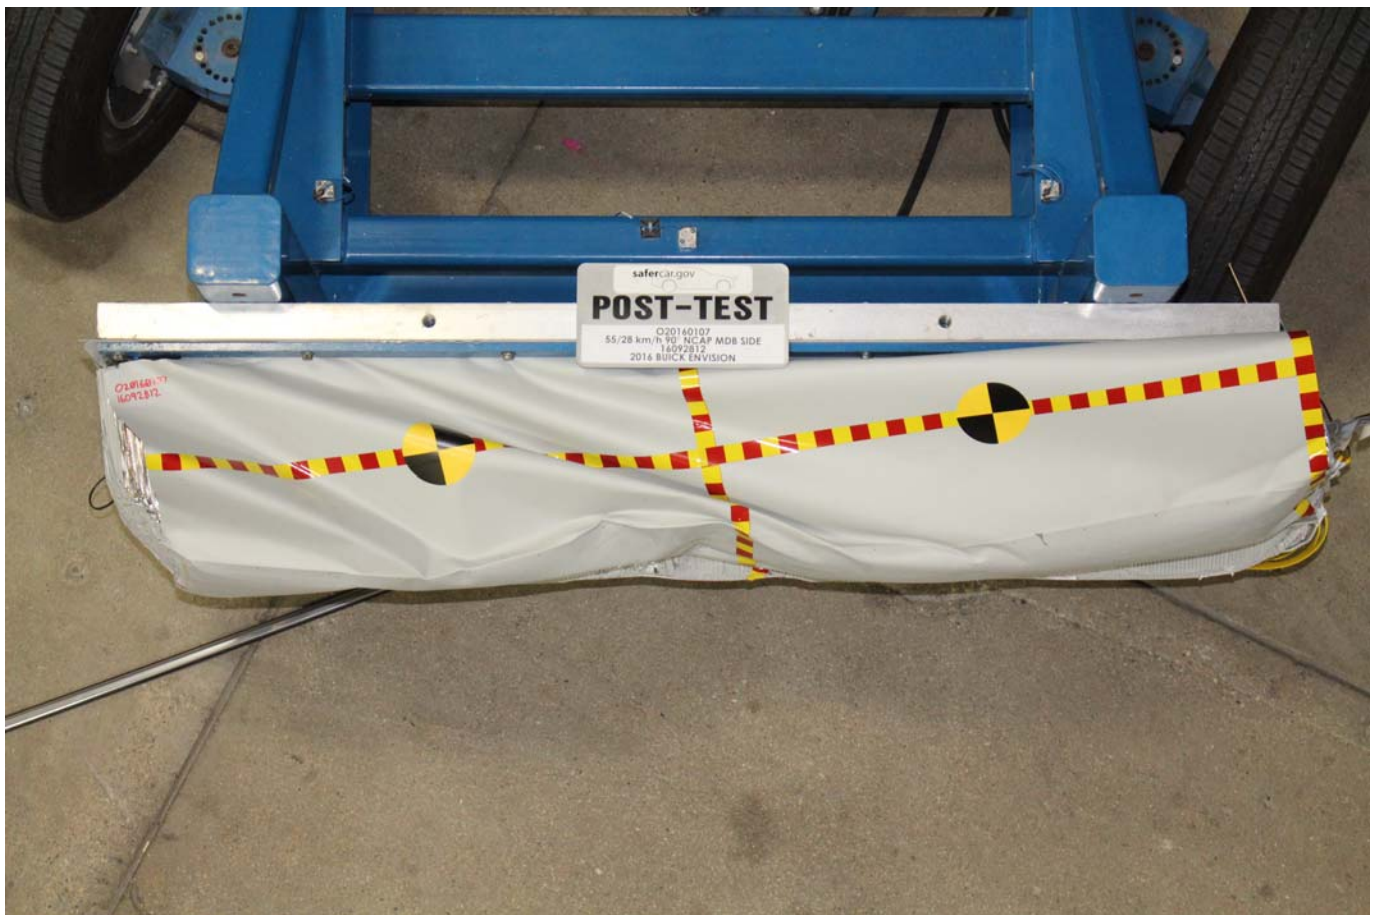
Photo No. 087 - Post-Test Top View of MDB Impactor Face
