**REPORT NUMBER: R&D-CAL-15-014**

**VEHICLE TO FRONTAL BARRIER CRASH TEST IN SUPPORT OF NHTSA'S  
FRONTAL RESEARCH PROGRAM**

**2016 Mazda CX-5**

**56.3 KPH RIGID BARRIER FRONTAL**

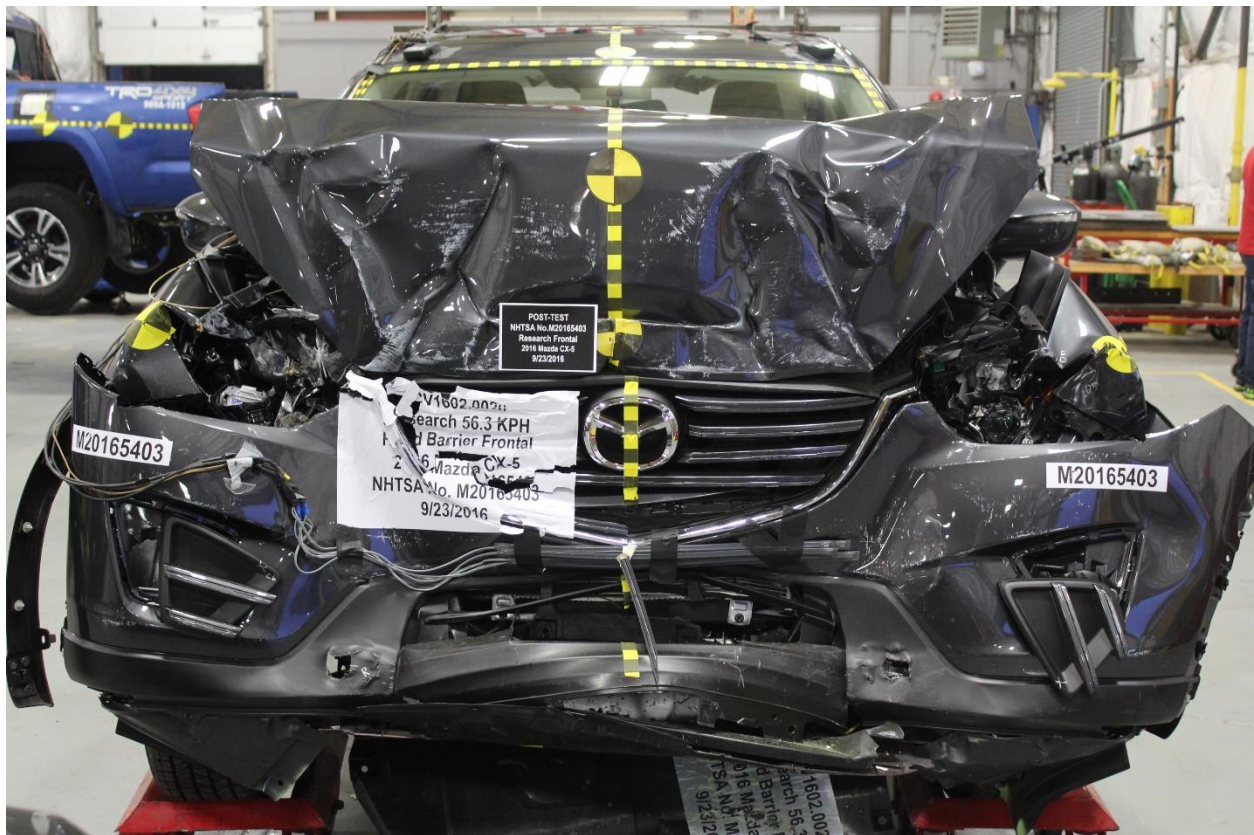
- Windshield had some minor cracks
- Hood bent inwards and engine went into firewall

**Figure A-8: Post-Test Front View of Test Vehicle**

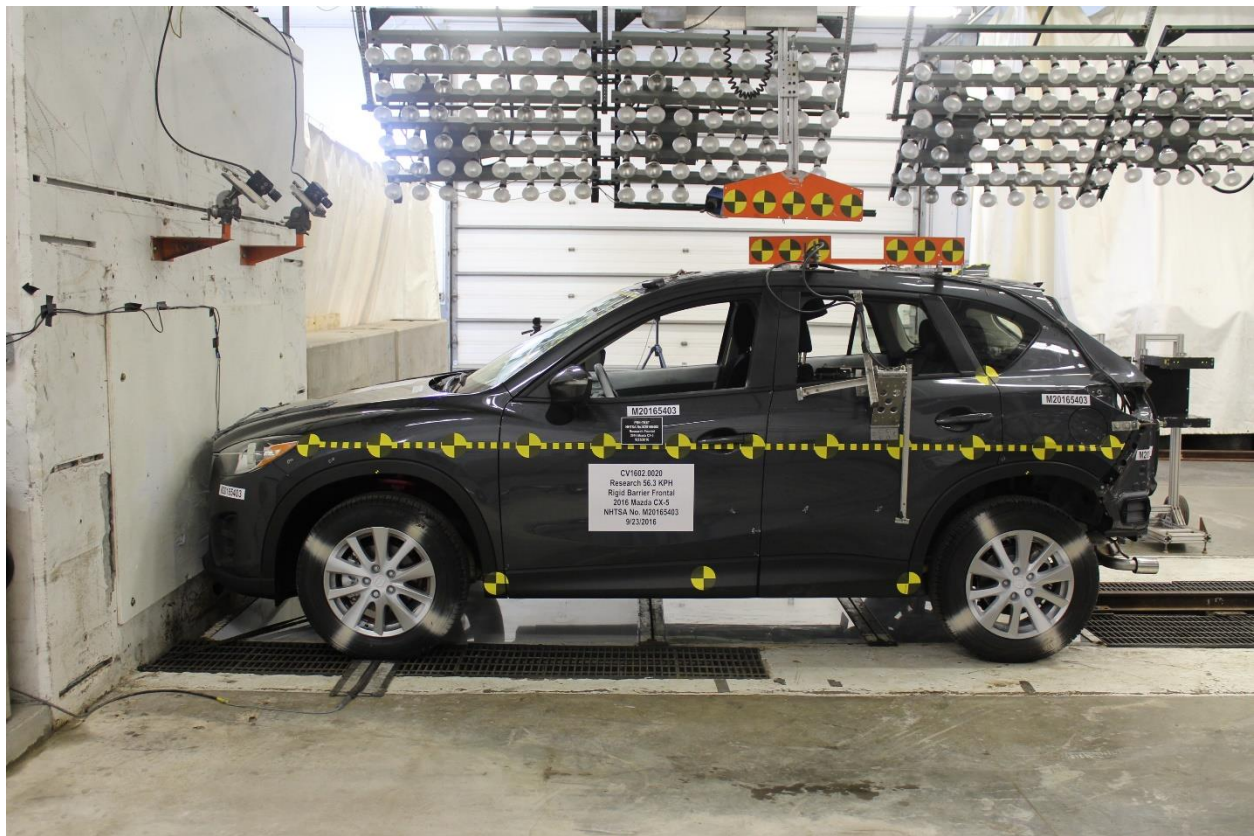
**Figure A-9: Pre-Test Left View of Test Vehicle**

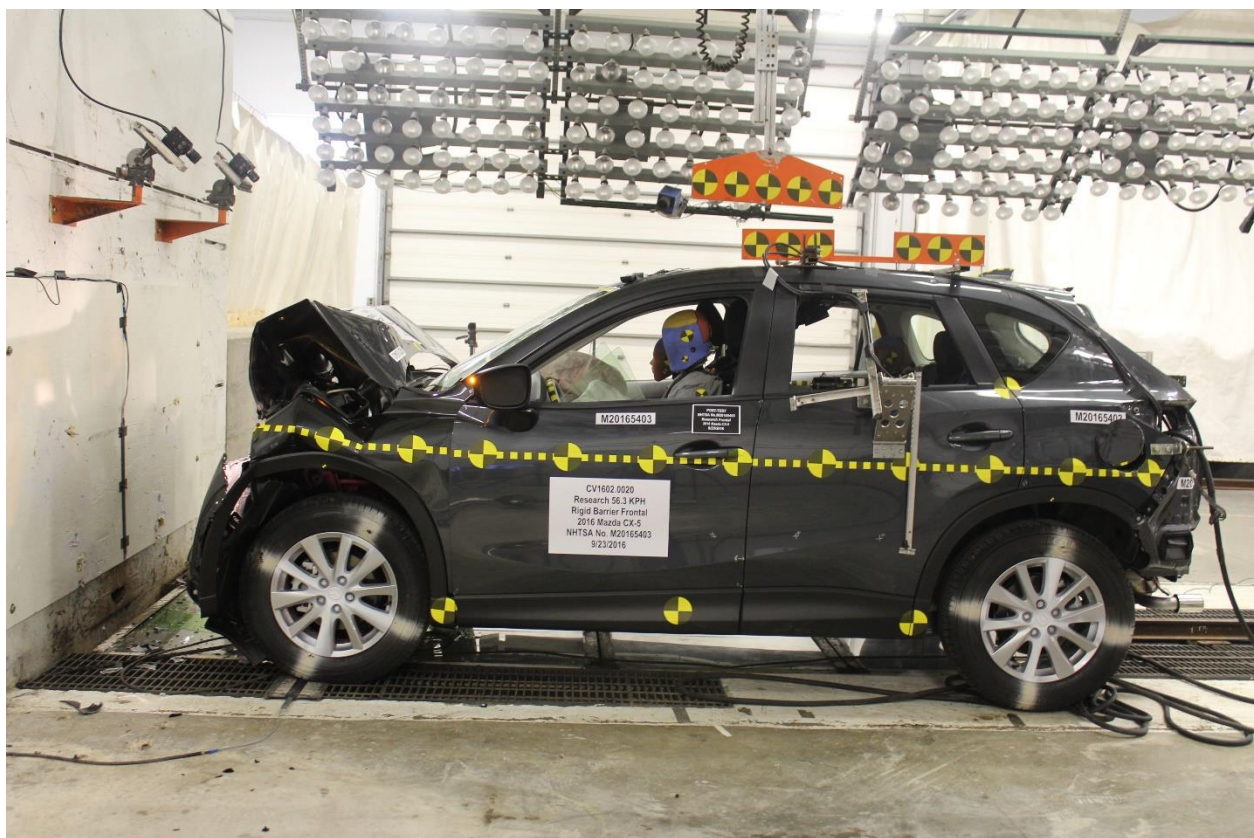
**Figure A-10: Post-Test Left View of Test Vehicle**

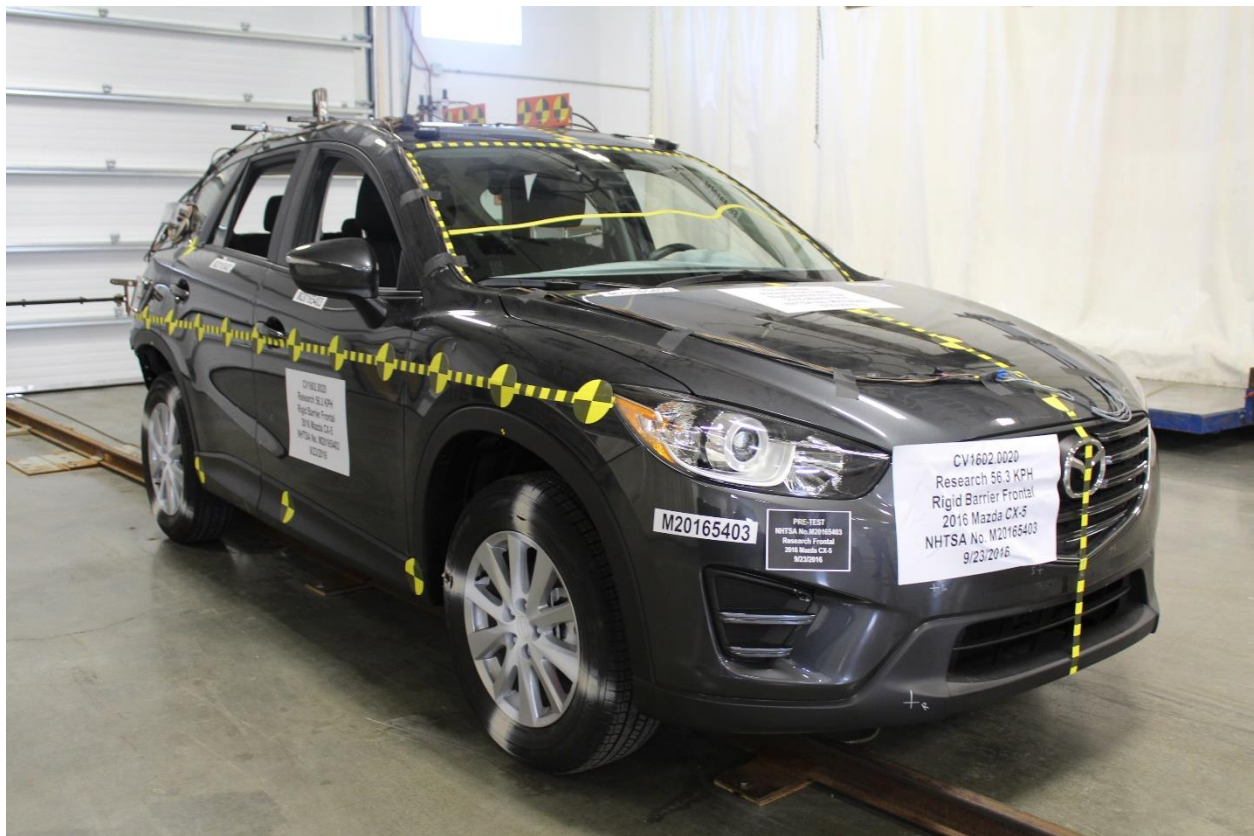
**Figure A-13: Pre-Test Right Front 3/4 View**

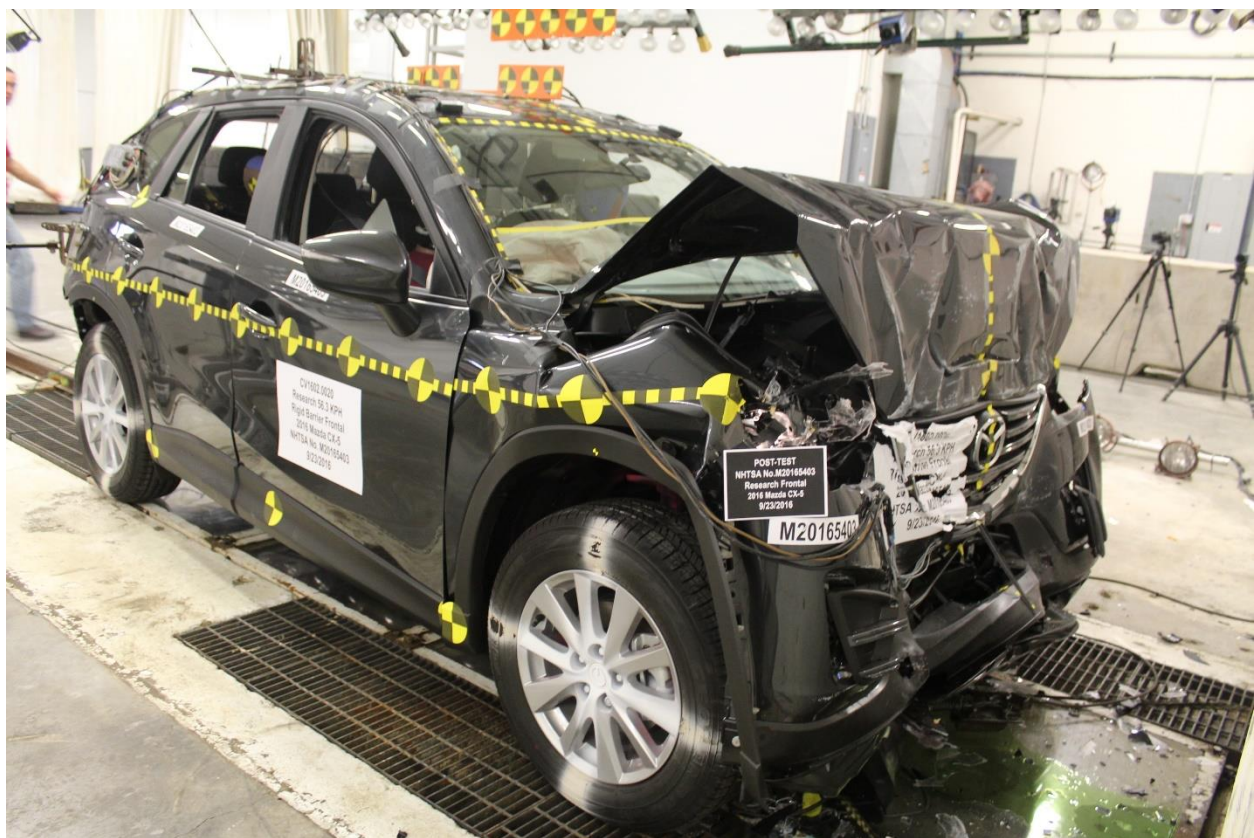
**Figure A-14: Post-Test Right Front 3/4 View**

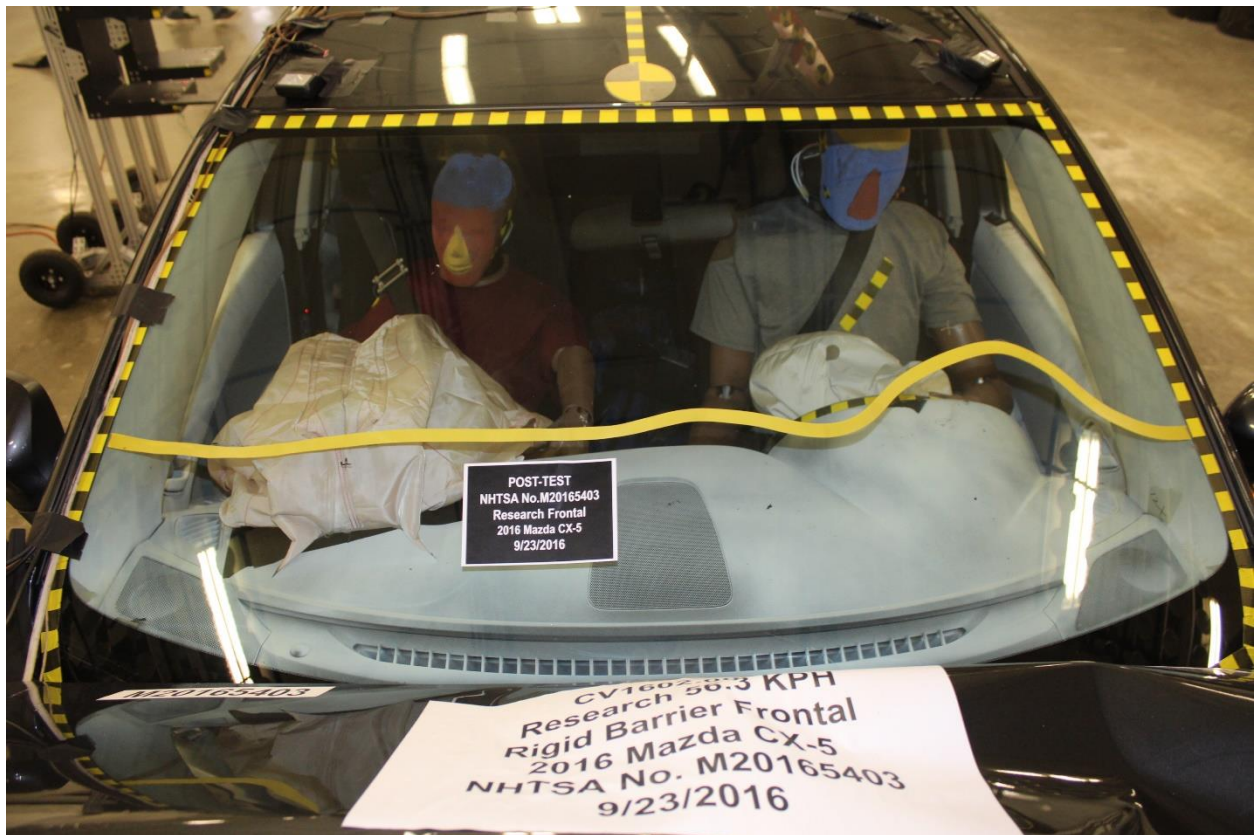
| Critical Areas of Performance | Observations and Conclusions |
|---|---|
| Windshield Damage | Minor Cracks |

Figure A-18: Post-Test Windshield View

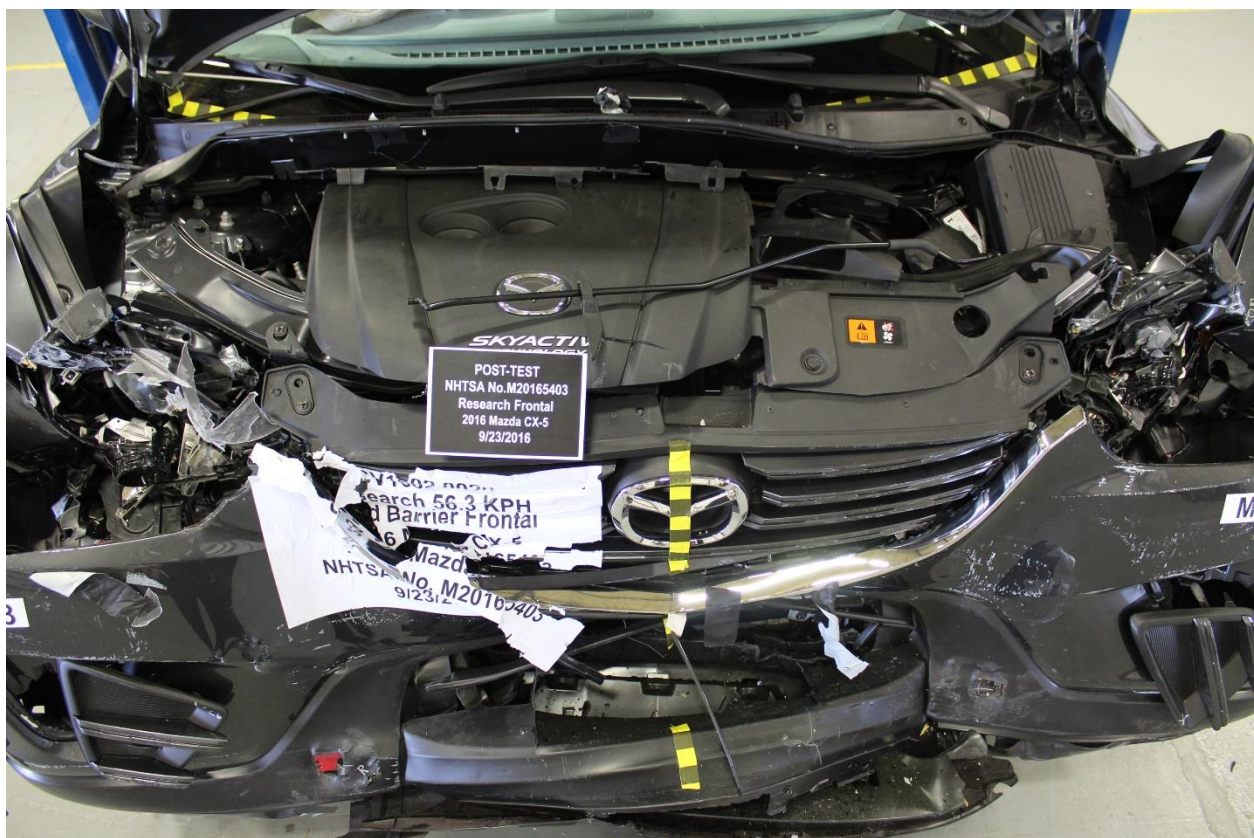
**Figure A-20: Post-Test Engine Compartment View**

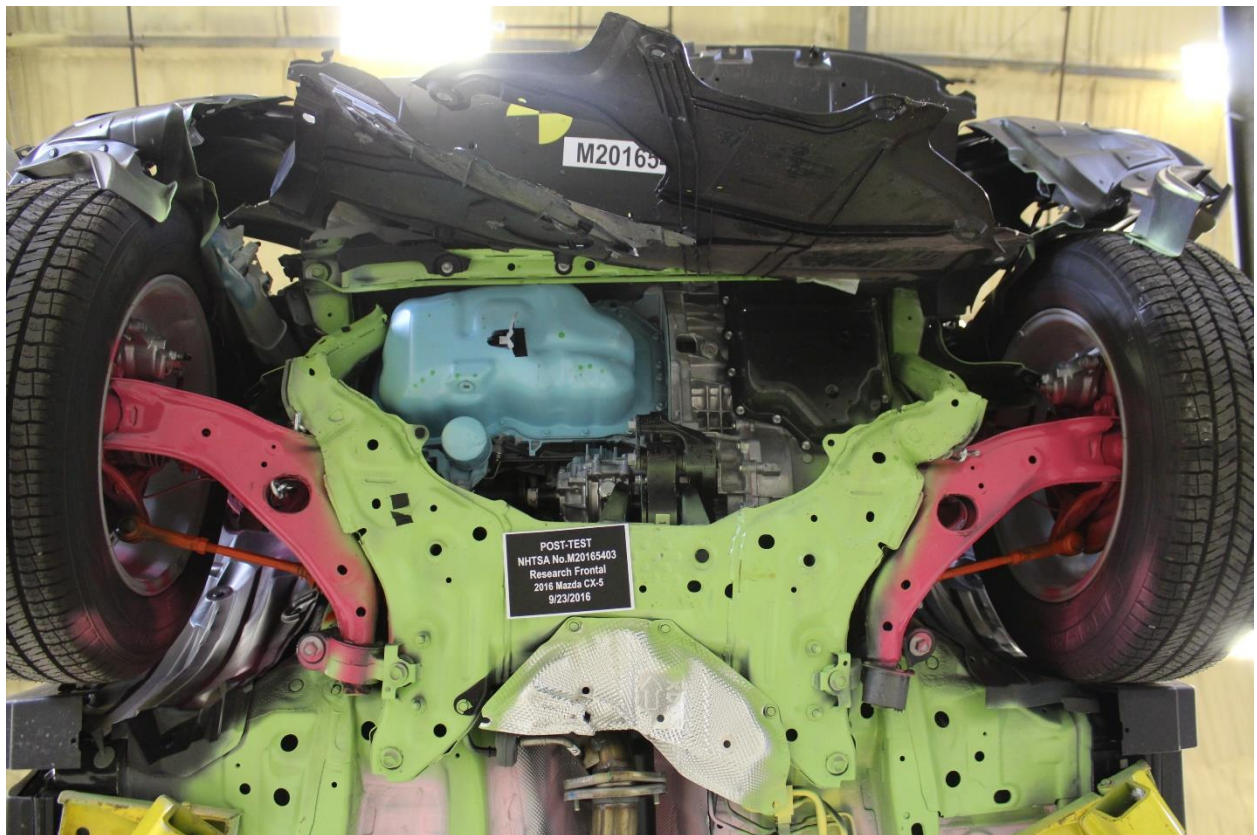
**Figure A-24: Post-Test Front Underbody View**

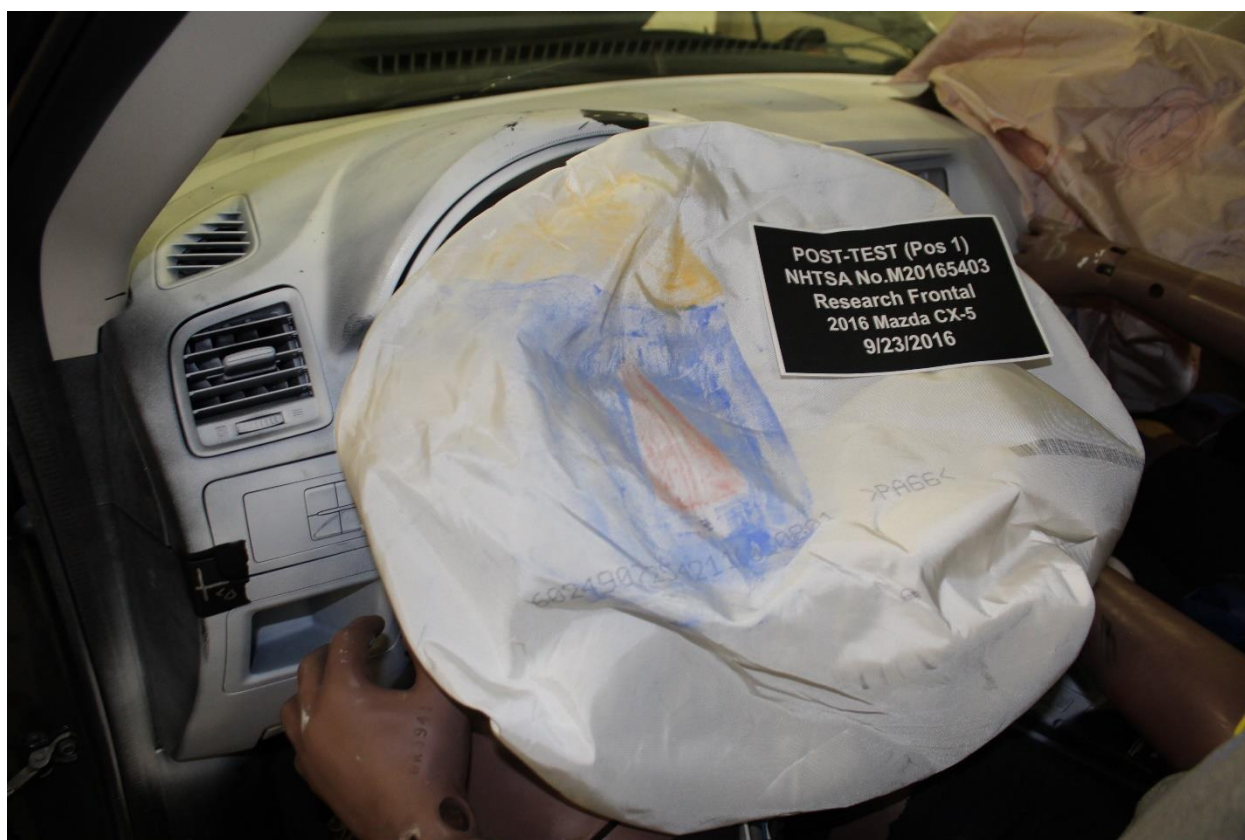
**Figure A-46: Post-Test Driver Dummy Contact With Airbag**

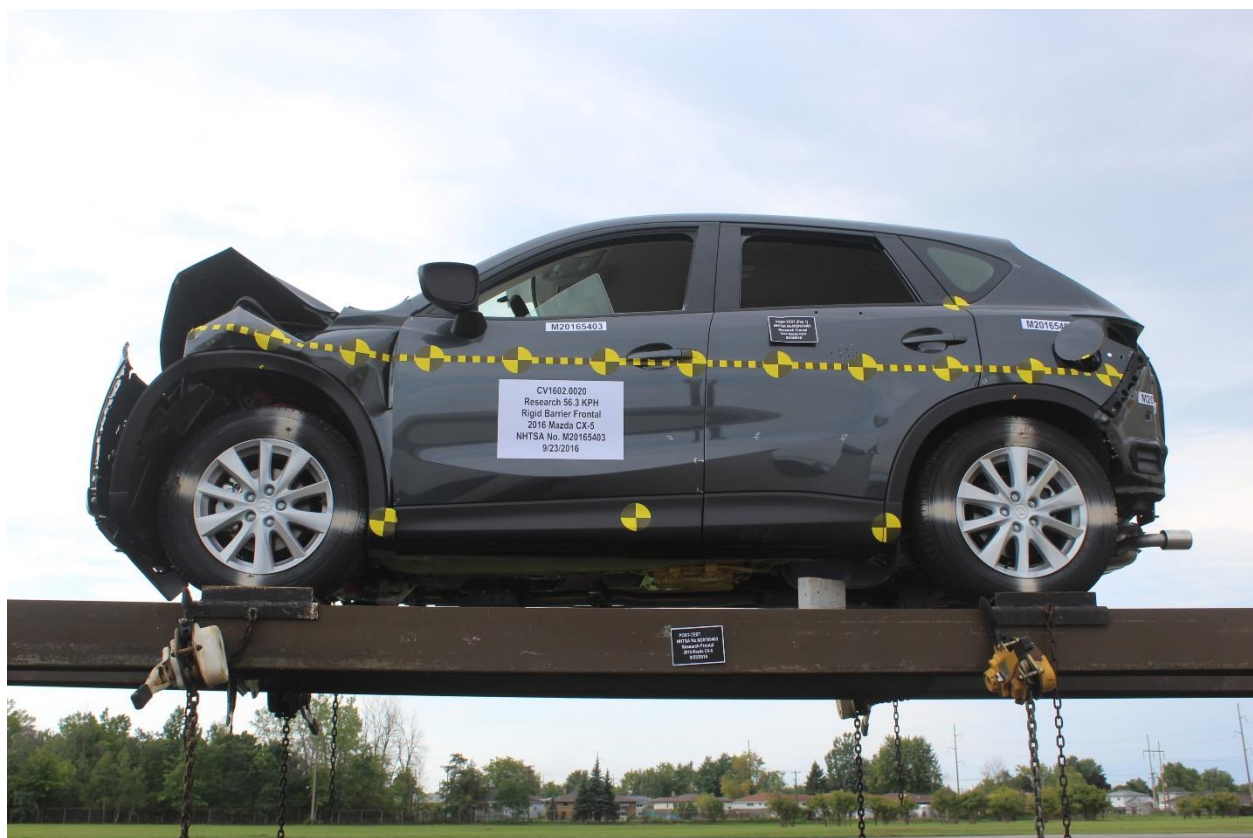
Figure A-72: Vehicle at 0° on Static Rollover Device

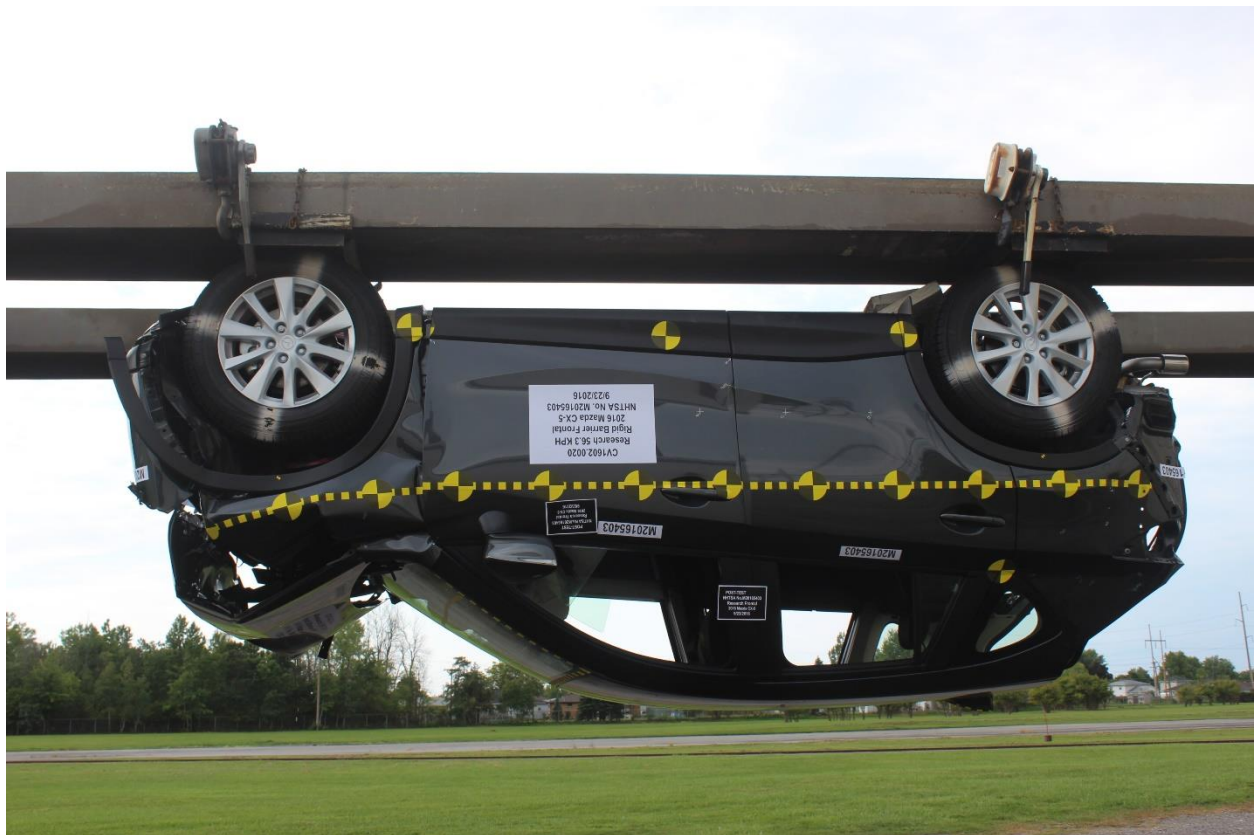
**Figure A-74: Vehicle at 180° on Static Rollover Device**

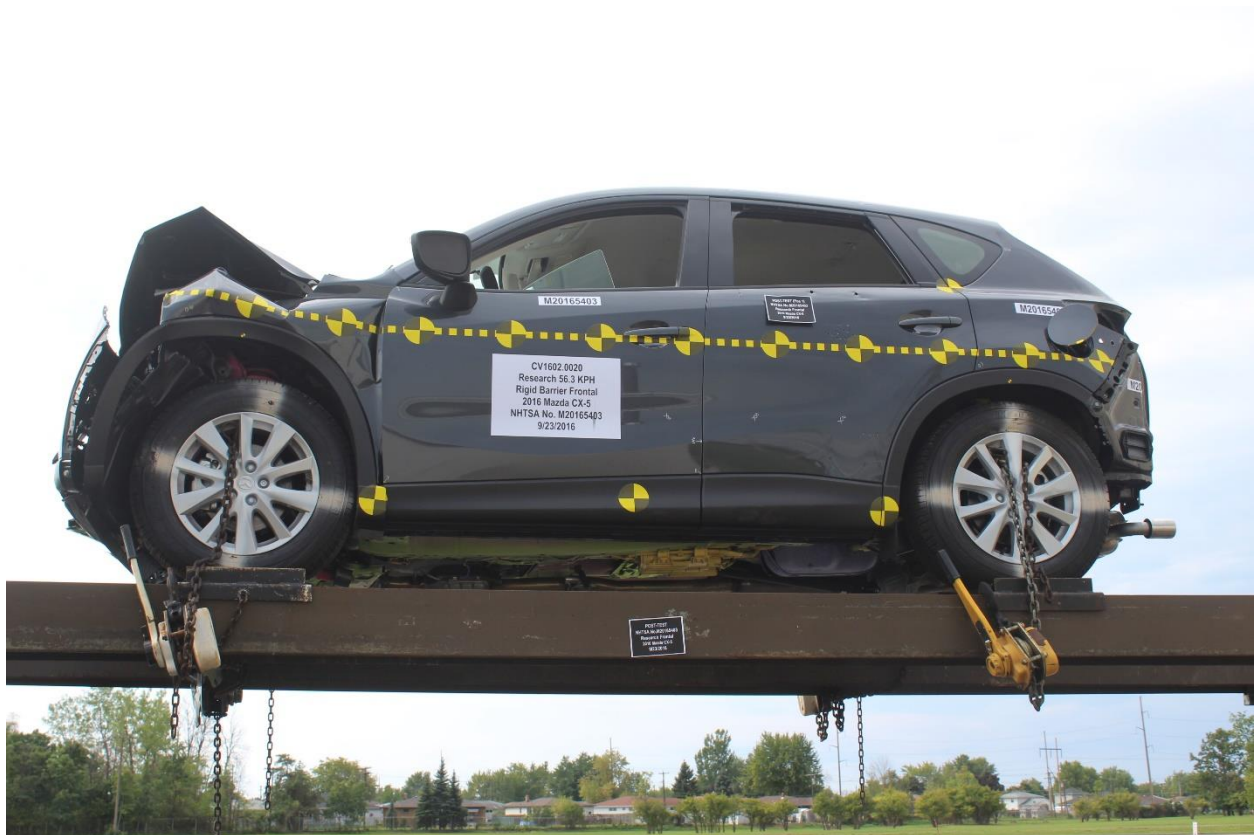
**Figure A-76: Vehicle at 360° on Static Rollover Device**

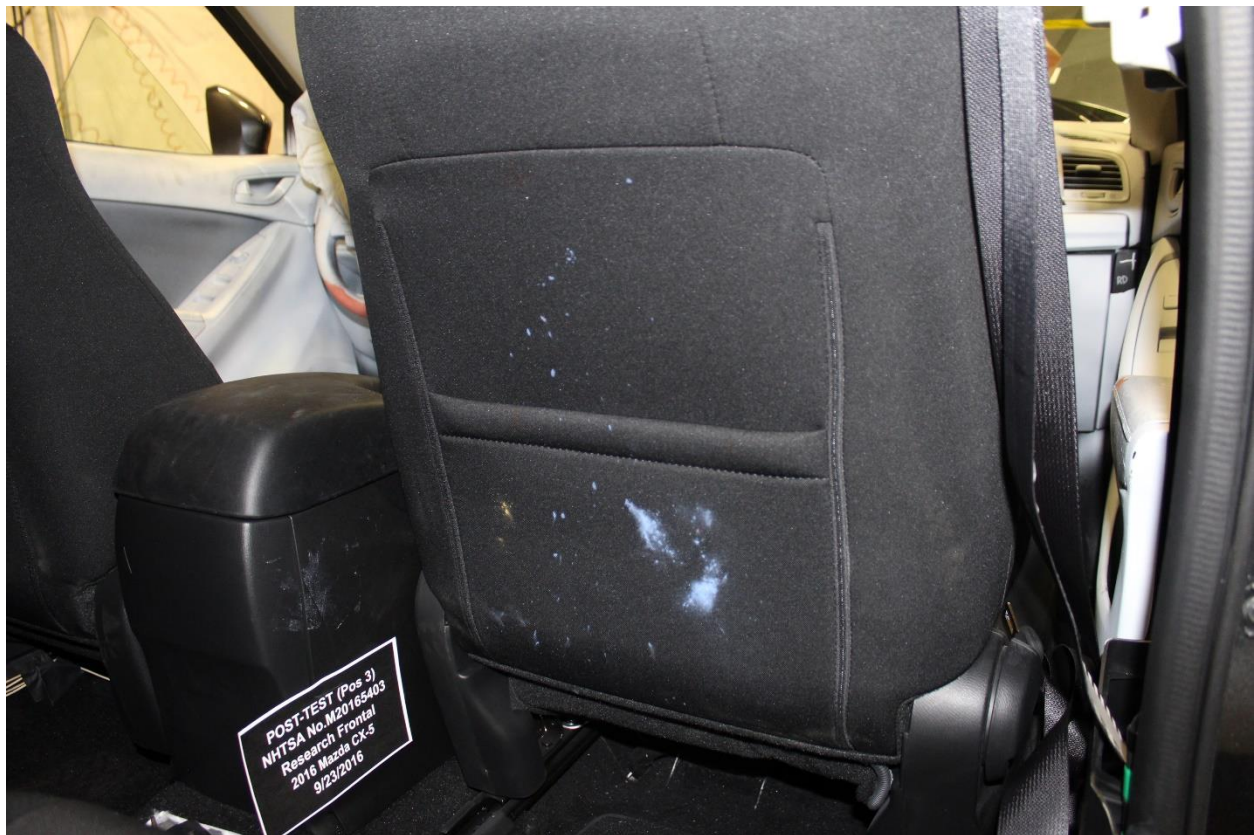
**Figure A-92: Post-Test Rear Passenger Dummy Knee Contact with Seatback**
