**FINAL REPORT NUMBER: SPNCAP-TRC-17-002**

**NEW CAR ASSESSMENT PROGRAM (NCAP)  
SIDE IMPACT POLE TEST**

**General Motors LLC  
2017 Chevrolet Camaro 2DR Coupe  
NHTSA NUMBER: M20170114**

**PREPARED BY:  
Transportation Research Center Inc.  
10820 State Route 347  
P. O. Box B-67  
East Liberty, OH 43319**

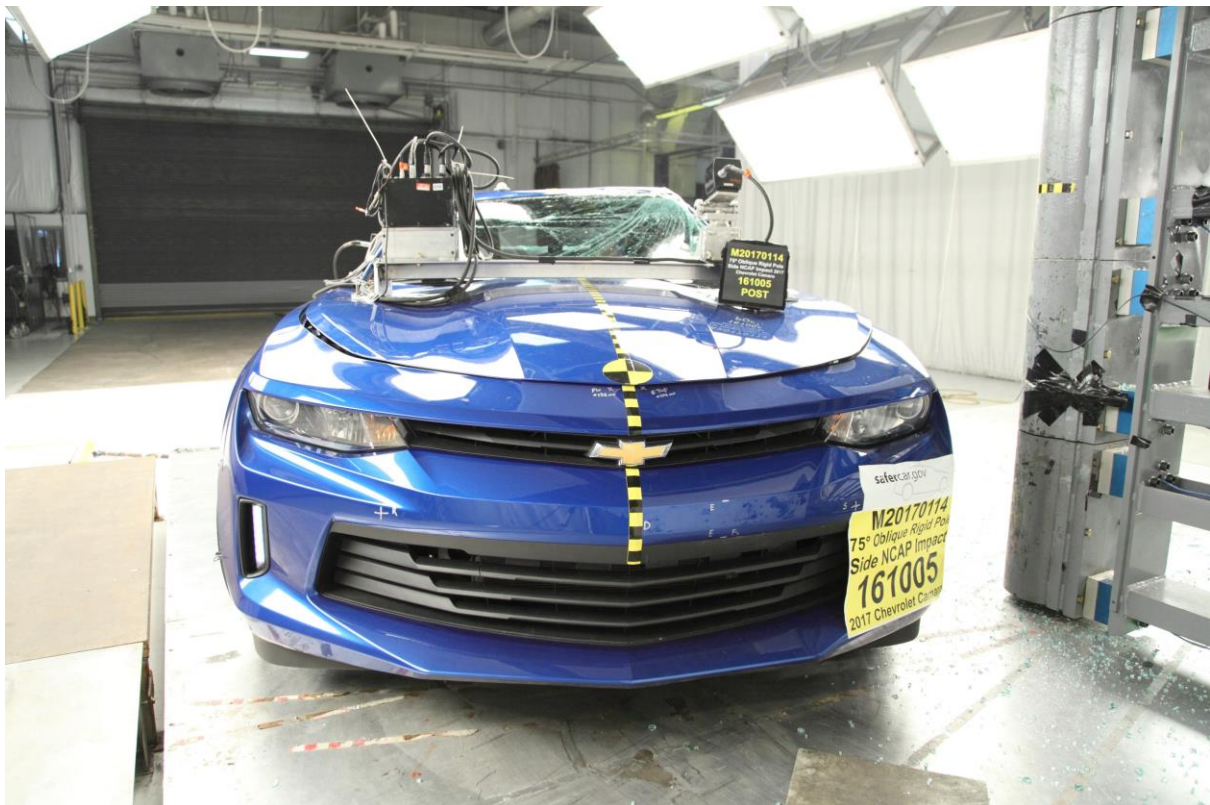
**No. 004 Post-Test Frontal View of Test Vehicle**

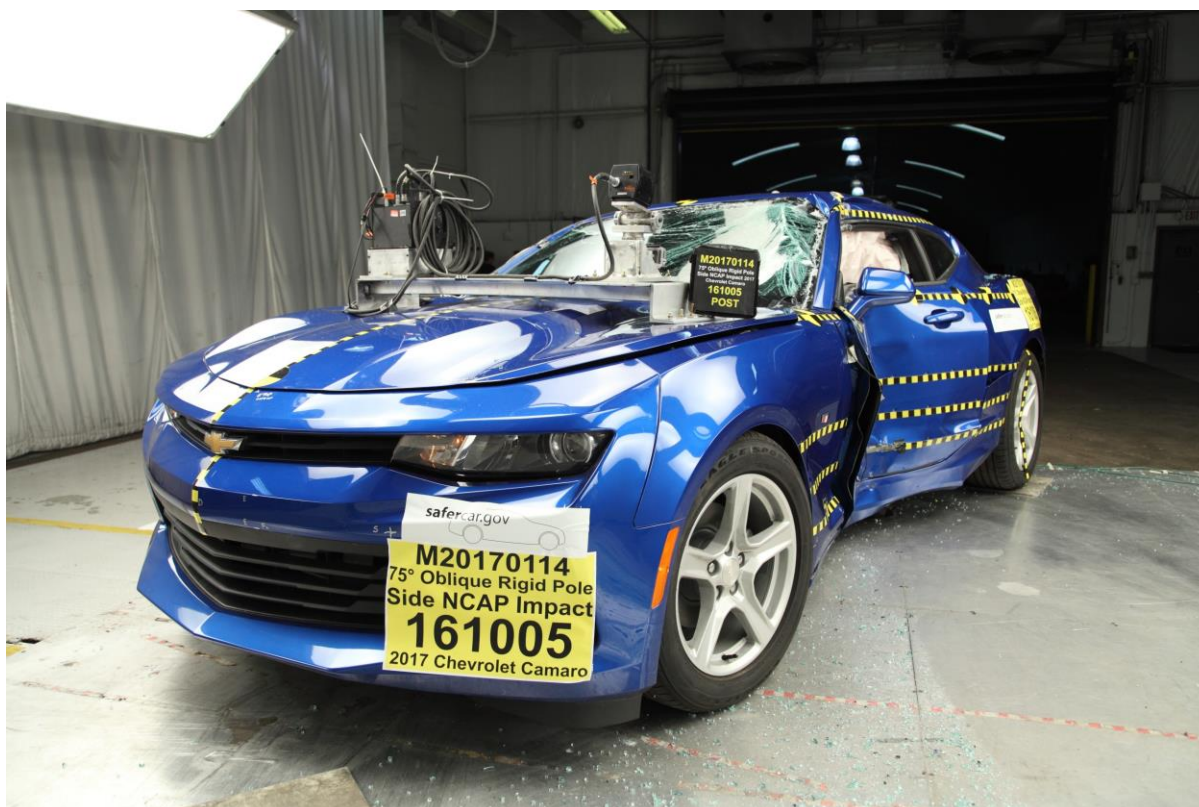
No. 006 Post-Test Left Front  $\frac{3}{4}$  View of Test Vehicle

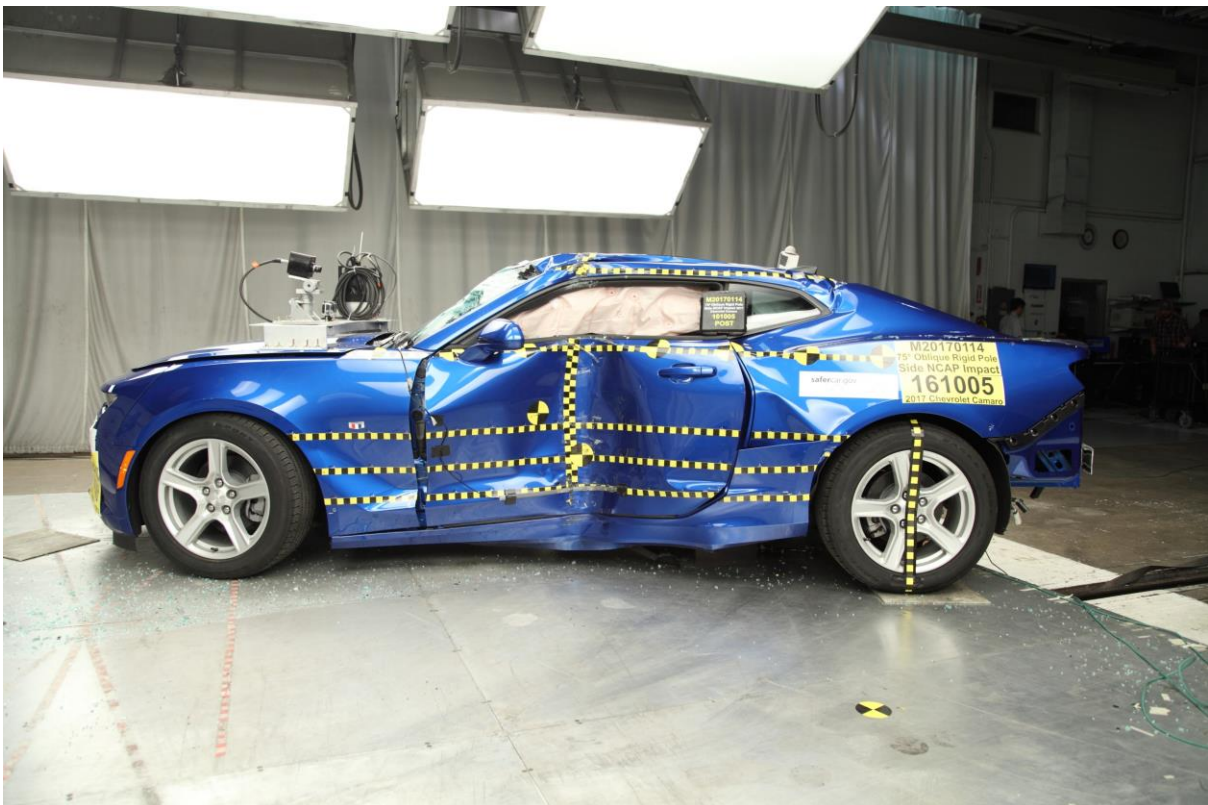
**No. 008 Post-Test Left Side View of Test Vehicle**

| Critical Areas of Performance | Observations and Conclusions |
|---|---|
| Windshield Damage | Broken down A pillar and across top |
| Side Window Damage | Driver door broken out |

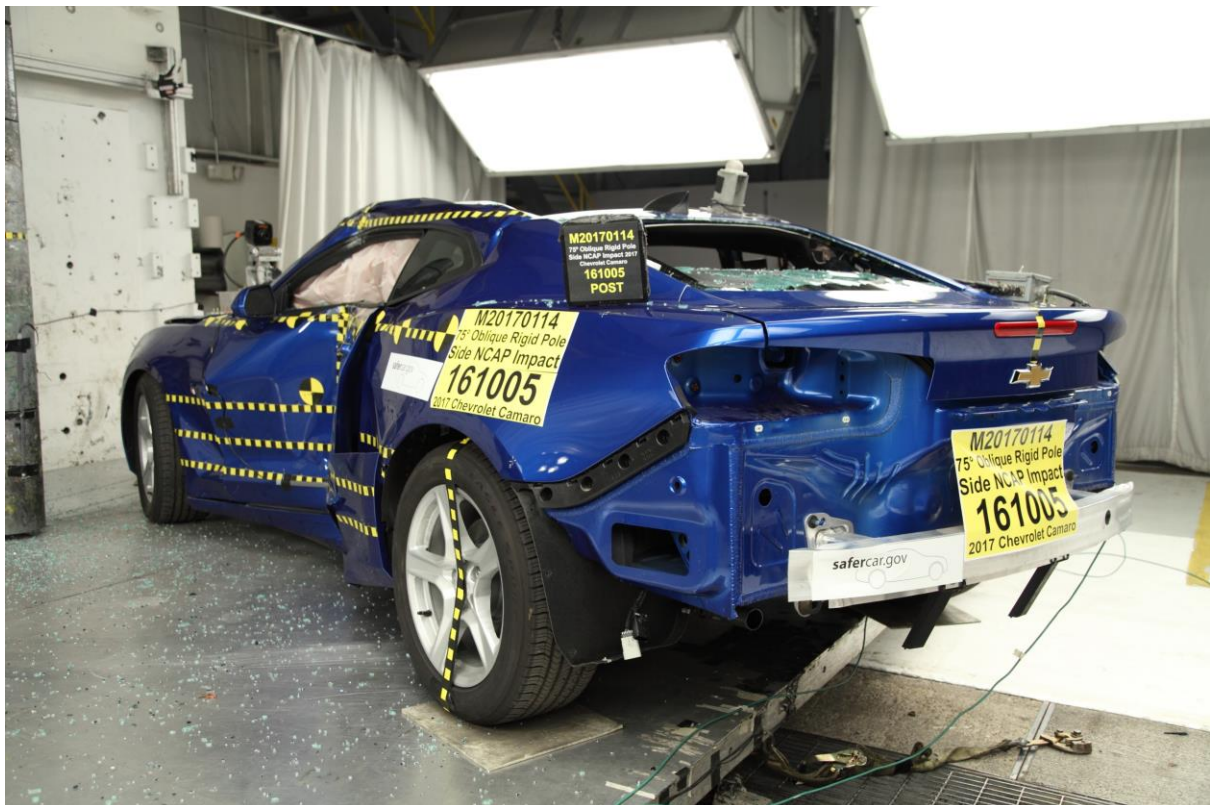
**No. 010 Post-Test Left Rear  $\frac{3}{4}$  View of Test Vehicle**

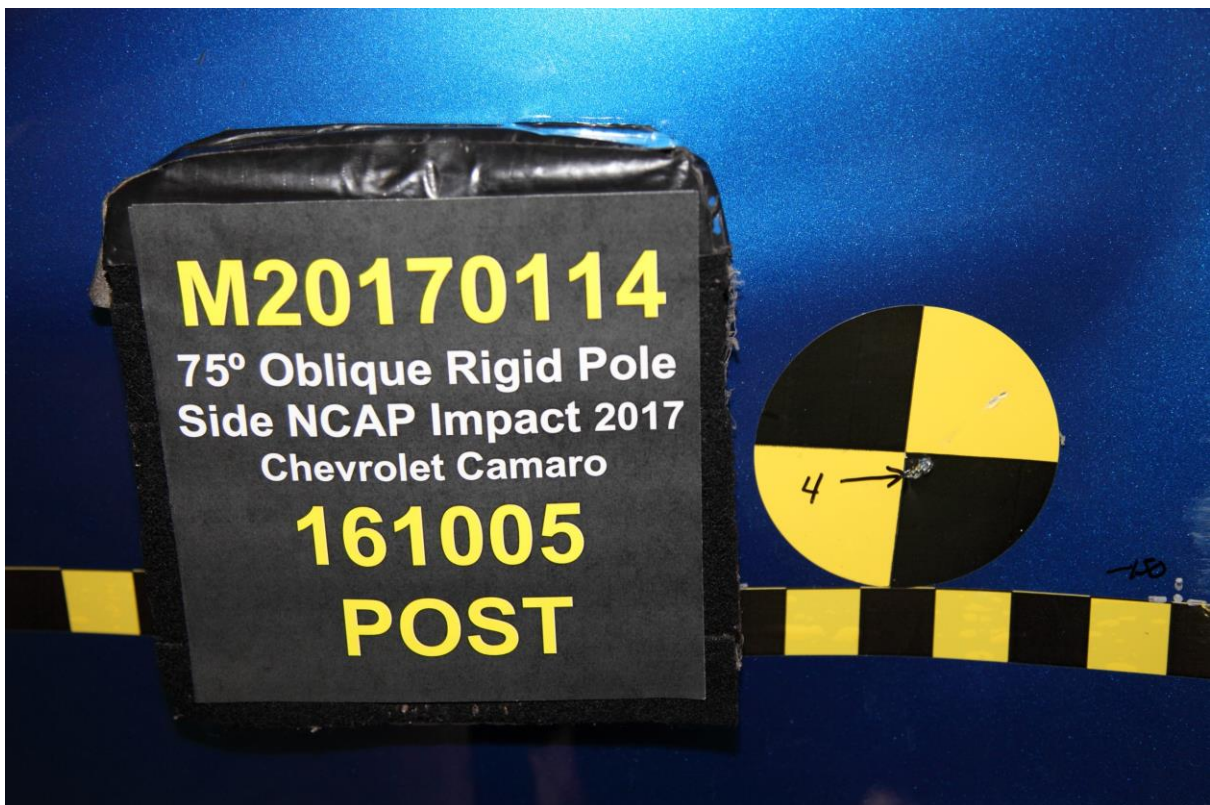
No. 020 Post-Test Close-Up View of Impact Point Target Showing Impact Location

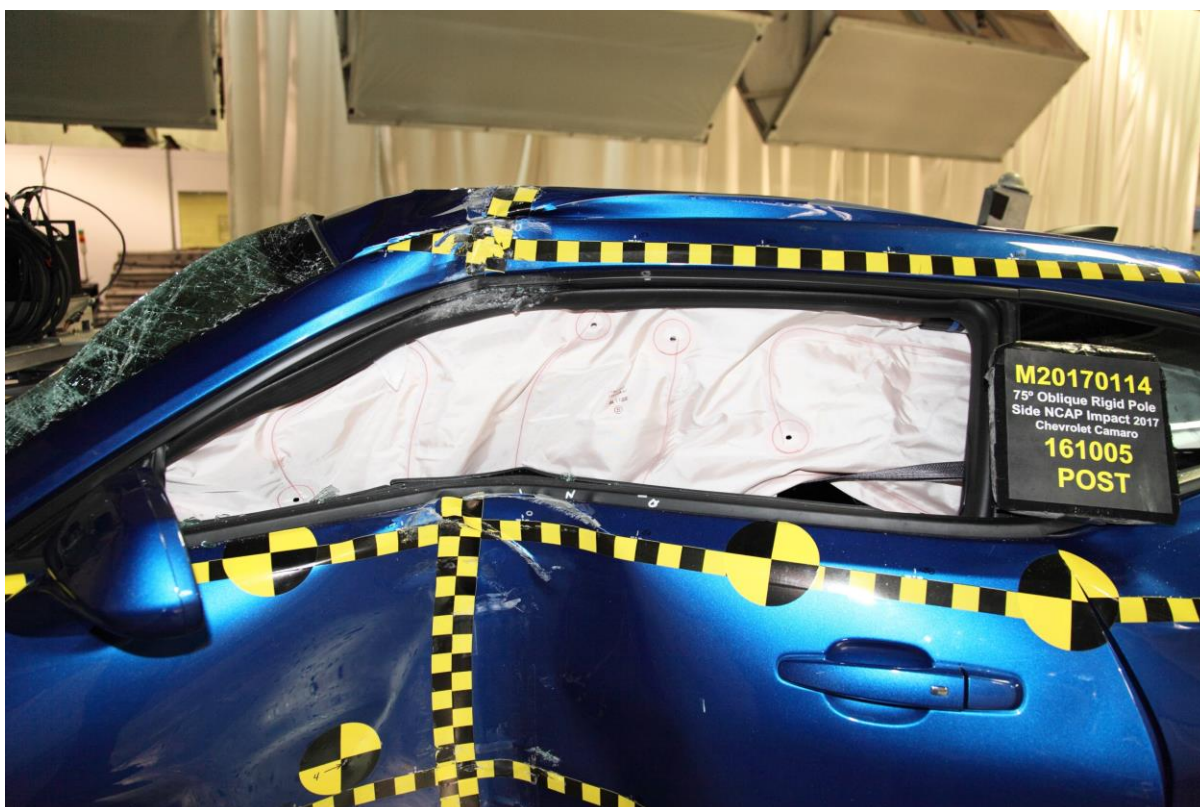
**No. 025 Post-Test Left Side View of Dummy Shoulder and Door Top View**

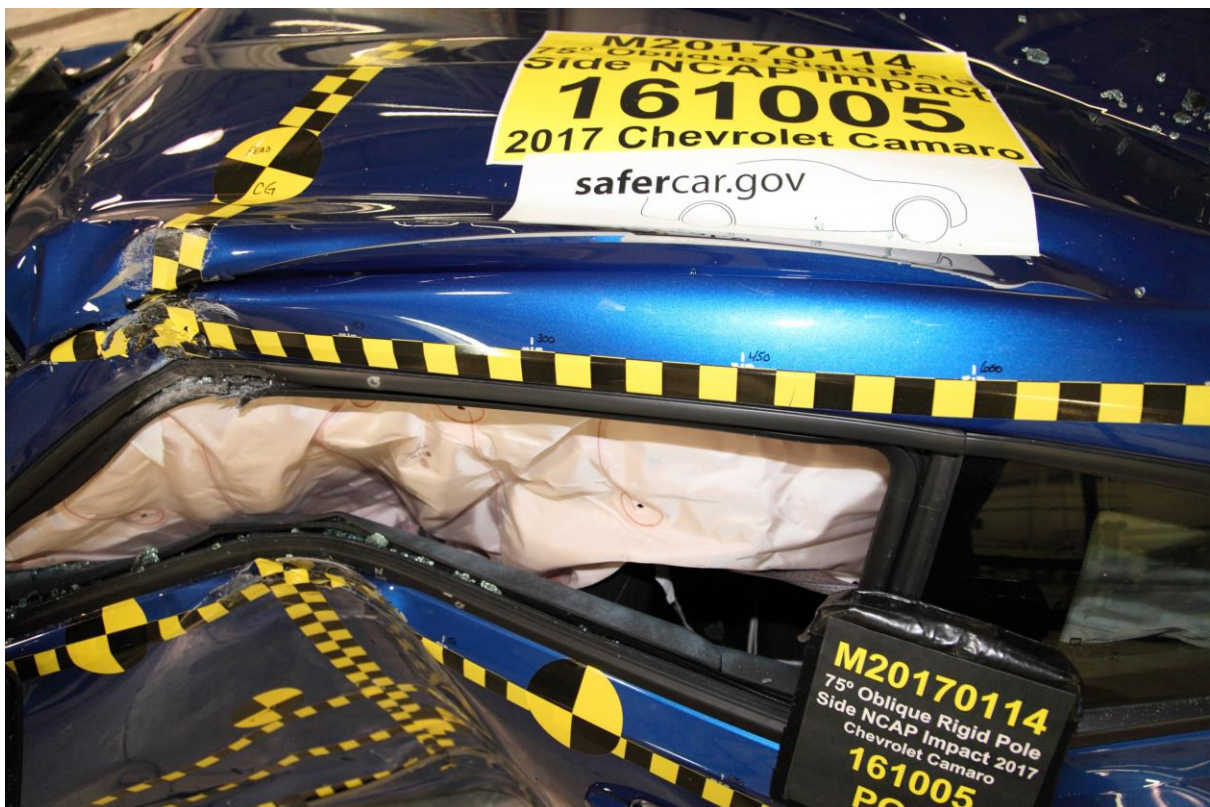
No. 041 Post-Test Dummy and Door Clearance View

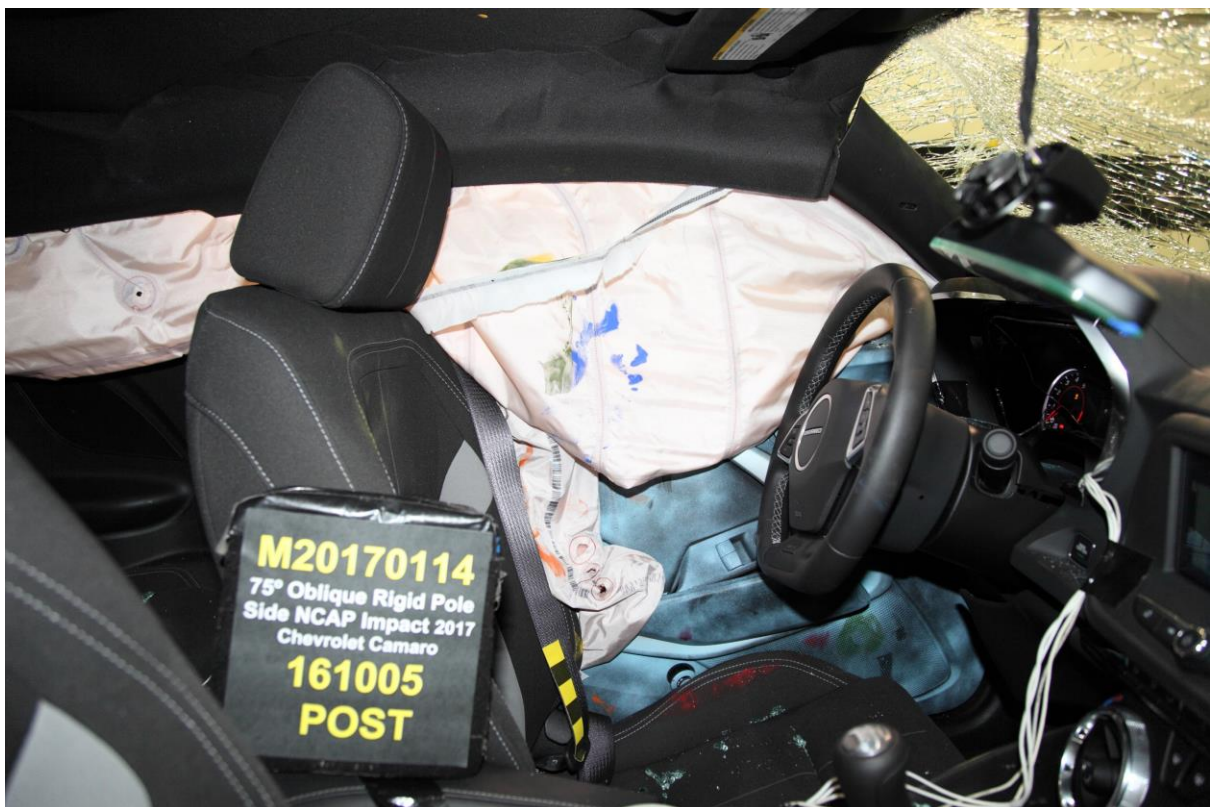
No. 045 Post-Test Inner Door Panel View Showing Dummy Contact Location

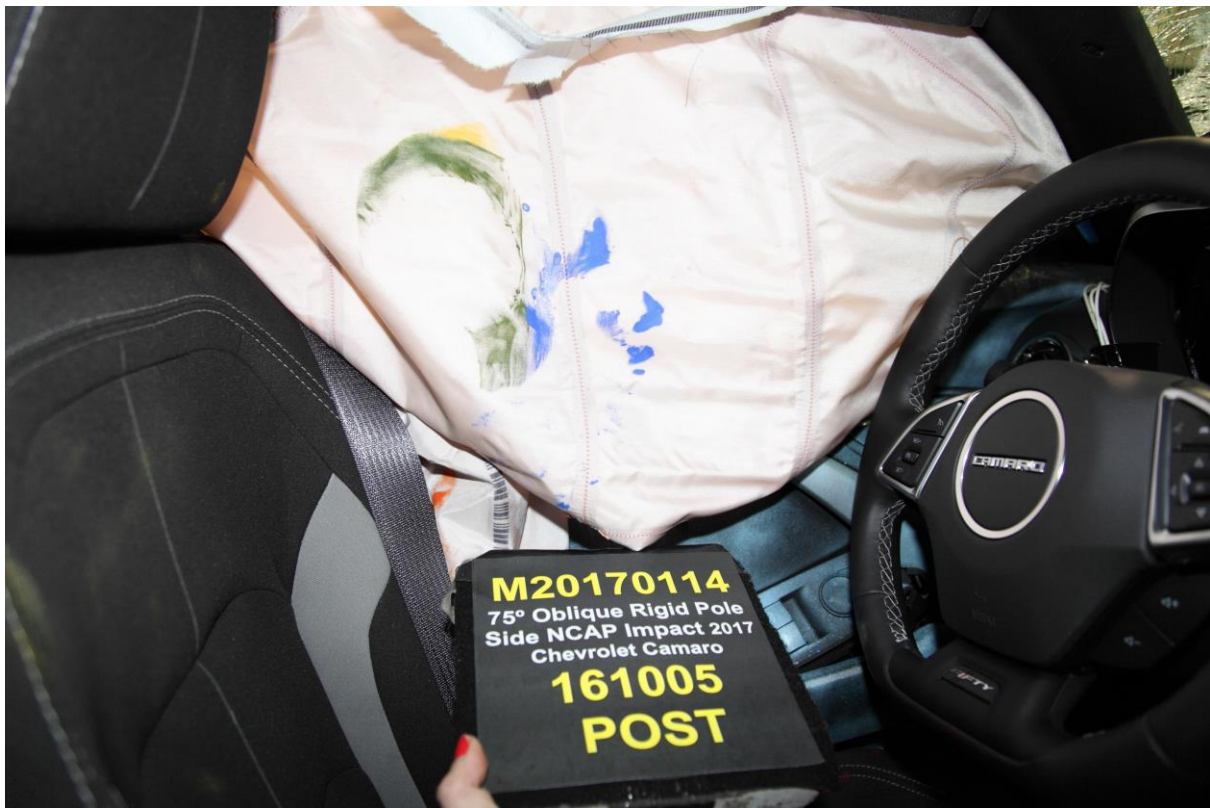
**No. 047 Post-Test Dummy Close-Up Head Contact with Side Airbag View**

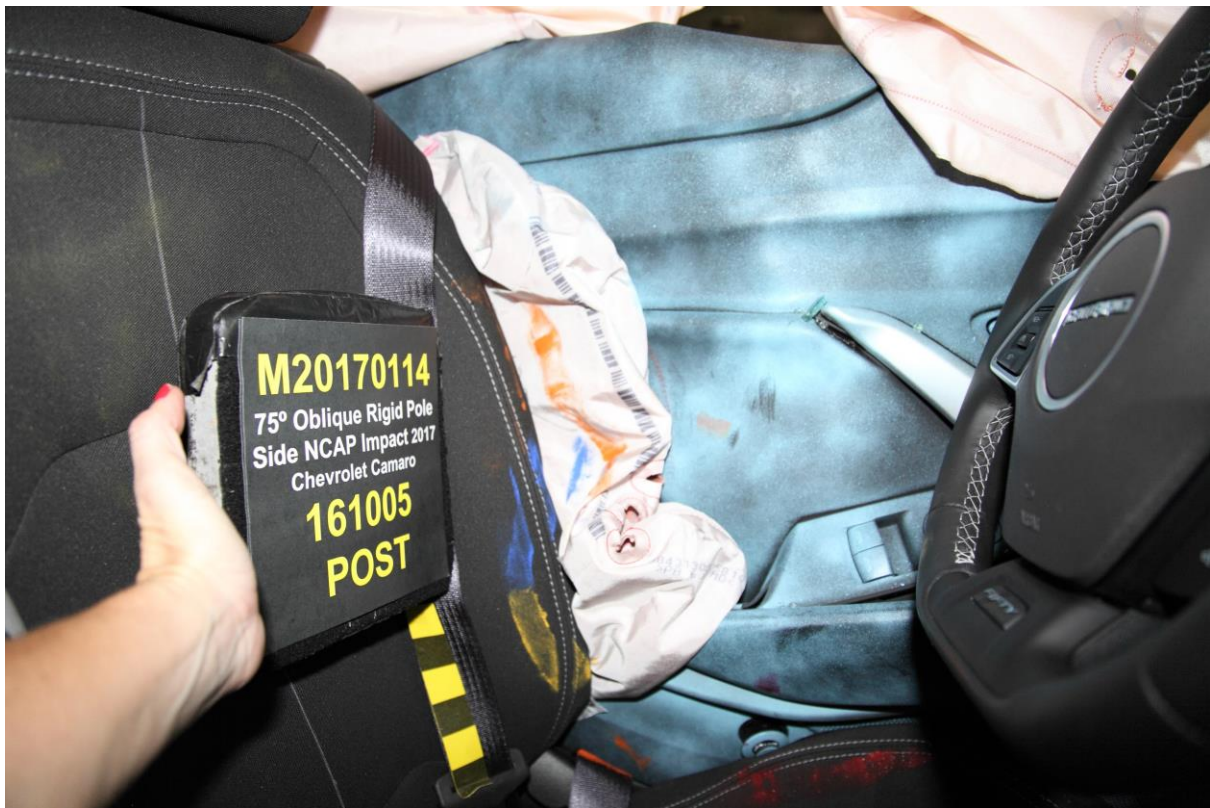
**No. 049 Post-Test Dummy Close-Up Torso Contact with Side Airbag View**

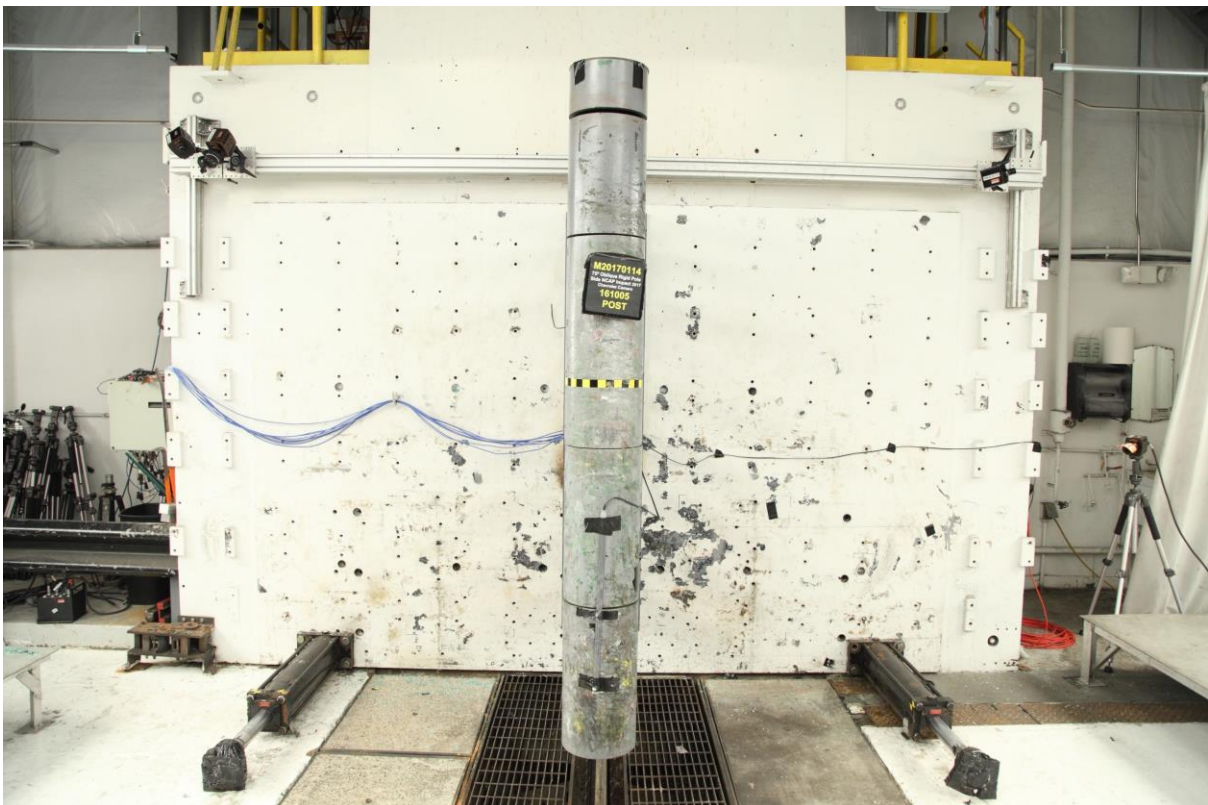
**No. 058 Post-Test Pole Barrier Front View**

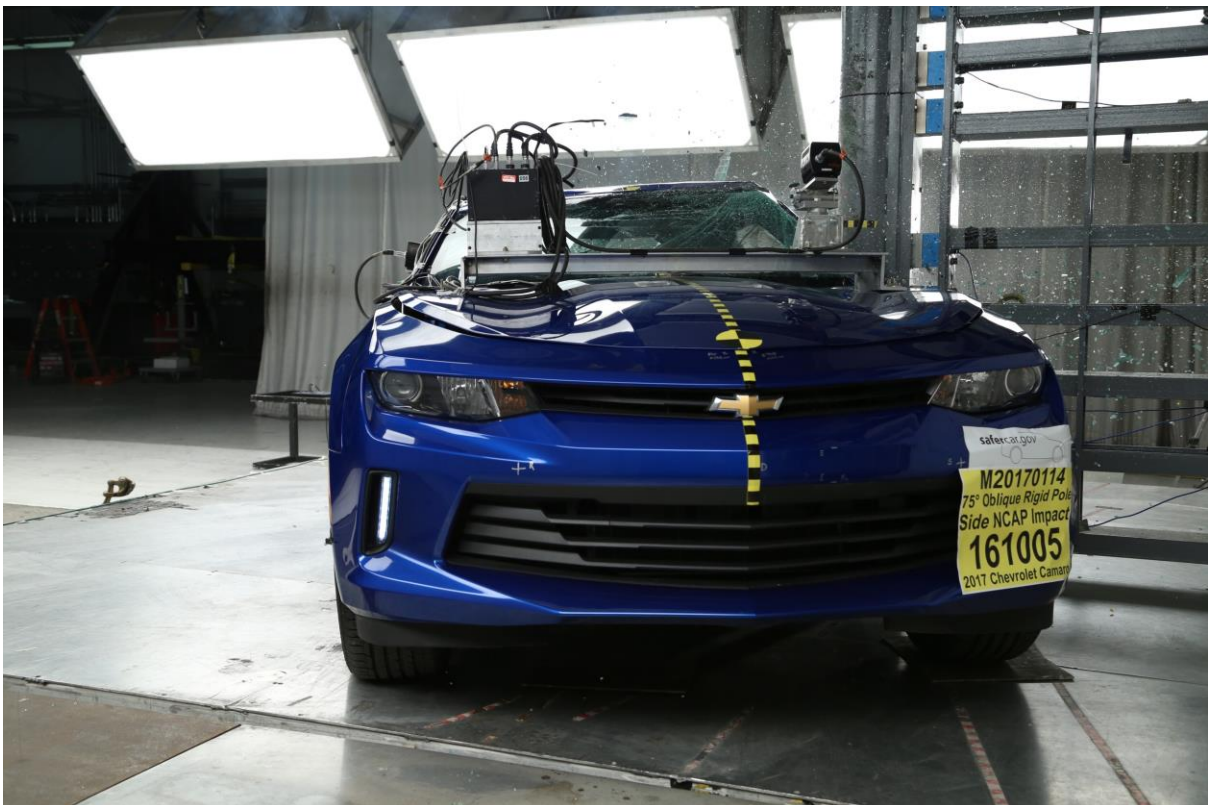
**No. 068 Impact Event**
