**REPORT NUMBER: SPNCAP-MGA-2017-011**

**NEW CAR ASSESSMENT PROGRAM (NCAP)  
Side Impact Pole Test**

**FCA US LLC  
2017 Chrysler Pacifica LX Minivan  
NHTSA No.: O20170301**

**MGA RESEARCH CORPORATION  
5000 Warren Road  
Burlington, WI 53105**

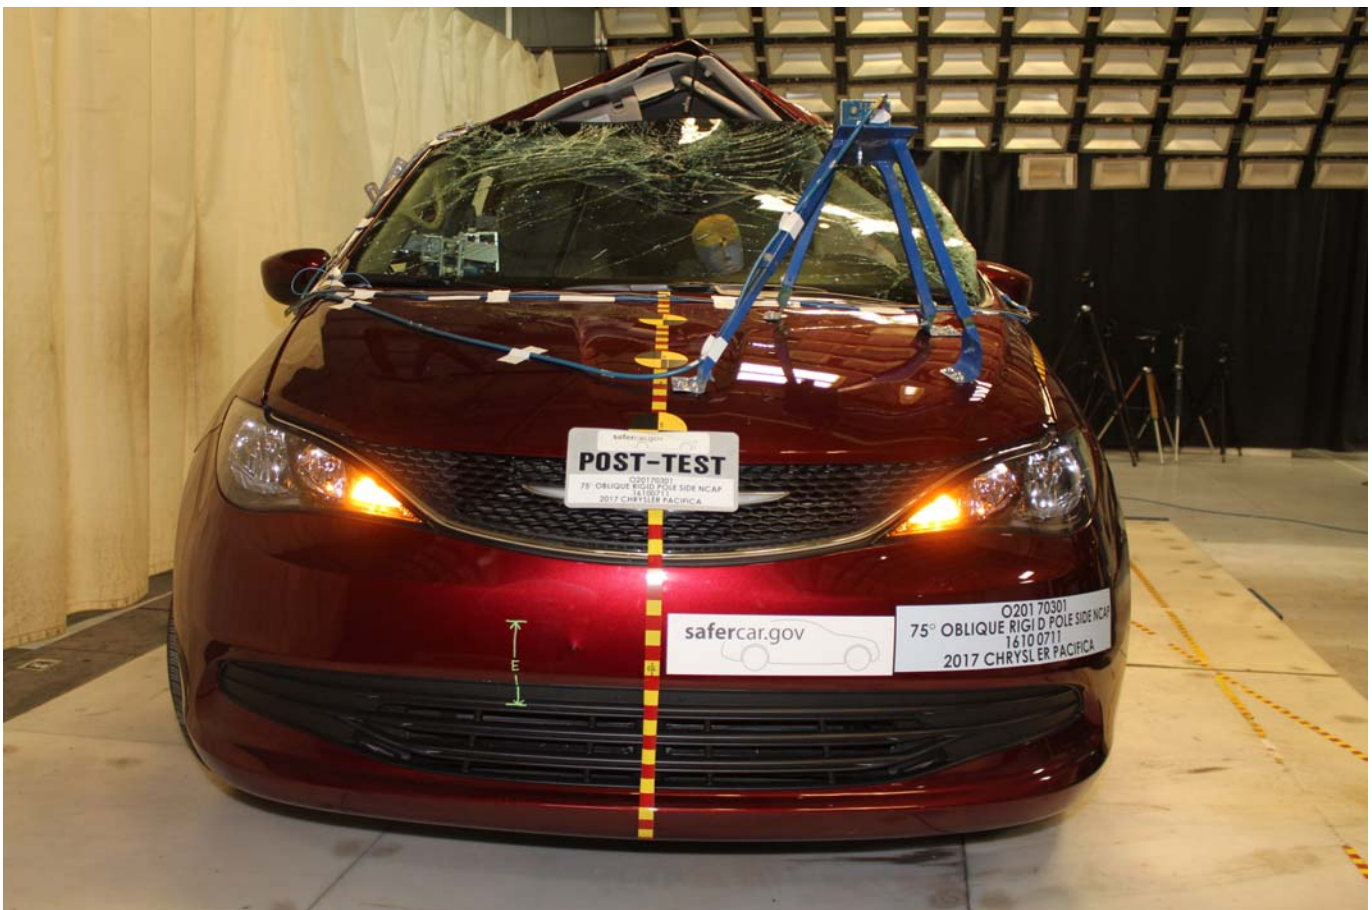
Photo No. 004 - Post-Test Frontal View of Test Vehicle

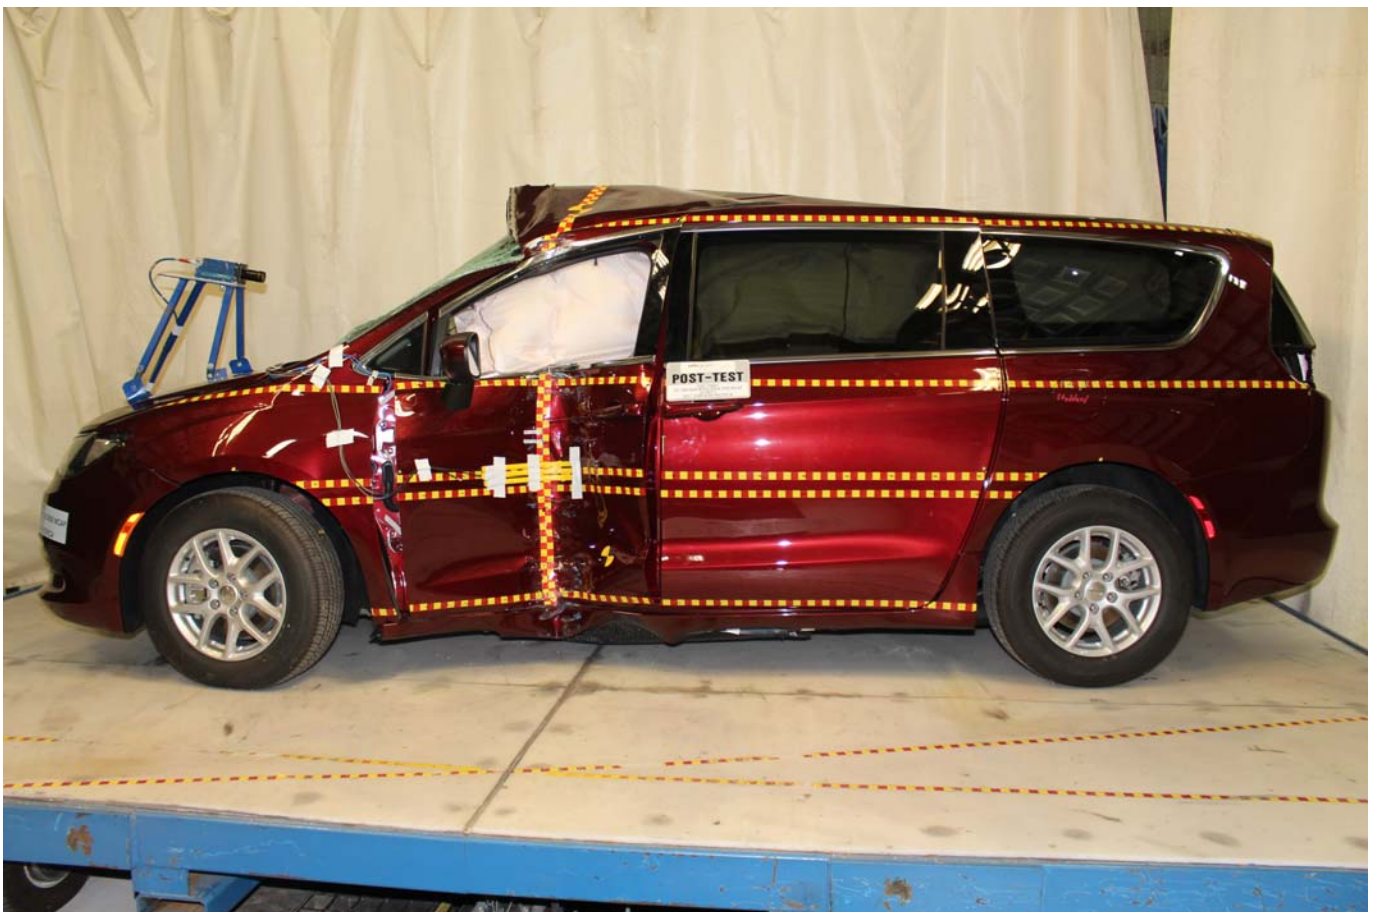
Photo No. 008 - Post-Test Left Side View of Test Vehicle

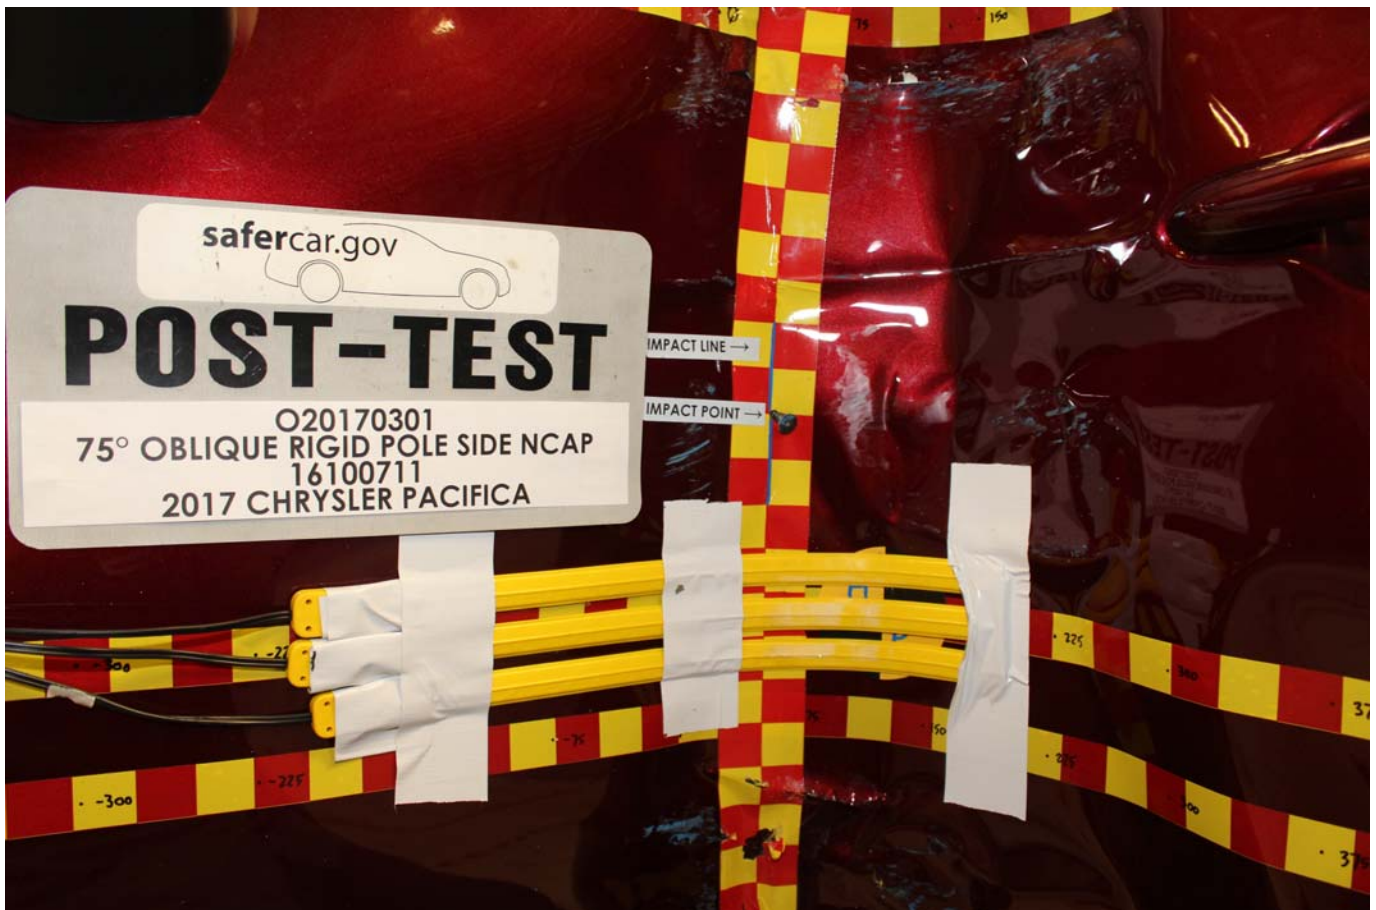
Photo No. 020 - Post-Test Close-Up View of Impact Point Target Showing Impact Location

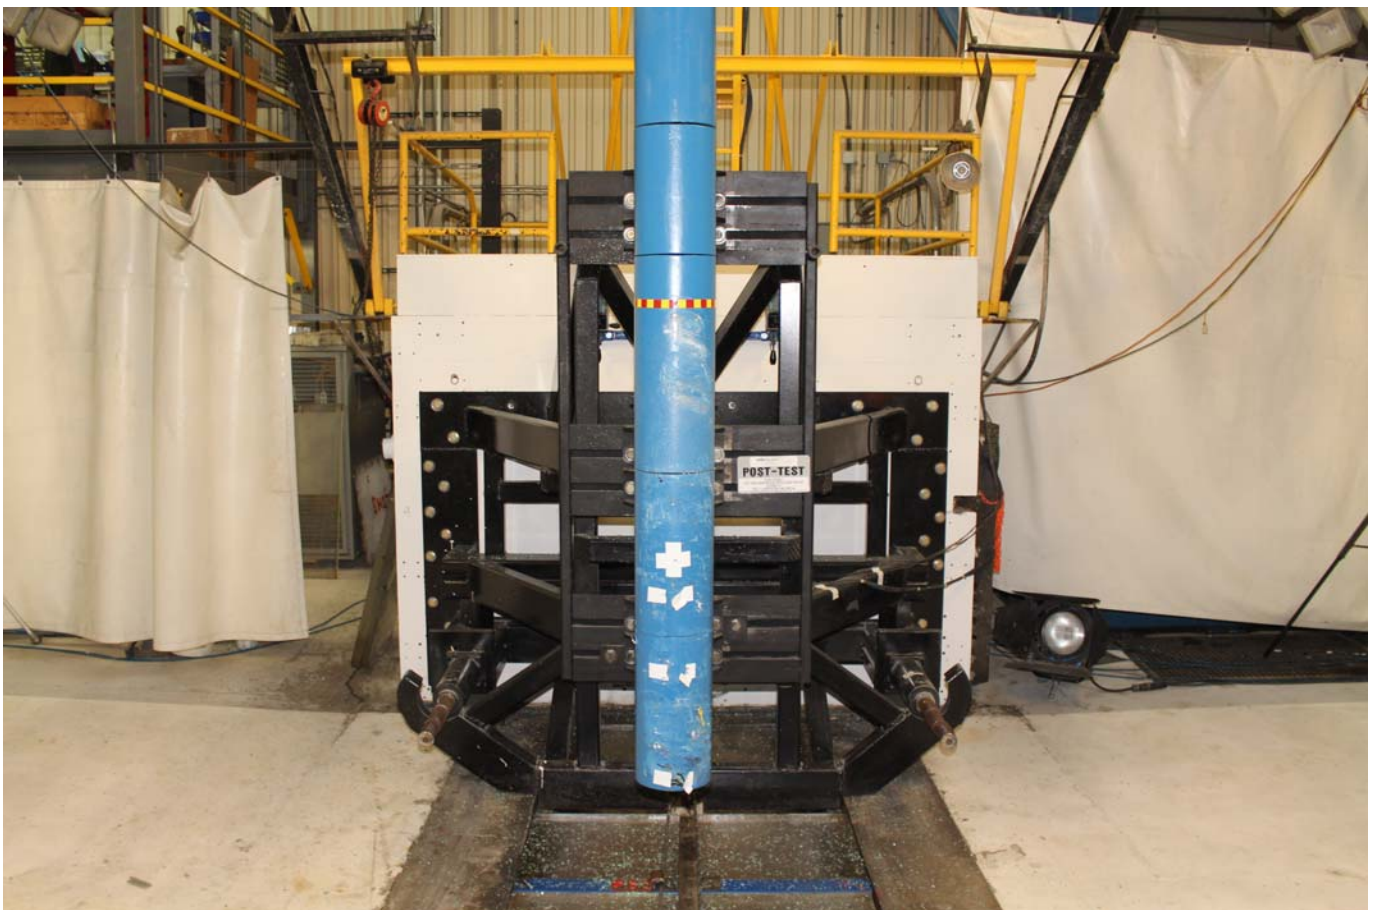
Photo No. 058 - Post-Test Pole Barrier Front View
