**REPORT NUMBER: SPNCAP-CAL-17-002**

**NEW CAR ASSESSMENT PROGRAM (NCAP)  
SIDE IMPACT POLE TEST**

**General Motors LLC  
2017 Cadillac XT5  
SUV**

**FINAL REPORT**

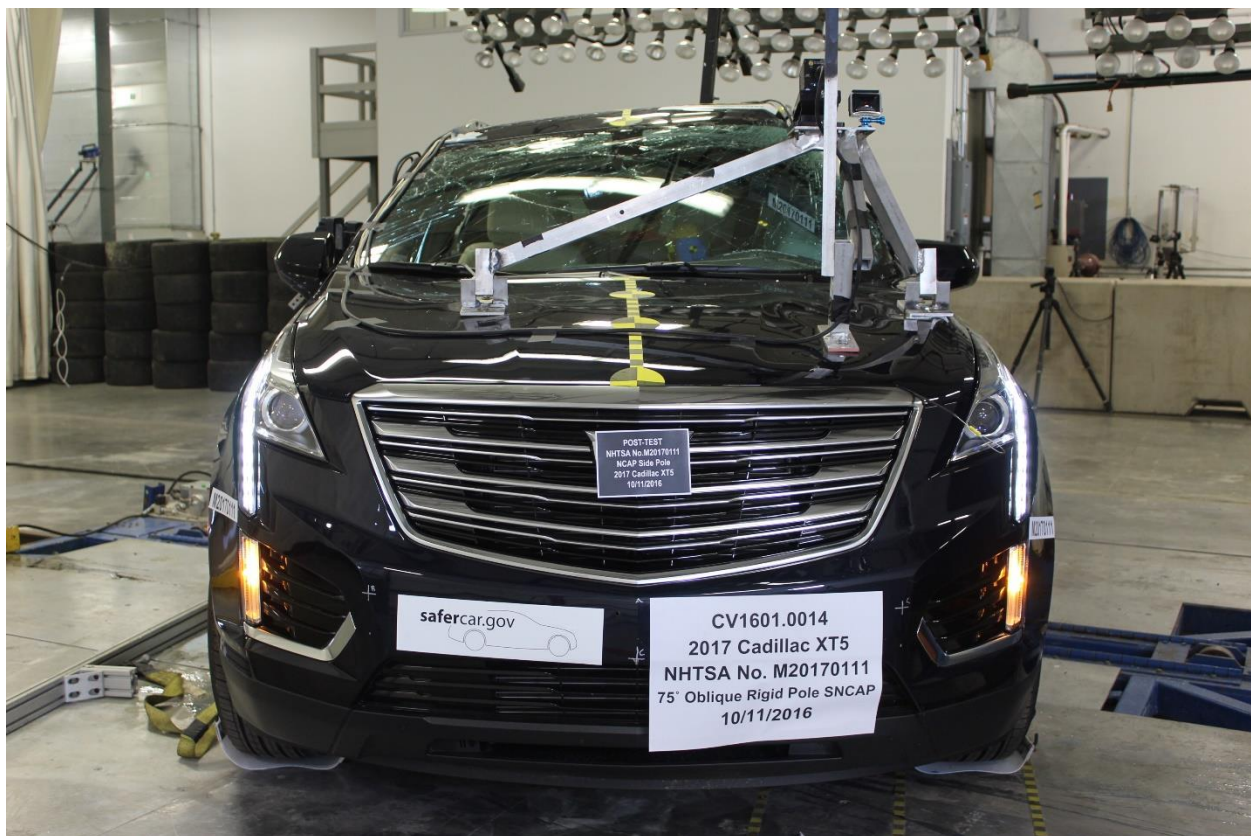
**Figure A-4: Post-Test Frontal View of Test Vehicle**

| Critical Areas of Performance | Observations and Conclusions |
|---|---|
| Windshield Damage | Cracks throughout with separation along driver's A-Pillar |

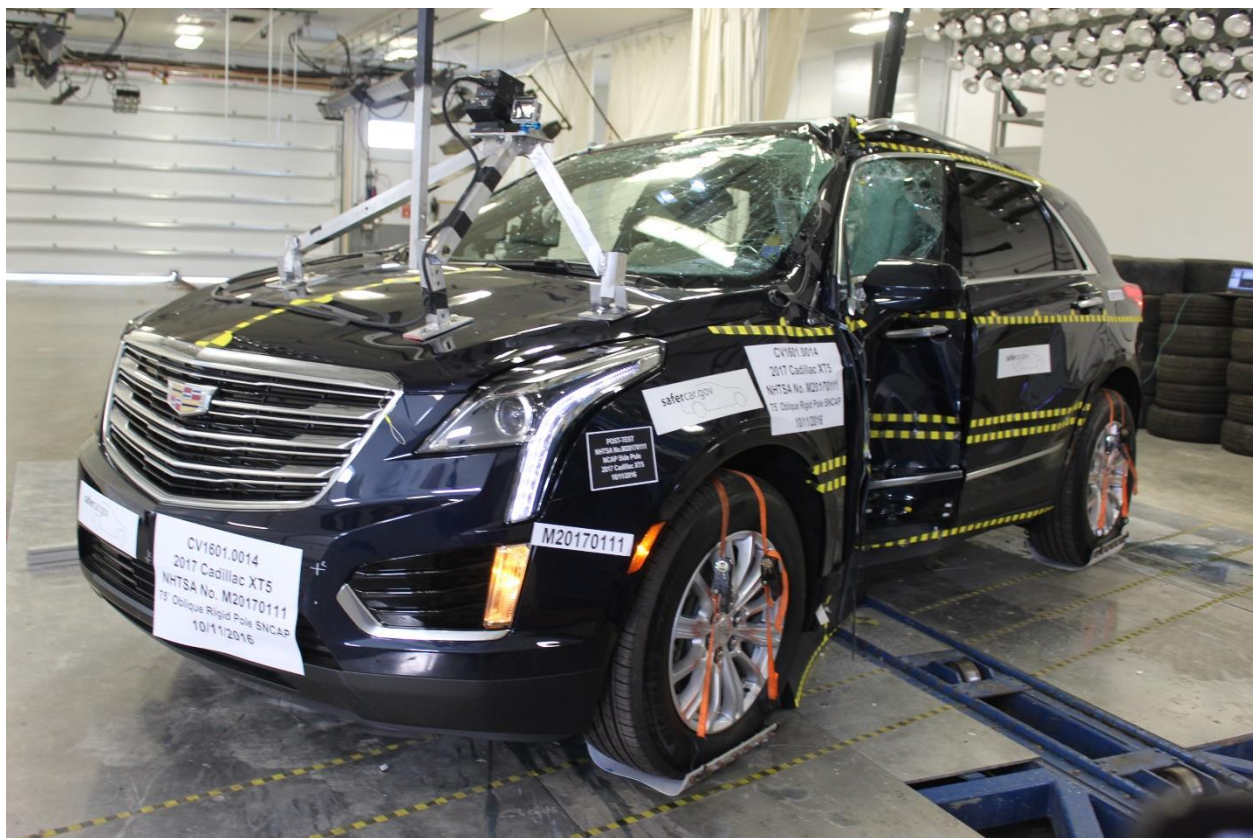
**Figure A-6: Post-Test Left Front  $\frac{3}{4}$  View of Test Vehicle**

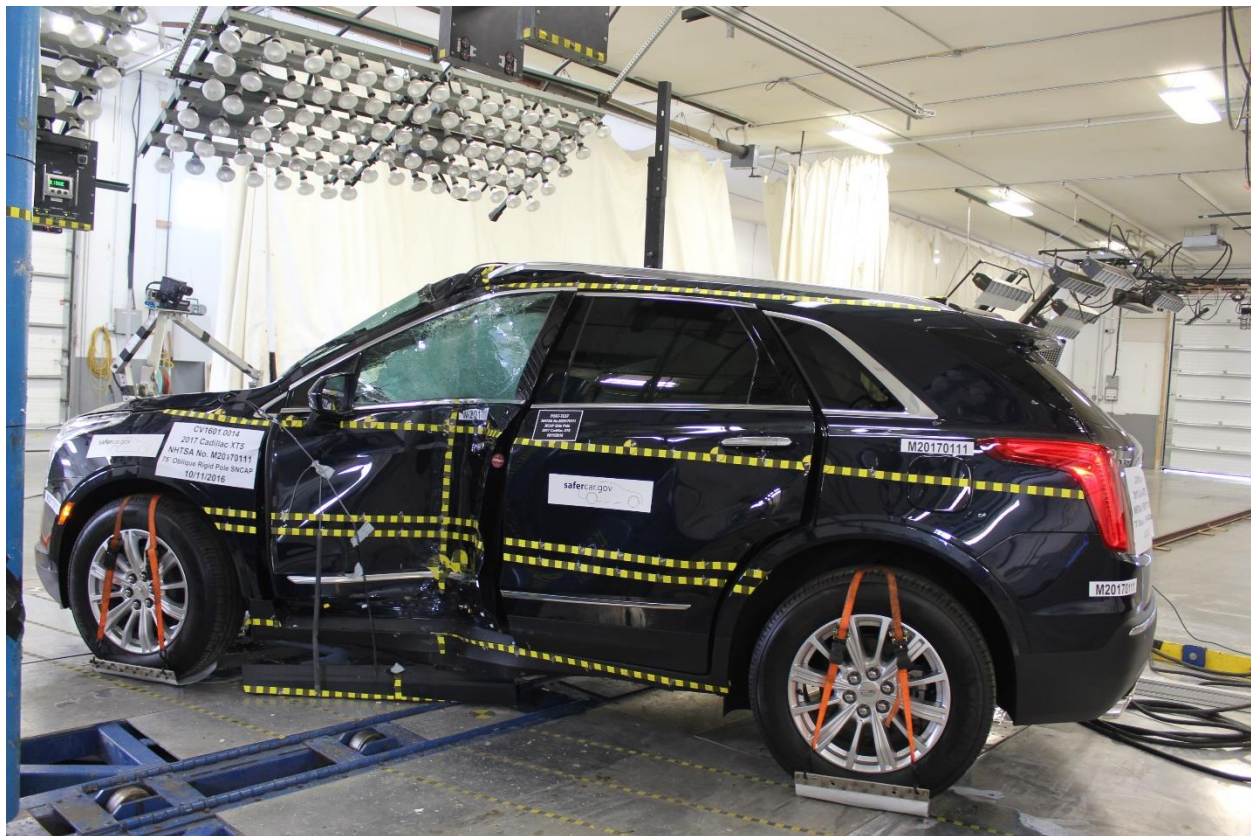
**Figure A-8: Post-Test Left Side View of Test Vehicle**

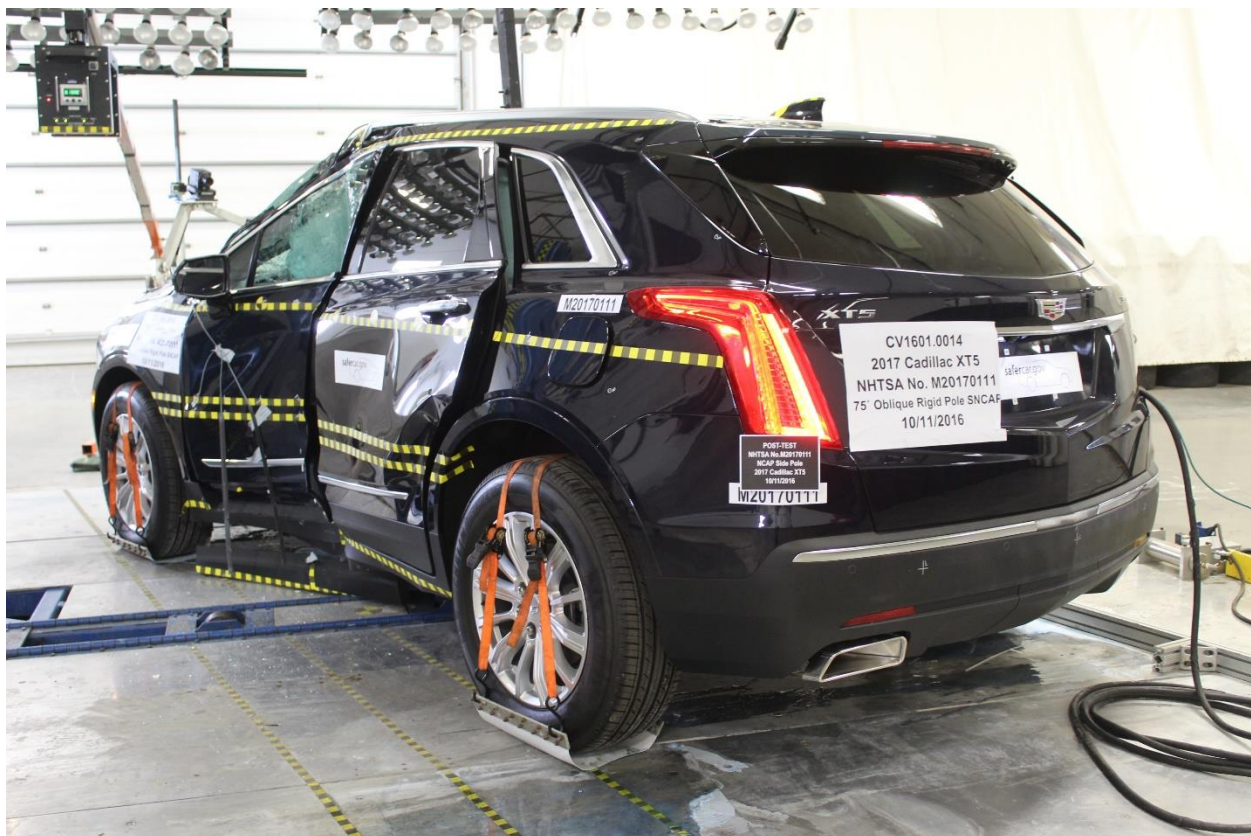
**Figure A-10: Post-Test Left Rear  $\frac{3}{4}$  View of Test Vehicle**

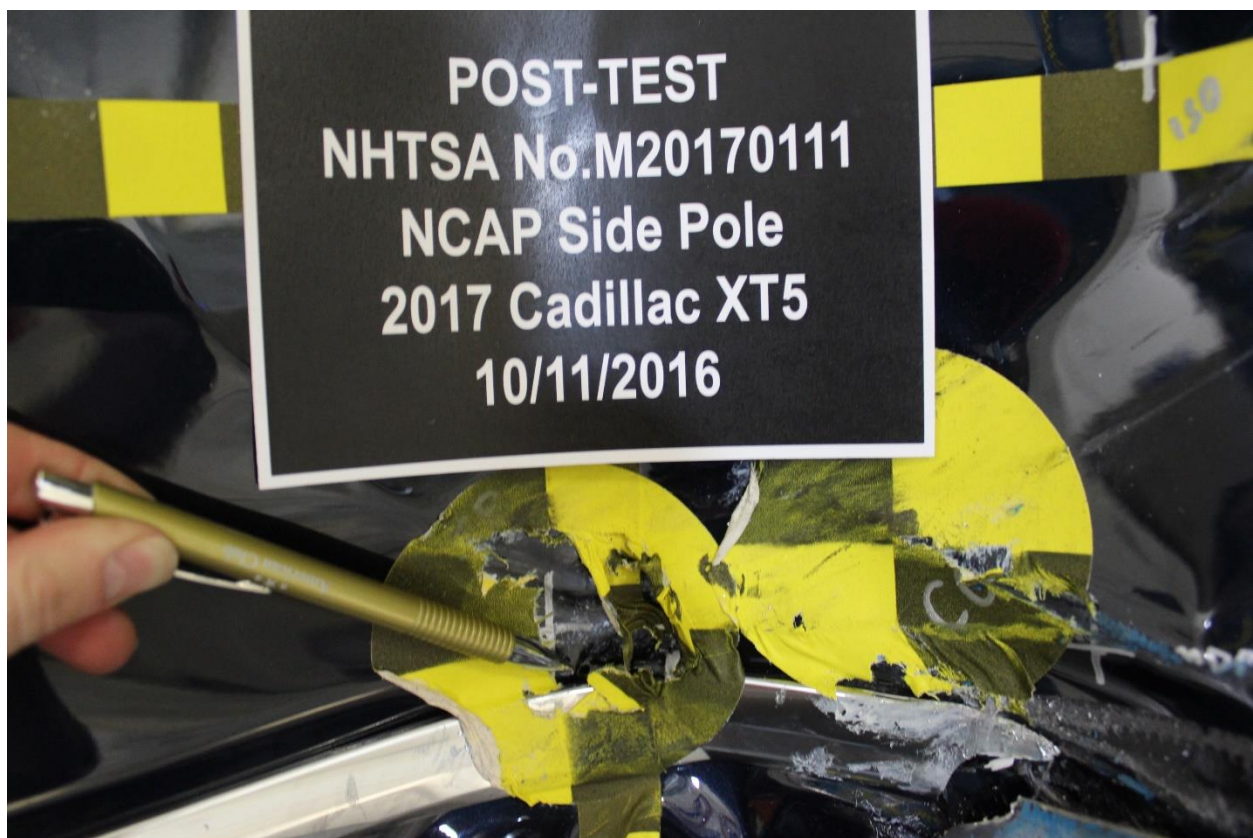
Figure A-20: Post-Test Close-Up View of Impact Point Target Showing Impact Location

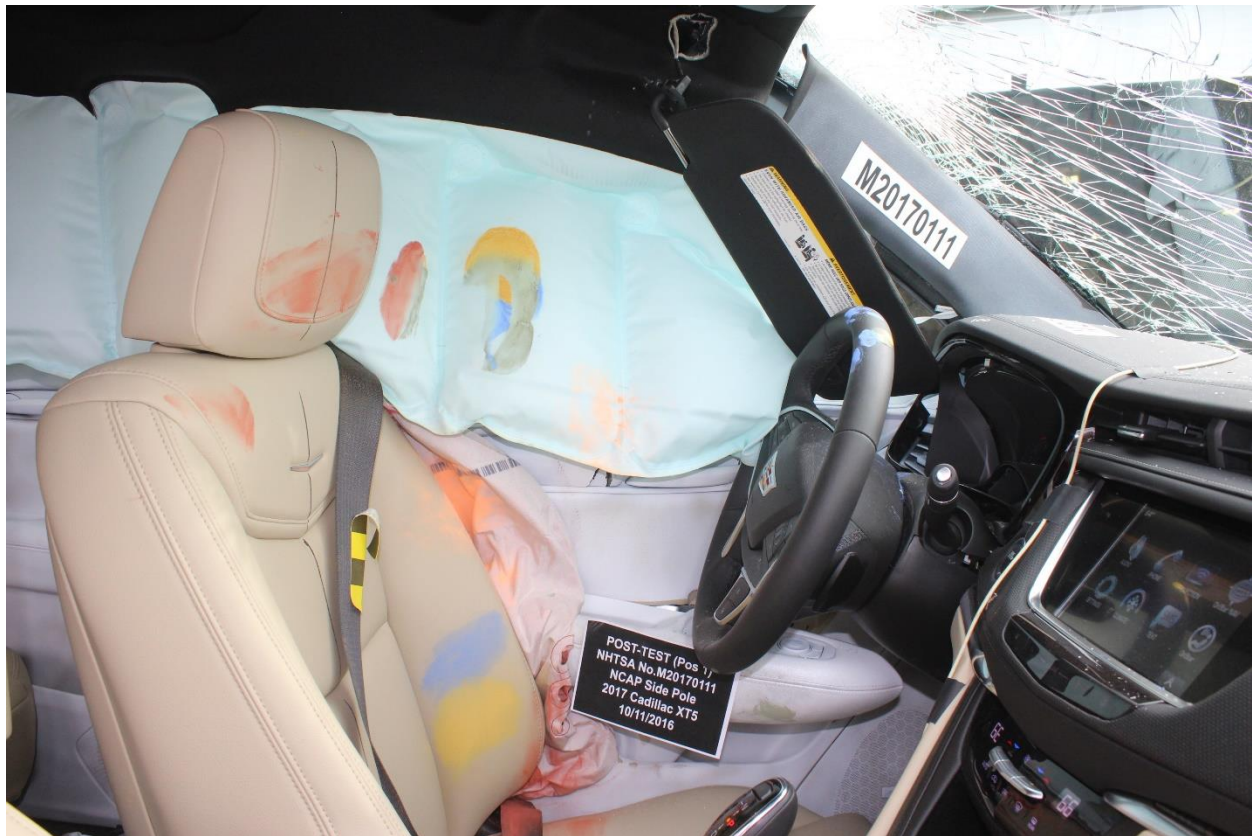
**Figure A-45: Post-Test Inner Door Panel View Showing Dummy Contact Location**

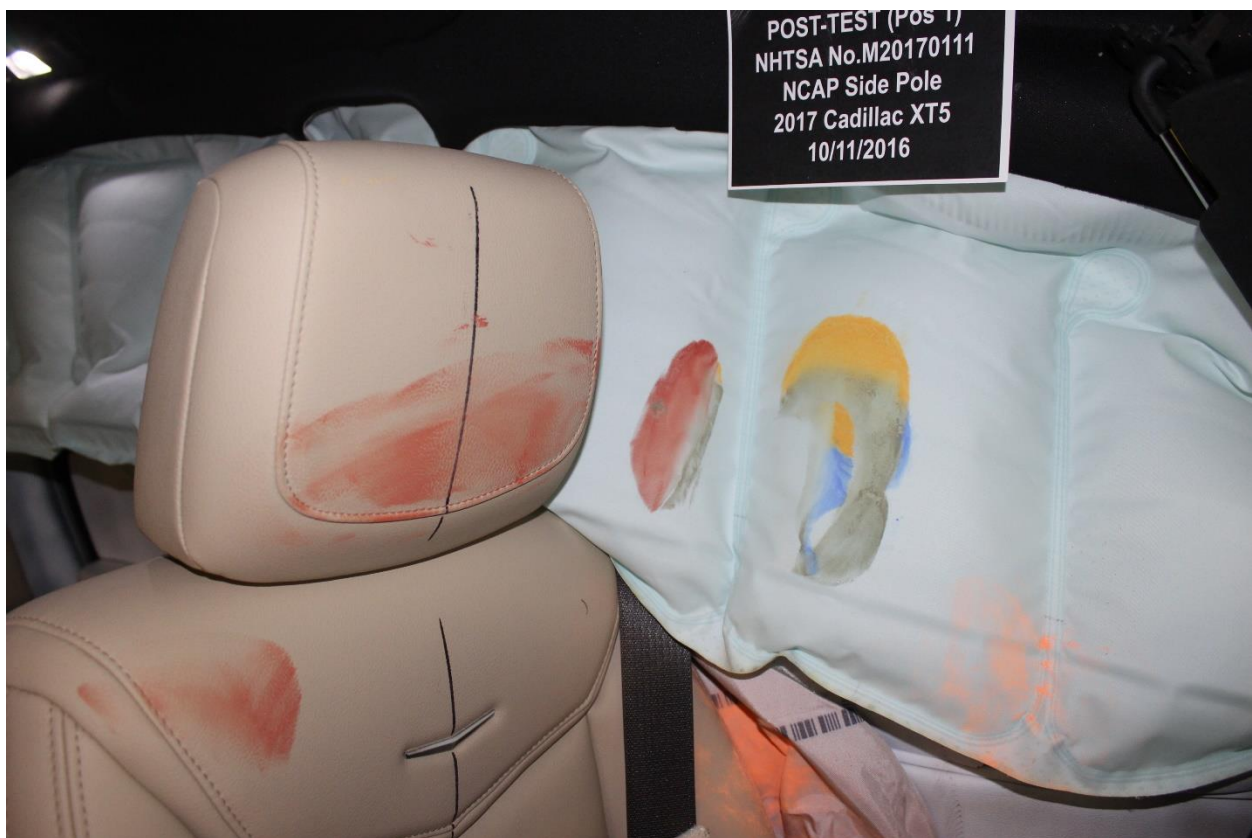
**Figure A-46: Post-Test Dummy Close-Up Head Contact with Vehicle Interior View**

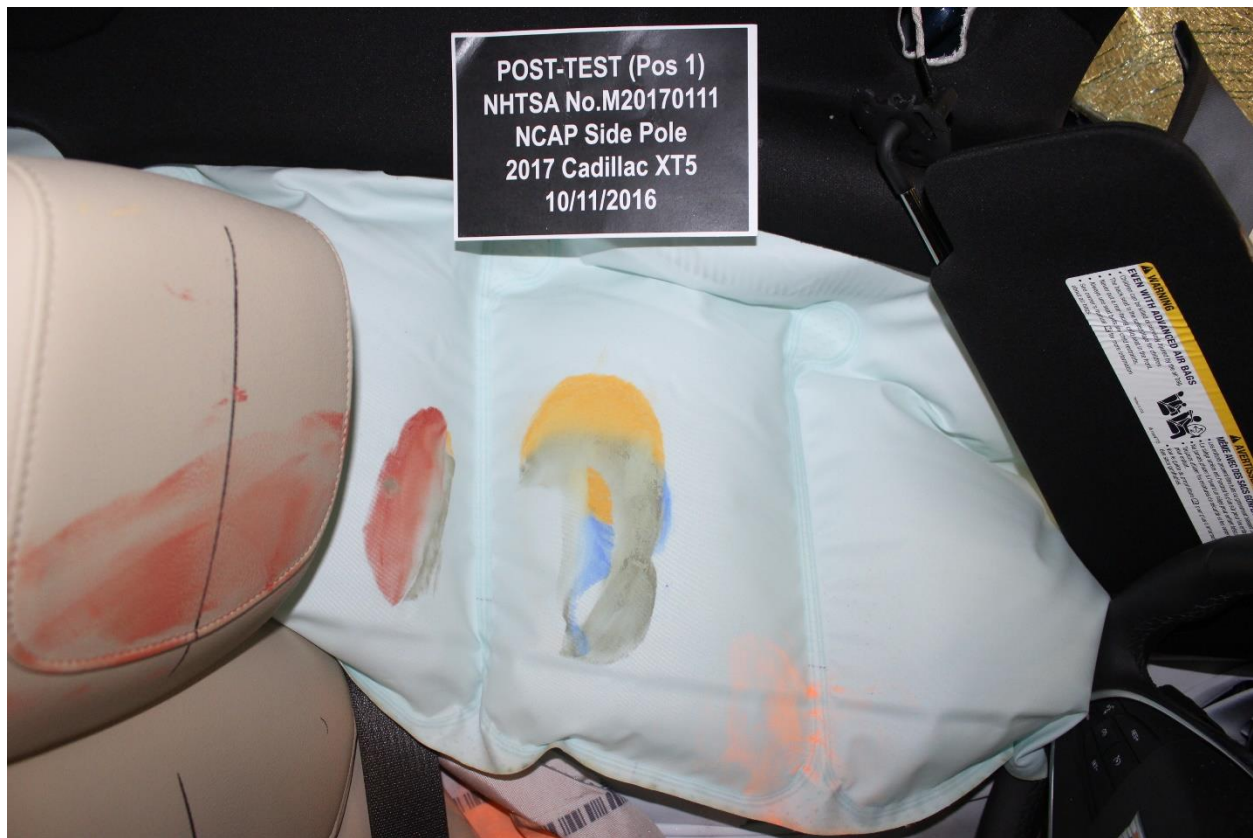
**Figure A-47: Post-Test Dummy Close-Up Head Contact with Side Airbag View**

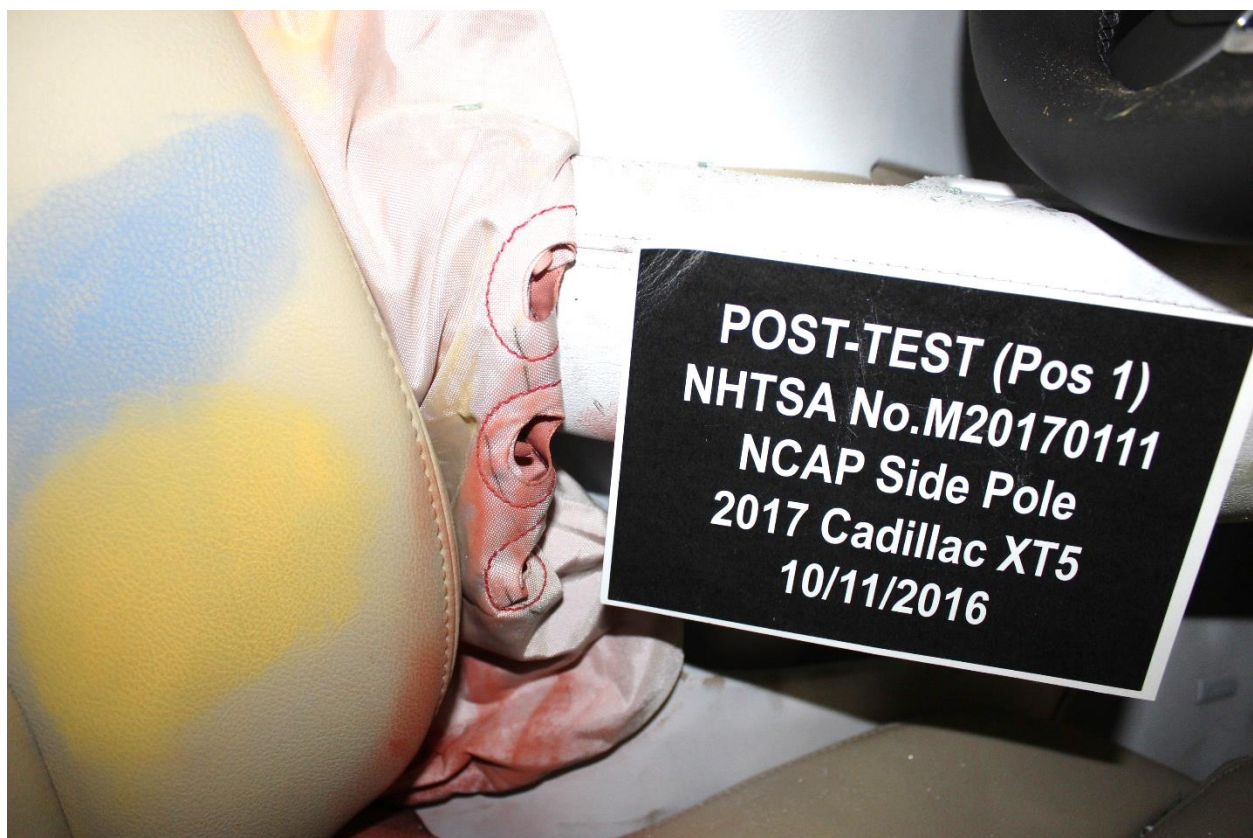
**Figure A-48: Post-Test Dummy Close-Up Torso Contact with Vehicle Interior View**

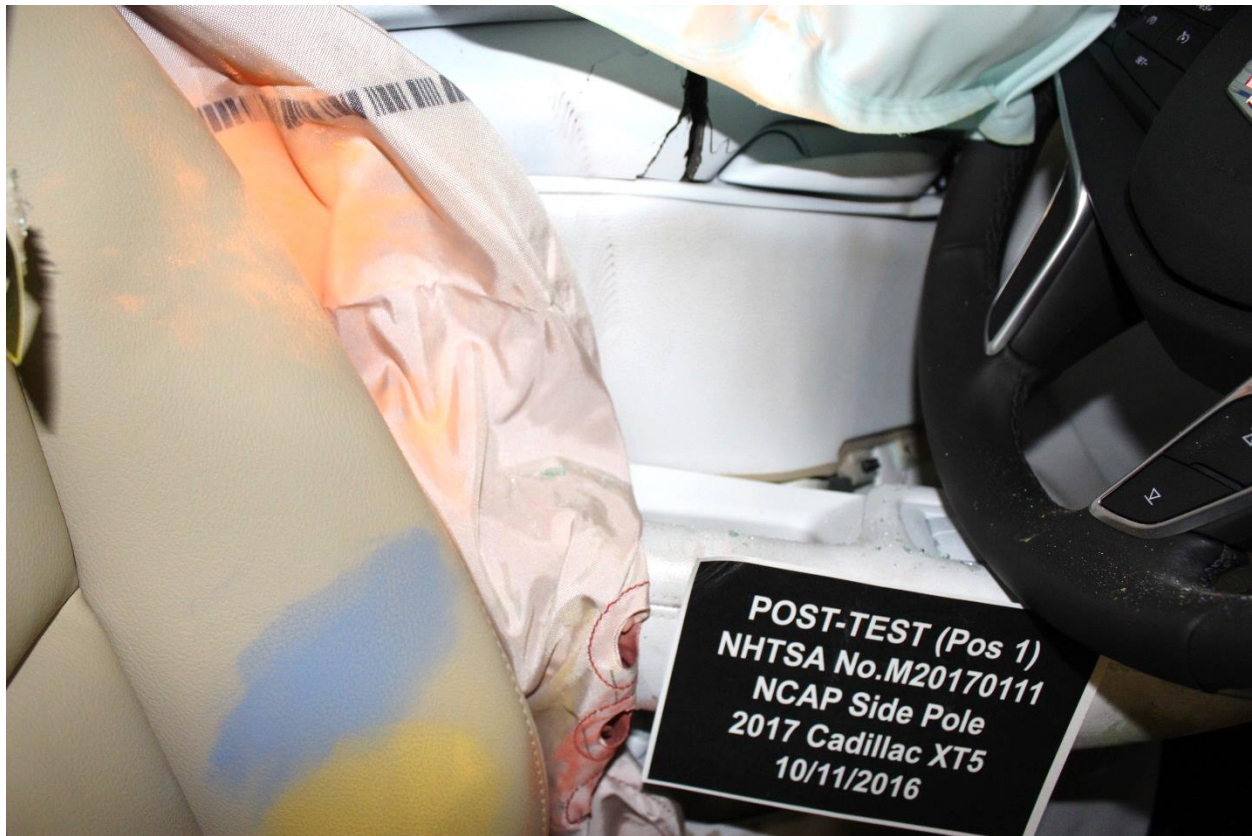
**Figure A-49: Post-Test Dummy Close-Up Torso Contact with Side Airbag View**

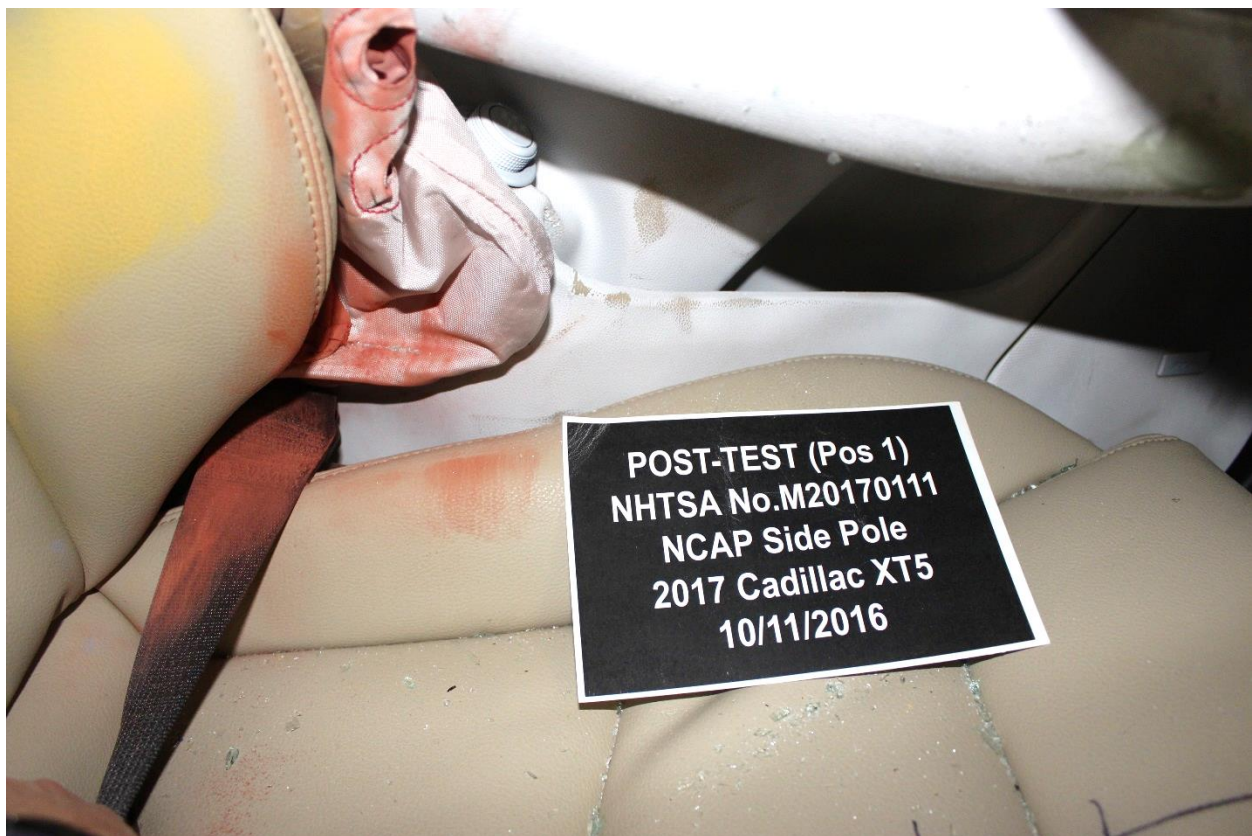
**Figure A-50: Post-Test Dummy Close-Up Pelvis Contact with Vehicle Interior View**

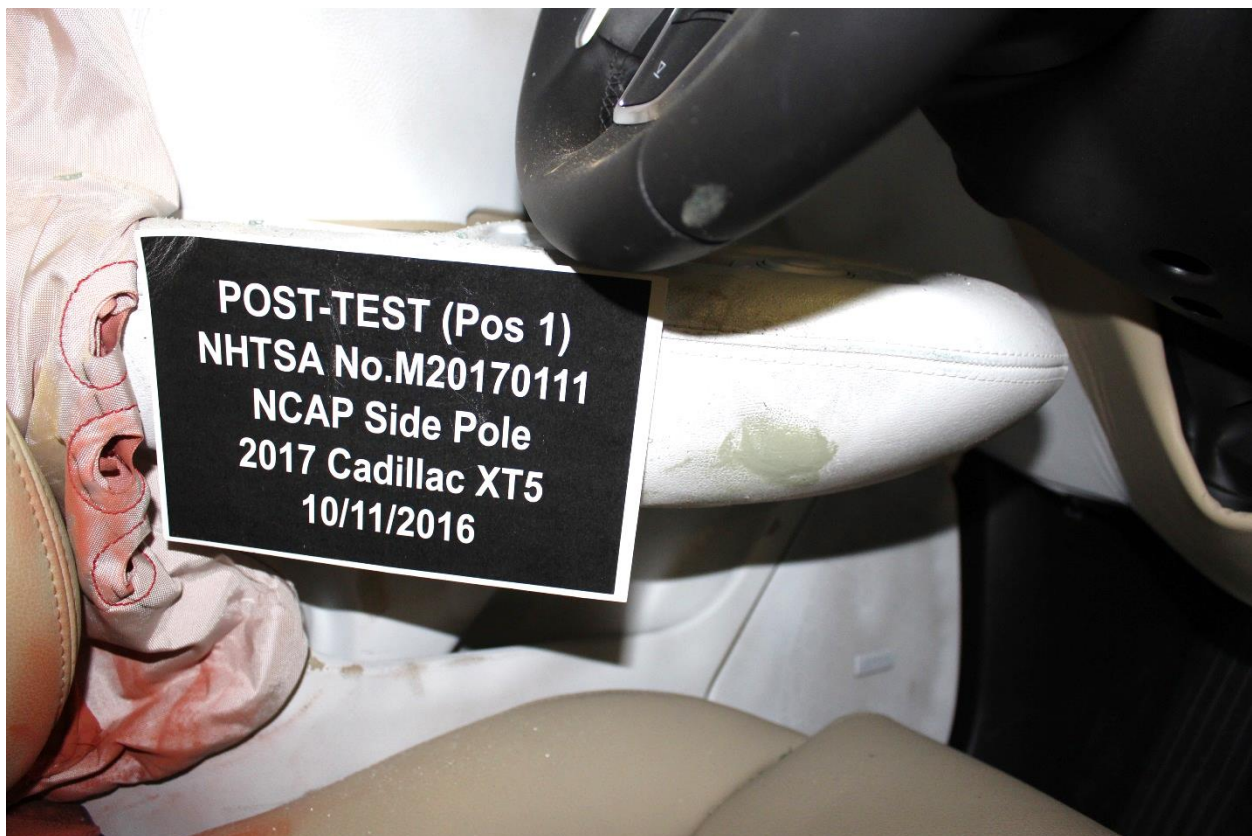
**Figure A-52: Post-Test Dummy Close-Up Knee Contact with Vehicle Interior View**

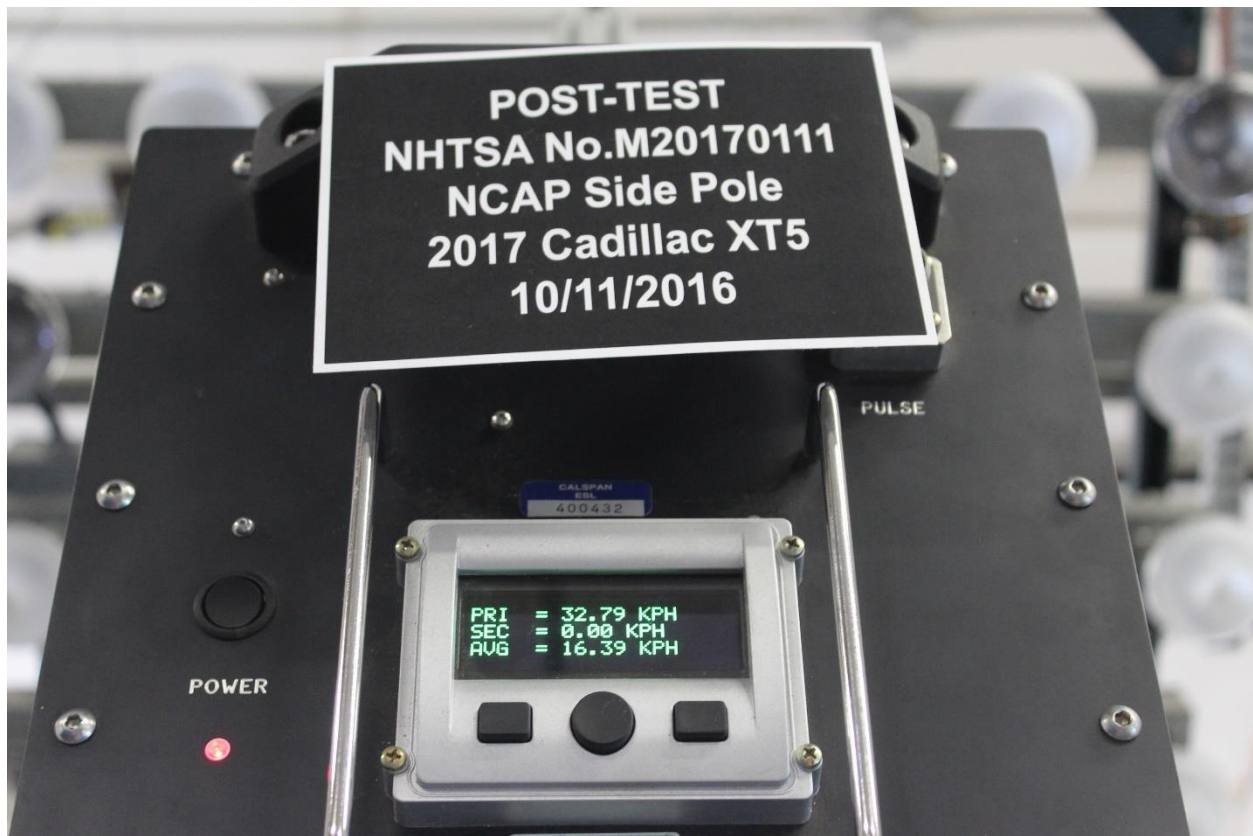
**Figure A-62: Post-Test Primary and Redundant Speed Trap Read-Out**

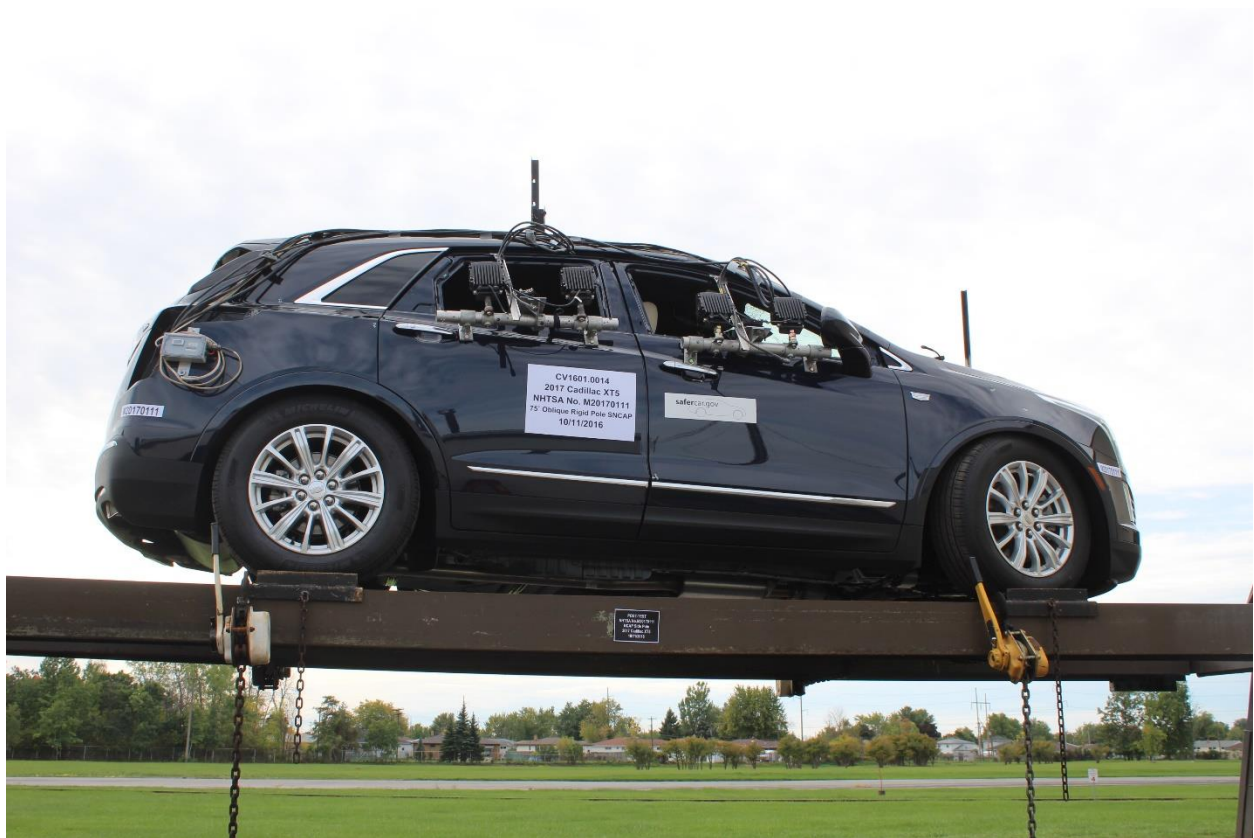
**Figure A-67: FMVSS No. 301 Static Rollover 360 Degrees**
