**REPORT NUMBER: R&D-CAL-15-046**

**MOVING BARRIER TO VEHICLE CRASH TEST IN SUPPORT OF NHTSA'S  
FRONTAL OBLIQUE OFFSET PROGRAM  
OBLIQUE MOVING DEFORMABLE BARRIER INTO LEFT FRONT OF A**

**2016 Mazda CX-5**

**90.1KPH, 15 DEGREE ANGLE, 35% OVERLAP**

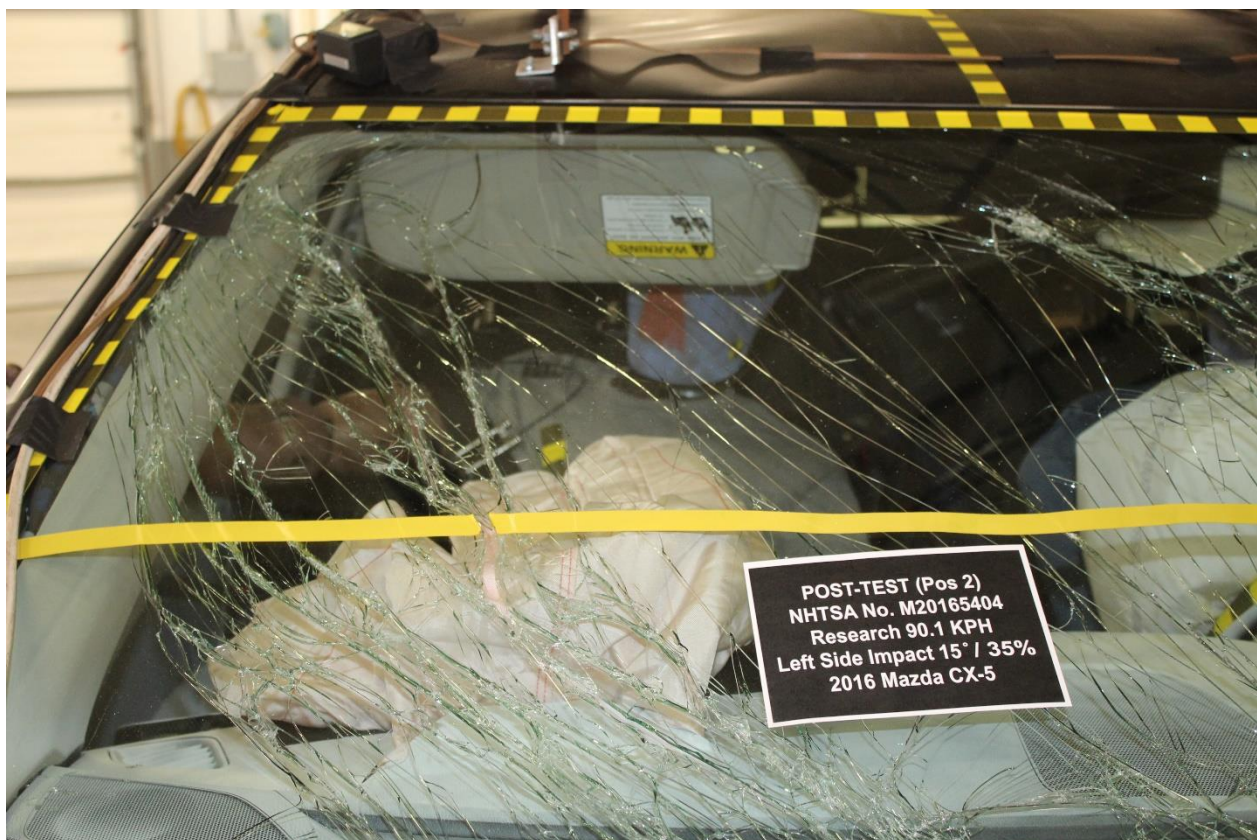
No. 094: Pre-Test Passenger Front Close-up View, Windshield

No. 095: Post-Test Passenger Front Close-up View, Windshield

| Critical Areas of Performance | Observations and Conclusions | Photo Taken (Y/N) |
|---|---|---|
| Windshield Damage | Cracks throughout with separation along bottom | Y |

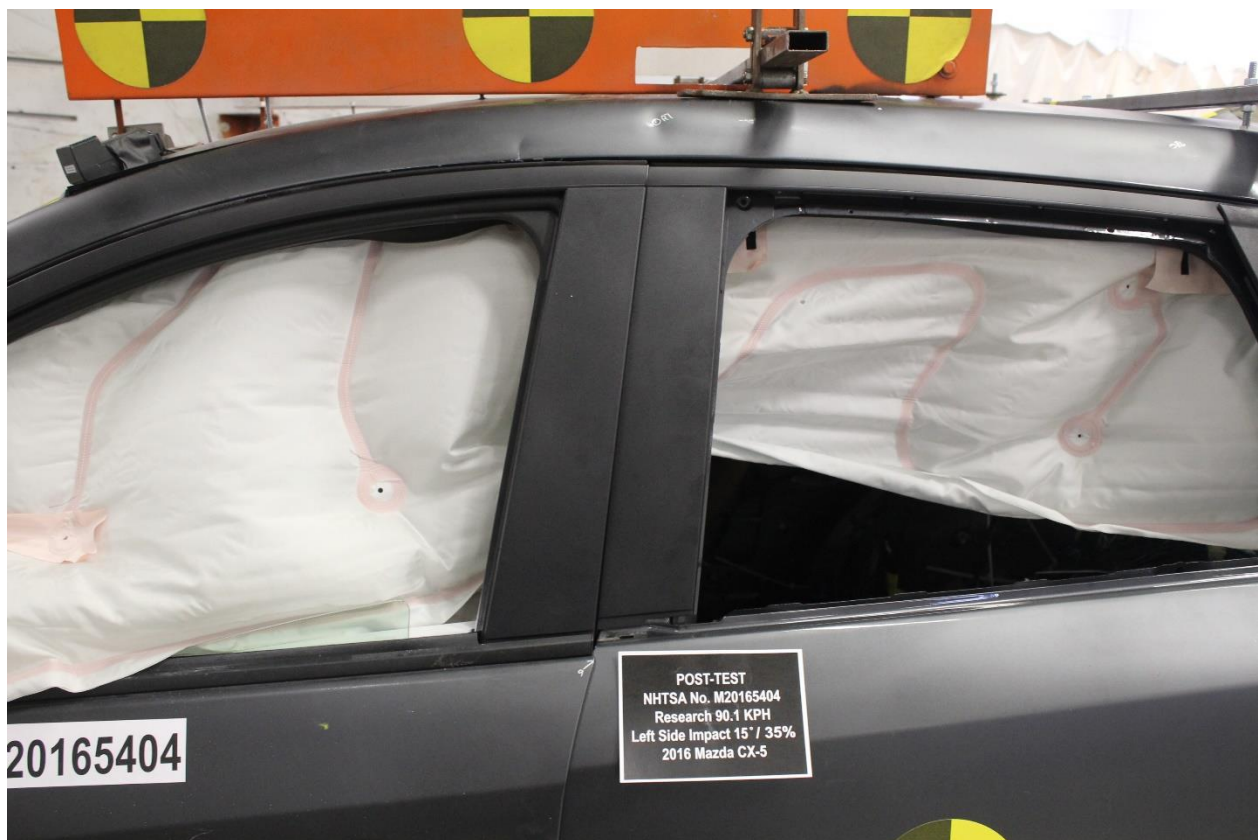
**No. 161: Post-Test View of Deformation of A pillar-Struck Side**

**No. 162: Post-Test View of Deformation of B pillar-Struck Side**

- Windshield had cracks throughout with minor separation along the bottom.
- The A-Pillar & B-Pillar Buckled during impact
- Hood bent inwards and exposed part of the engine compartment

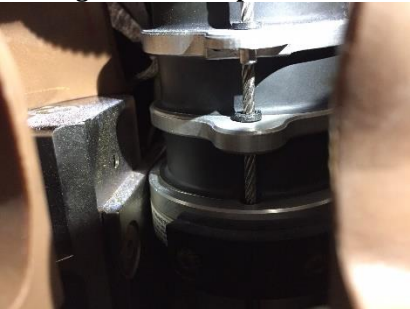
| HEAD | |
|---|---|
| Y / N | No evidence of de-bonding or permanent compression in neck soft stop assemblies<br><b>Missing neck soft stop</b><br> |

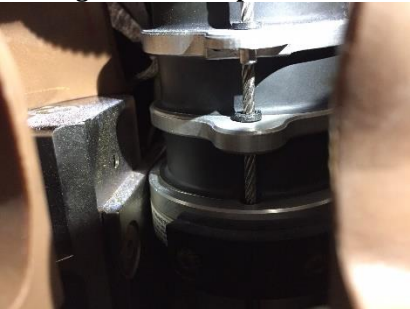
| HEAD | |
|---|---|
| Y / N | No evidence of de-bonding or permanent compression in neck soft stop assemblies<br><b>Missing neck soft stop</b><br> |
