**REPORT NUMBER: NCAP-CAL-17-004**

**NEW CAR ASSESSMENT PROGRAM (NCAP)  
FRONTAL BARRIER IMPACT TEST**

**General Motors LLC  
2017 Buick LaCrosse  
Four Door Sedan**

**FINAL REPORT**

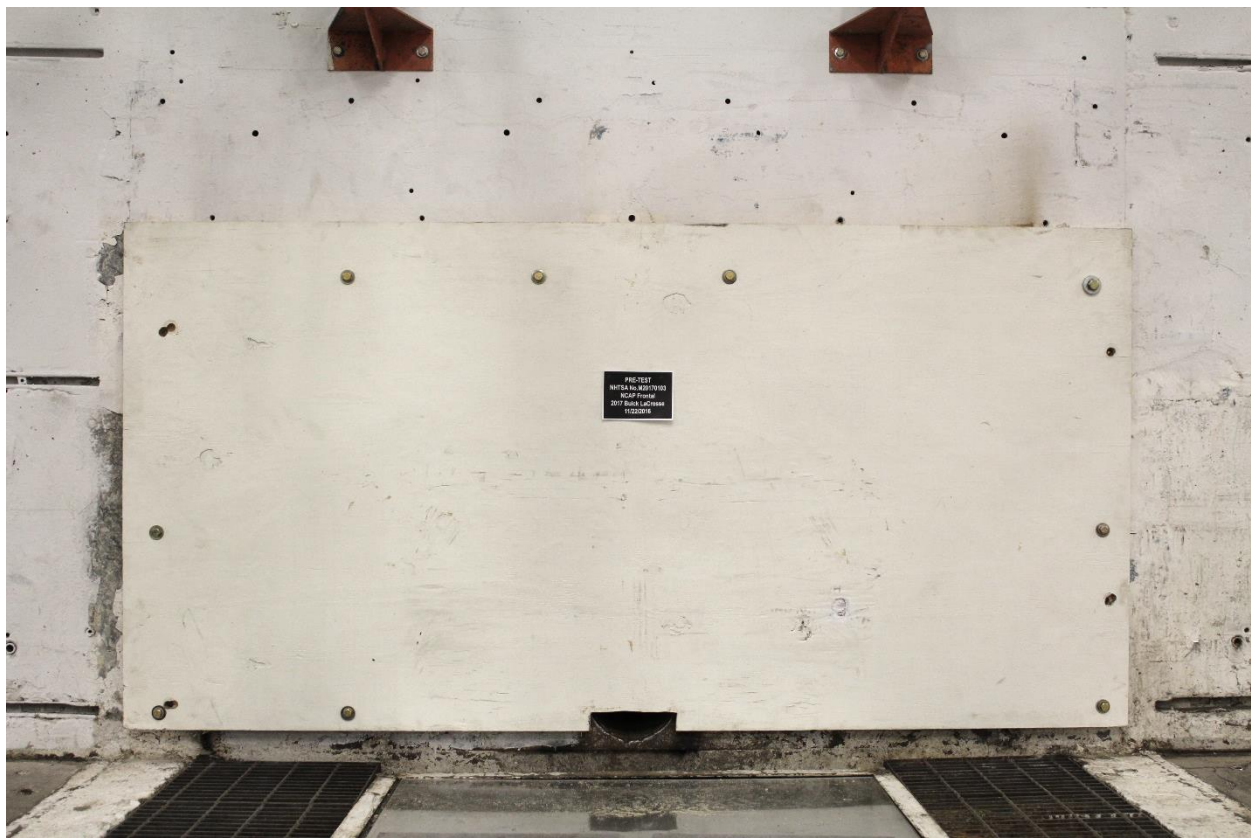
Figure A-2: Pre-Test Load Cell Wall

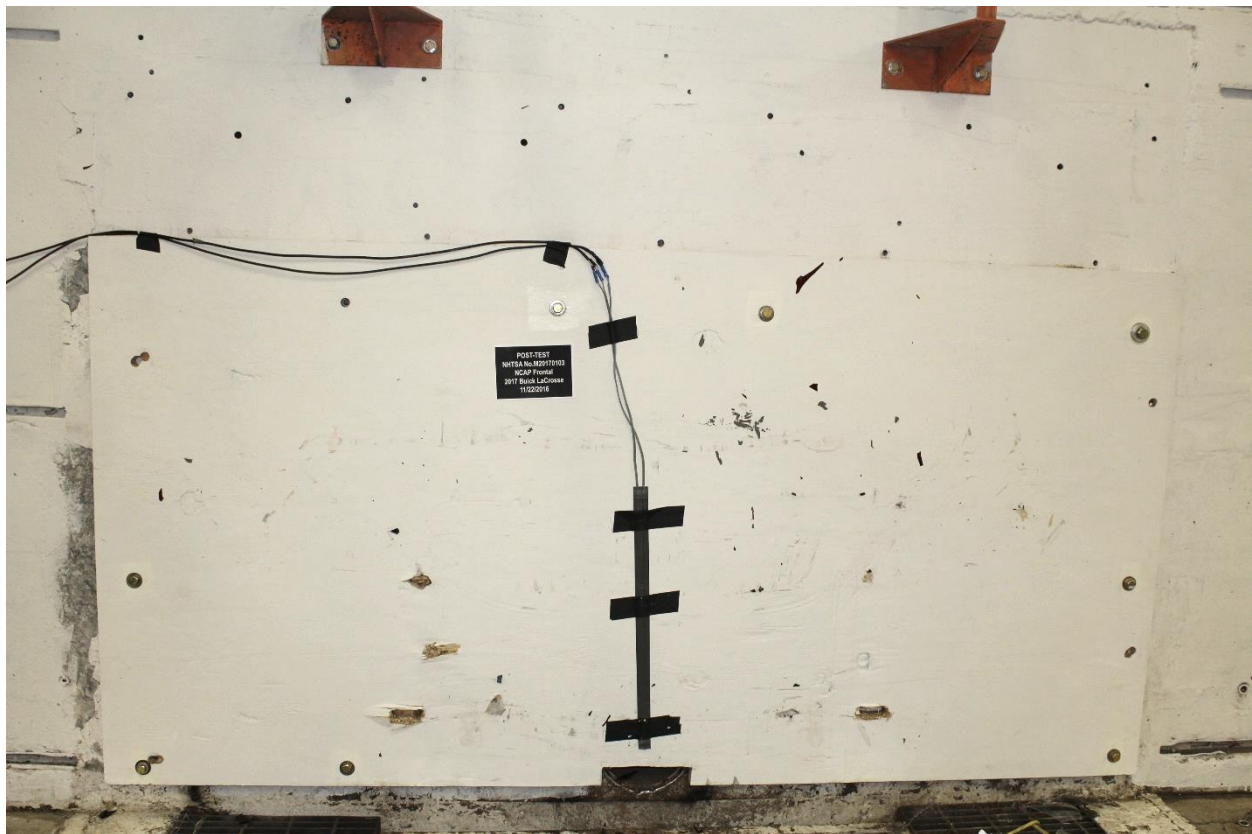
Figure A-3: Post-Test Load Cell Wall

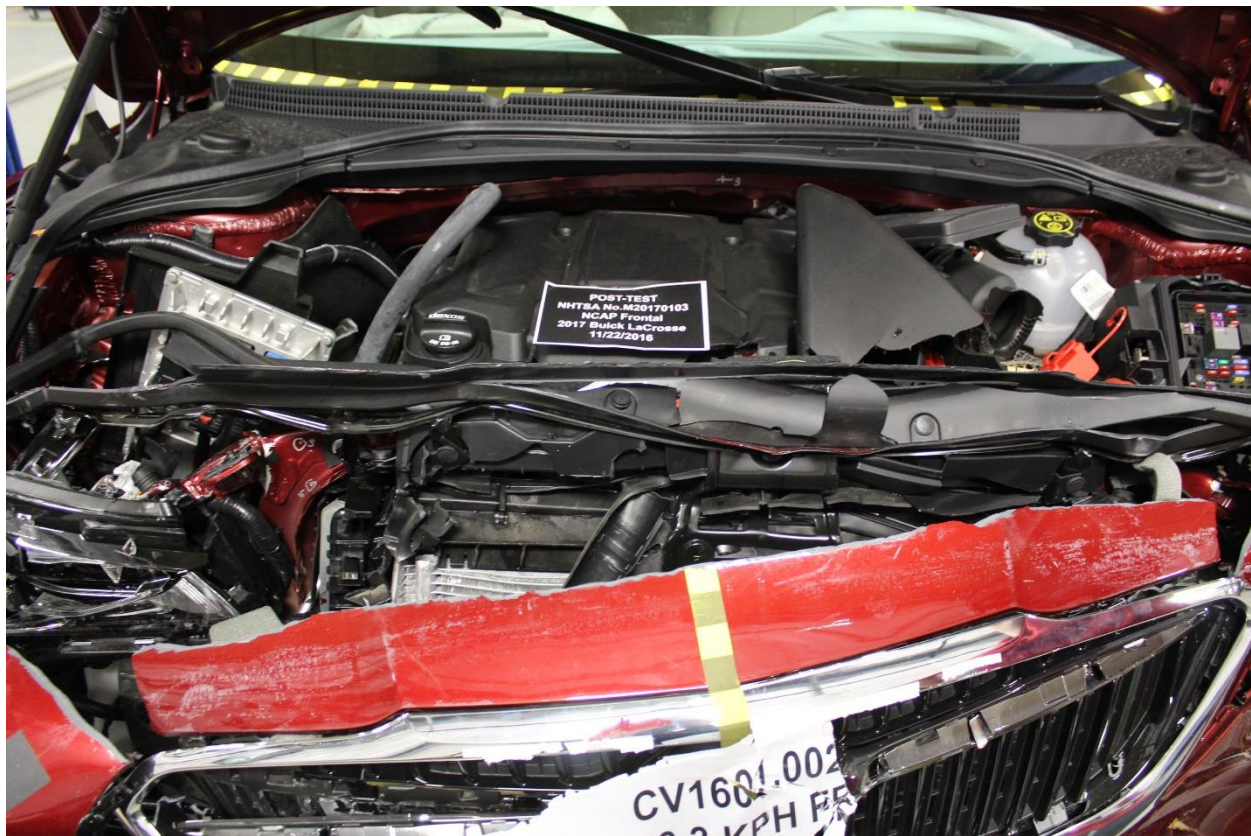
Figure A-21: Post-Test Engine Compartment View

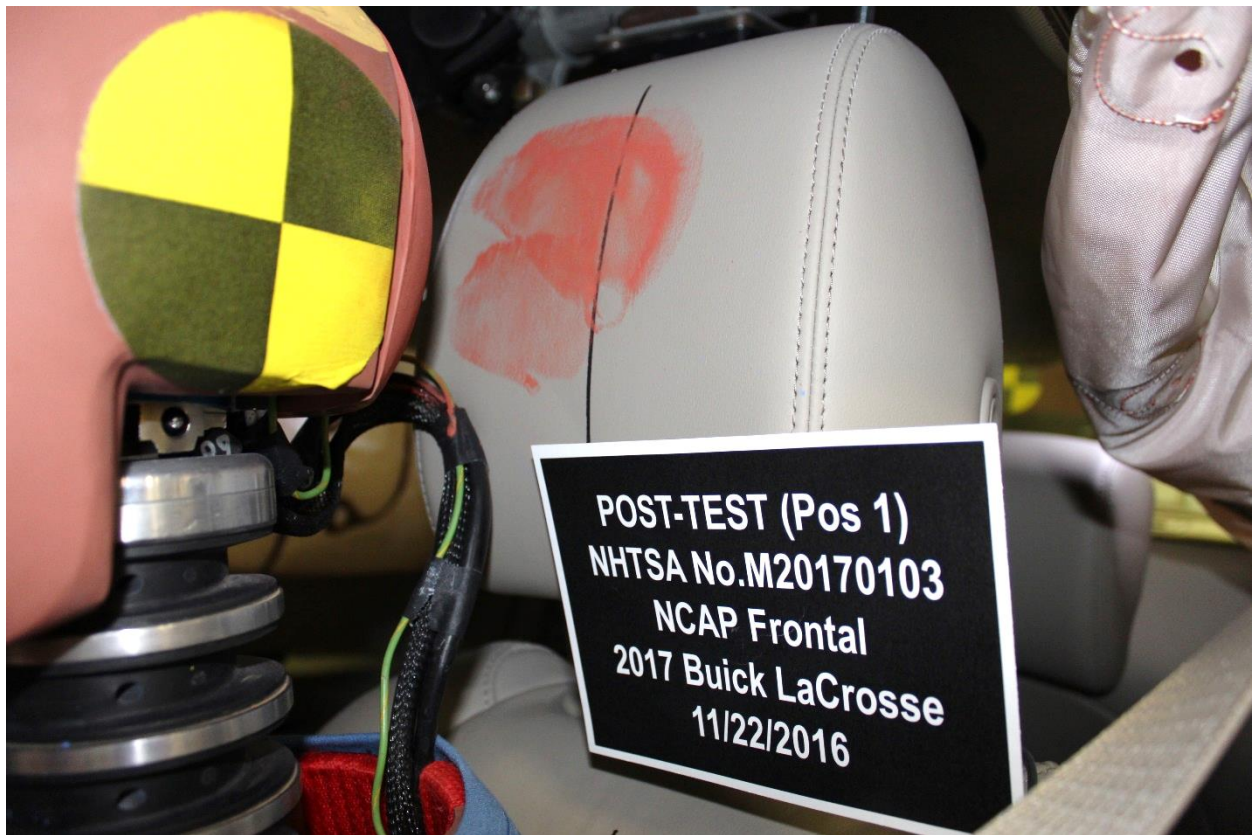
**Figure A-48: Post-Test Driver Dummy Contact With Headrest**

The driver's visible contact points were as follows: The driver's head contacted the frontal airbag and then the head restraint. The upper torso contacted the frontal airbag. Both knees contacted the knee air bag.

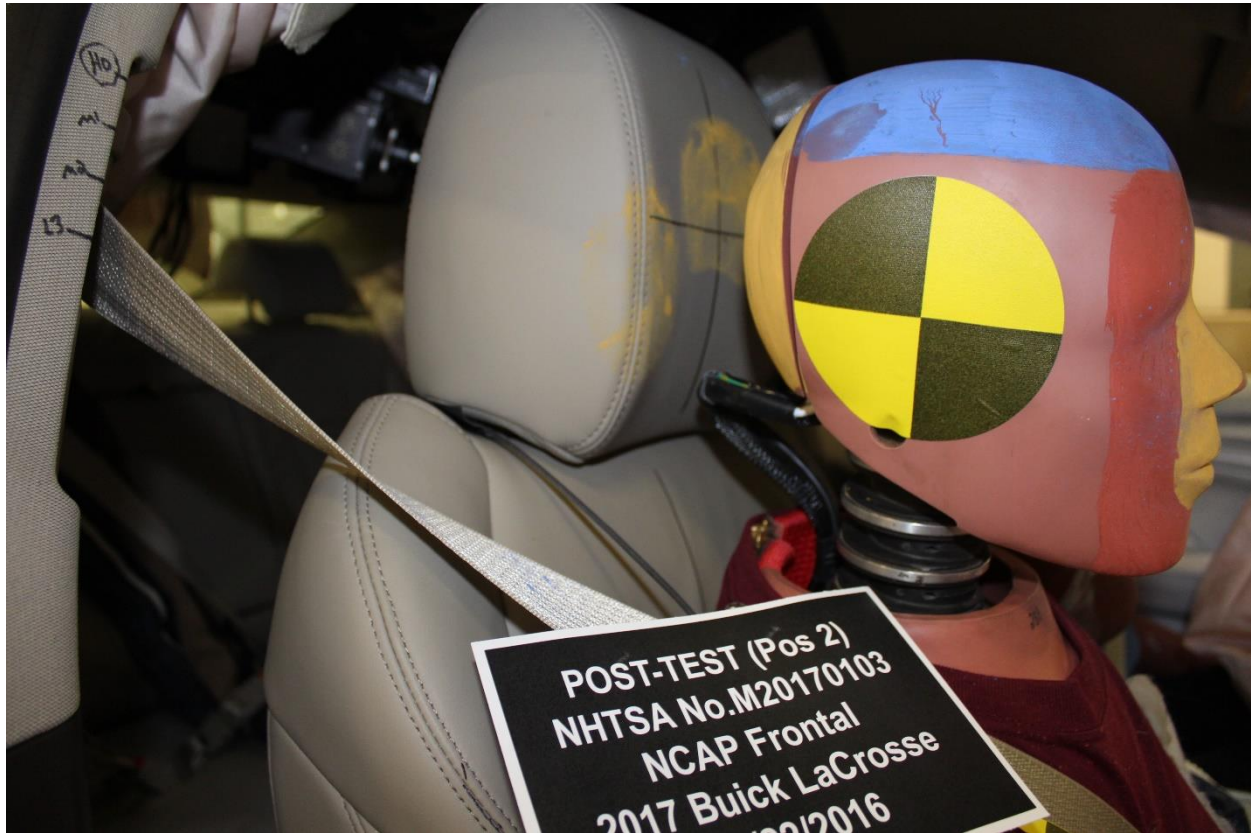
**Figure A-69: Post-Test Passenger Dummy Contact With Headrest**

The passenger's visible contact points were as follows: The passenger's head contacted the frontal airbag and then the head restraint. The upper torso contacted the frontal airbag. Both knees contacted the knee airbag

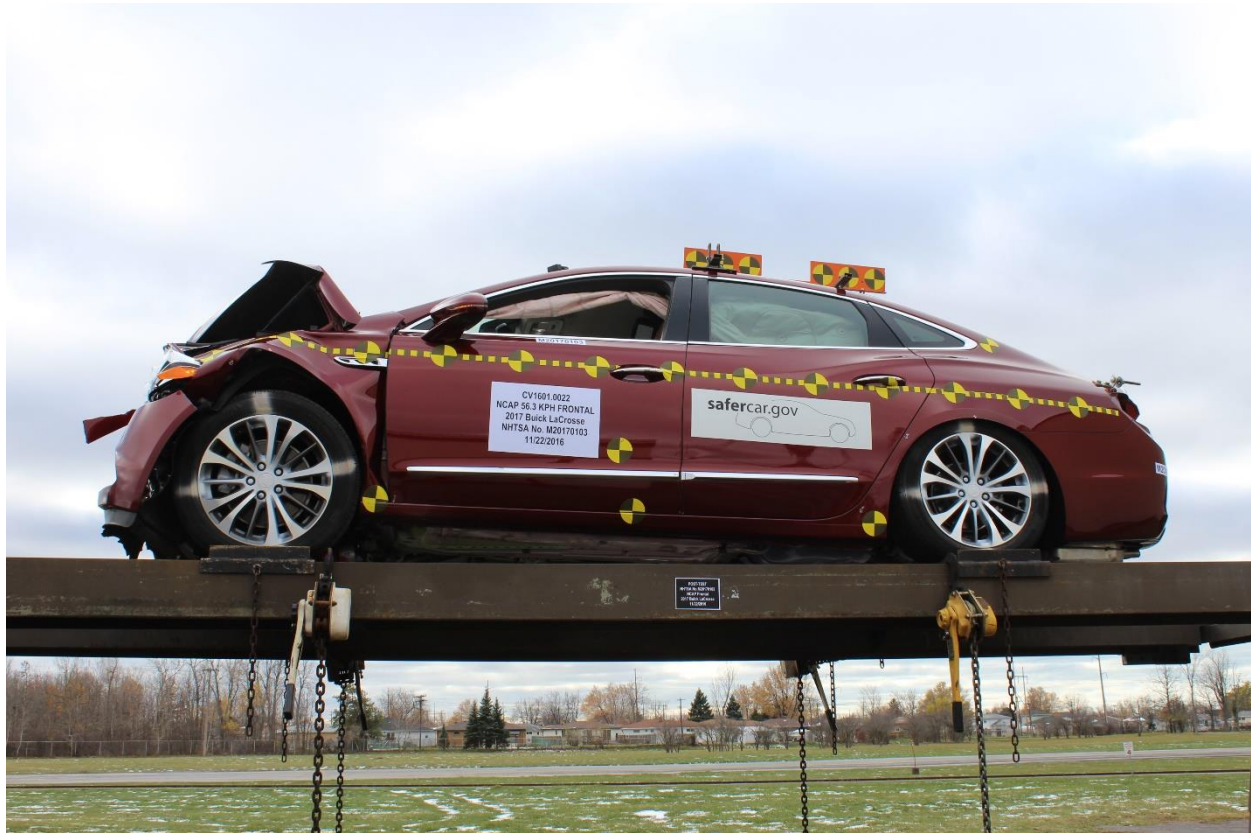
**Figure A-73: Vehicle at 0° on Static Rollover Device**

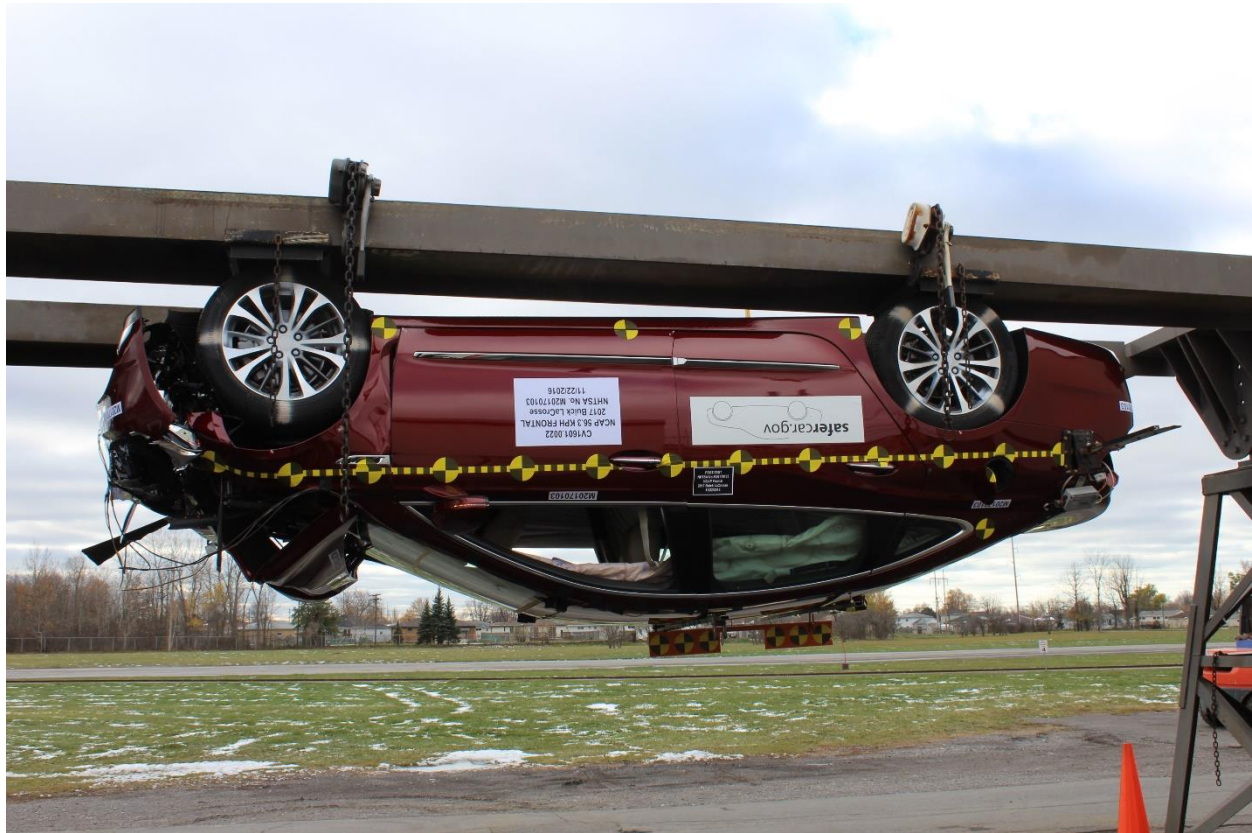
**Figure A-75: Vehicle at 180° on Static Rollover Device**
