**REPORT NUMBER: SINCAP-CAL-17-004**

**NEW CAR ASSESSMENT PROGRAM (NCAP)  
MOVING DEFORMABLE BARRIER SIDE IMPACT TEST**

**General Motors LLC  
2017 Buick LaCrosse  
Four Door Sedan**

**NHTSA No: M20170105**

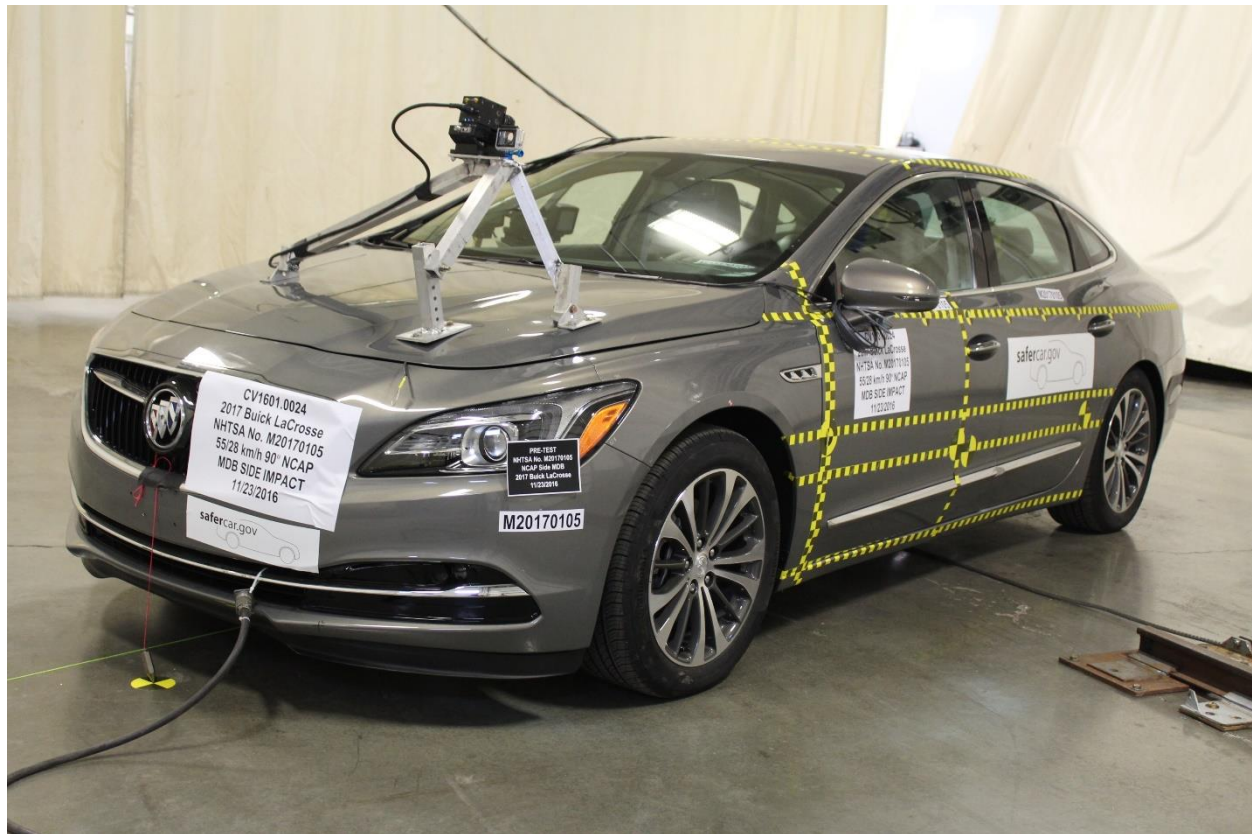
**Figure A-5: Pre-Test Left Front  $\frac{3}{4}$  View of Test Vehicle**

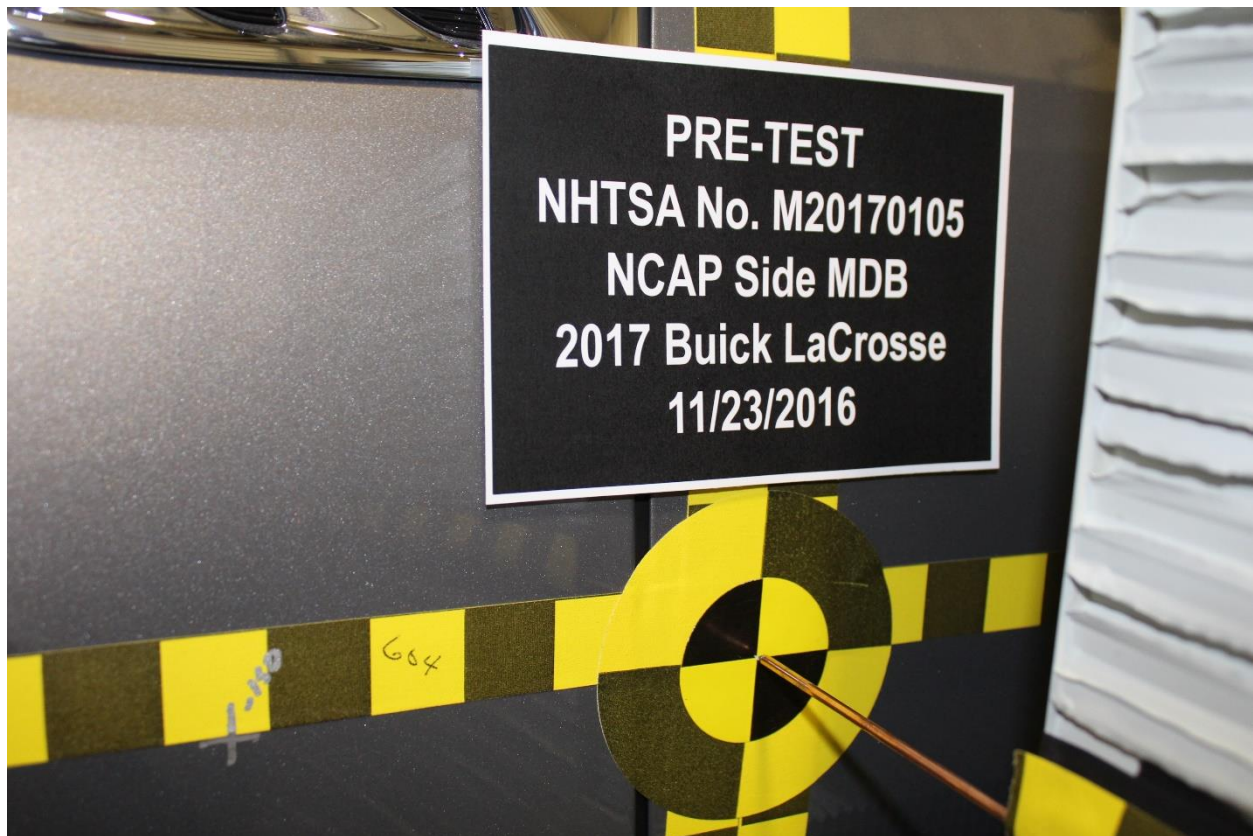
Figure A-19: Pre-Test Close-up View of Impact Point Target

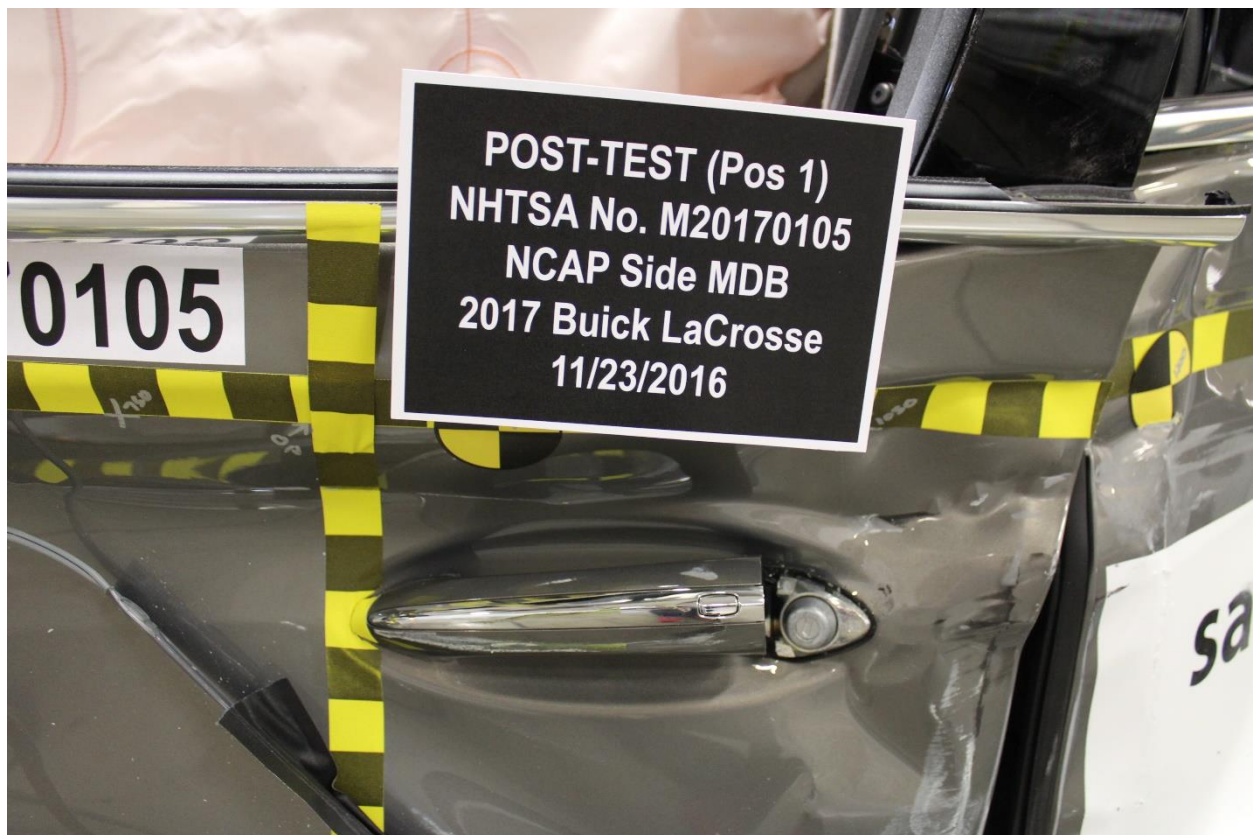
Figure A-22: Post-Test Left Front Door Latch Close-Up

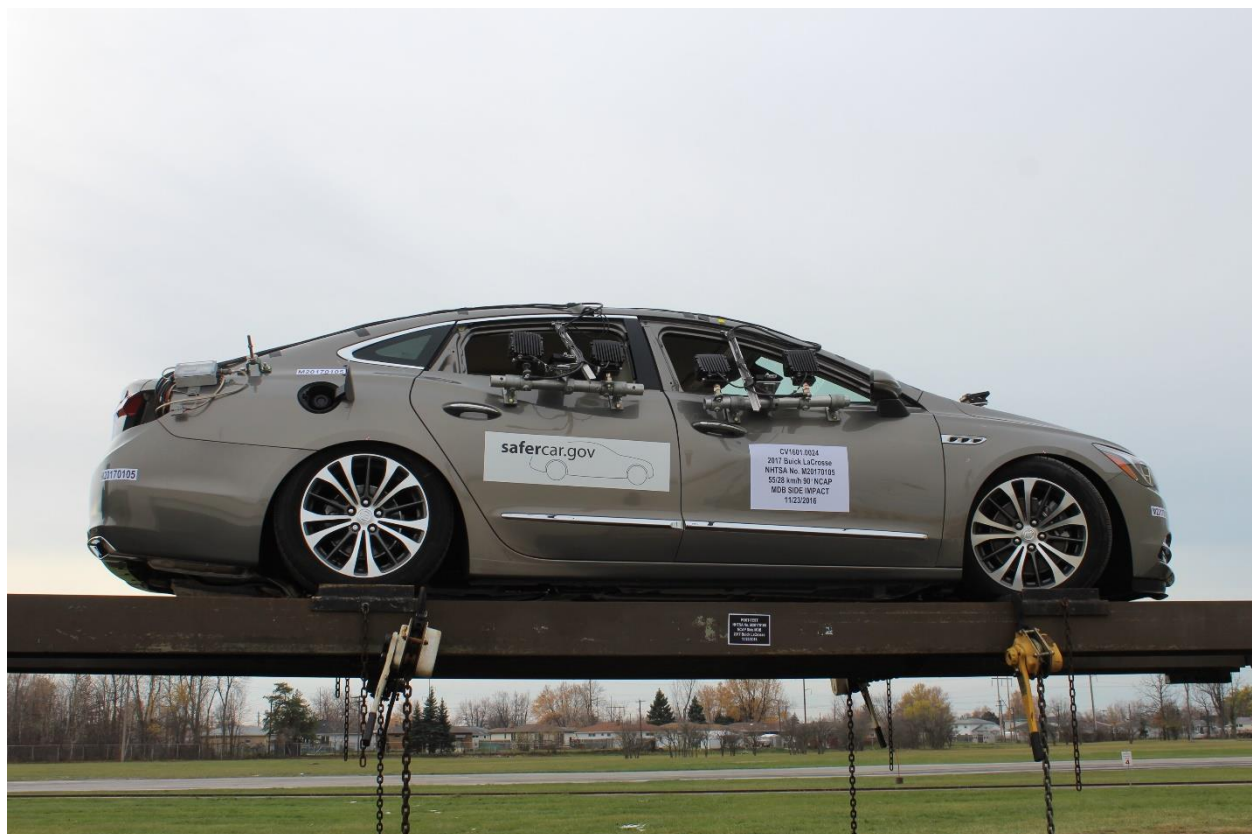
Figure A-96: FMVSS No. 301 Static Rollover 0 Degrees

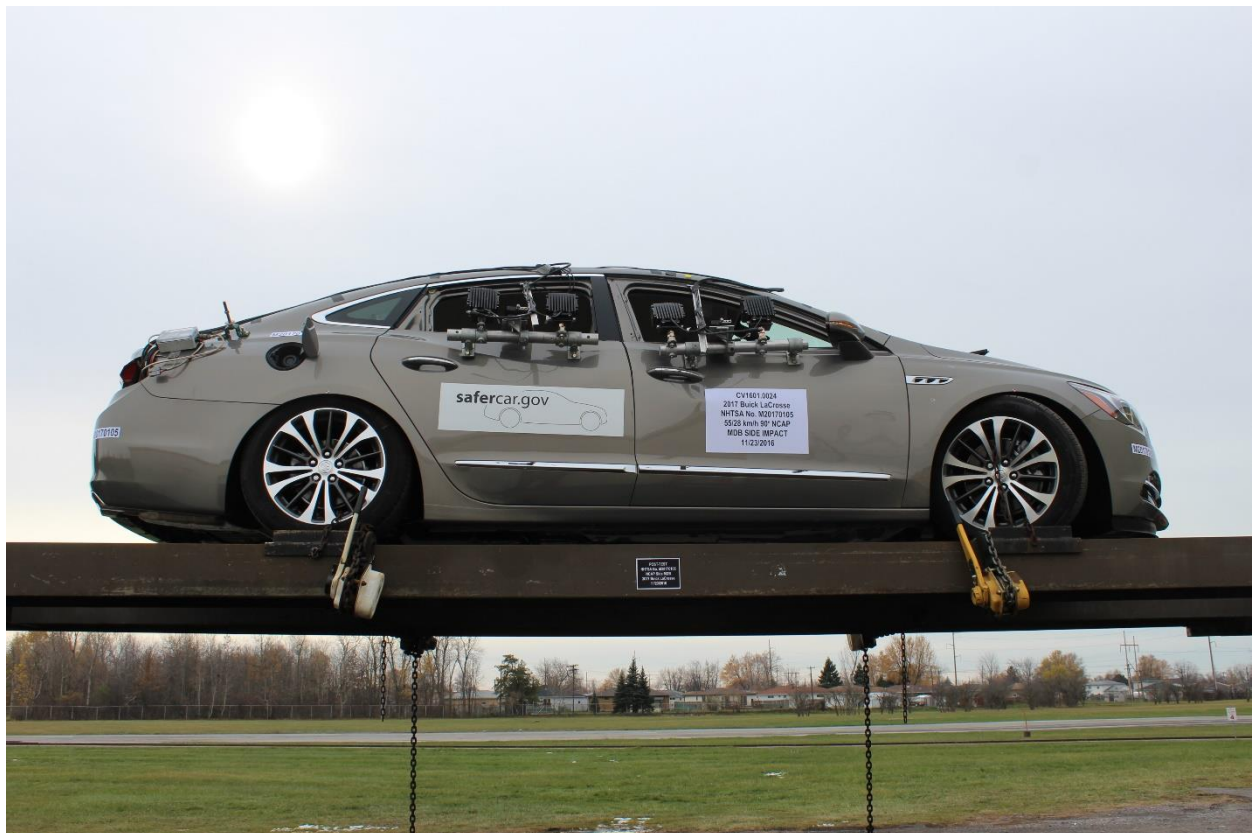
**Figure A-100: FMVSS No. 301 Static Rollover 360 Degrees**
