**REPORT NUMBER: NCAP-MGA-2017-013**

**NEW CAR ASSESSMENT PROGRAM (NCAP)  
Frontal Barrier Impact Test**

**AUDI AG  
2017 Audi A4 2.0T Quattro 4-Door Sedan  
NHTSA No.: O20175800**

**MGA RESEARCH CORPORATION  
5000 Warren Road  
Burlington, WI 53105**

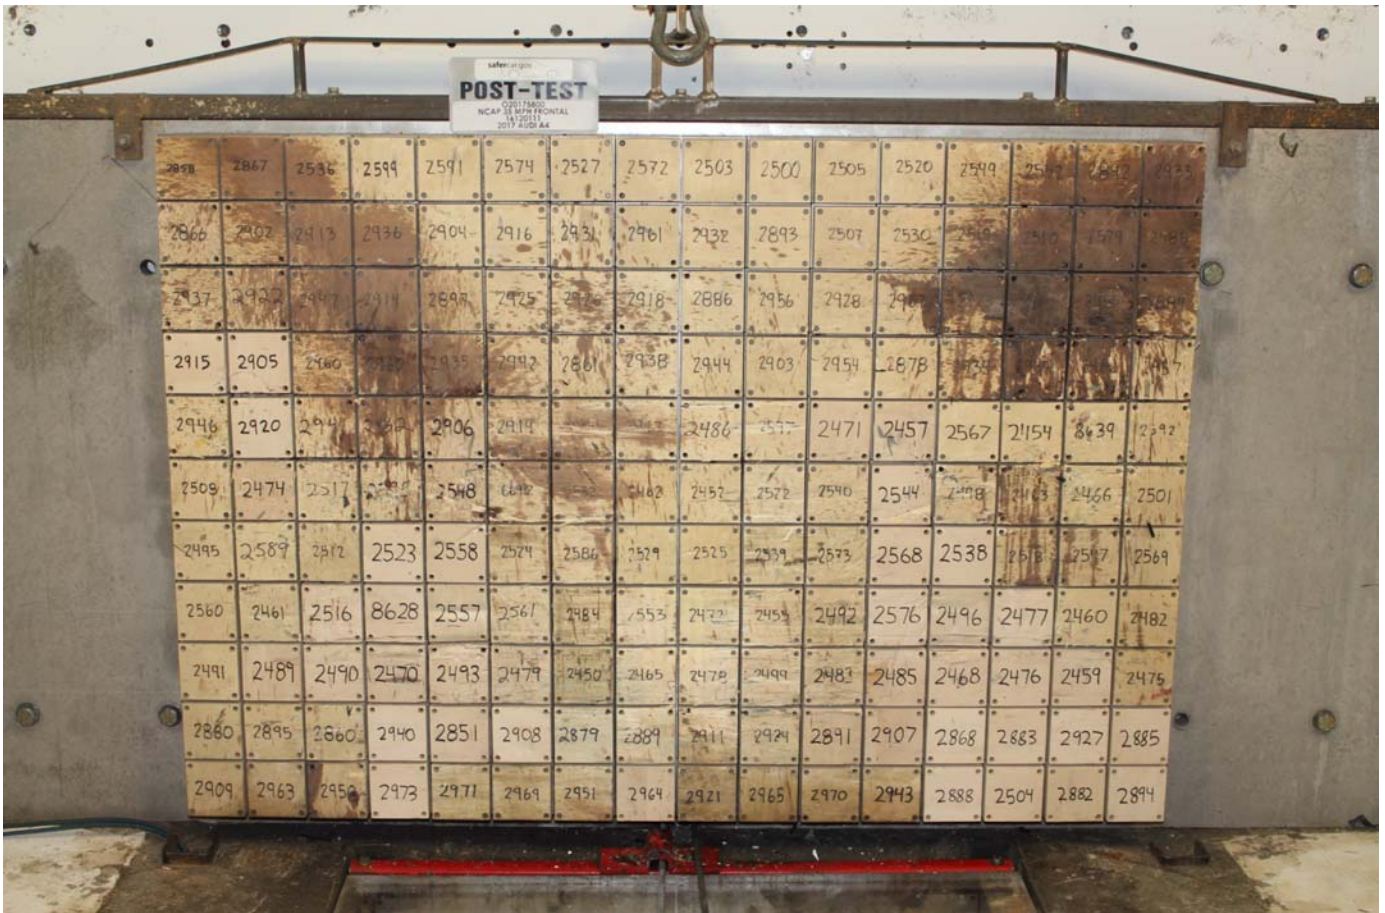
Photo No. 003 - Post-Test Load Cell Wall

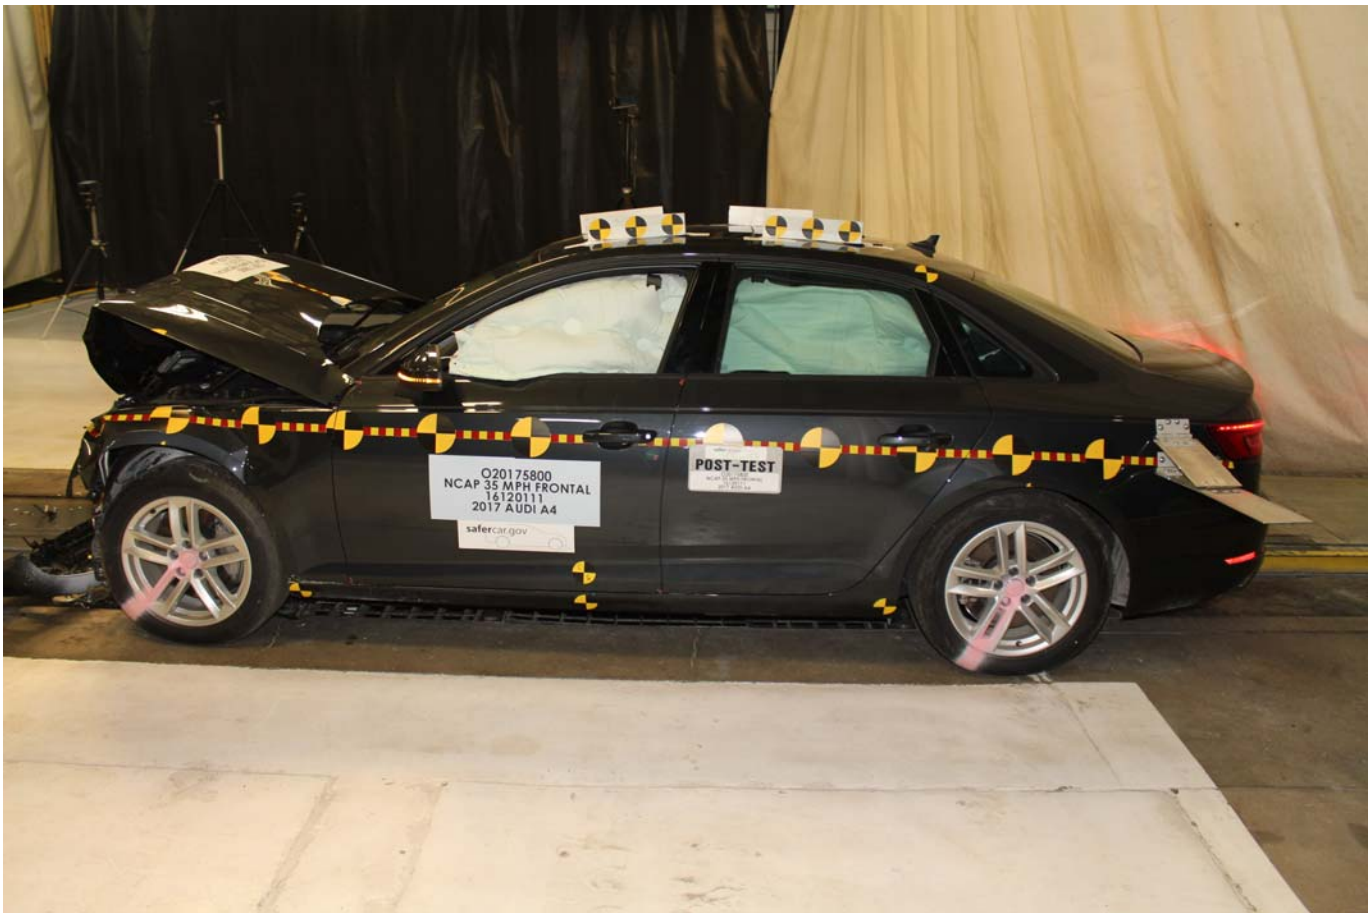
Photo No. 011 - Post-Test Left View of Test Vehicle

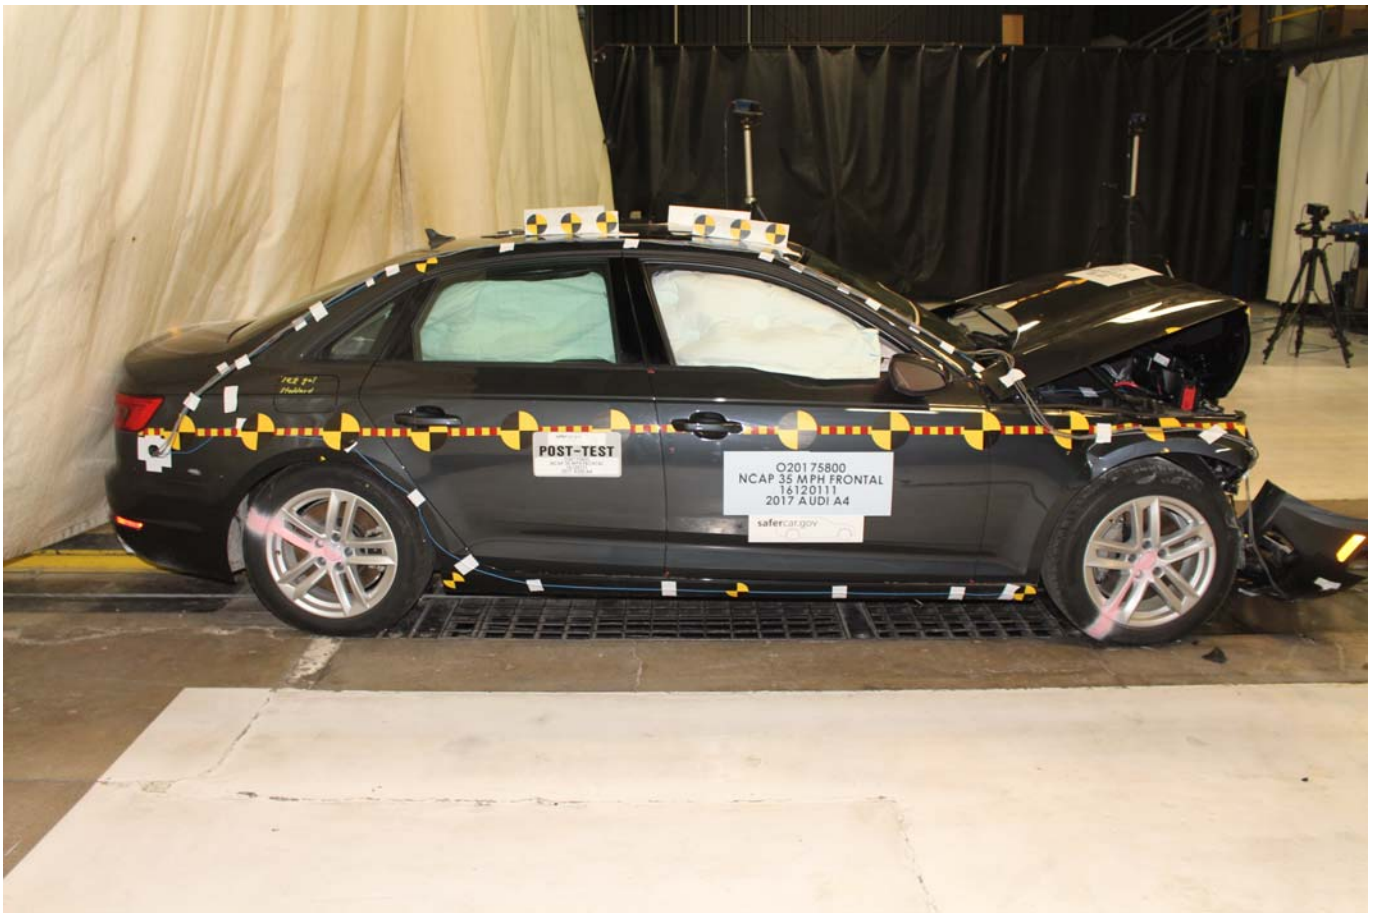
Photo No. 013 - Post-Test Right View of Test Vehicle

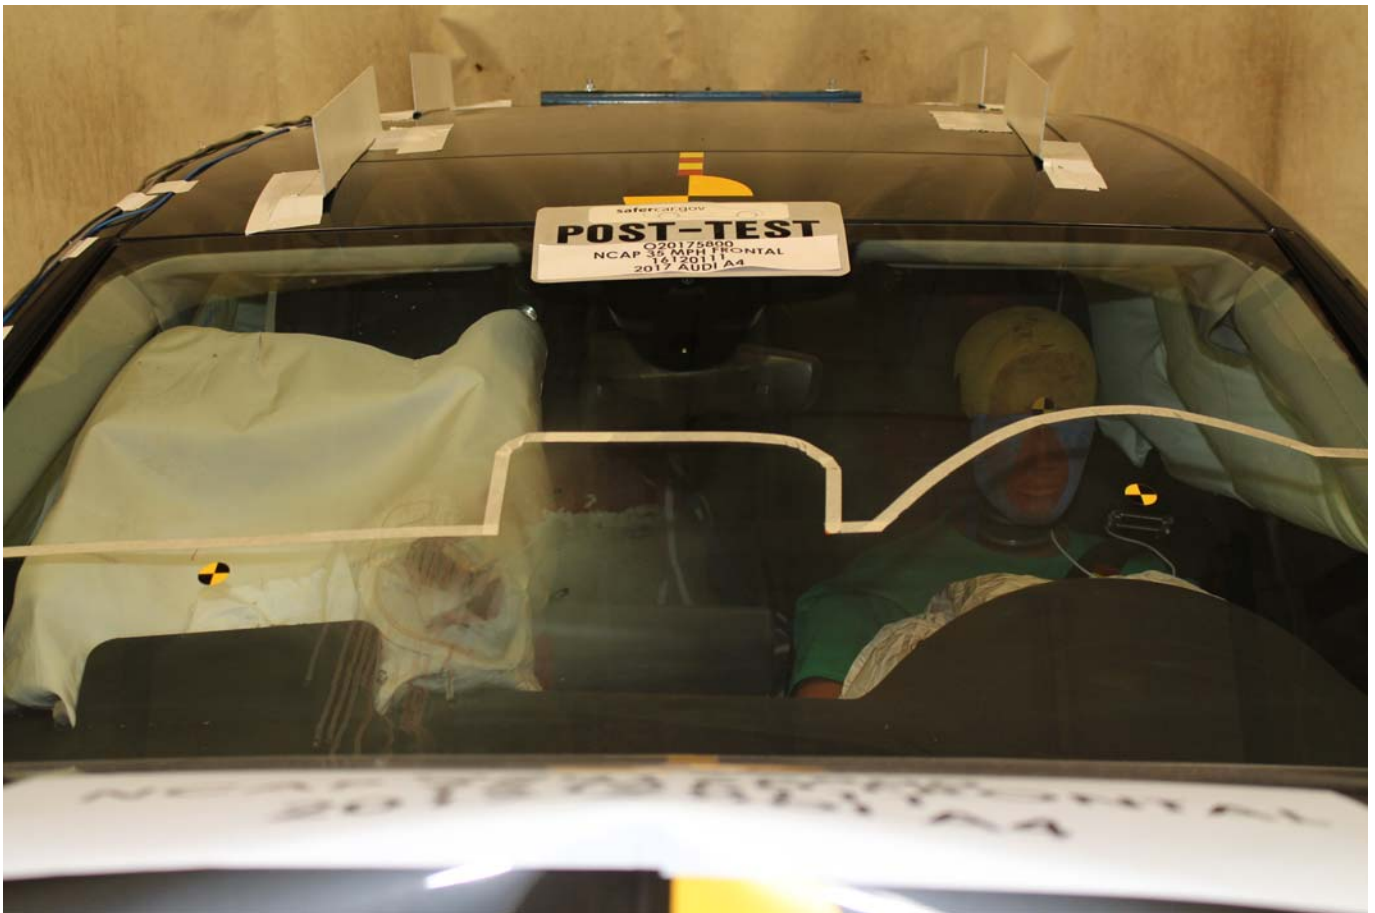
Photo No. 019 - Post-Test Windshield View

There was 100 percent windshield retention and no intrusion into the protected zone of the windshield during the event. There was no Stoddard Solvent leakage after the event or during any phase of the static rollover.

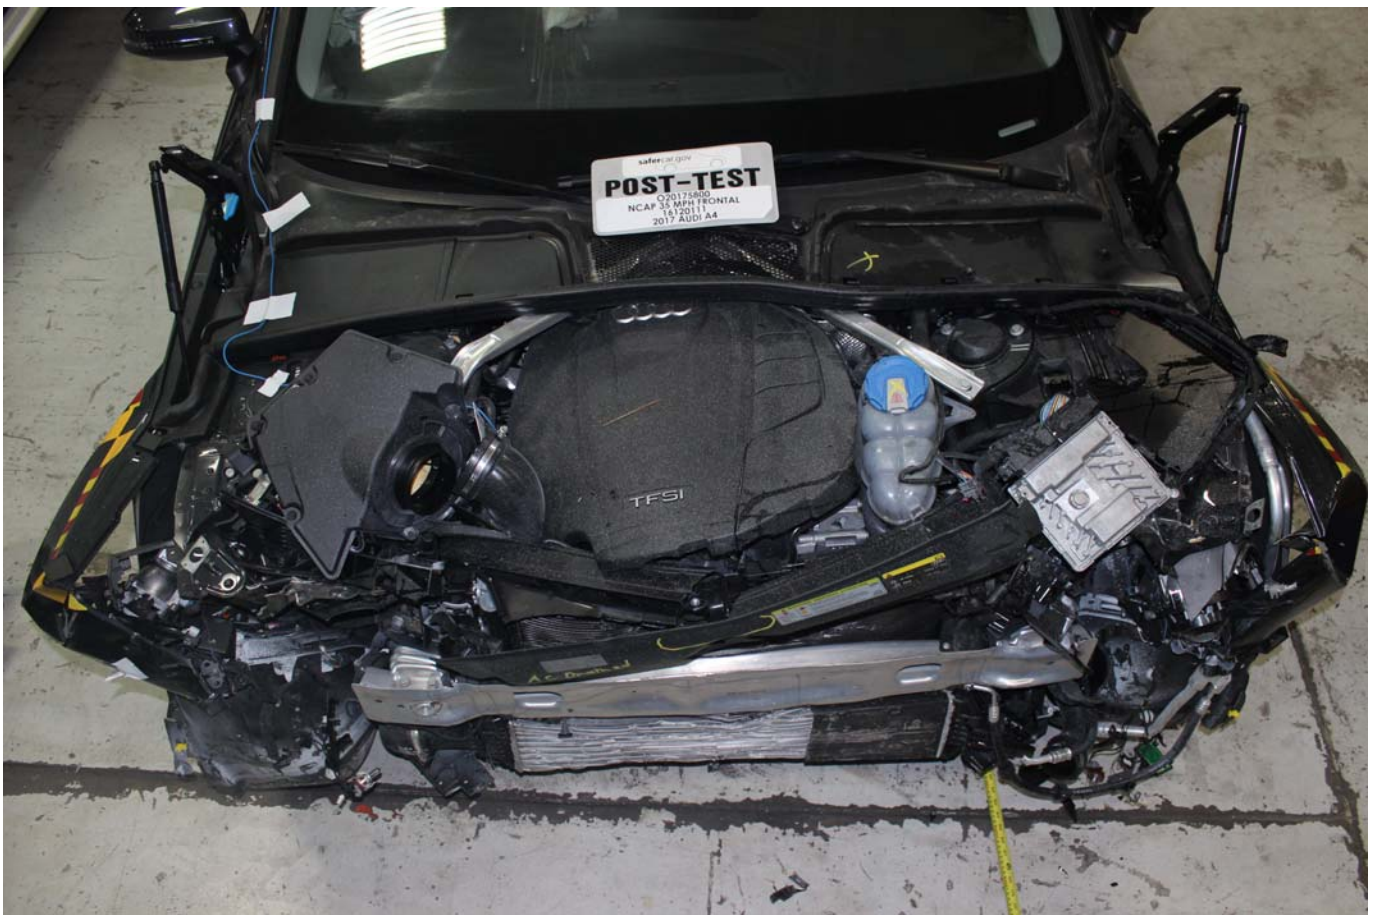
Photo No. 021 - Post-Test Engine Compartment View

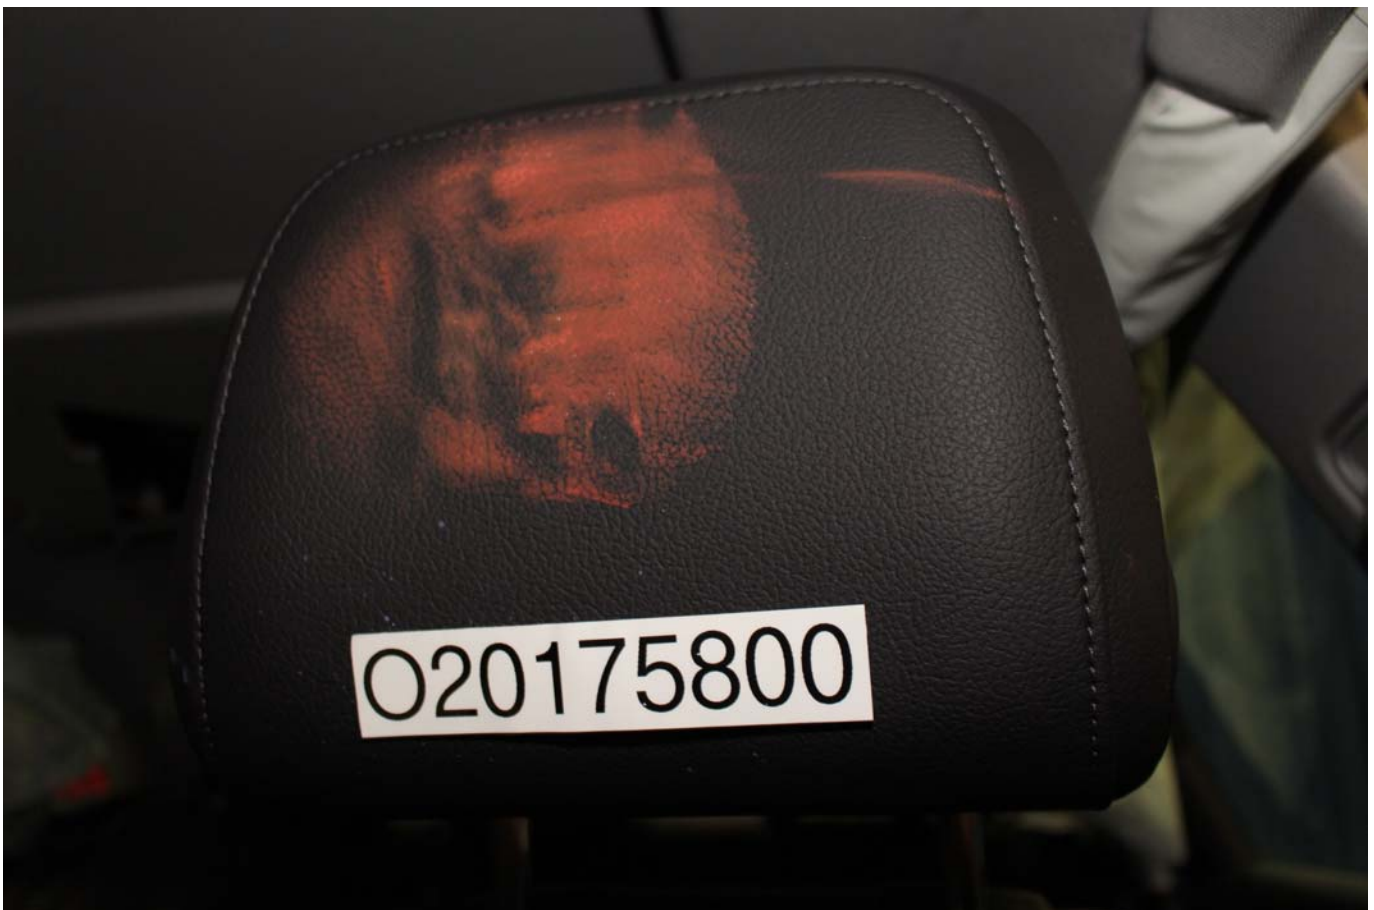
Photo No. 048 - Post-Test Driver Dummy Contact with Headrest

The driver's visible contact points were as follows: The driver's head contacted the airbag. The driver's head also contacted the headrest. The driver's knees contacted the knee airbag. The passenger's visible contact points were as follows: The passenger's head contacted the airbag. The passenger's head also contacted the headrest and side curtain airbag. The passenger's knees contacted the knee airbag.

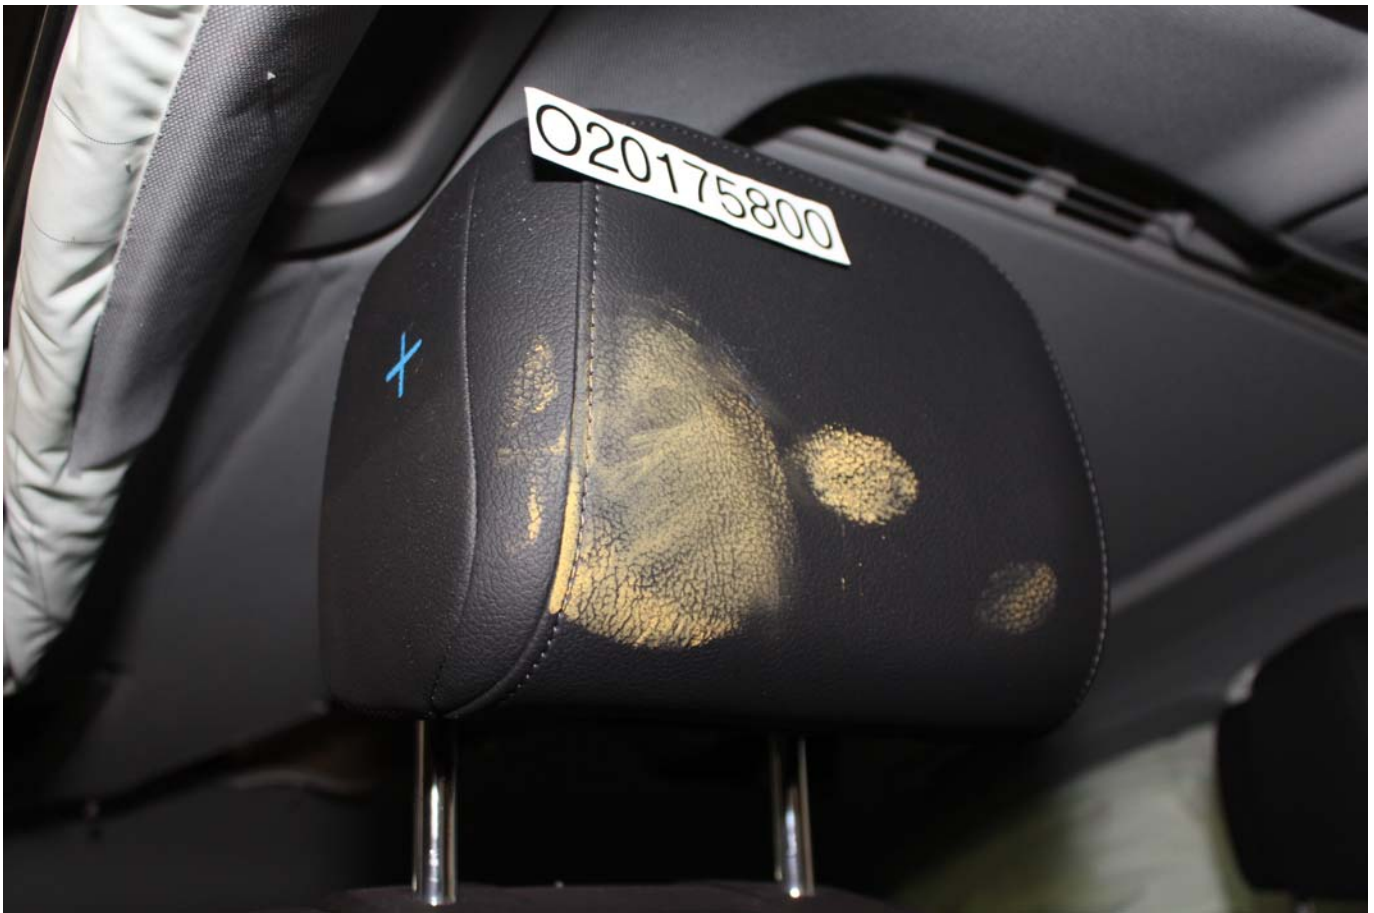
Photo No. 069 - Post-Test Passenger Dummy Contact with Headrest

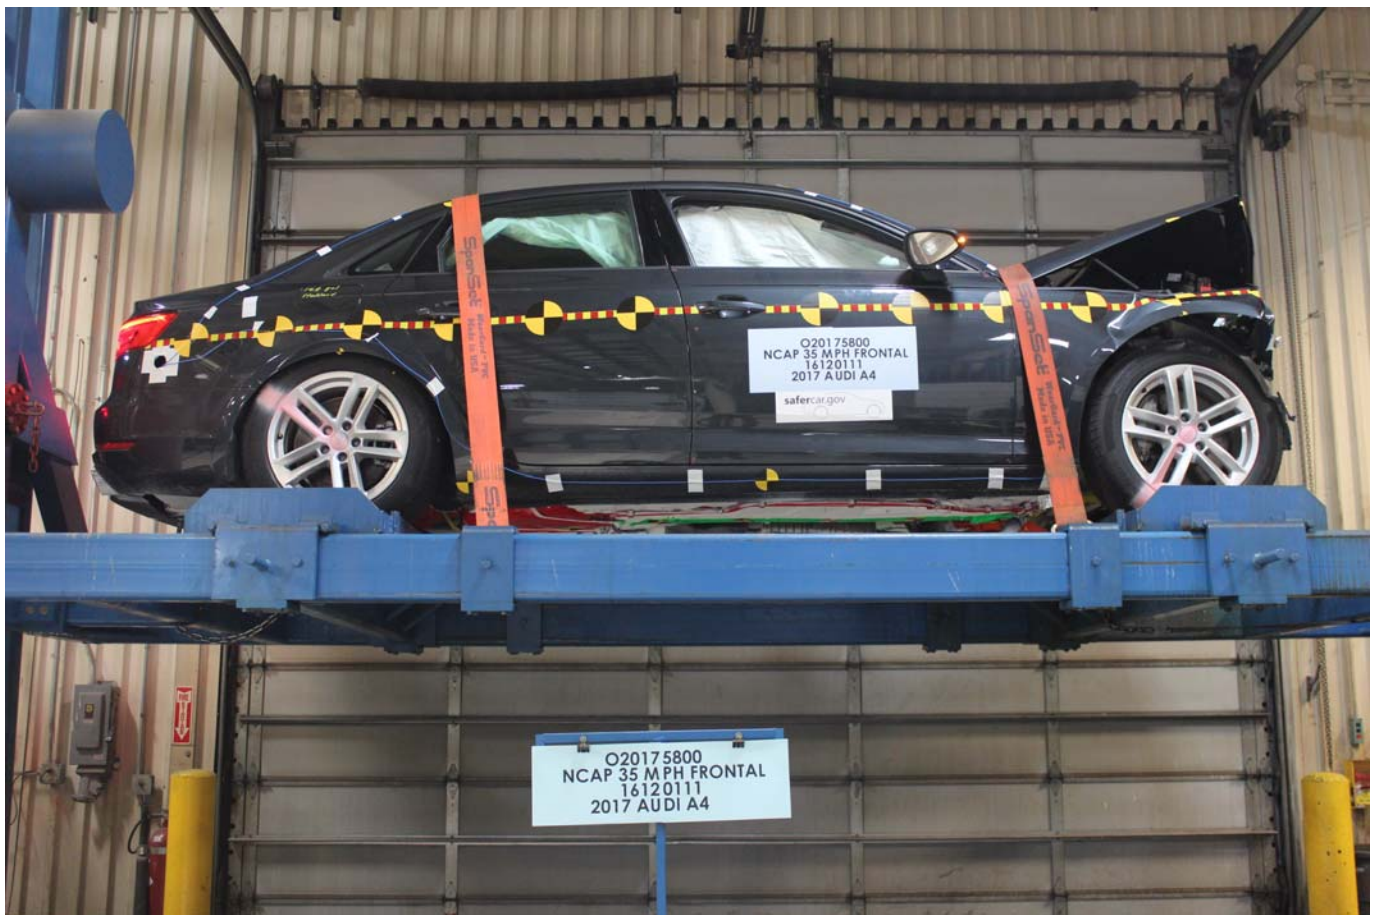
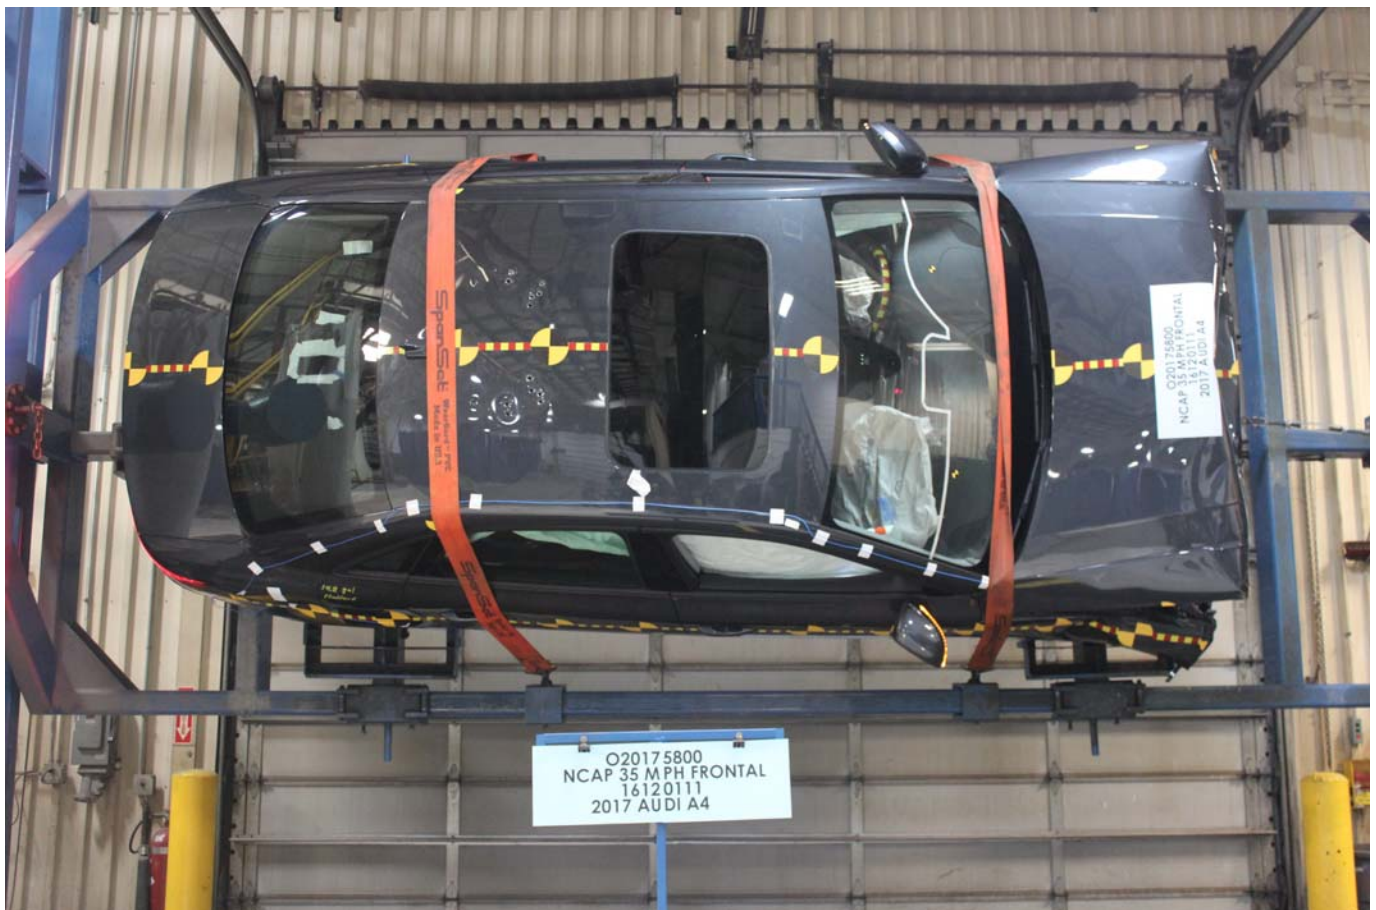
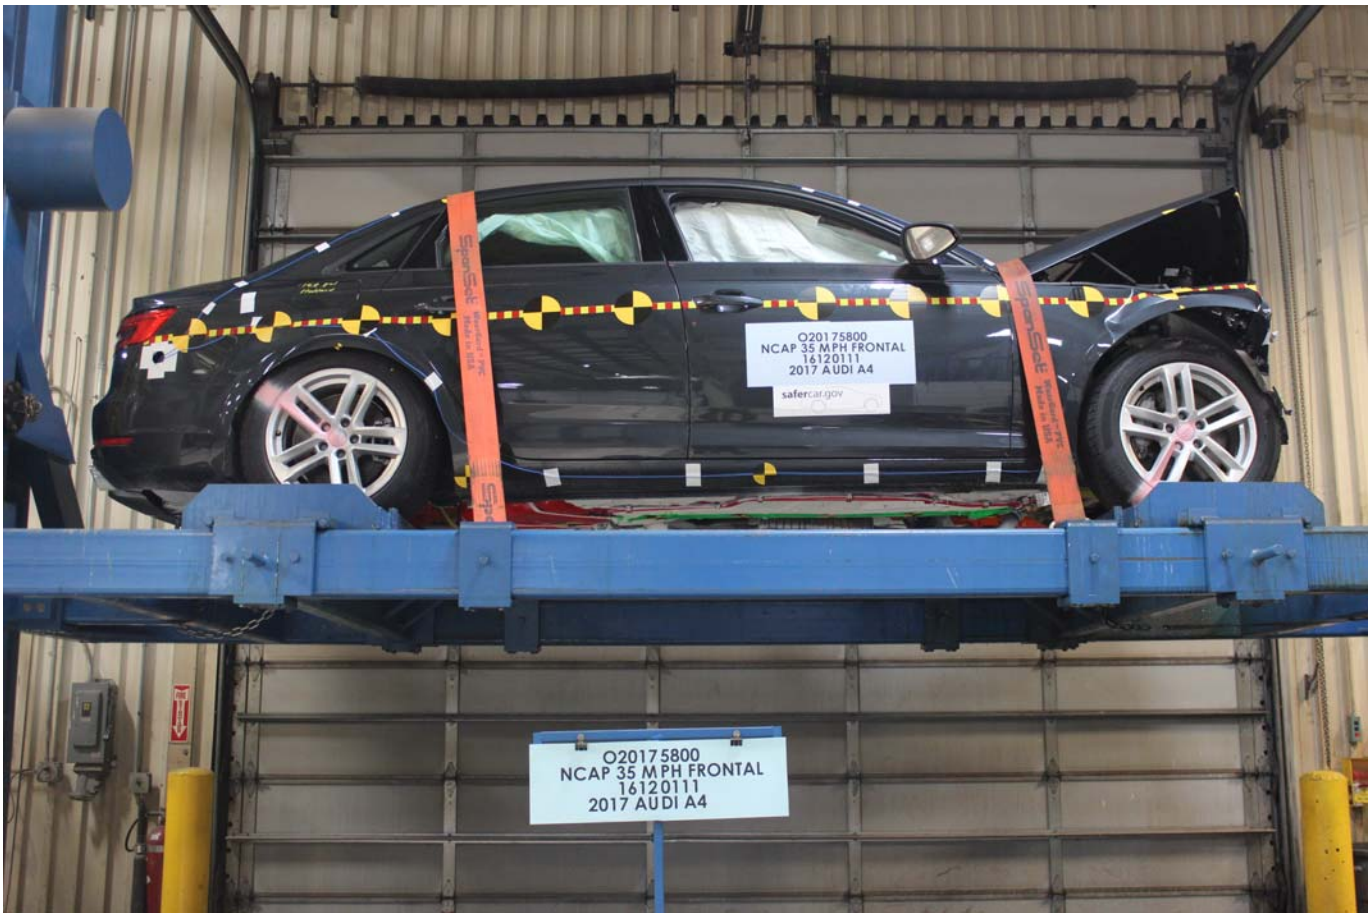
Photo No. 073 - Vehicle at 0 Degree on Static Rollover Device

Photo No. 074 - Vehicle at 90 Degrees on Static Rollover Device

Photo No. 075 - Vehicle at 180 Degrees on Static Rollover Device

Photo No. 076 - Vehicle at 270 Degrees on Static Rollover Device

Photo No. 077 - Vehicle at 360 Degrees on Static Rollover Device
