**FINAL REPORT NUMBER: SPNCAP-TRC-17-005**

**NEW CAR ASSESSMENT PROGRAM (NCAP)  
SIDE IMPACT POLE TEST**

**DAIMLER AG STUTTGART  
2017 Mercedes-Benz E-Class Sedan  
NHTSA NUMBER: M20174301**

**PREPARED BY:  
Transportation Research Center Inc.  
10820 State Route 347  
P. O. Box B-67  
East Liberty, OH 43319**

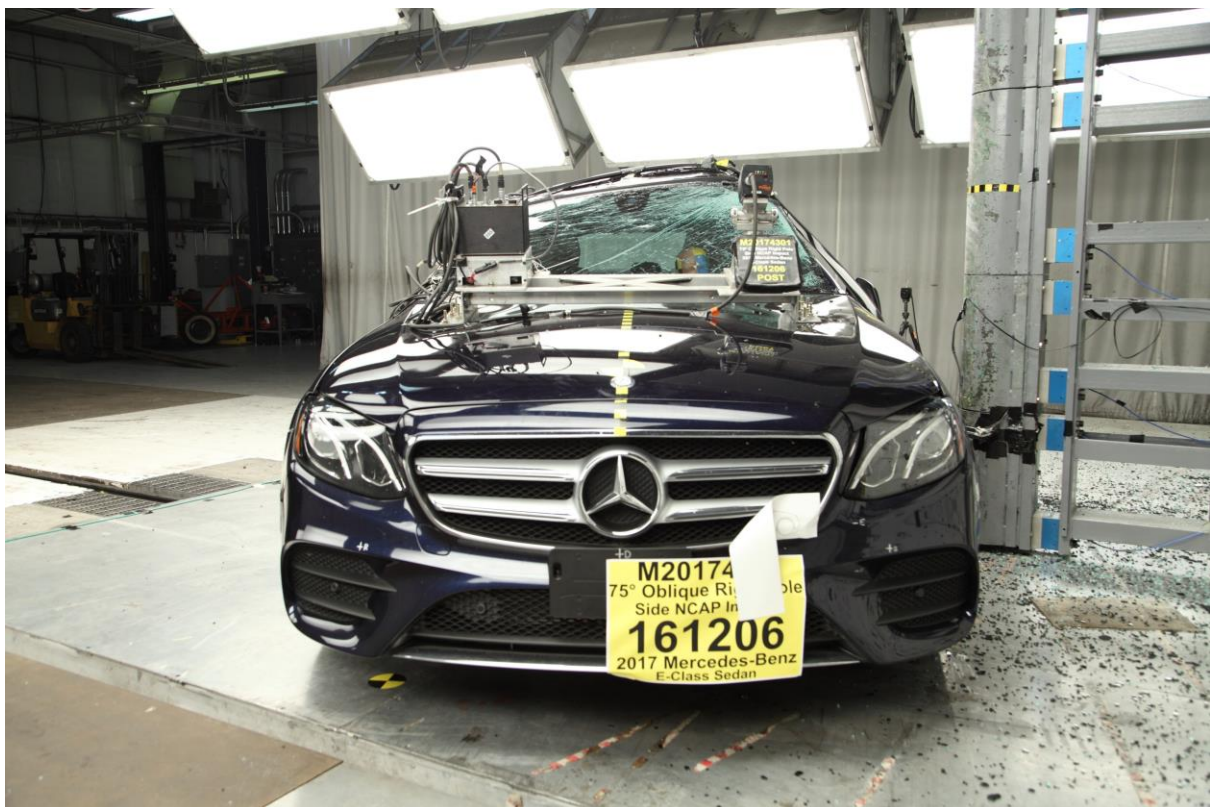
**No. 004 Post-Test Frontal View of Test Vehicle**

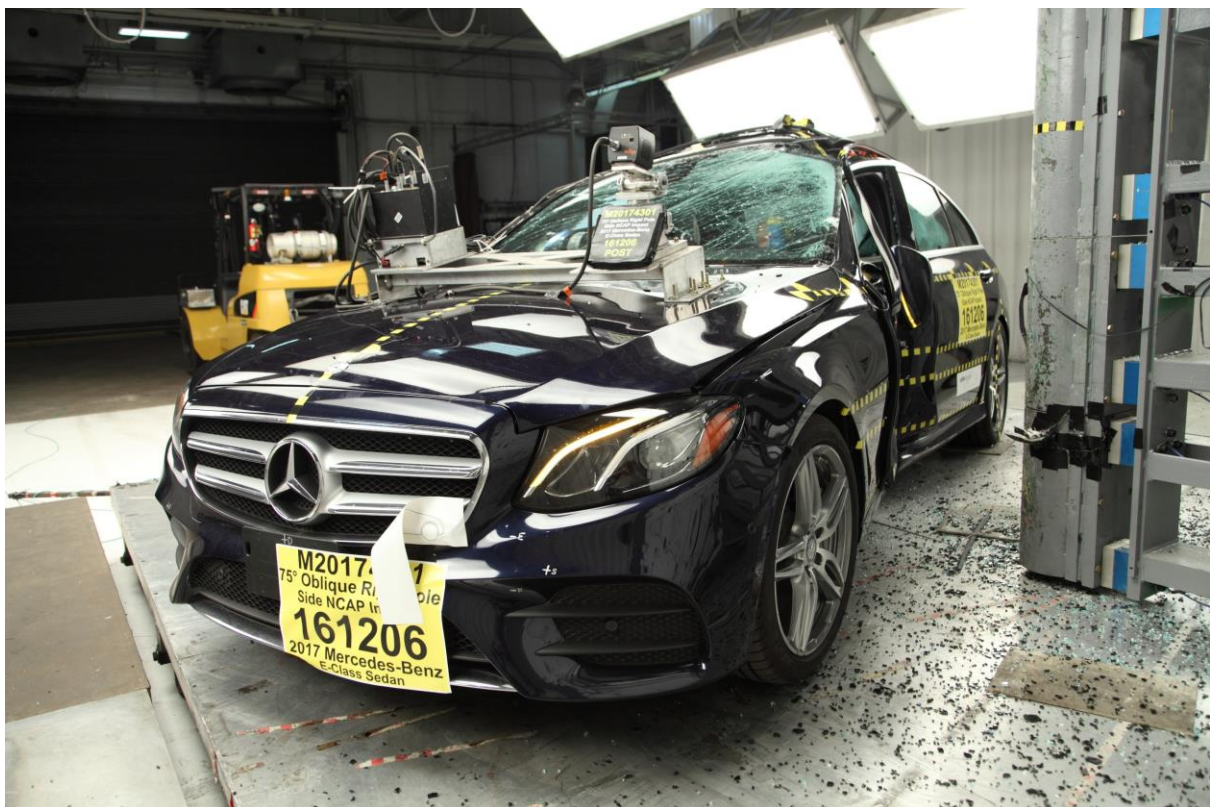
**No. 006 Post-Test Left Front  $\frac{3}{4}$  View of Test Vehicle**

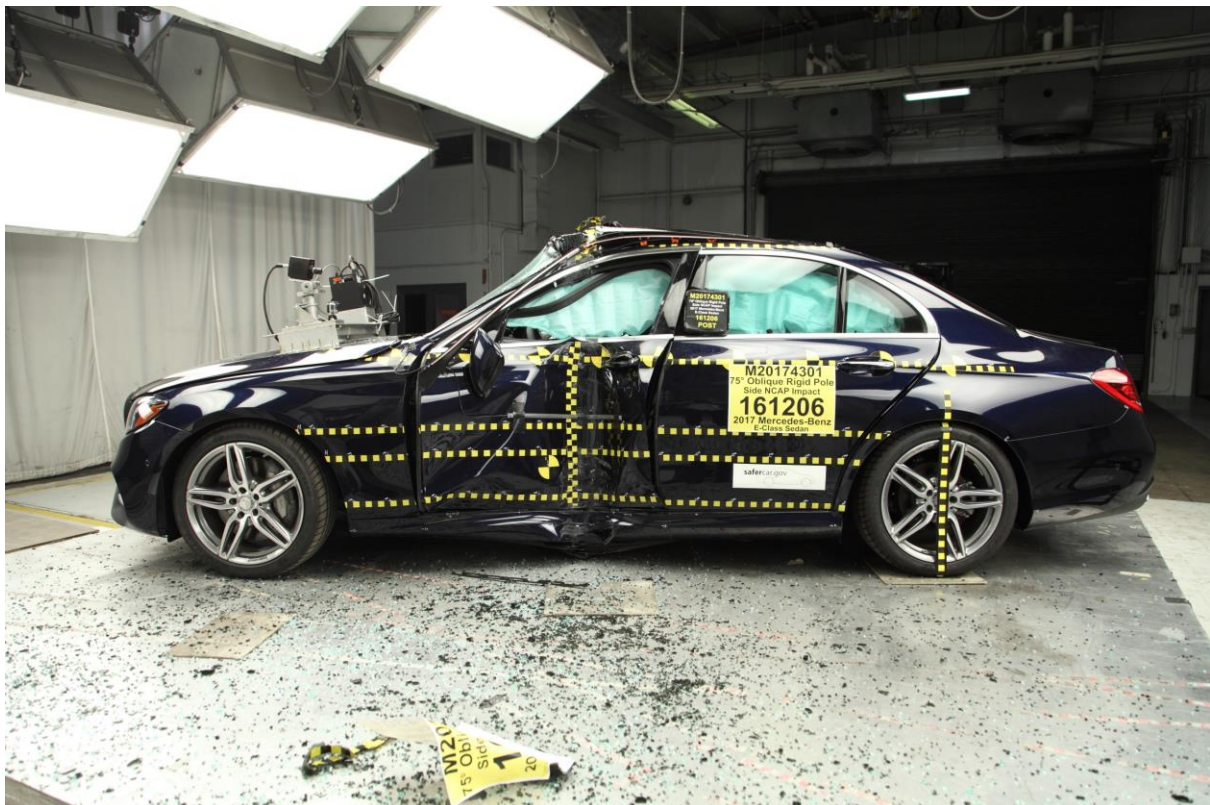
**No. 008 Post-Test Left Side View of Test Vehicle**

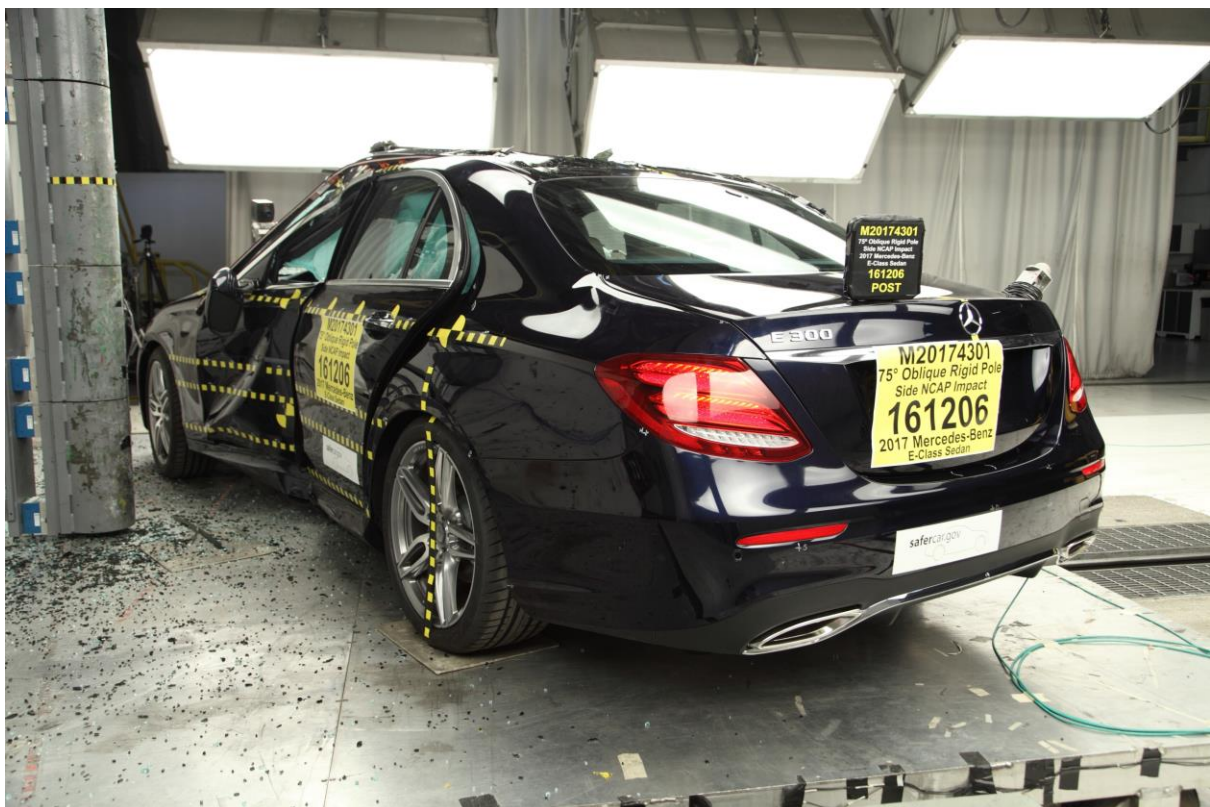
**No. 010 Post-Test Left Rear  $\frac{3}{4}$  View of Test Vehicle**

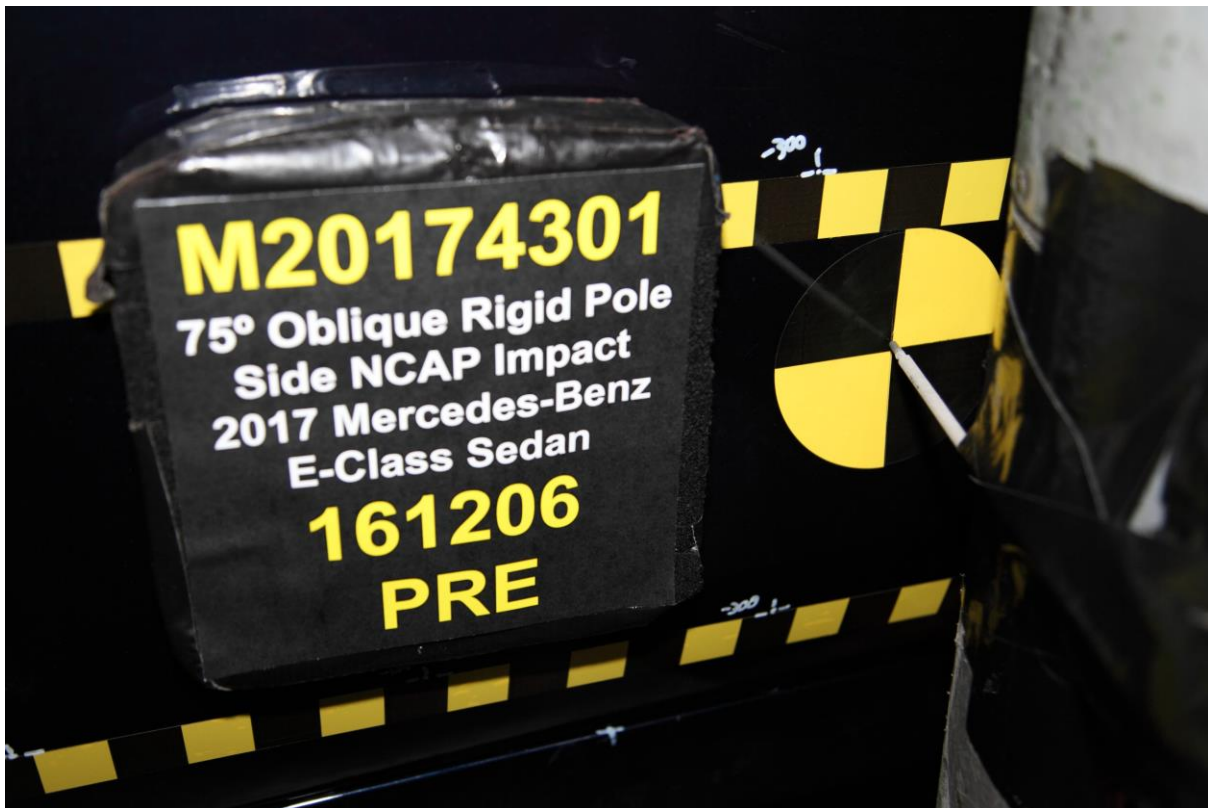
No. 019 Pre-Test Close-Up View of Impact Point Target

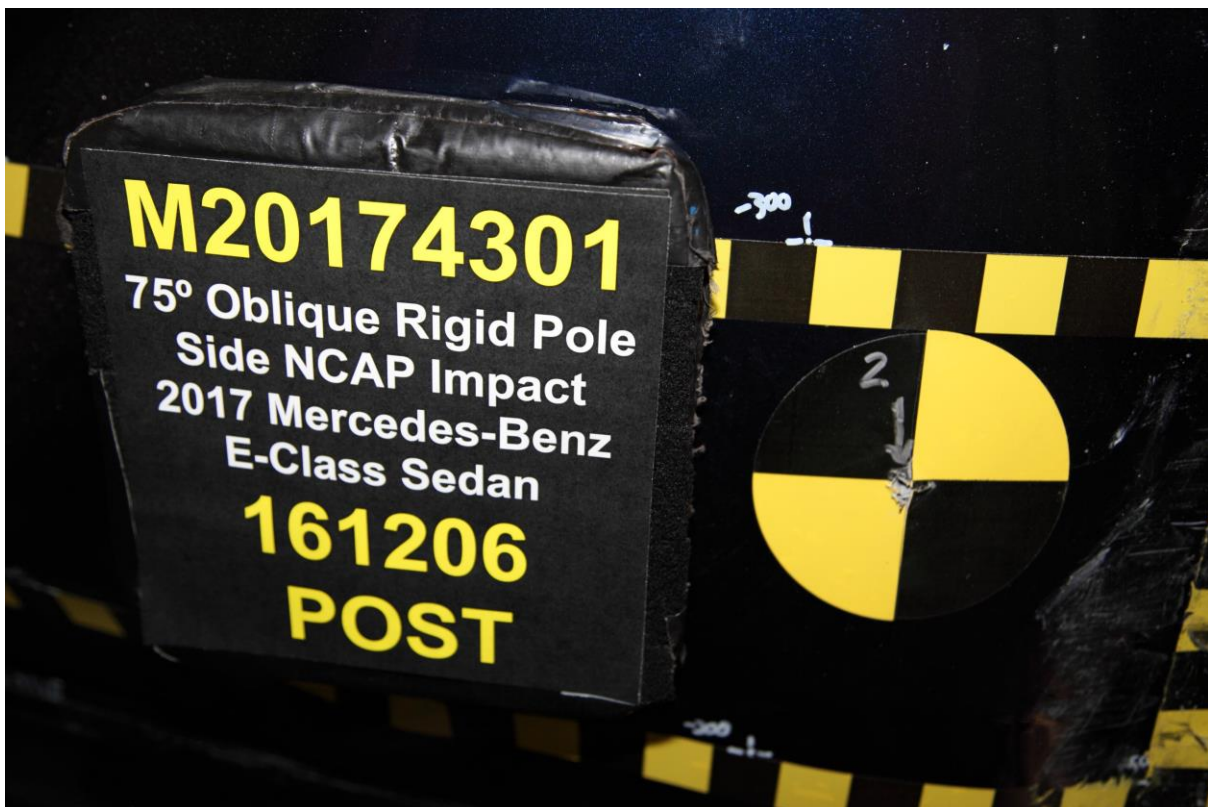
No. 020 Post-Test Close-Up View of Impact Point Target Showing Impact Location

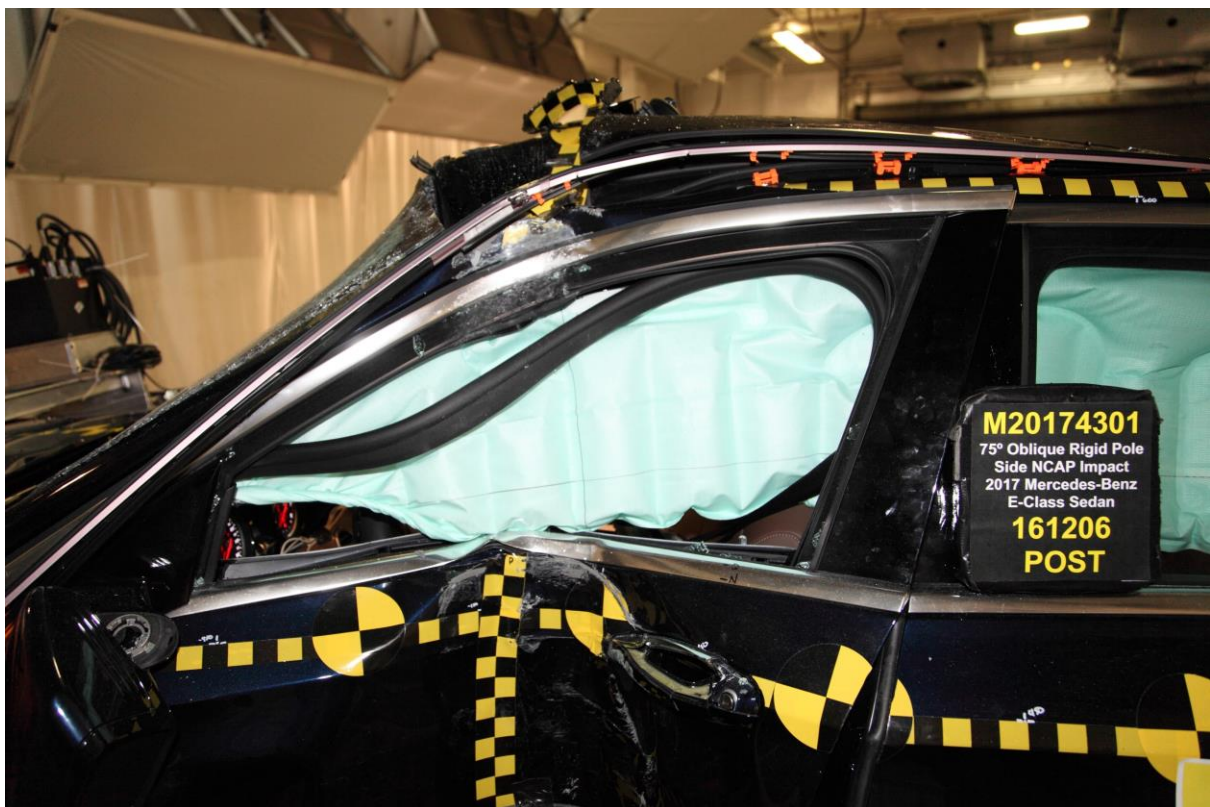
**No. 025 Post-Test Left Side View of Dummy Shoulder and Door Top View**

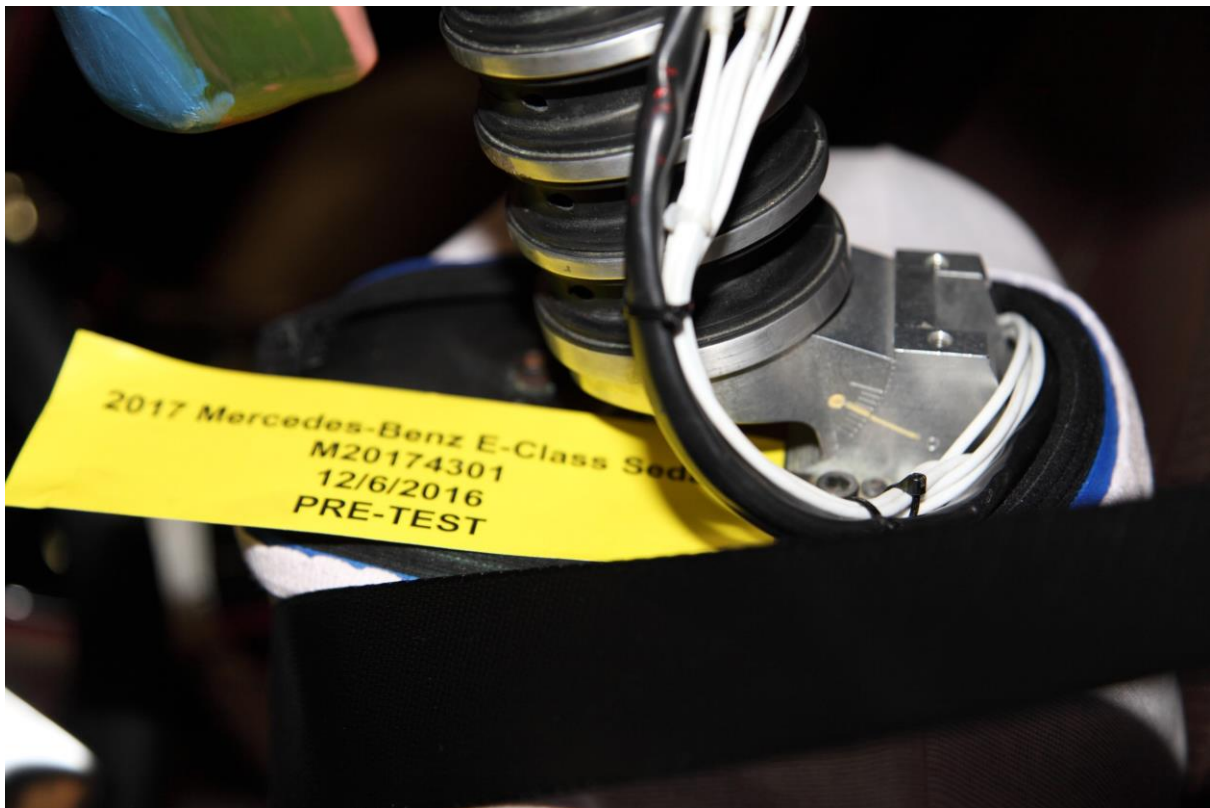
**No. 030 Pre-Test Left Side View of Dummy Neck Showing Position of Adjustable Neck Bracket**

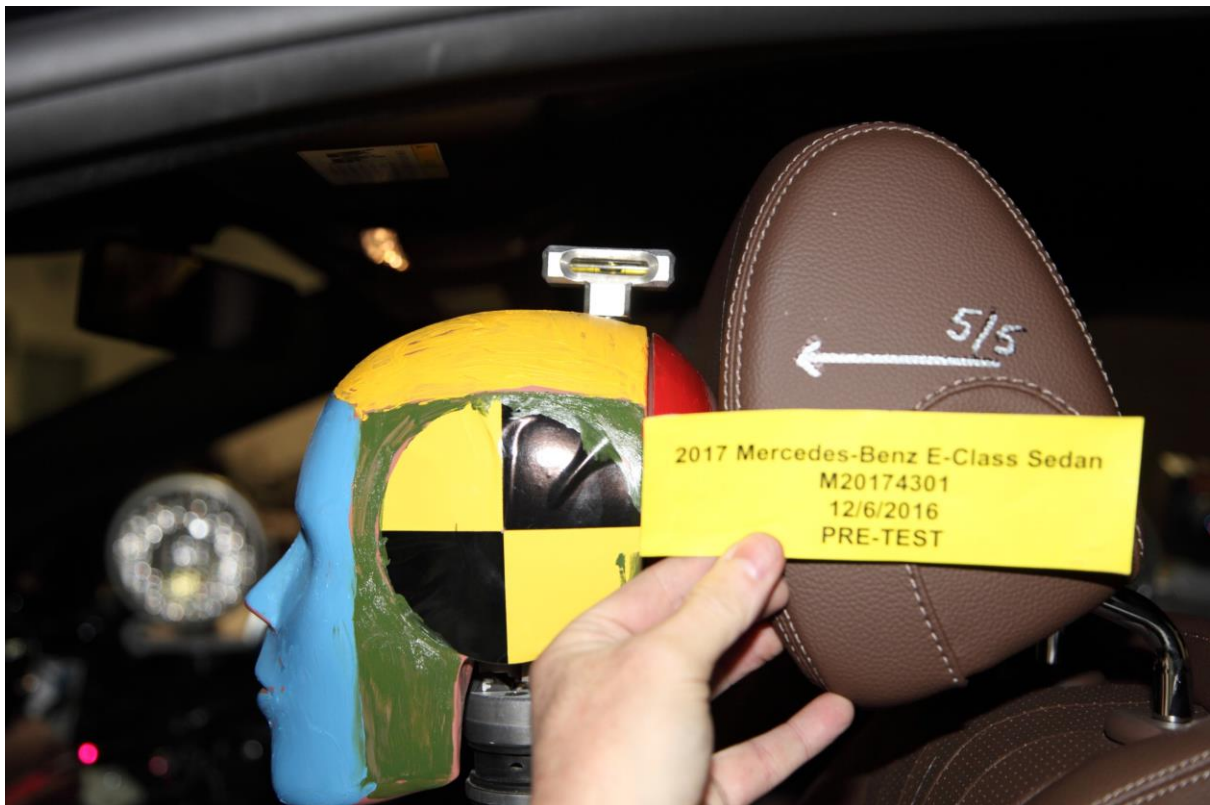
**No. 031 Pre-Test Left Side View of Dummy Head Showing Dummy Head is Level**

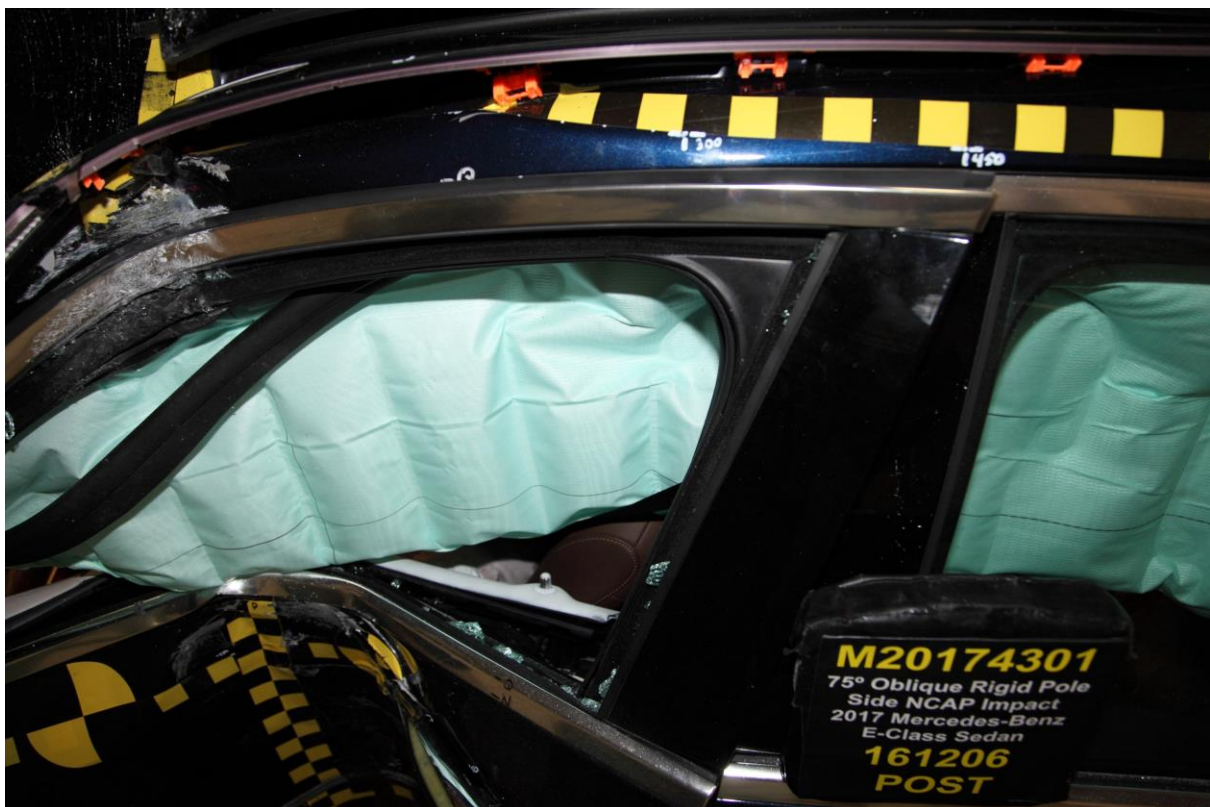
No. 041 Post-Test Dummy and Door Clearance View

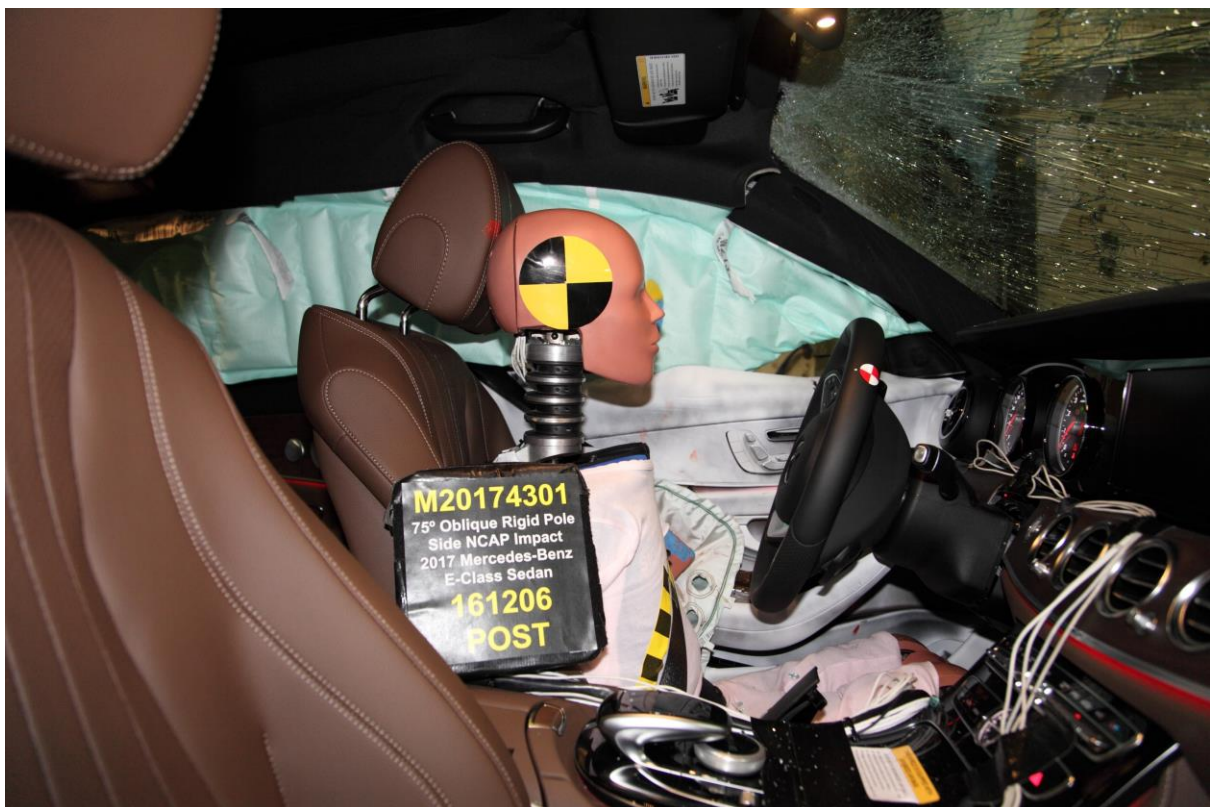
No. 045 Post-Test Inner Door Panel View Showing Dummy Contact Location

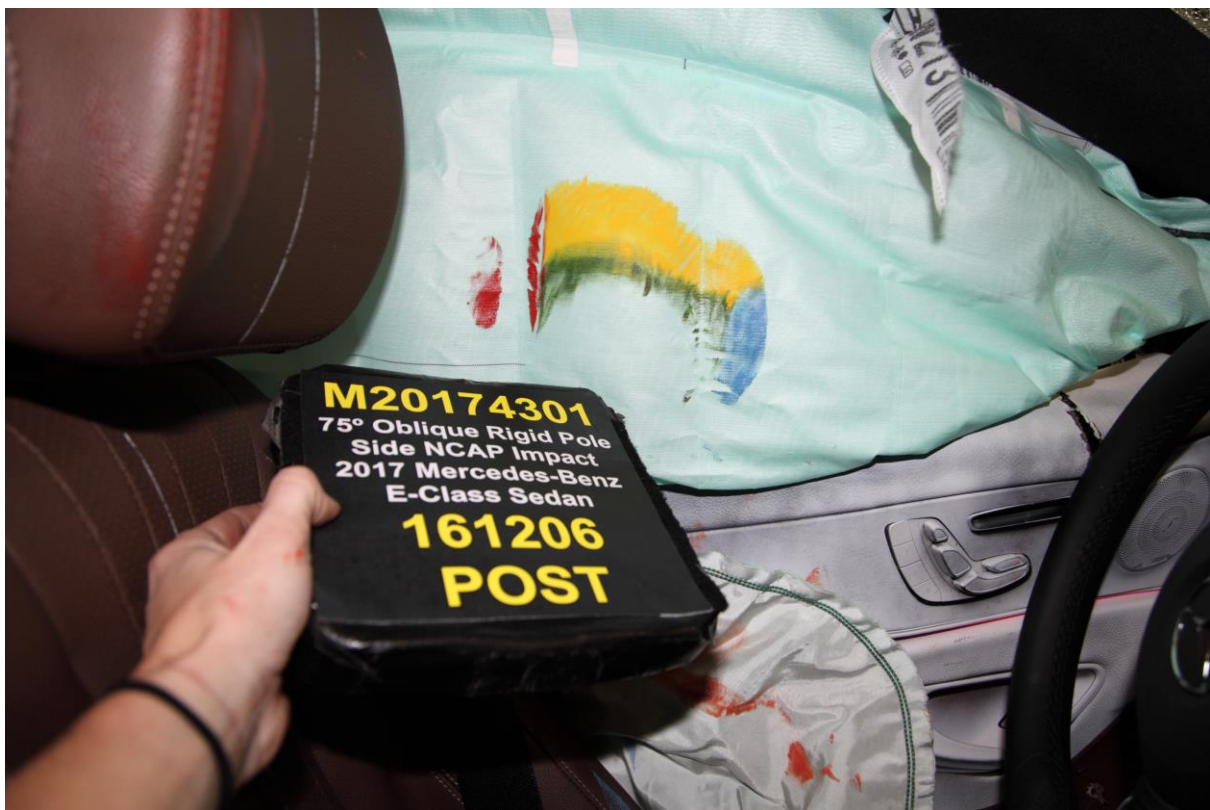
No. 047 Post-Test Dummy Close-Up Head Contact with Side Airbag View

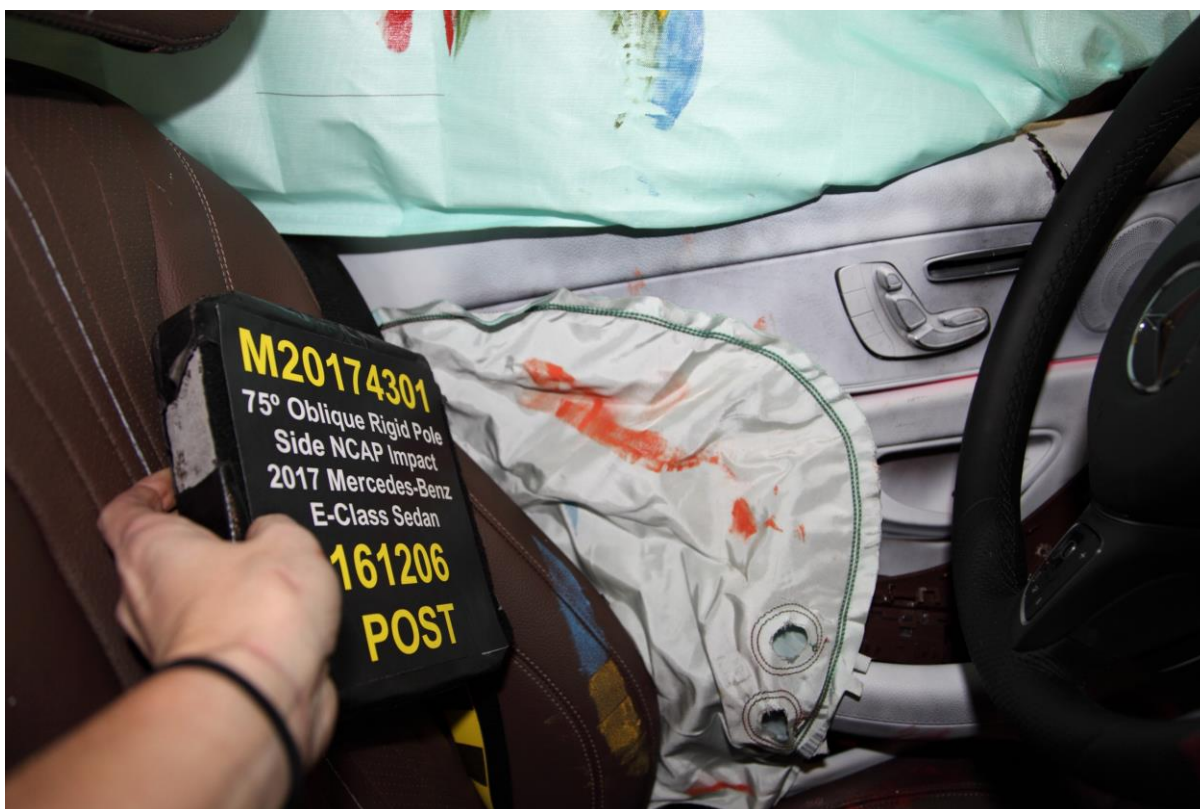
No. 049 Post-Test Dummy Close-Up Torso Contact with Side Airbag View

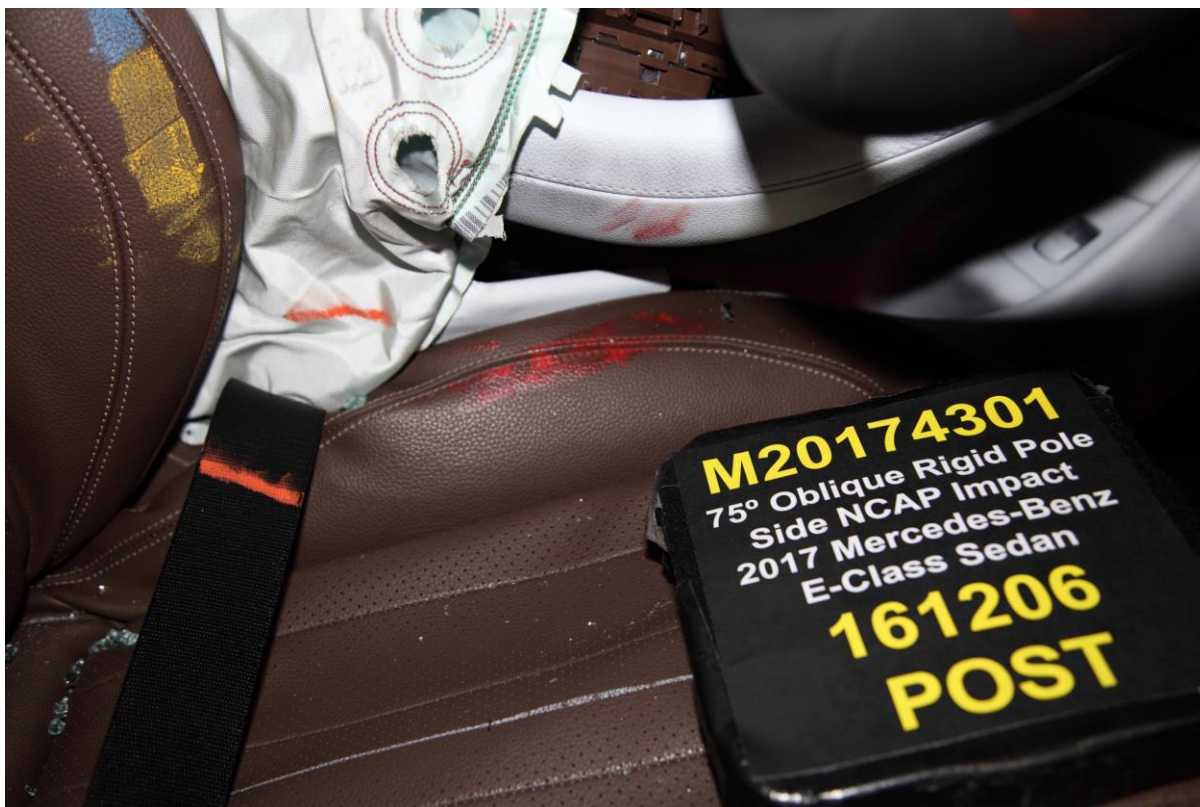
No. 051 Post-Test Dummy Close-Up Pelvis Contact with Side Airbag View

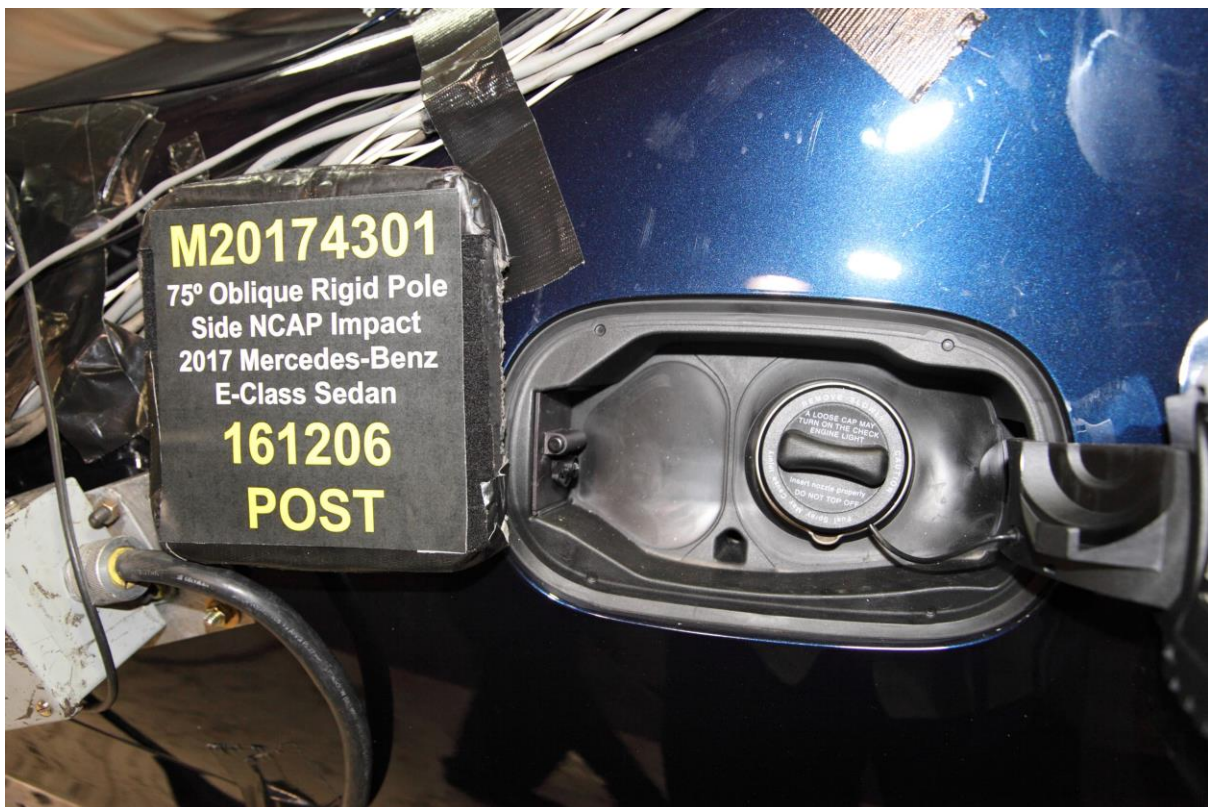
No. 054 Post-Test View of Fuel Filler Cap or Fuel Filler Neck

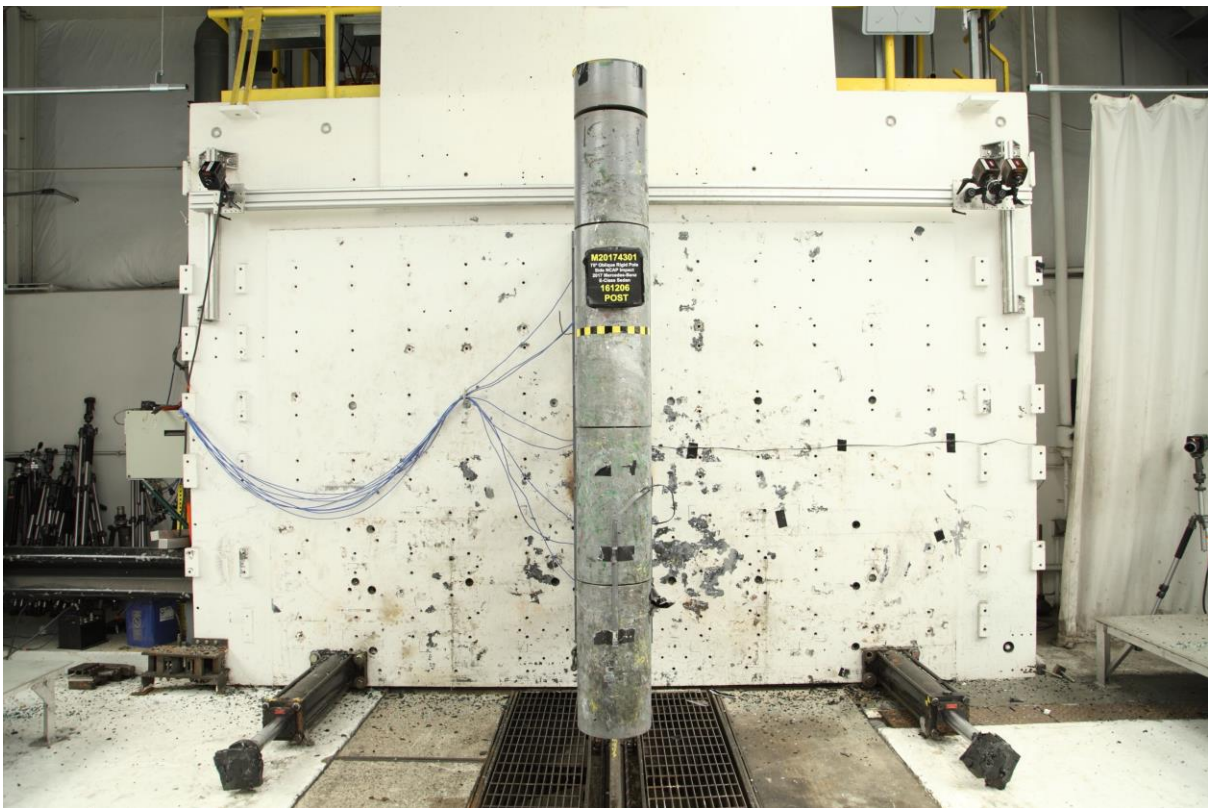
**No. 058 Post-Test Pole Barrier Front View**

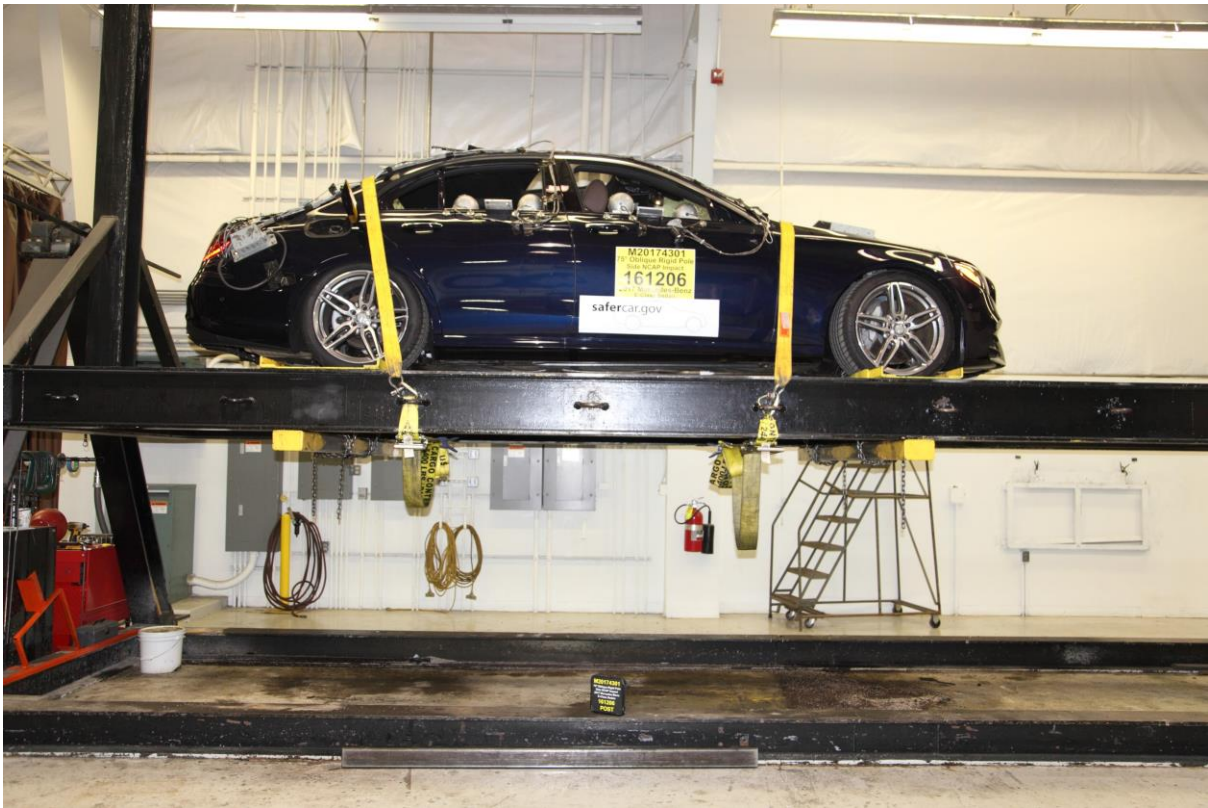
**No. 063 FMVSS No. 301 Static Rollover 0 Degrees**

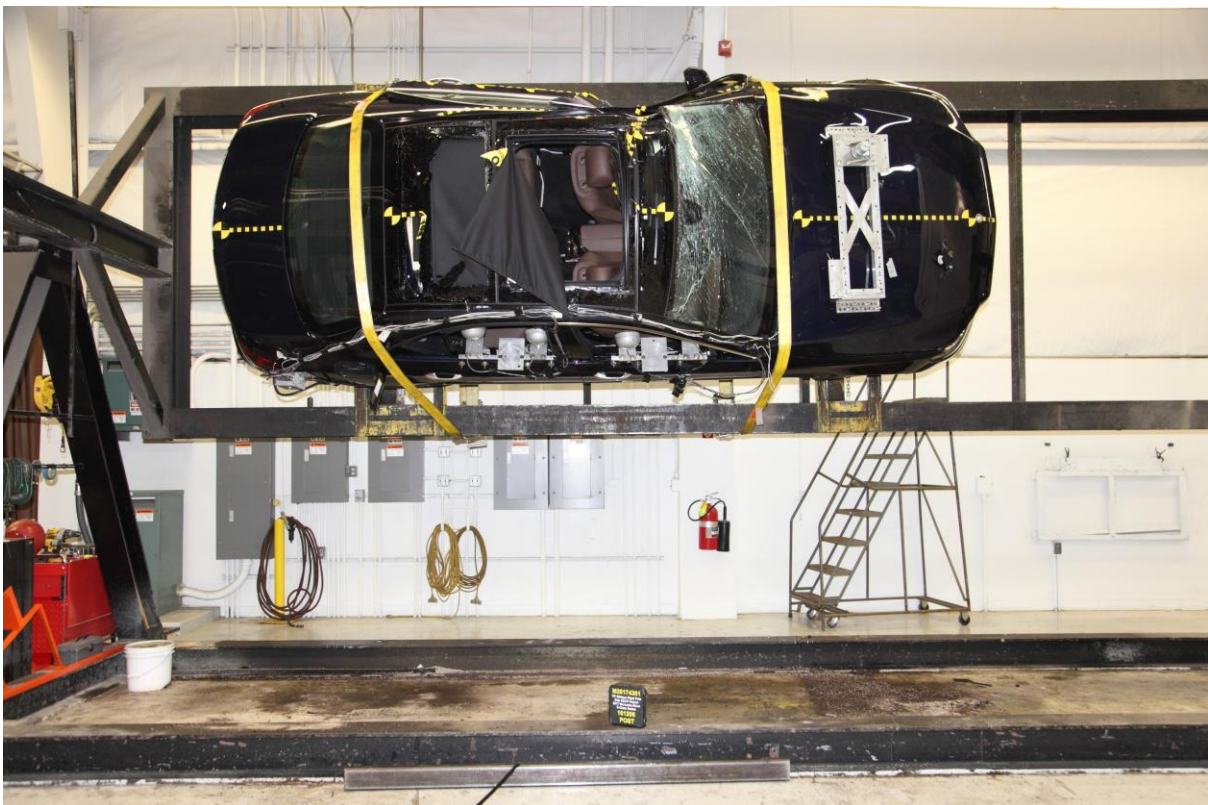
**No. 064 FMVSS No. 301 Static Rollover 90 Degrees**

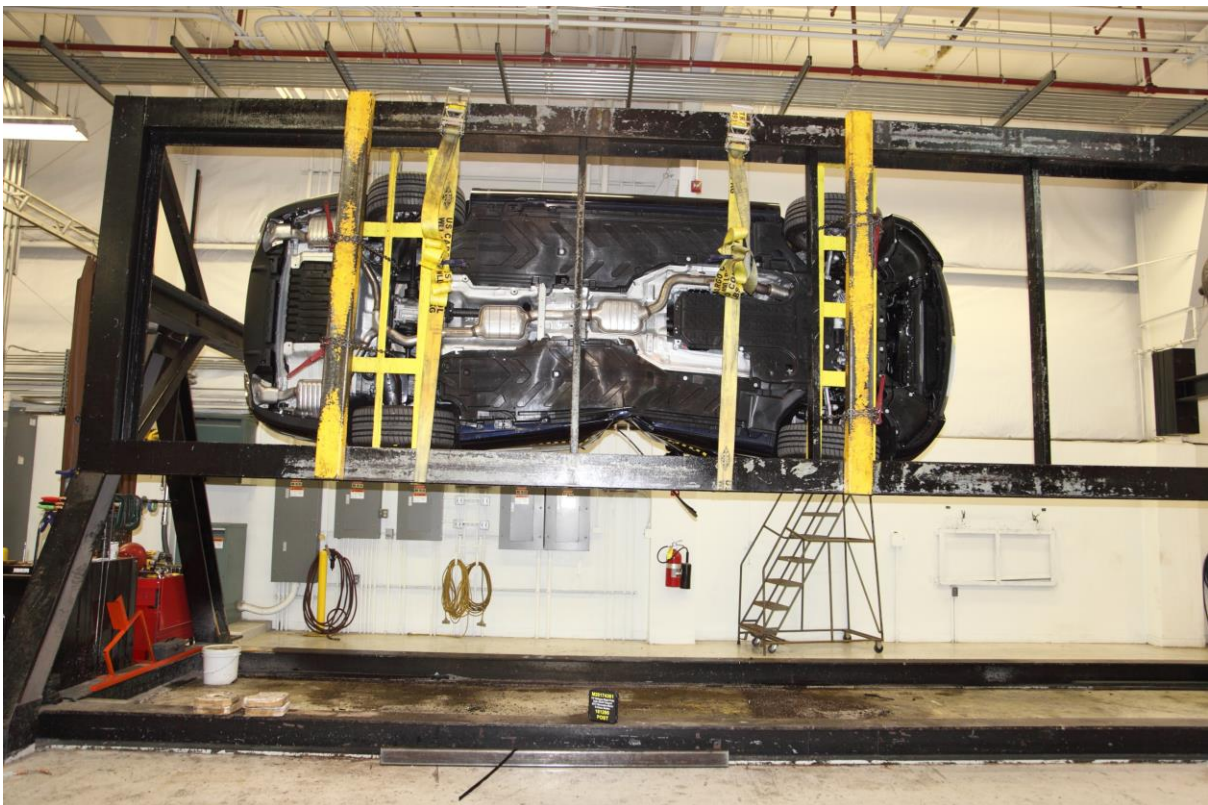
**No. 066 FMVSS No. 301 Static Rollover 270 Degrees**

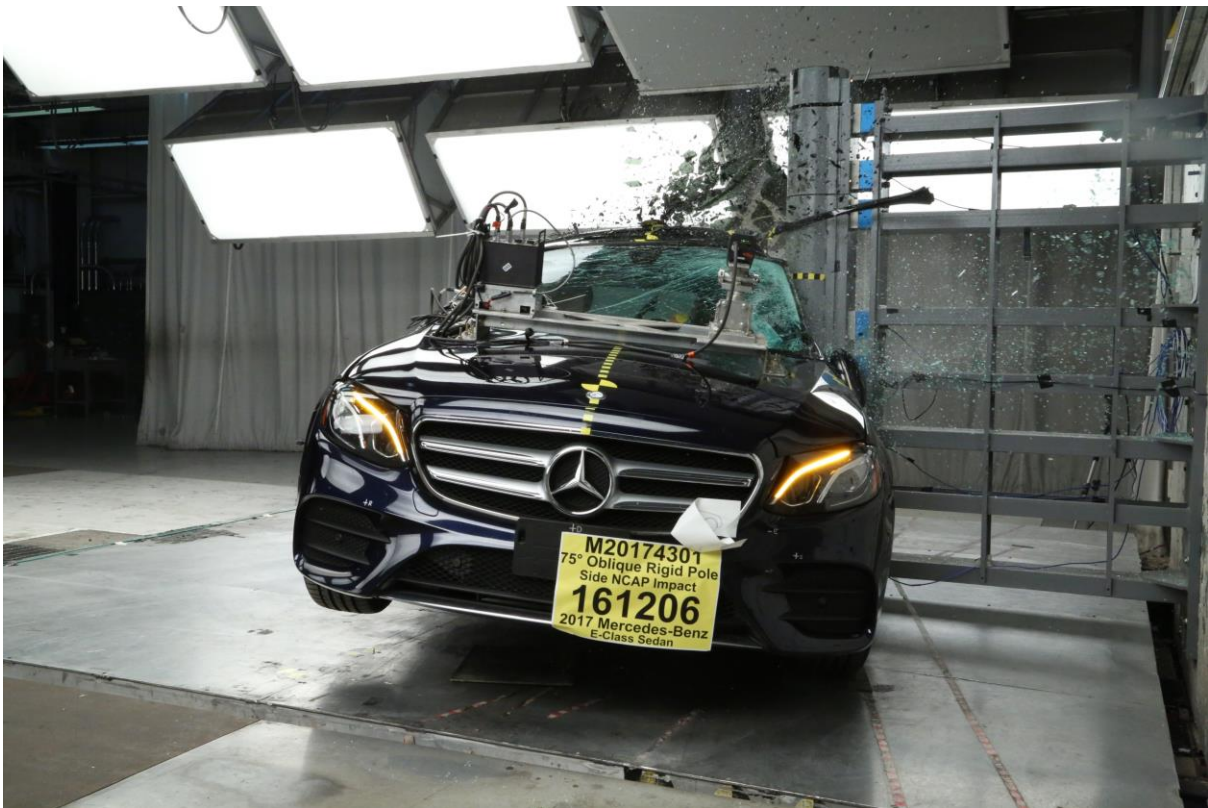
**No. 068 Impact Event**
