**REPORT NUMBER: NCAP-KAR-17-001**

**NEW CAR ASSESSMENT PROGRAM (NCAP)  
FRONTAL BARRIER IMPACT TEST**

**FCA US LLC  
2017 CHRYSLER 200C AWD 4-DOOR SEDAN**

**PREPARED BY:  
KARCO ENGINEERING, LLC.  
9270 HOLLY ROAD  
ADELANTO, CA 92301**

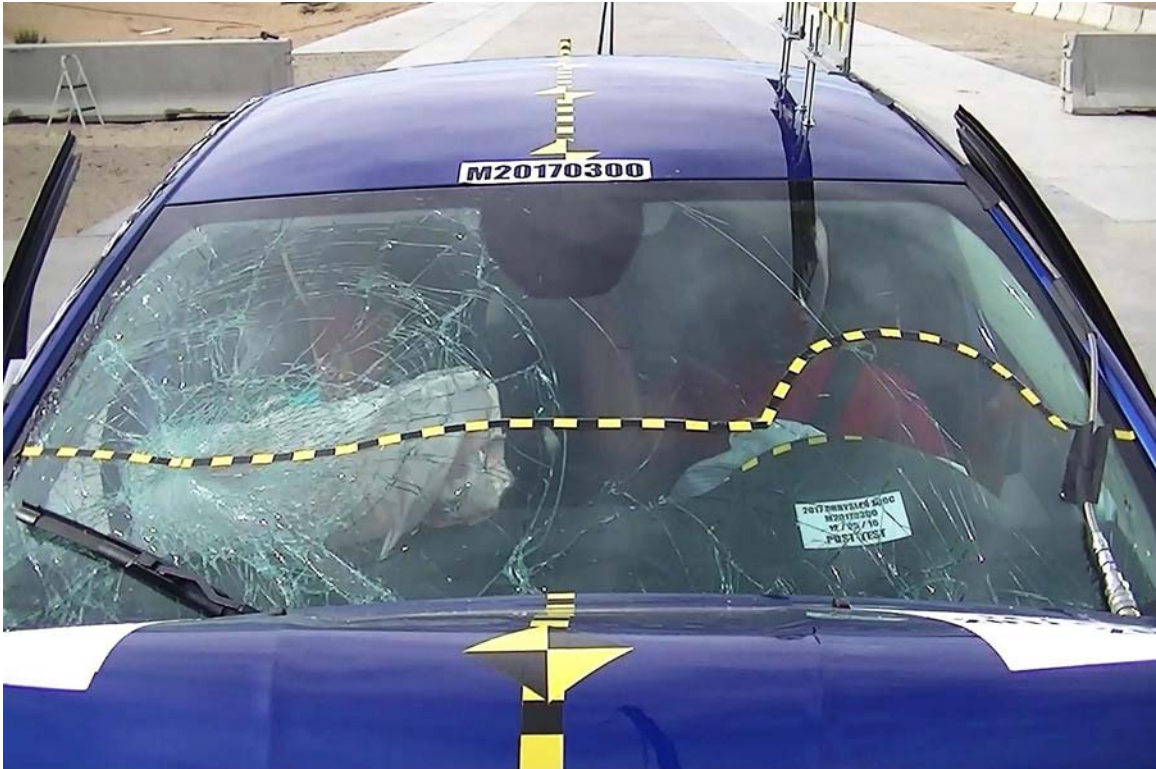
FIGURE 19. Post-Test Windshield View

| Critical Areas of Performance | Observations and Conclusions |
|---|---|
| Windshield Damage | Broken |
