**REPORT NUMBER: NCAP-KAR-17-009**

**NEW CAR ASSESSMENT PROGRAM (NCAP)  
FRONTAL BARRIER IMPACT TEST**

**DAIMLER AG  
2017 SMART FORTWO 2-DOOR COUPE**

**FINAL REPORT**

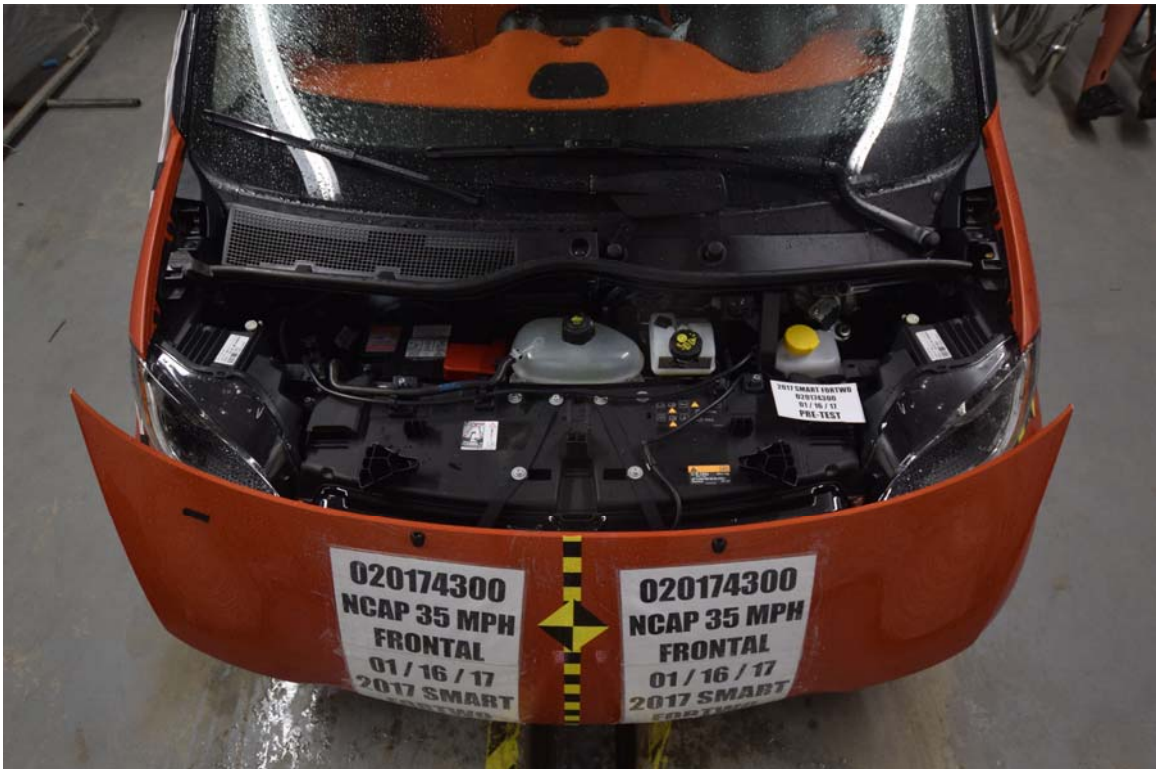
FIGURE 19. Post-Test Windshield View

There was 100% windshield retention and no intrusion into the protected zone of the windshield during the event.

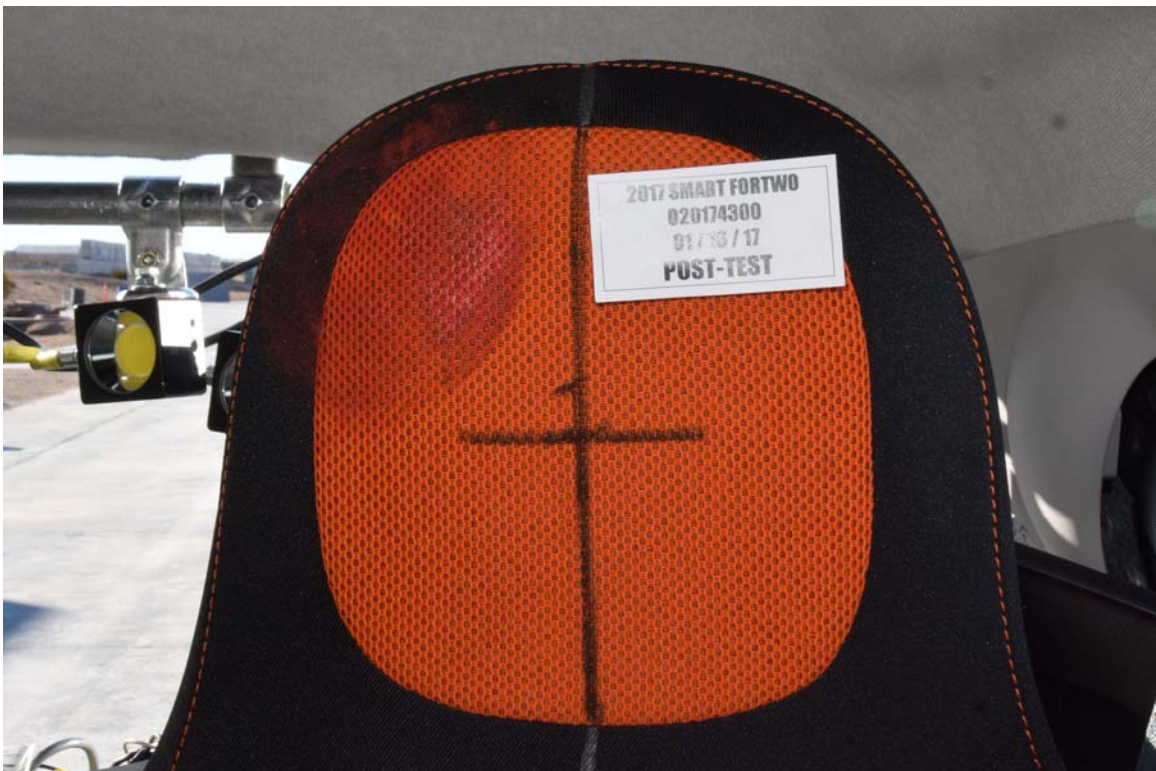
FIGURE 47. Post-Test Driver Dummy Contact with Airbag

The driver's visible contact points were as follows: The driver ATD's head contacted the frontal airbag and headrest. The upper torso contacted the frontal airbag. Both the left and right knees contacted the knee airbag.

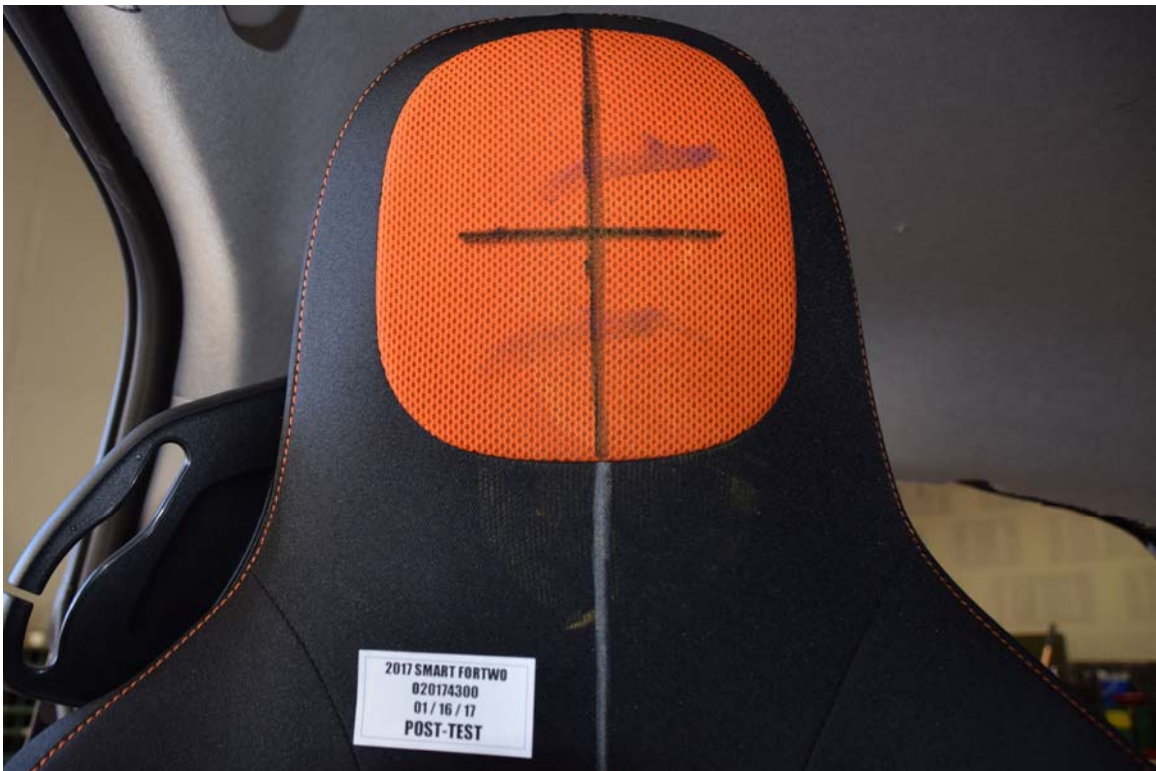
FIGURE 68. Post-Test Passenger Dummy Contact with Airbag

The passenger's visible contact points were as follows: The passenger ATD's head contacted the frontal airbag and headrest. The upper torso contacted the frontal airbag. Both the left and right knees contacted the knee airbag.

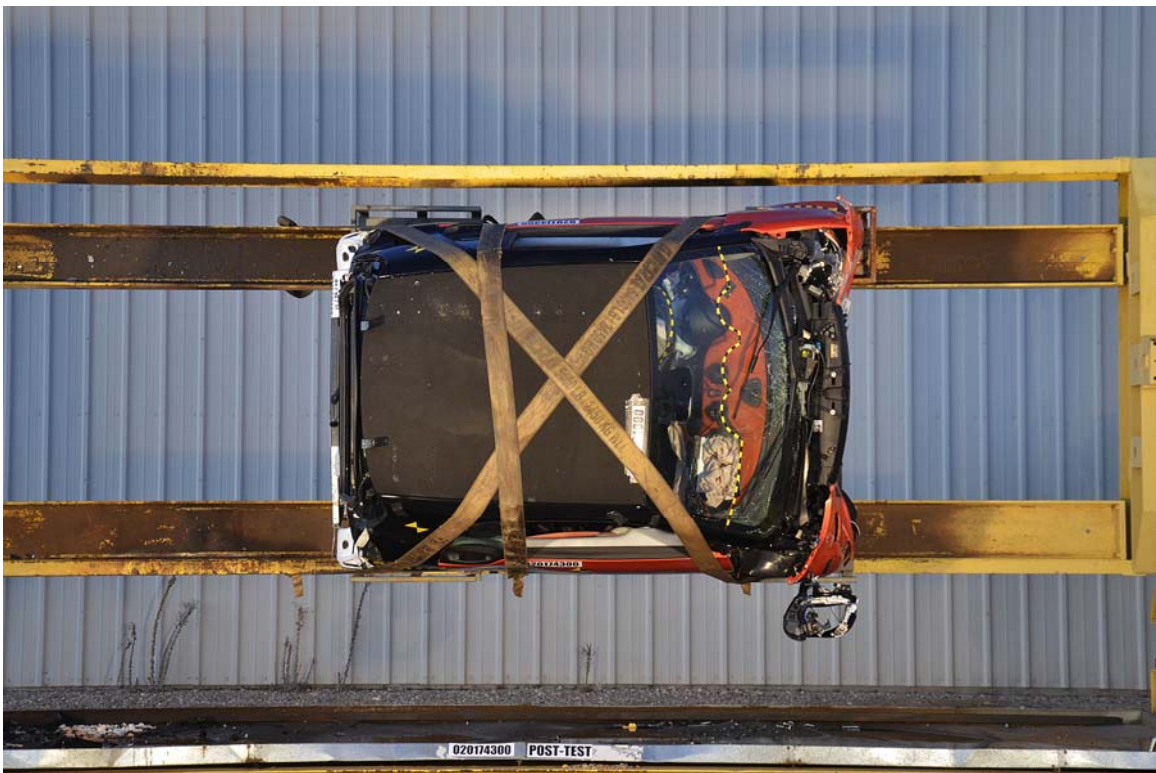
FIGURE 73. Vehicle at 0° on Static Rollover Device

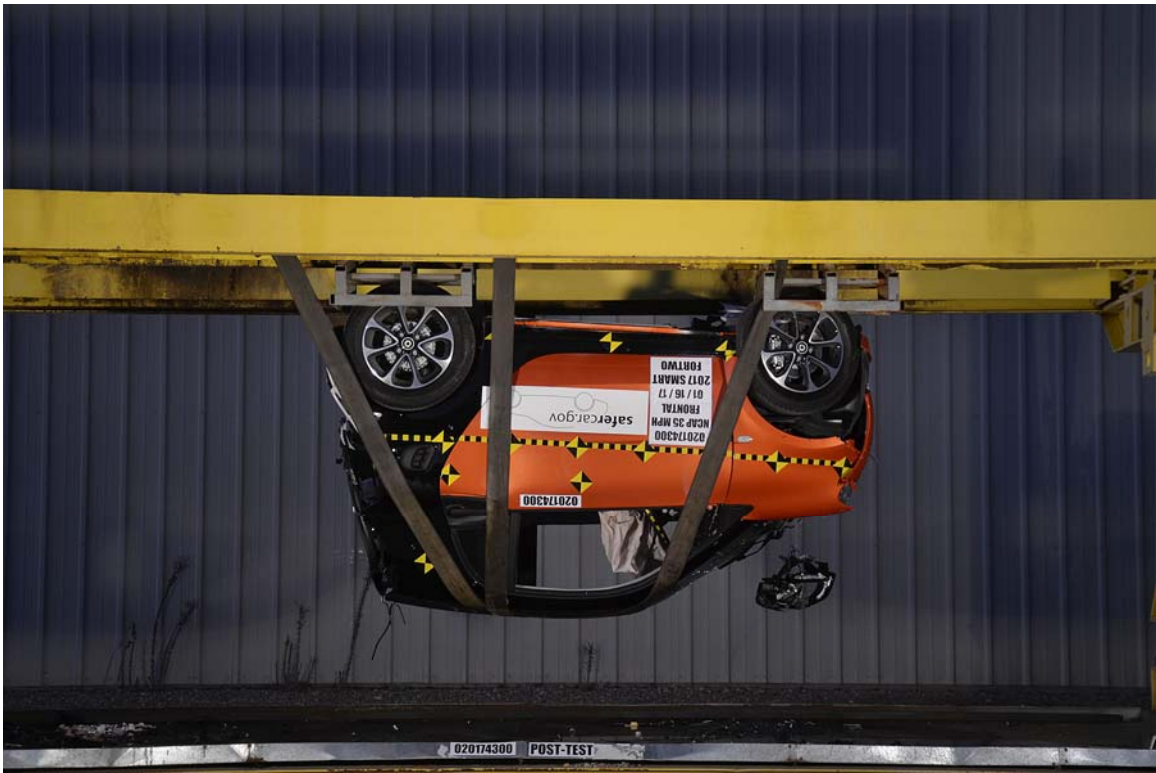
FIGURE 74. Vehicle at 90° on Static Rollover Device

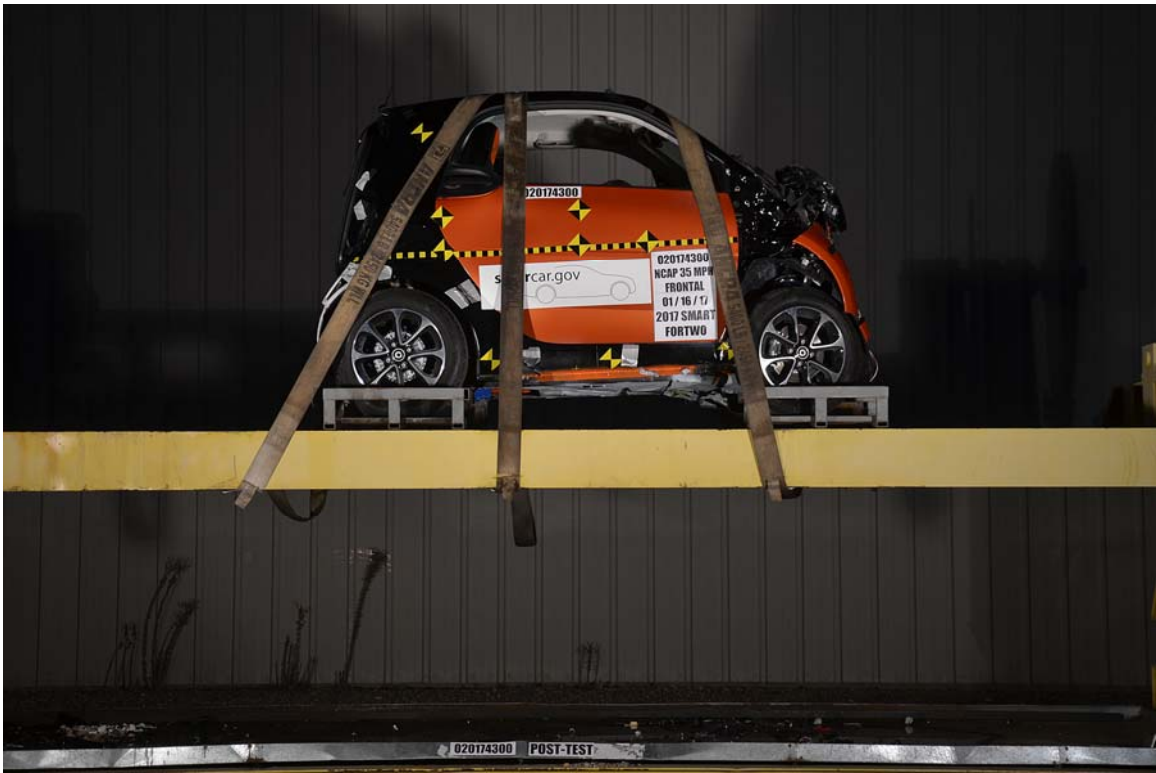
FIGURE 76. Vehicle at 270° on Static Rollover Device
