REPORT NUMBER: NCAP-KAR-17-013

**NEW CAR ASSESSMENT PROGRAM (NCAP)
FRONTAL BARRIER IMPACT TEST**

**NISSAN MOTOR CO LTD
2017 NISSAN FRONTIER CREW CAB 4WD 4-DOOR TRUCK**

FINAL REPORT

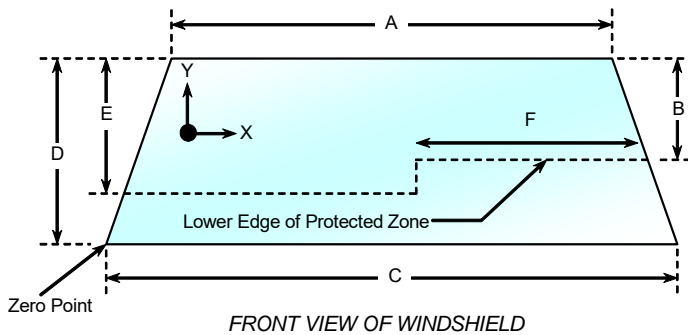
WINDSHIELD PERIPHERY MEASUREMENTS

Measurement	Pre-Test (mm)	Post-Test (mm)	% Retention
Left Side	2191	2191	100.0%
Right Side	2191	2191	100.0%
Total	4382	4382	100.0%

Item	Units	Value
A	mm	1235
B	mm	404
C	mm	1525
D	mm	811
E	mm	485
F	mm	500

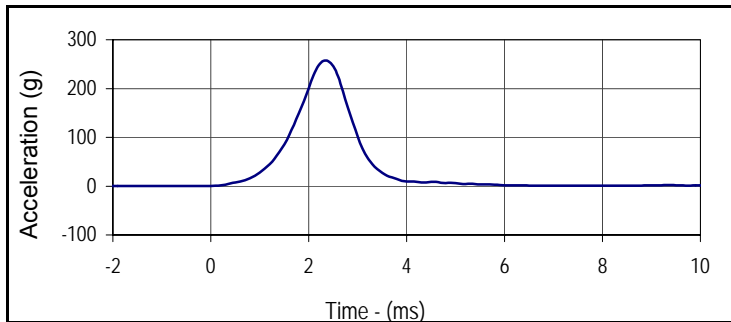
Curve Description			
Head Resultant			
Plot No.	Type	SAE Class	Units
001	RES	1000	g
Max	Time	Min	Time
257.0	2.3	0.1	58.1

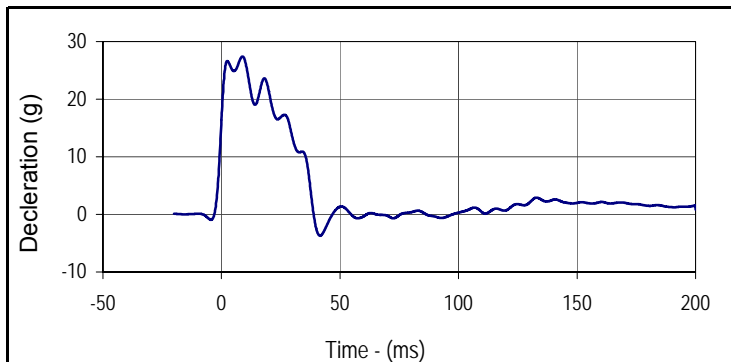
Curve Description			
Pendulum Deceleration			
Plot No.	Type	SAE Class	Units
001	FIL	60	g
Max	Time	Min	Time
27.4	8.9	-3.7	41.6

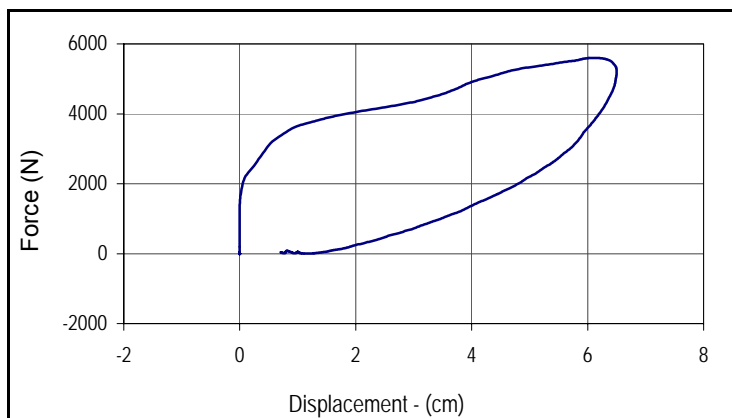
Curve Description			
Probe Force vs. Chest Deflection			
Plot No.	Type	SAE Class	Hysteresis
001	FIL	600	71.6
Peak Probe Force		Peak Chest Deflection	
5598		6.50

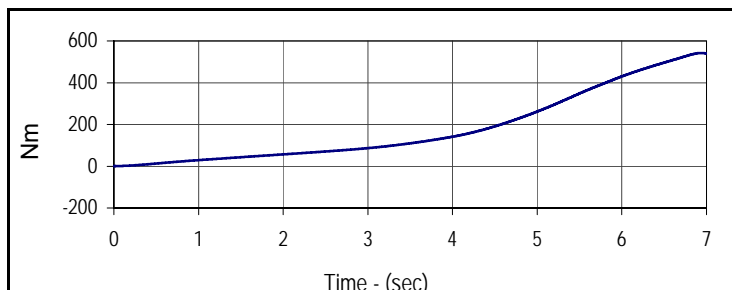
Curve Description			
Right Femur Torque			
Plot No.	Type	SAE Class	Units
004	FIL	600	Nm
Max	Time	Min	Time
542.3	6.9	0.4	0.0

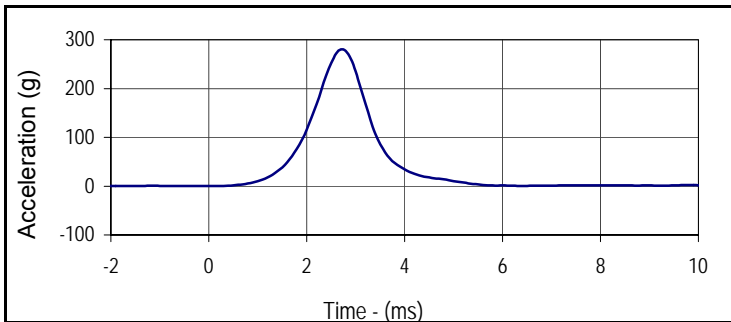
Curve Description			
Head Resultant			
Plot No.	Type	SAE Class	Units
001	RES	1000	g
Max	Time	Min	Time
280.6	2.7	0.2	147.6

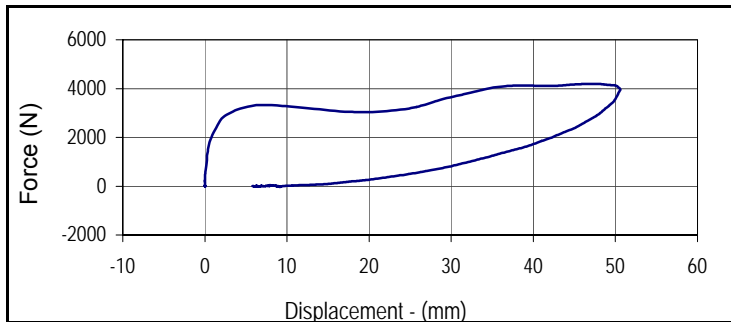
Curve Description			
Probe Force vs. Chest Deflection			
Plot No.	Type	SAE Class	Hysteresis
001	FIL	180	74.1
Peak Probe Force		Peak Chest Deflection	
4188.6		50.6

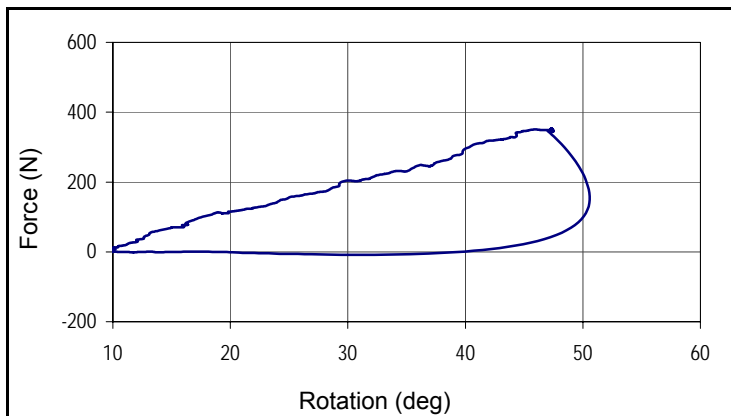
Curve Description		
Force vs Torso Rotation		
Plot No.	Type	Filter Freq
001	FIL	1 Hz
Peak Force		Peak Rotation
353.1		50.6

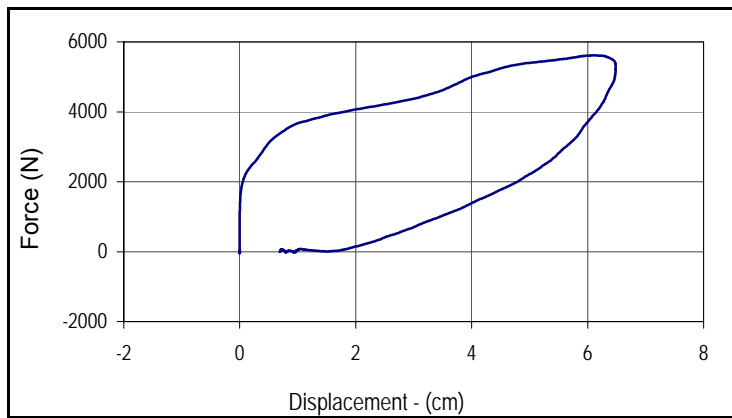
Curve Description			
Probe Force vs. Chest Deflection			
Plot No.	Type	SAE Class	Hysteresis
001	FIL	600	71.9
Peak Probe Force		Peak Chest Deflection	
5612		6.48

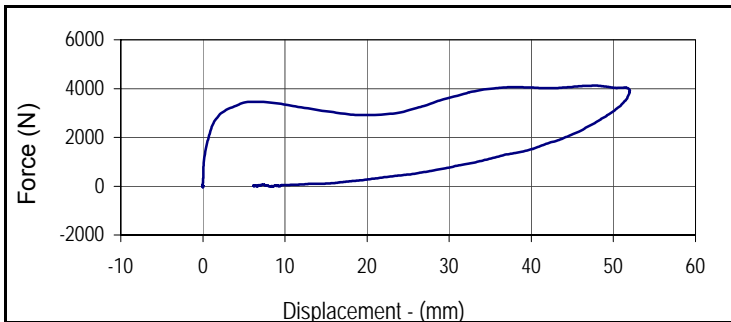
Curve Description			
Probe Force vs. Chest Deflection			
Plot No.	Type	SAE Class	Hysteresis
001	FIL	180	74.5
Peak Probe Force		Peak Chest Deflection	
4121.8		52.0

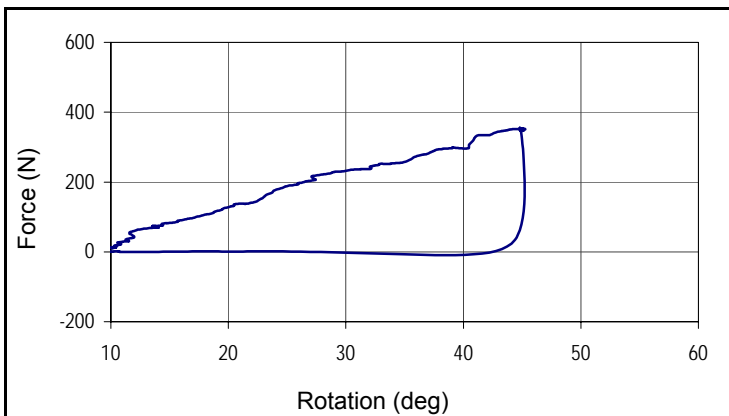
Curve Description		
Force vs Torso Rotation		
Plot No.	Type	Filter Freq
001	FIL	1 Hz
Peak Force		Peak Rotation
354.9		45.3
