**REPORT NUMBER: SINCAP-CAL-17-011**

**NEW CAR ASSESSMENT PROGRAM (NCAP)  
MOVING DEFORMABLE BARRIER SIDE IMPACT TEST**

**Mazda Motor Corporation  
2017 Mazda CX-5  
4 Door SUV**

**NHTSA No: M20175402**

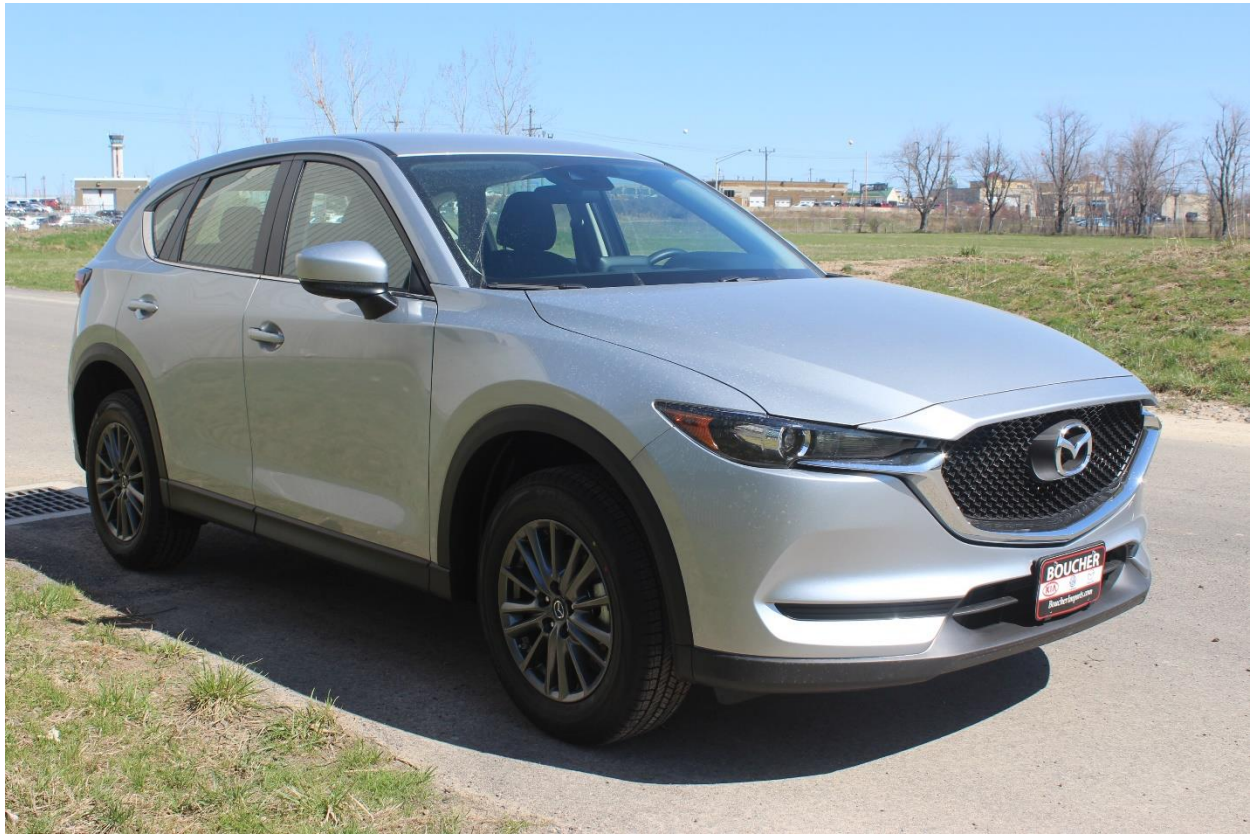
**Figure A-1: As-Delivered Right Front 3/4 View of Test Vehicle**

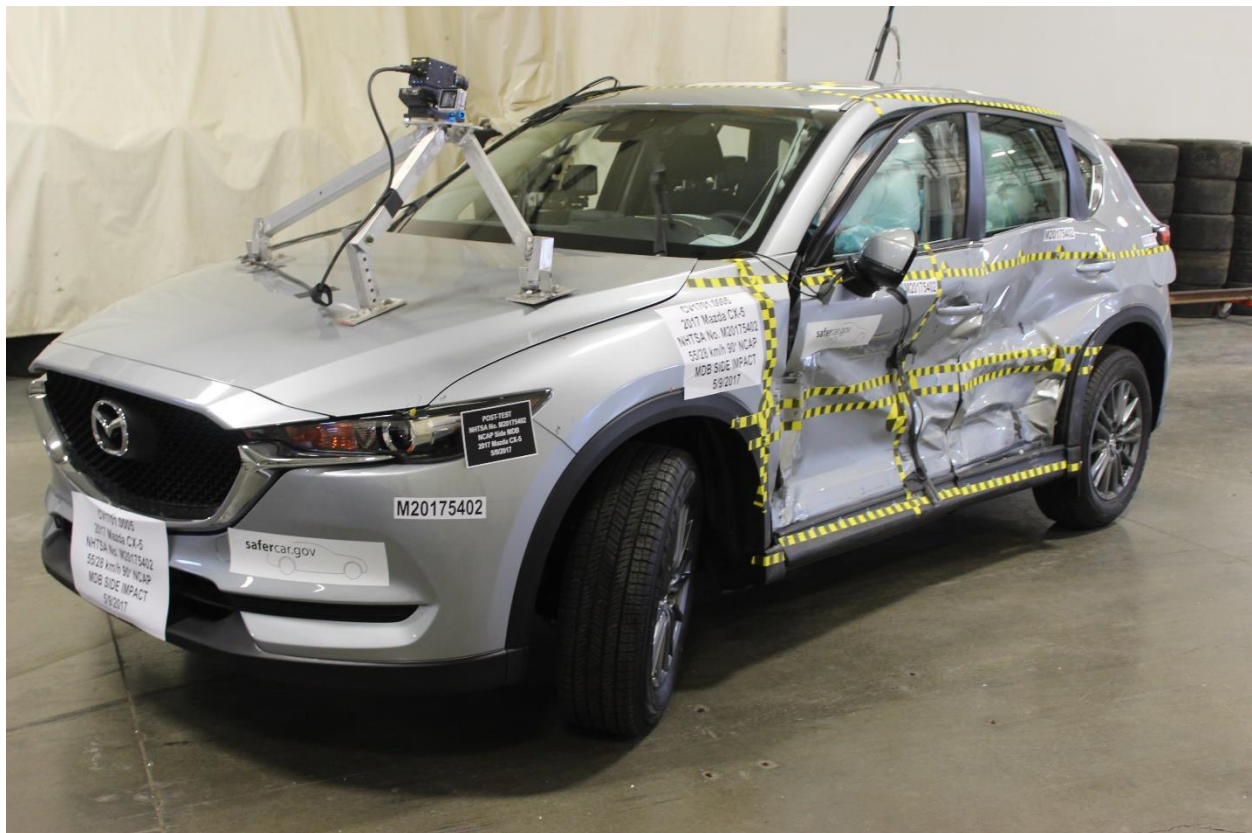
**Figure A-6: Post-Test Left Front  $\frac{3}{4}$  View of Test Vehicle**

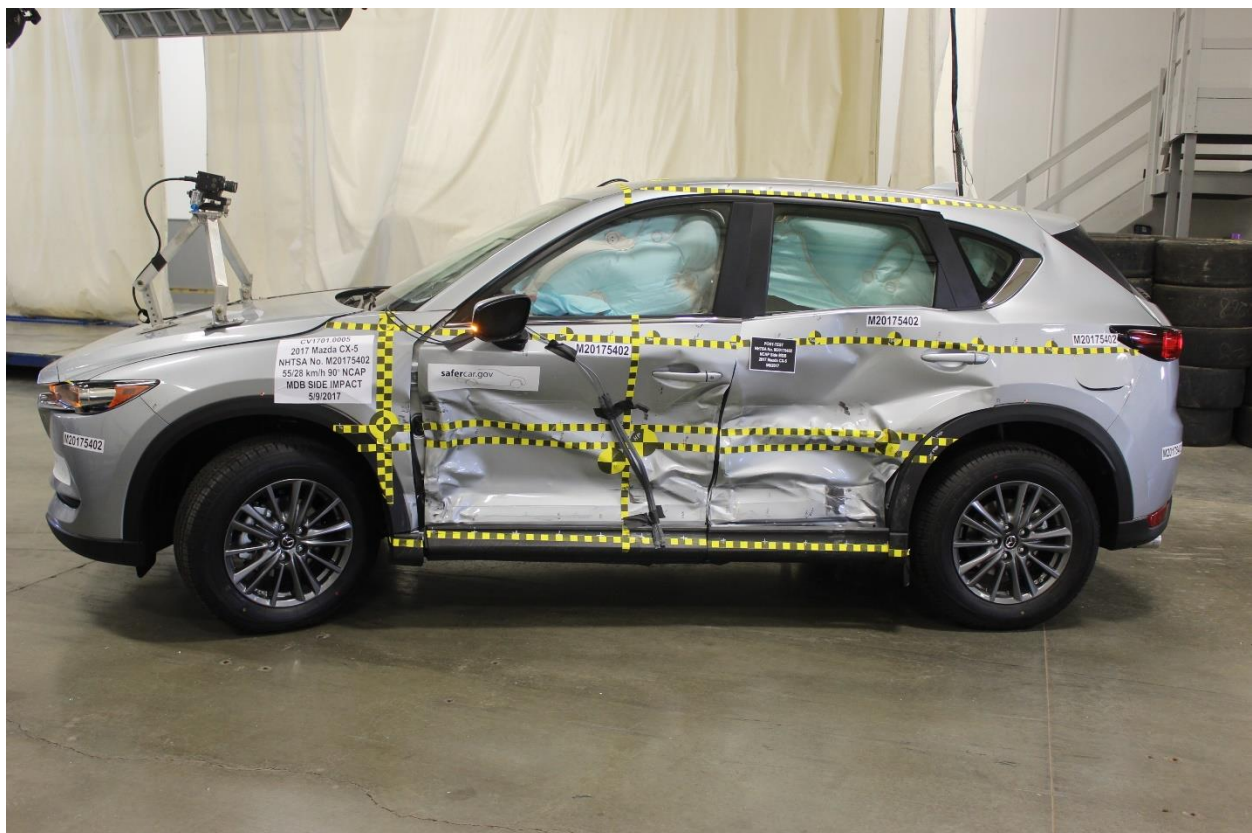
**Figure A-8: Post-Test Left Side View of Test Vehicle**

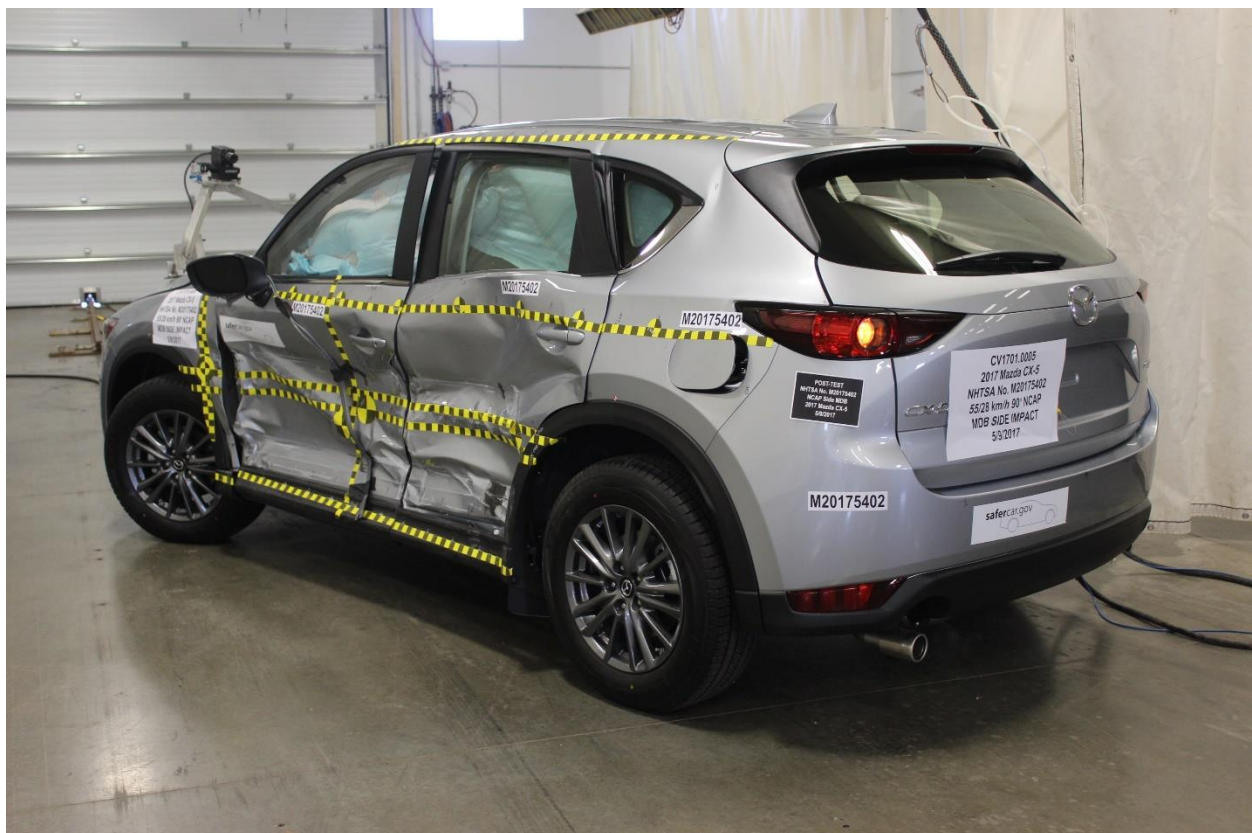
**Figure A-10: Post-Test Left Rear  $\frac{3}{4}$  View of Test Vehicle**

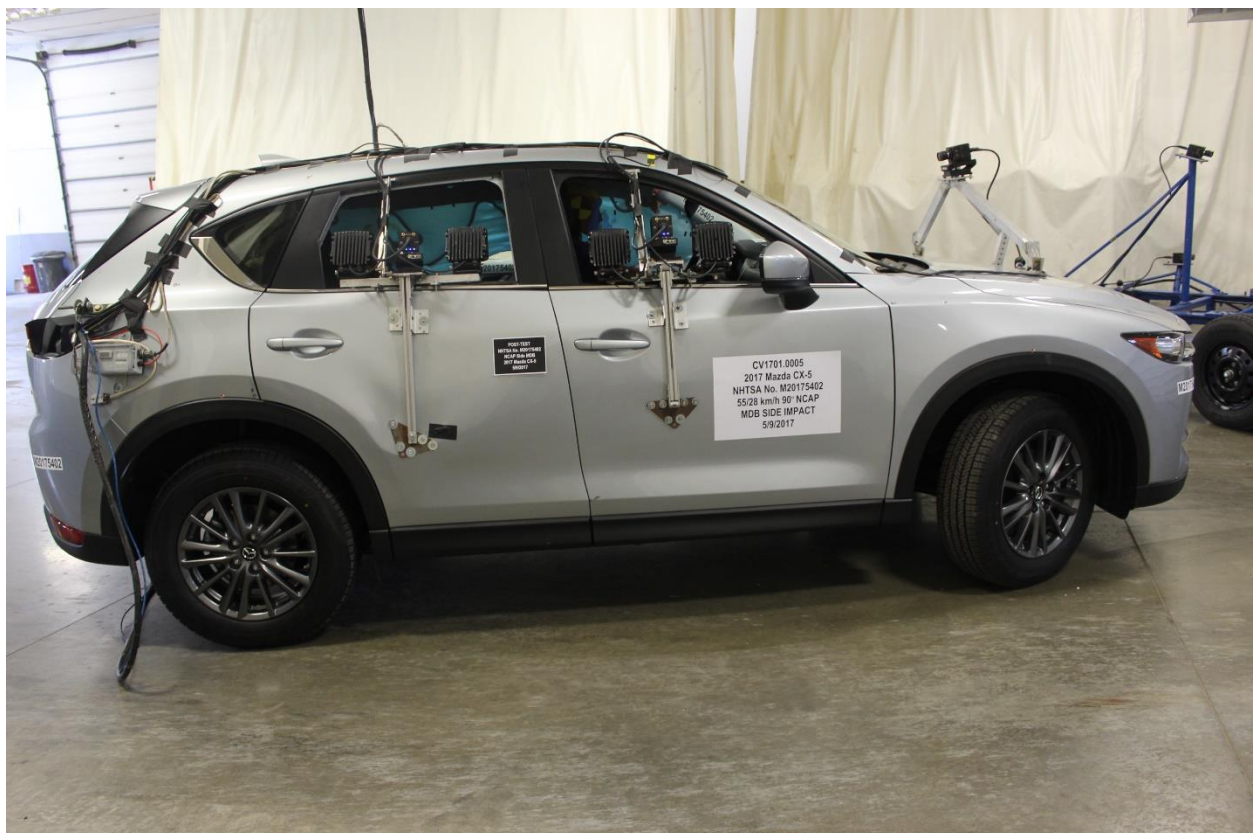
**Figure A-14: Post-Test Right Side View of Test Vehicle**

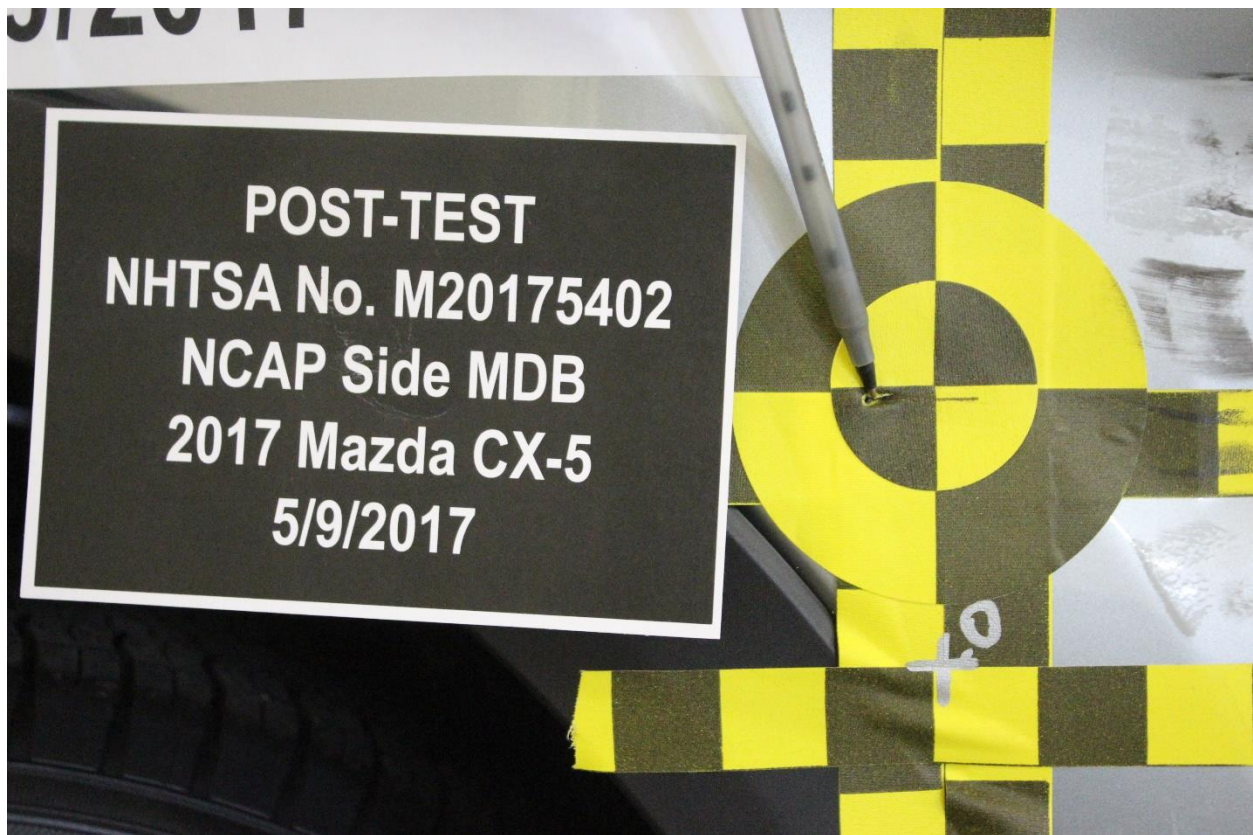
Figure A-20: Post-Test Close-up View of Impact Point Target

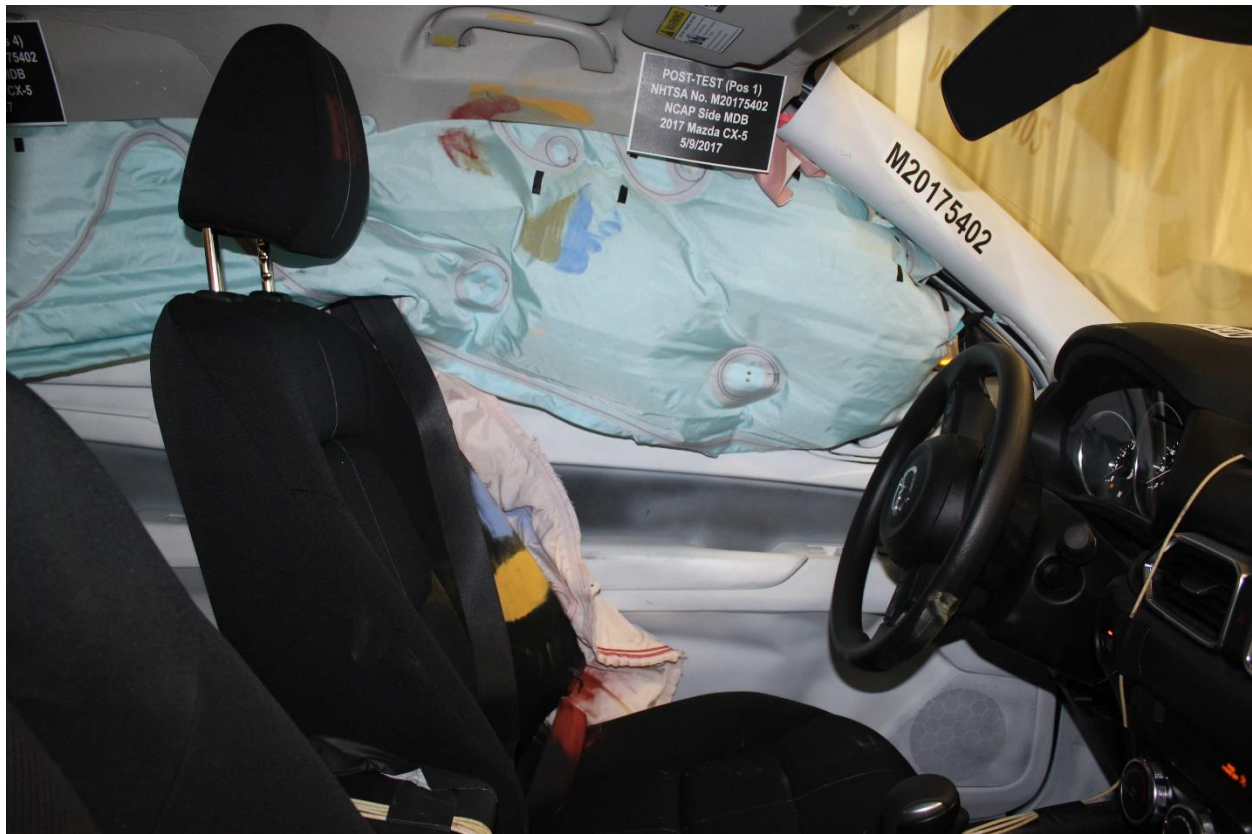
**Figure A-47: Post-Test Driver Inner Door Panel View**

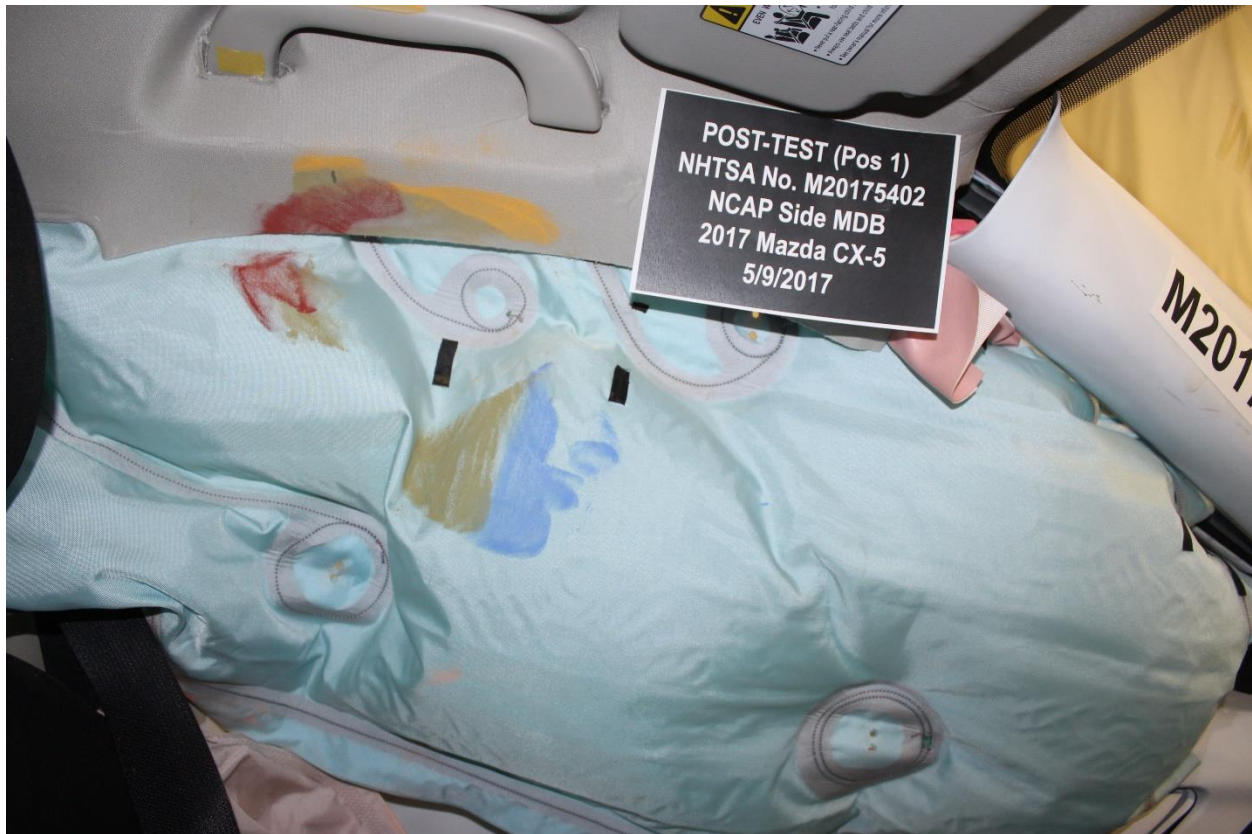
**Figure A-49: Post-Test Driver Dummy Close-Up Head Contact with Side Airbag View**

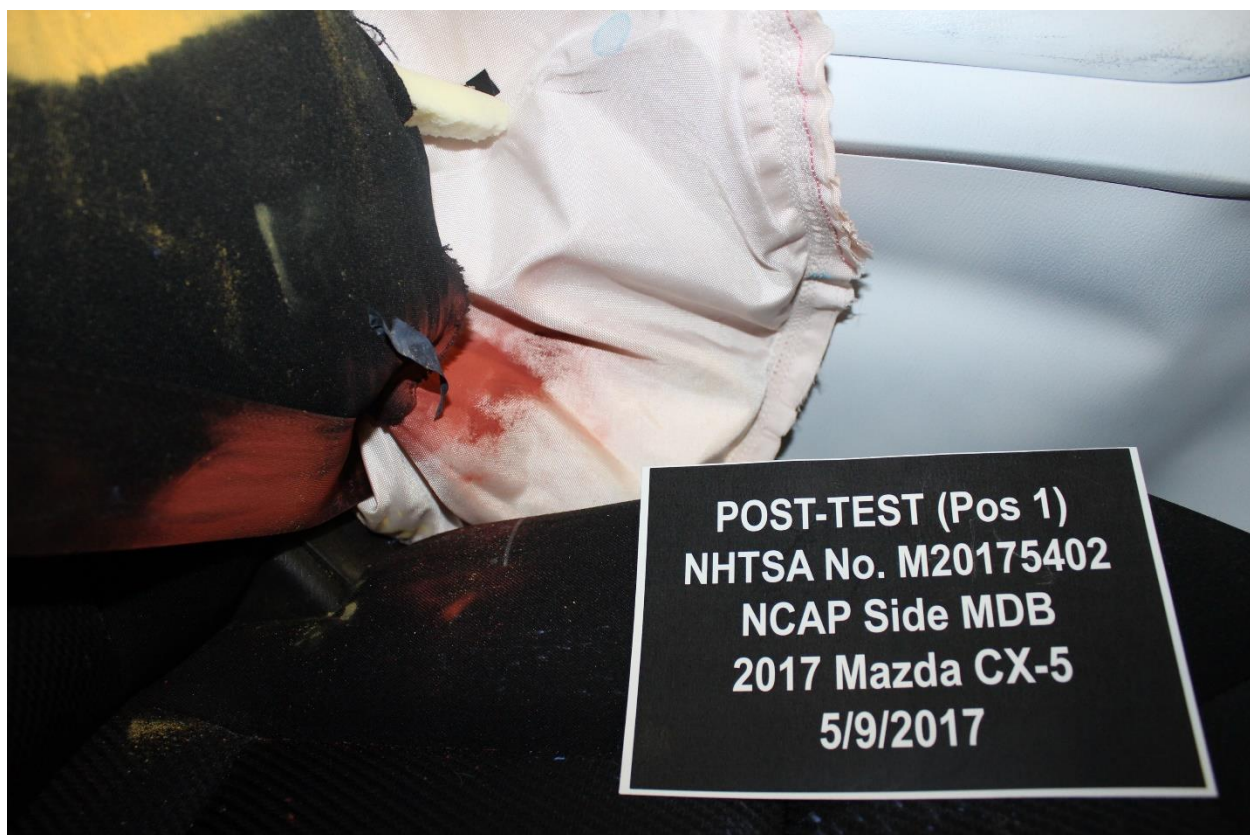
**Figure A-52: Post-Test Driver Dummy Close-Up Pelvis Contact View**

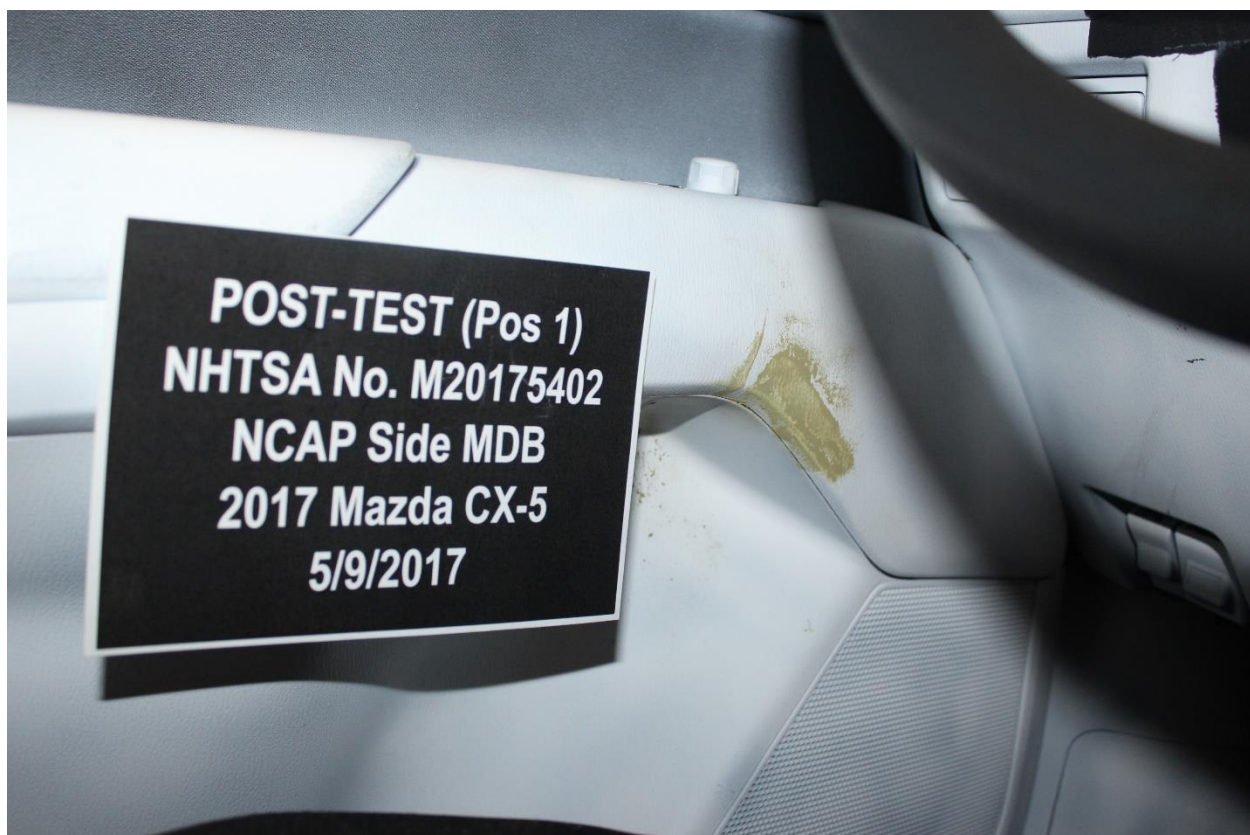
**Figure A-54: Post-Test Driver Dummy Close-Up Knee Contact View**

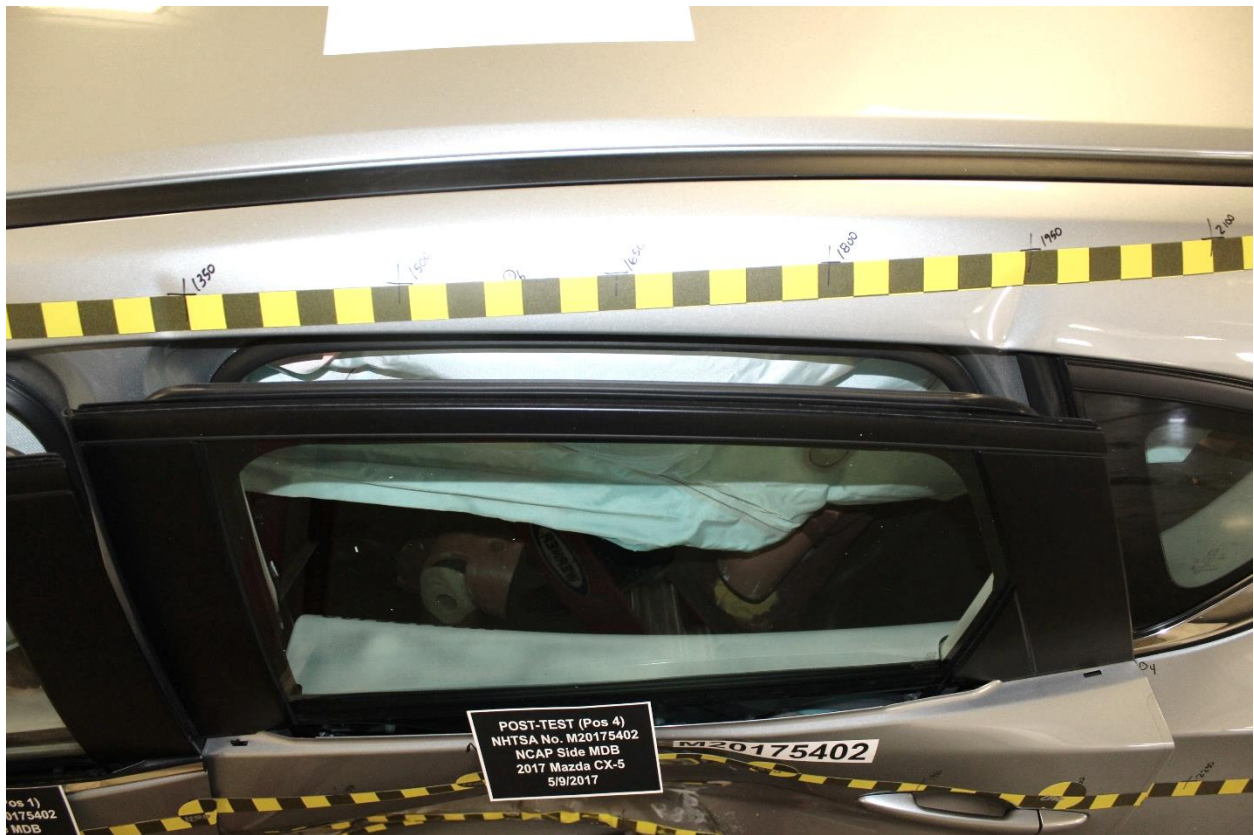
**Figure A-70: Post-Test Passenger Dummy and Door Clearance View**

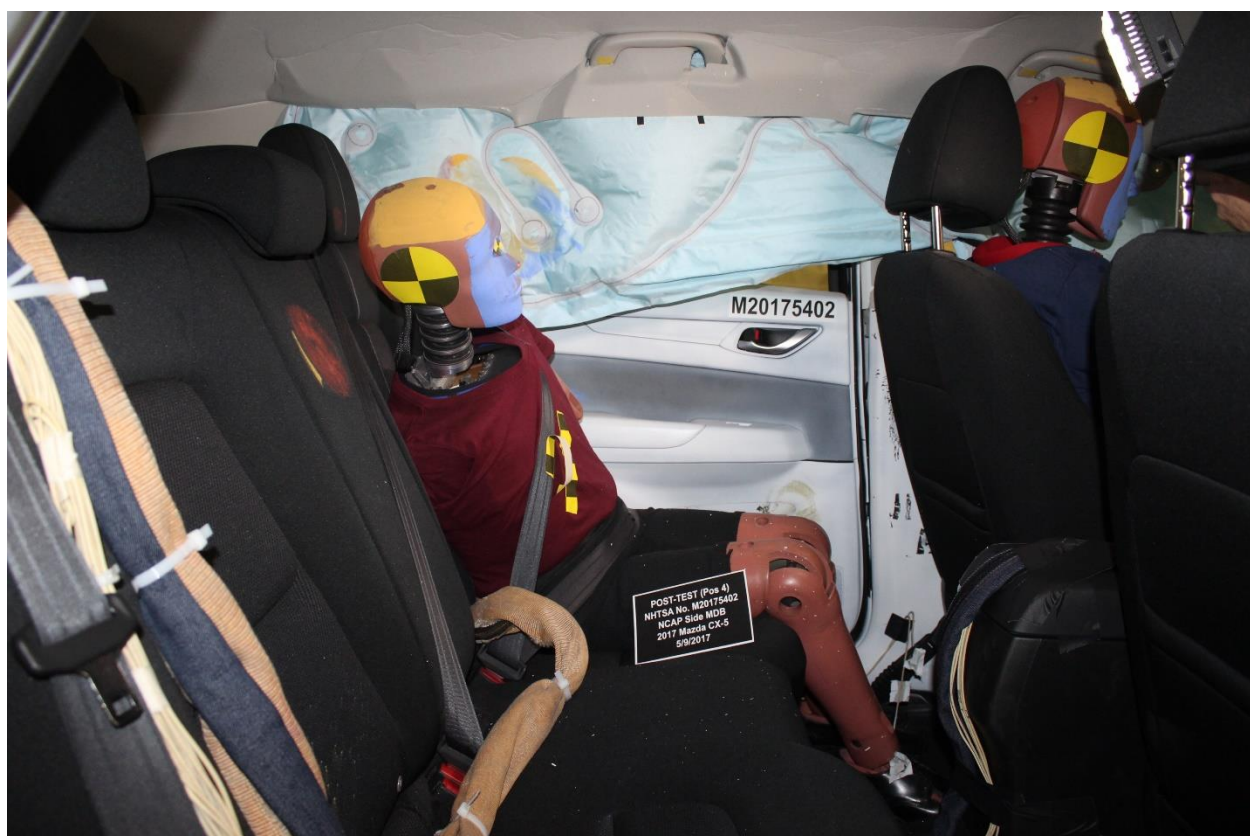
**Figure A-72: Post-Test Right Side View of Rear Passenger Dummy and Rear Seat Occupant Compartment**

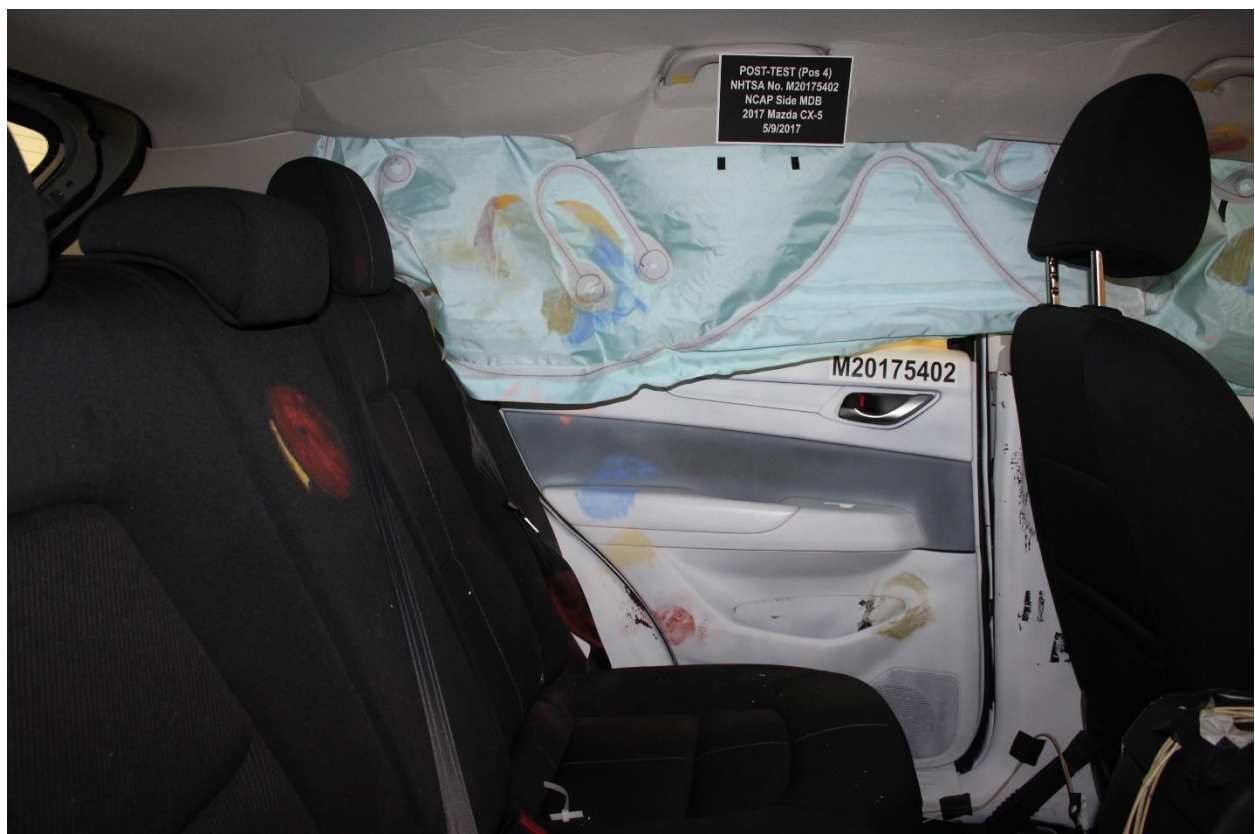
**Figure A-74: Post-Test Passenger Inner Door Panel View**

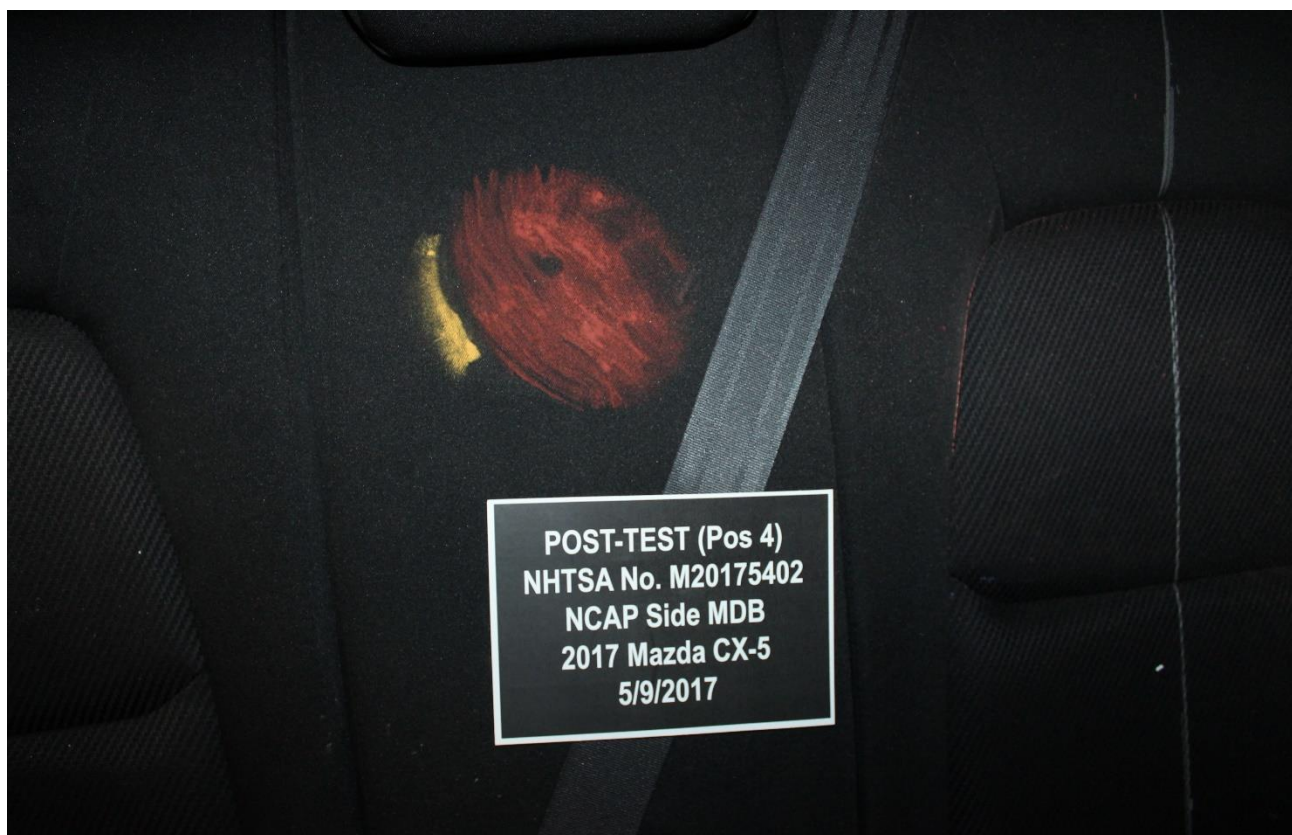
**Figure A-75: Post-Test Rear Passenger Dummy Close-Up Head Contact with Vehicle View**

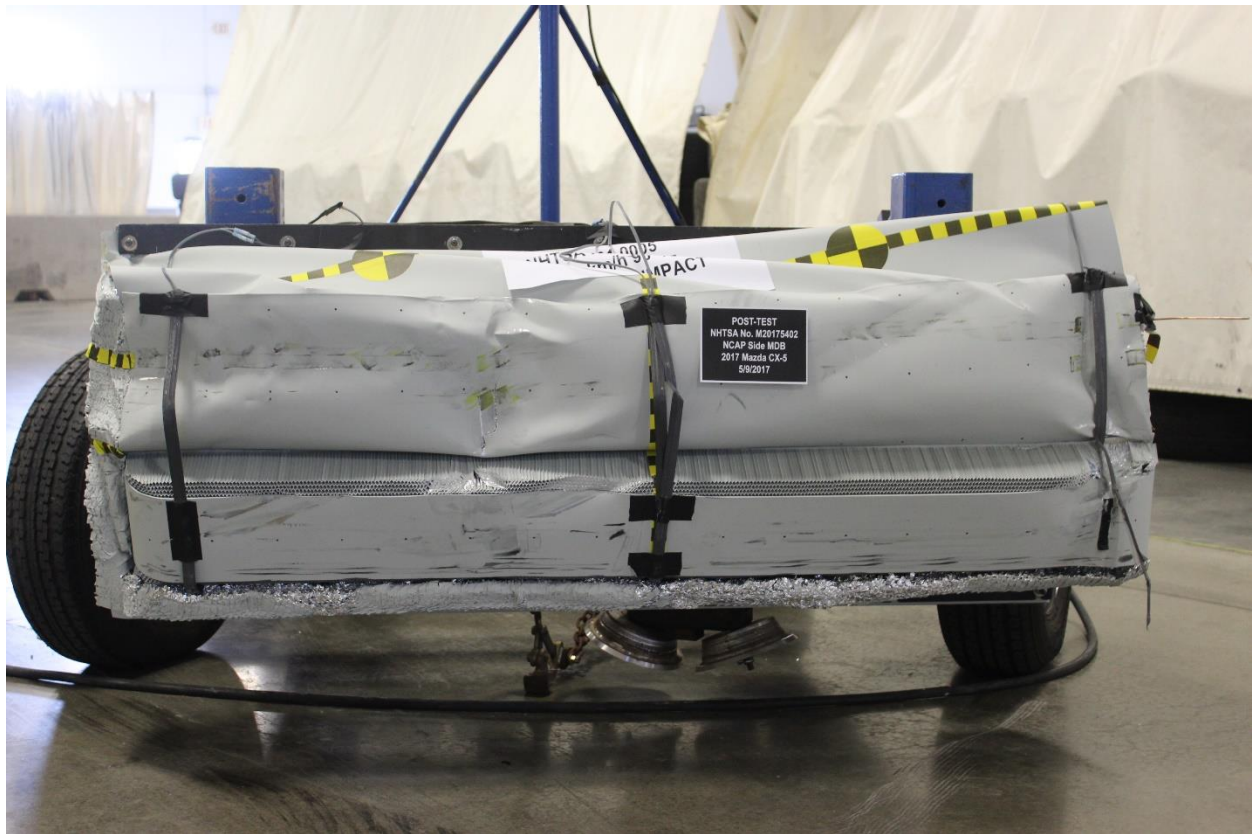
**Figure A-85: Post-Test Front View of MDB Impactor Face**

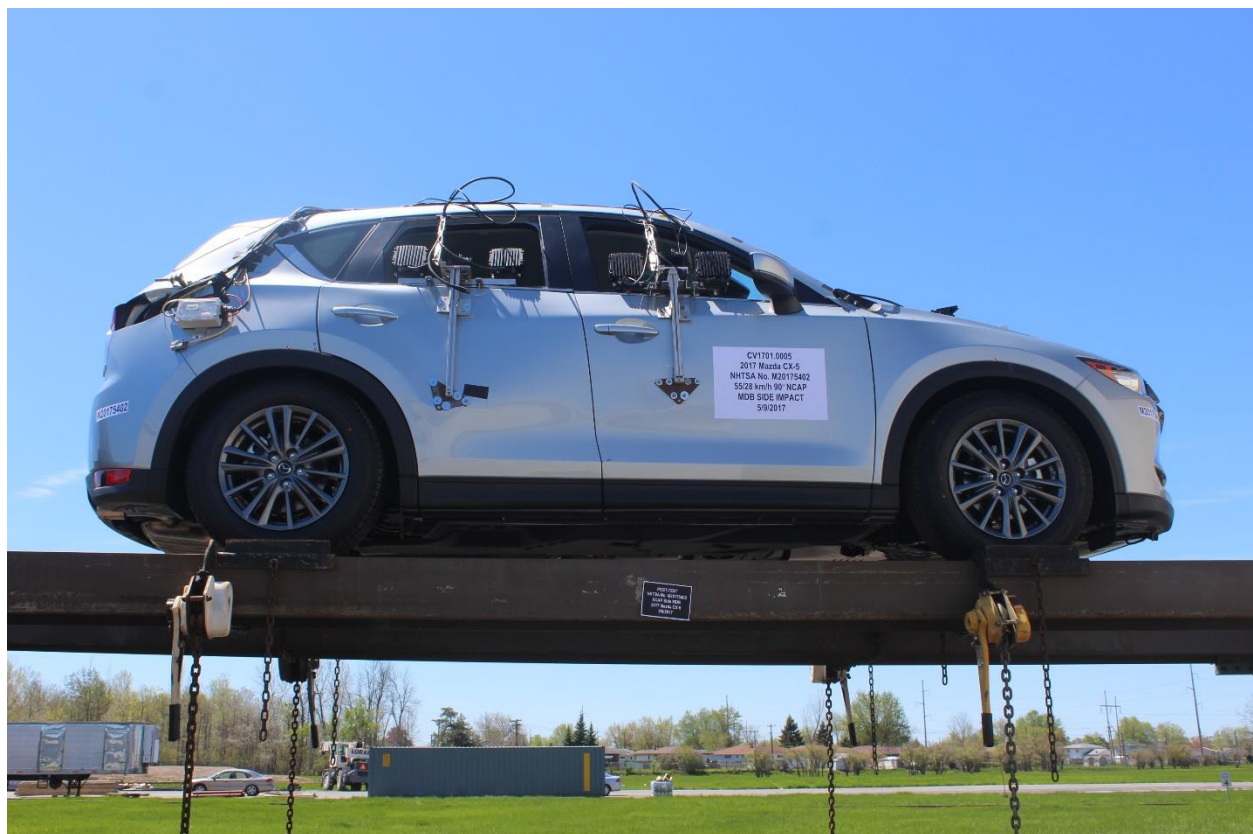
**Figure A-96: FMVSS No. 301 Static Rollover 0 Degrees**

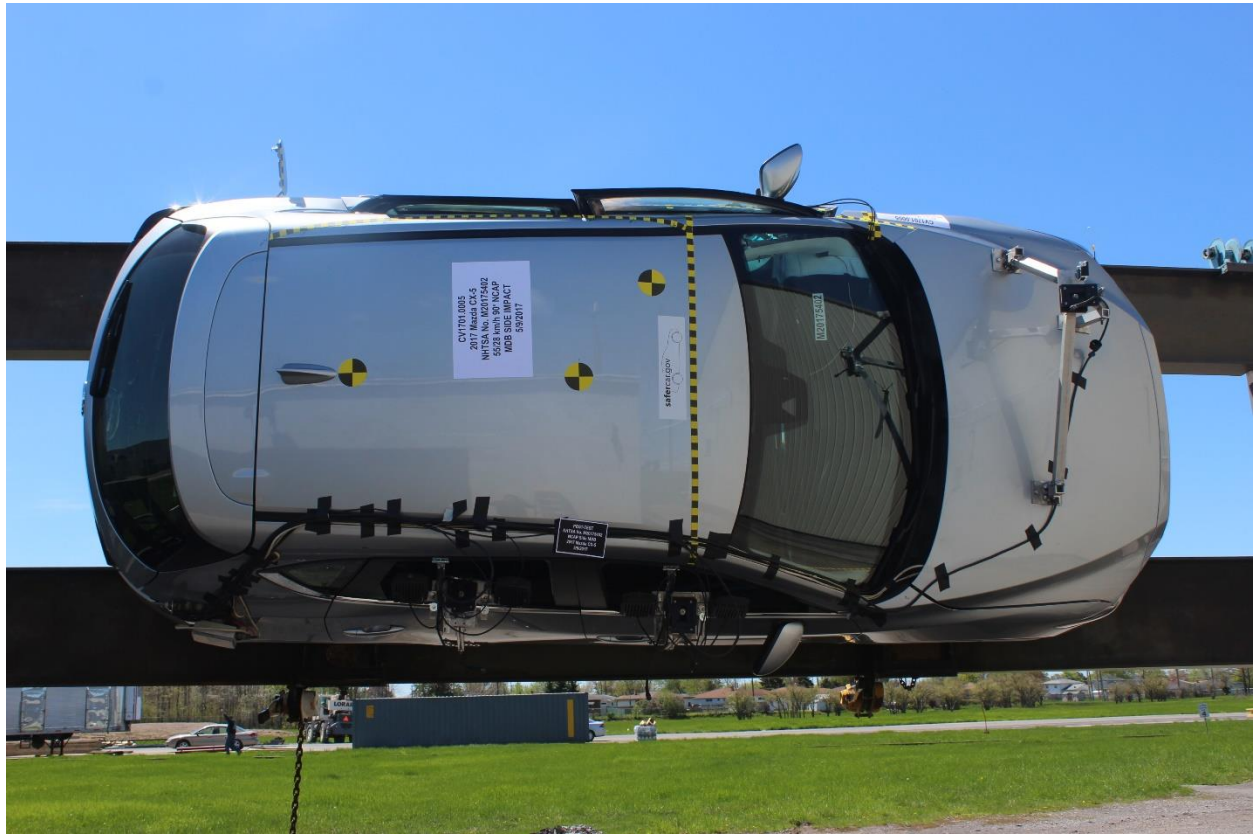
**Figure A-99: FMVSS No. 301 Static Rollover 270 Degrees**

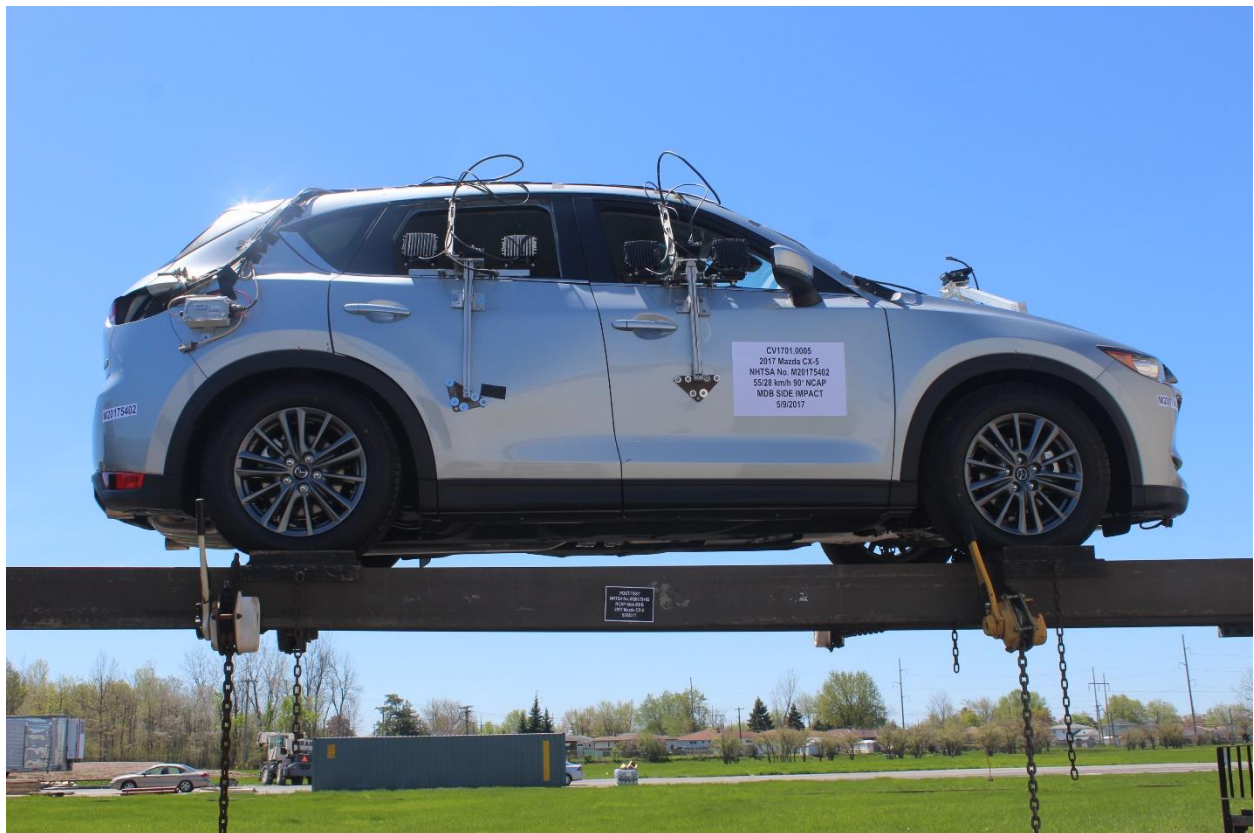
**Figure A-100: FMVSS No. 301 Static Rollover 360 Degrees**
