**REPORT NUMBER: 301R-CAL-17-002**

**SAFETY COMPLIANCE TESTING FOR FMVSS 301R  
FUEL SYSTEM INTEGRITY – REAR IMPACT**

**Mitsubishi Motors  
2017 Mitsubishi Mirage G4**

**FINAL REPORT**

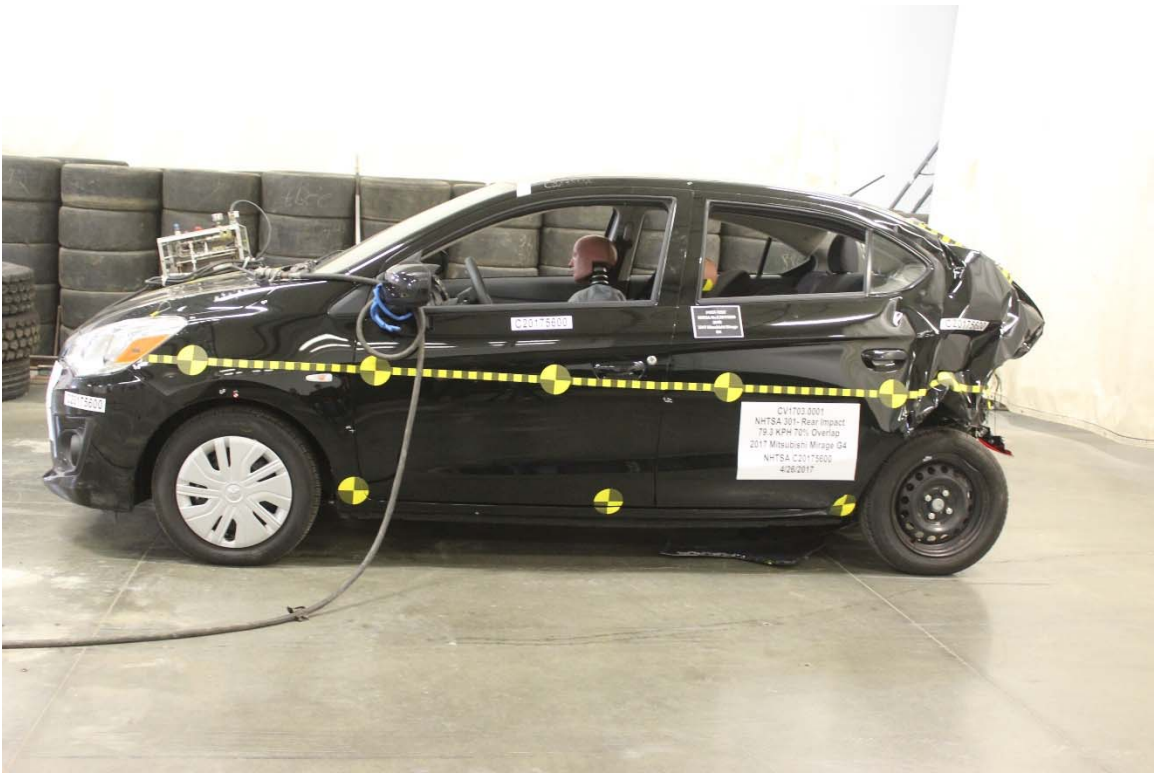
**Figure A-6: Post-Test Left Side View**

Measurement	Left Side	Centerline	Right Side
Pre-Test	4202	4304	4198
Post-Test	3605	3694	3748
Crush	597	610	450

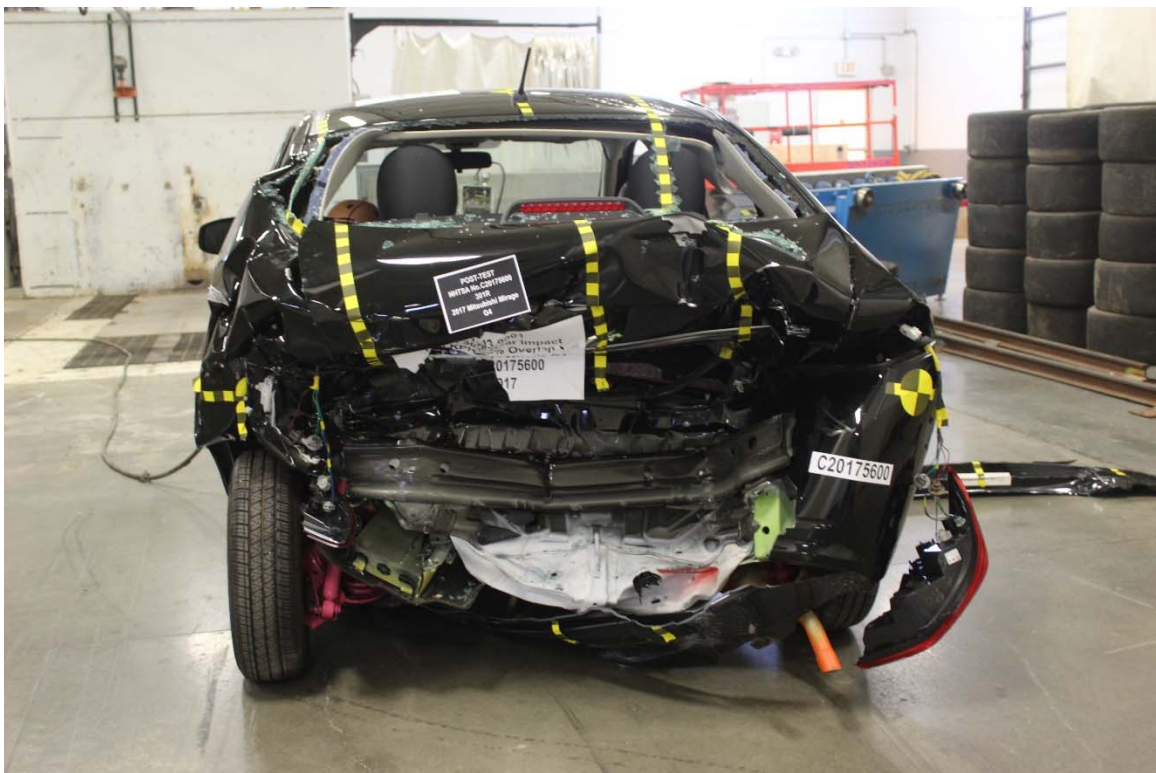
**Figure A-18: Post-Test Rear View**

Critical Areas of Performance	Observations and Conclusions
Windshield Damage	None
Window Damage	None
Other Notable Effects	Rear Windshield Shattered

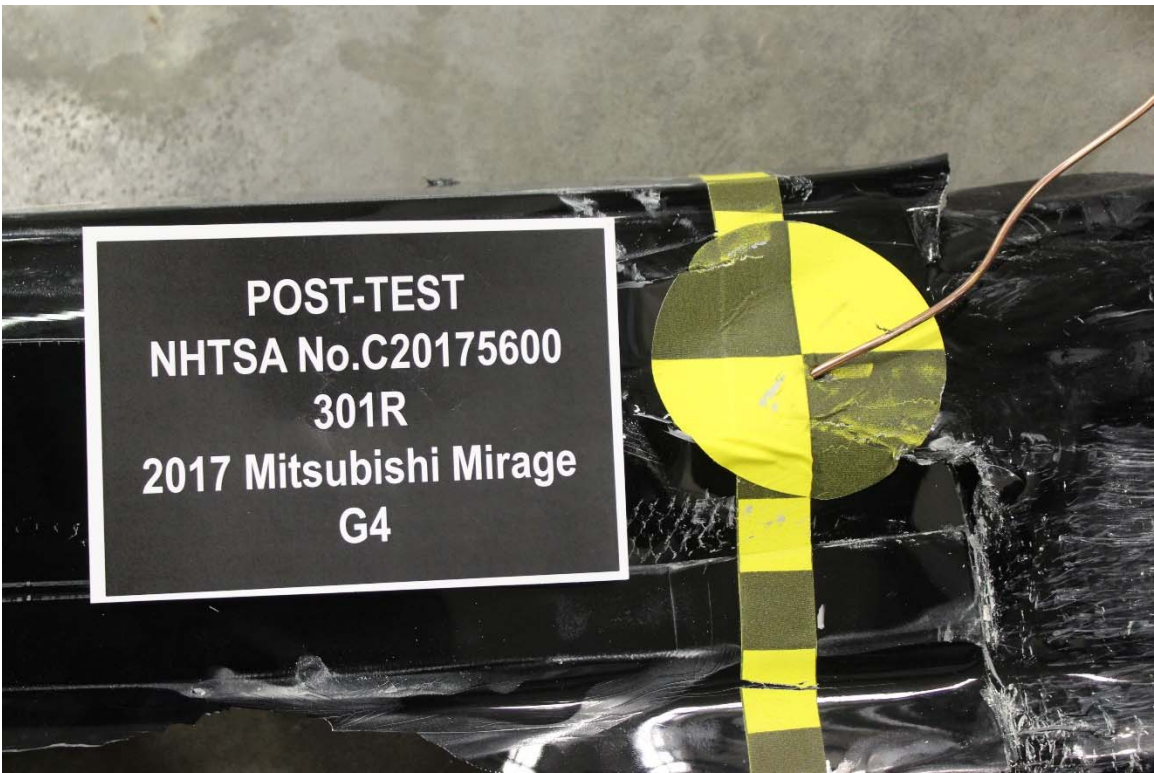
**Figure A-28: Post-Test Impact Target View**

Measurement Description	Tolerance	Units	Value
Vertical distance from target center (+ is above)	±40 mm	mm	-7
Horizontal distance from target center (+ is right)	±50 mm	mm	+3

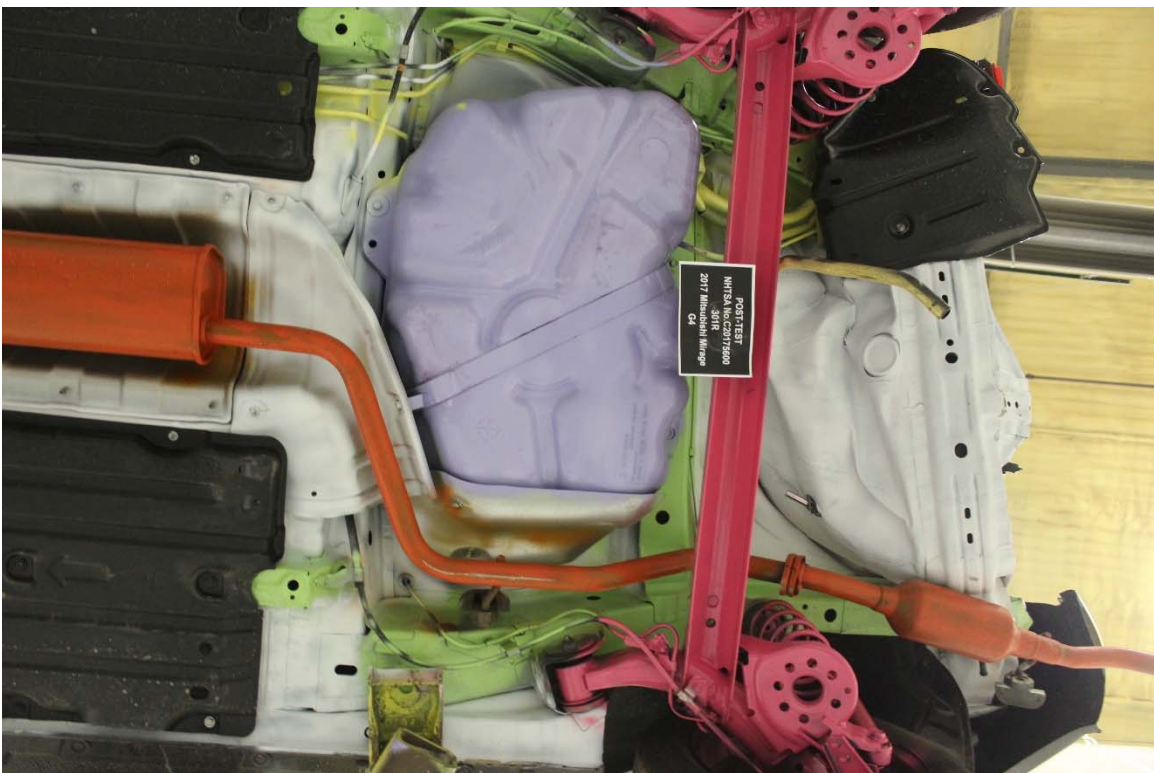
**Figure A-34: Post-Test Rear Underbody View**

D. Spillage Details: No Spillage Occurred
