REPORT NUMBER: SPNCAP-MGA-2018-002

**NEW CAR ASSESSMENT PROGRAM (NCAP)
Side Impact Pole Test**

**HONDA MFG. OF ALABAMA, LLC
2018 Honda Odyssey EX Minivan
NHTSA No.: O20185301**

**MGA RESEARCH CORPORATION
5000 Warren Road
Burlington, WI 53105**

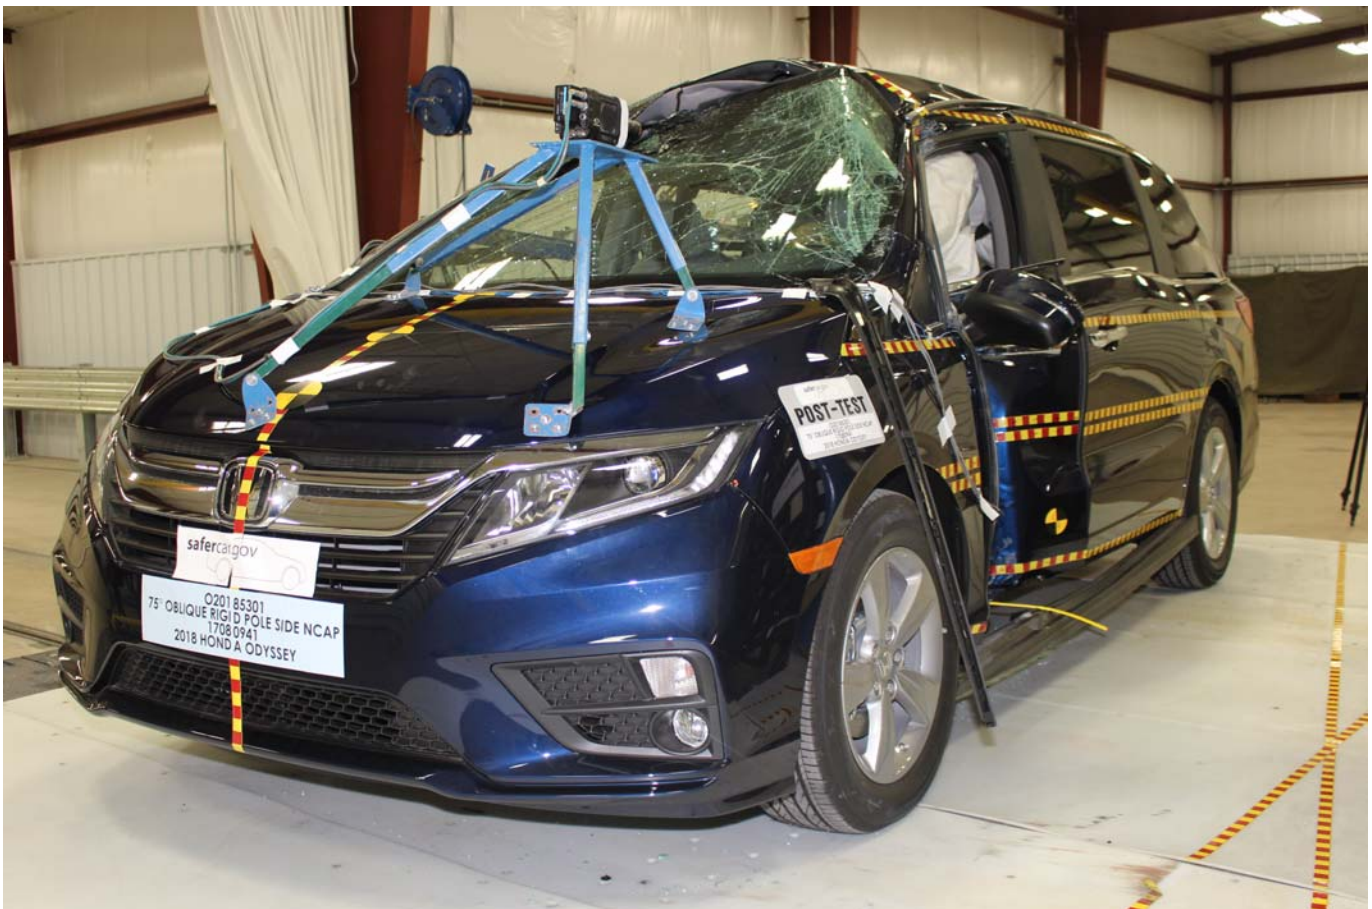
Photo No. 006 - Post-Test Left Front Three-Quarter View of Test Vehicle

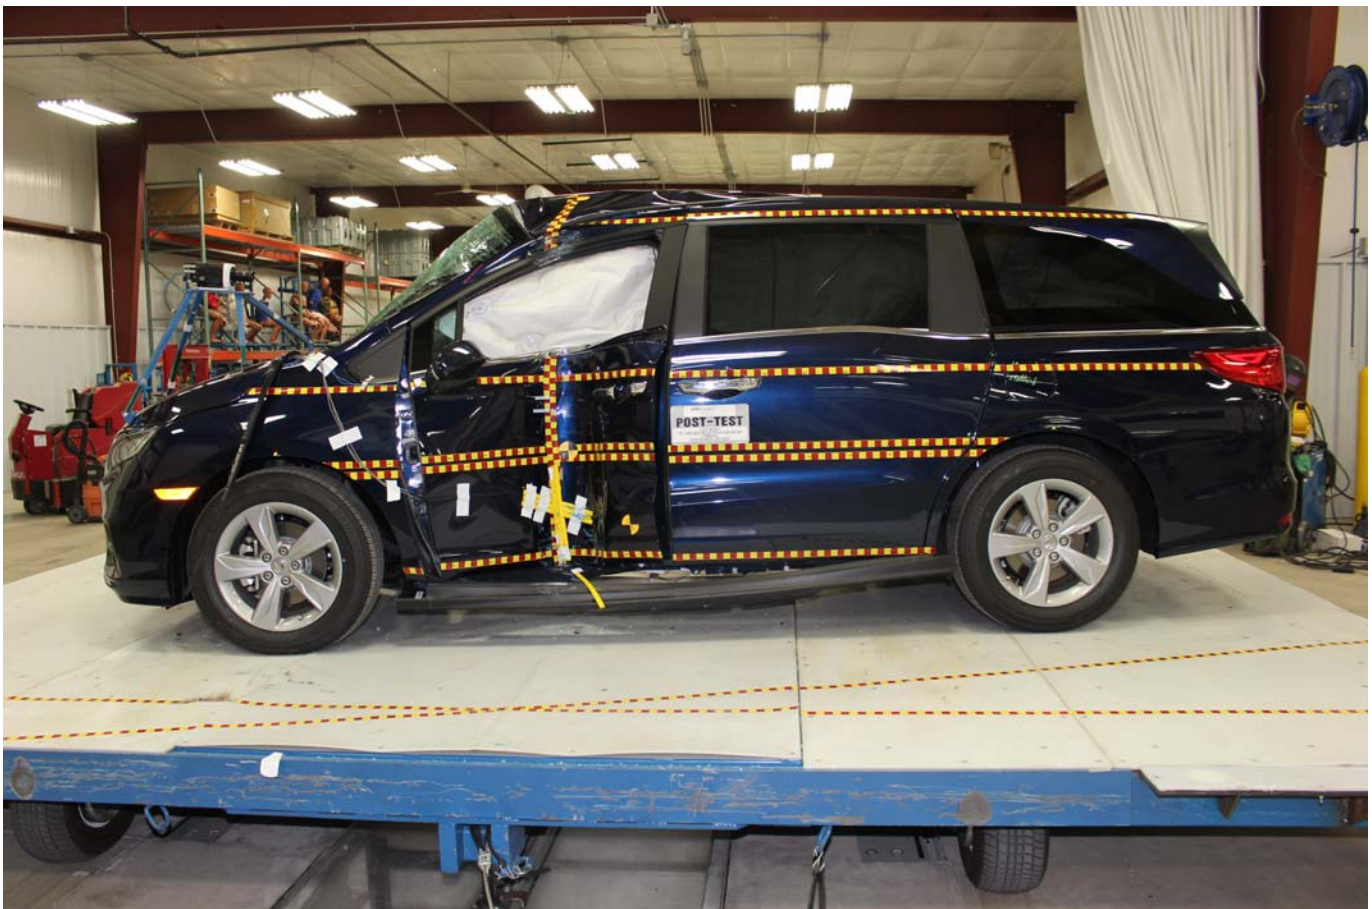
Photo No. 008 - Post-Test Left Side View of Test Vehicle

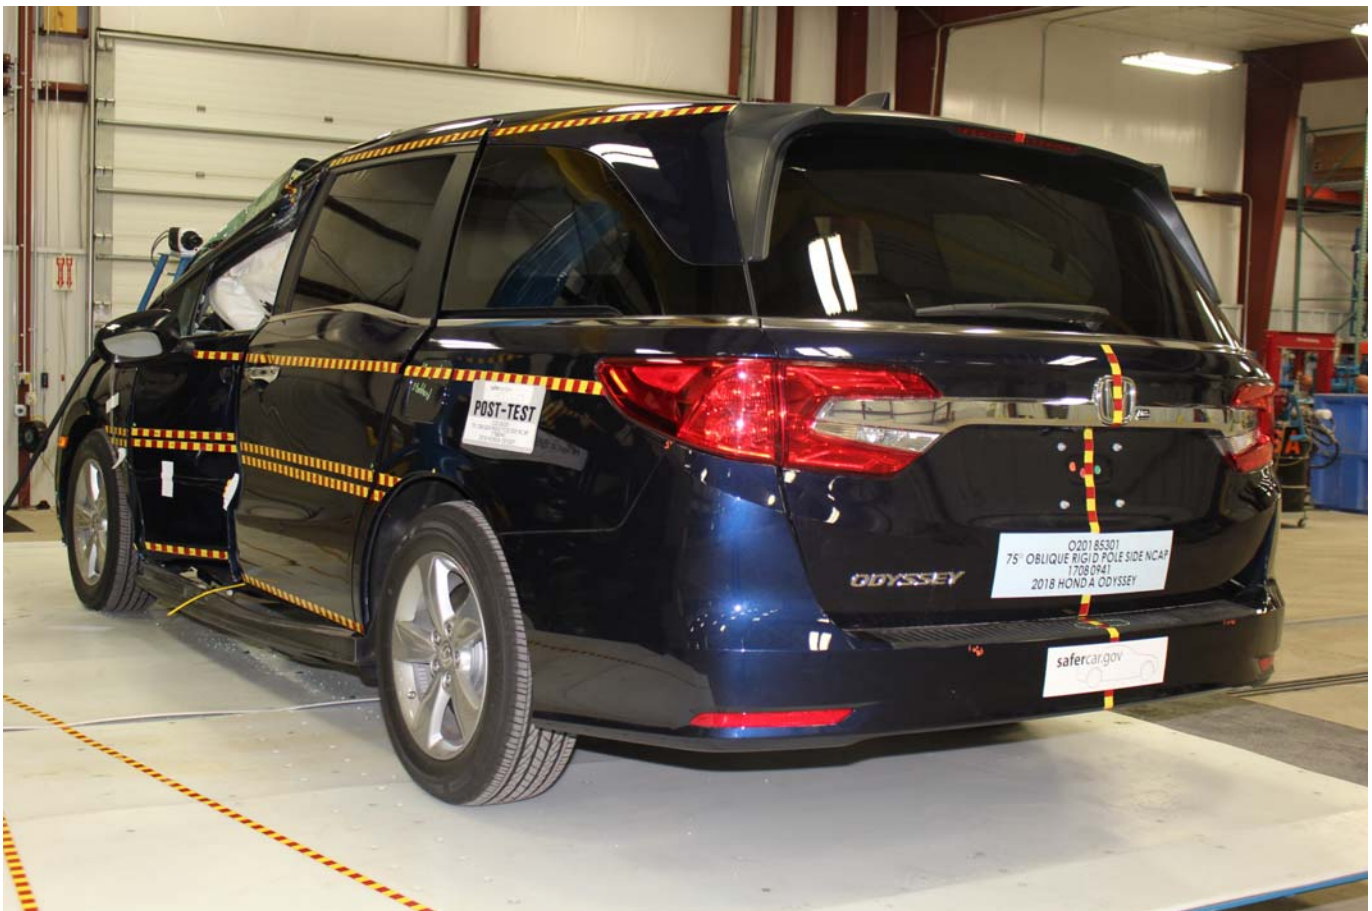
Photo No. 010 - Post-Test Left Rear Three-Quarter View of Test Vehicle

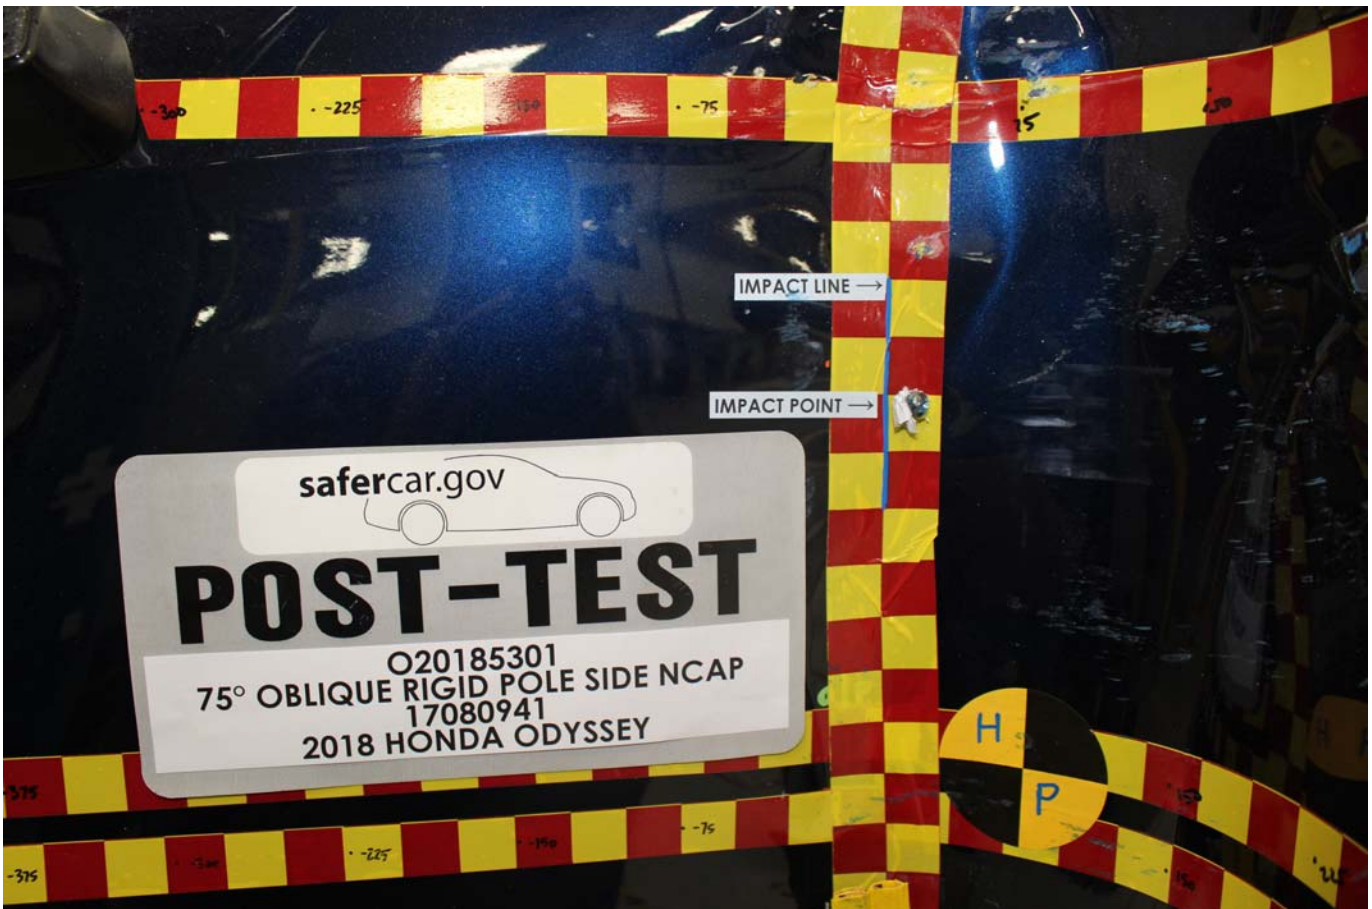
Photo No. 020 - Post-Test Close-Up View of Impact Point Target Showing Impact Location

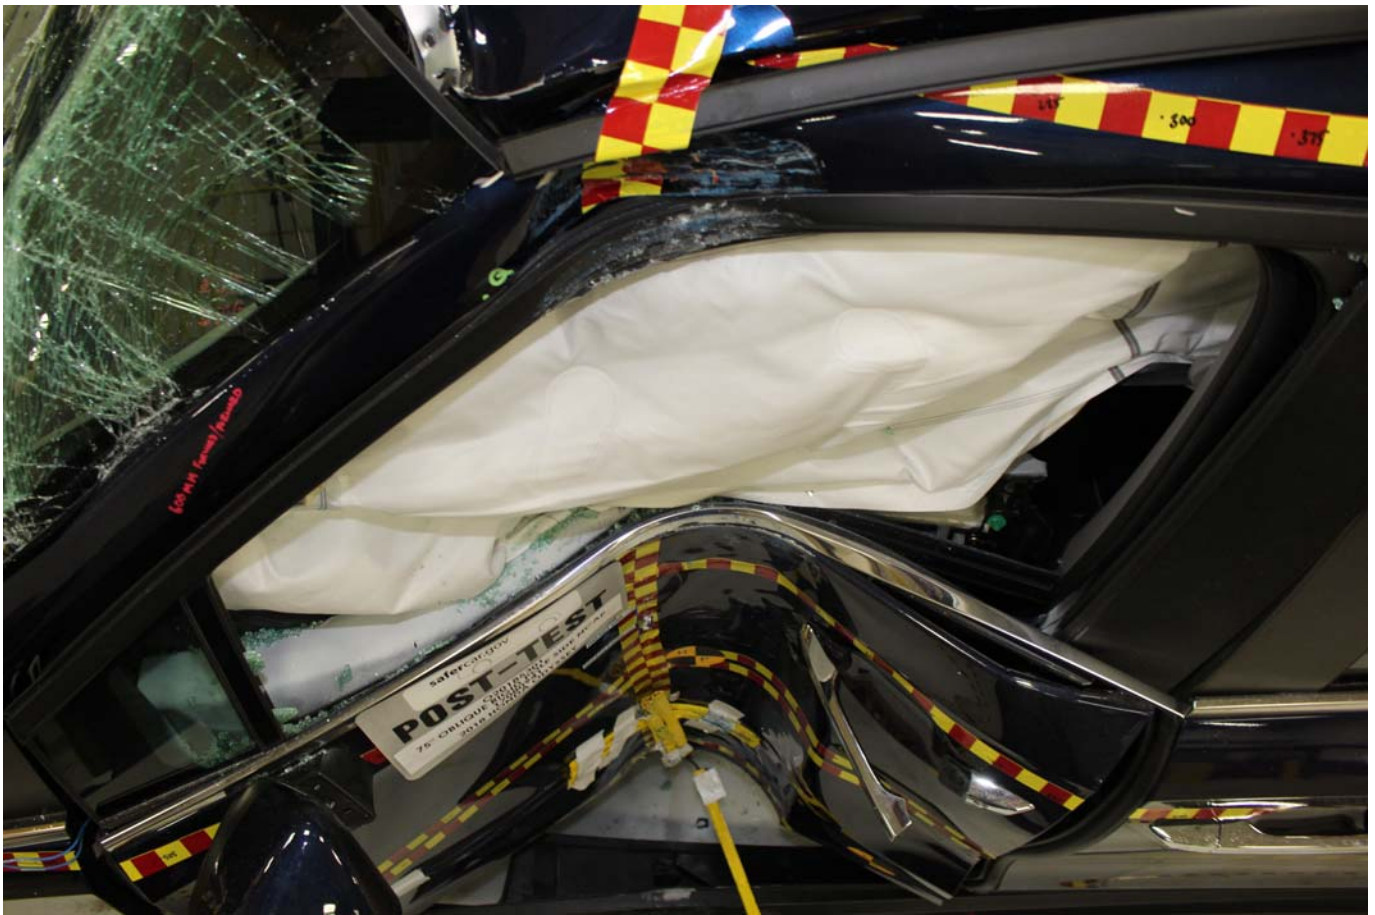
Photo No. 041 - Post-Test Dummy and Door Clearance View

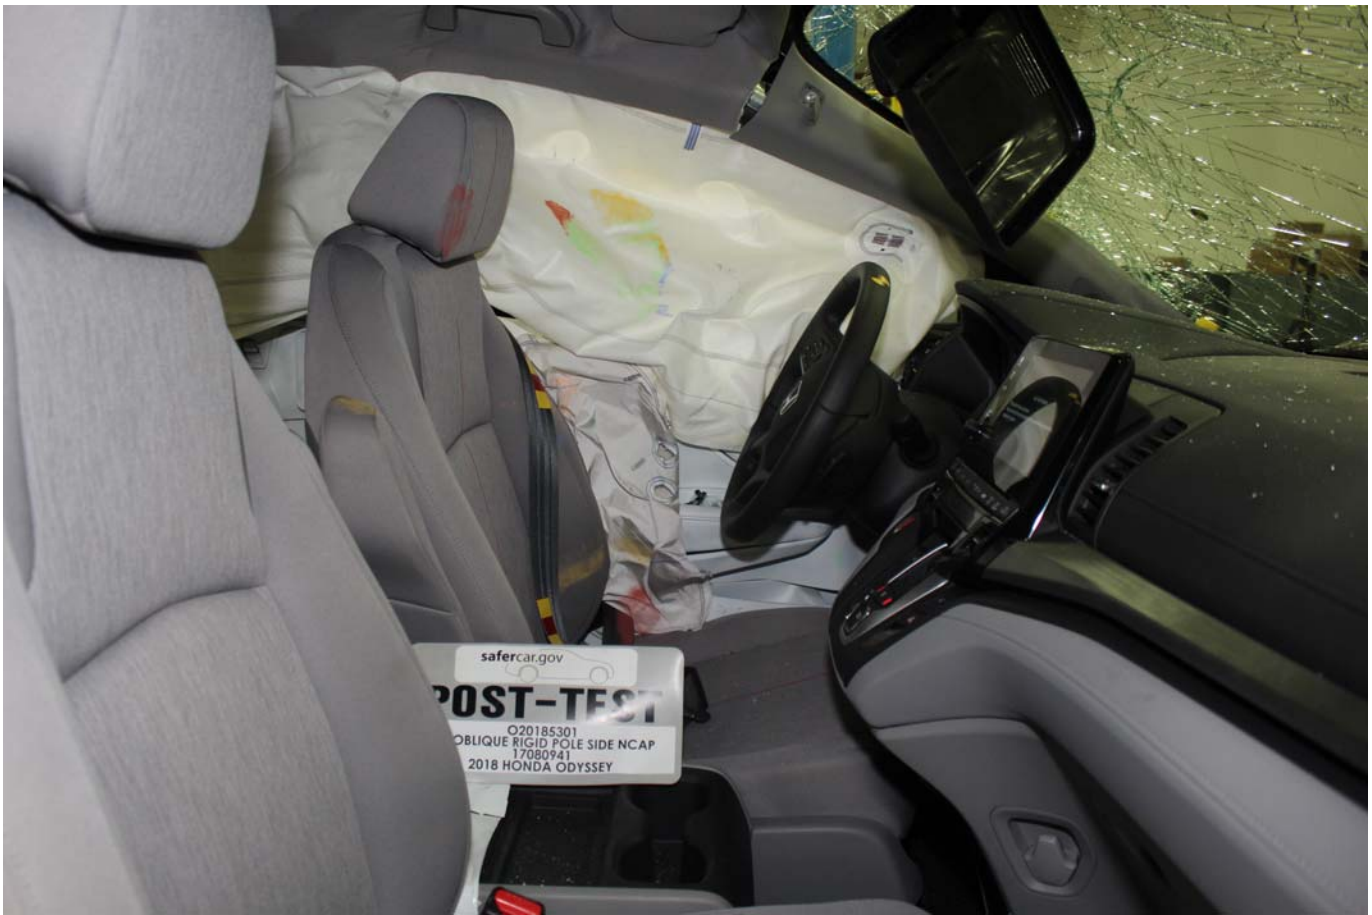
Photo No. 045 - Post-Test Inner Door Panel View Showing Dummy Contact Location

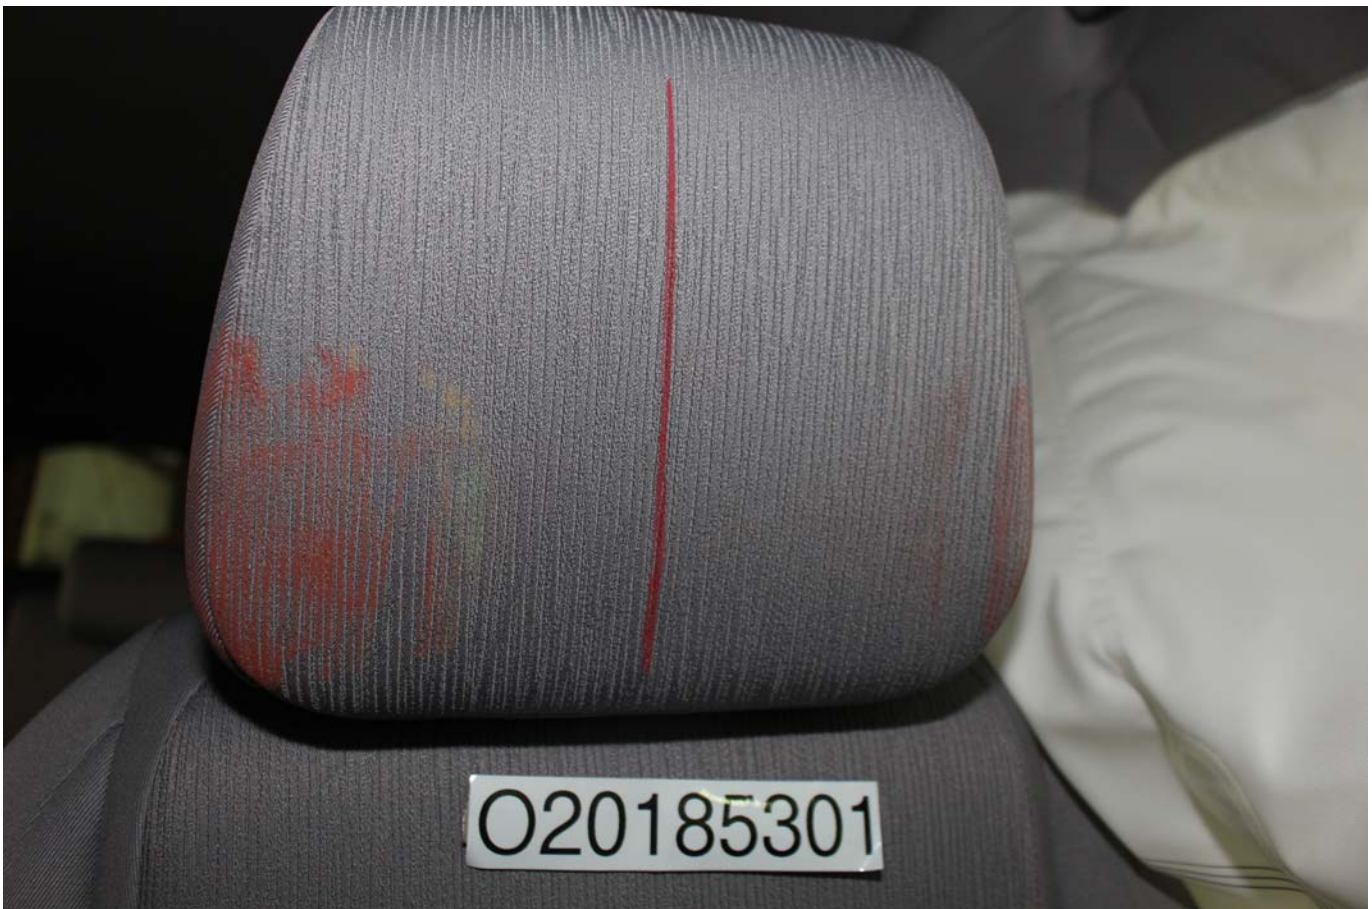
Photo No. 046 - Post-Test Dummy Close-Up Head Contact with Vehicle Interior View

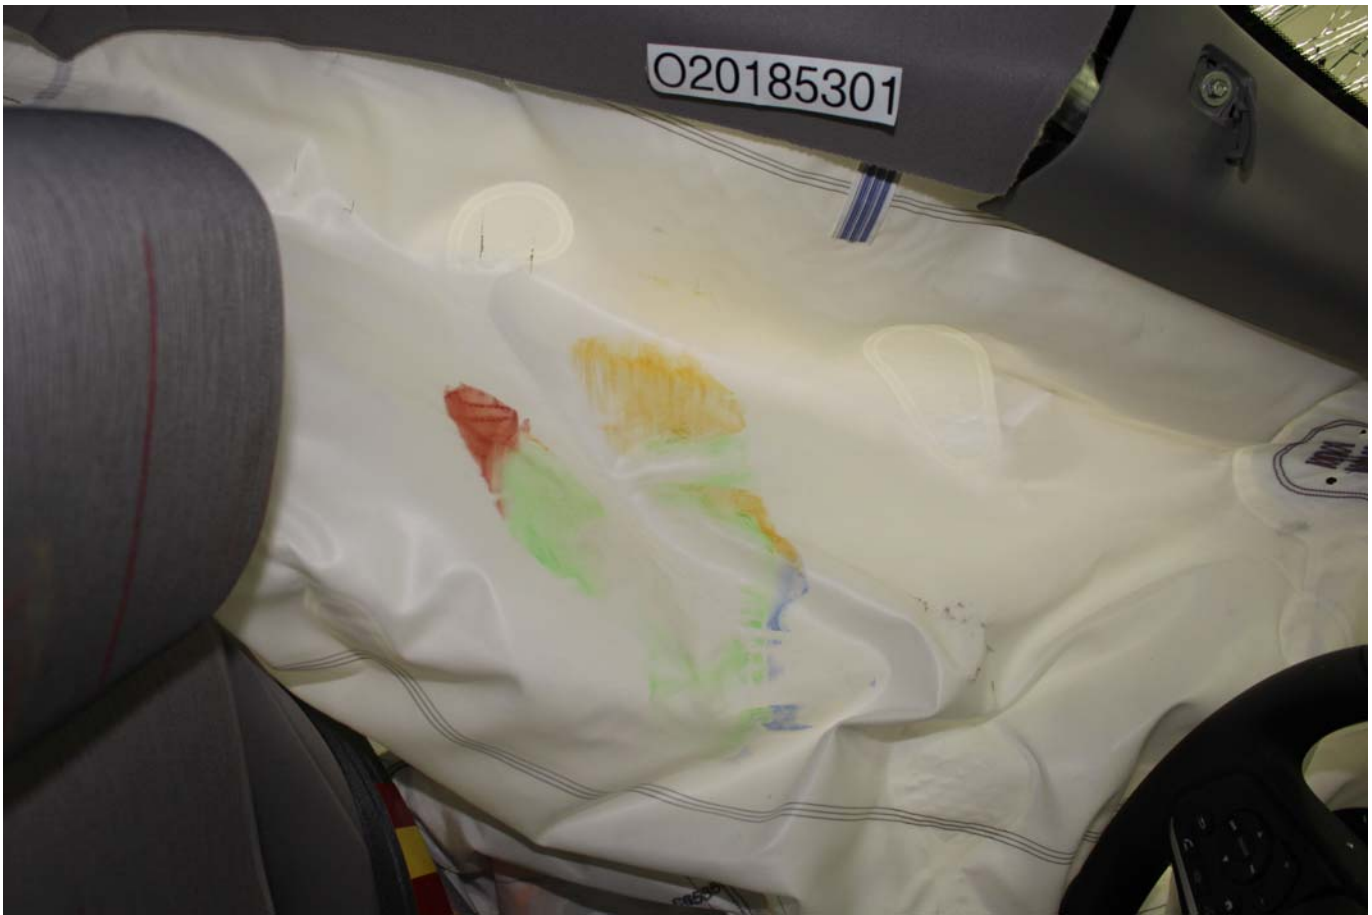
Photo No. 047 - Post-Test Dummy Close-Up Head Contact with Side Air Bag View

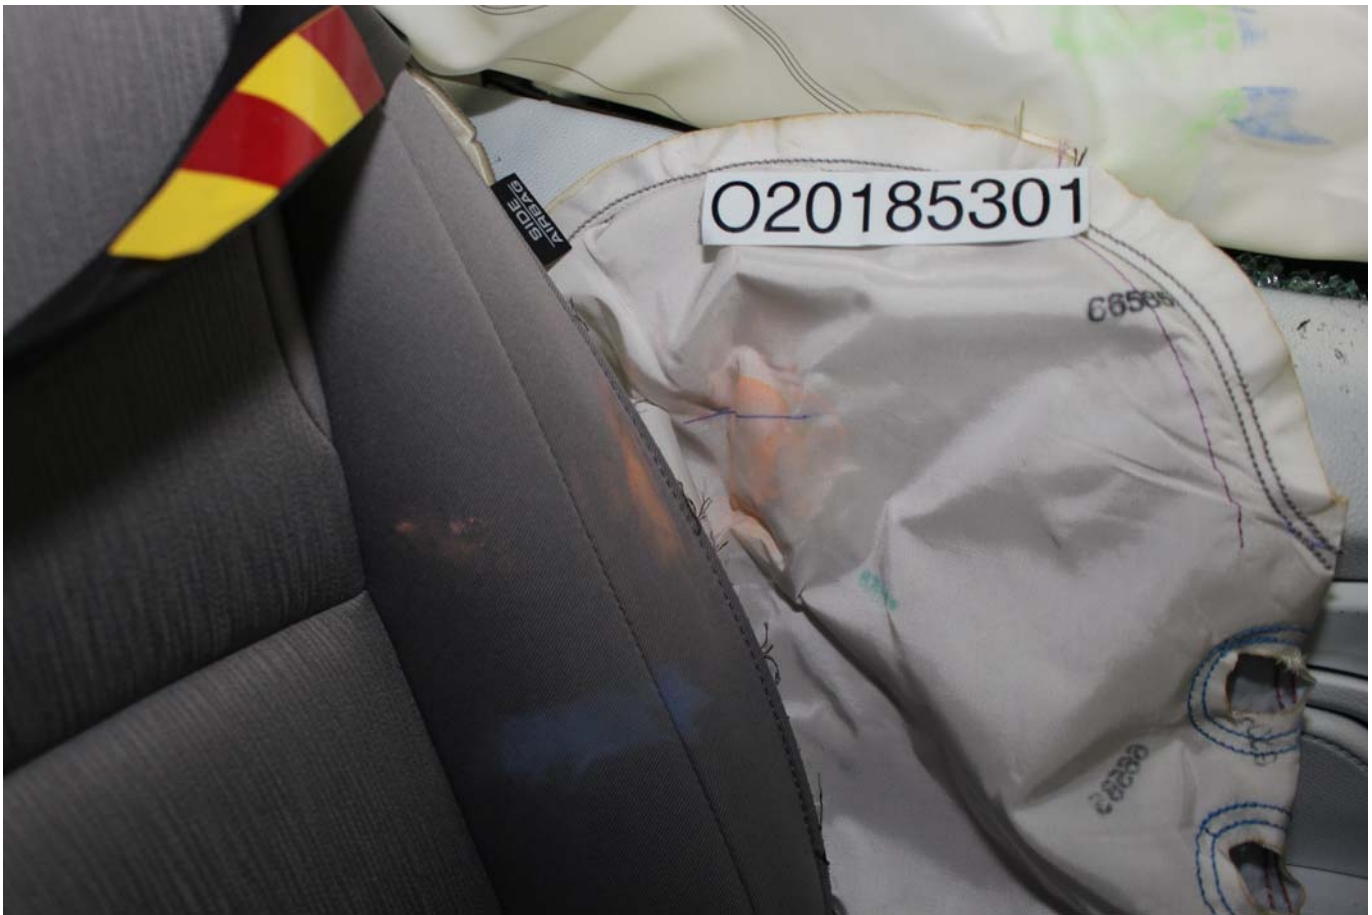
Photo No. 049 - Post-Test Dummy Close-Up Torso Contact with Side Air Bag View

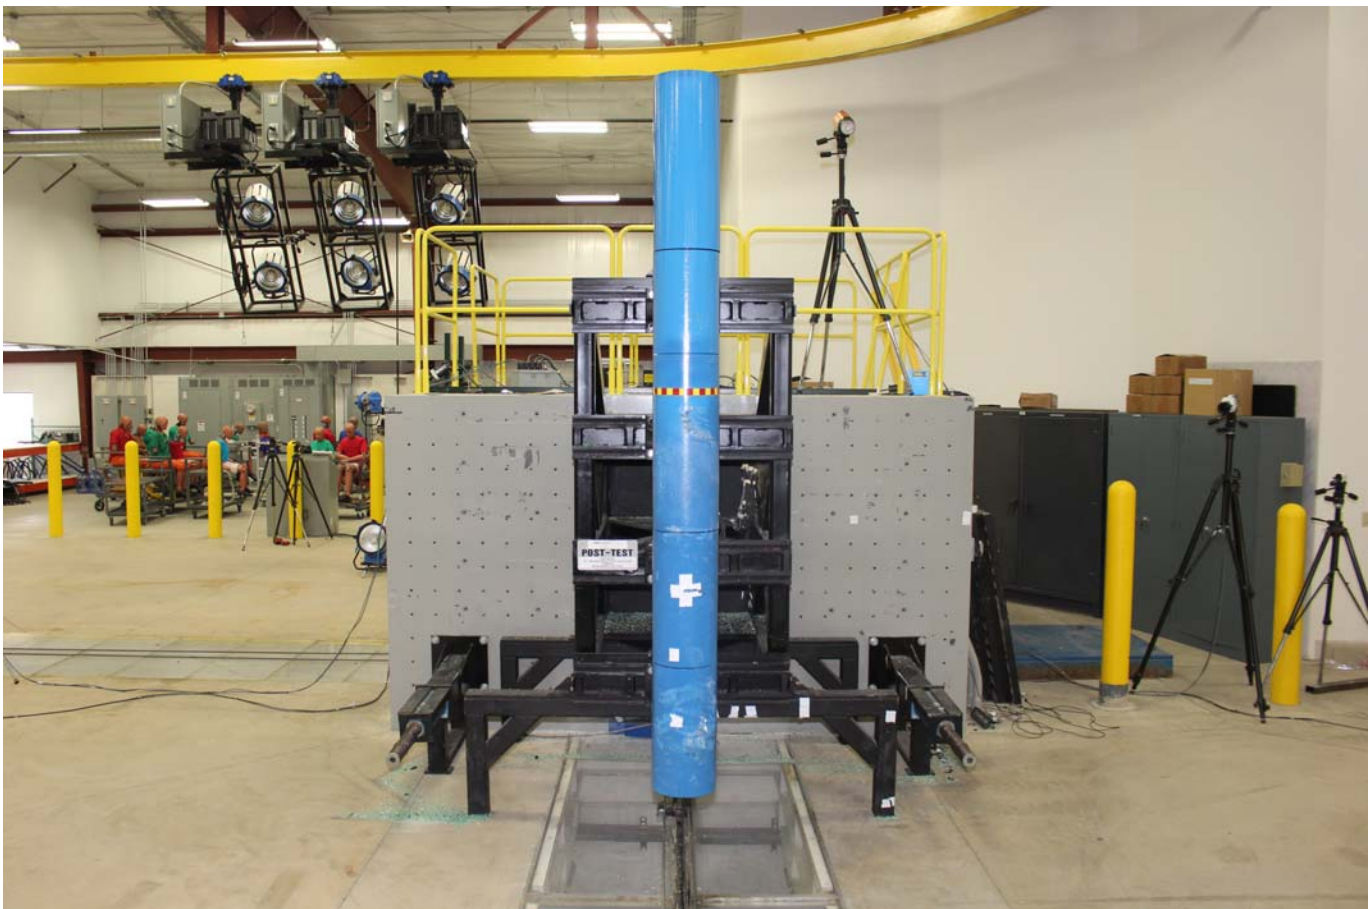
Photo No. 058 - Post-Test Pole Barrier Front View

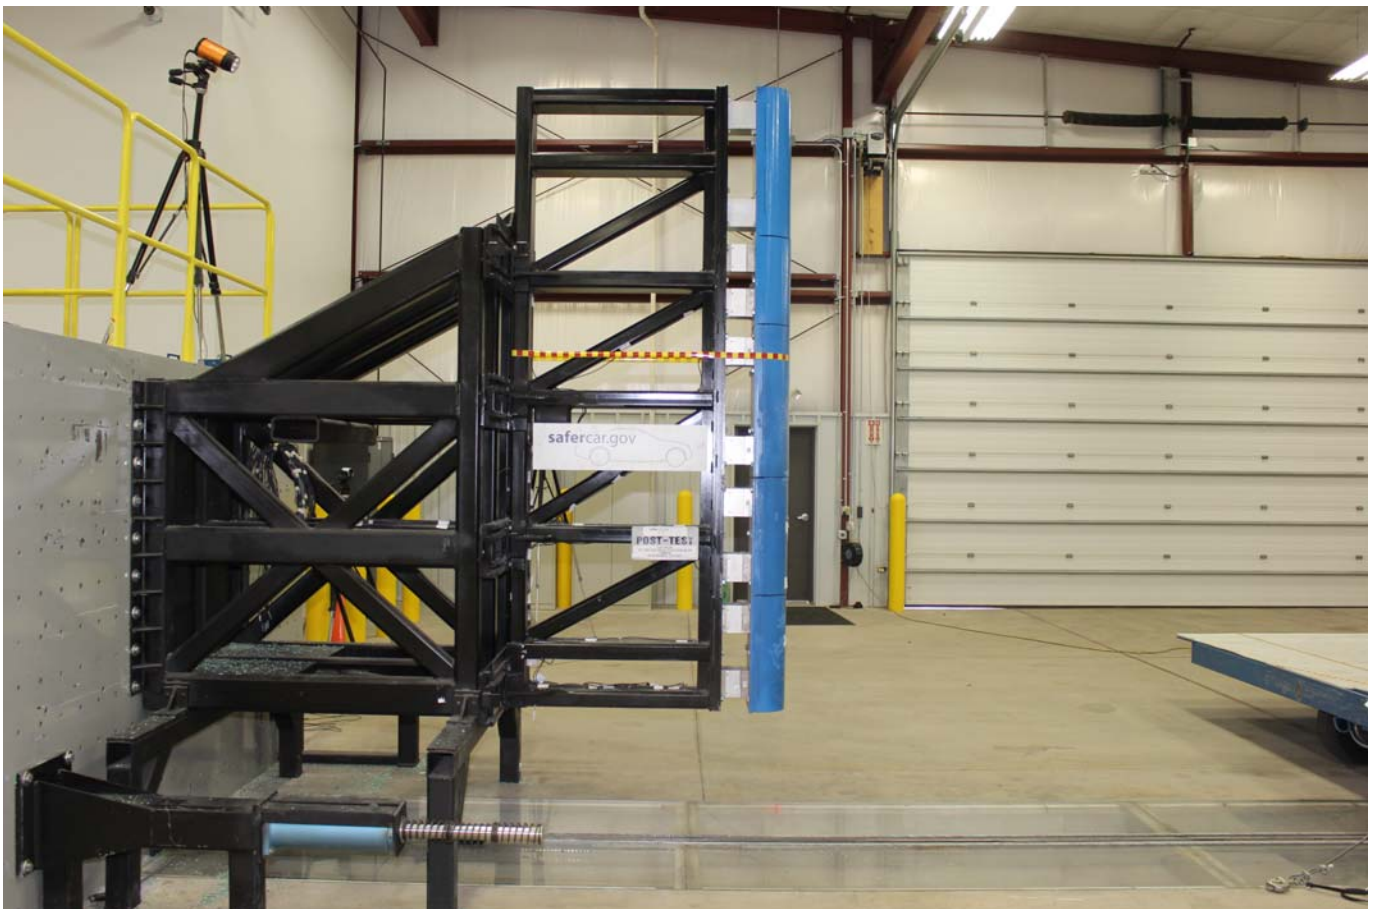
Photo No. 060 - Post-Test Pole Barrier Side View
