**REPORT NUMBER: NCAP-MGA-2018-001**

**NEW CAR ASSESSMENT PROGRAM (NCAP)  
Frontal Barrier Impact Test**

**HONDA MFG. OF ALABAMA, LLC  
2018 Honda Odyssey EX Minivan  
NHTSA No.: O20185300**

**FINAL REPORT**

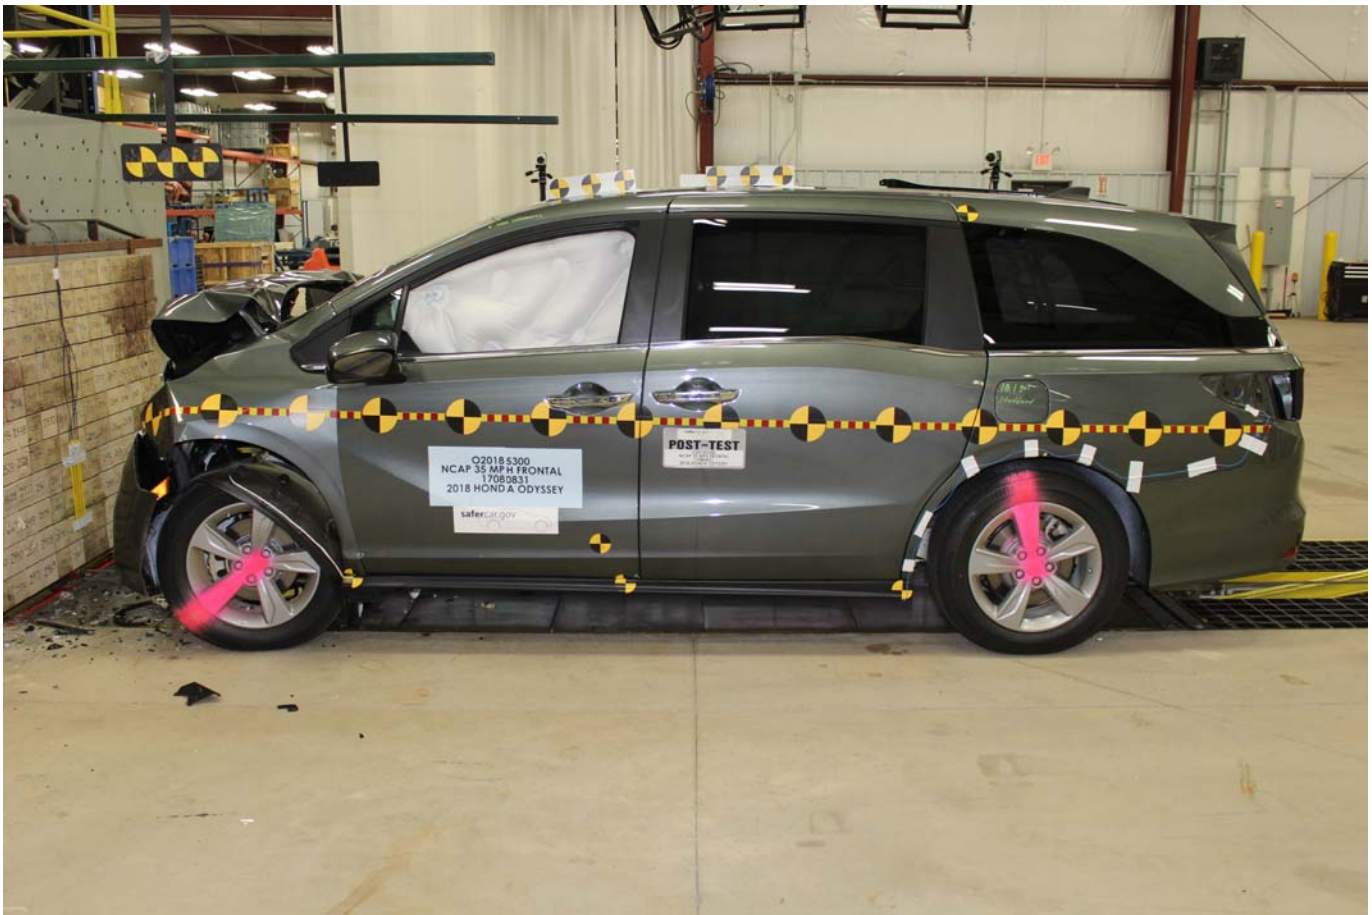
Photo No. 011 - Post-Test Left View of Test Vehicle

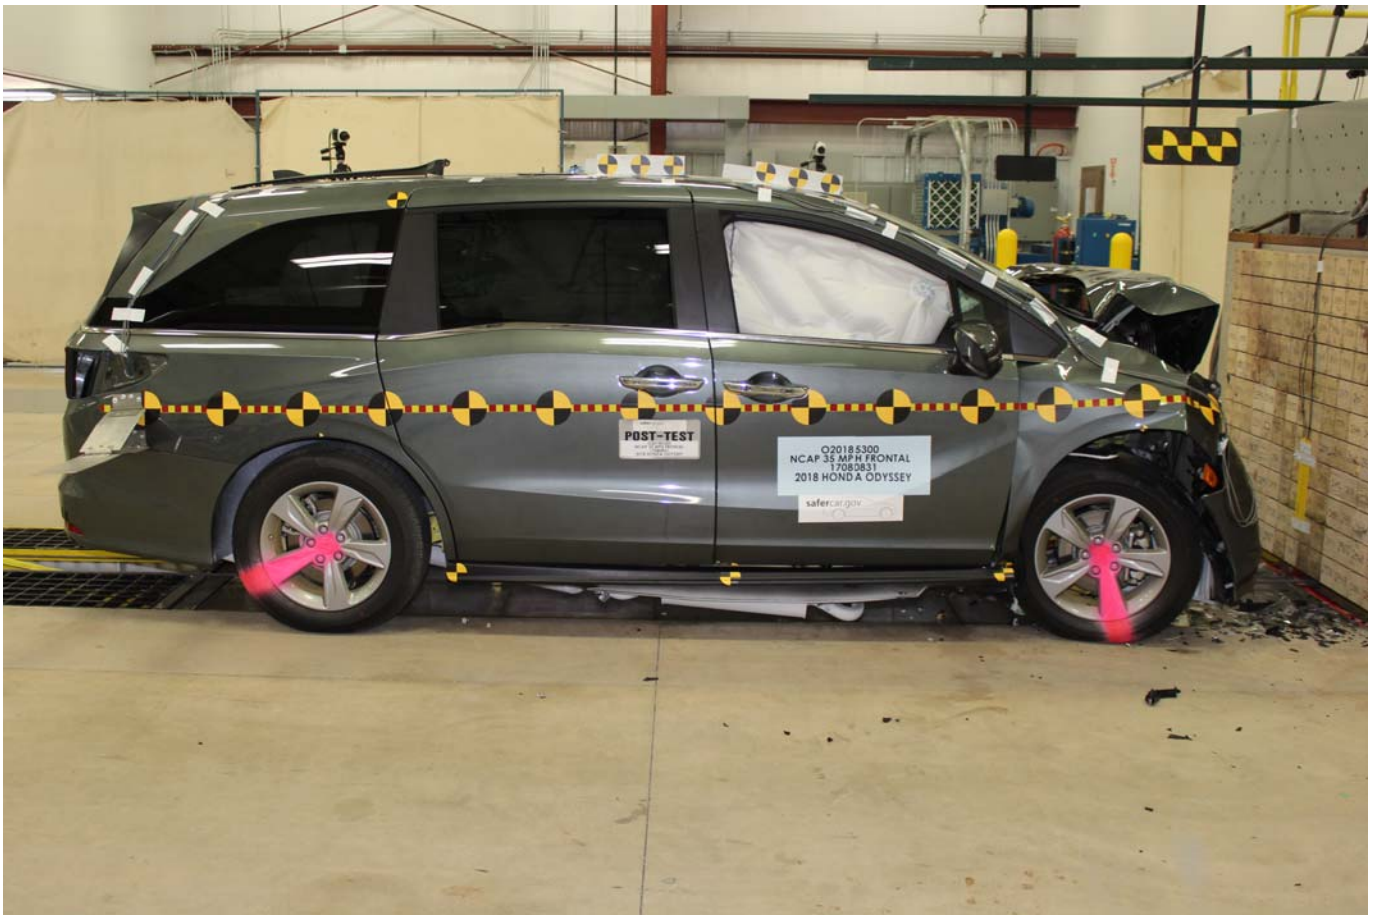
Photo No. 013 - Post-Test Right View of Test Vehicle

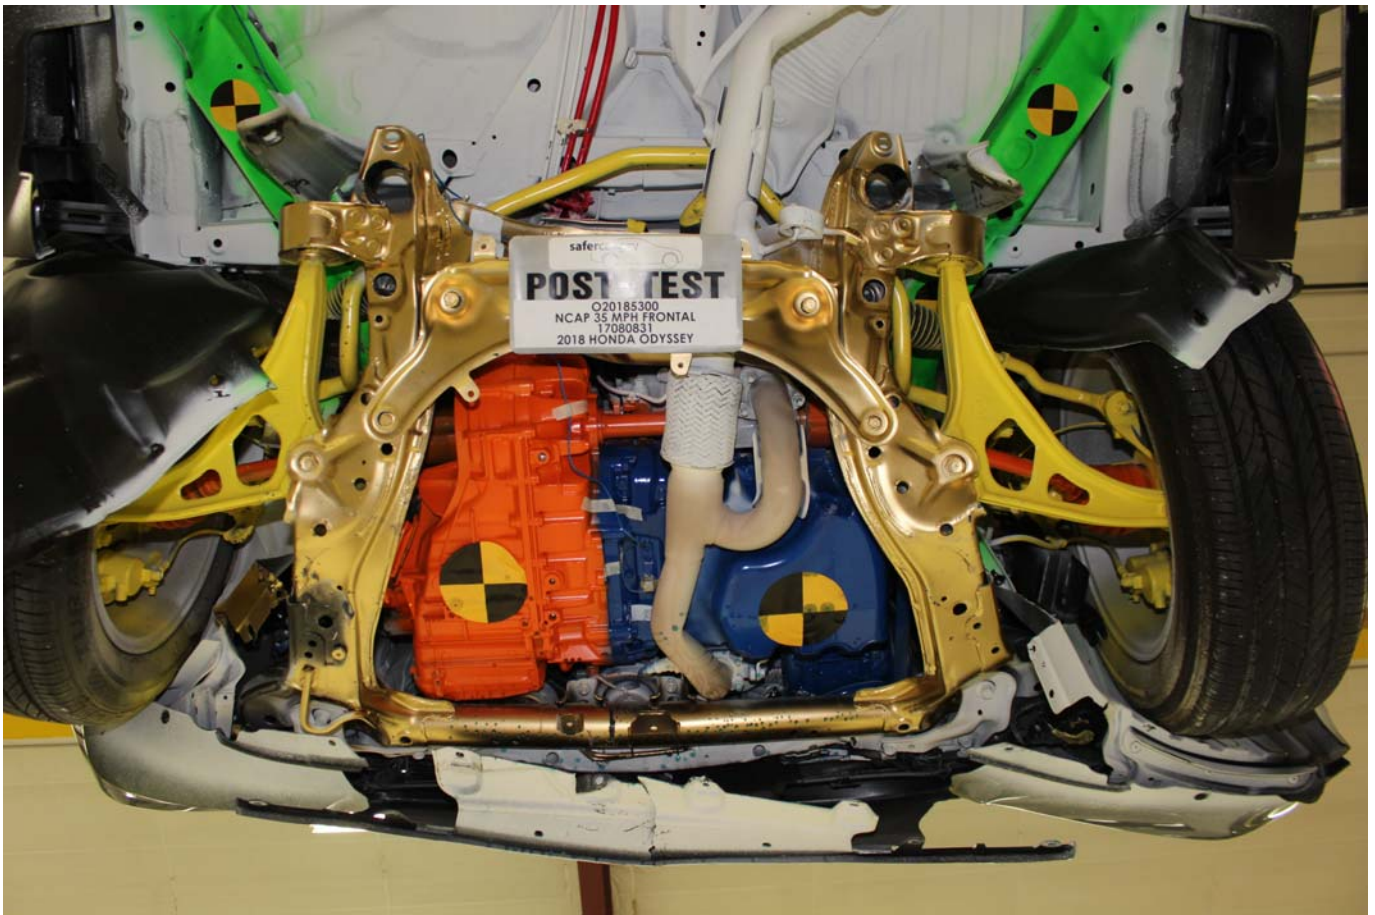
Photo No. 025 - Post-Test Front Underbody View

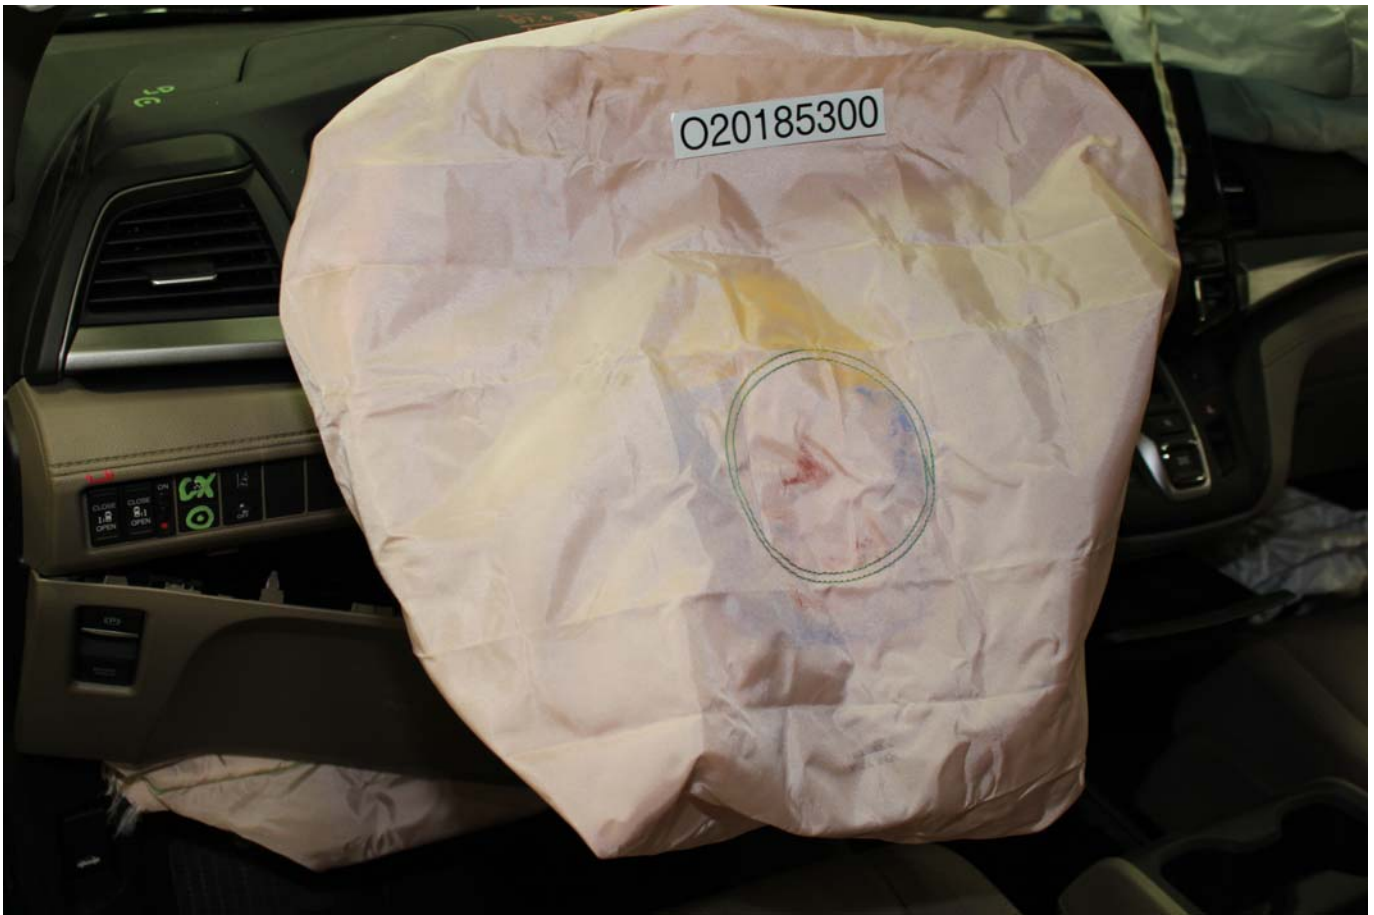
Photo No. 047 - Post-Test Driver Dummy Contact with Airbag

The driver's visible contact points were as follows: The driver's head contacted the airbag. The driver's head also contacted the headrest. The driver's knees contacted the knee bolster trim and knee airbag. The passenger's visible contact points were as follows: The passenger's head contacted the airbag. The passenger's head also contacted the headrest. The passenger's knees contacted the knee airbag.

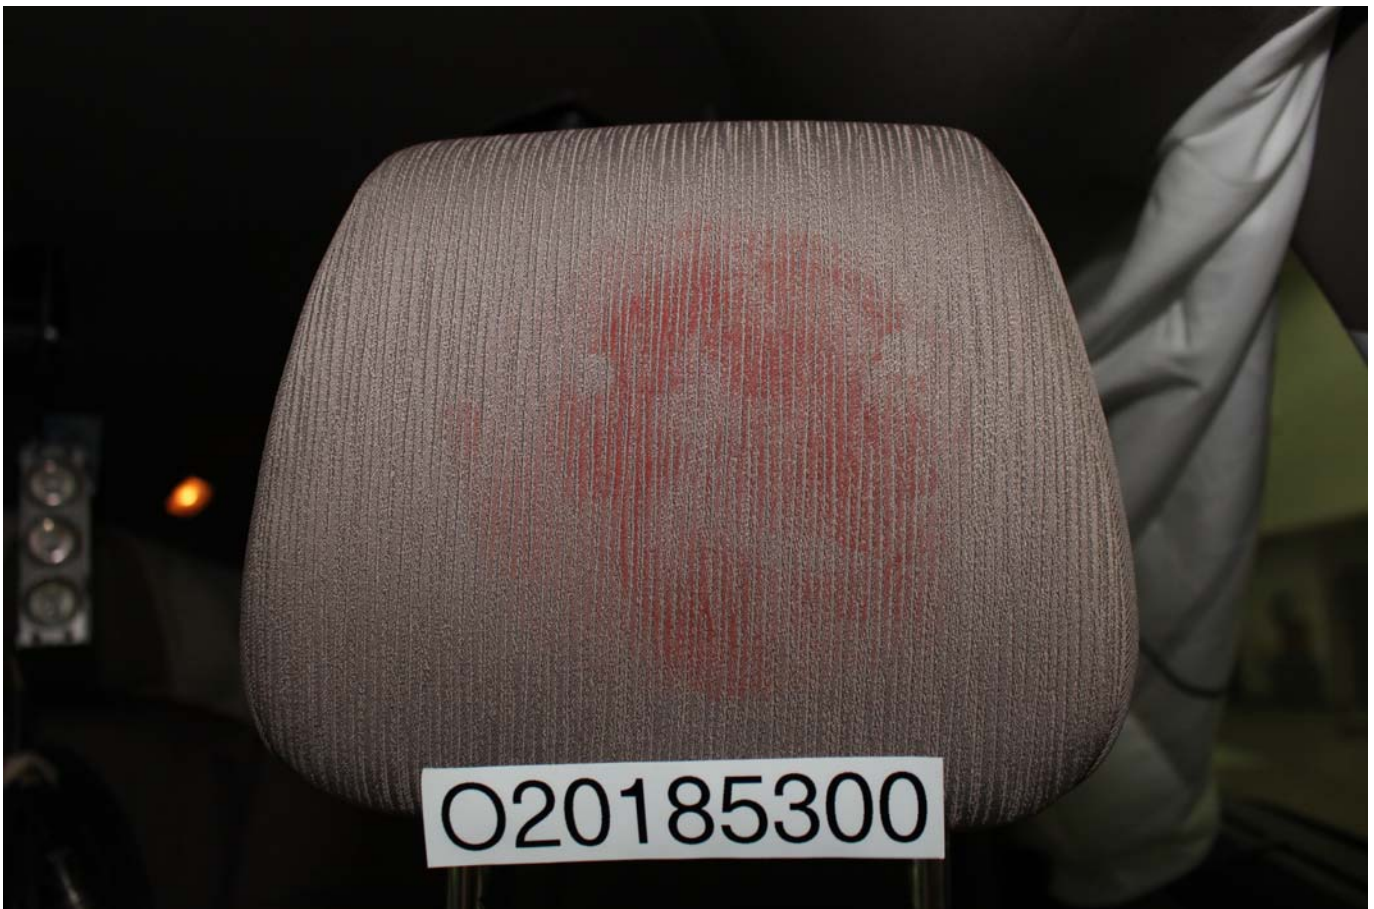
Photo No. 048 - Post-Test Driver Dummy Contact with Headrest

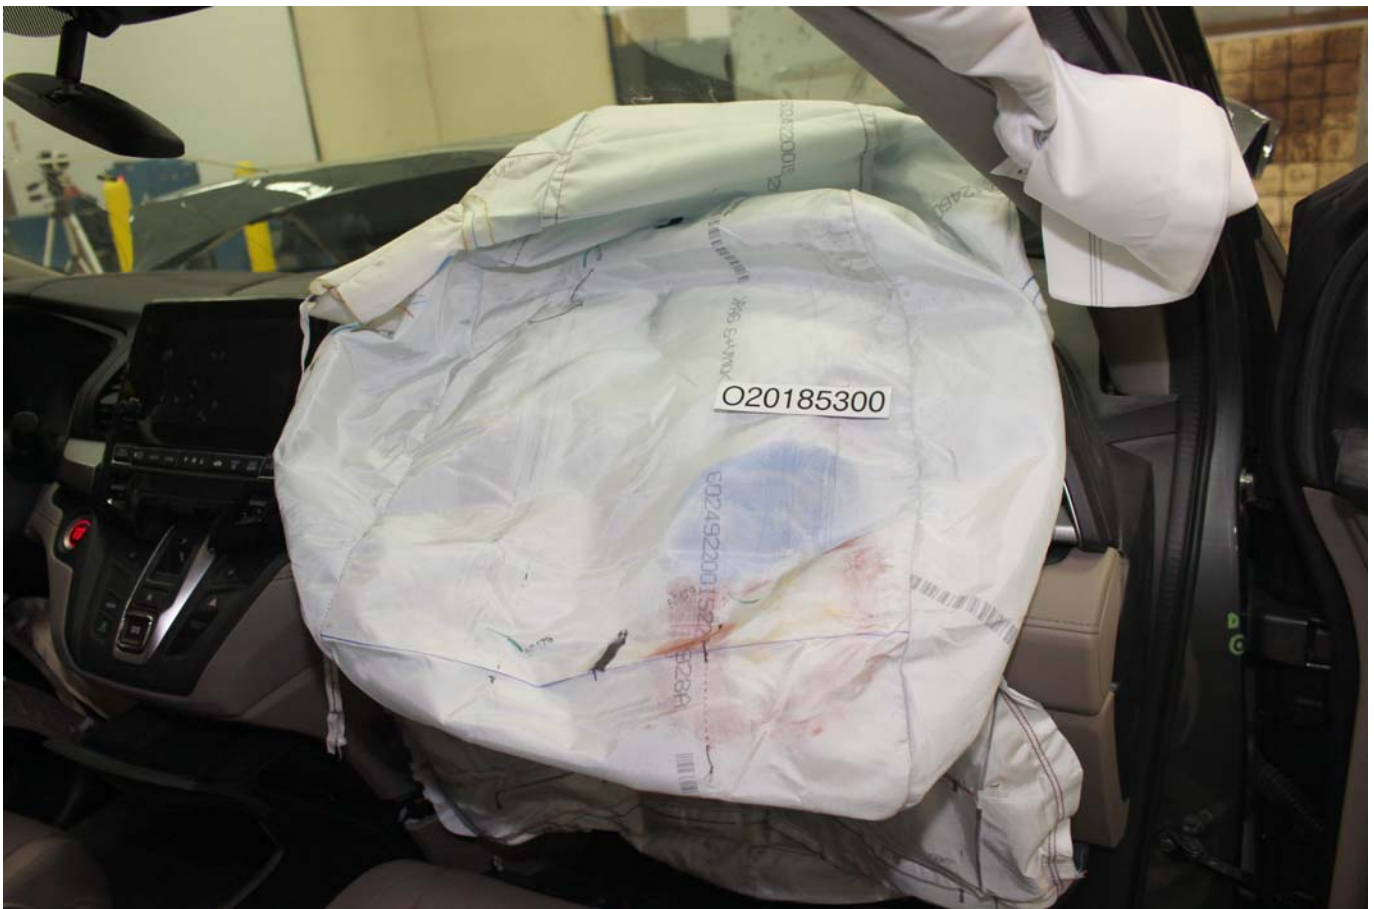
Photo No. 068 - Post-Test Passenger Dummy Contact with Airbag

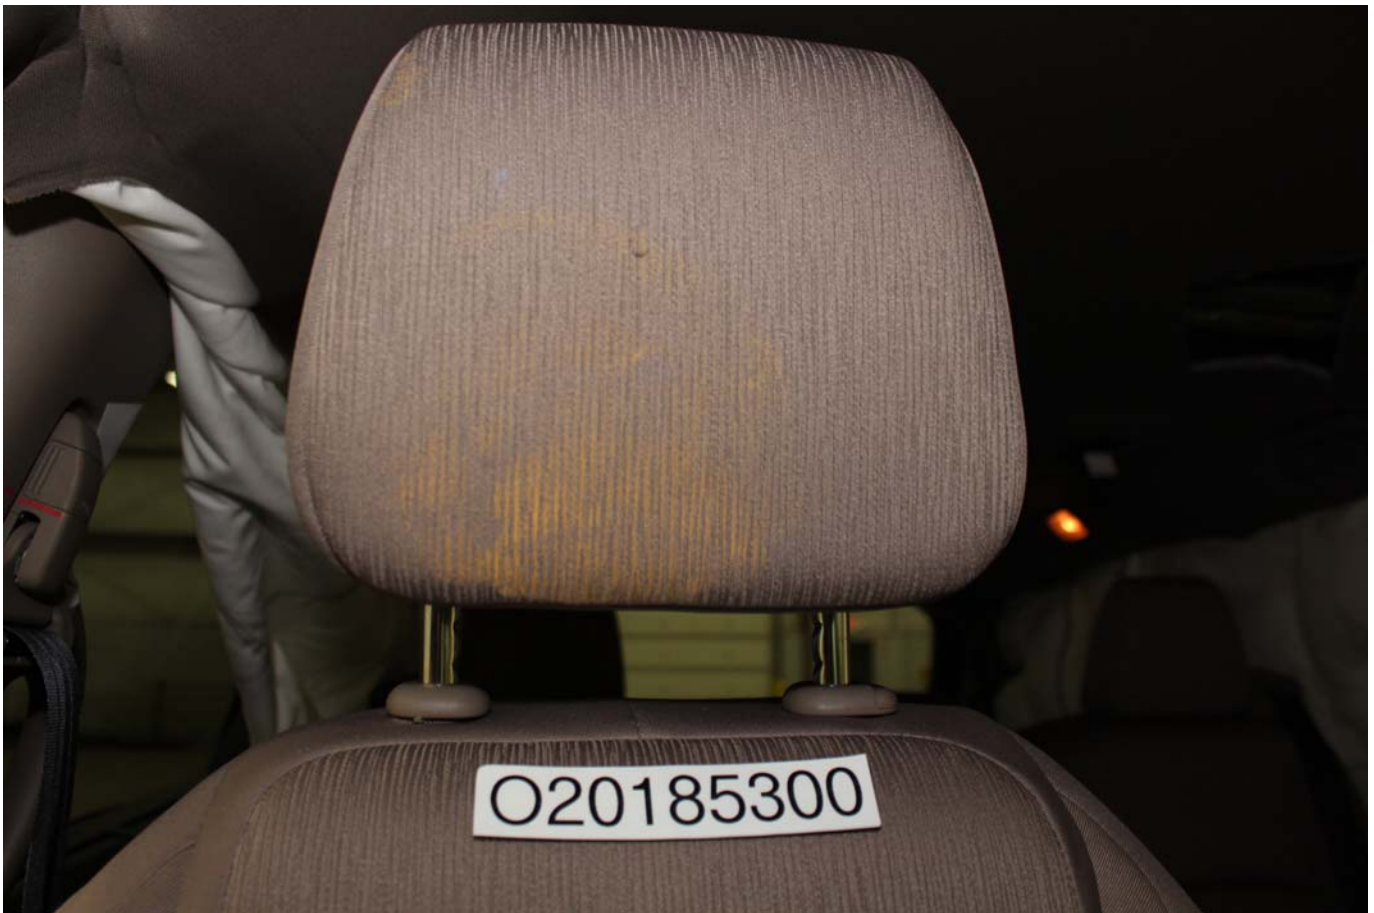
Photo No. 069 - Post-Test Passenger Dummy Contact with Headrest

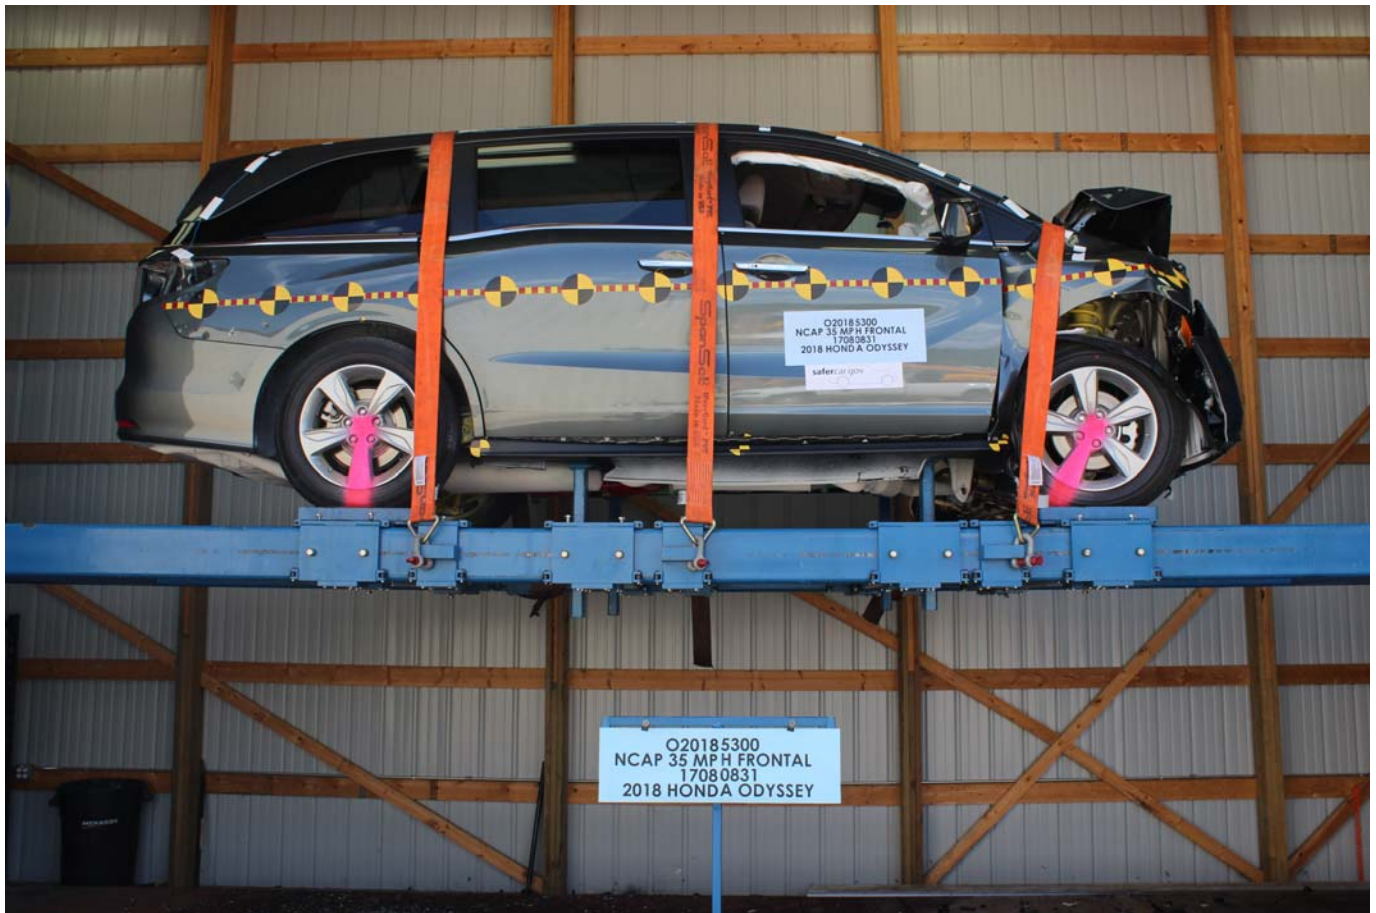
Photo No. 073 - Vehicle at 0 Degree on Static Rollover Device

There was 100 percent windshield retention and no intrusion into the protected zone of the windshield during the event. There was no Stoddard Solvent leakage after the event or during any phase of the static rollover.

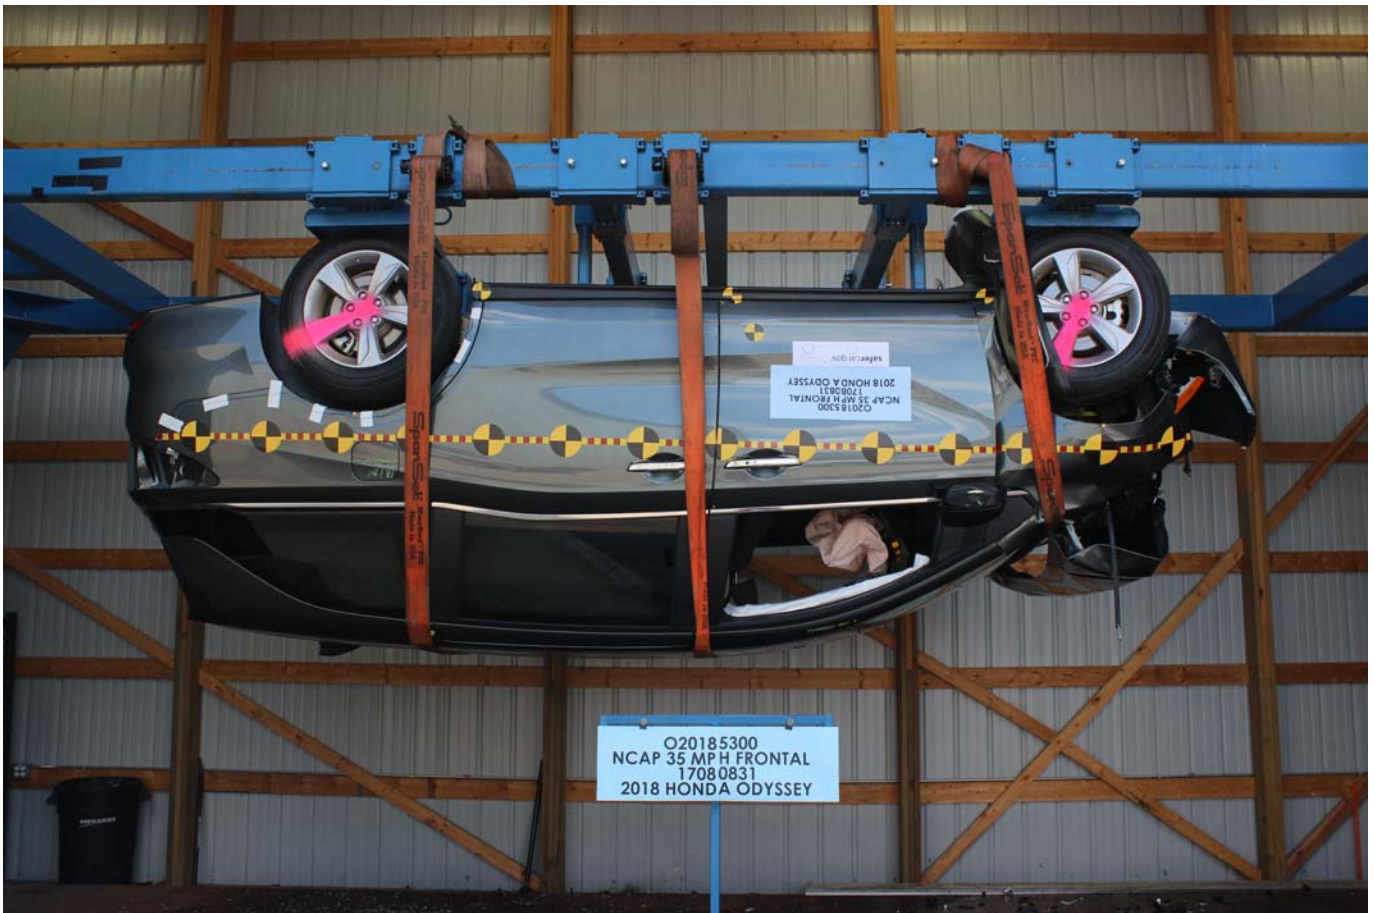
Photo No. 075 - Vehicle at 180 Degrees on Static Rollover Device

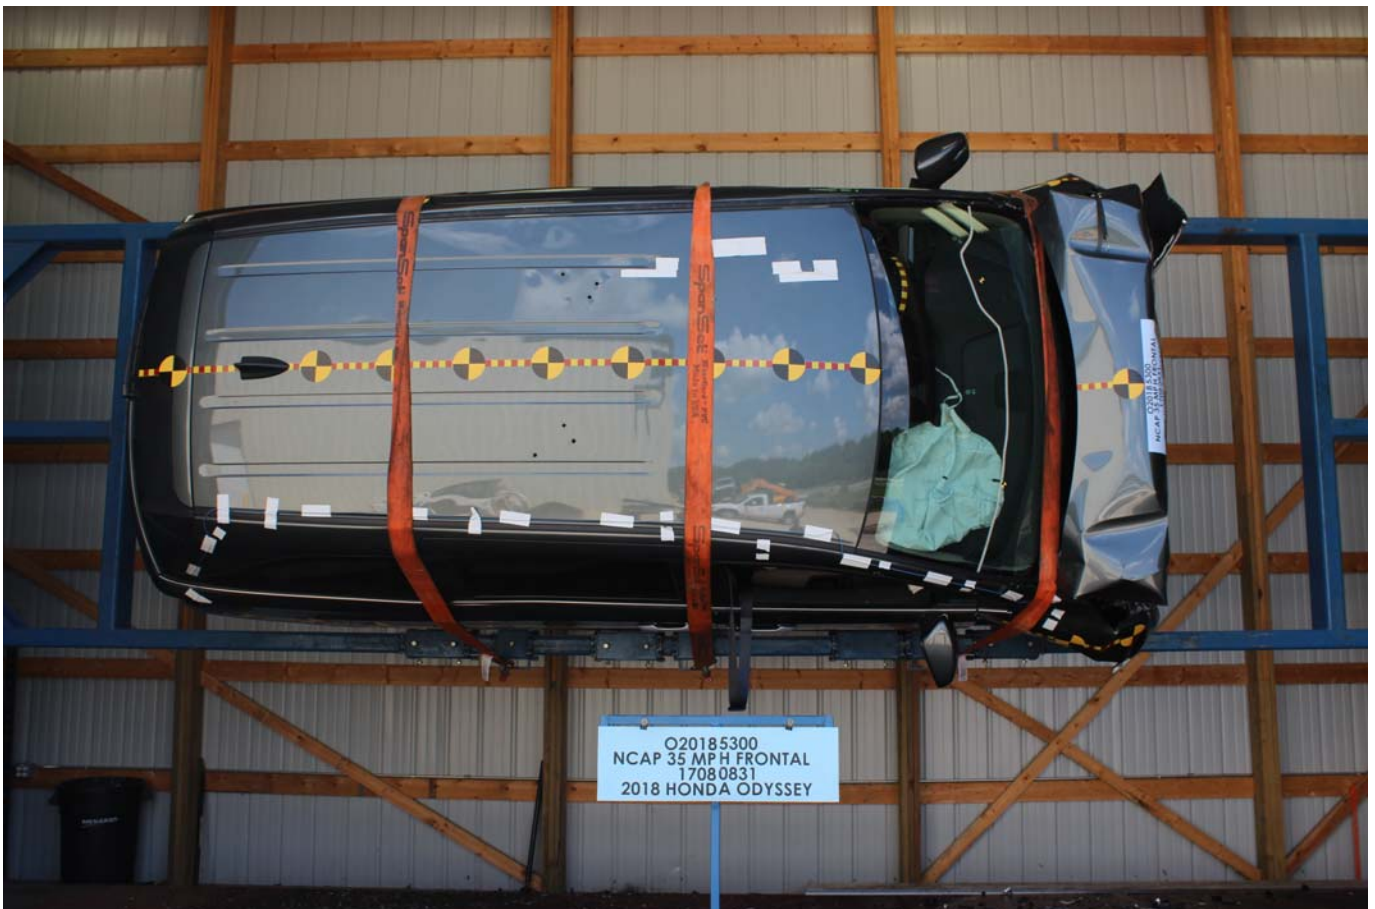
Photo No. 076 - Vehicle at 270 Degrees on Static Rollover Device

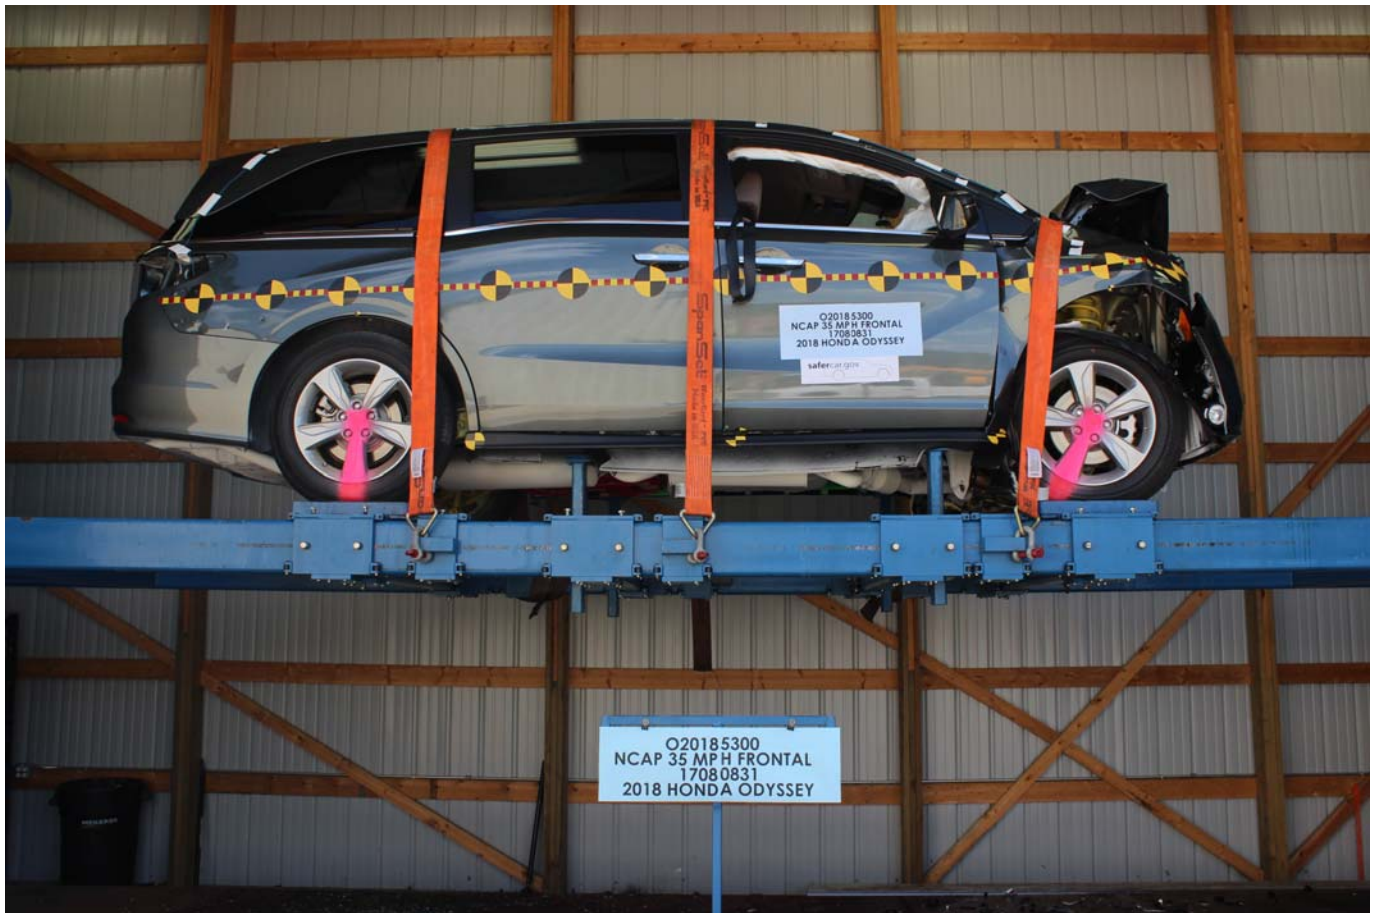
Photo No. 077 - Vehicle at 360 Degrees on Static Rollover Device

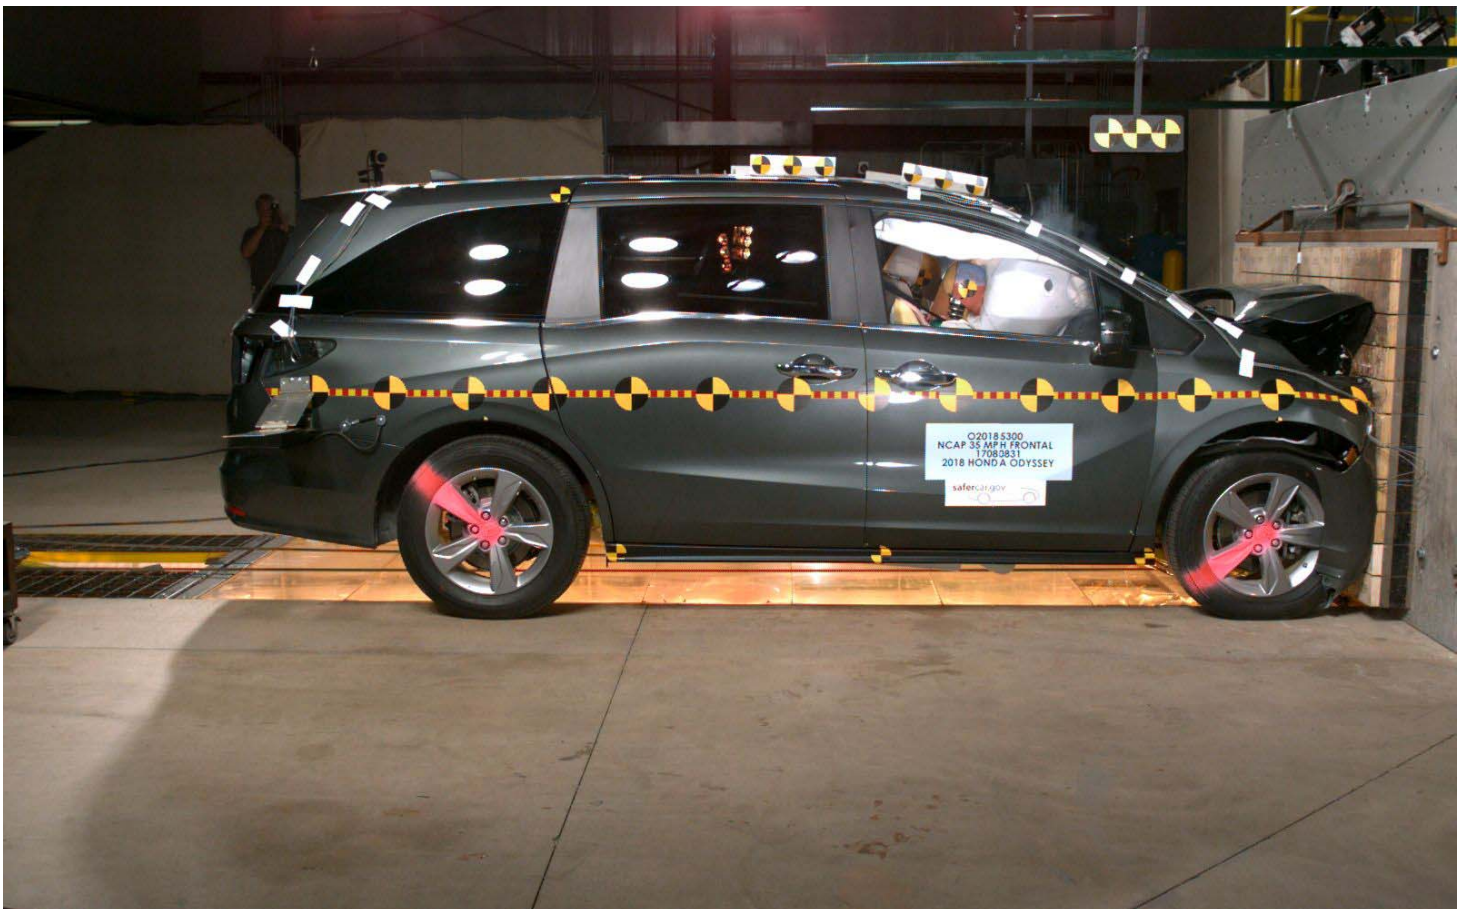
Photo No. 078 - 2018 Honda Odyssey EX Minivan Frontal Impact Event
