REPORT NUMBER: SINCAP-MGA-2018-003

**NEW CAR ASSESSMENT PROGRAM (NCAP)
Moving Deformable Barrier Side Impact Test**

**HONDA MFG. OF ALABAMA, LLC
2018 Honda Odyssey EX Minivan
NHTSA No.: O20185302**

**MGA RESEARCH CORPORATION
5000 Warren Road
Burlington, WI 53105**

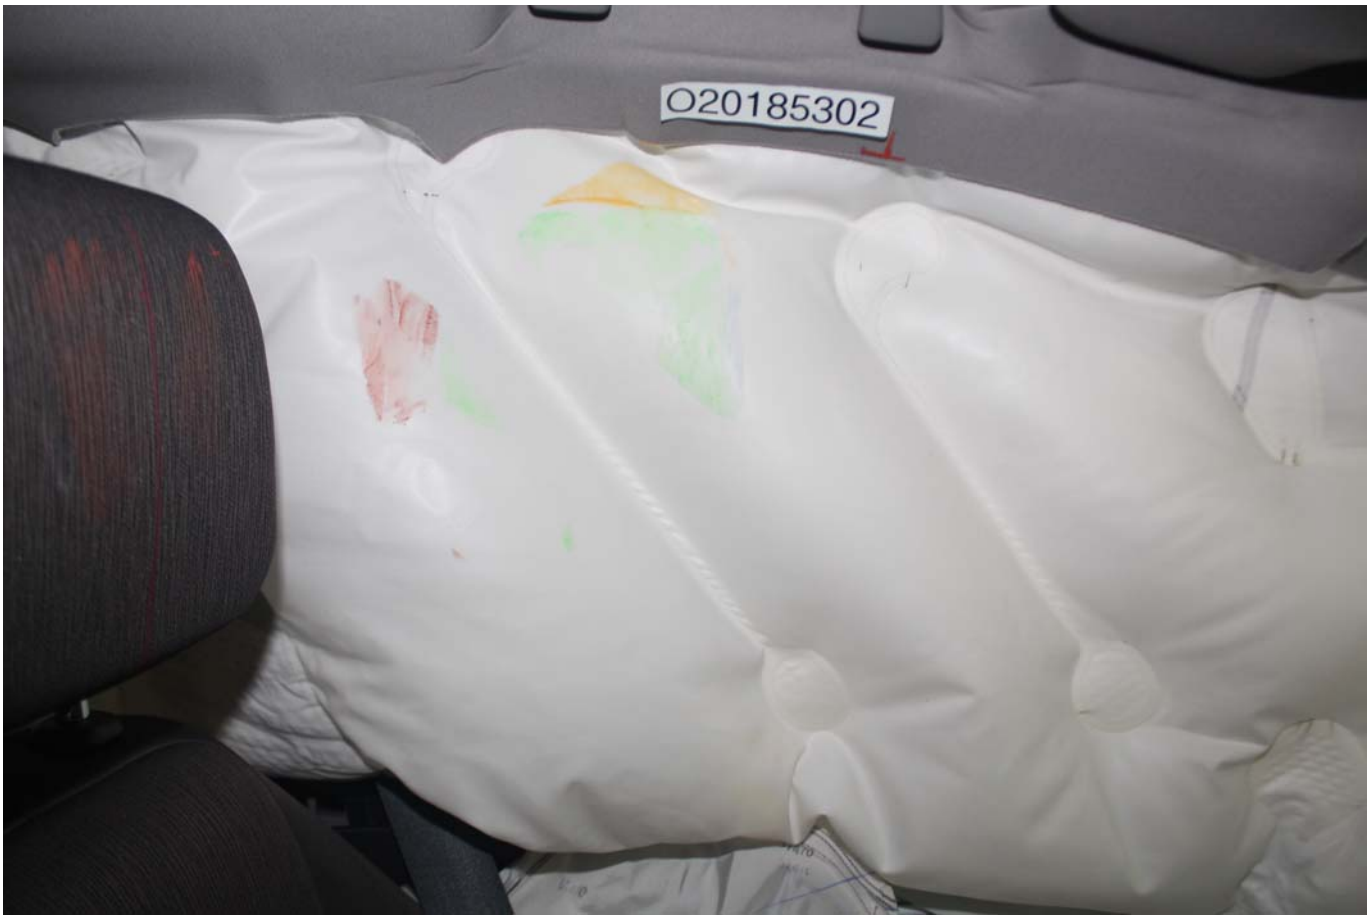
Photo No. 049 - Post-Test Driver Dummy Close-up Head Contact with Side Airbag View

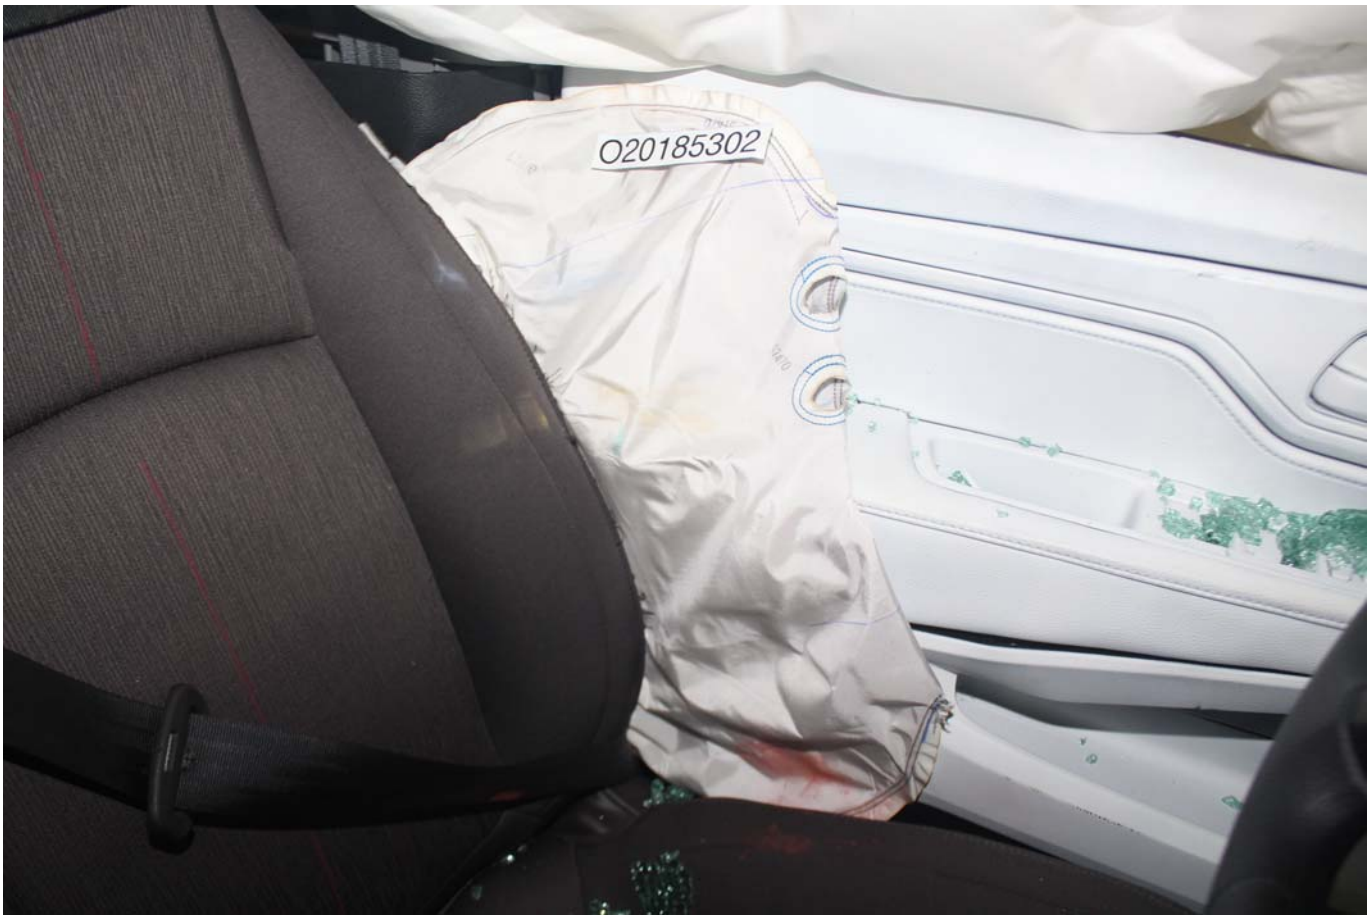
Photo No. 051 - Post-Test Driver Dummy Close-up Torso Contact with Side Airbag View

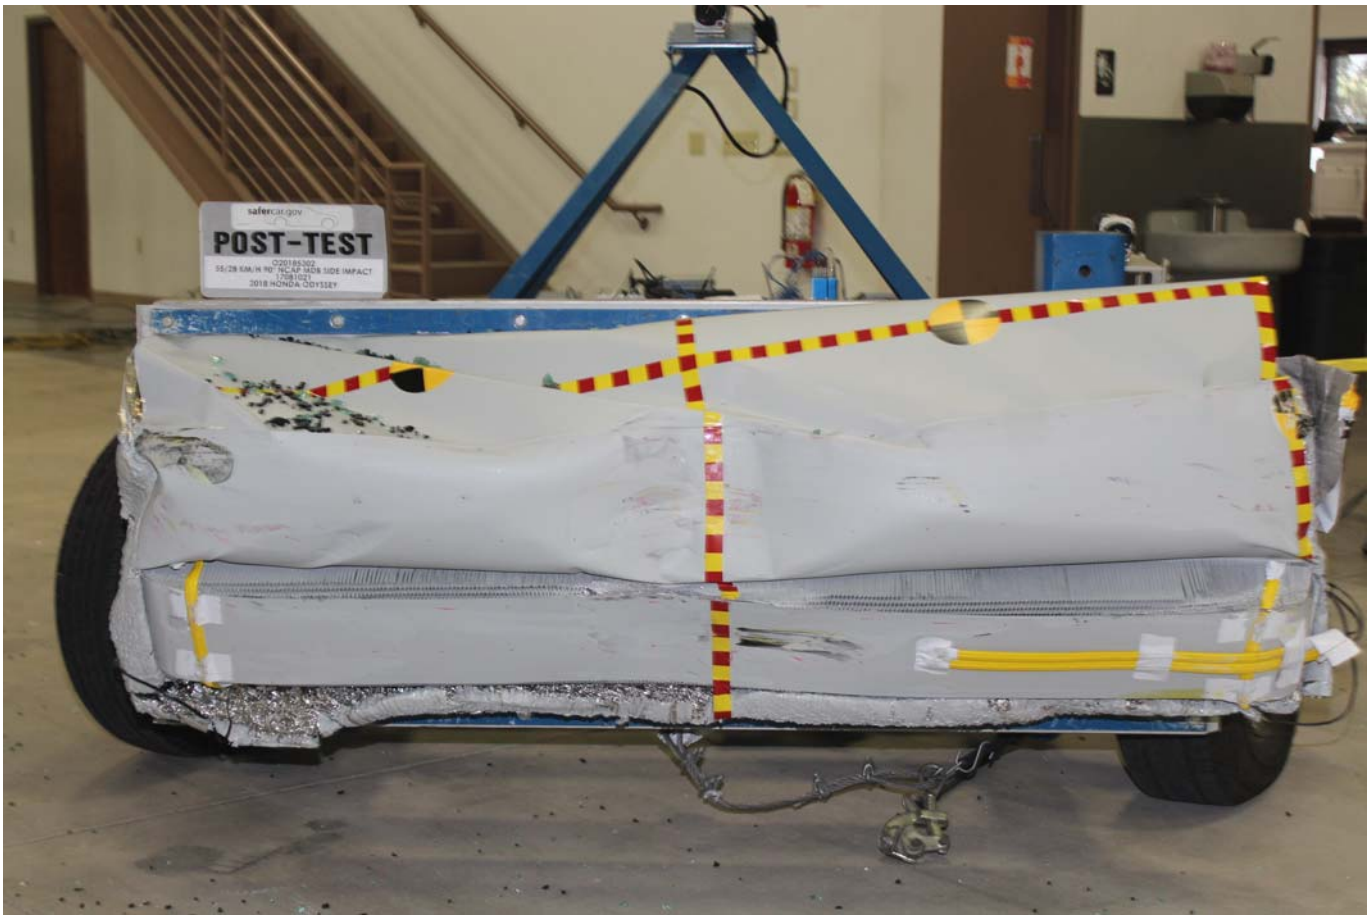
Photo No. 085 - Post-Test Front View of MDB Impactor Face
