**REPORT NUMBER: SPNCAP-MGA-2018-004**

**NEW CAR ASSESSMENT PROGRAM (NCAP)  
Side Impact Pole Test**

**VOLKSWAGEN GROUP OF AMERICA CHATTANOOGA OPERATIONS, LLC  
2018 Volkswagen Atlas Launch Edition 5-Door SUV  
NHTSA No.: O20185801**

**MGA RESEARCH CORPORATION  
5000 Warren Road  
Burlington, WI 53105**

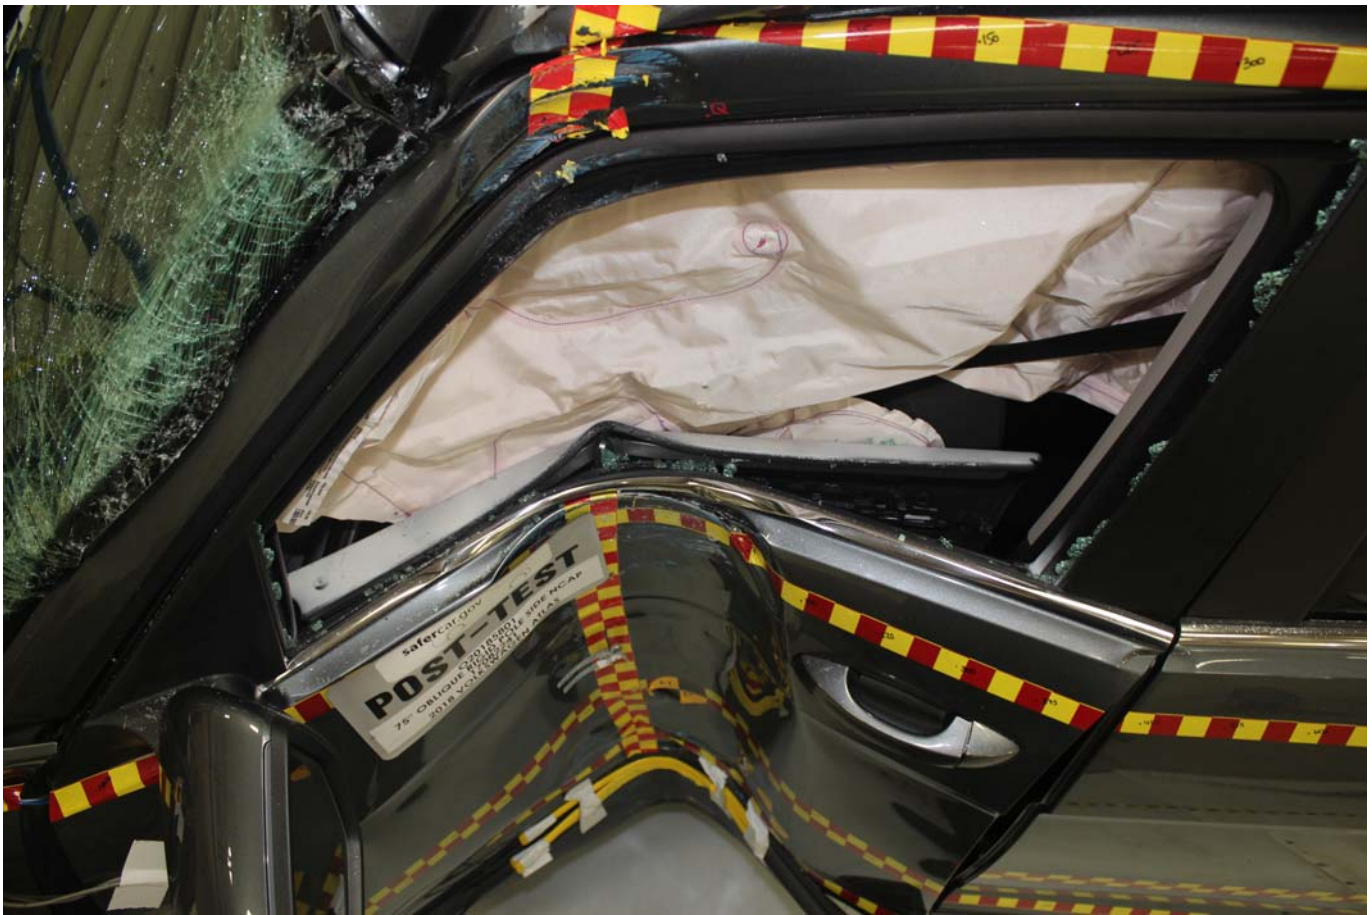
Photo No. 041 - Post-Test Dummy and Door Clearance View

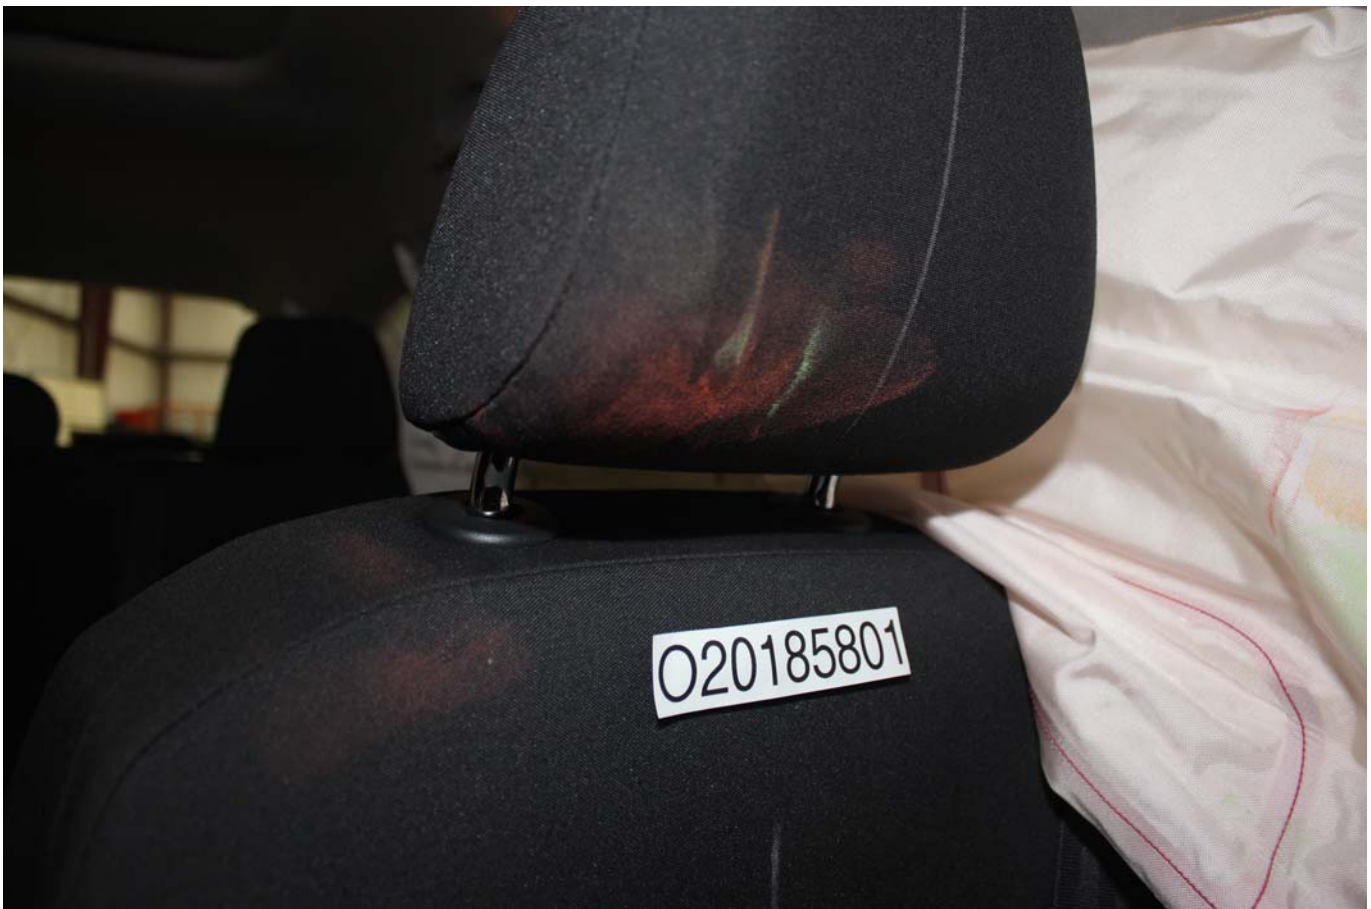
Photo No. 046 - Post-Test Dummy Close-Up Head Contact with Vehicle Interior View

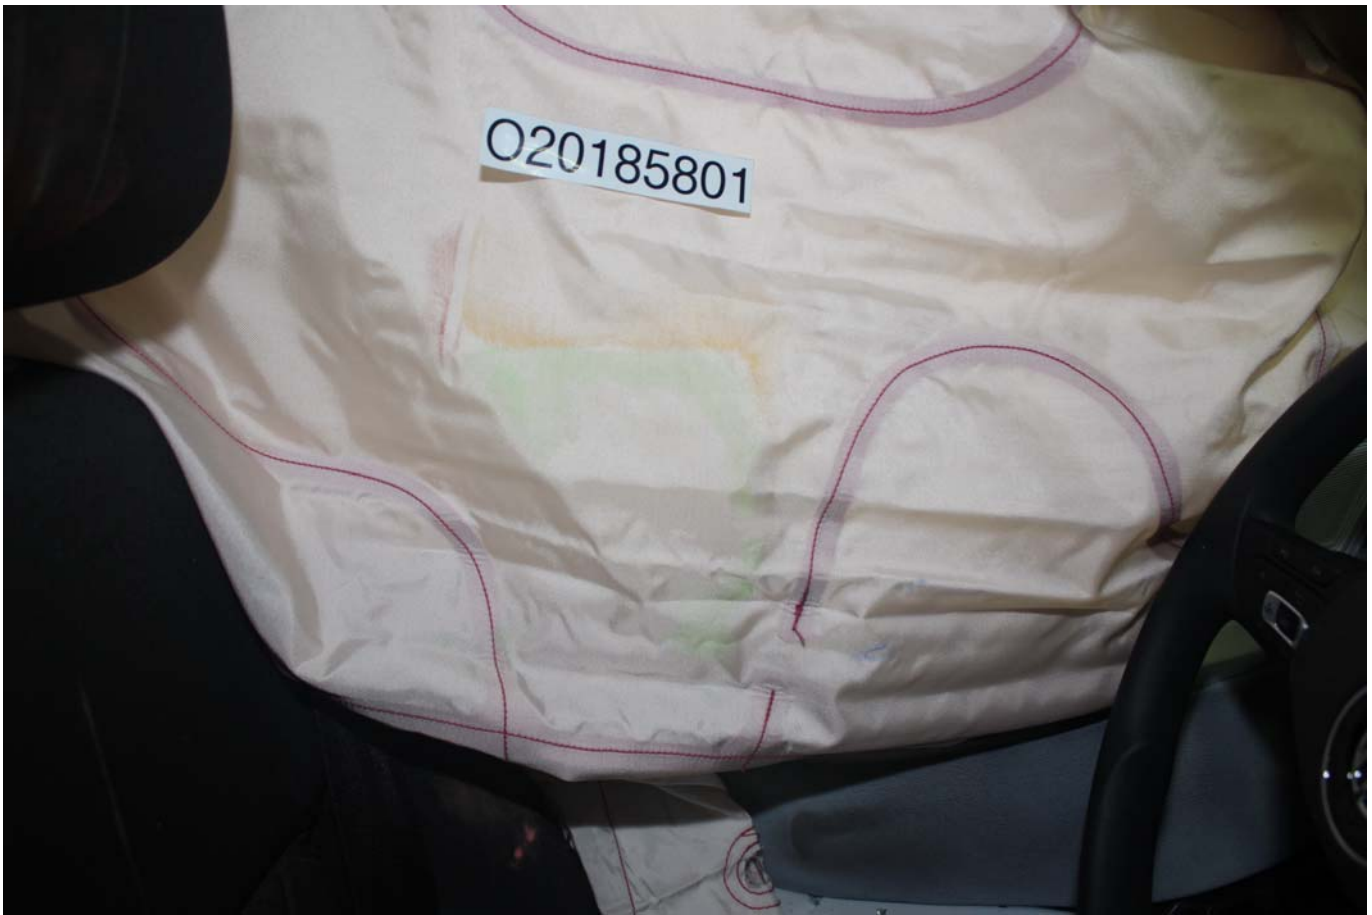
Photo No. 047 - Post-Test Dummy Close-Up Head Contact with Side Air Bag View

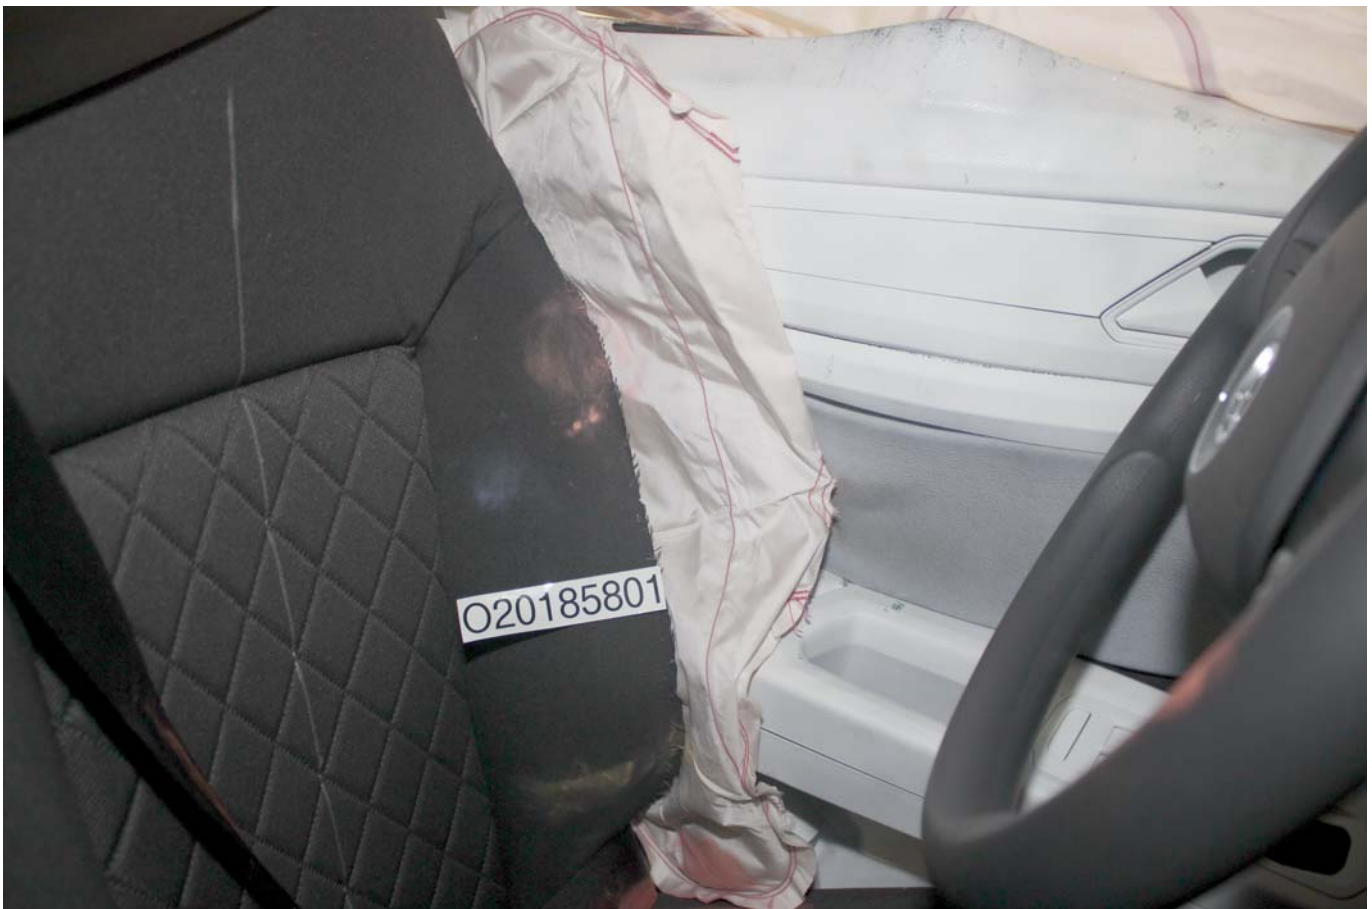
Photo No. 048 - Post-Test Dummy Close-Up Torso Contact with Vehicle Interior View

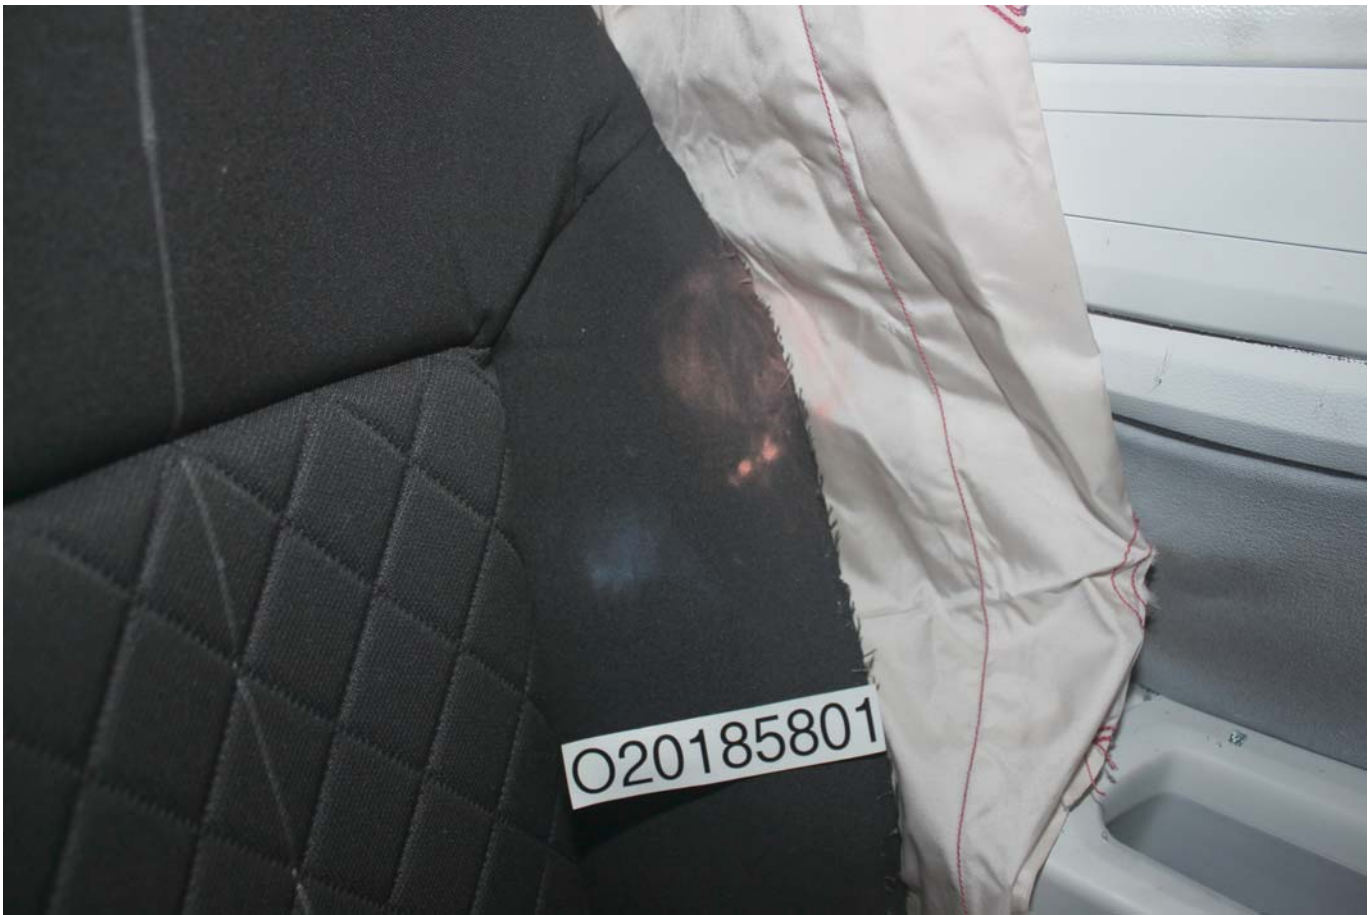
Photo No. 049 - Post-Test Dummy Close-Up Torso Contact with Side Air Bag View

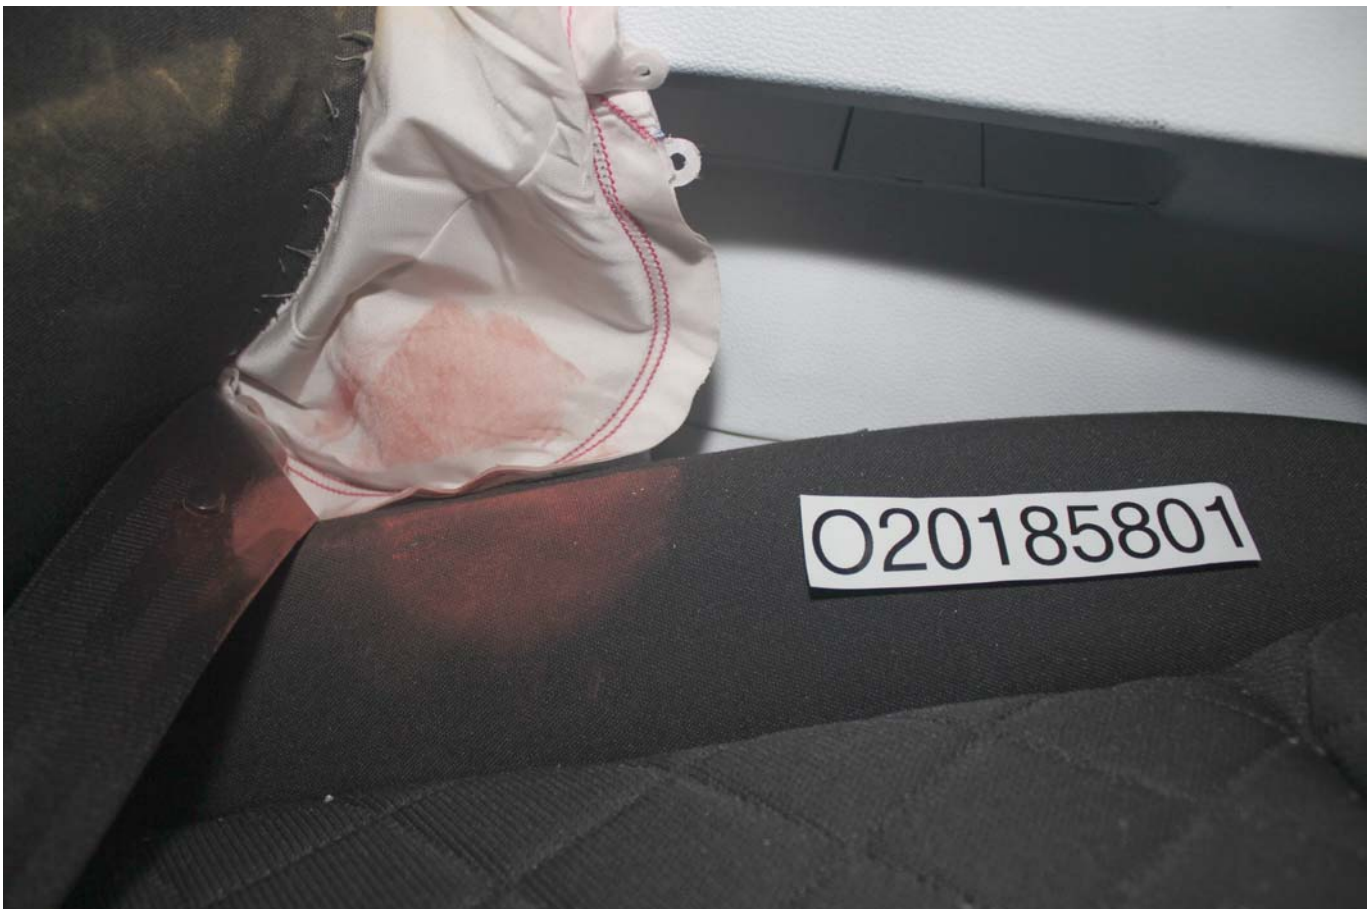
Photo No. 050 - Post-Test Dummy Close-Up Pelvis Contact with Vehicle Interior View

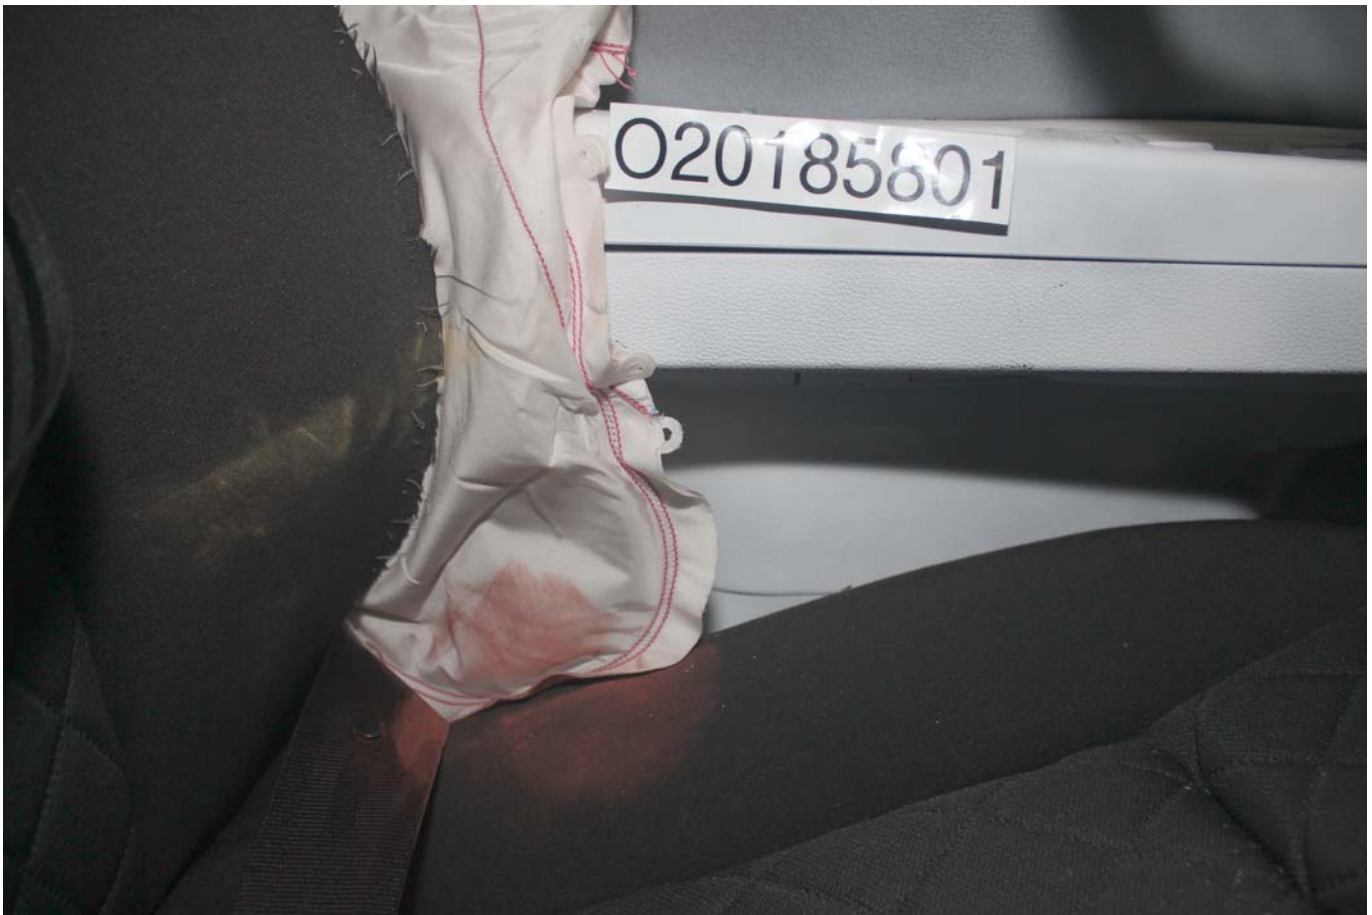
Photo No. 051 - Post-Test Dummy Close-Up Pelvis Contact with Side Air Bag View

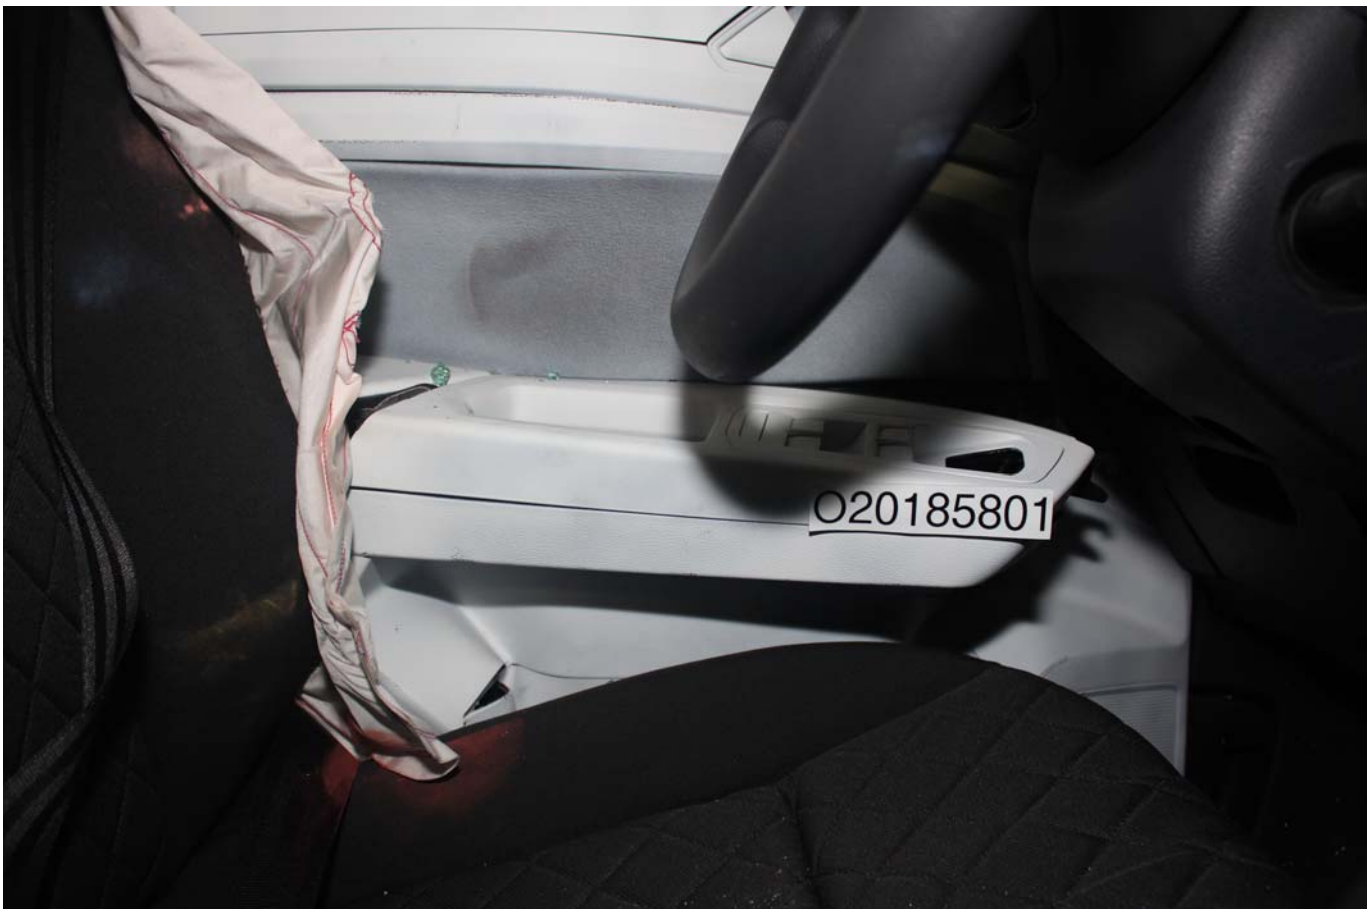
Photo No. 052 - Post-Test Dummy Close-Up Knee Contact with Vehicle Interior View

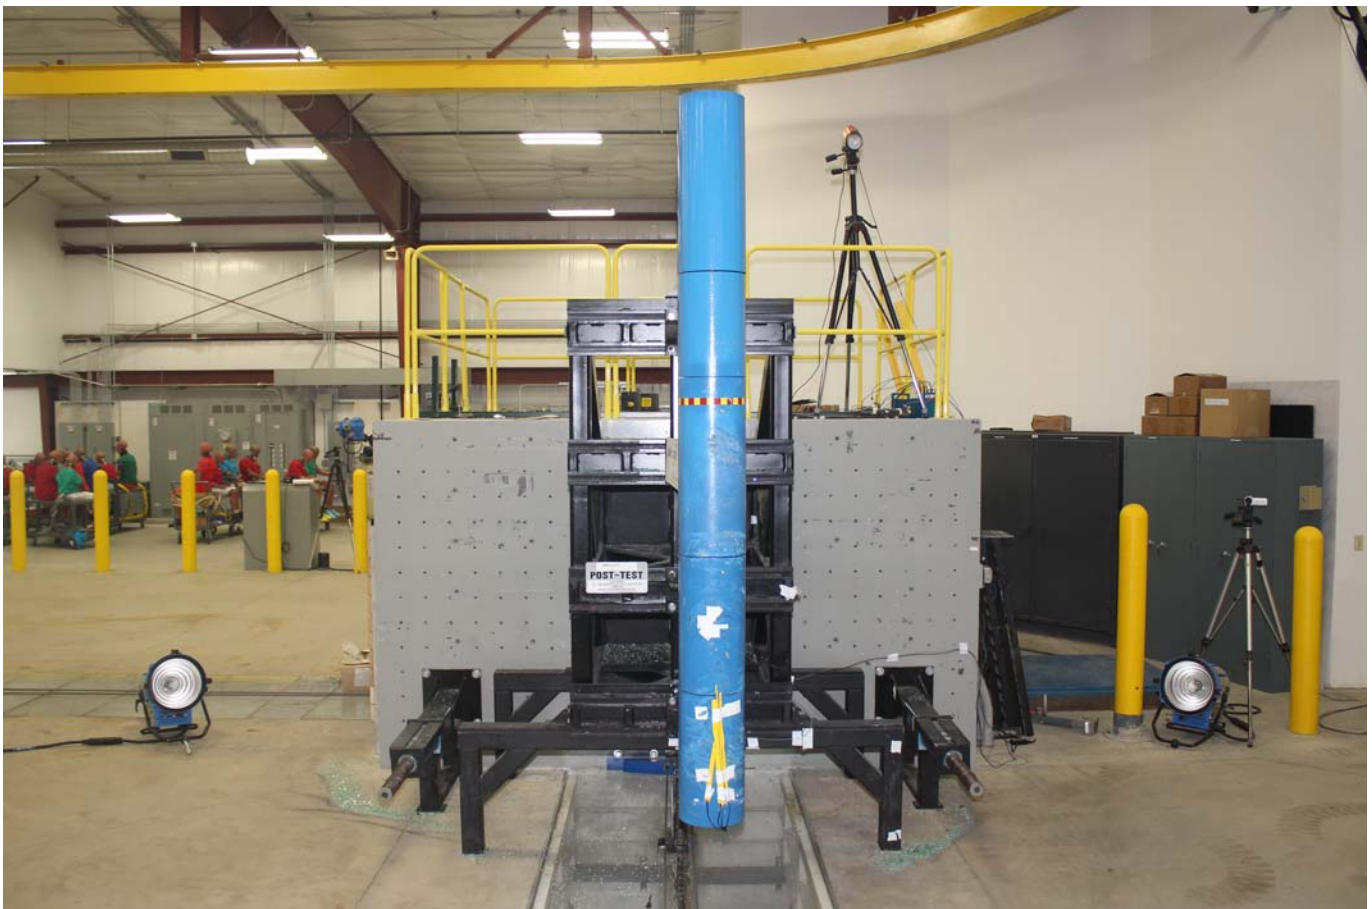
Photo No. 058 - Post-Test Pole Barrier Front View

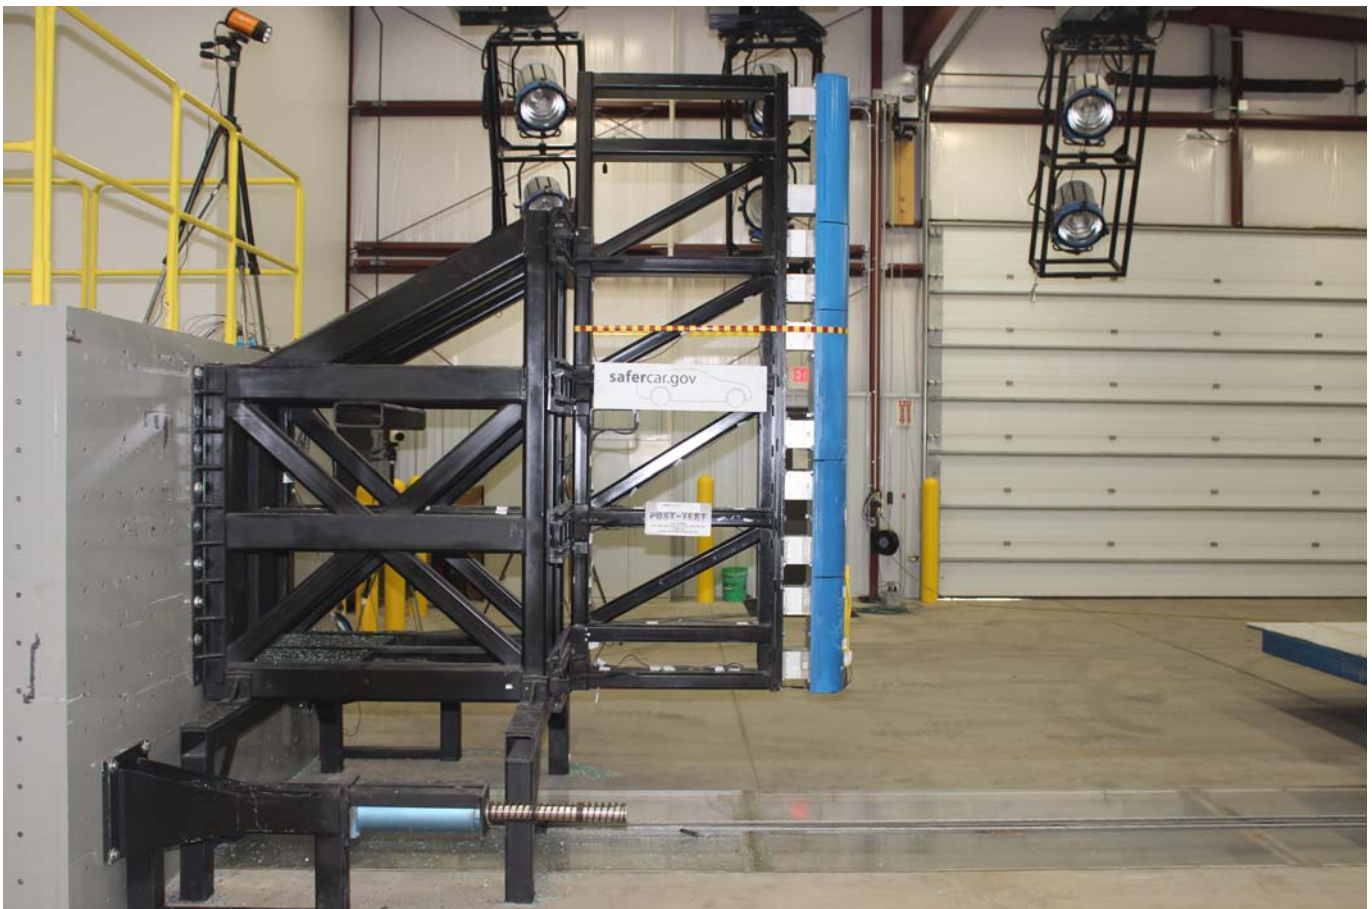
Photo No. 060 - Post-Test Pole Barrier Side View

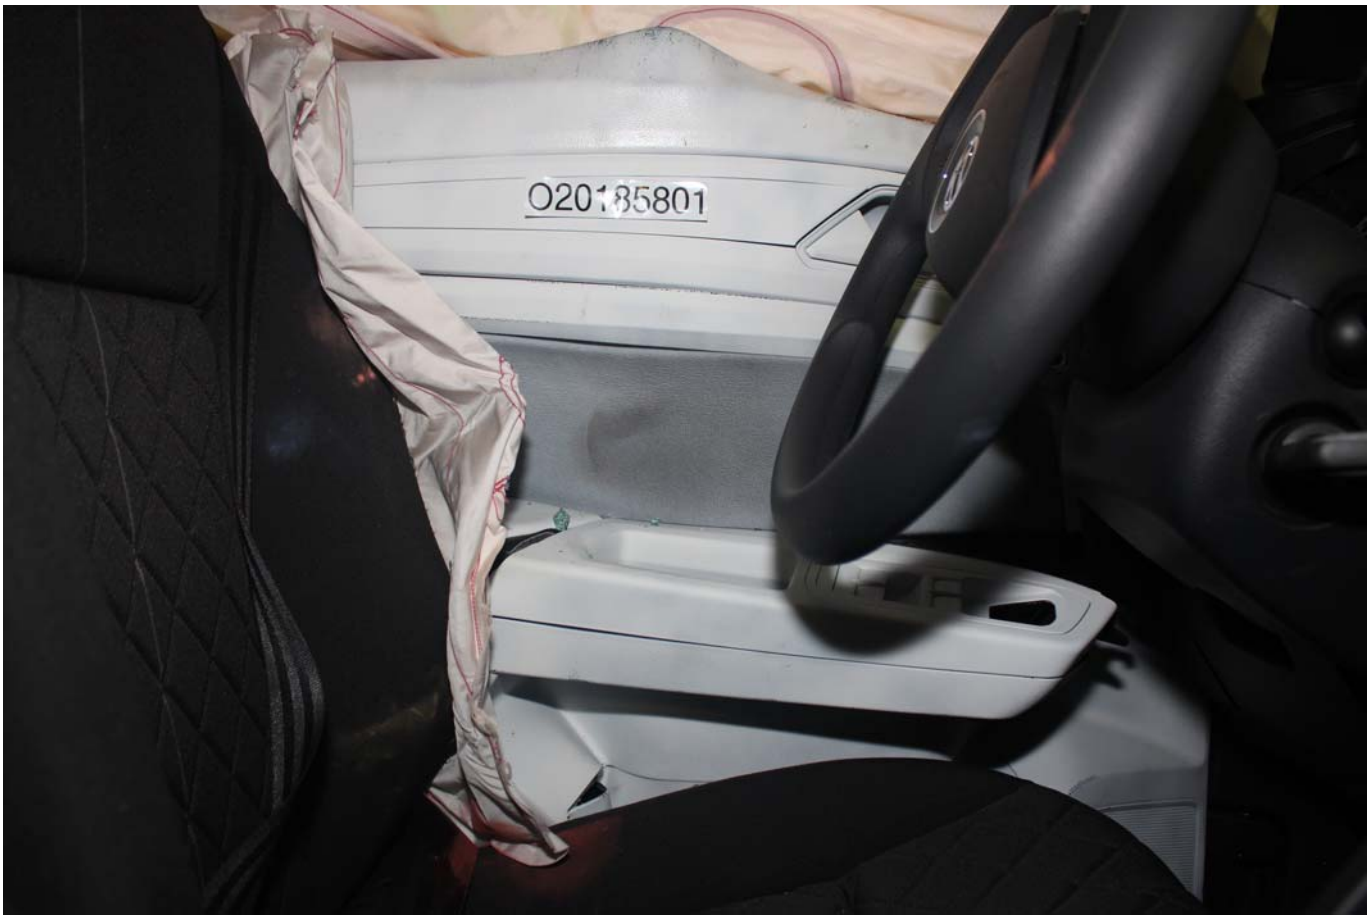
Photo No. 071 - Post-Test View of Shattered Vehicle Inner Door Panel
