**REPORT NUMBER: SINCAP-MGA-2018-005**

**NEW CAR ASSESSMENT PROGRAM (NCAP)  
Moving Deformable Barrier Side Impact Test**

**VOLKSWAGEN GROUP OF AMERICA CHATTANOOGA OPERATIONS, LLC  
2018 Volkswagen Atlas Launch Edition 5-Door SUV  
NHTSA No.: O20185802**

**FINAL REPORT**

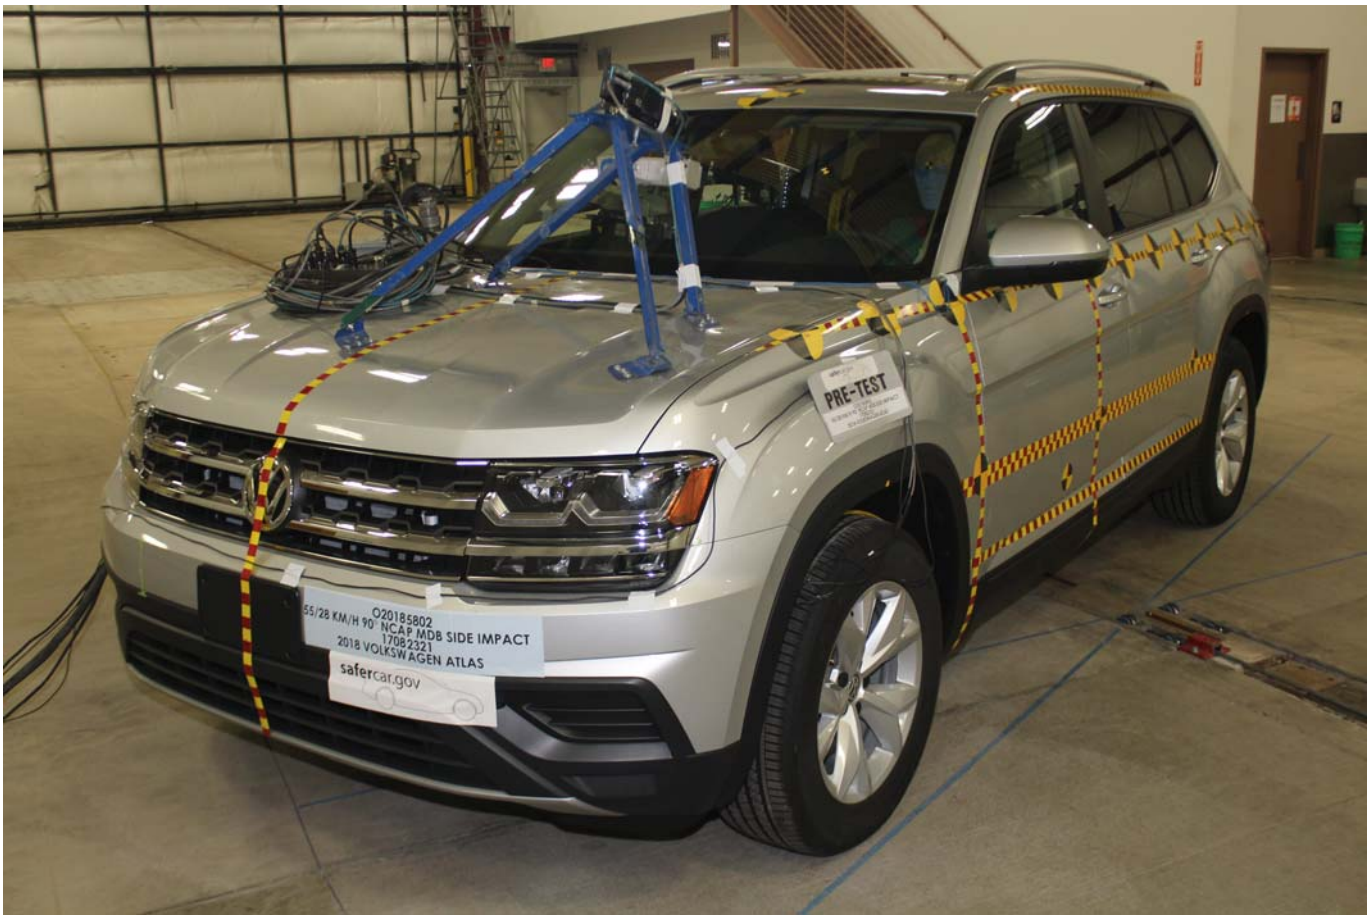
Photo No. 005 - Pre-Test Left Front Three-Quarter View of Test Vehicle

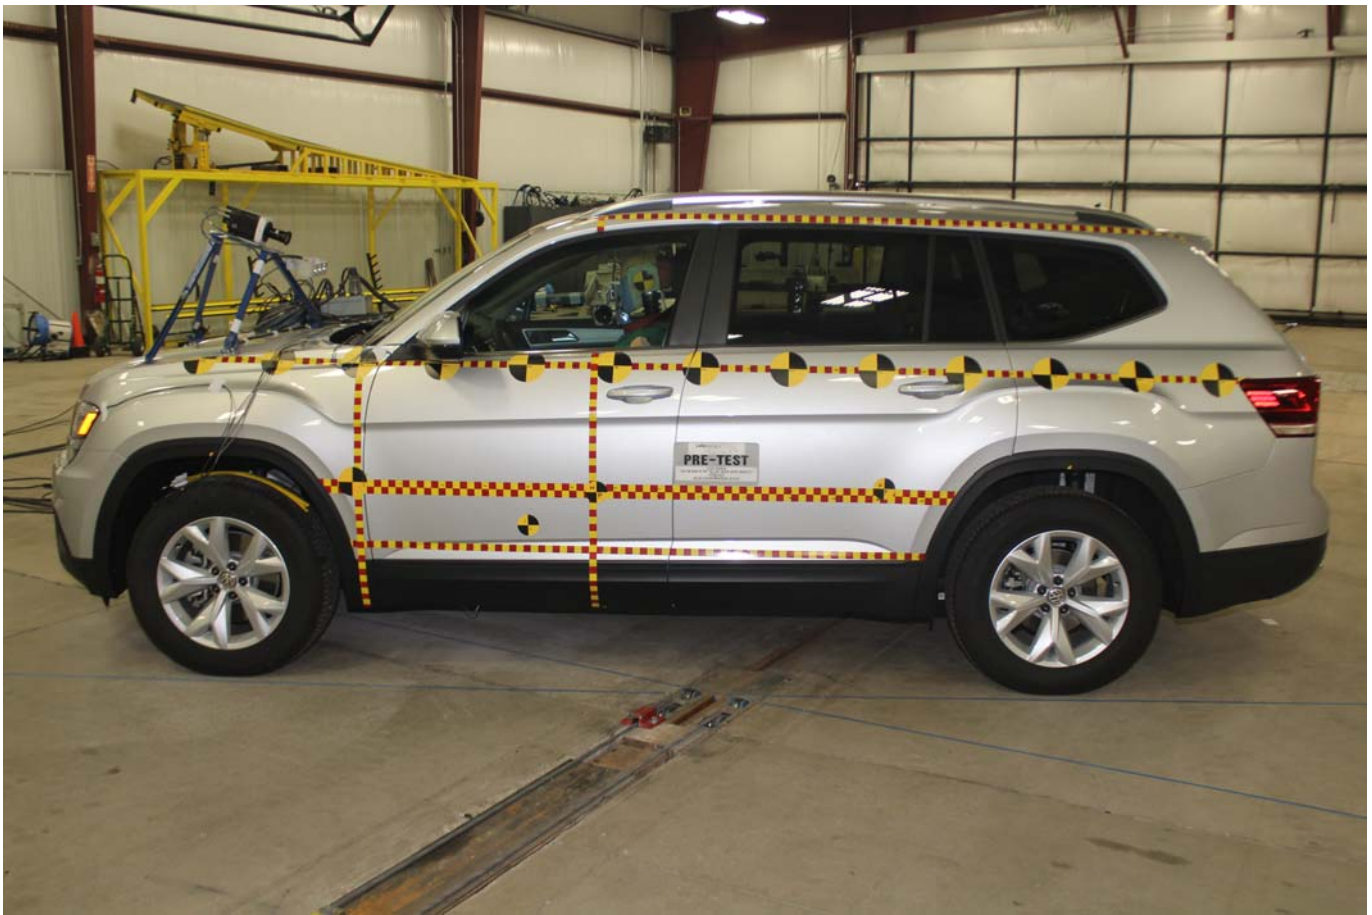
Photo No. 007 - Pre-Test Left Side View of Test Vehicle

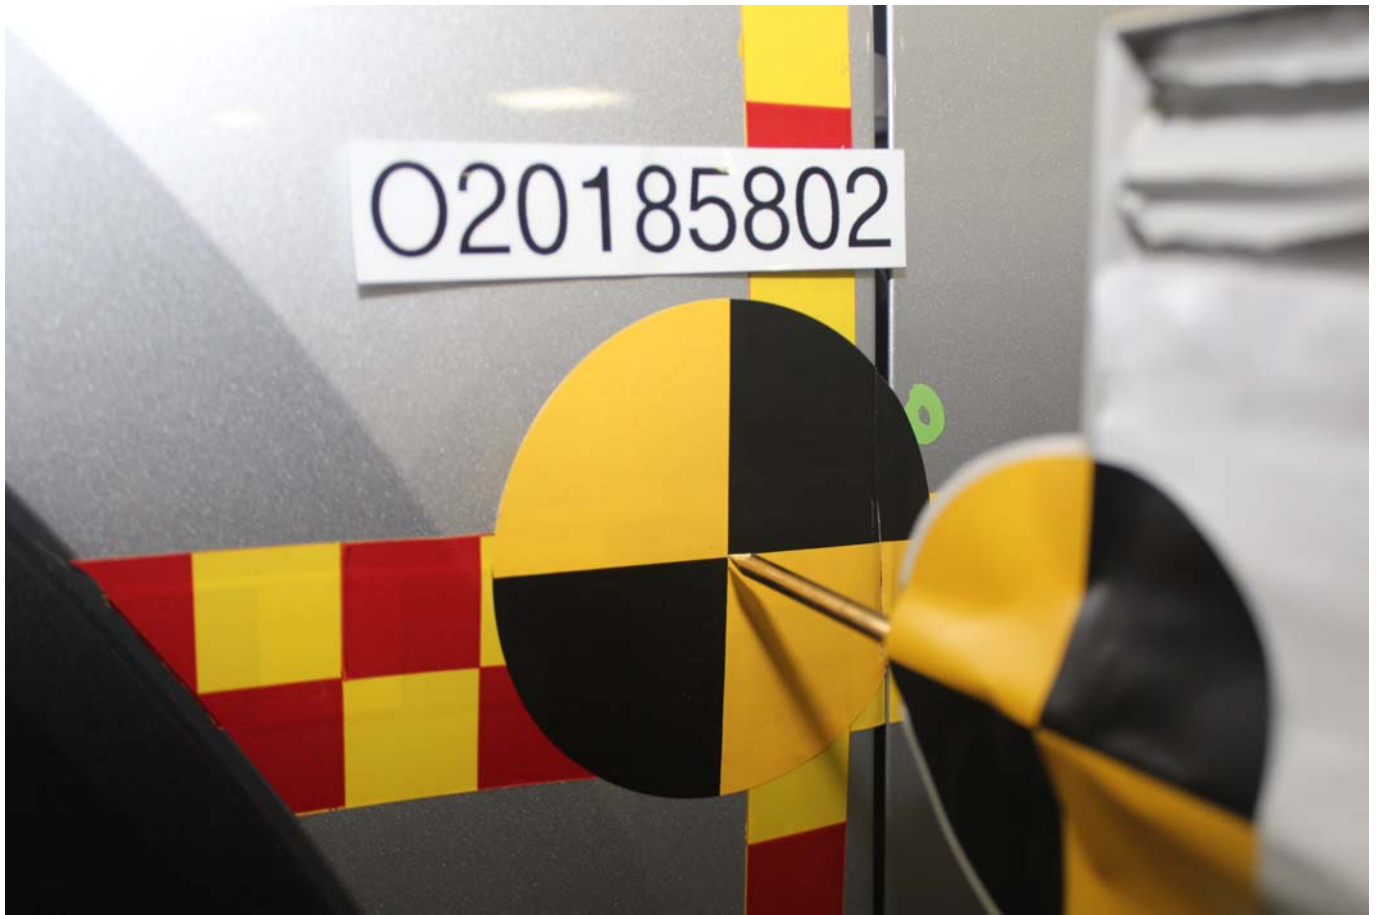
Photo No. 019 - Pre-Test Close-Up View of Impact Point Target

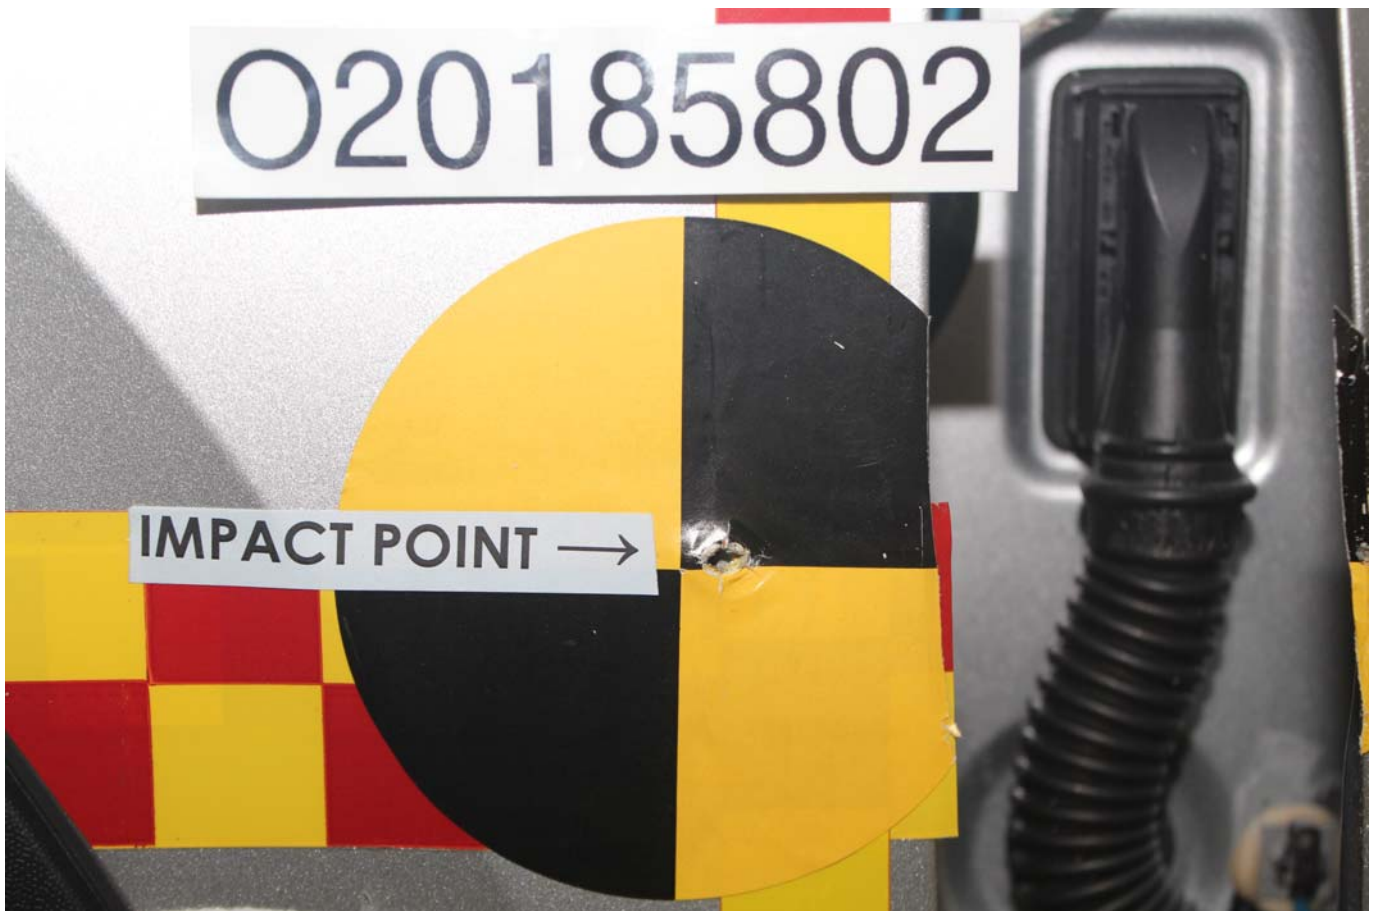
Photo No. 020 - Post-Test Close-Up View of Impact Point Target

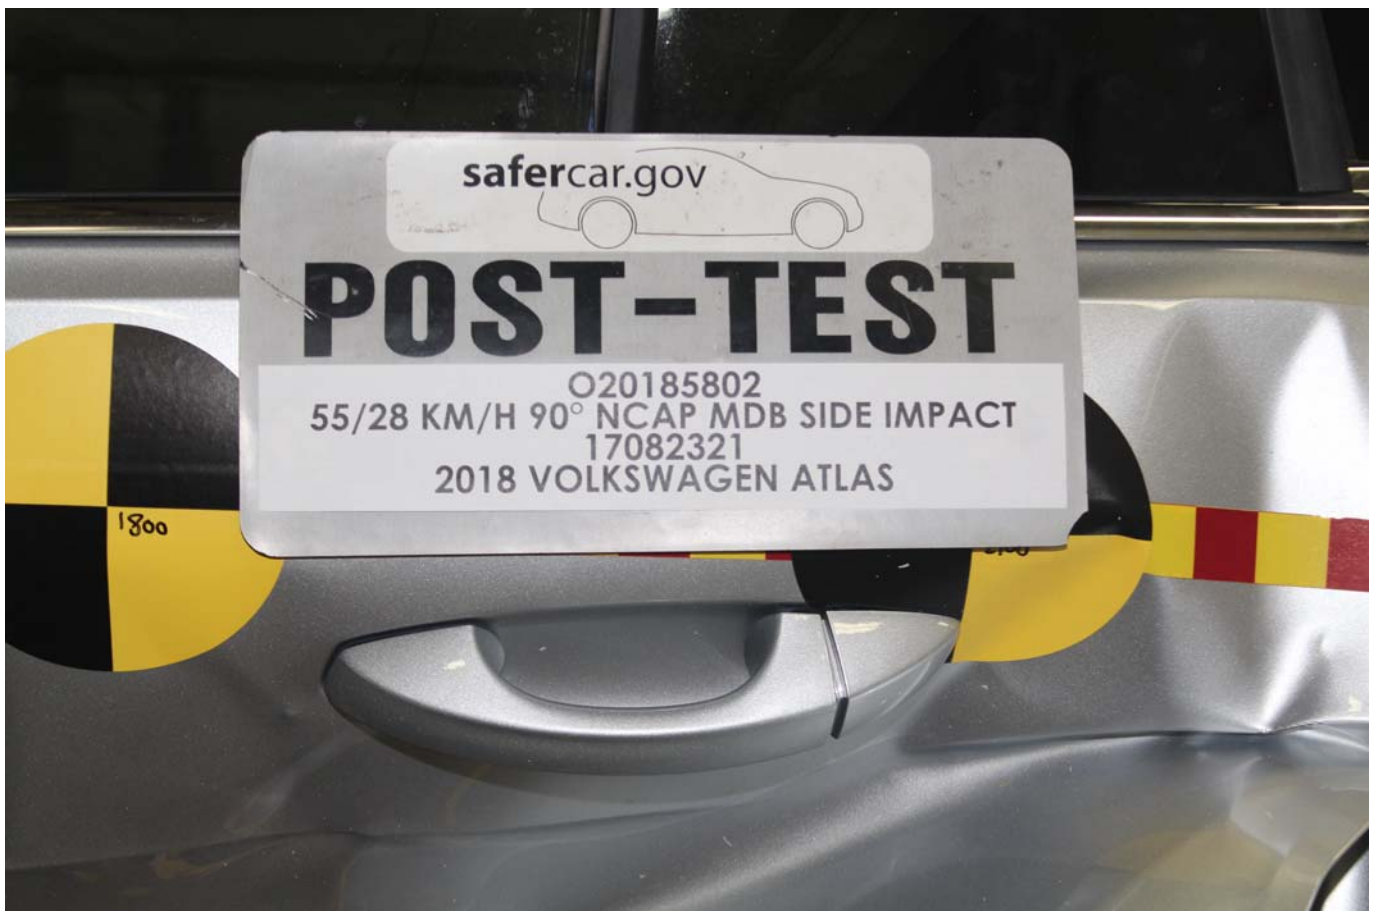
Photo No. 024 - Post-Test Left Rear Door Latch Close-Up

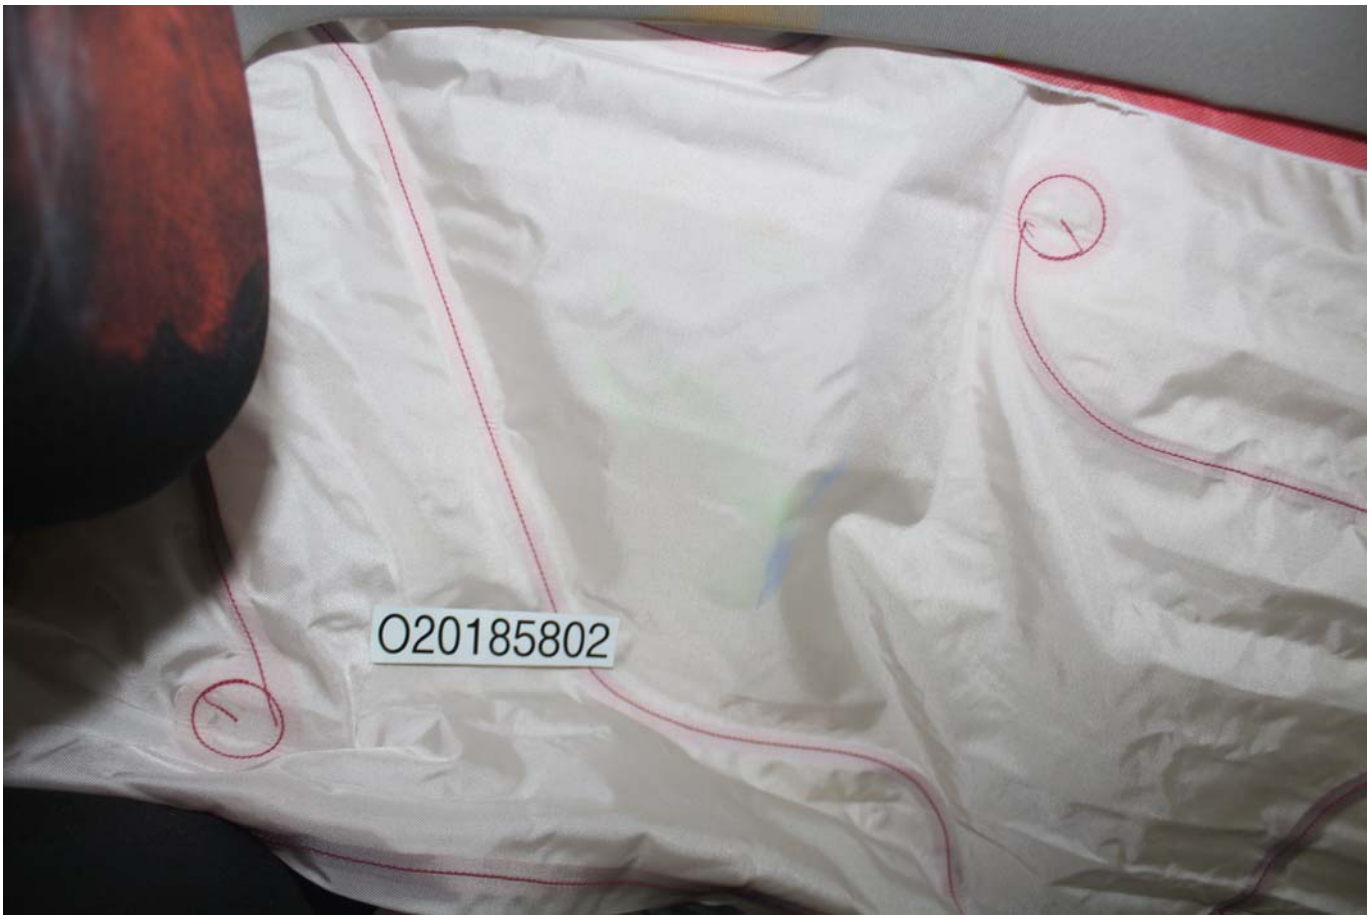
Photo No. 049 - Post-Test Driver Dummy Close-up Head Contact with Side Airbag View

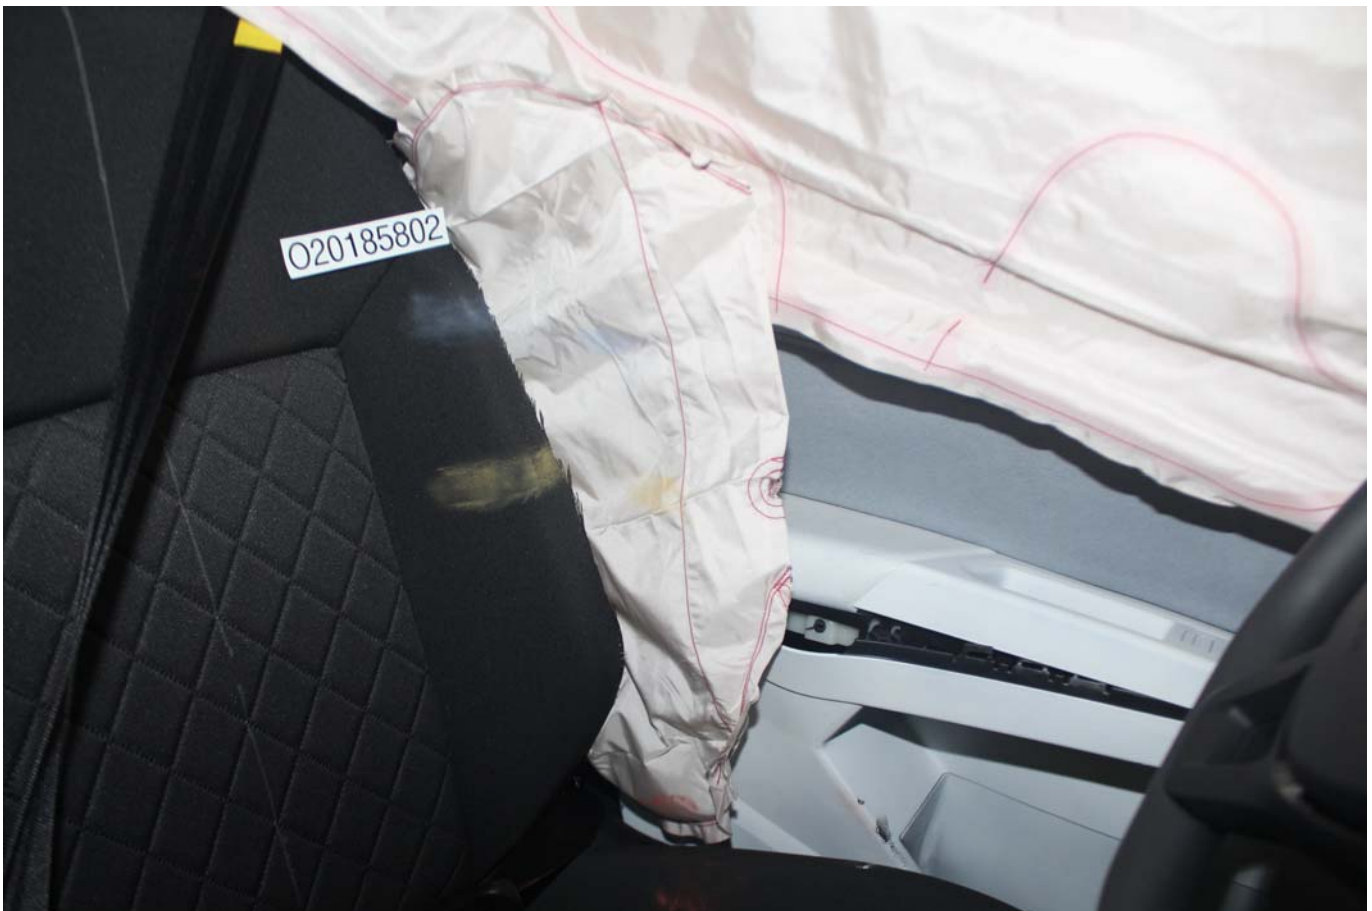
Photo No. 050 - Post-Test Driver Dummy Close-up Torso Contact with Vehicle Interior View

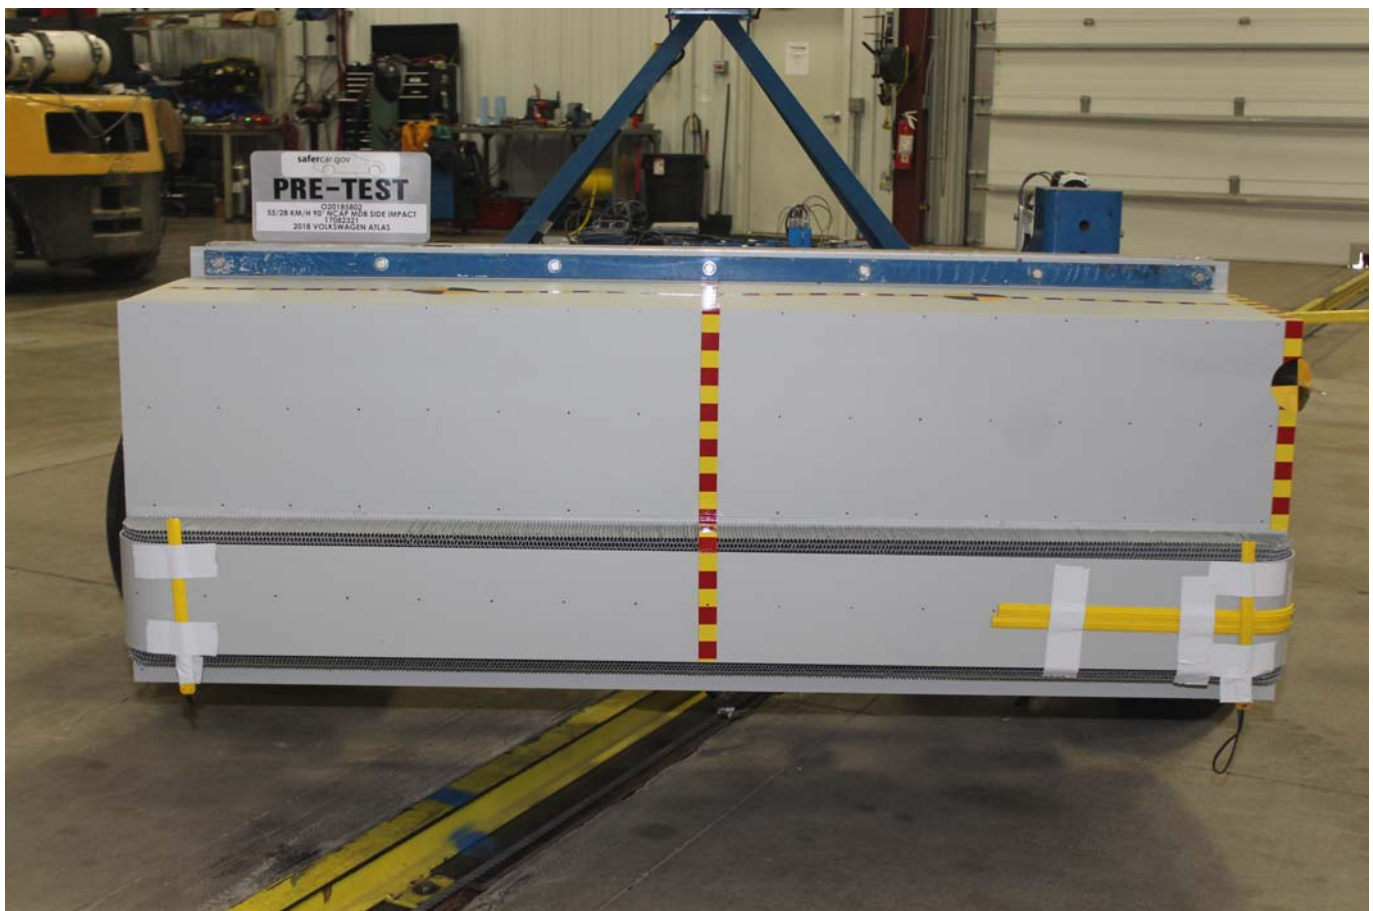
Photo No. 084 - Pre-Test Front View of MDB Impactor Face

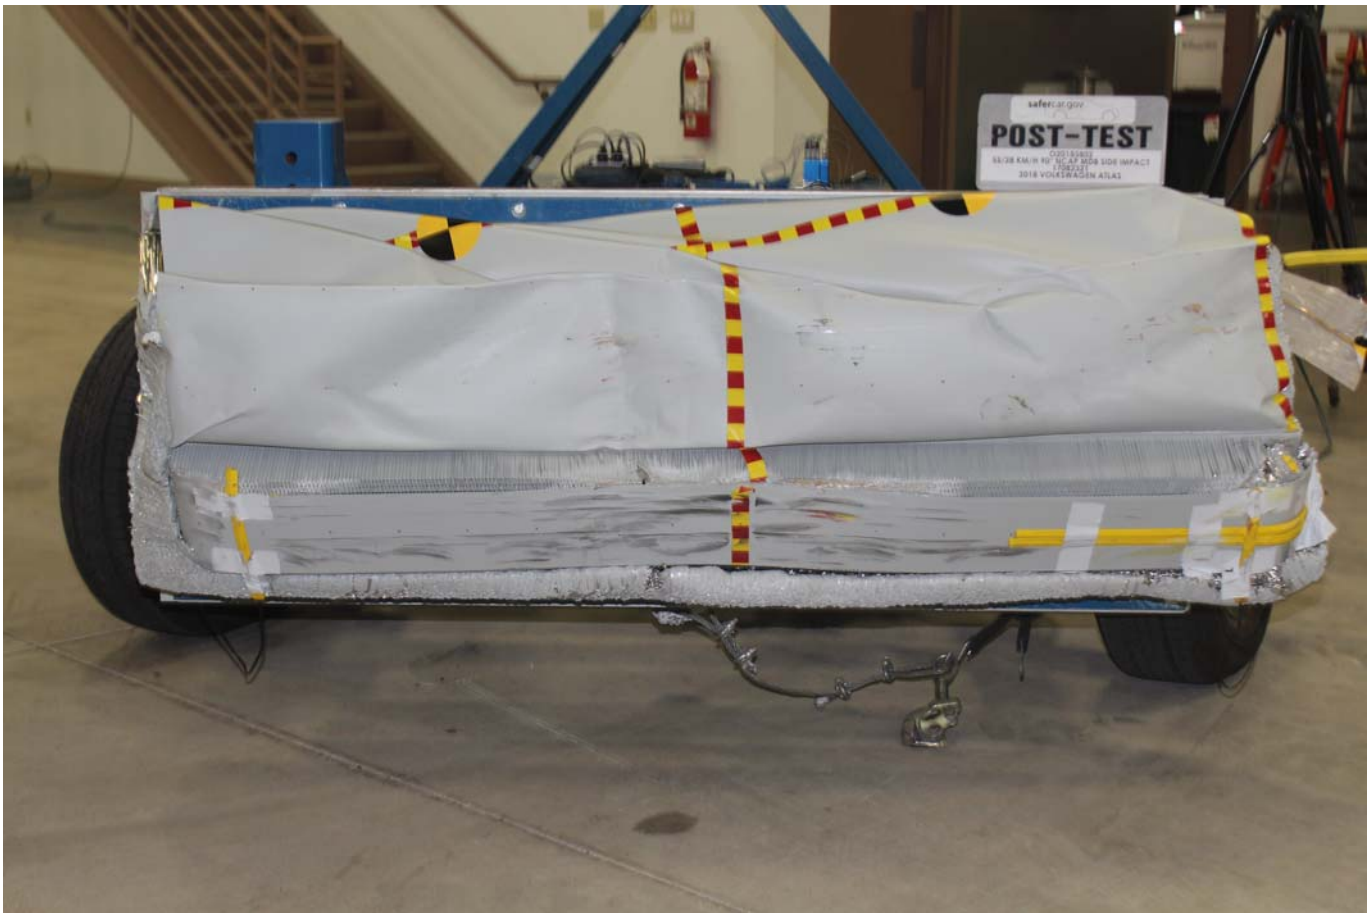
Photo No. 085 - Post-Test Front View of MDB Impactor Face
