**FINAL REPORT NUMBER: SINCAP-TRC-18-001**

**NEW CAR ASSESSMENT PROGRAM (NCAP)  
MOVING DEFORMABLE BARRIER SIDE IMPACT TEST**

**GENERAL MOTORS DE MEXICO, S. DE R.L. DE C.V.  
2018 Chevrolet Equinox SUV  
NHTSA NUMBER: M20180106**

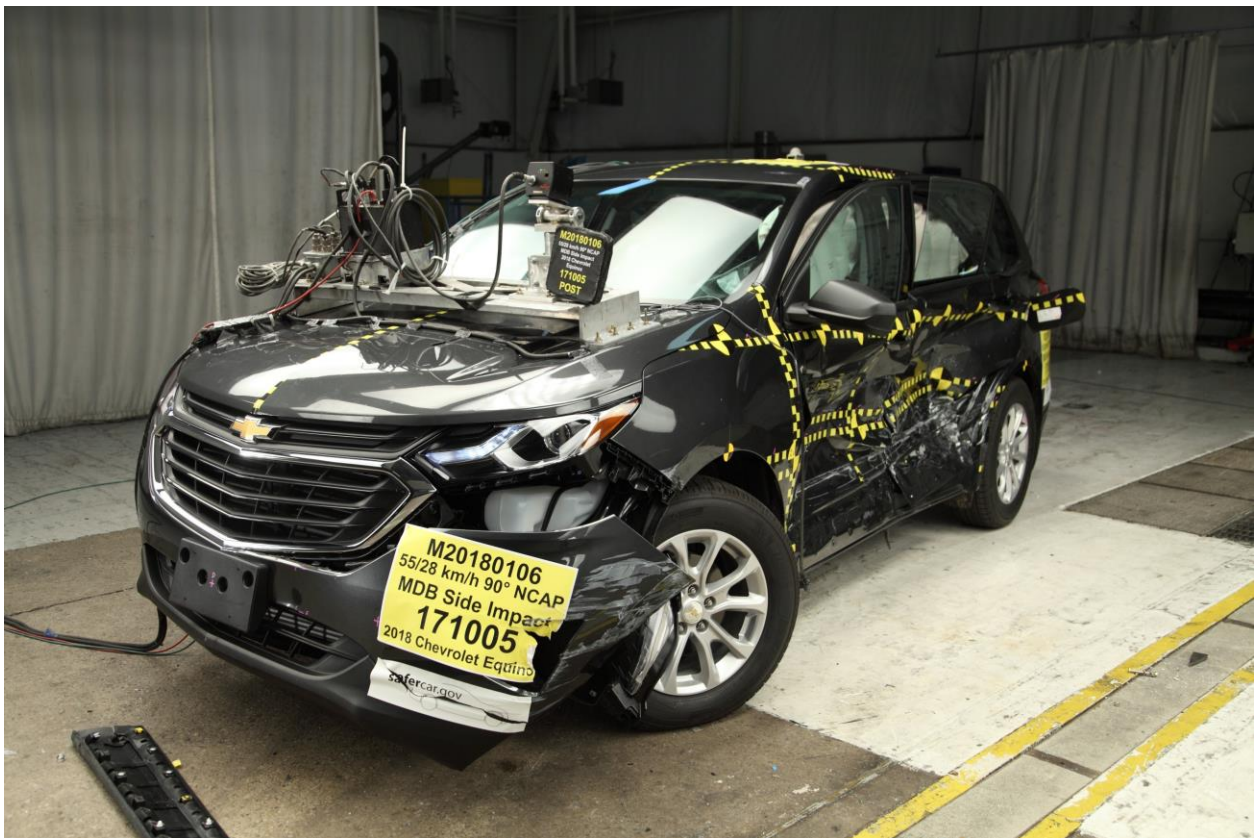
**006** Post-Test Left Front  $\frac{3}{4}$  View of Test Vehicle

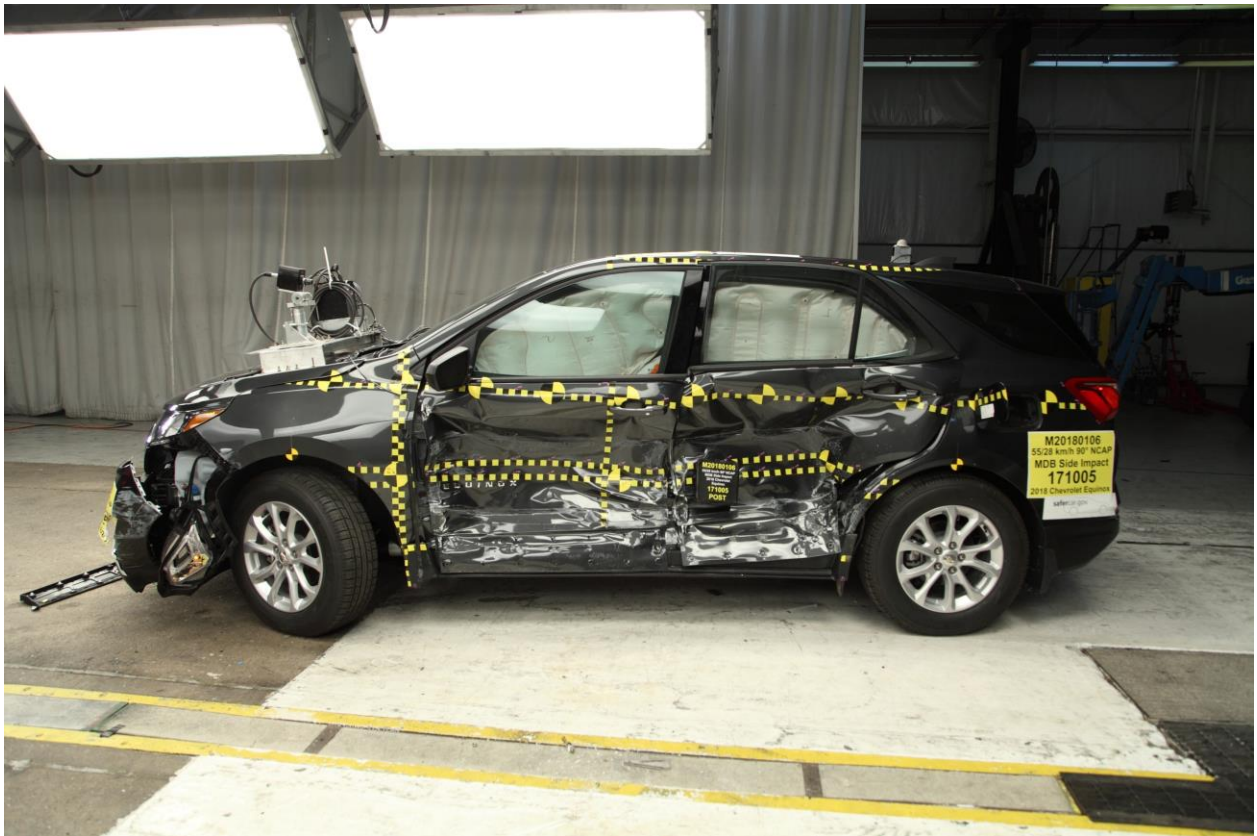
**008** Post-Test Left Side View of Test Vehicle

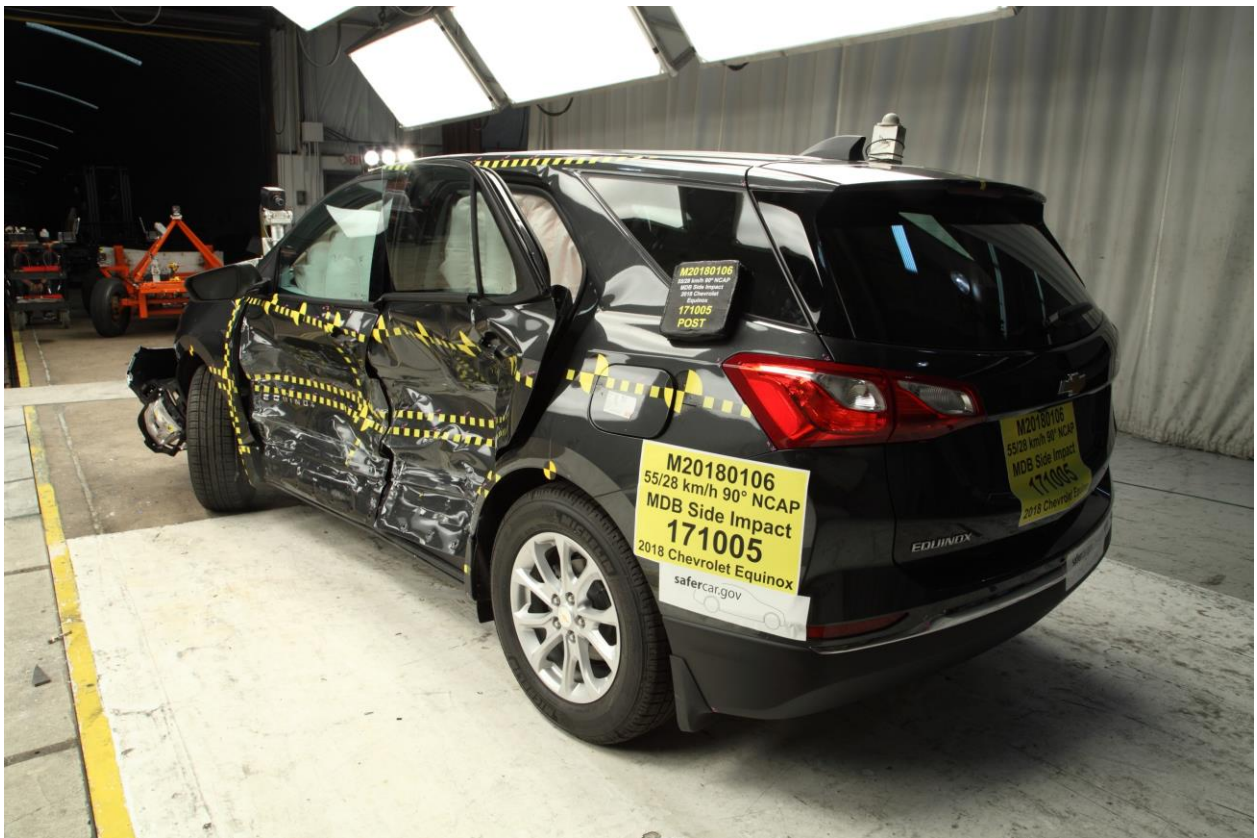
**010** Post-Test Left Rear  $\frac{3}{4}$  View of Test Vehicle

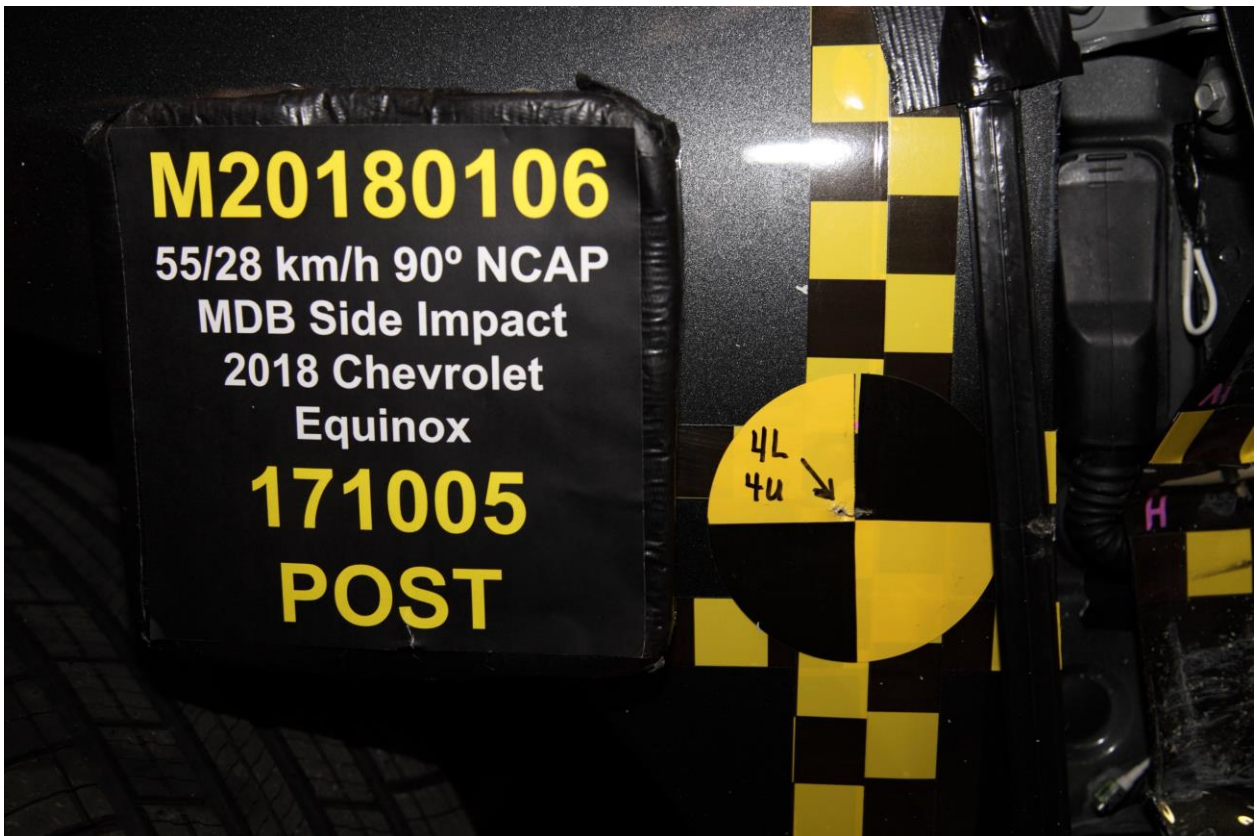
020 Post-Test Close-Up View of Impact Point Target

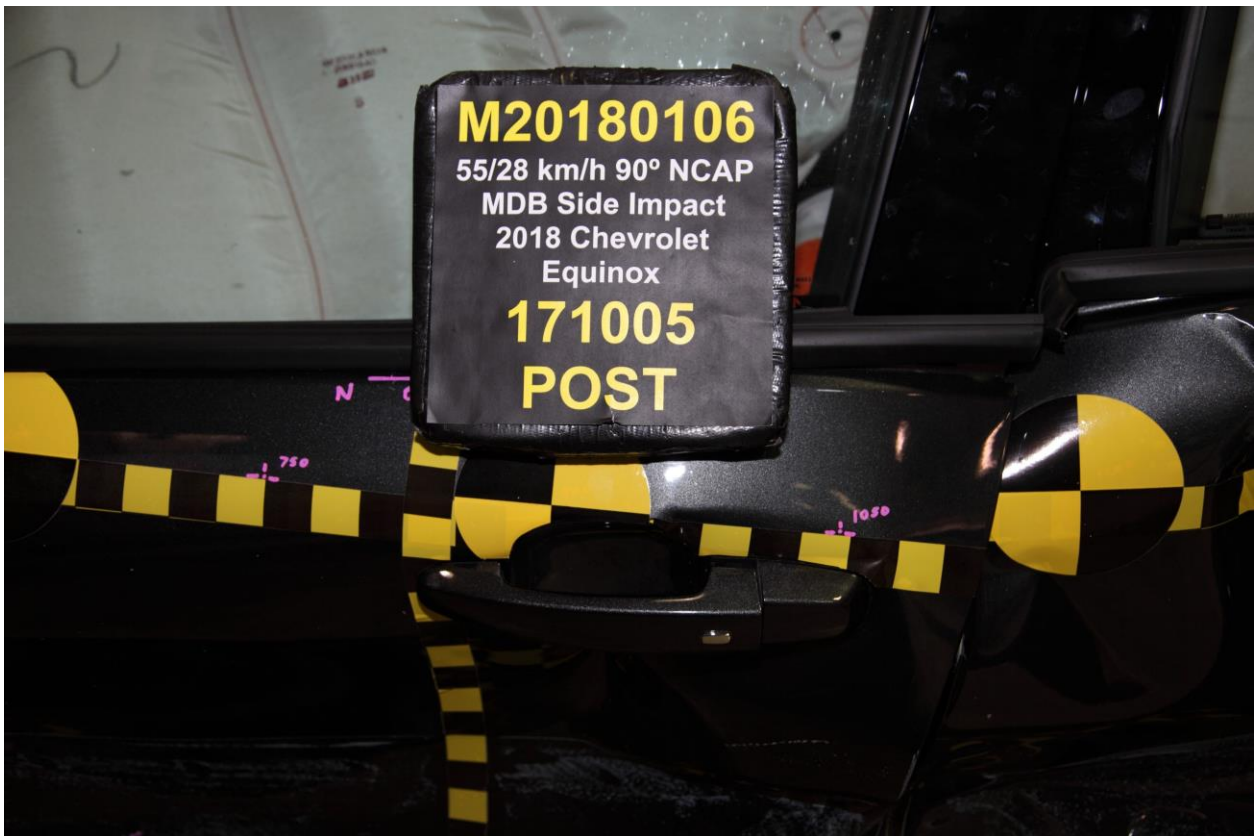
022 Post-Test Left Front Door Latch Close-Up

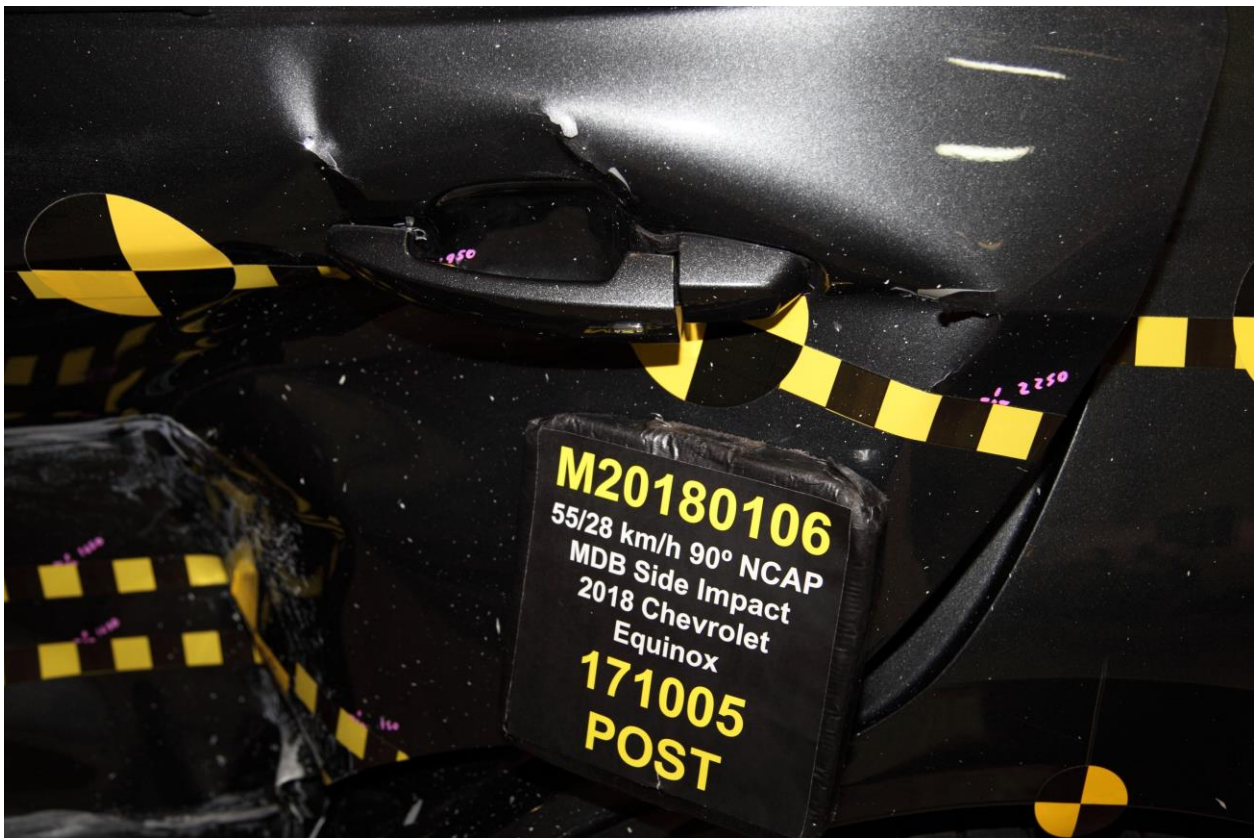
024 Post-Test Left Rear Door Latch Close-Up

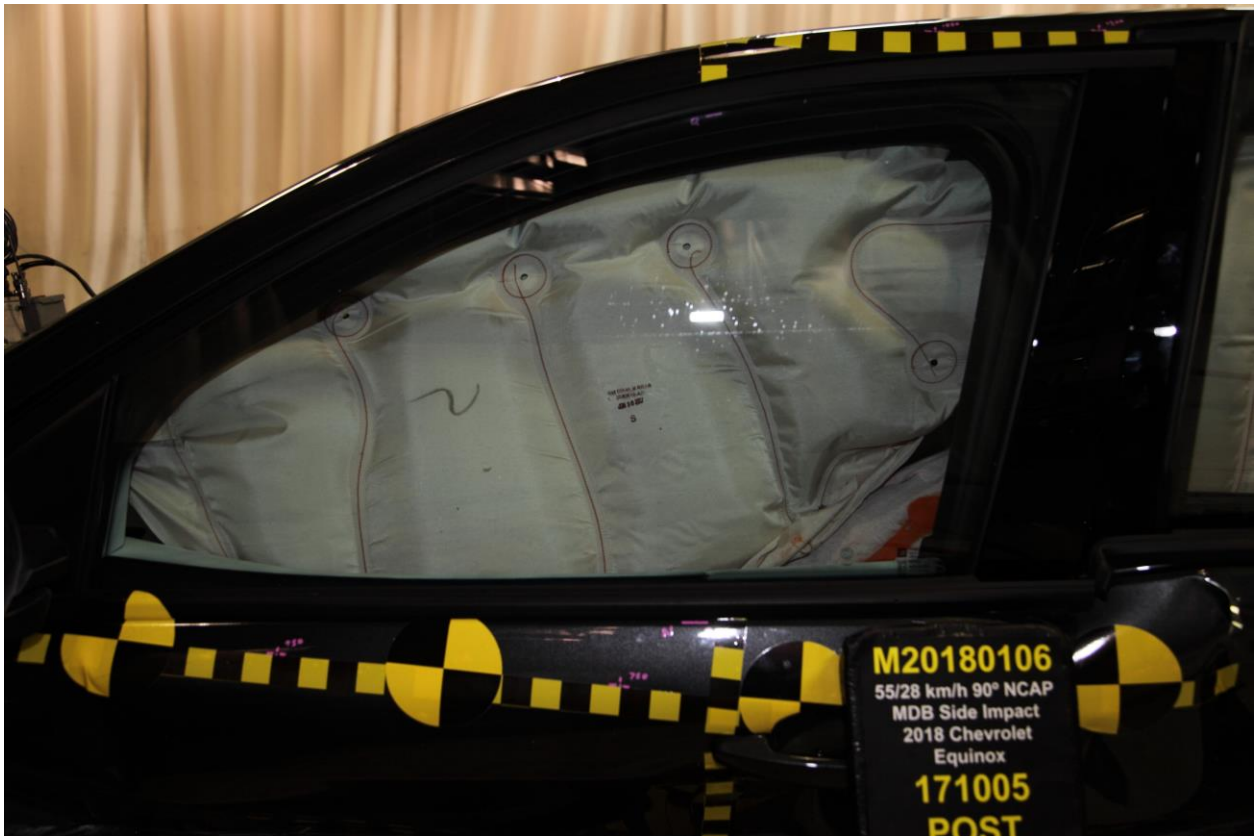
**029** Post-Test Left Side View of Driver Dummy Shoulder and Door Top

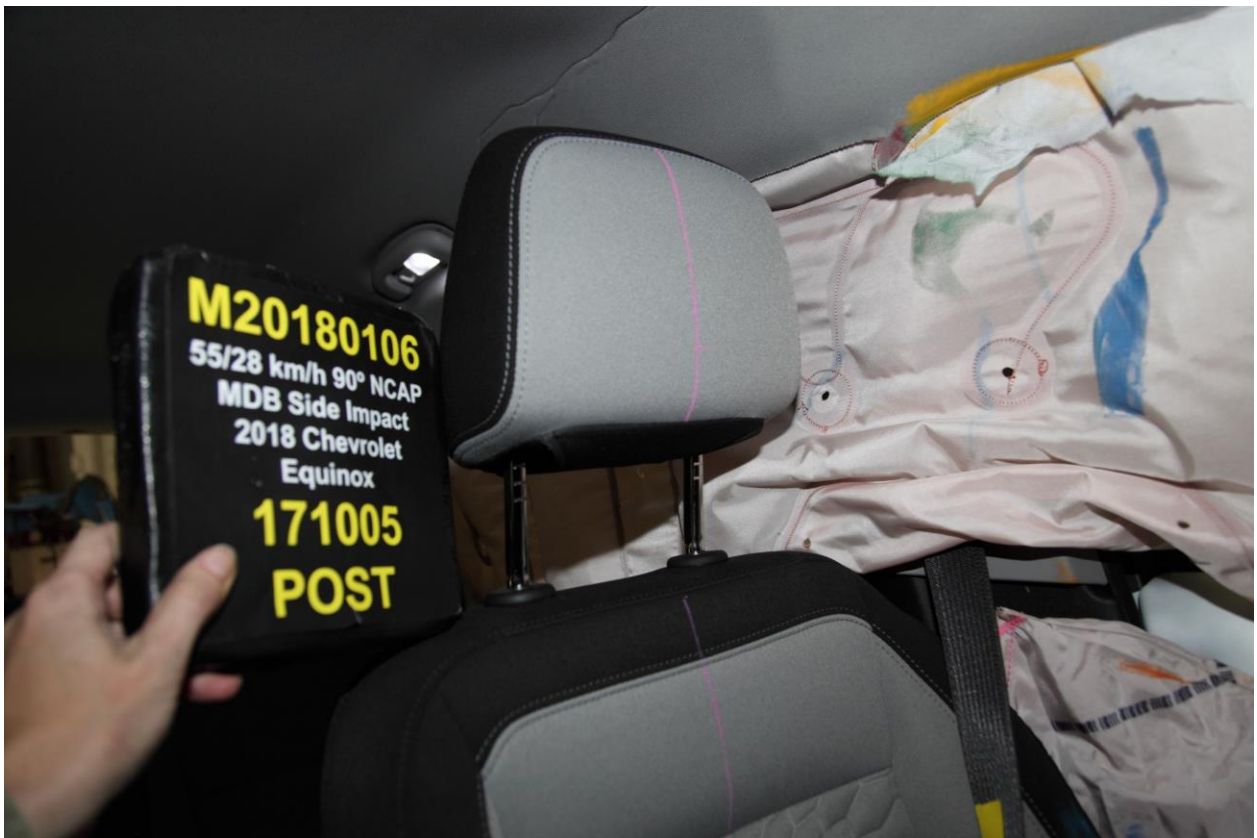
048 Post-Test Driver Dummy Close-Up Head Contact with Vehicle View

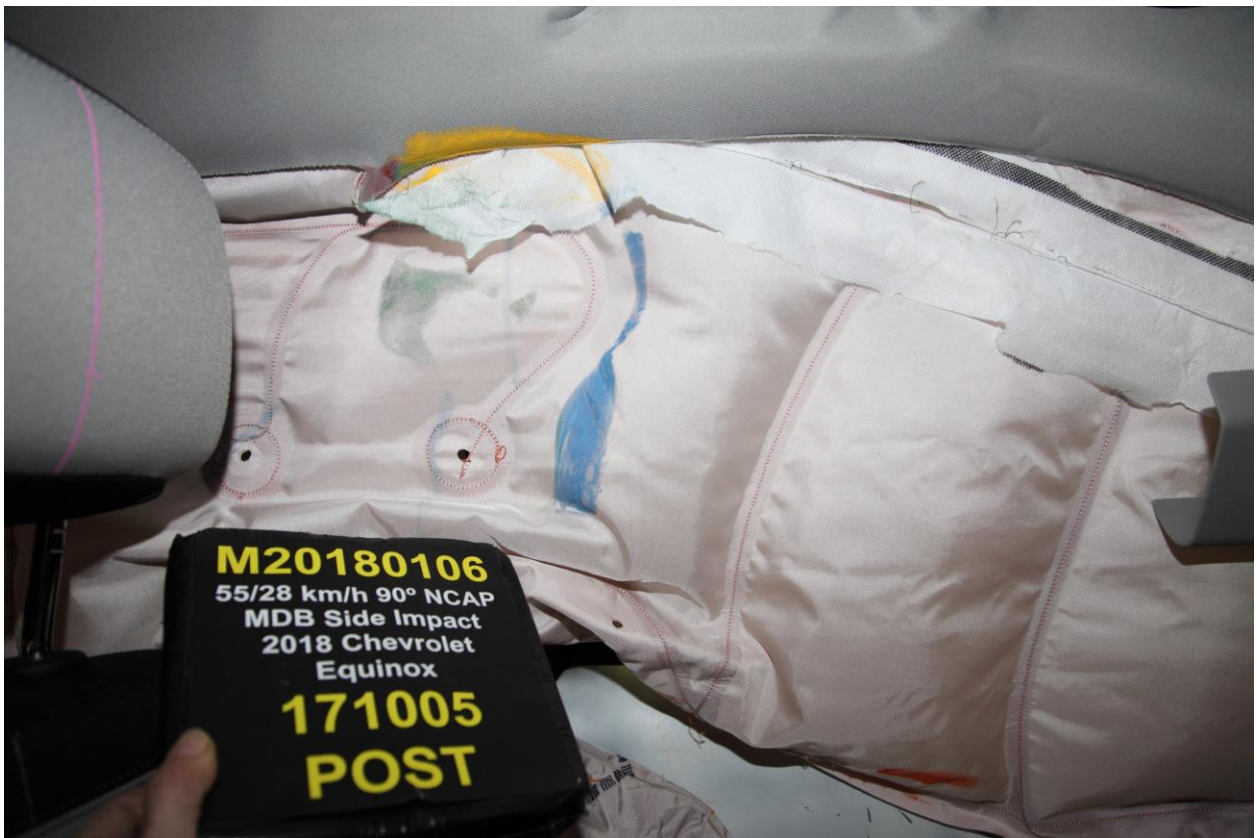
049 Post-Test Driver Dummy Close-Up Head Contact with Side Airbag View

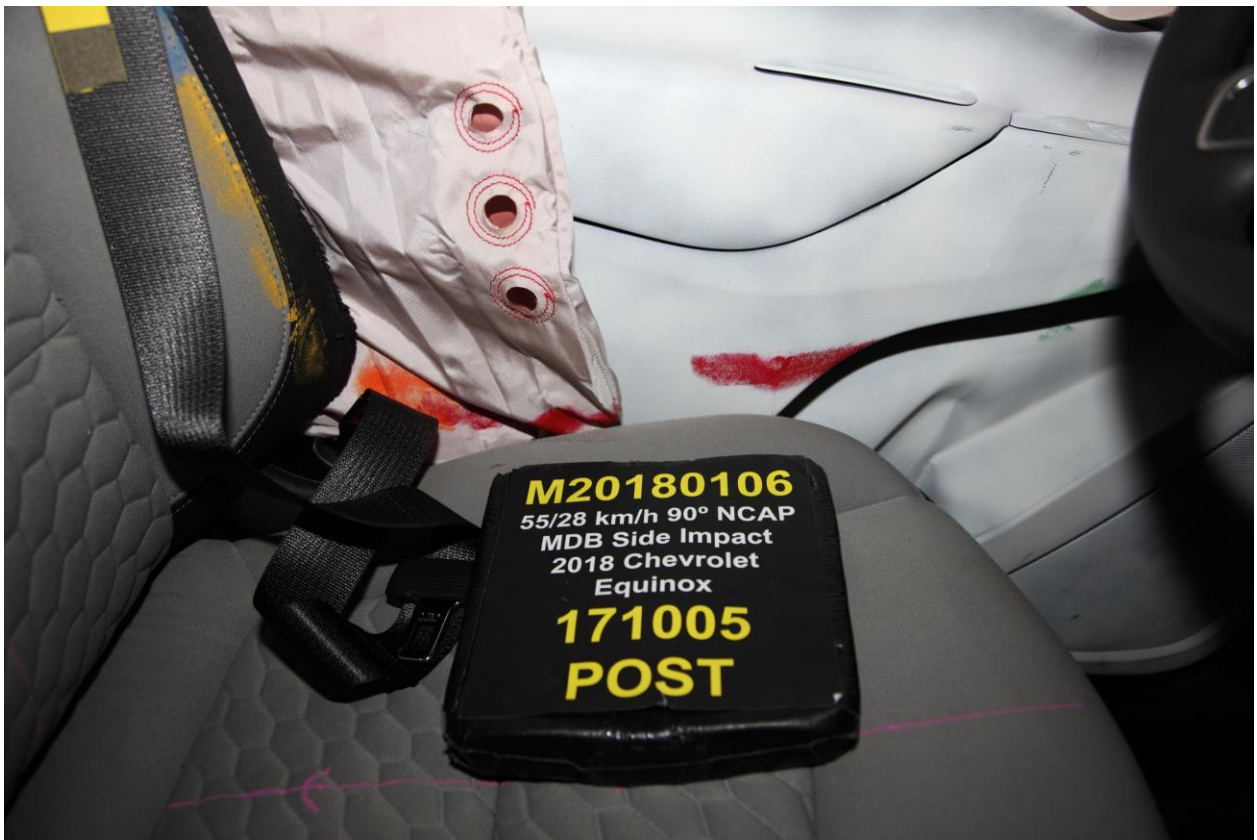
052 Post-Test Driver Dummy Close-Up Pelvis Contact View

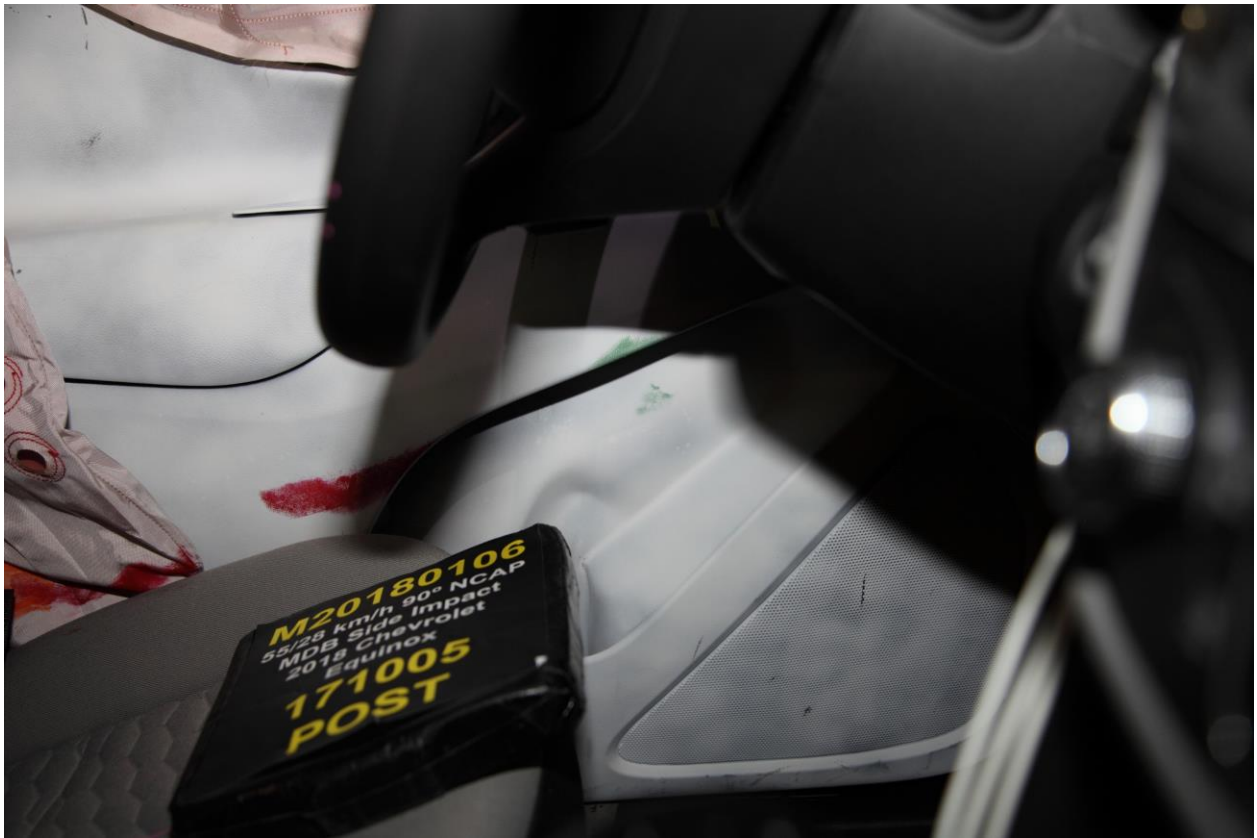
**054** Post-Test Driver Dummy Close-Up Knee Contact View

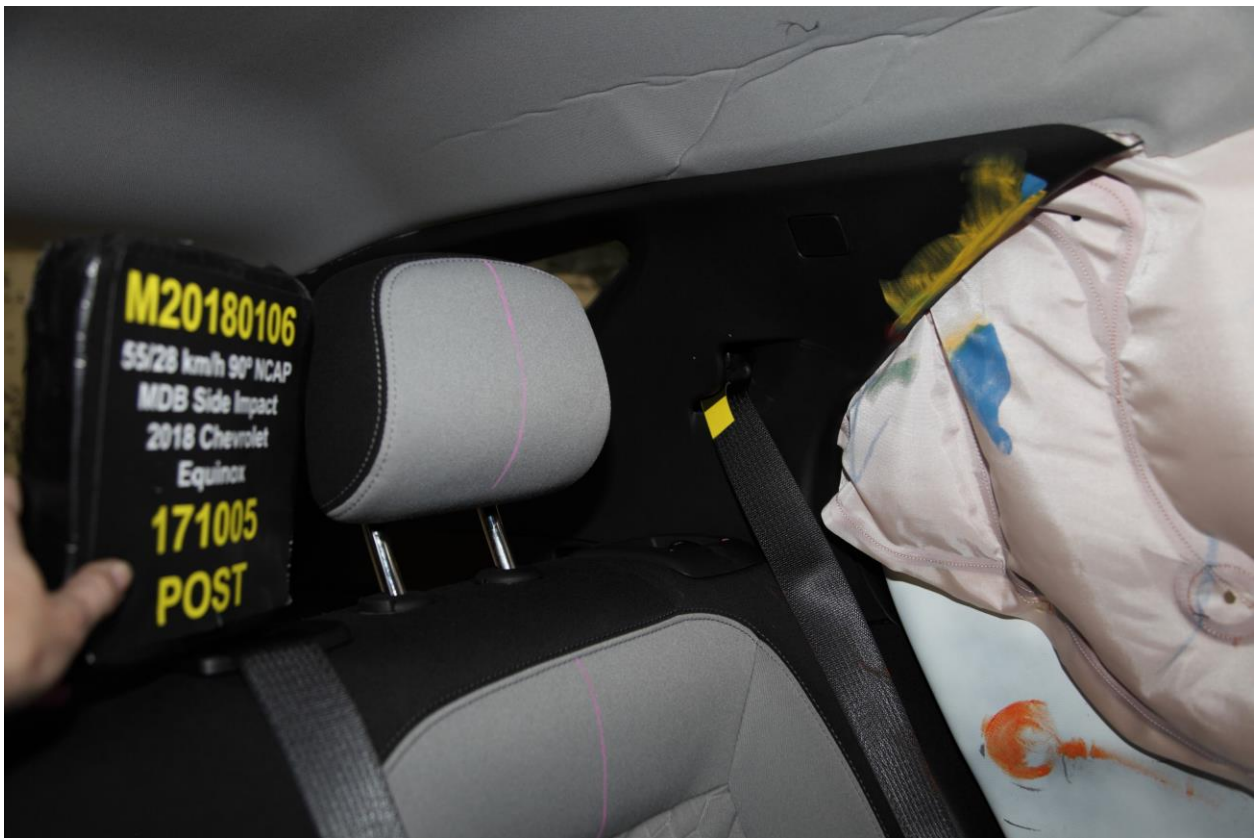
075 Post-Test Rear Passenger Dummy Close-Up Head Contact with Vehicle View

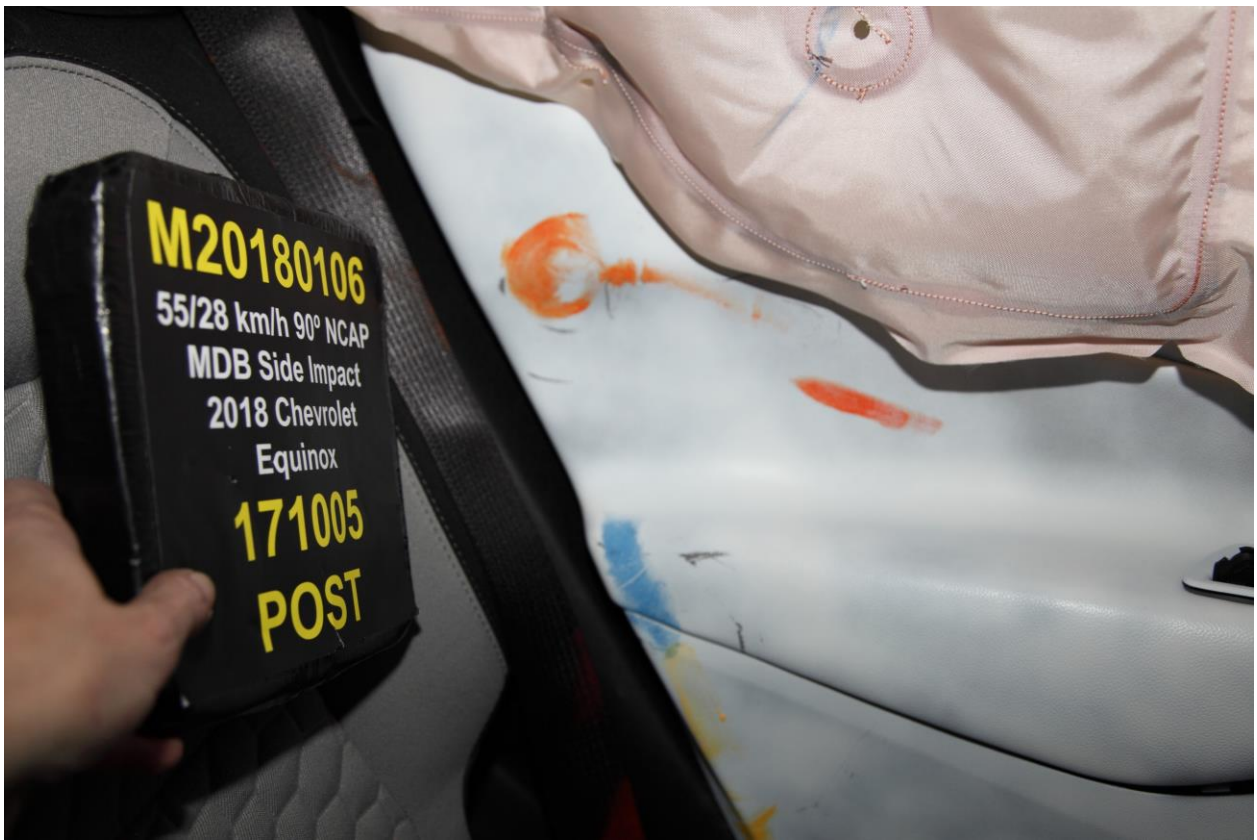
**077** Post-Test Rear Passenger Dummy Close-Up Torso Contact with Vehicle Interior View

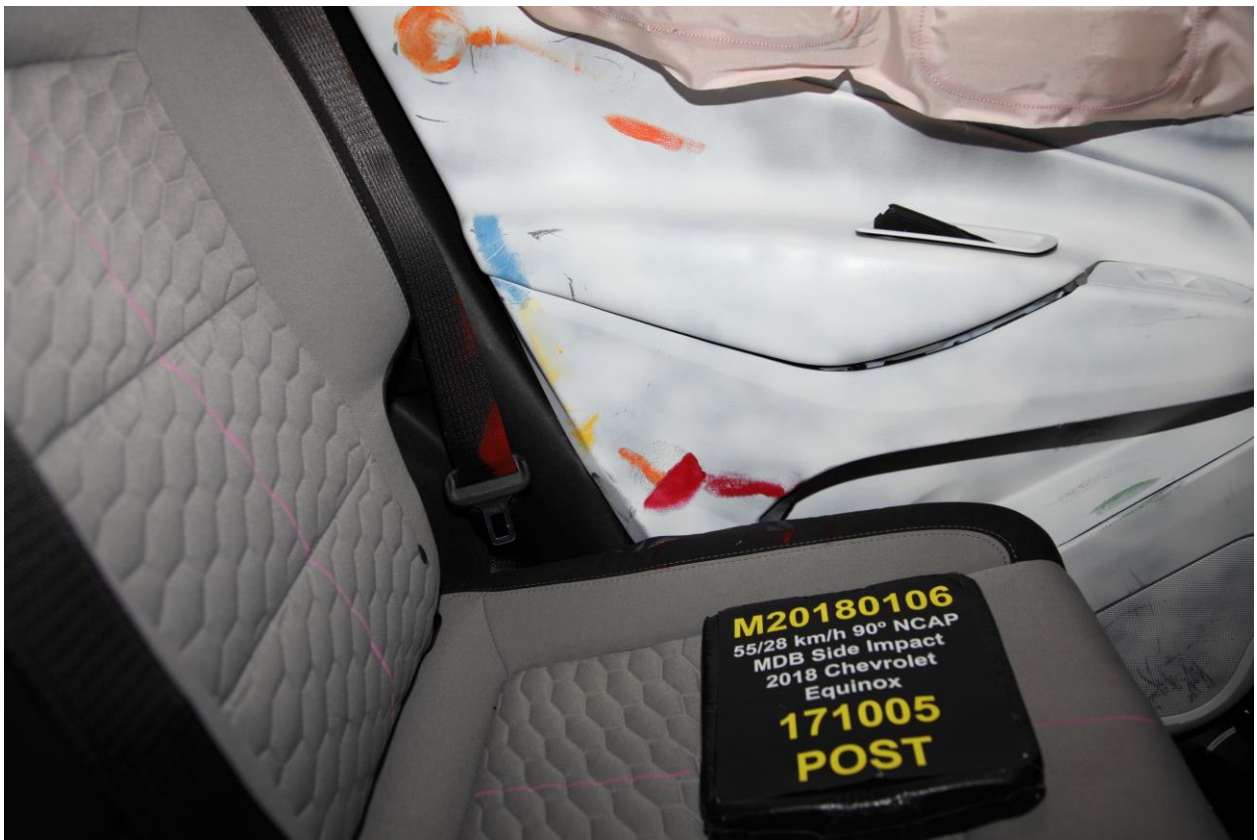
**079** Post-Test Rear Passenger Dummy Close-Up Pelvis Contact View

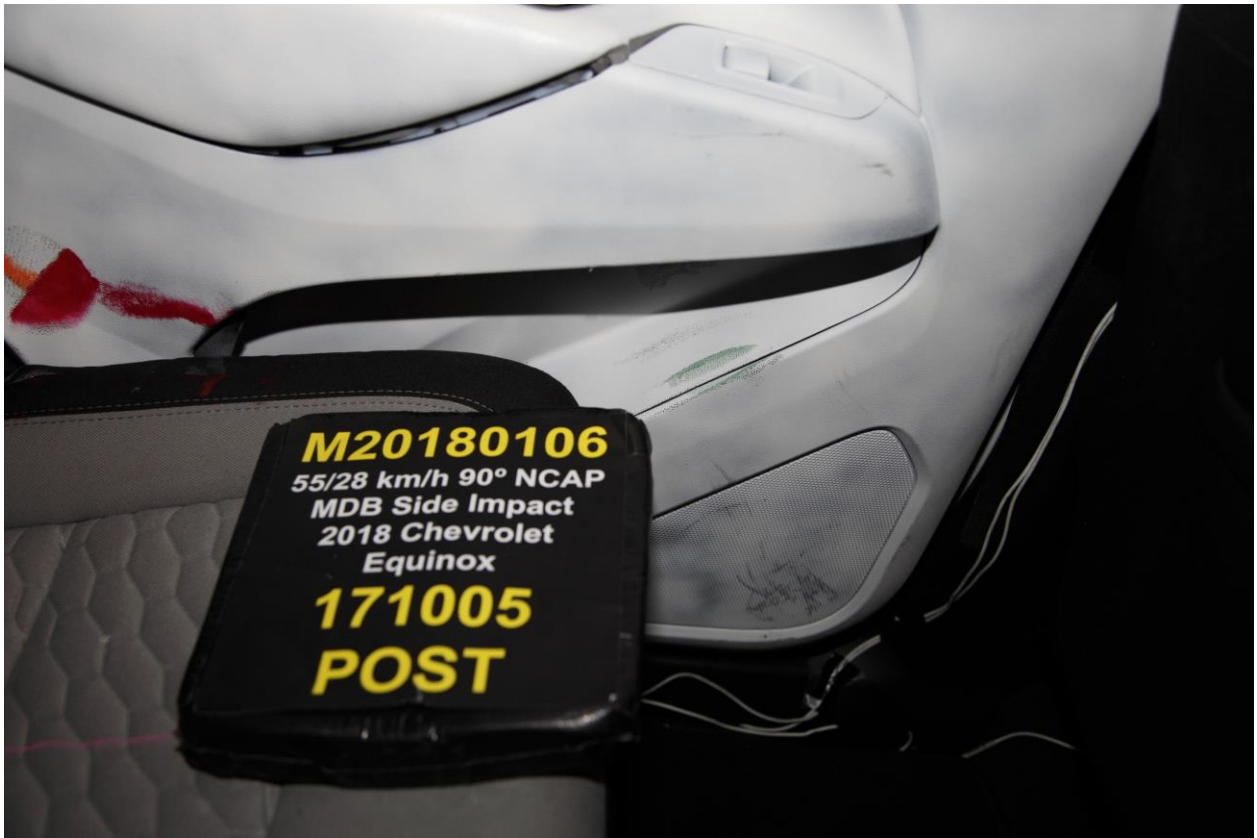
**081** Post-Test Rear Passenger Dummy Close-Up Knee Contact View

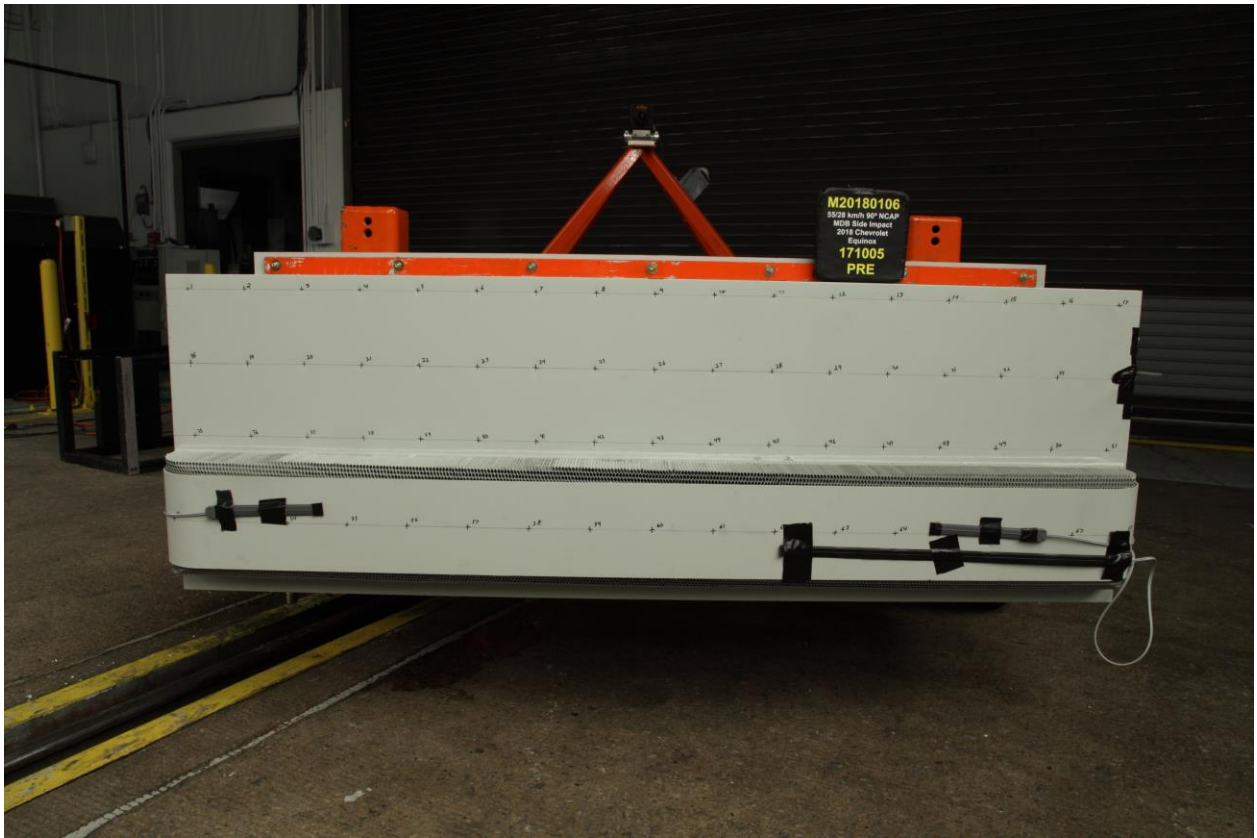
**084** Pre-Test Front View of MDB Impactor Face

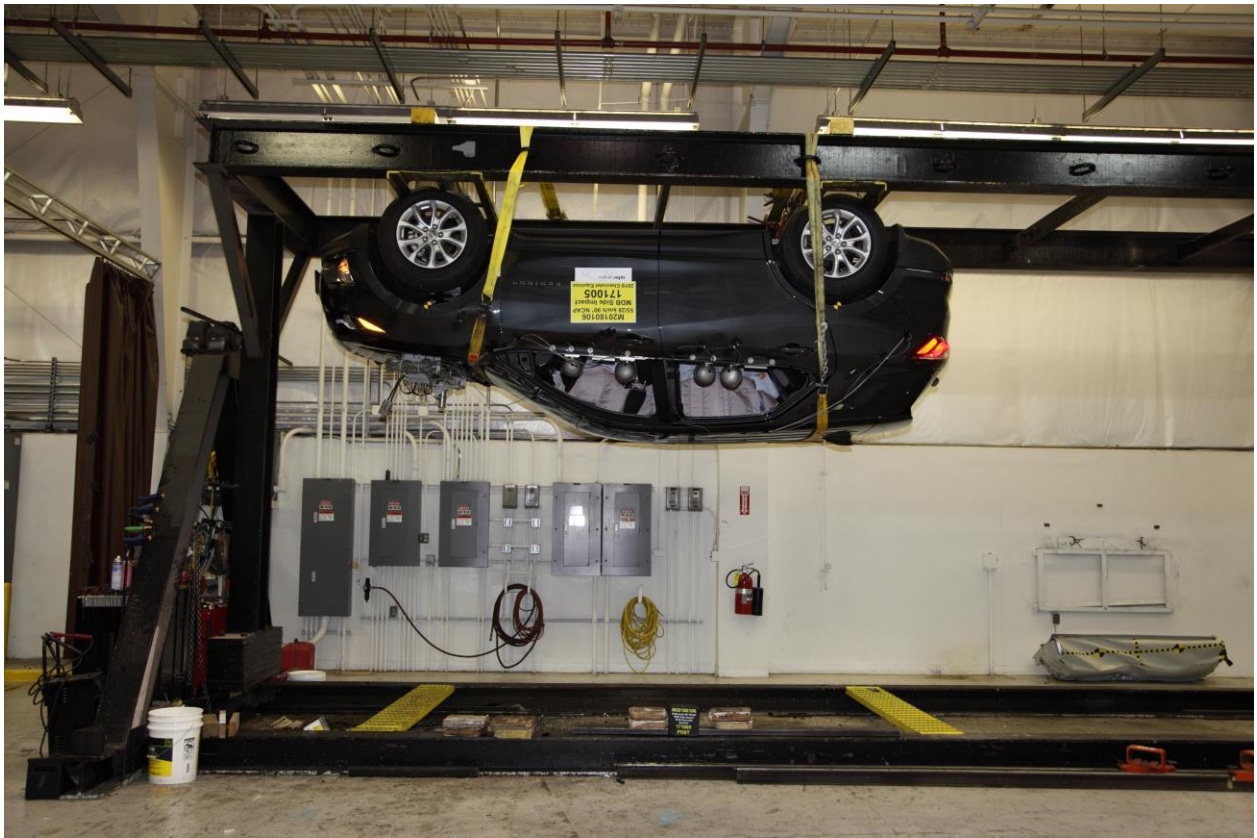
**098** FMVSS No. 301 Static Rollover 180 Degrees
