**REPORT NUMBER: SPNCAP-MGA-2018-011**

**NEW CAR ASSESSMENT PROGRAM (NCAP)  
Side Impact Pole Test**

**TOYOTA MOTOR MANUFACTURING TURKEY INC.  
2018 Toyota C-HR XLE 5-Door Hatchback  
NHTSA No.: M20185104**

**MGA RESEARCH CORPORATION  
5000 Warren Road  
Burlington, WI 53105**

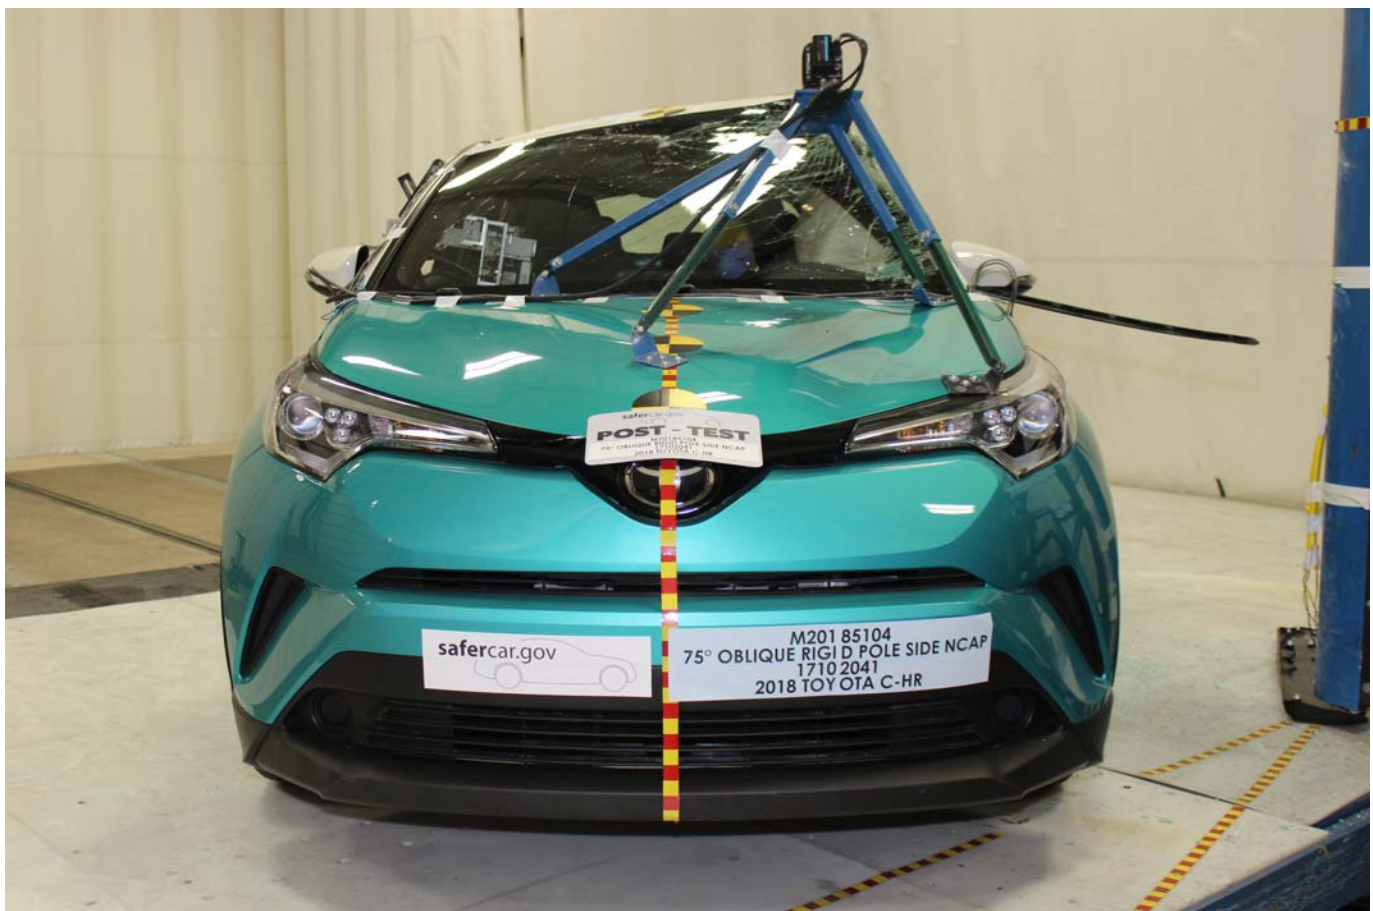
Photo No. 004 - Post-Test Frontal View of Test Vehicle

| Critical Areas of Performance | Observations and Conclusions |
|---|---|
| Windshield Damage | Cracked |

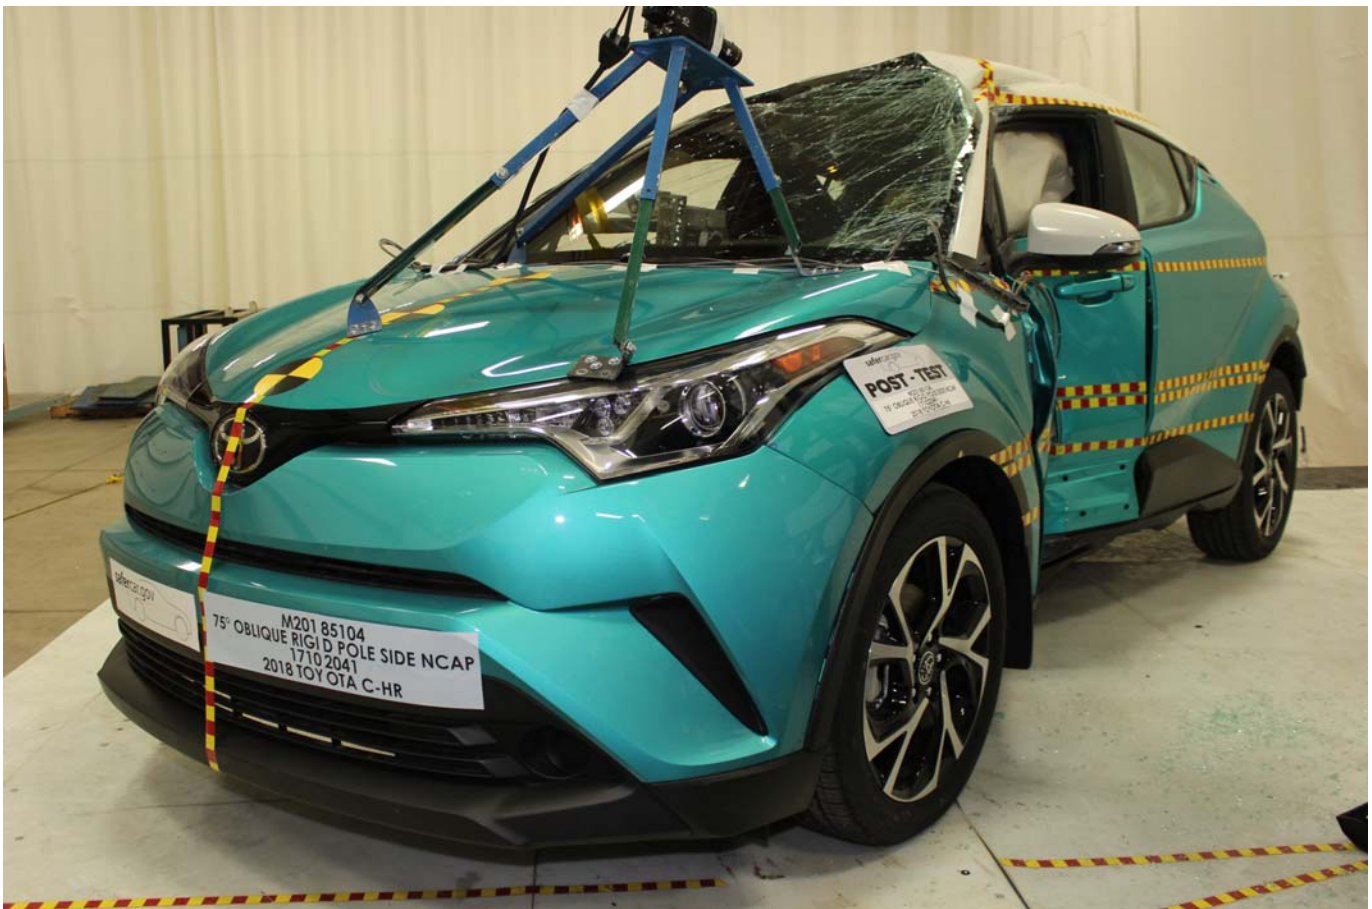
Photo No. 006 - Post-Test Left Front Three-Quarter View of Test Vehicle

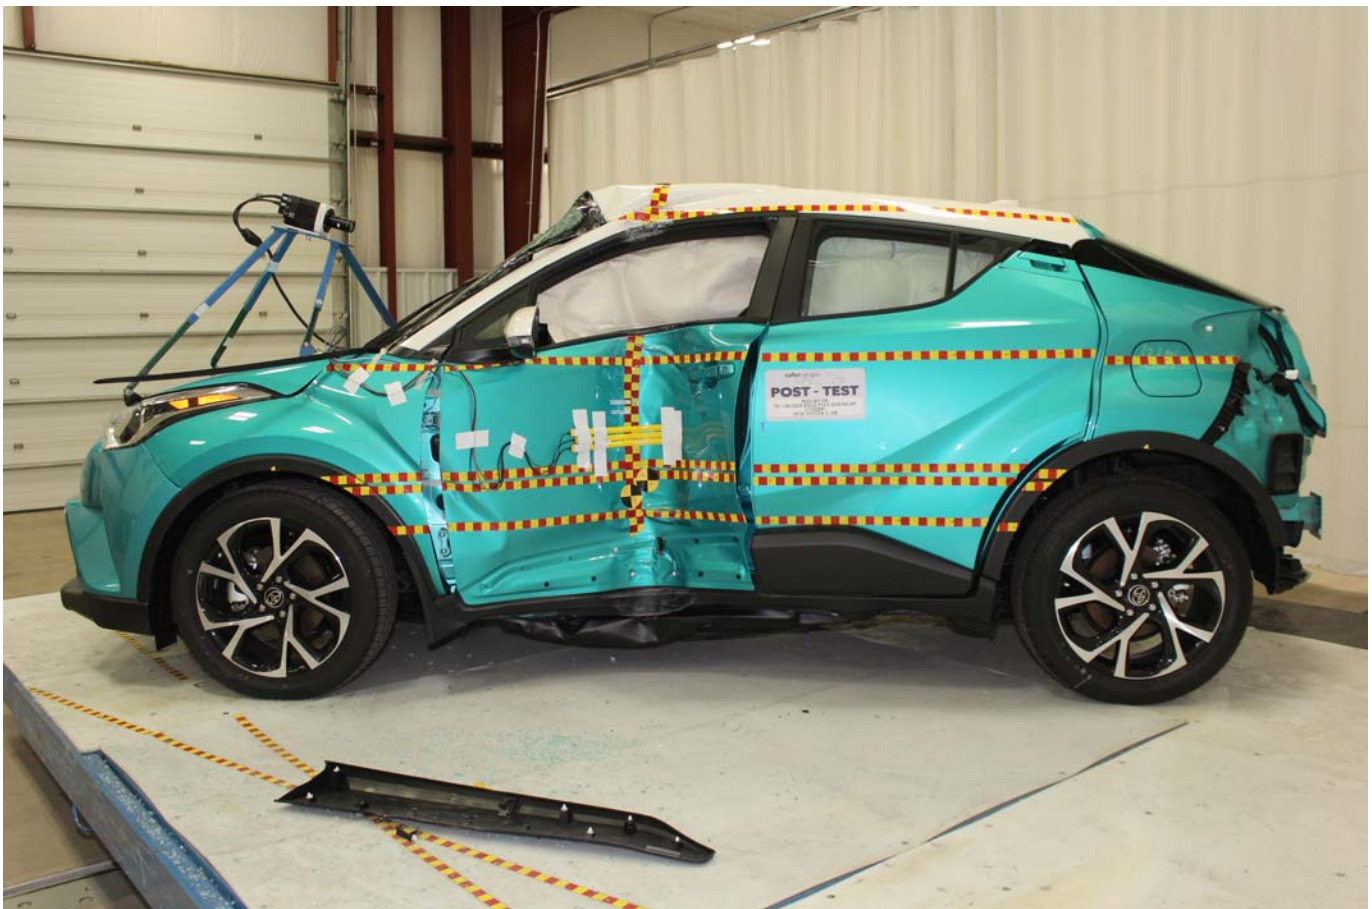
Photo No. 008 - Post-Test Left Side View of Test Vehicle

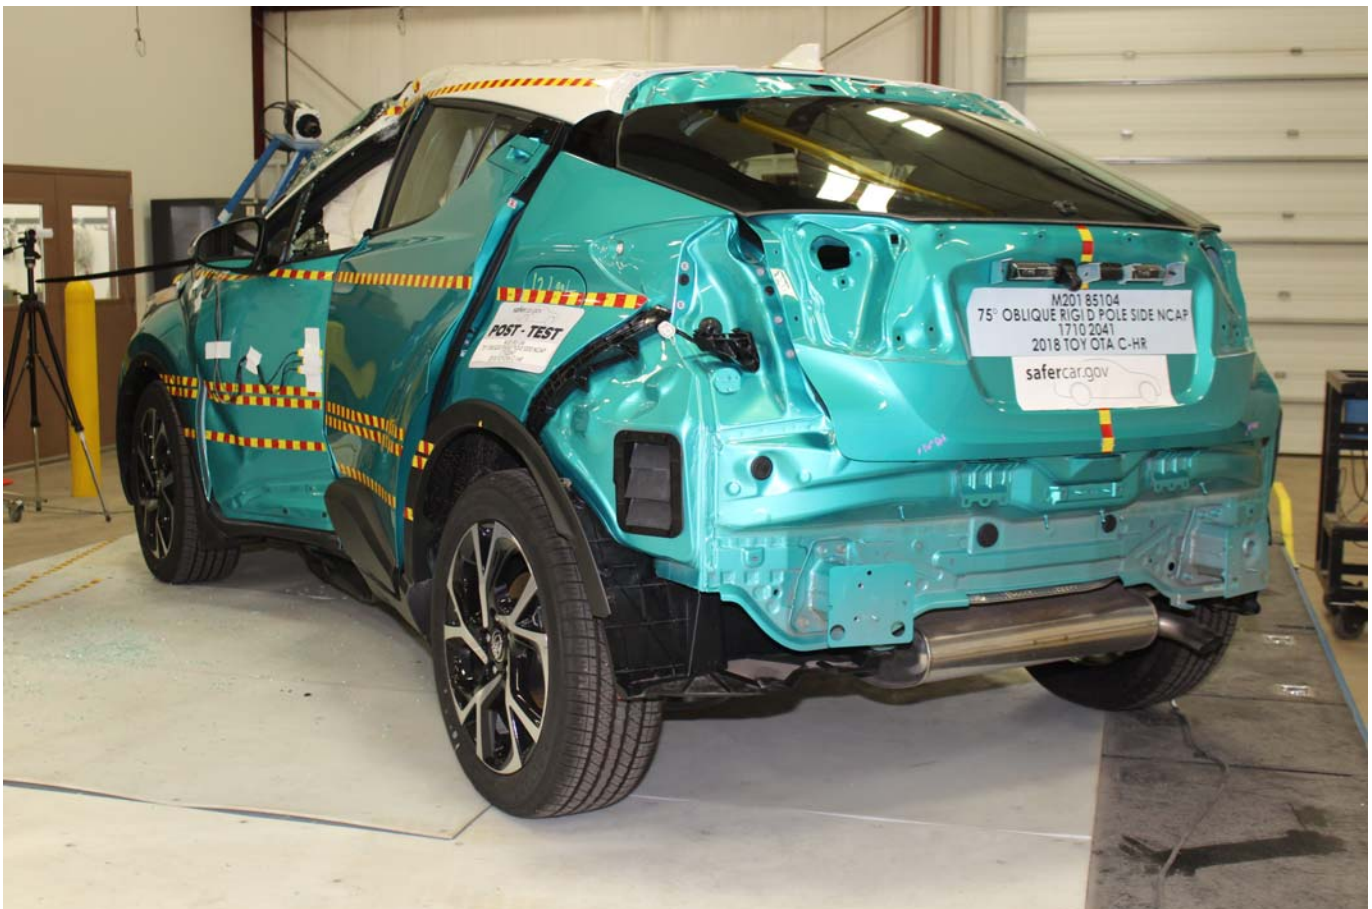
Photo No. 010 - Post-Test Left Rear Three-Quarter View of Test Vehicle

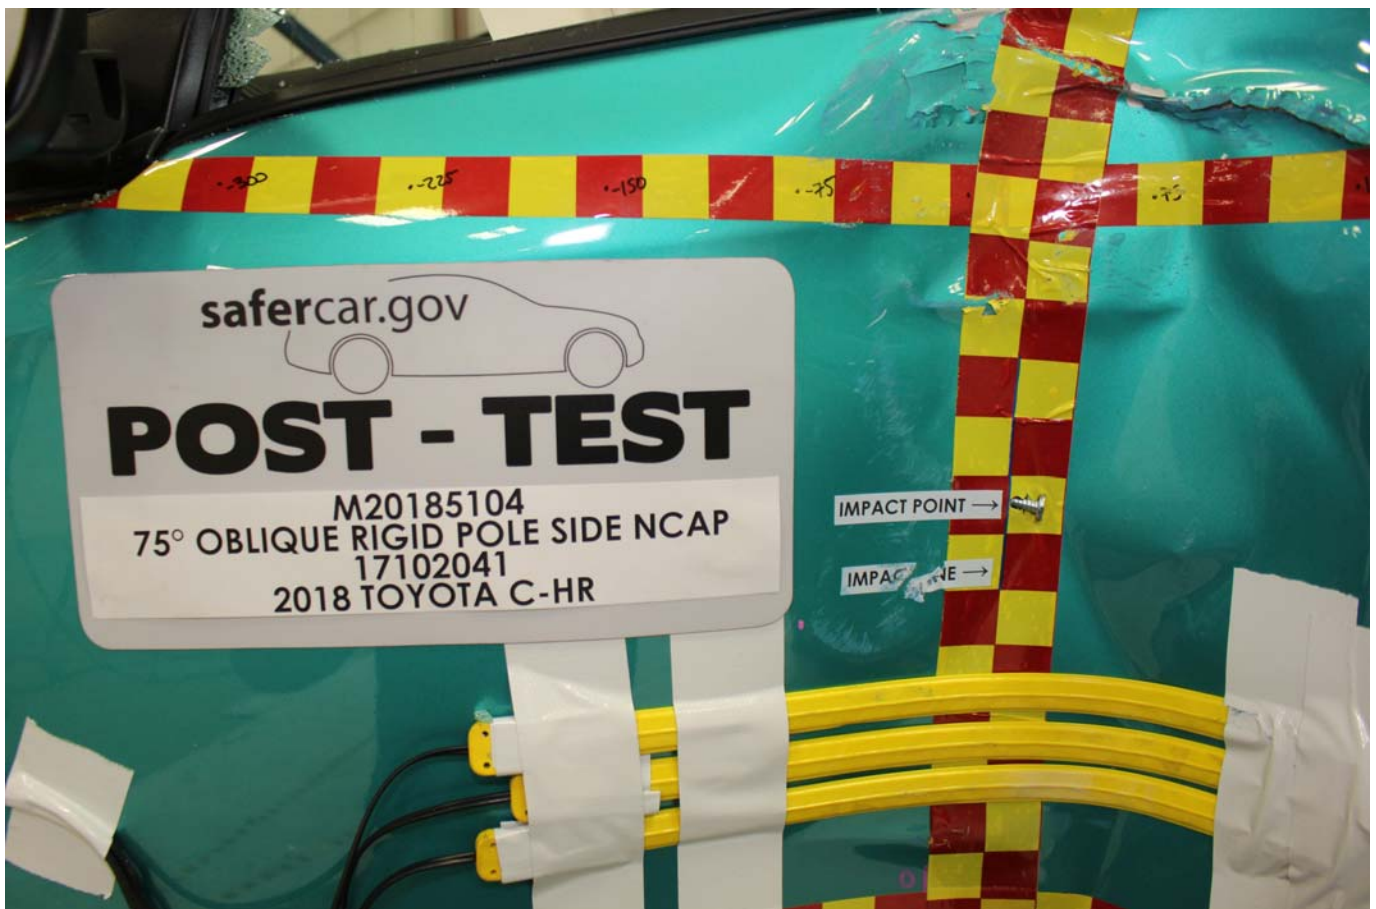
Photo No. 020 - Post-Test Close-Up View of Impact Point Target Showing Impact Location

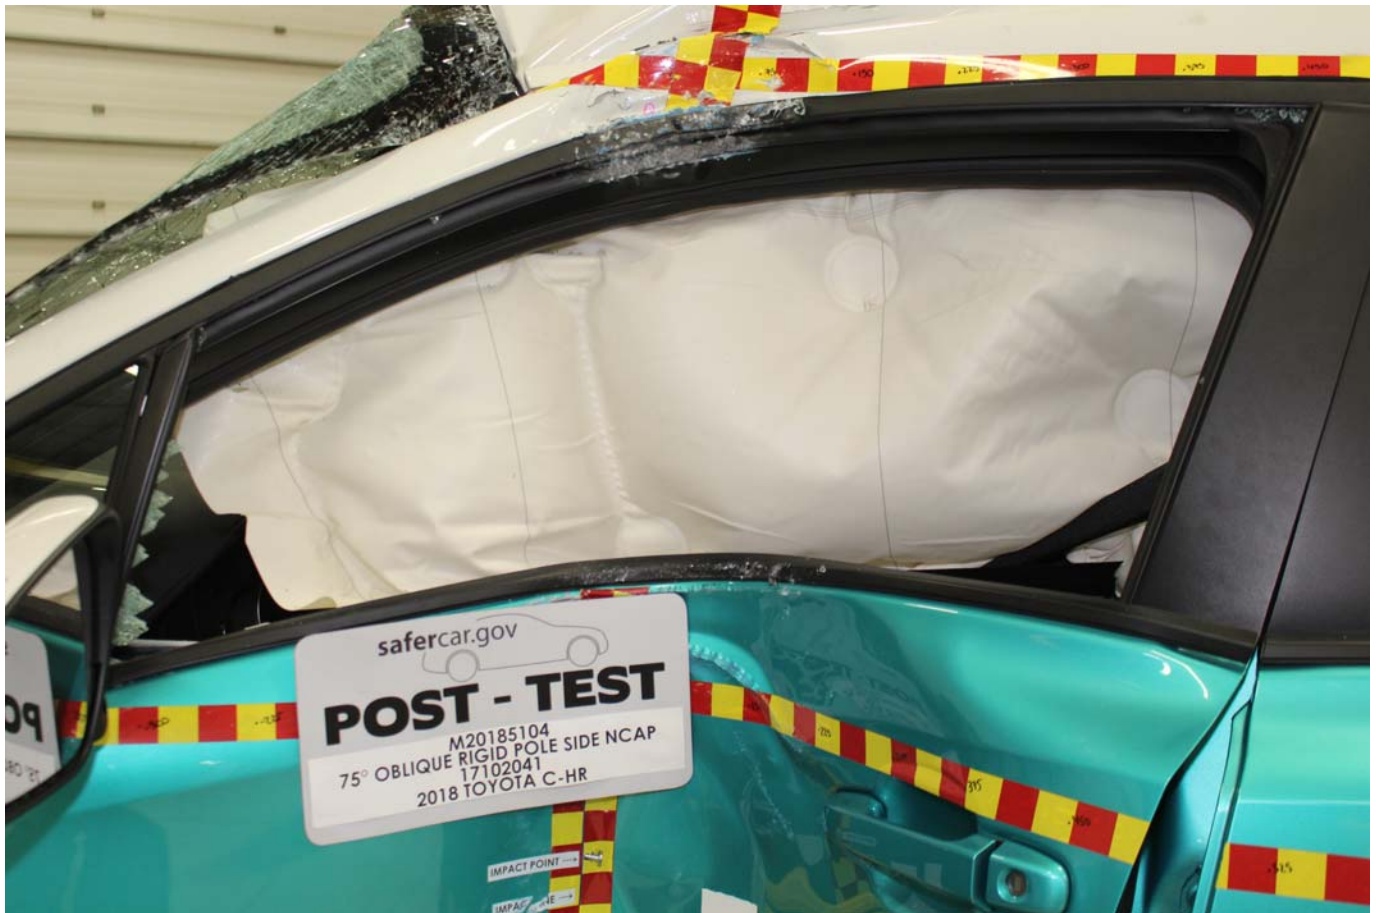
Photo No. 025 - Post-Test Left Side View of Dummy Shoulder and Door Top View

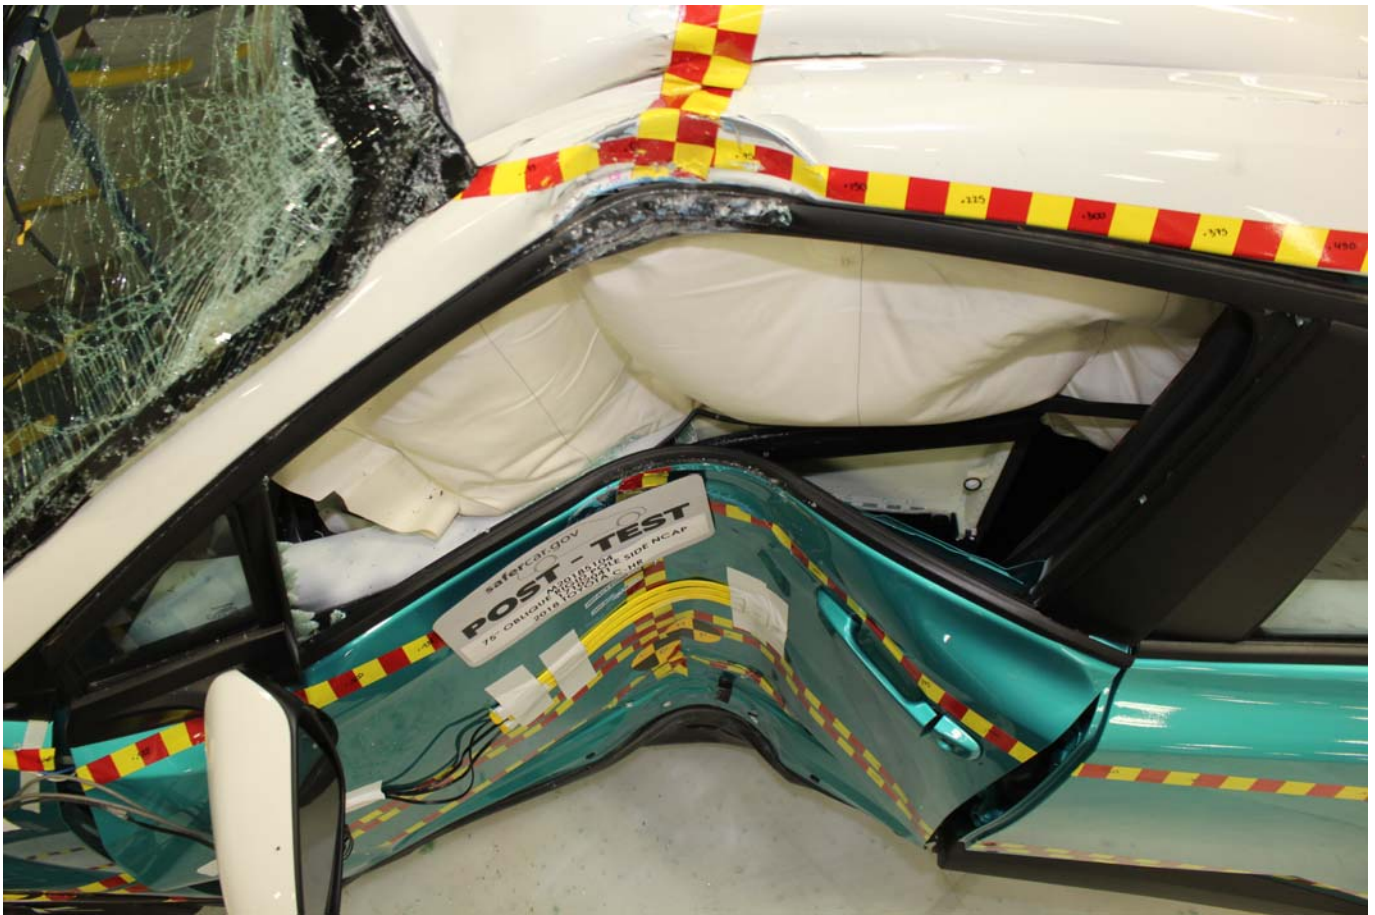
Photo No. 041 - Post-Test Dummy and Door Clearance View

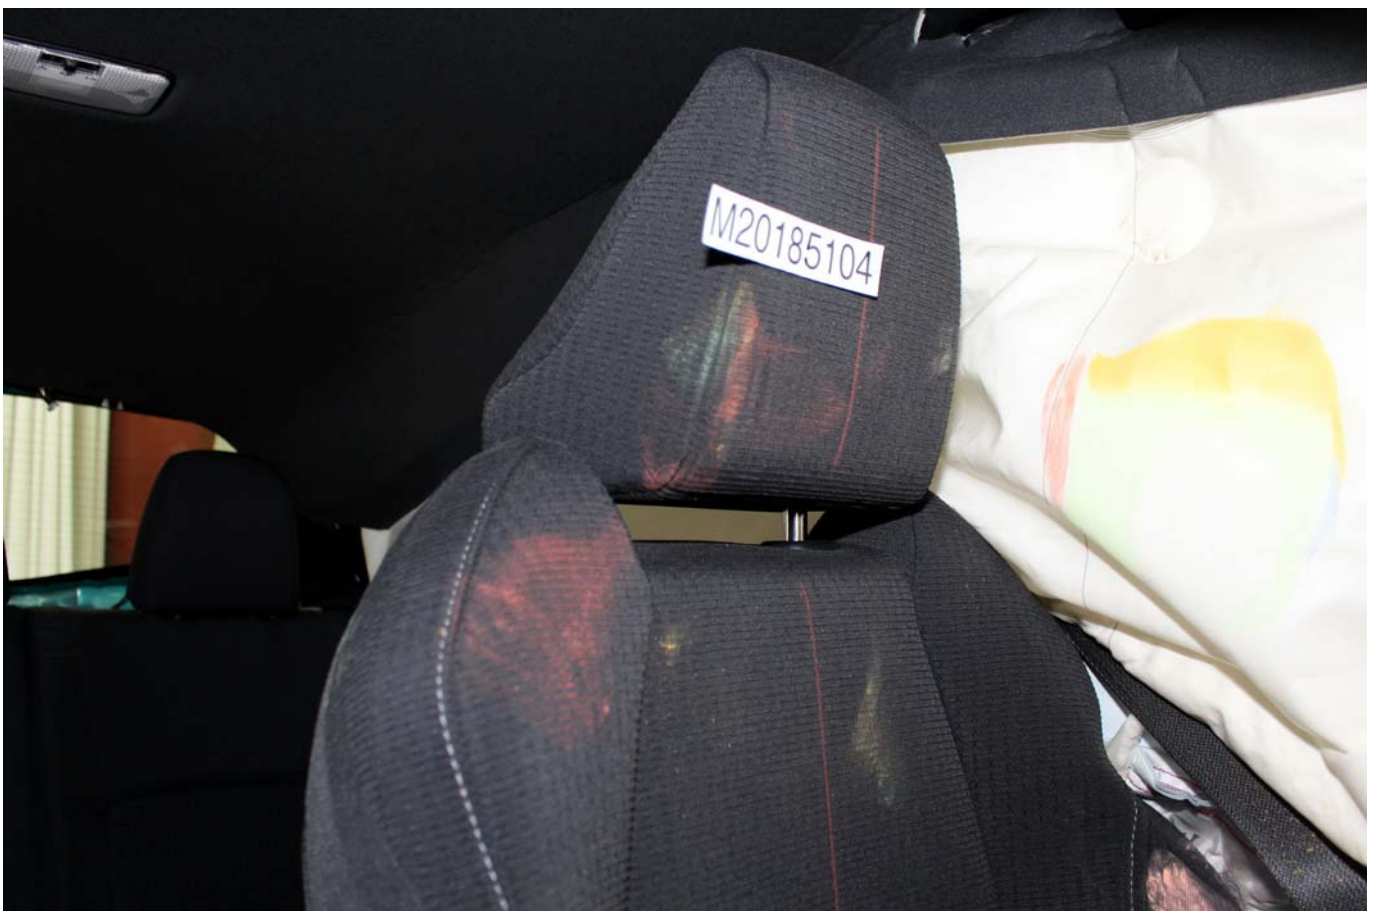
Photo No. 046 - Post-Test Dummy Close-Up Head Contact with Vehicle Interior View

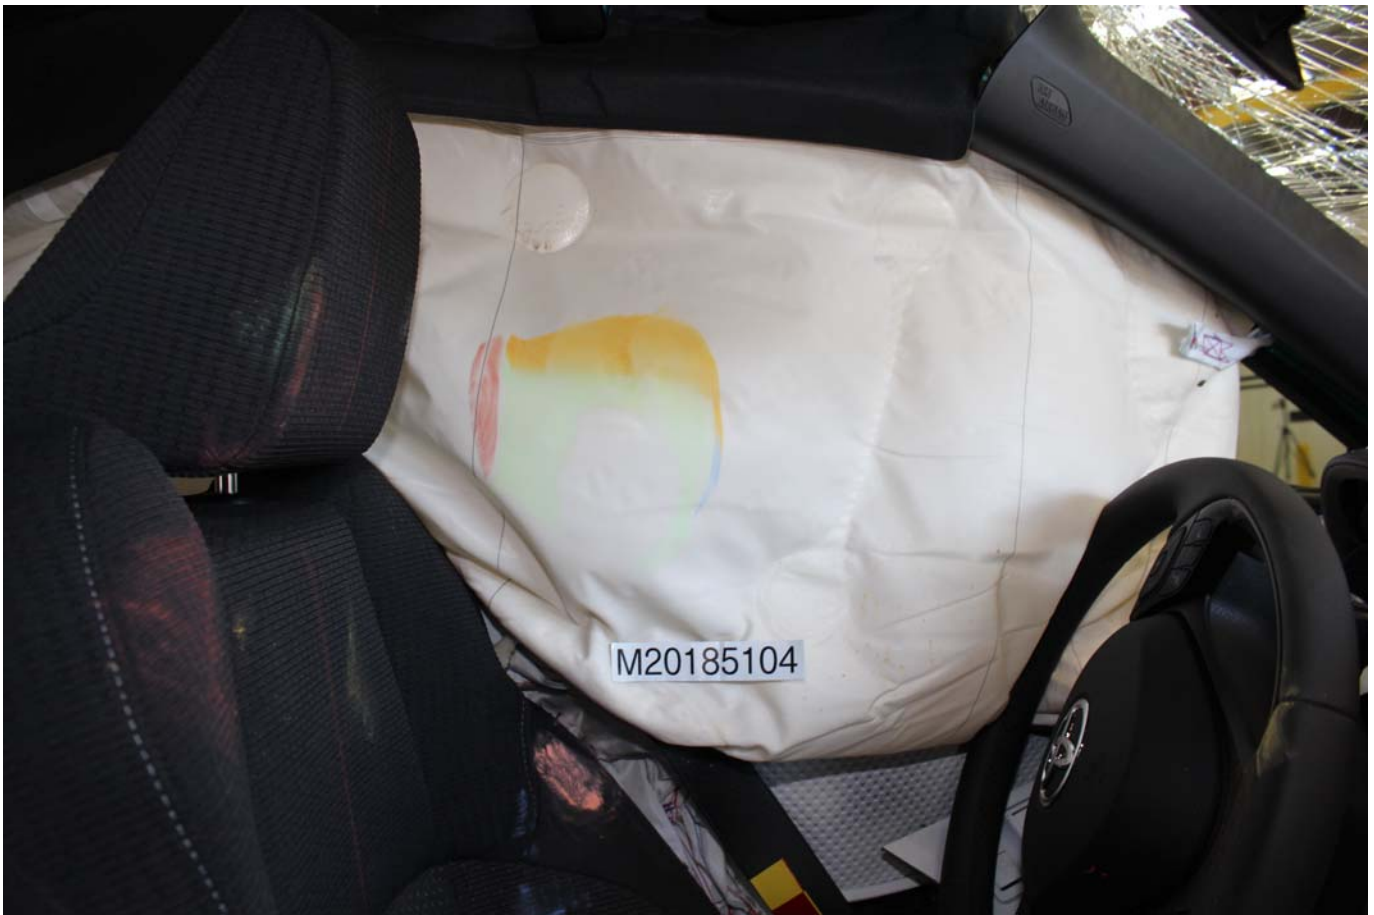
Photo No. 047 - Post-Test Dummy Close-Up Head Contact with Side Air Bag View

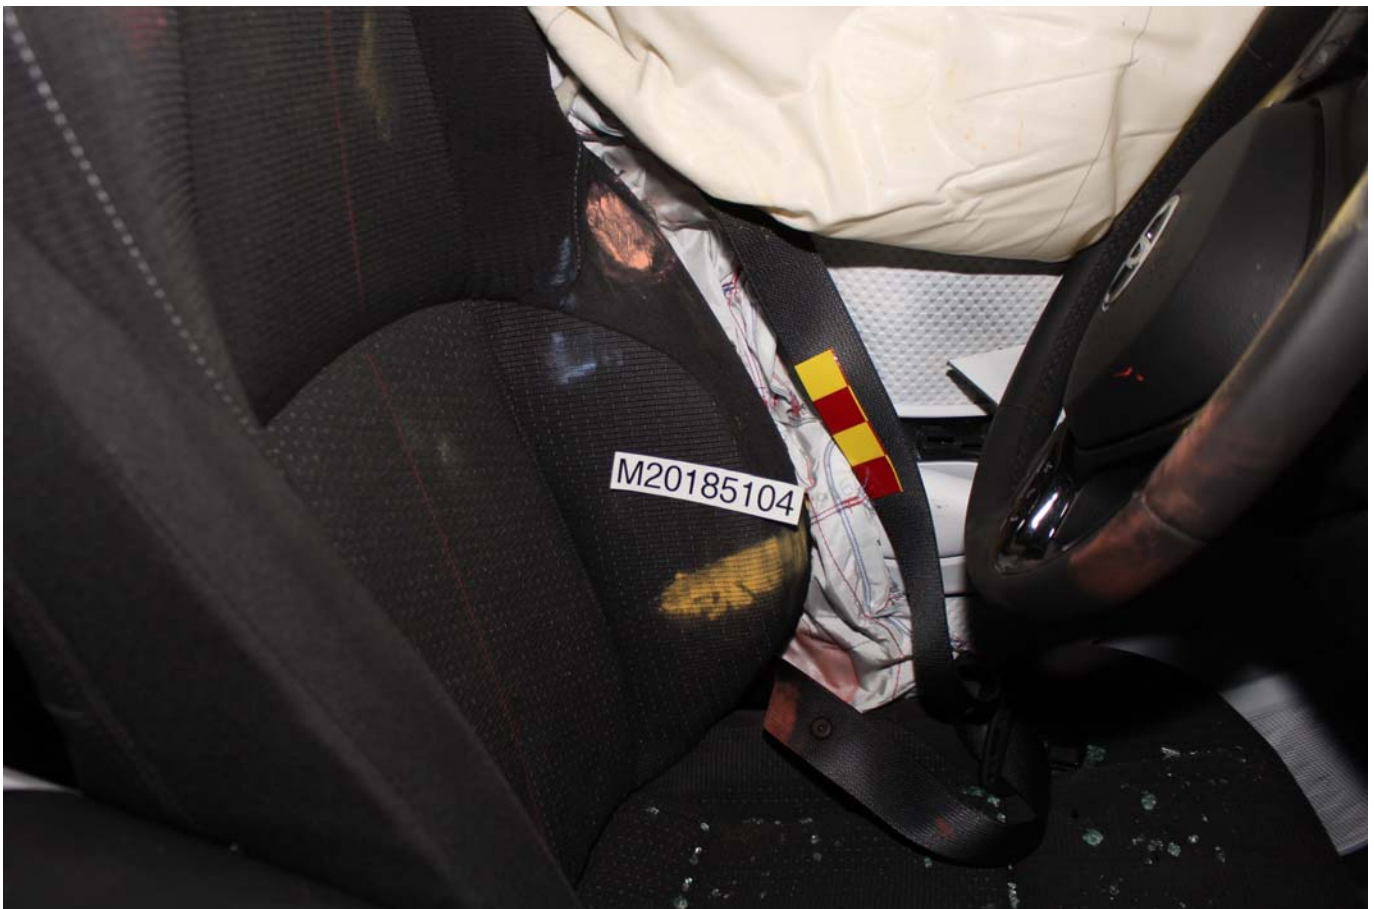
Photo No. 048 - Post-Test Dummy Close-Up Torso Contact with Vehicle Interior View

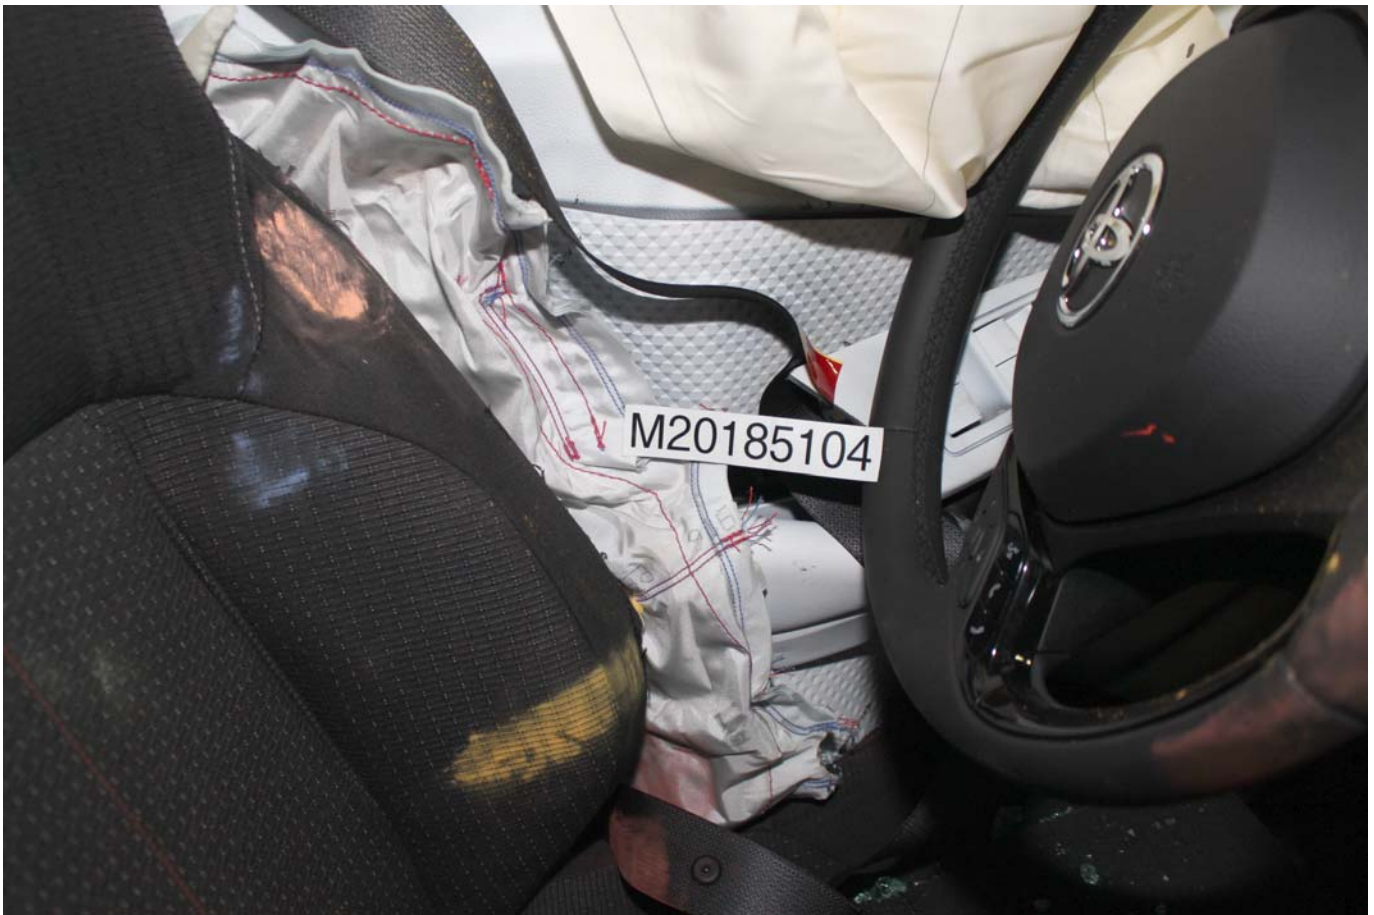
Photo No. 049 - Post-Test Dummy Close-Up Torso Contact with Side Air Bag View

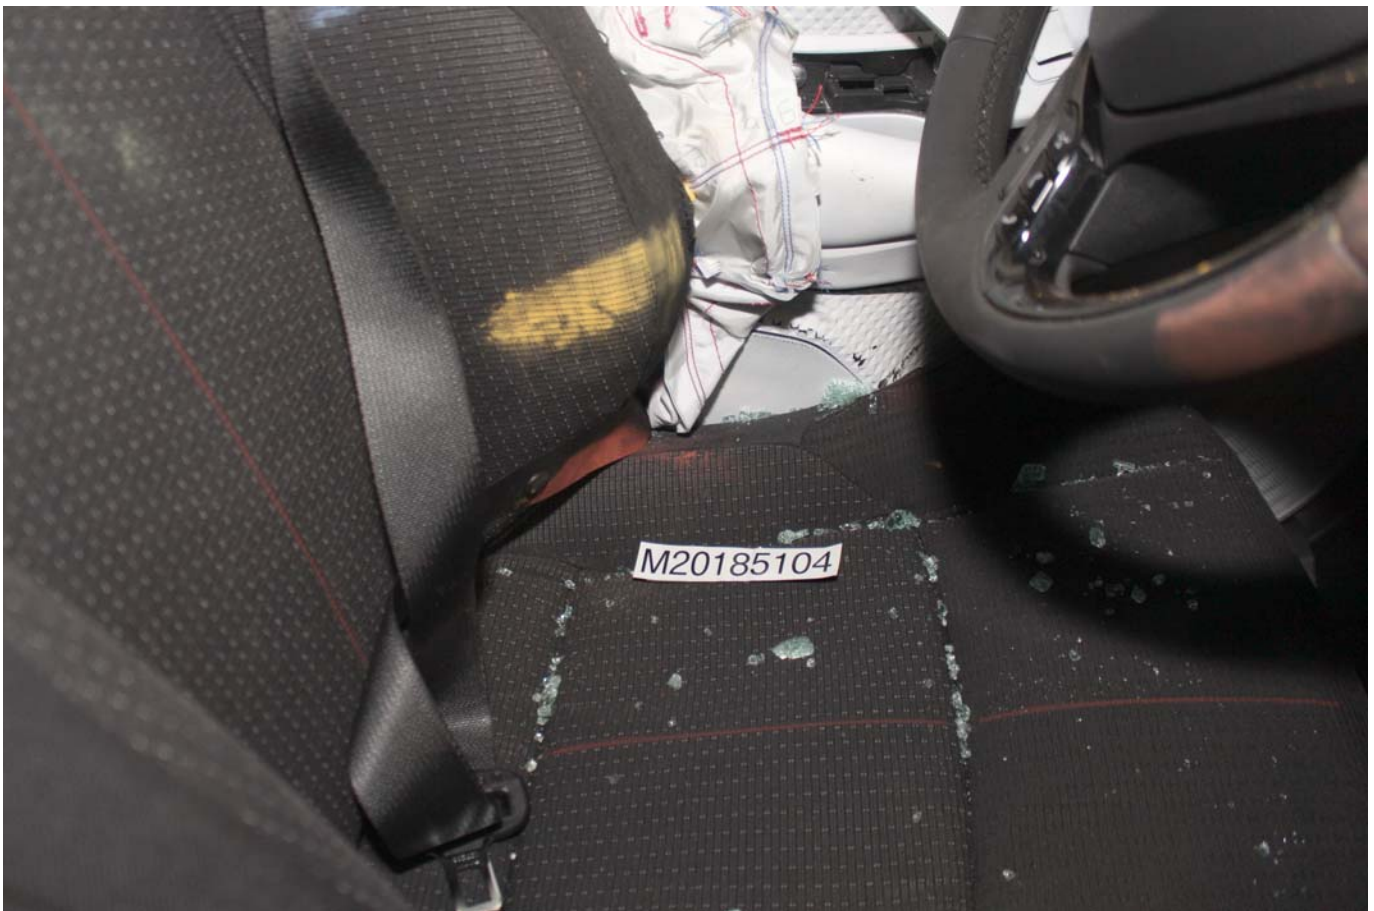
Photo No. 050 - Post-Test Dummy Close-Up Pelvis Contact with Vehicle Interior View

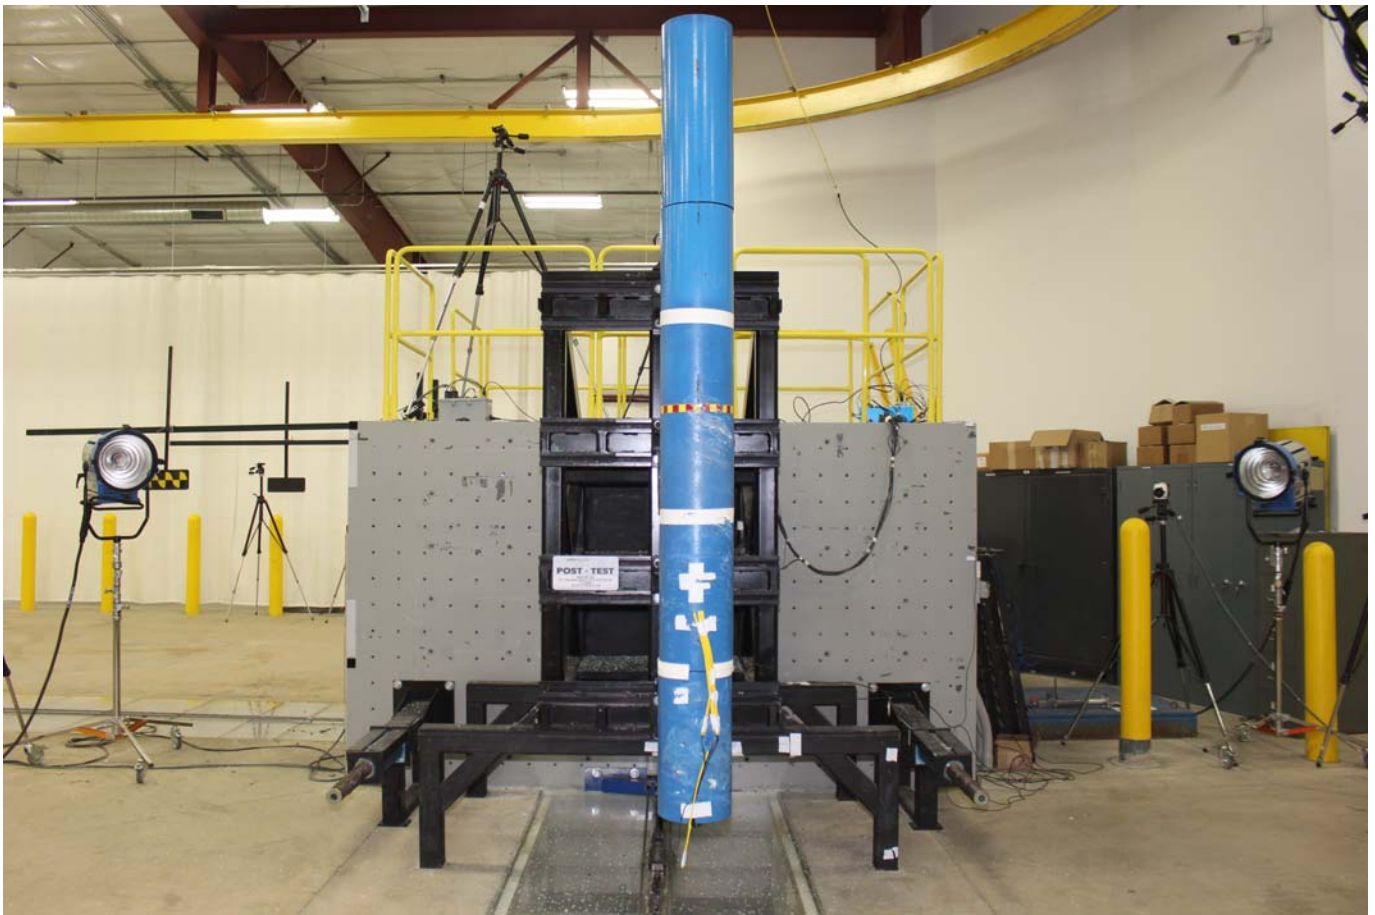
Photo No. 059 - Pre-Test Pole Barrier Side View

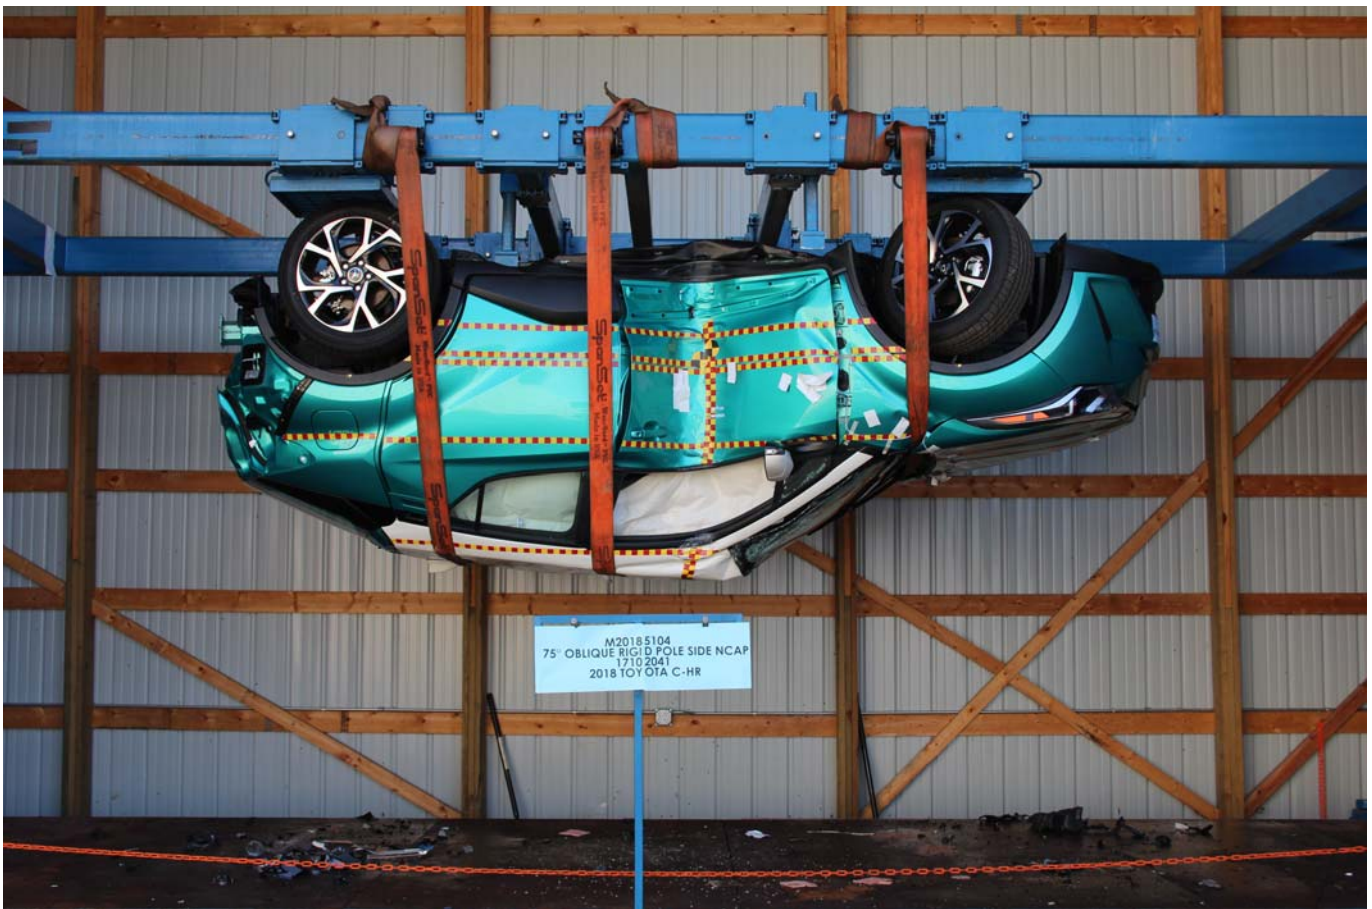
Photo No. 065 - FMVSS Photo No. 301 Static Rollover 180 Degrees

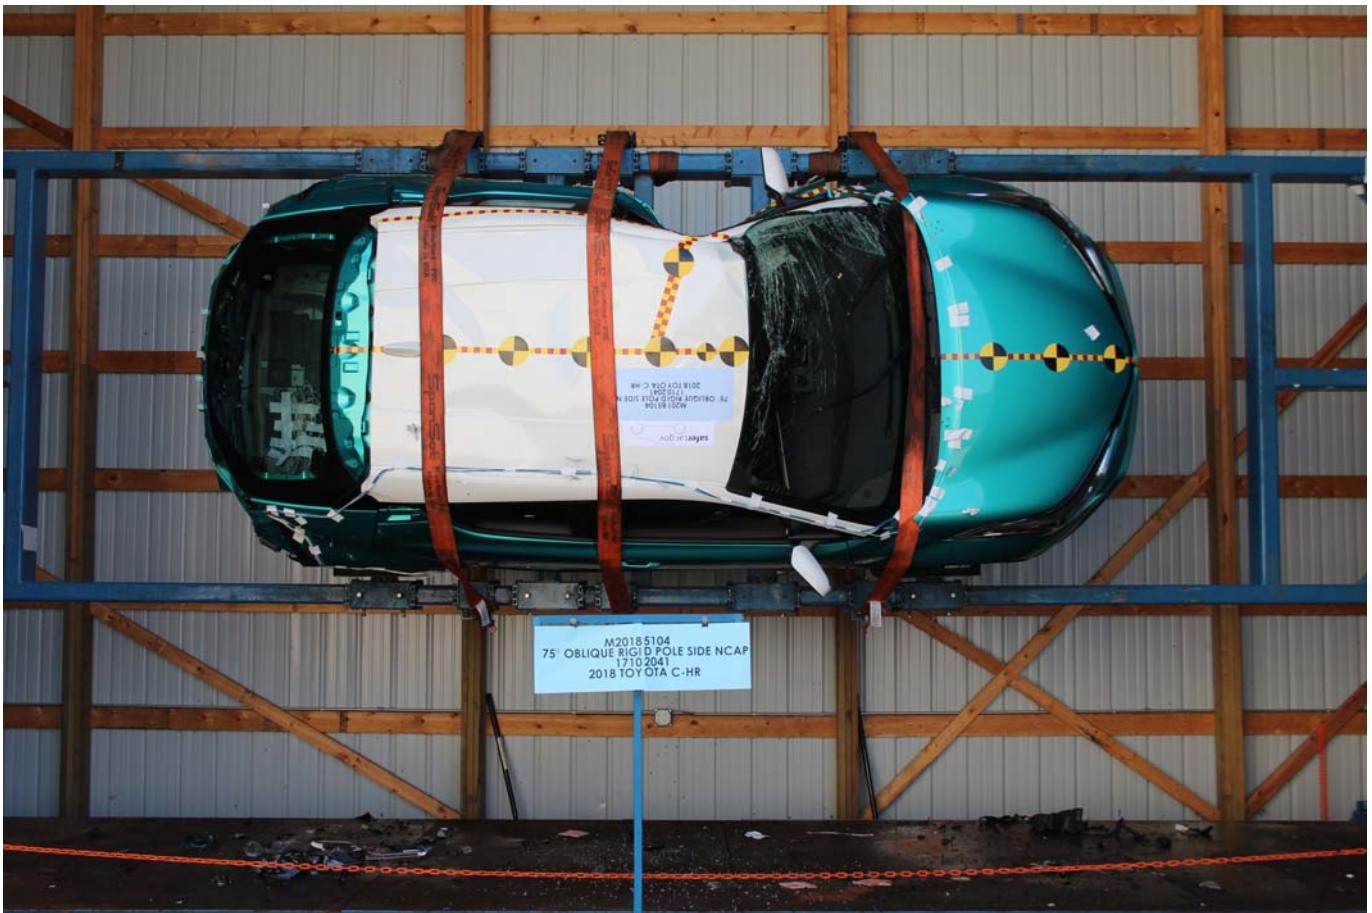
Photo No. 066 - FMVSS Photo No. 301 Static Rollover 270 Degrees
