REPORT NUMBER: SINCAP-KAR-18-003

**NEW CAR ASSESSMENT PROGRAM (NCAP)
MOVING DEFORMABLE BARRIER SIDE IMPACT TEST**

**FCA US LLC
2018 JEEP COMPASS SPORT 5-DOOR MPV**

NHTSA No: M20180308

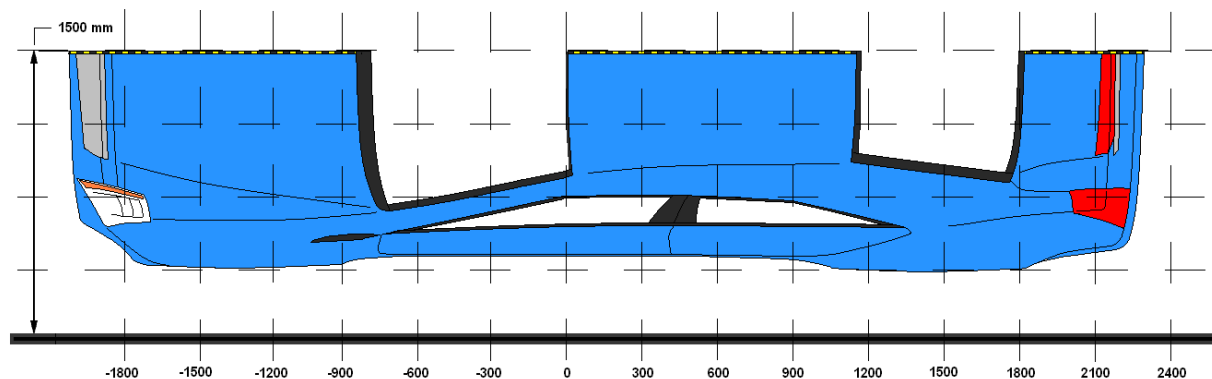
VEHICLE AND MDB DAMAGE PROFILE DISTANCES

VEHICLE DAMAGE PROFILE DISTANCES

DPD	Distance From Impact Point (mm)	Level	Pre-Test (mm)	Post-Test (mm)	Crush (mm)
1	2700	4	677	681	4
2	2100	5	907	913	6
3	1500	2	625	823	198
4	750	3	614	795	181
5	150	2	611	705	94
6	-450	4	675	681	6
