**REPORT NUMBER: SPNCAP-KAR-18-002
NEW CAR ASSESSMENT PROGRAM (NCAP)
SIDE IMPACT POLE TEST**

**FCA US LLC.
2018 JEEP COMPASS SPORT 5-DOOR MPV**

NHTSA No: M20180307

**PREPARED BY:
KARCO ENGINEERING, LLC.
9270 HOLLY ROAD
ADELANTO, CA 92301**

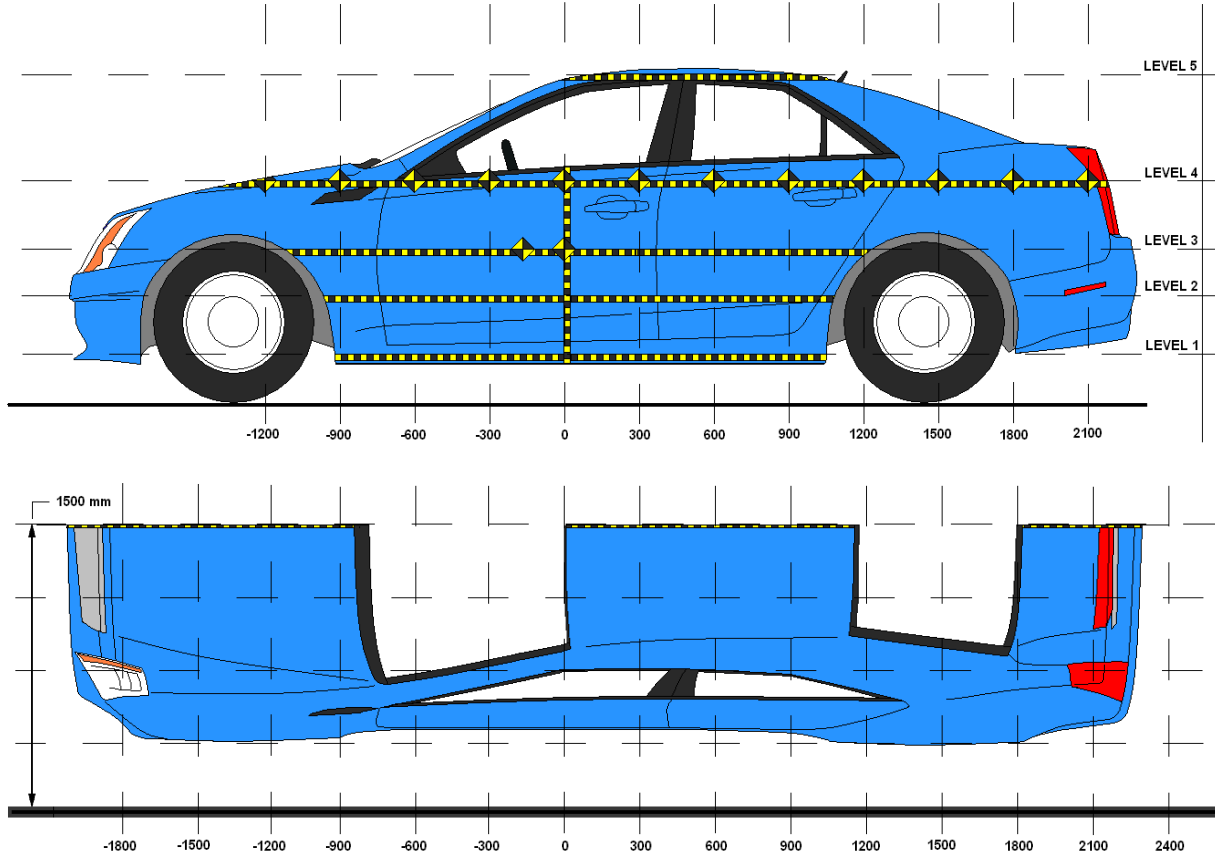
NOTE: All measurements in mm with tolerance of ± 3 mm

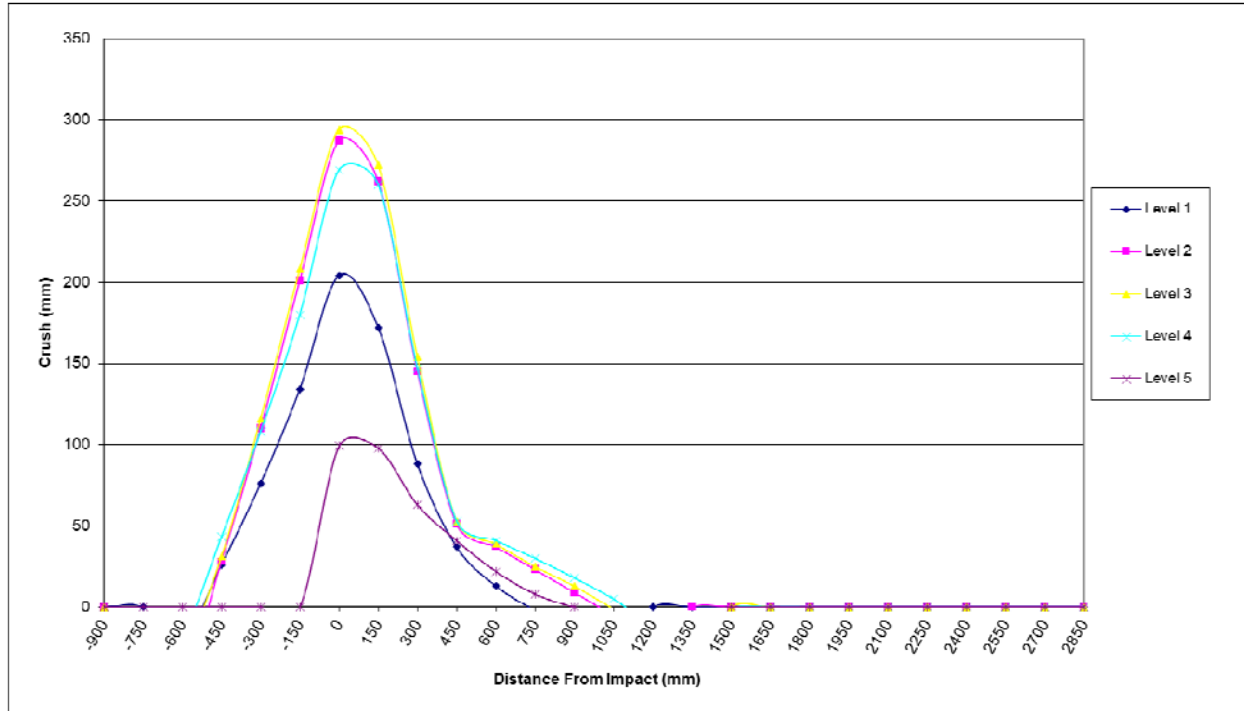
DATA SHEET NO. 11

VEHICLE DAMAGE PROFILE DISTANCES

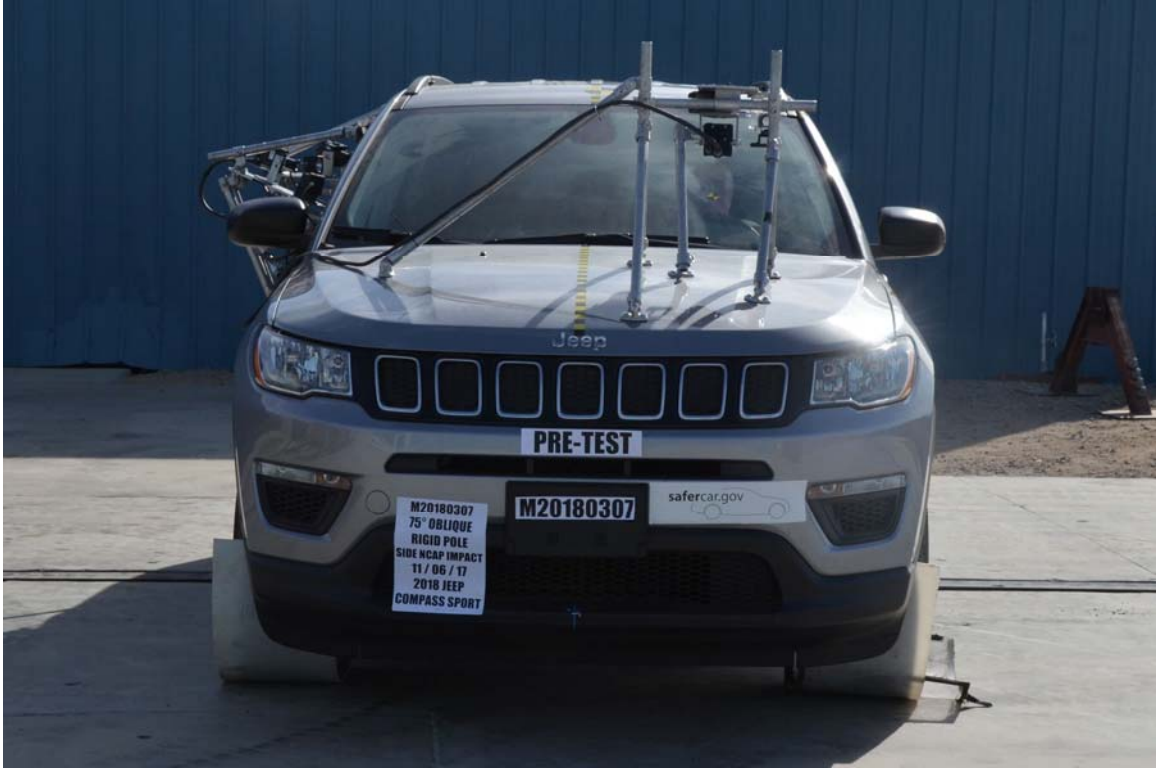
FIGURE 3. Pre-Test Frontal View of Test Vehicle

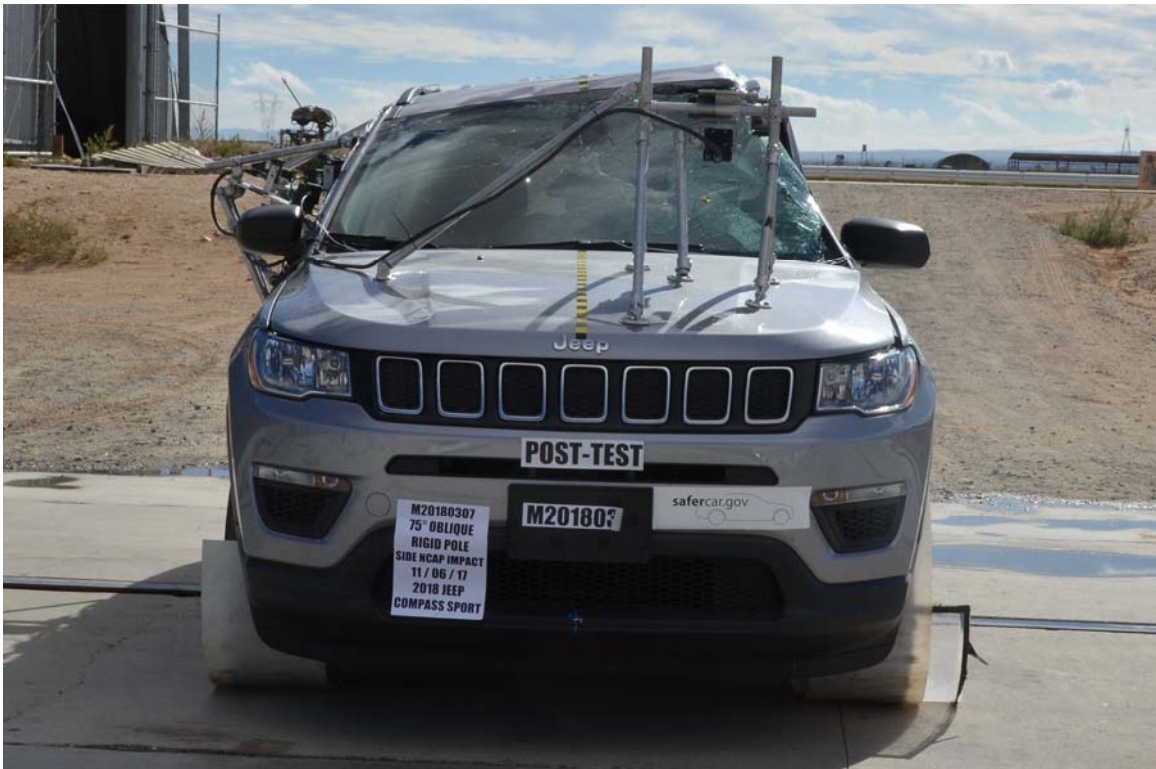
FIGURE 4. Post-Test Frontal View of Test Vehicle

Both the front and rear doors on the struck side of the vehicle were jammed shut while remaining closed and latched. The windshield and front driver window broke as a result of the impact. There was no separation at the hinges or latches. Both doors on the non-struck side remained closed and latched. There were no ATD values that exceeded limits.

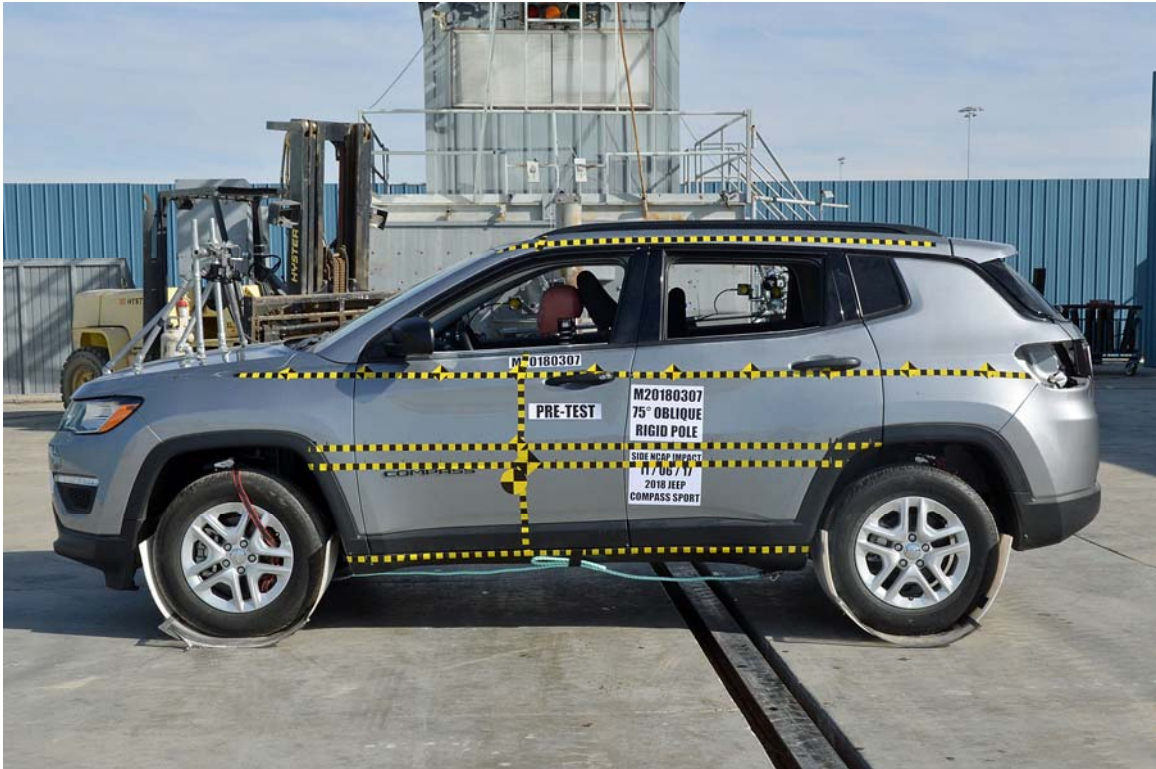
FIGURE 7. Pre-Test Left Side View of Test Vehicle

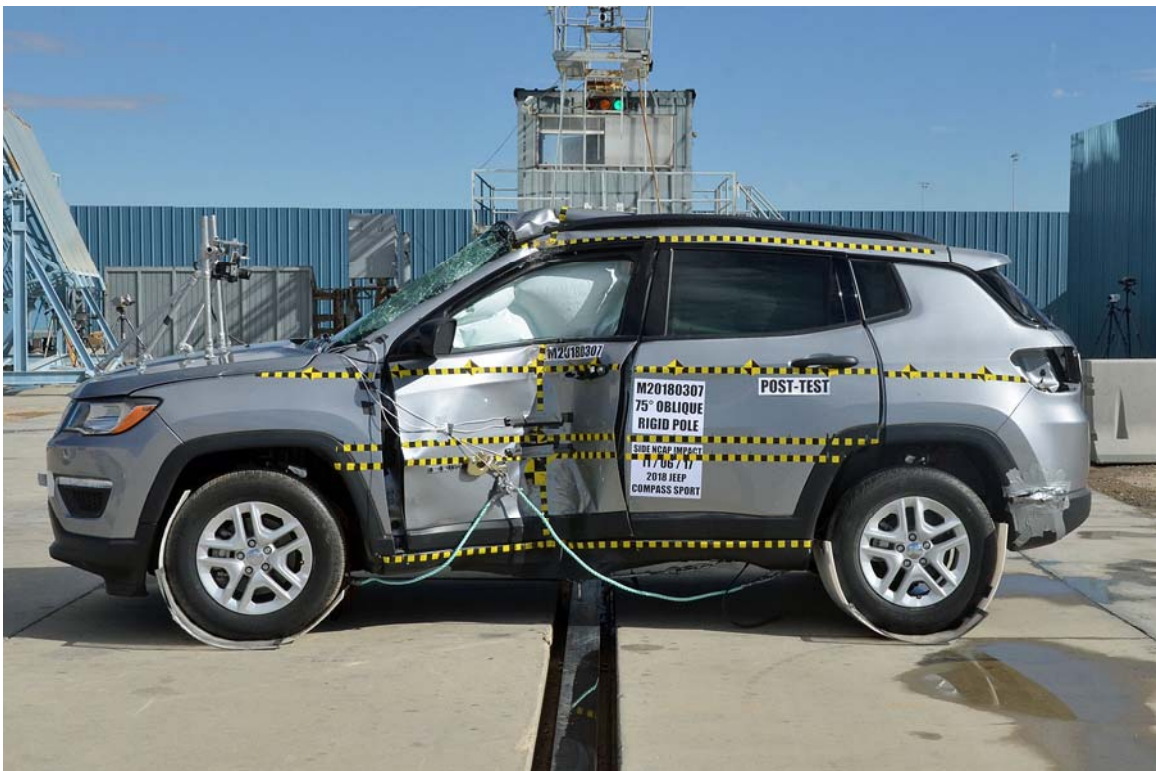
FIGURE 8. Post-Test Left Side View of Test Vehicle

Critical Areas of Performance	Observations and Conclusions
Pillar Performance	No separation occurred
Sill Separation	No separation occurred
Windshield Damage	Broken
Side Window Damage	Driver front window broken
Other Notable Effects	None

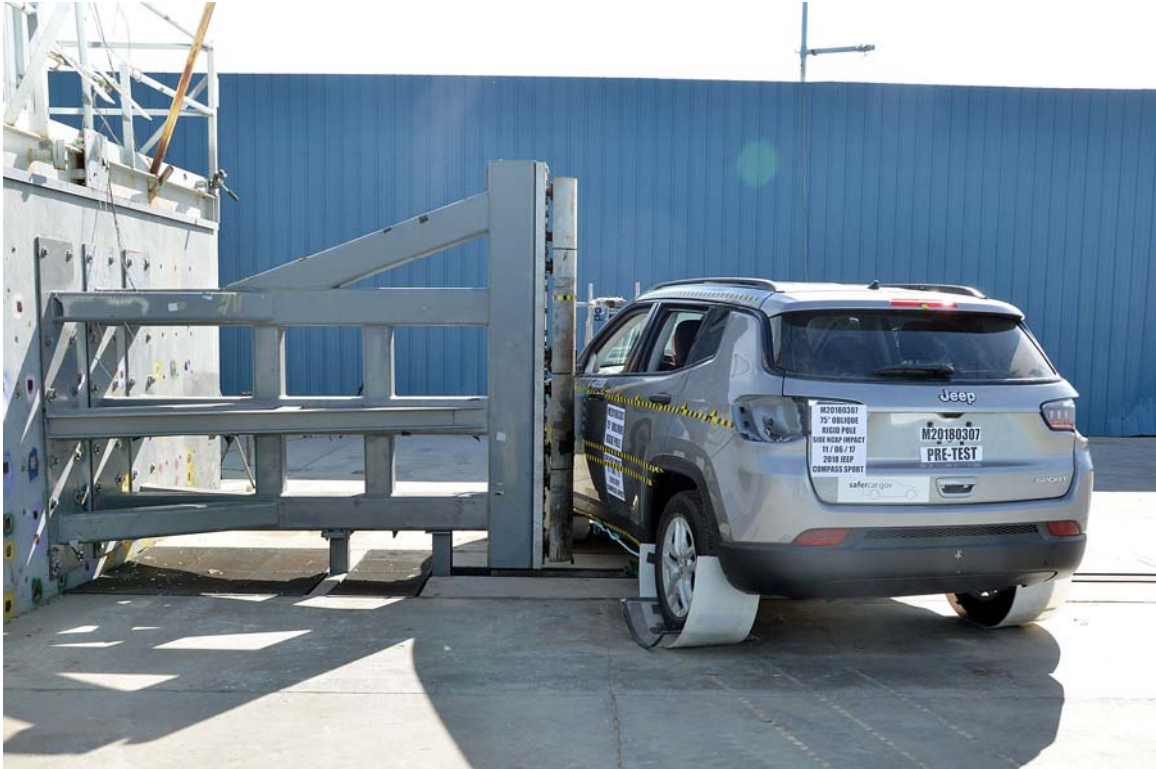
FIGURE 17. Pre-Test Left Side View of Pole Positioned Against Side of Vehicle

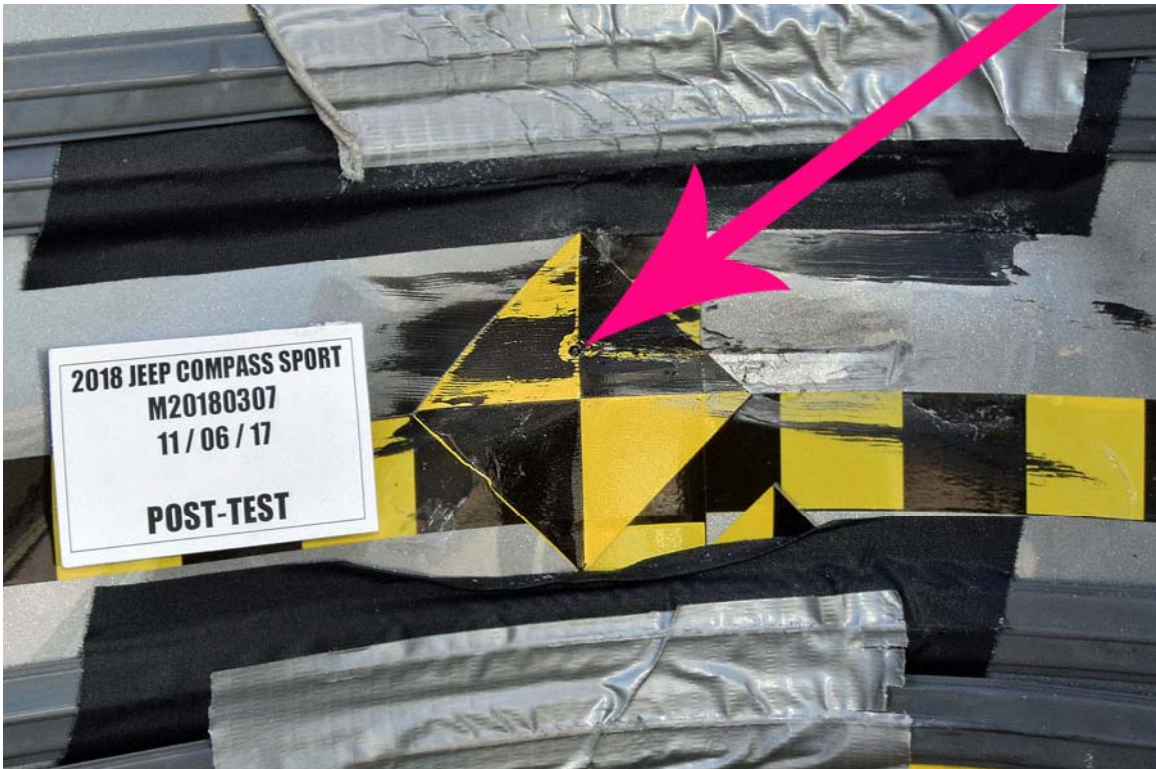
FIGURE 19. Pre-Test Close-Up View of Impact Point Target
