**REPORT NUMBER: NCAP-KAR-18-004**

**NEW CAR ASSESSMENT PROGRAM (NCAP)  
FRONTAL BARRIER IMPACT TEST**

**FCA US LLC  
2018 JEEP COMPASS SPORT 4X4 5-DOOR MPV**

**FINAL REPORT**

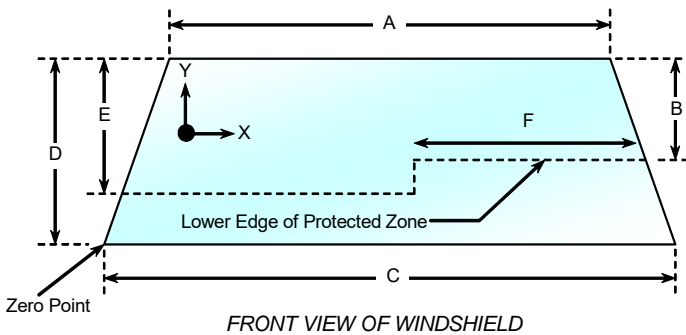
**WINDSHIELD PERIPHERY MEASUREMENTS**

Measurement	Pre-Test (mm)	Post-Test (mm)	% Retention
Left Side	2260	2260	100.0%
Right Side	2260	2260	100.0%
Total	4520	4520	100.0%

Item	Units	Value
A	mm	1230
B	mm	390
C	mm	1470
D	mm	910
E	mm	532
F	mm	500

There was 100% windshield retention and no intrusion into the protected zone of the windshield during the event.
