REPORT NUMBER: SINCAP-CAL-18-002

**NEW CAR ASSESSMENT PROGRAM (NCAP)
MOVING DEFORMABLE BARRIER SIDE IMPACT TEST**

**General Motors LLC
2018 Chevrolet Traverse
Four Door SUV**

NHTSA No: M20180109

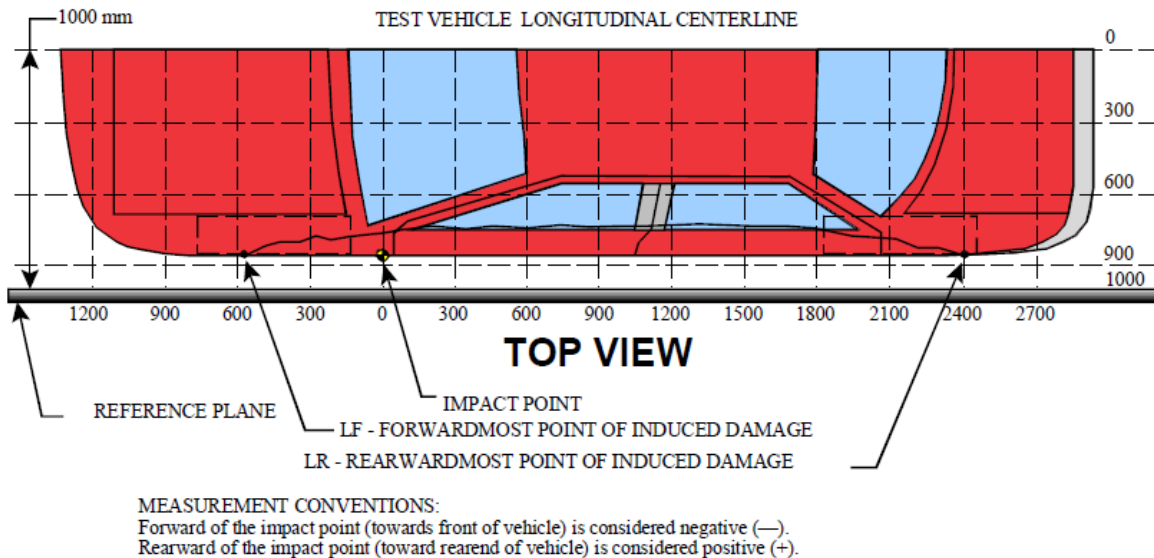
For guidance regarding damage profile distance measurements, please refer to the latest version of the *NHTSA Test Reference Guide, Volume 1: Vehicle Tests*.

VEHICLE DAMAGE PROFILE DISTANCES

DPD	Distance From Impact Point (mm)	Level	Post-Test (mm)	Pre-Test (mm)	Crush (mm)
1	-150	3	5	10	-5
2	300	3	229	27	202
3	750	3	256	26	230
4	1200	3	263	26	237
5	1650	3	275	29	246
6	2100	3	43	8	35

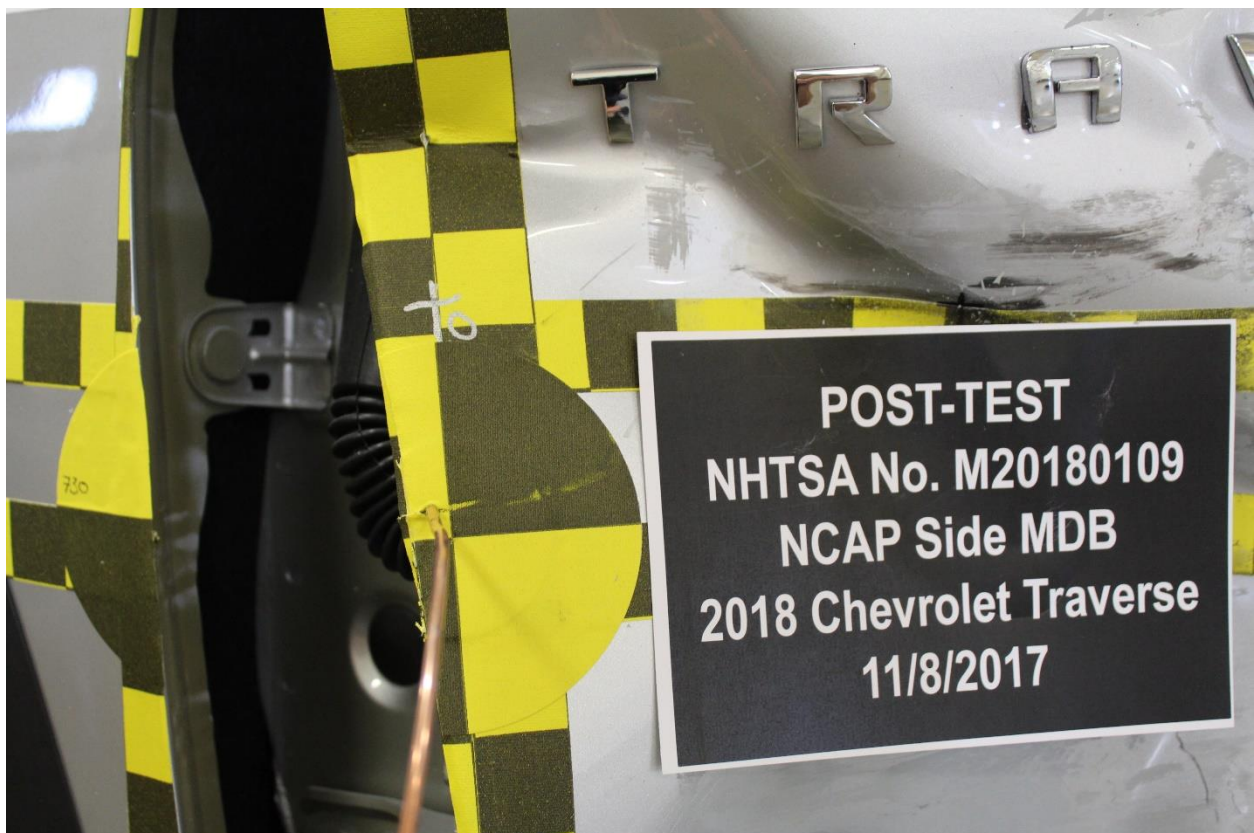
Figure A-20: Post-Test Close-up View of Impact Point Target

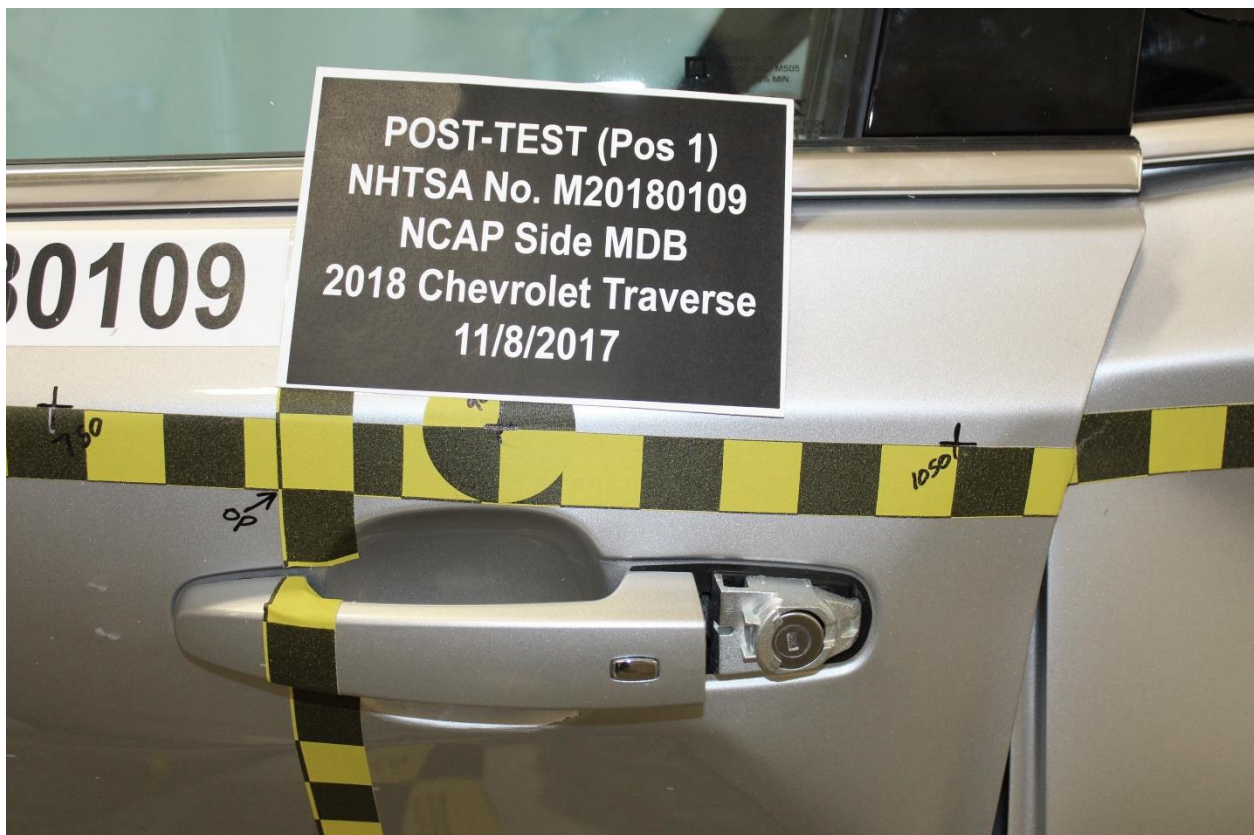
Figure A-22: Post-Test Left Front Door Latch Close-Up

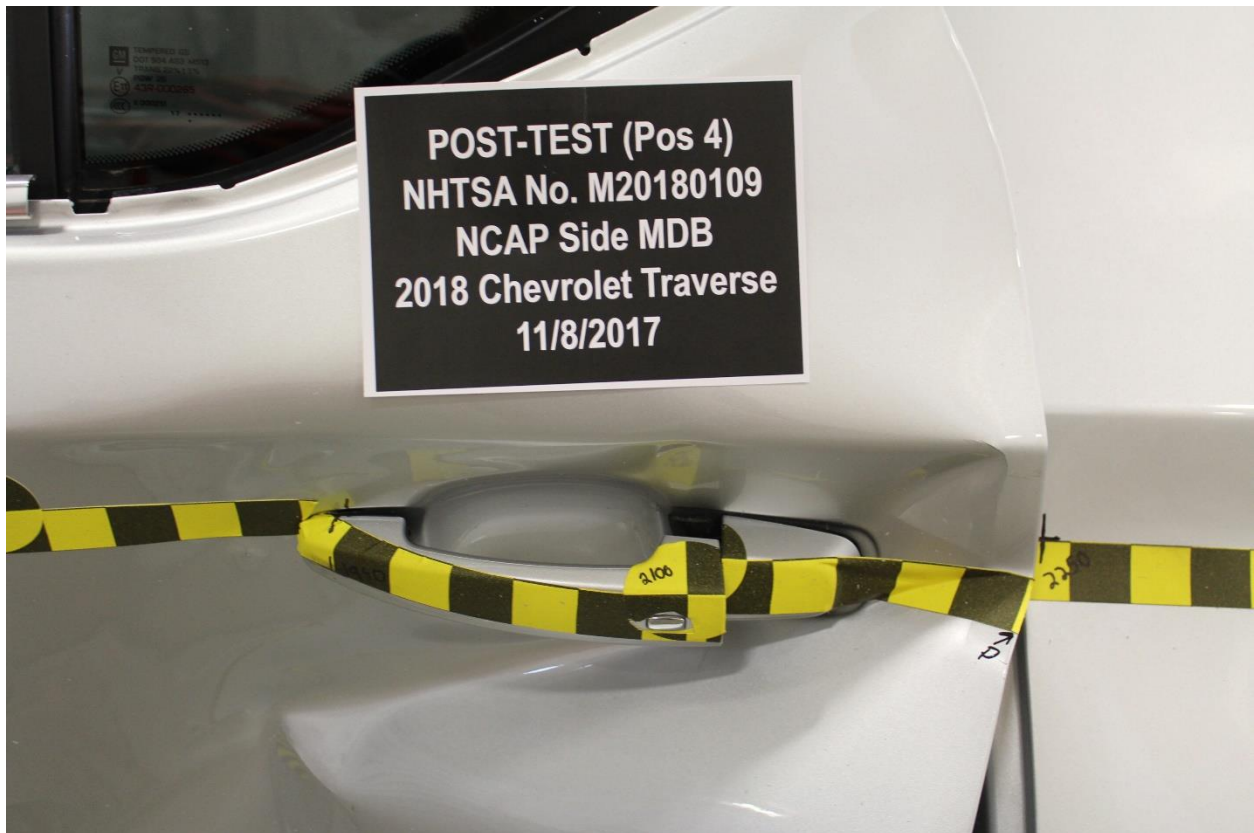
Figure A-24: Post-Test Left Rear Door Latch Close-Up

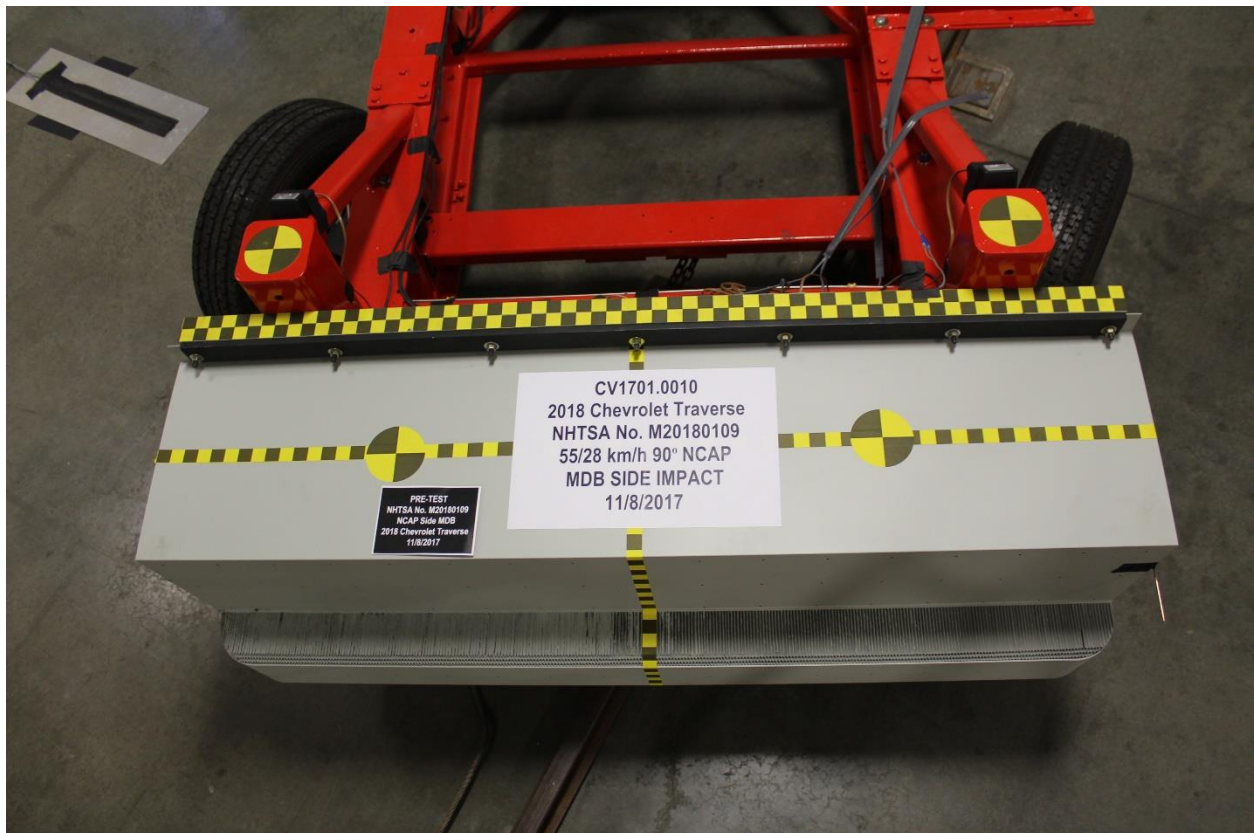
Figure A-87: Post-Test Top View of MDB Impactor Face

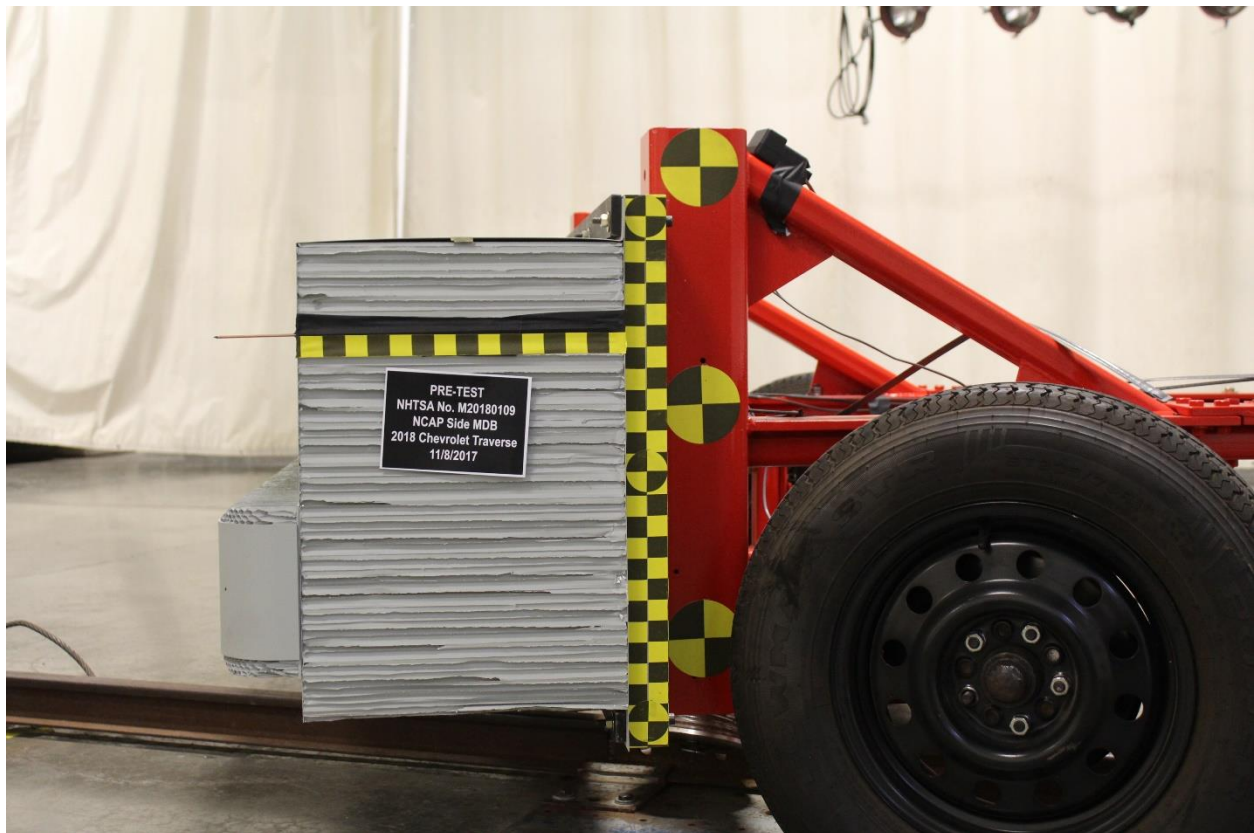
Figure A-89: Post-Test Left Side View of MDB Impactor Face
