**REPORT NUMBER: SPNCAP305I-CAL-18-002**

**NEW CAR ASSESSMENT PROGRAM (NCAP)  
SIDE IMPACT POLE TEST  
FMVSS No. 305 Indicant Test**

**Toyota Motor Corporation  
2018 Toyota Prius C  
Five Door Hatchback**

**NHTSA No: M20185106**

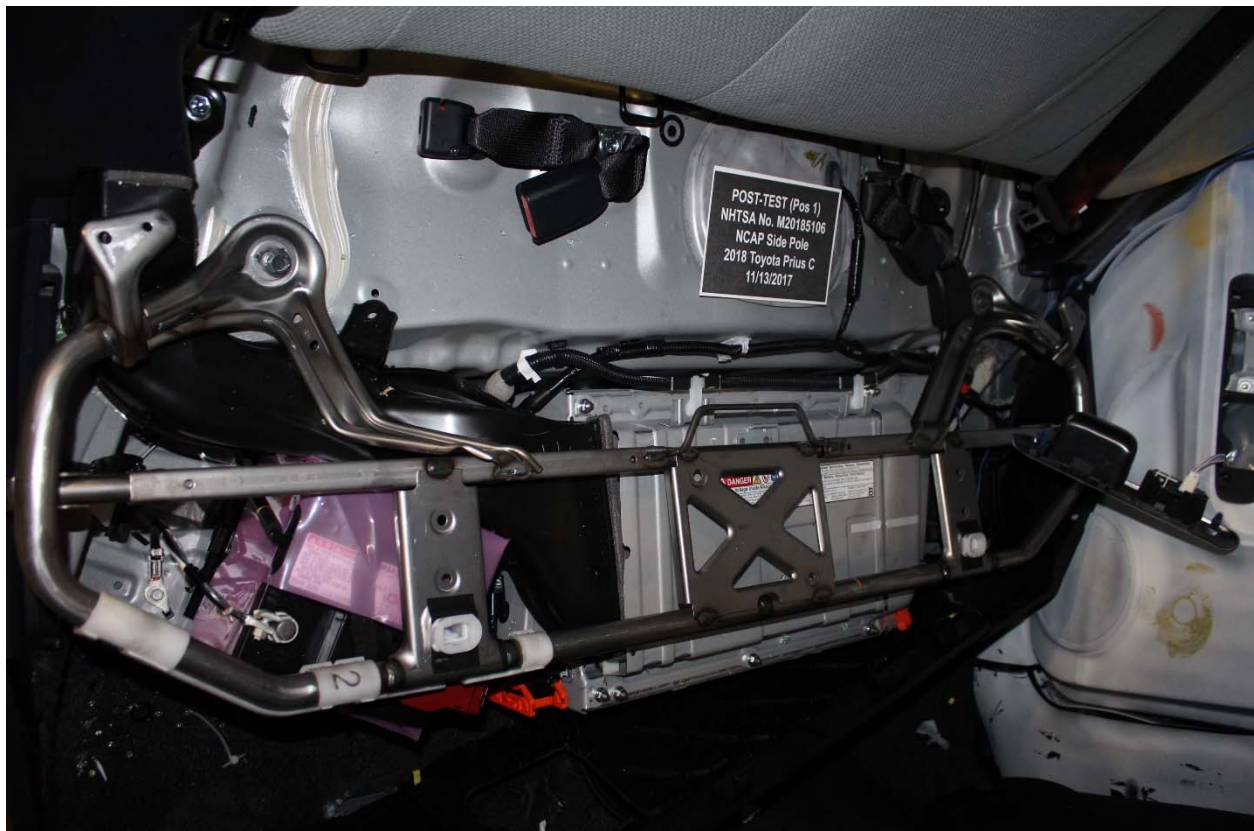
**Figure A-10: Post-Impact Front View of Propulsion Battery**

| Measured Parameter | Comments | Passed | Failed |
|---|---|---|---|
| Propulsion Battery Module movement within the passenger compartment | No Movement | X | |
| Intrusion of an outside Propulsion Battery Component into the passenger compartment | No Intrusions | X | |

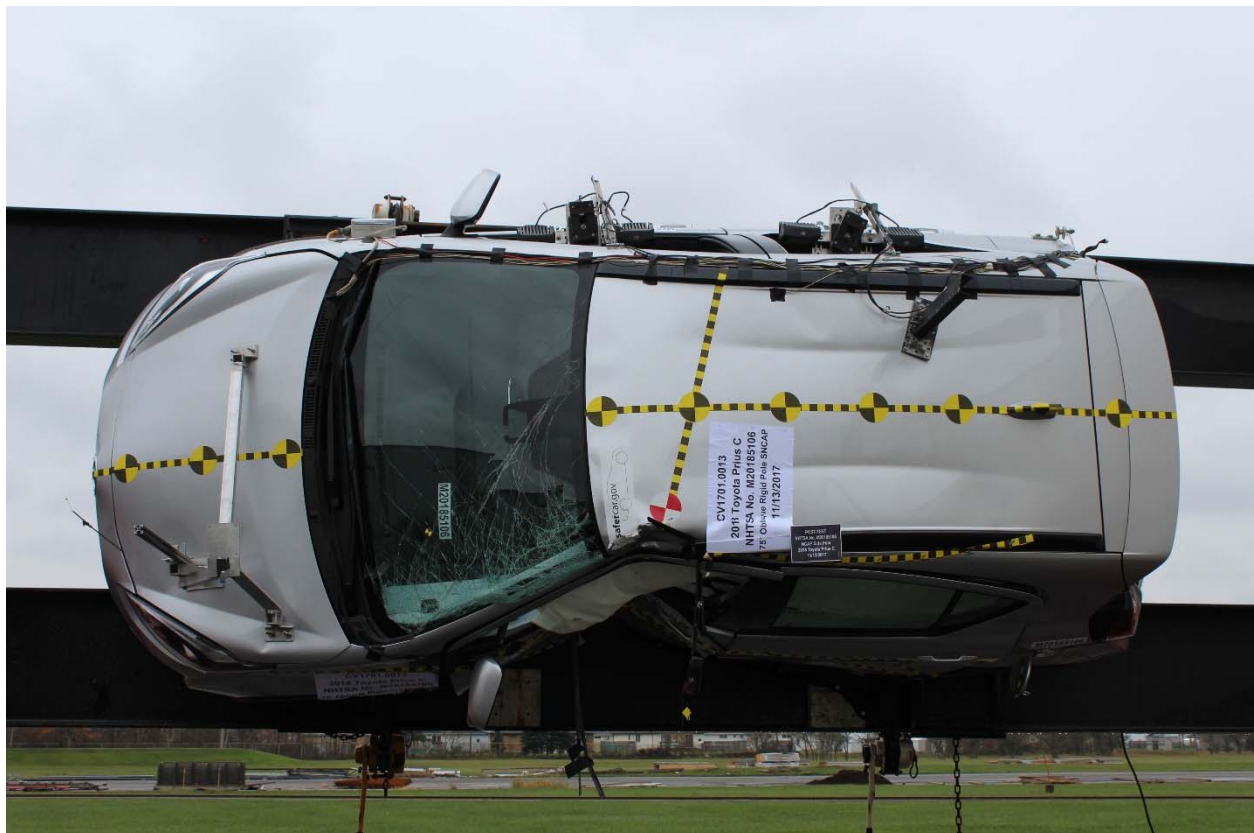
Figure A-28: FMVSS No. 305 Static Rollover 90 Degrees

| Rollover Stage | Propulsion Battery Electrolyte Spillage | Units | Spillage Location |
|---|---|---|---|
| 0° to 90° | 0.0 | Liters | None |

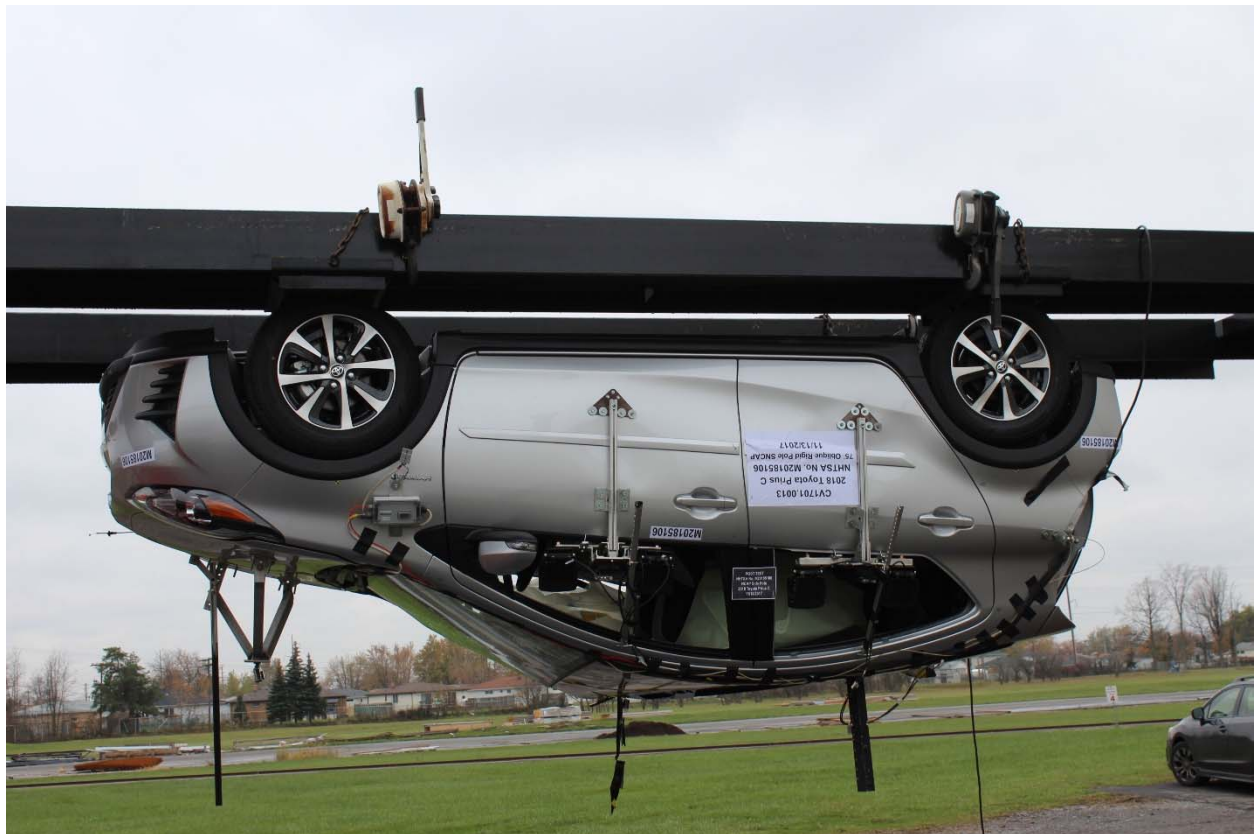
**Figure A-29: FMVSS No. 305 Static Rollover 180 Degrees**

| Rollover Stage | Propulsion Battery Electrolyte Spillage | Units | Spillage Location |
|---|---|---|---|
| 90° to 180° | 0.0 | Liters | None |

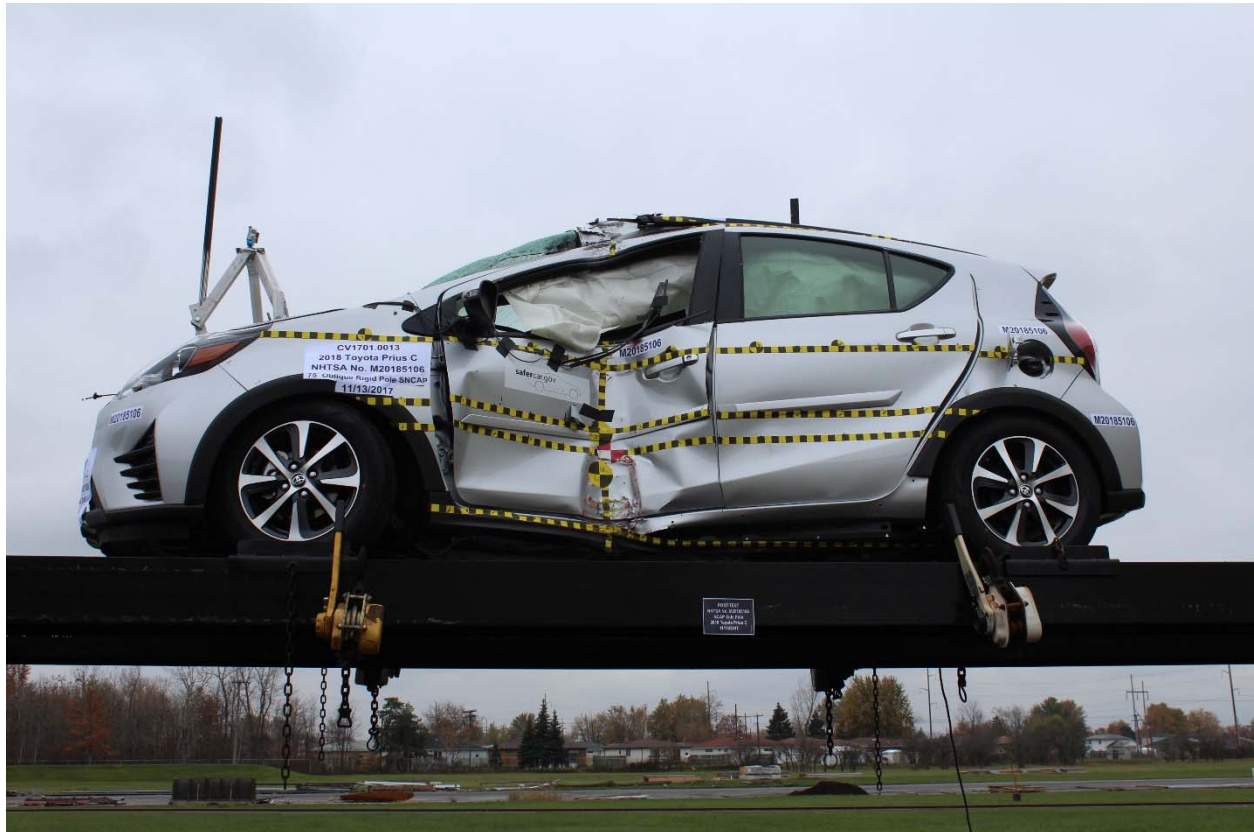
**Figure A-31: FMVSS No. 305 Static Rollover 360 Degrees**

| Rollover Stage | Propulsion Battery Electrolyte Spillage | Units | Spillage Location |
|---|---|---|---|
| 270° to 360° | 0.0 | Liters | None |

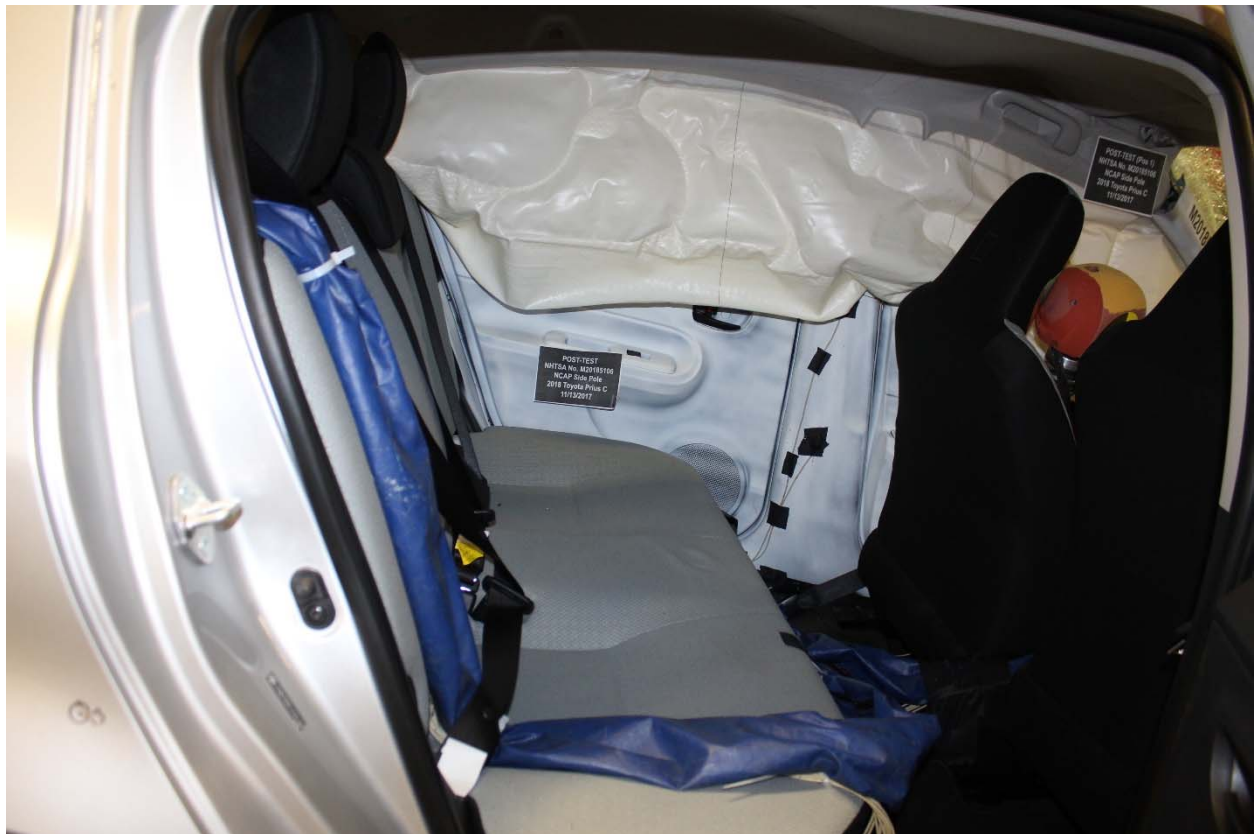
**Figure A-33: Post-Impact View of the Vehicle Passenger Compartment Adjacent to Propulsion Battery**

| Measured Parameter | Comments | Passed | Failed |
|---|---|---|---|
| Is propulsion battery electrolyte spillage visible in the passenger compartment? | | X | |
