**REPORT NUMBER: NCAP-MGA-2018-016**

**NEW CAR ASSESSMENT PROGRAM (NCAP)  
Frontal Barrier Impact Test**

**HYUNDAI MOTOR COMPANY  
2018 Hyundai Santa Fe SE AWD 5-Door SUV  
NHTSA No.: M20184200**

**FINAL REPORT**

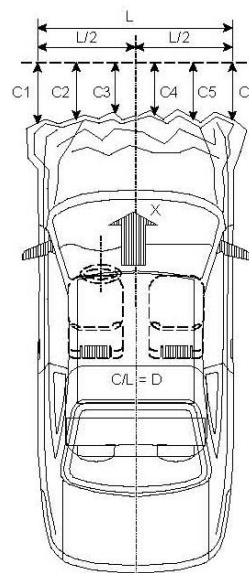
No.	Measurement Description	Units	Pre-Test	Post-Test	Difference
C1	Crush zone 1 at left side	mm	4730	4262	468
C2	Crush zone 2 at left side	mm	4816	4369	447
C3	Crush zone 3 at left side	mm	4852	4396	456
C4	Crush zone 4 at right side	mm	4852	4388	464
C5	Crush zone 5 at right side	mm	4816	4360	456
C6	Crush zone 6 at right side	mm	4730	4338	392
L	C1 TO C6	mm	1260	1267	-7

The maximum static crush of the vehicle was 469mm at the vehicle centerline and both the driver and passenger side doors remained closed during the impact event and were operable after the impact.

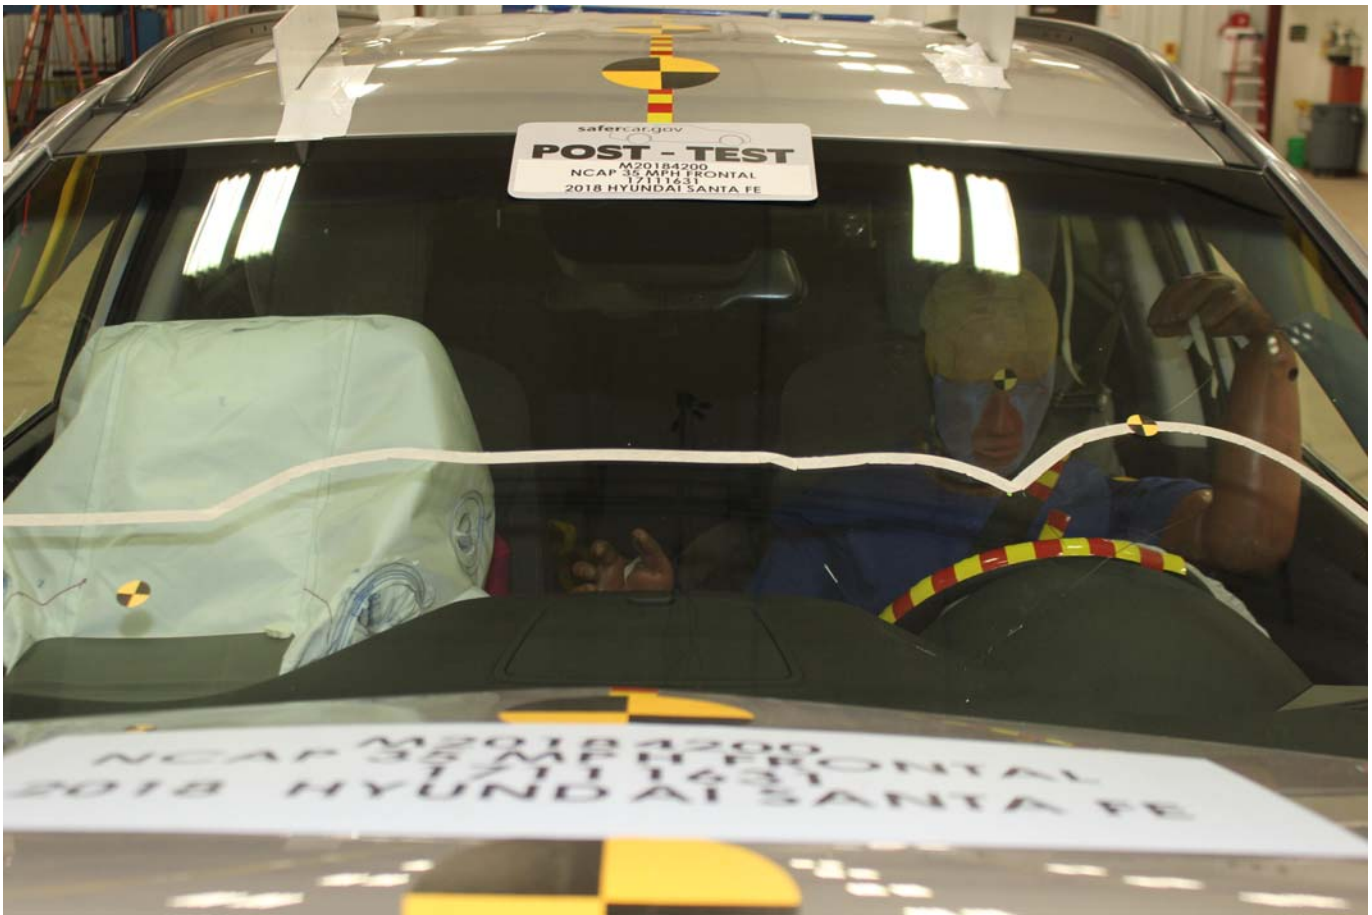
Photo No. 019 - Post-Test Windshield View

Critical Areas of Performance	Observations and Conclusions
Windshield Damage	Cracked
Window Damage	None
Other Notable Effects	None

There was 100 percent windshield retention and no intrusion into the protected zone of the windshield during the event. There was no Stoddard Solvent leakage after the event or during any phase of the static rollover.

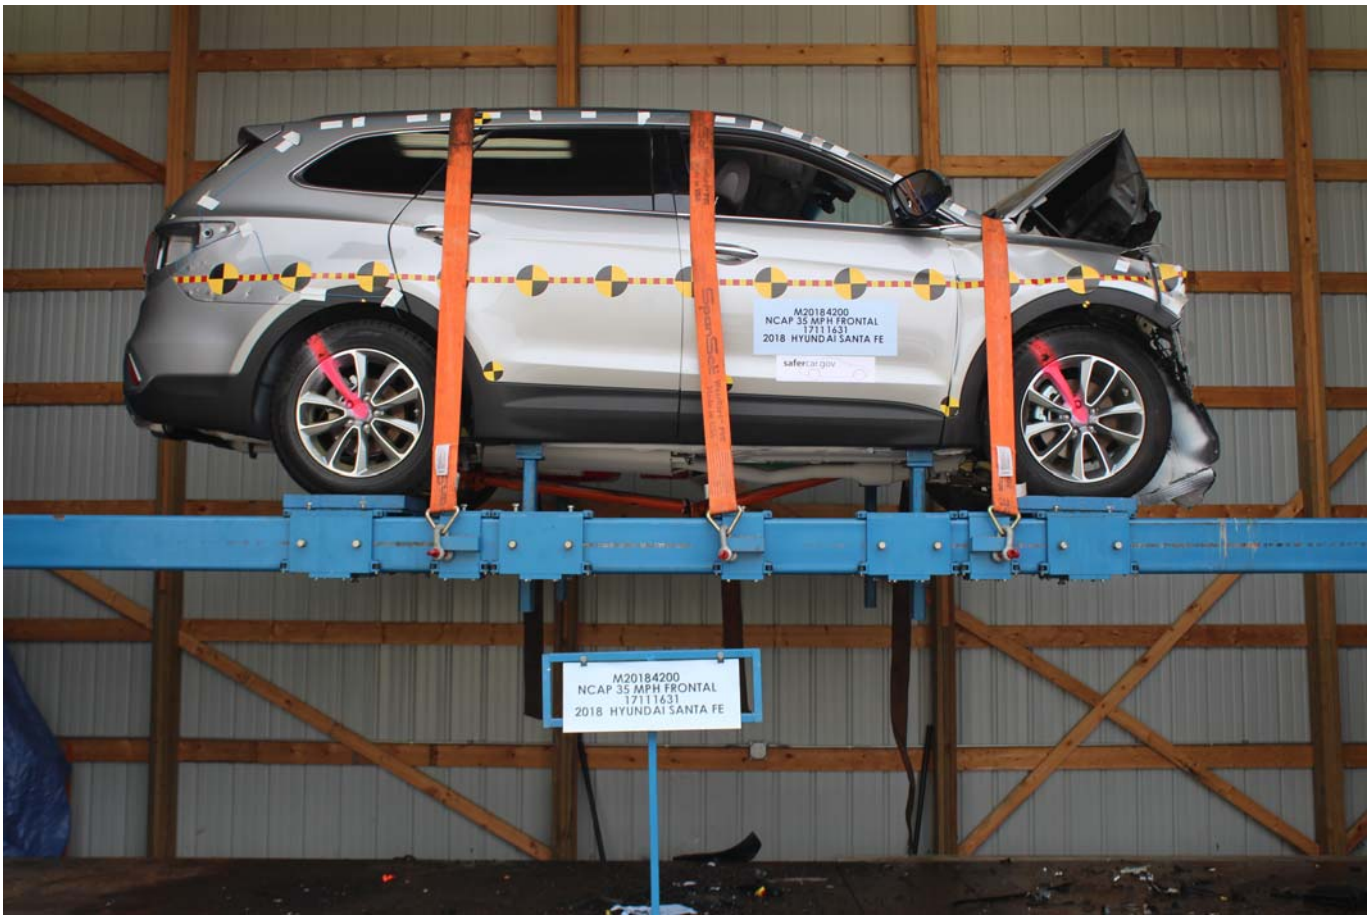
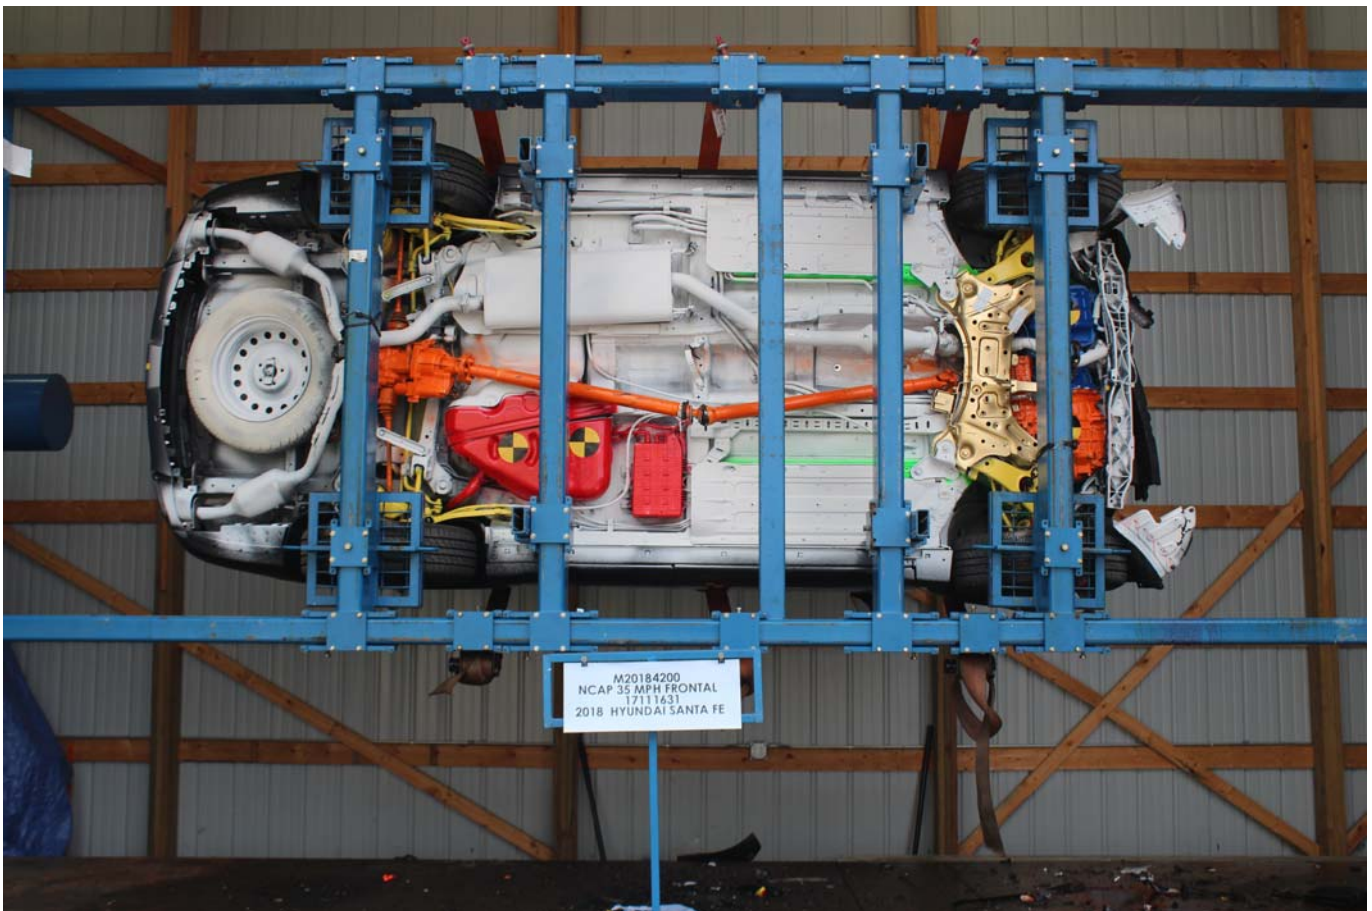
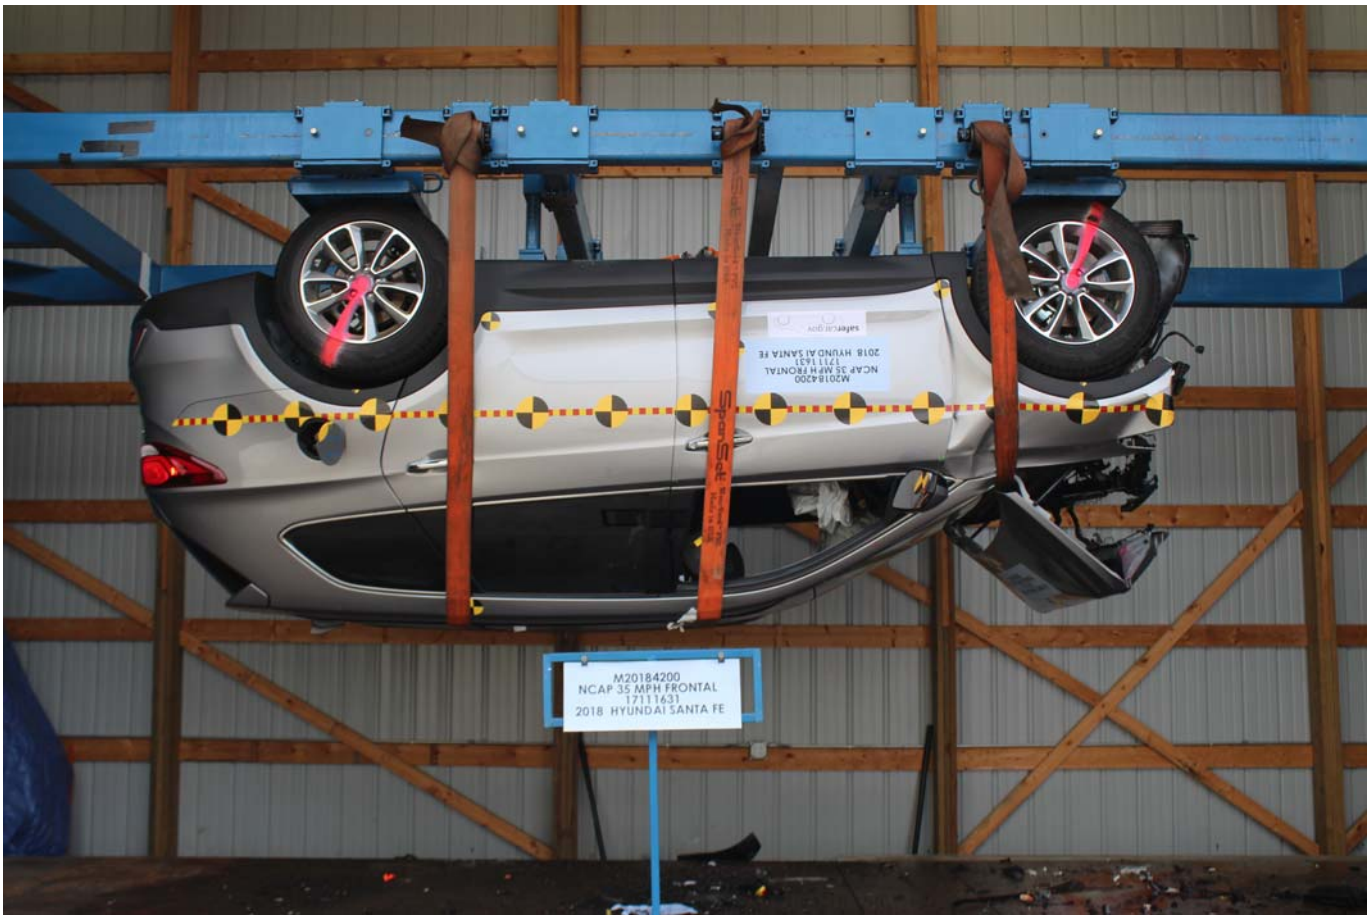
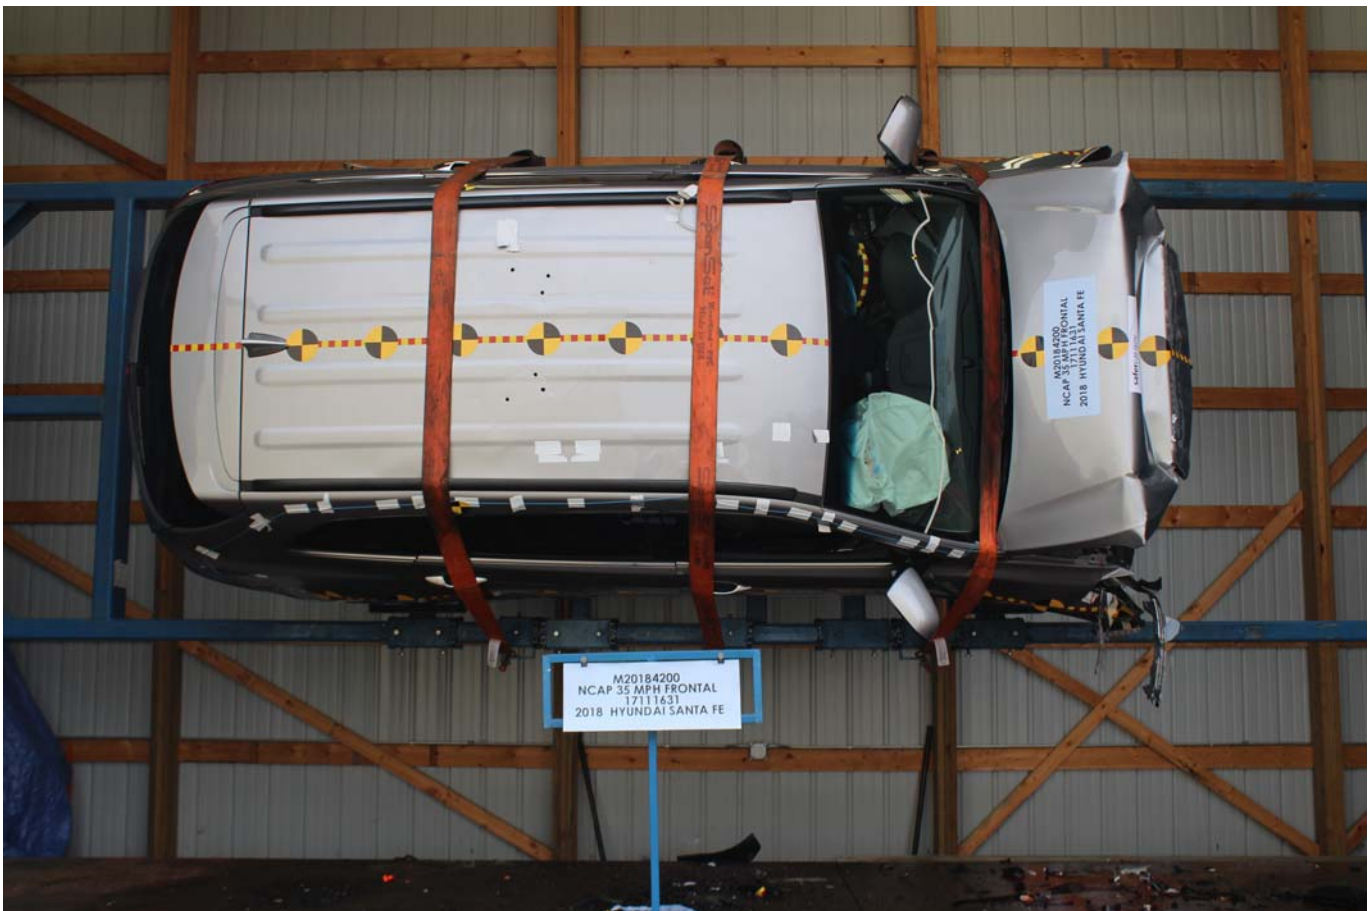
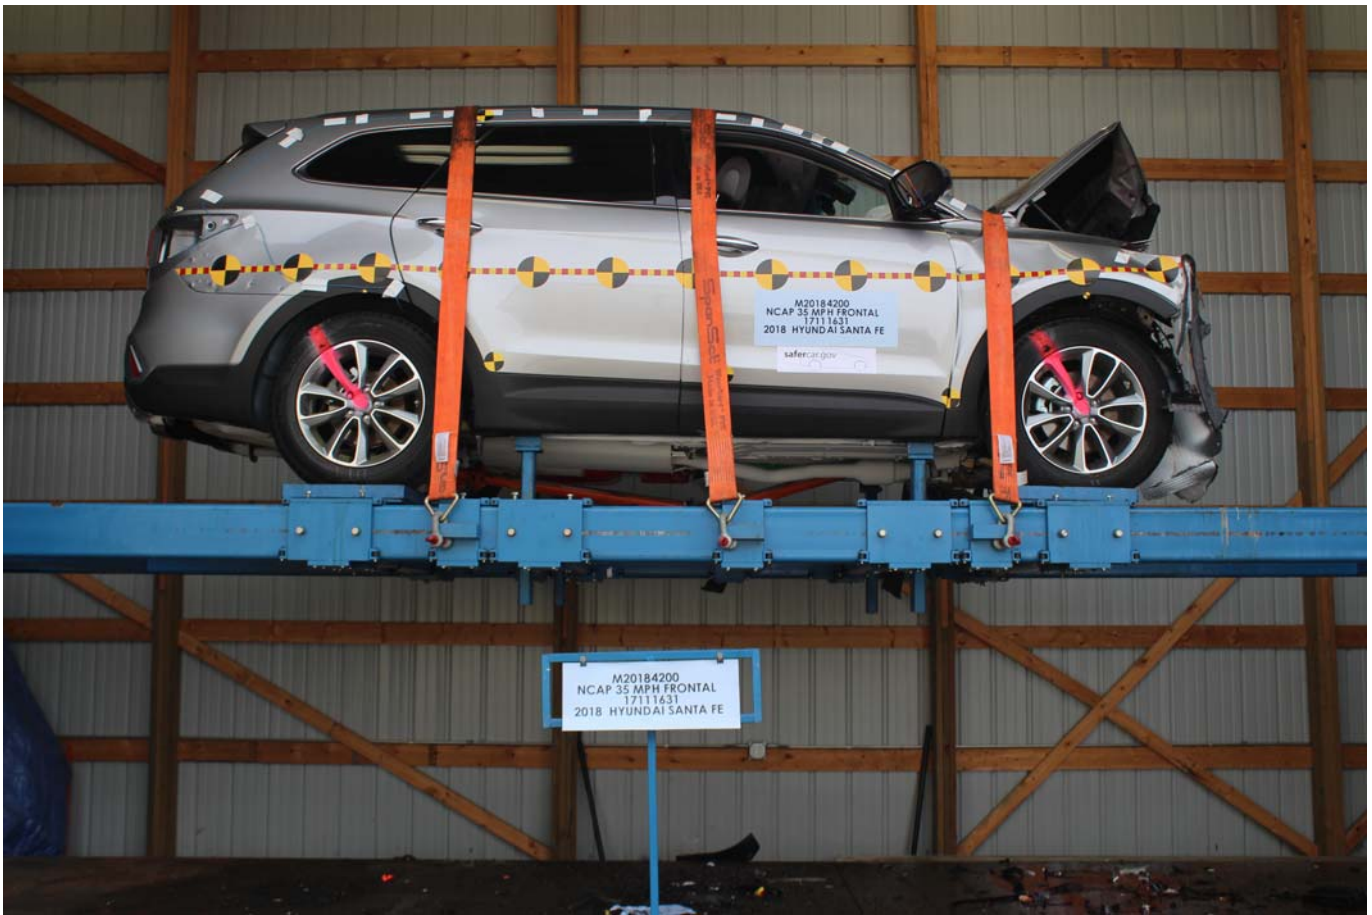
Photo No. 073 - Vehicle at 0 Degree on Static Rollover Device

Photo No. 074 - Vehicle at 90 Degrees on Static Rollover Device

Photo No. 075 - Vehicle at 180 Degrees on Static Rollover Device

Photo No. 076 - Vehicle at 270 Degrees on Static Rollover Device

Photo No. 077 - Vehicle at 360 Degrees on Static Rollover Device
