**REPORT NUMBER: SPNCAP-MGA-2018-017**

**NEW CAR ASSESSMENT PROGRAM (NCAP)  
Side Impact Pole Test**

**HYUNDAI MOTOR COMPANY  
2018 Hyundai Santa Fe SE 5-Door SUV  
NHTSA No.: M20184201**

**FINAL REPORT**

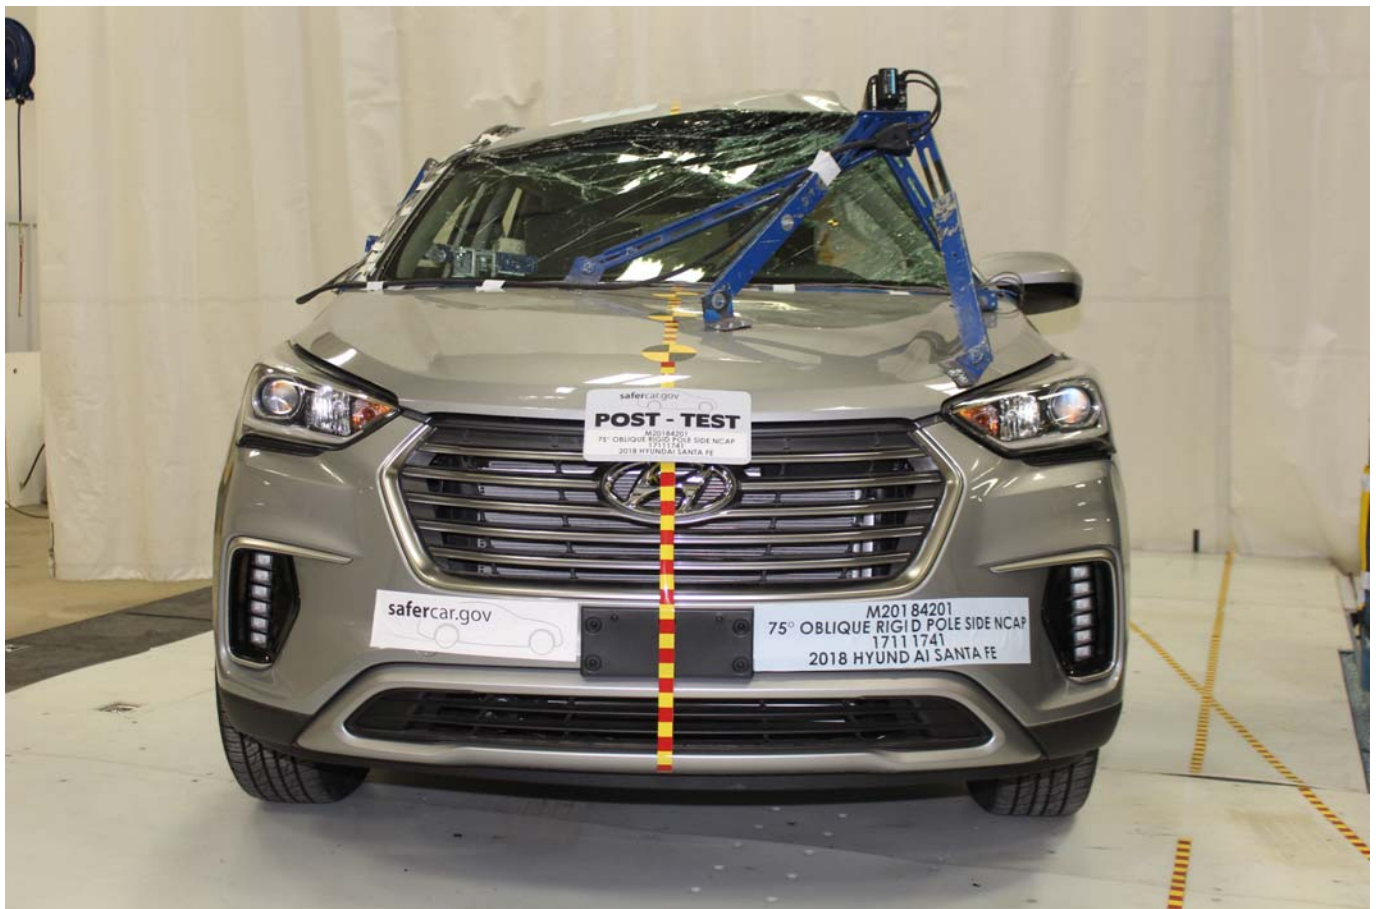
Photo No. 004 - Post-Test Frontal View of Test Vehicle

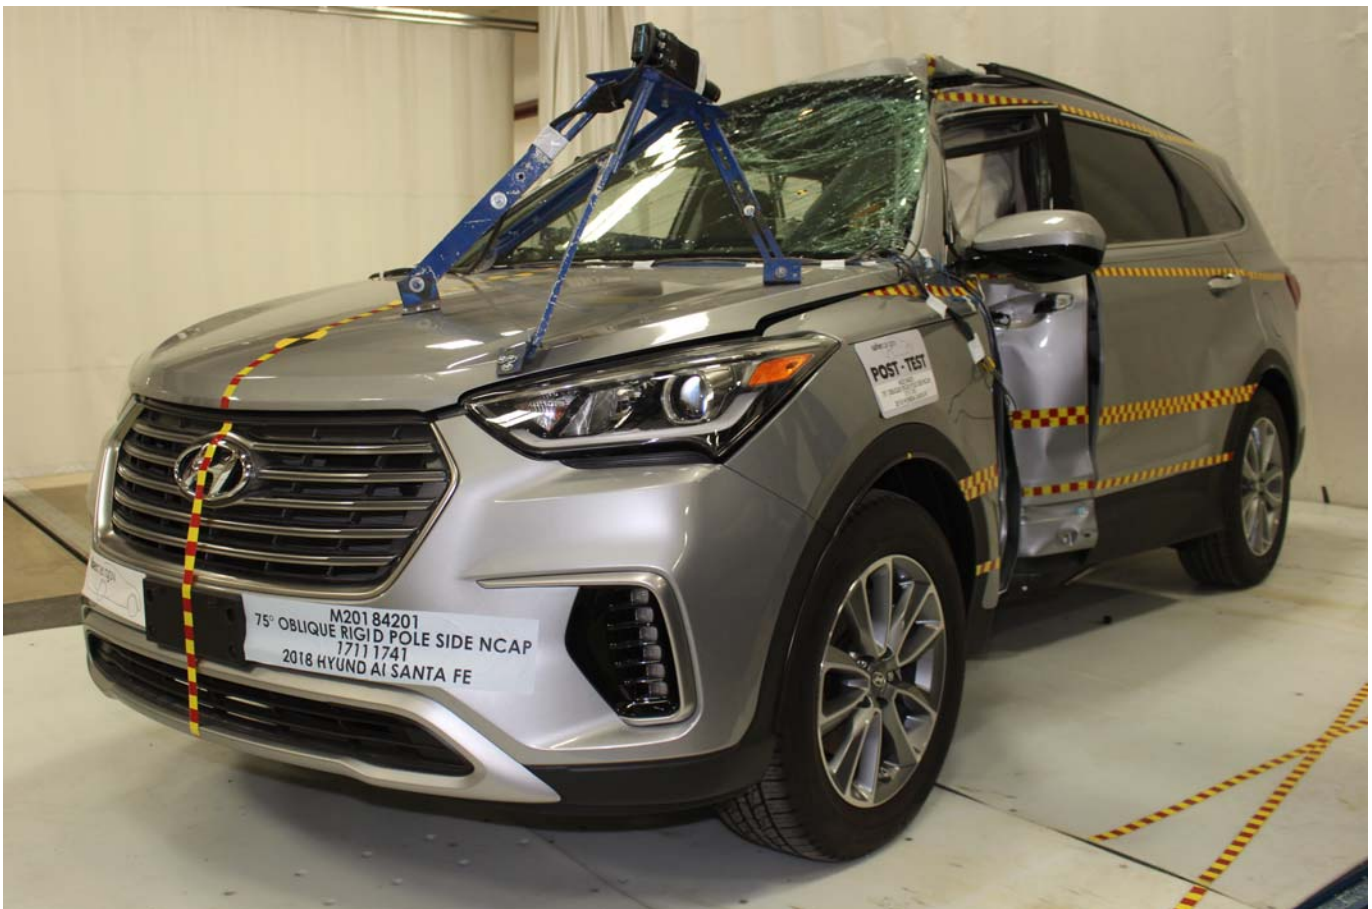
Photo No. 006 - Post-Test Left Front Three-Quarter View of Test Vehicle

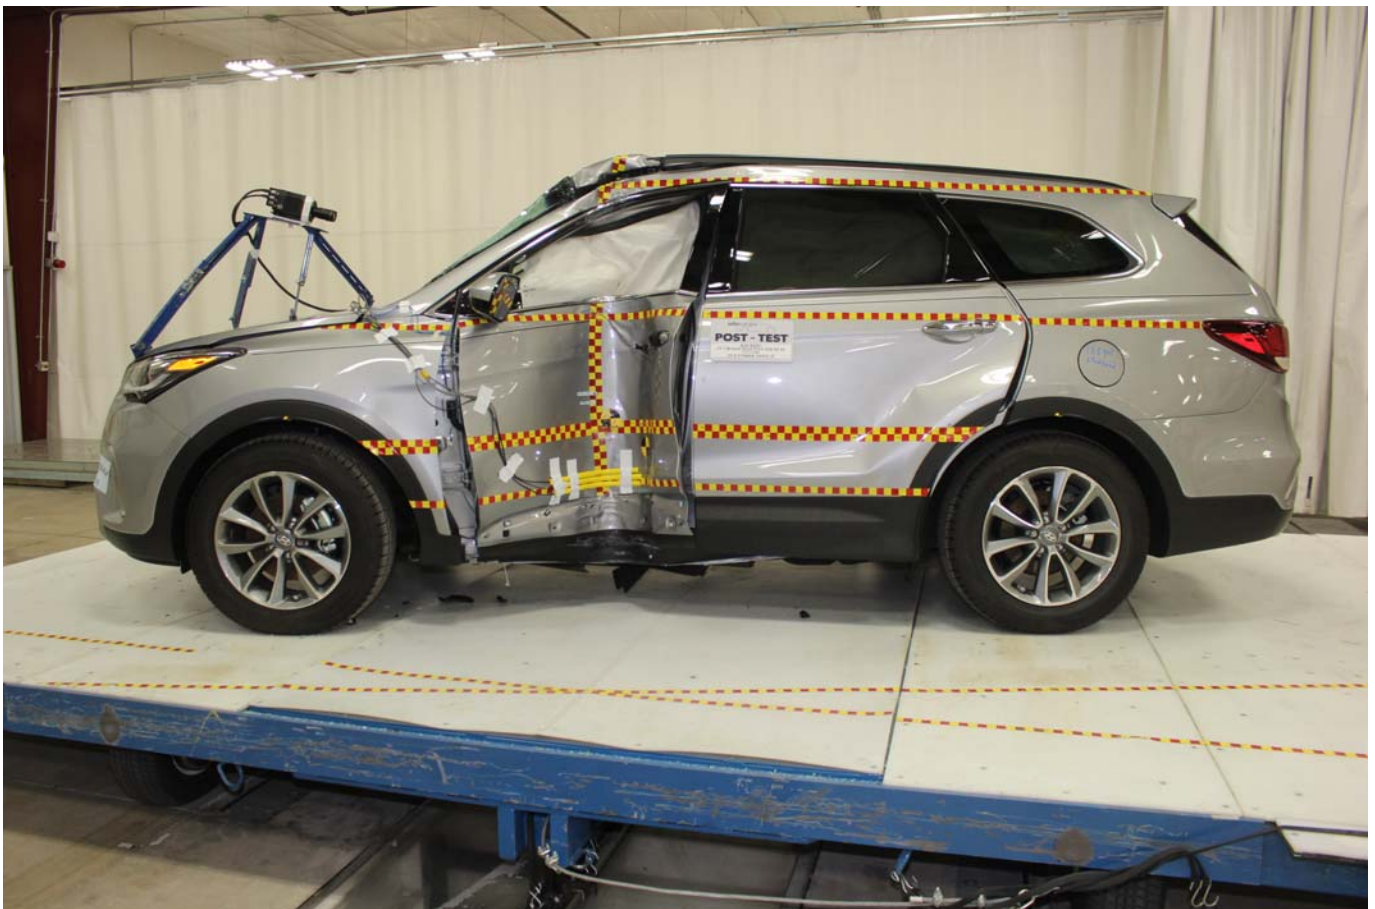
Photo No. 008 - Post-Test Left Side View of Test Vehicle

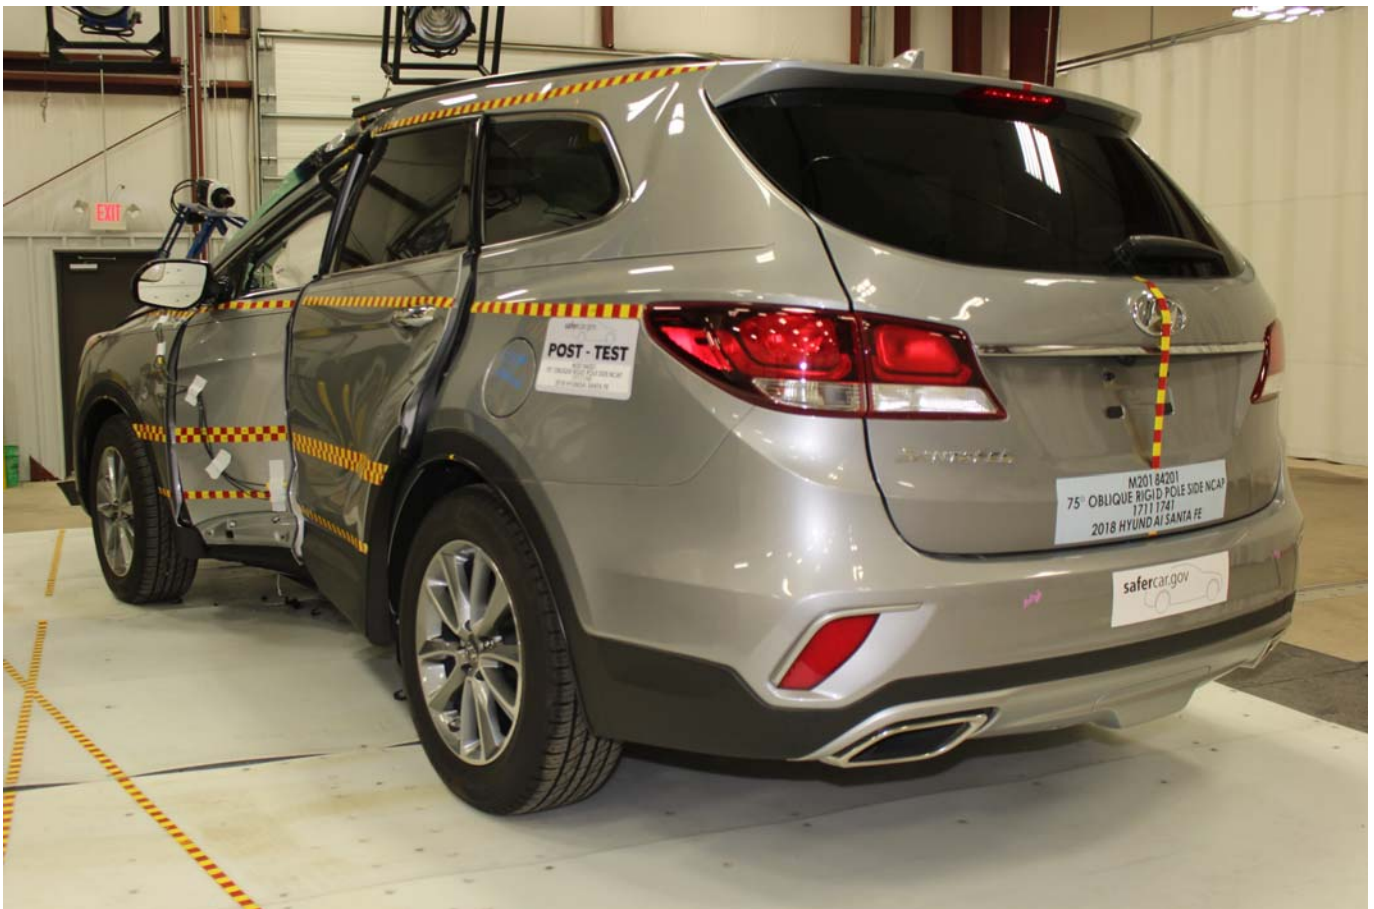
Photo No. 010 - Post-Test Left Rear Three-Quarter View of Test Vehicle

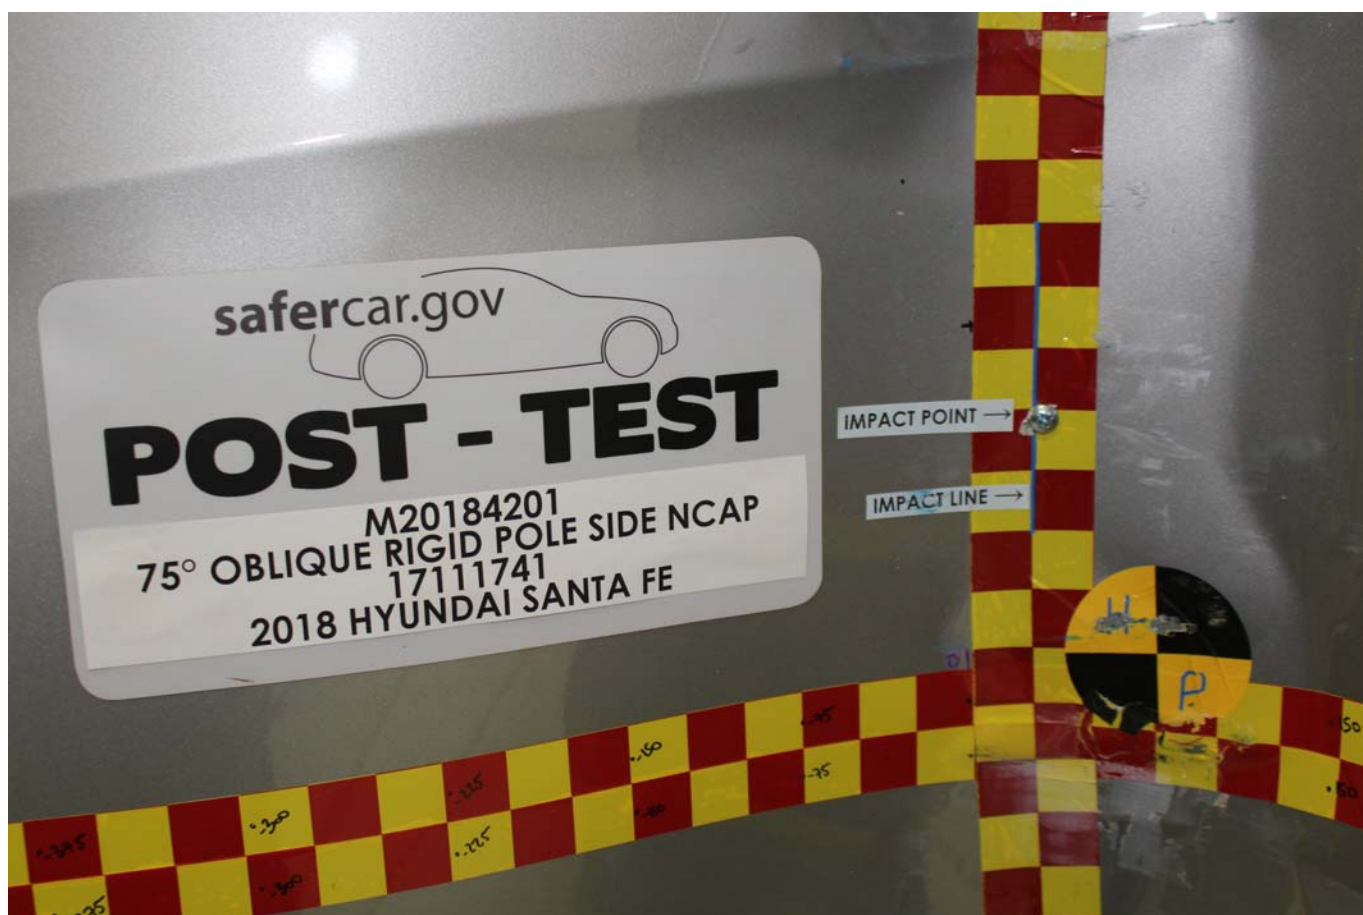
Photo No. 020 - Post-Test Close-Up View of Impact Point Target Showing Impact Location

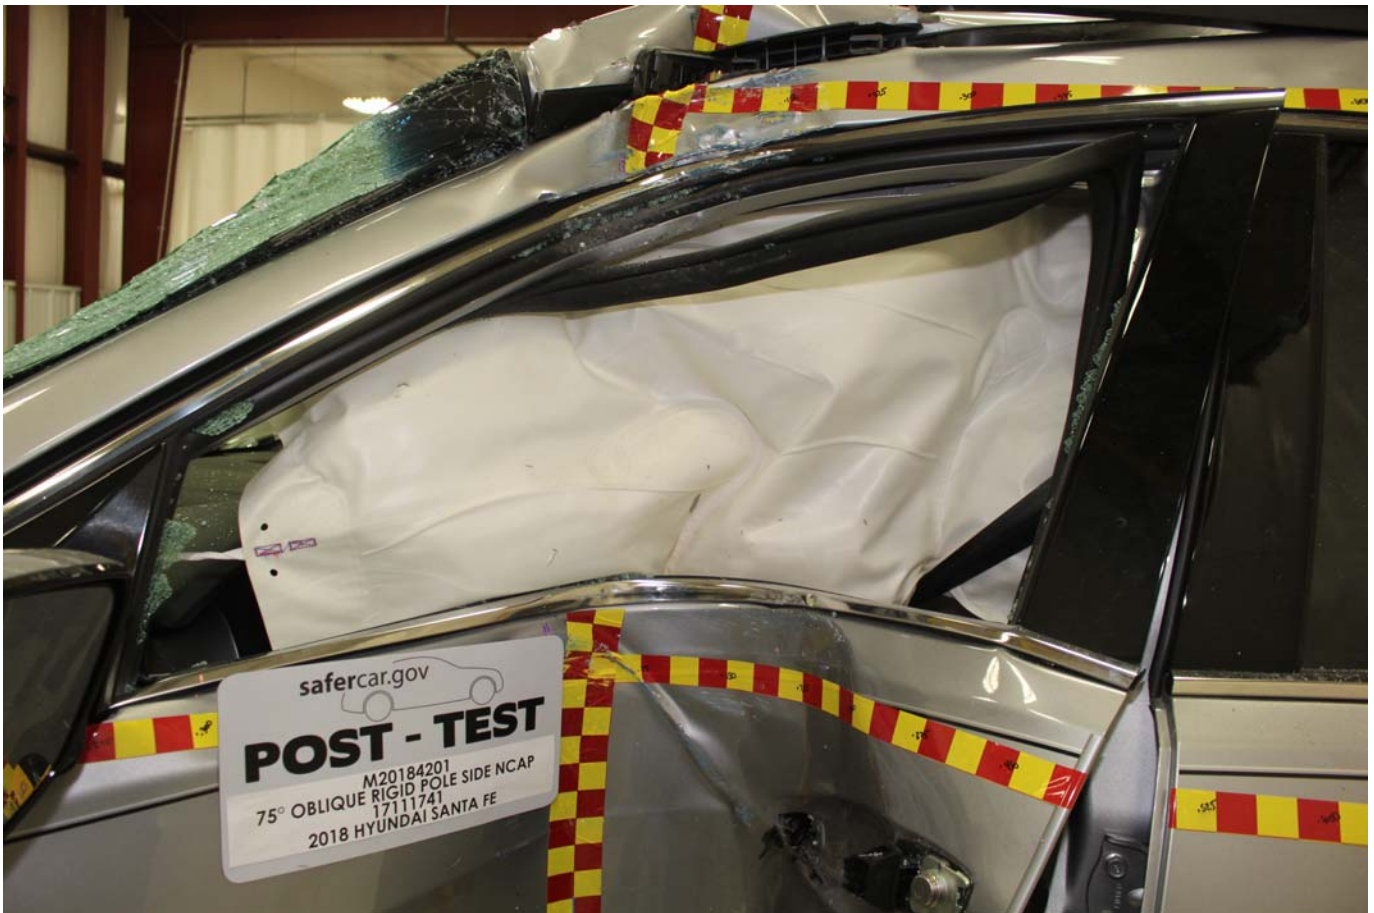
Photo No. 025 - Post-Test Left Side View of Dummy Shoulder and Door Top View

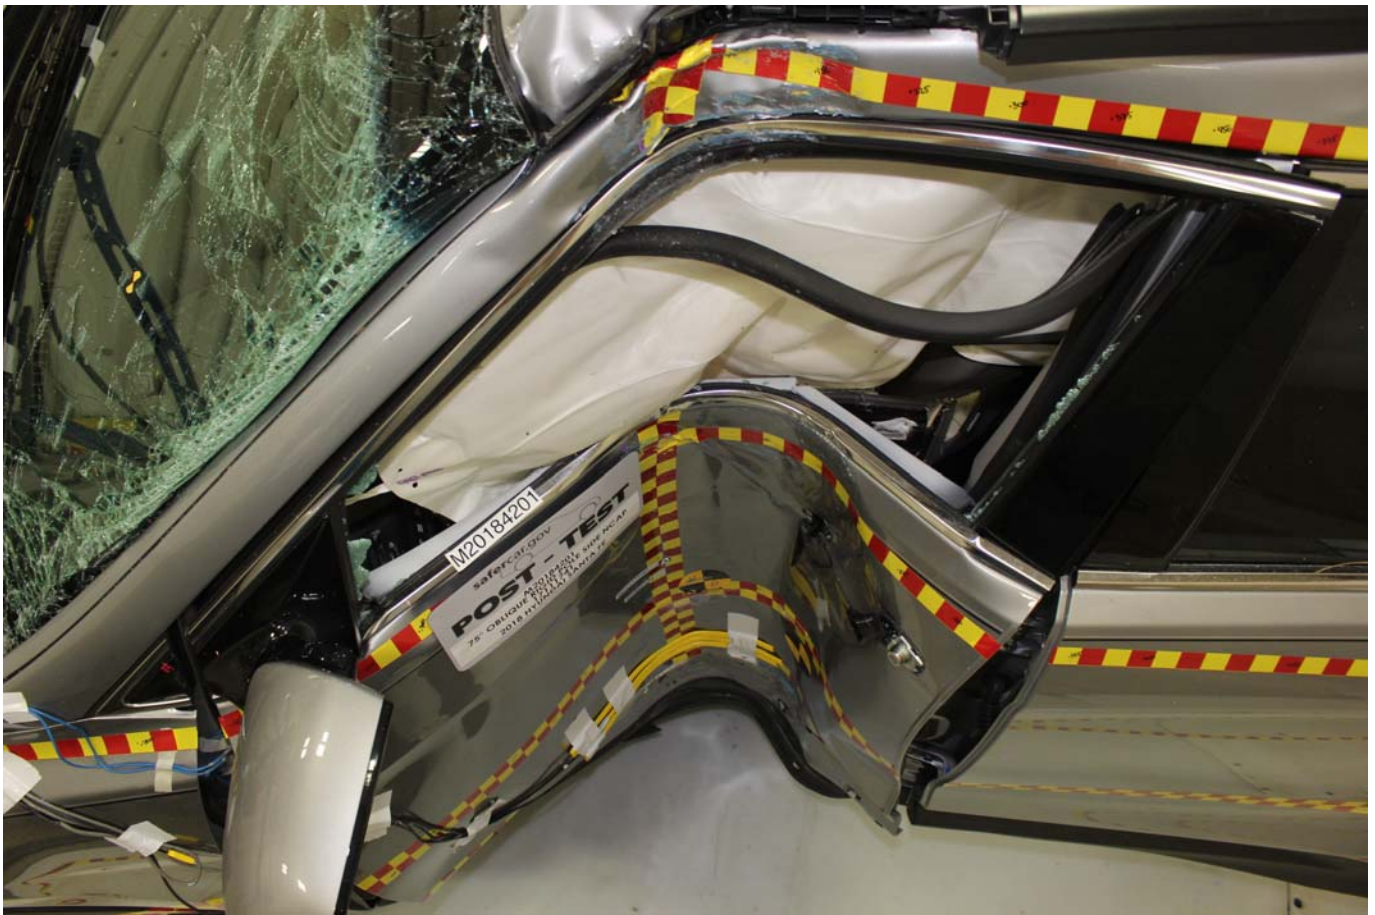
Photo No. 041 - Post-Test Dummy and Door Clearance View

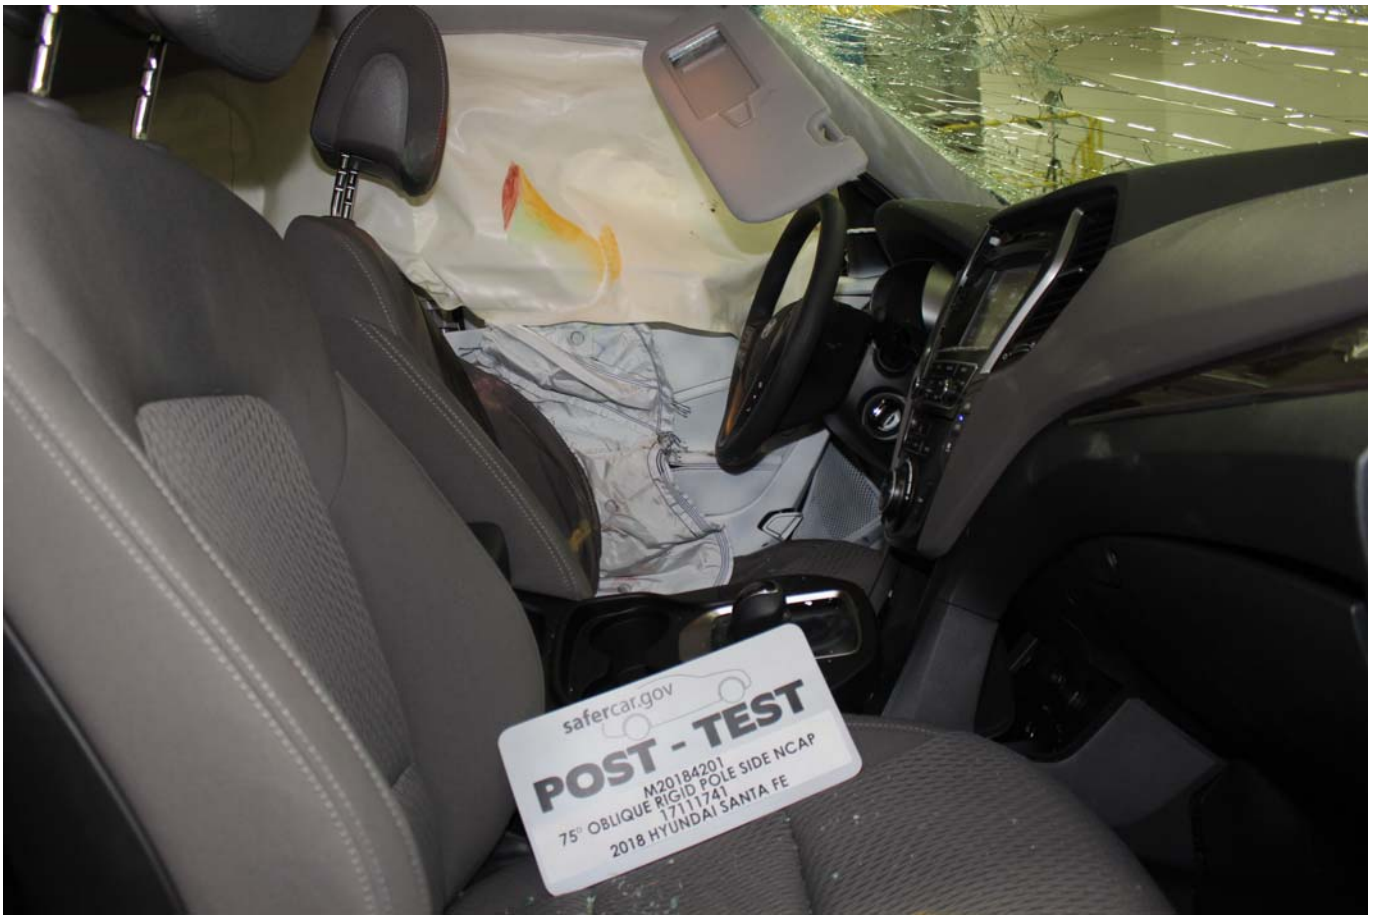
Photo No. 045 - Post-Test Inner Door Panel View Showing Dummy Contact Location

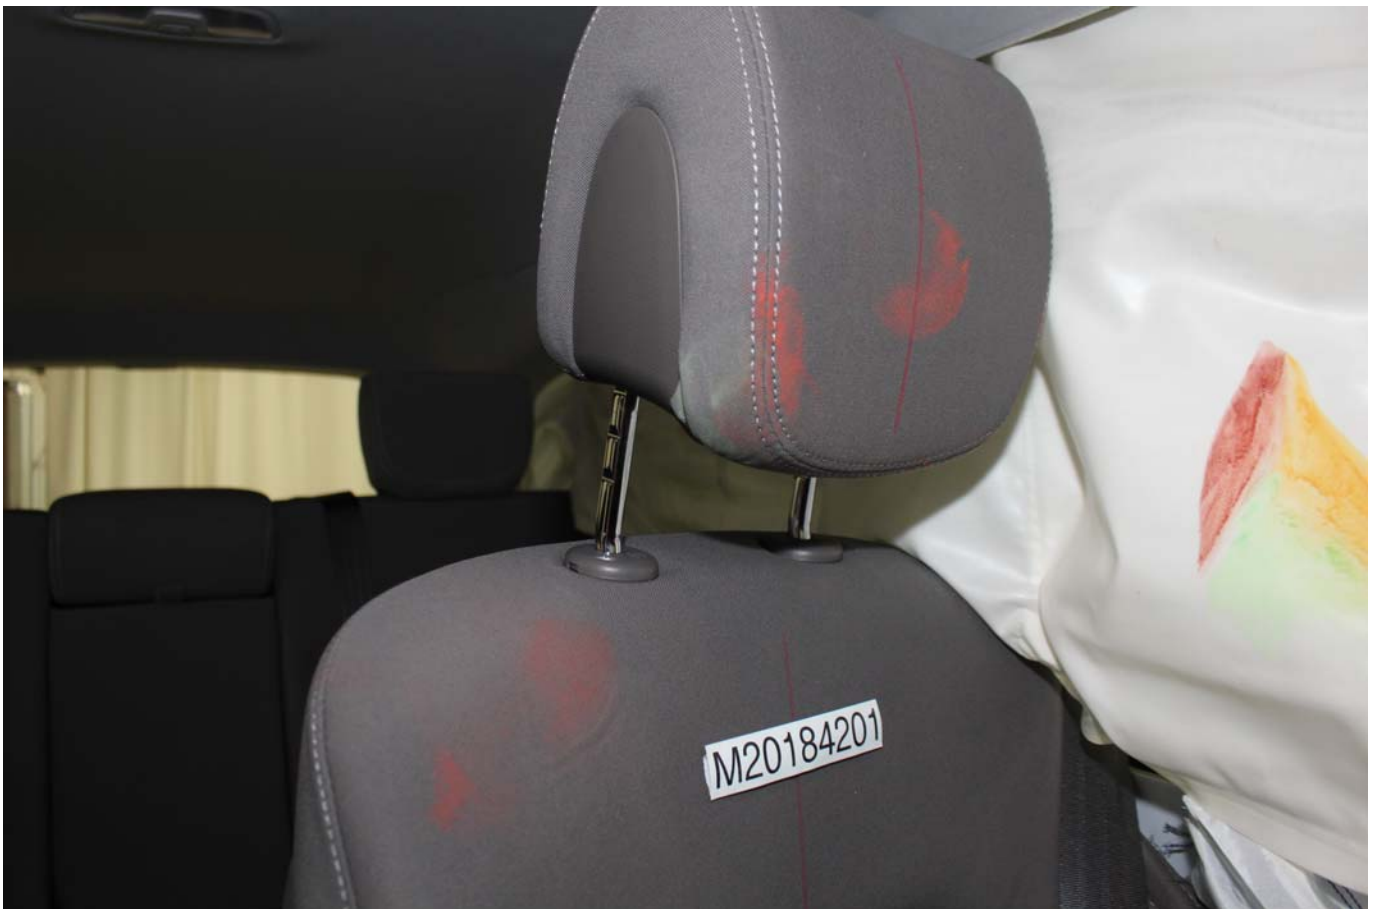
Photo No. 046 - Post-Test Dummy Close-Up Head Contact with Vehicle Interior View

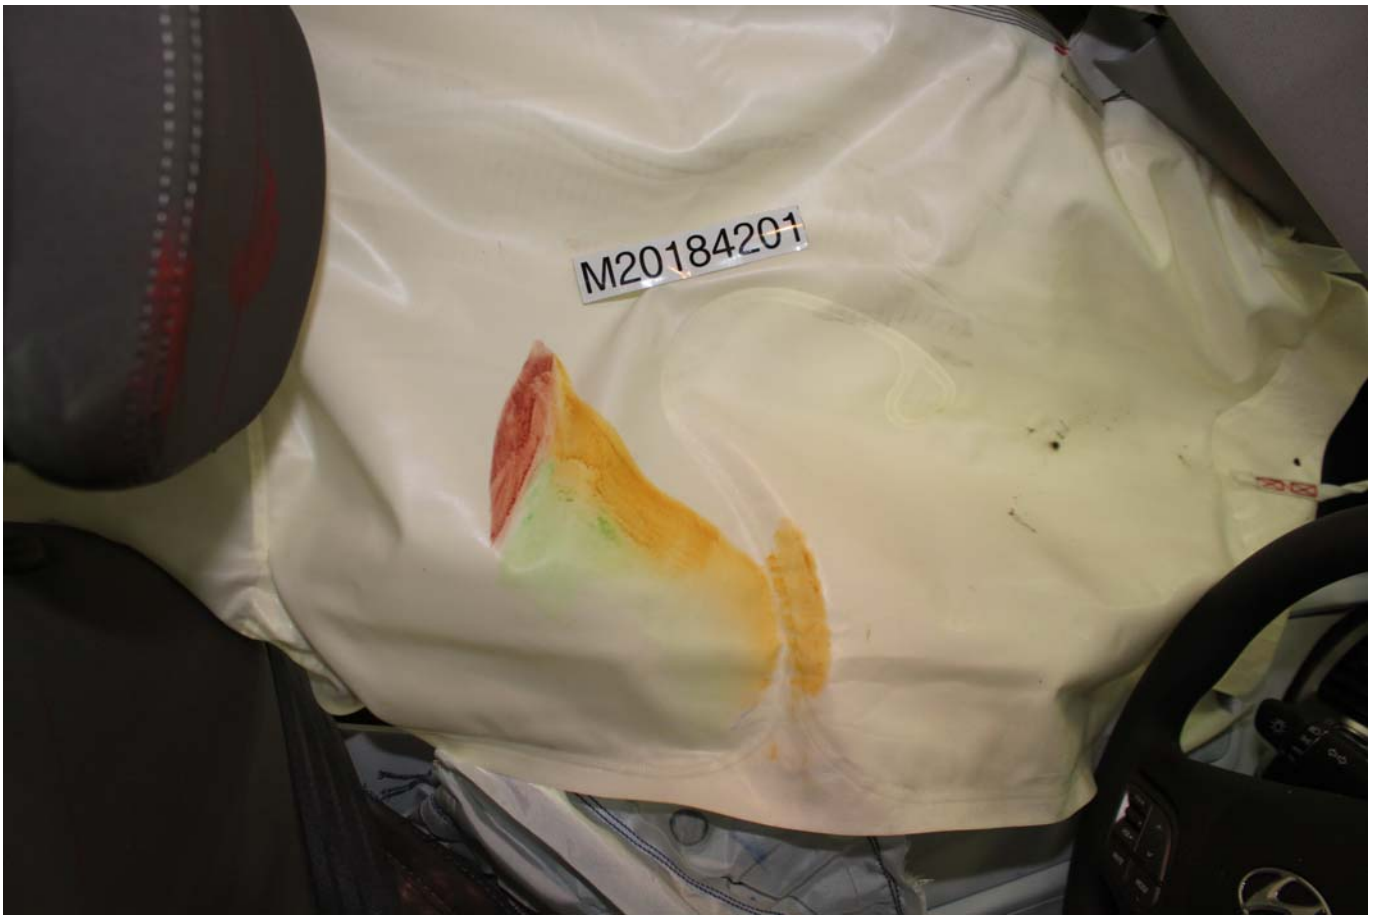
Photo No. 047 - Post-Test Dummy Close-Up Head Contact with Side Air Bag View
