REPORT NUMBER: NCAP-MGA-2018-019

**NEW CAR ASSESSMENT PROGRAM (NCAP)
Frontal Barrier Impact Test**

**BAYERISCHE MOTOREN WERKE AG
2018 BMW X1 xDrive28i 5-Door SUV
NHTSA No.: M20184100**

**MGA RESEARCH CORPORATION
5000 Warren Road
Burlington, WI 53105**

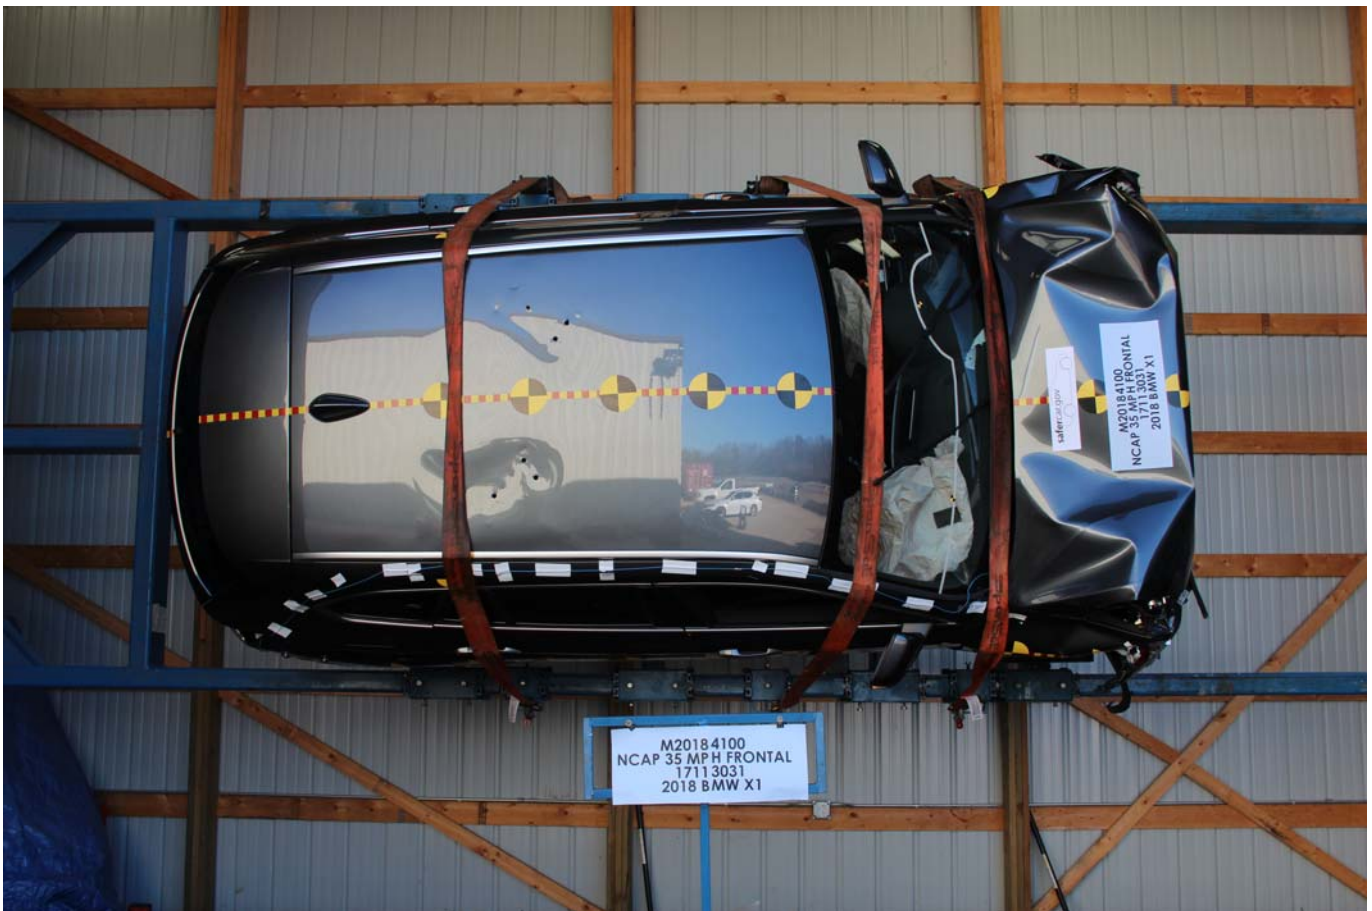
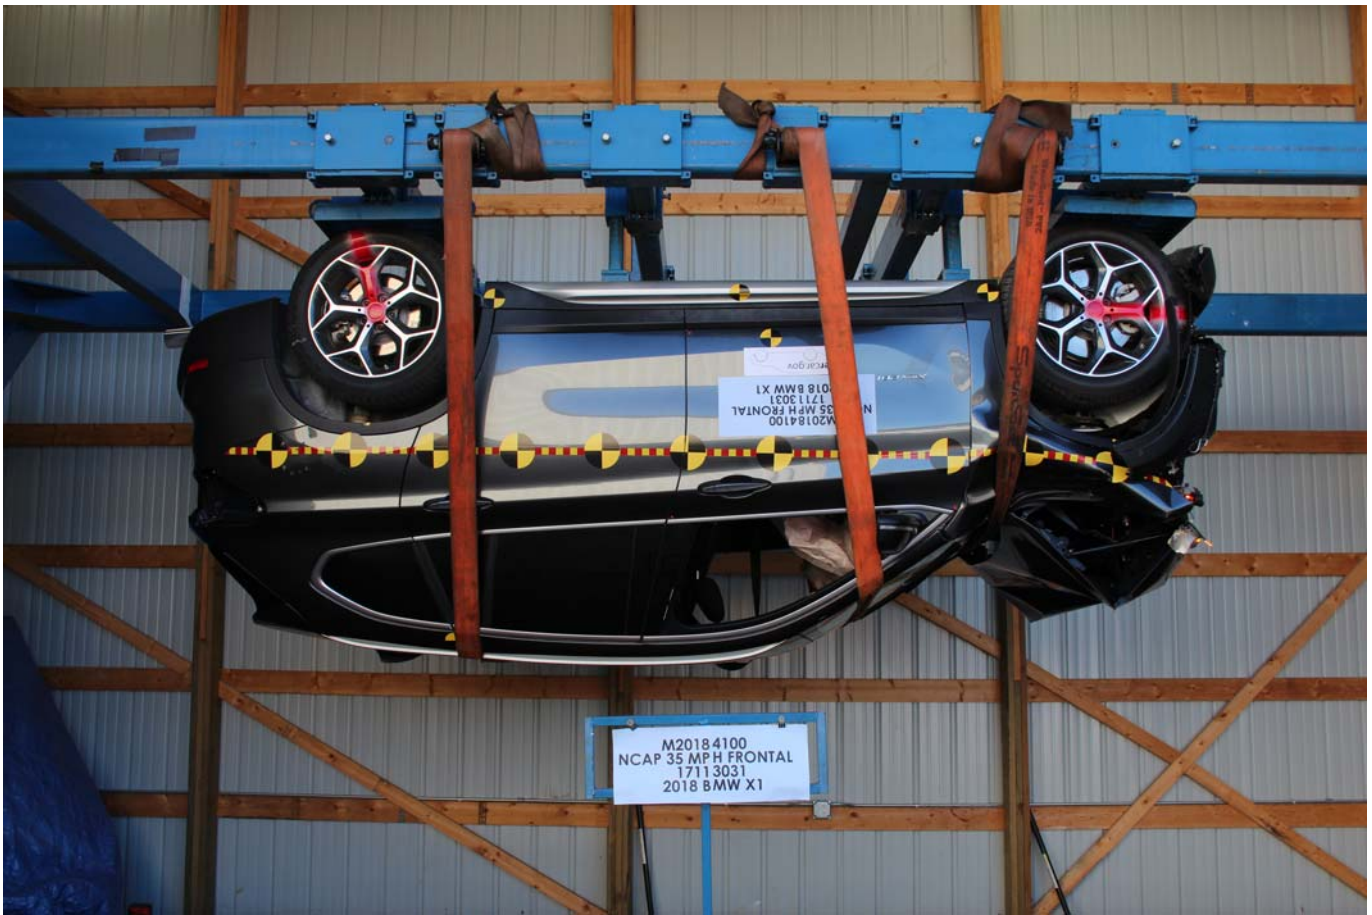
Photo No. 073 - Vehicle at 0 Degree on Static Rollover Device

Photo No. 074 - Vehicle at 90 Degrees on Static Rollover Device

Photo No. 075 - Vehicle at 180 Degrees on Static Rollover Device

Photo No. 077 - Vehicle at 360 Degrees on Static Rollover Device

There was 100 percent windshield retention and no intrusion into the protected zone of the windshield during the event. There was no Stoddard Solvent leakage after the event or during any phase of the static rollover.
