**REPORT NUMBER: SINCAP-MGA-2018-021**

**NEW CAR ASSESSMENT PROGRAM (NCAP)  
Moving Deformable Barrier Side Impact Test**

**BAYERISCHE MOTOREN WERKE AG  
2018 BMW X1 sDrive28i 5-Door SUV  
NHTSA No.: M20184102**

**MGA RESEARCH CORPORATION  
5000 Warren Road  
Burlington, WI 53105**

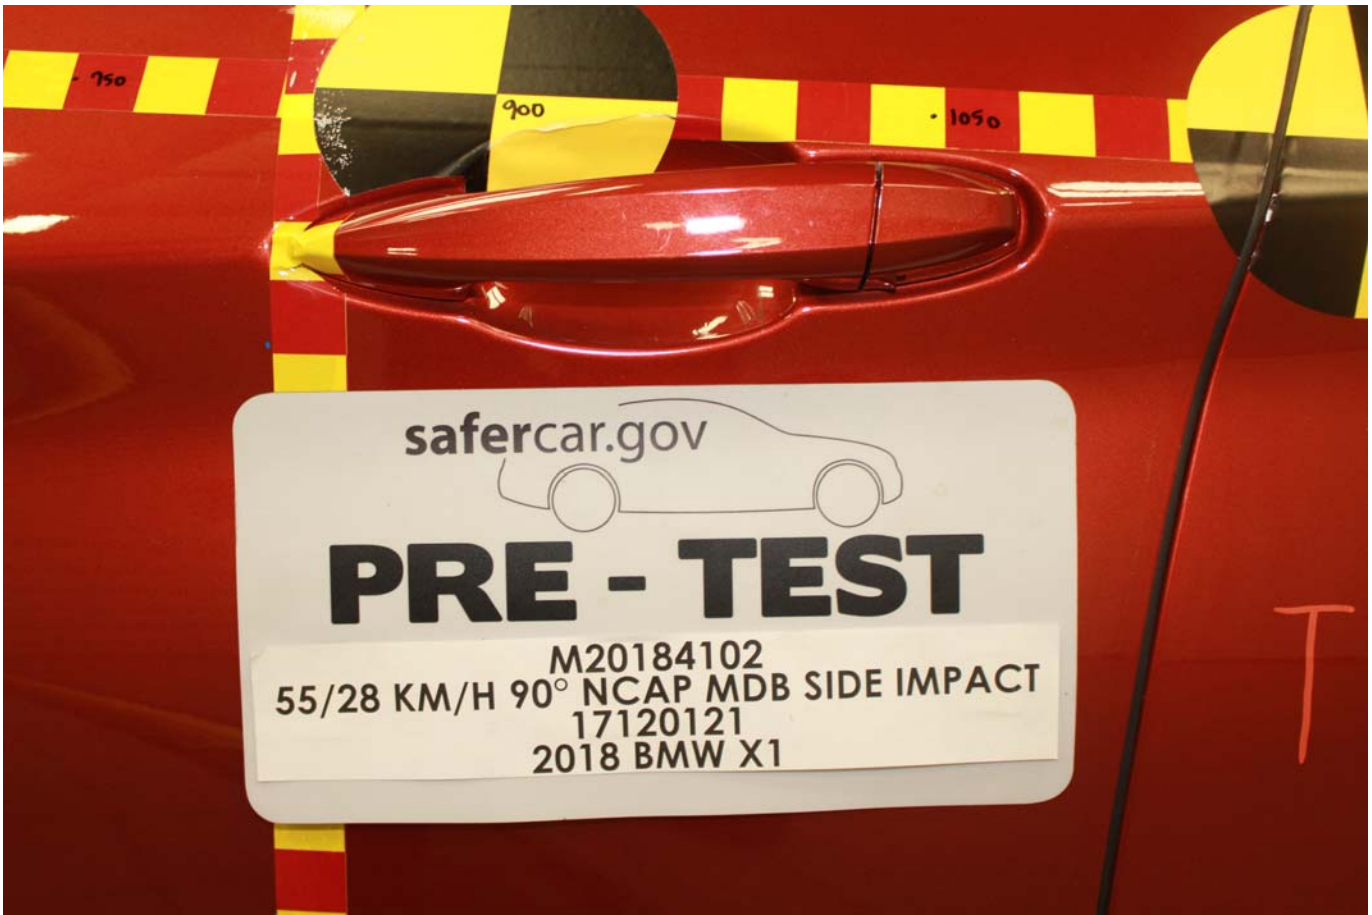
Photo No. 021 - Pre-Test Left Front Door Latch Close-Up

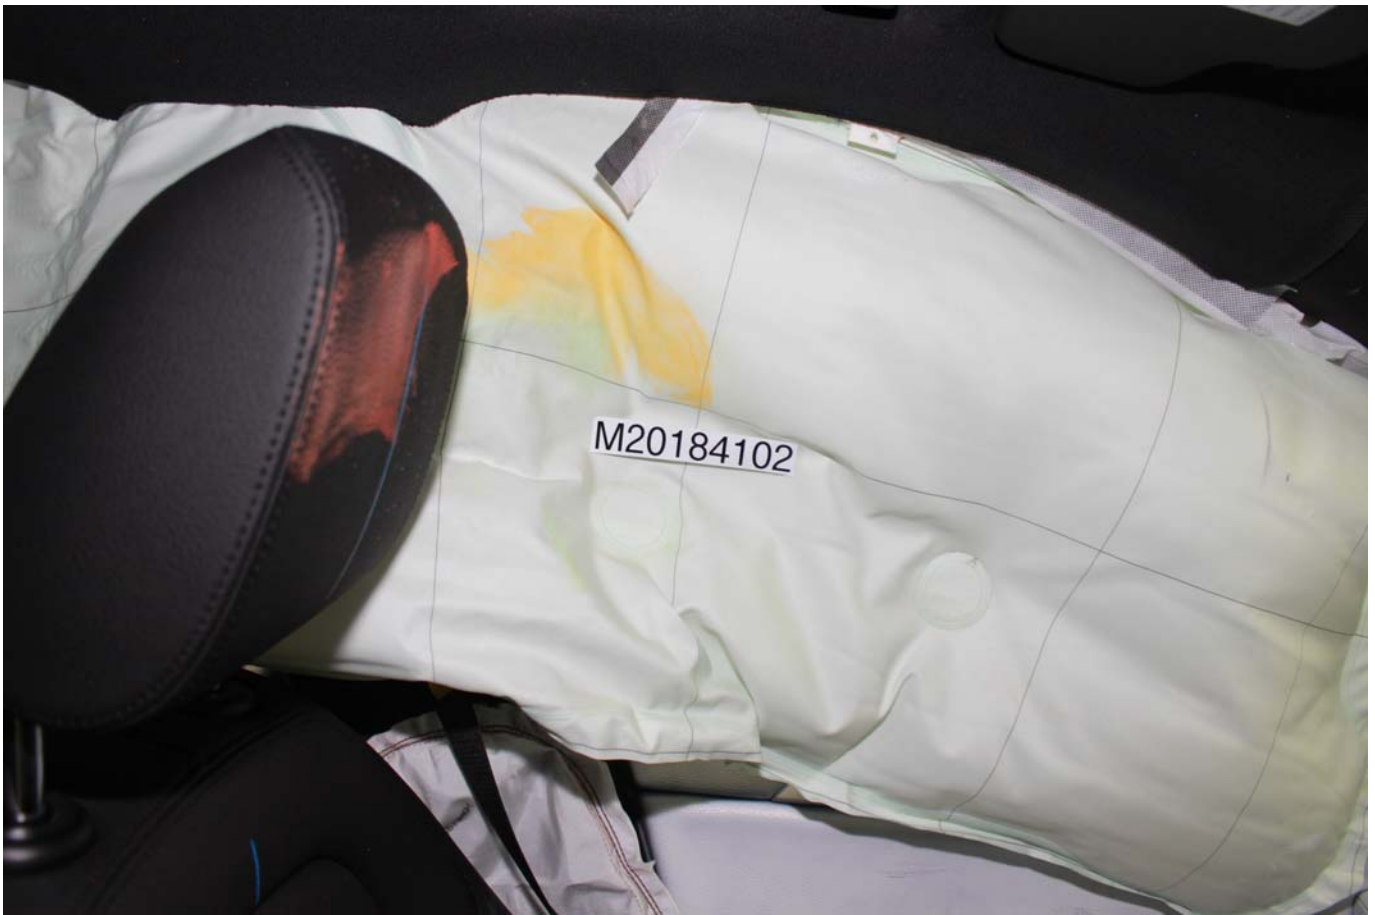
Photo No. 048 - Post-Test Driver Dummy Close-up Head Contact with Vehicle Interior View

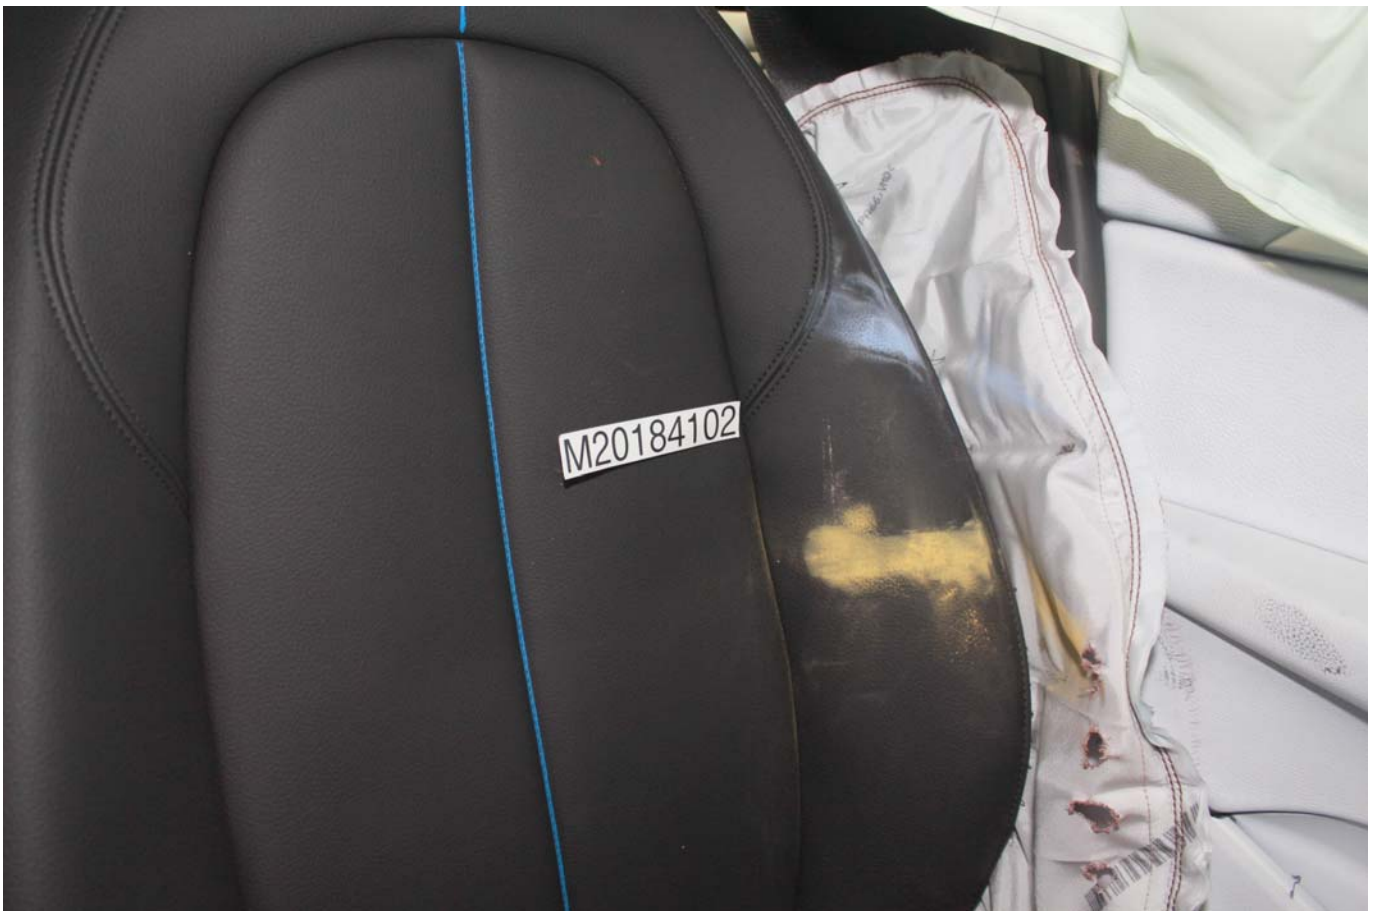
Photo No. 049 - Post-Test Driver Dummy Close-up Head Contact with Side Airbag View

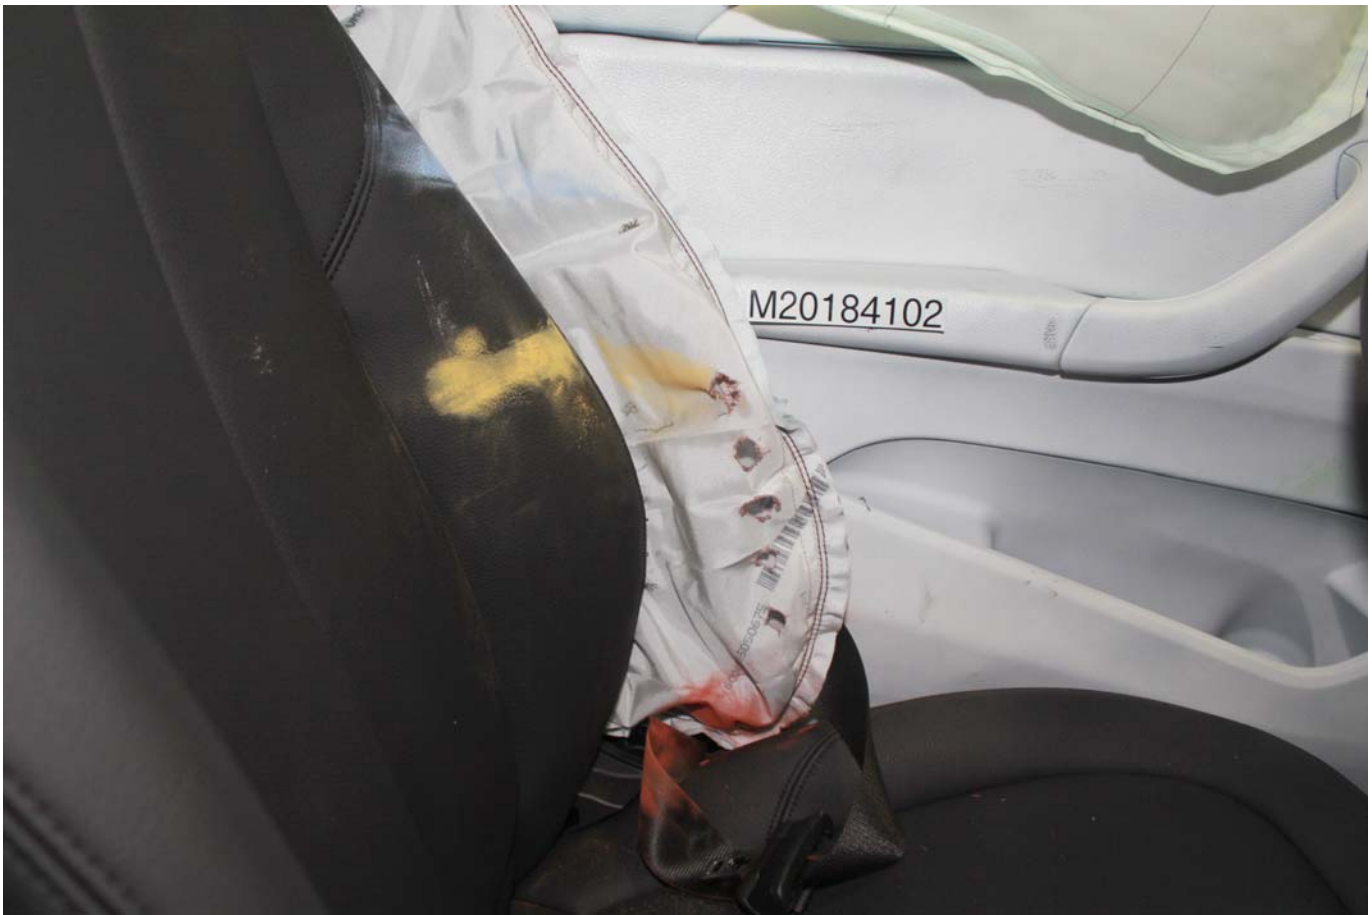
Photo No. 050 - Post-Test Driver Dummy Close-up Torso Contact with Vehicle Interior View

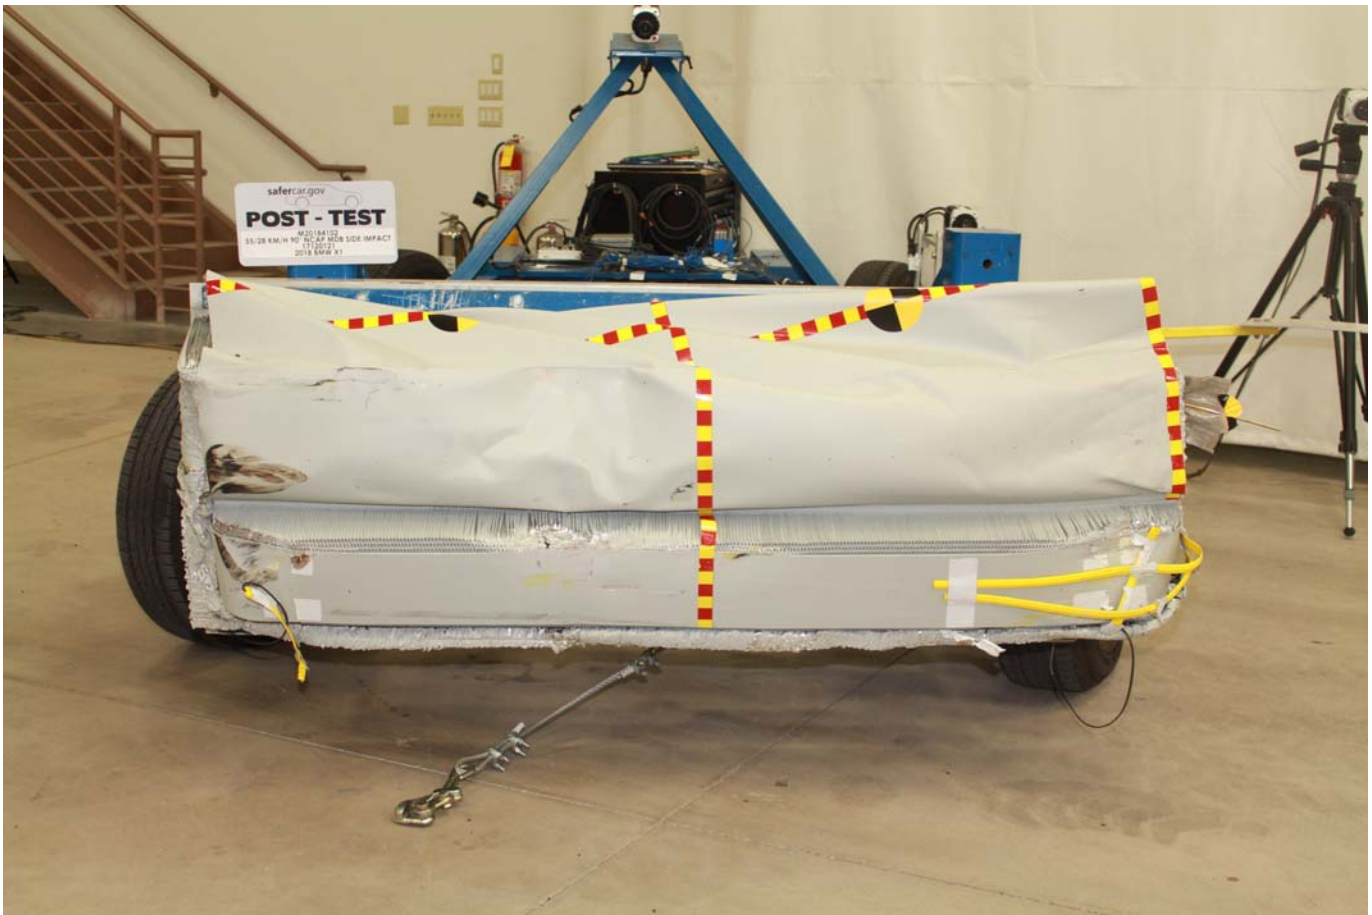
Photo No. 085 - Post-Test Front View of MDB Impactor Face

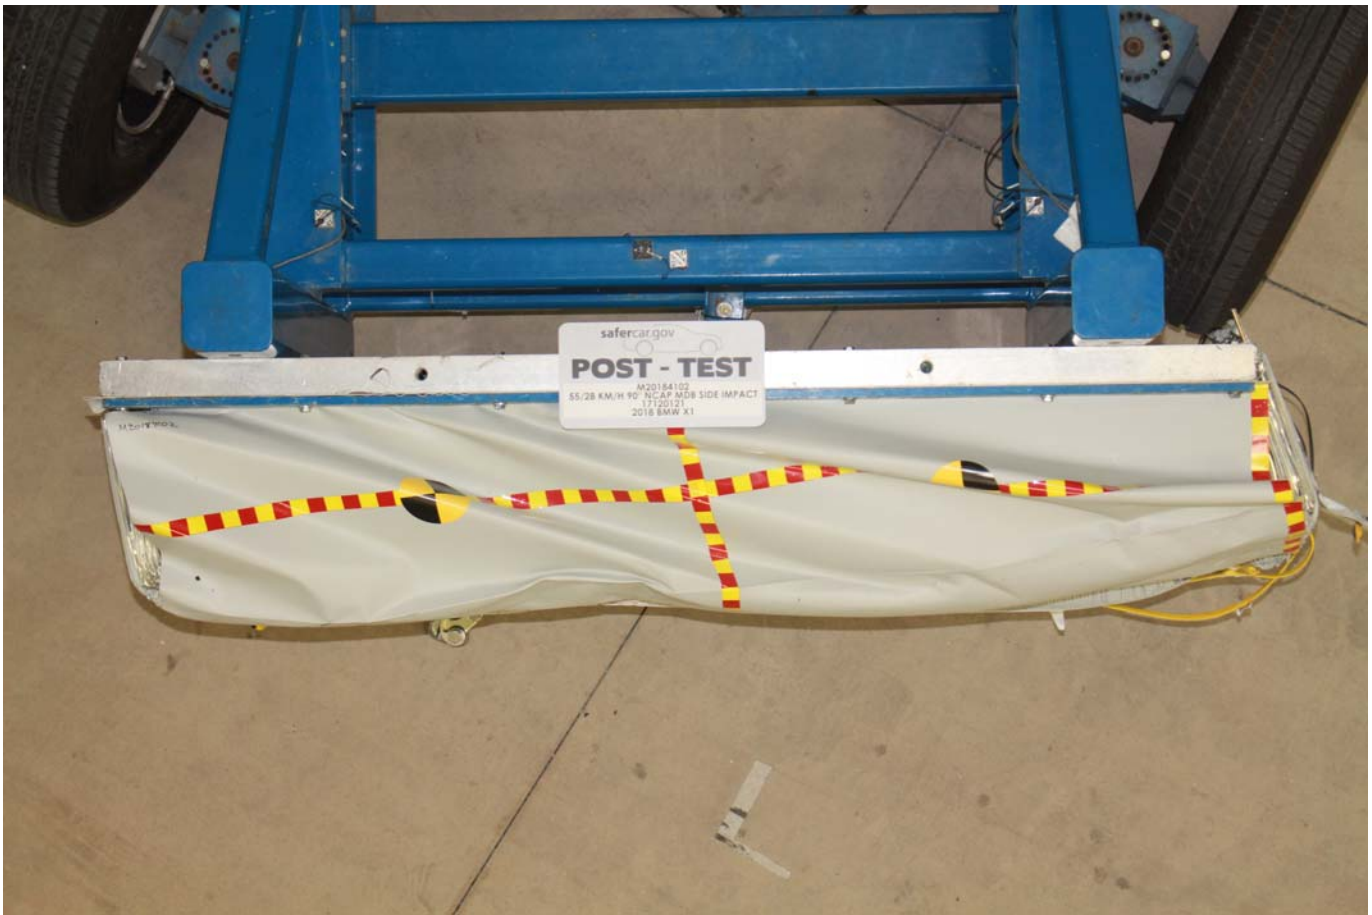
Photo No. 087 - Post-Test Top View of MDB Impactor Face
