**REPORT NUMBER: SPNCAP-MGA-2018-020**

**NEW CAR ASSESSMENT PROGRAM (NCAP)  
Side Impact Pole Test**

**BAYERISCHE MOTOREN WERKE AG  
2018 BMW X1 sDrive28i 5-Door SUV  
NHTSA No.: M20184101**

**FINAL REPORT**

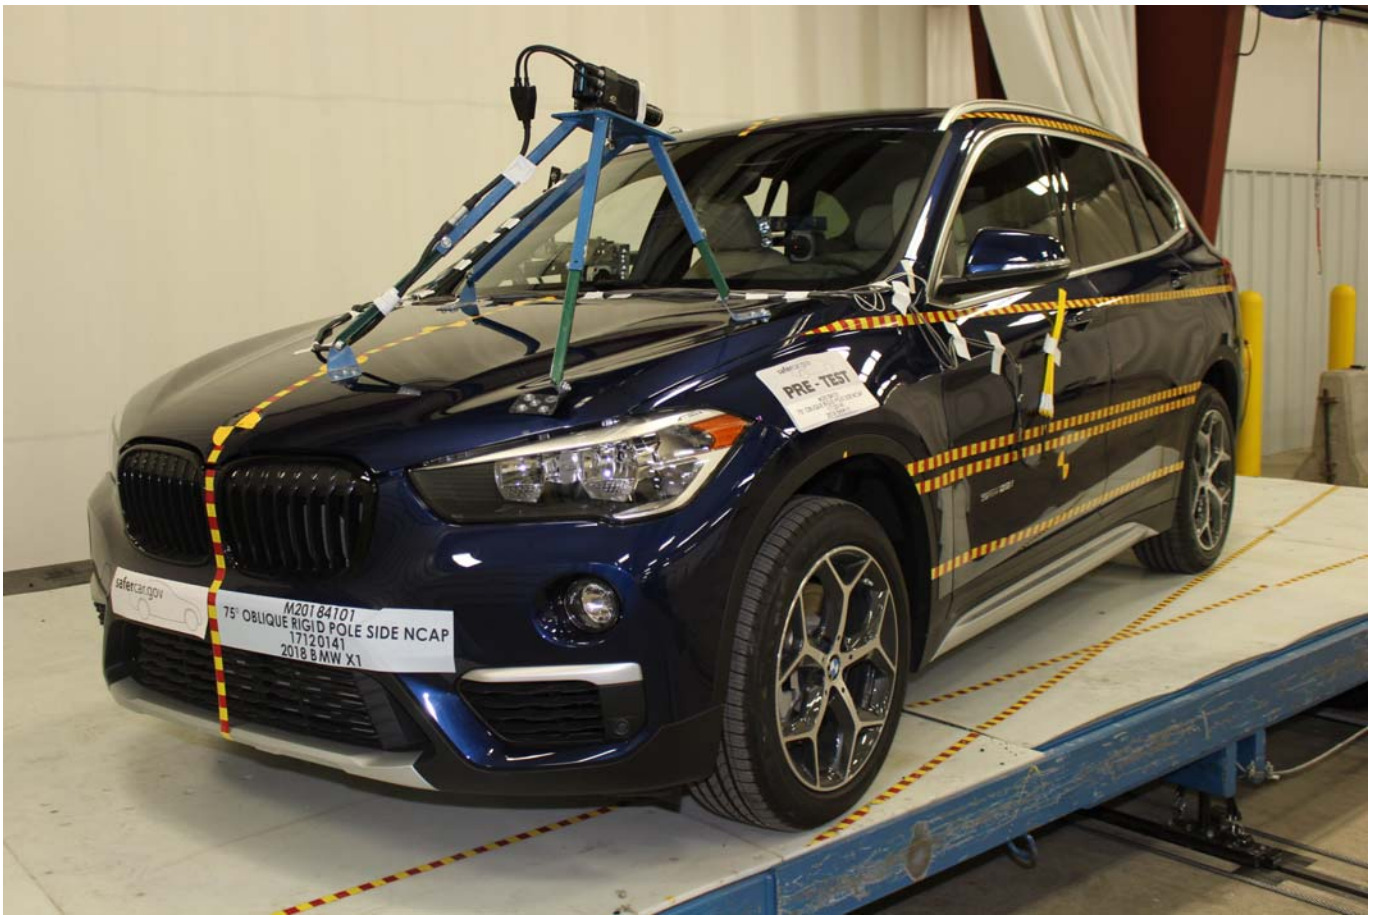
Photo No. 004 - Post-Test Frontal View of Test Vehicle

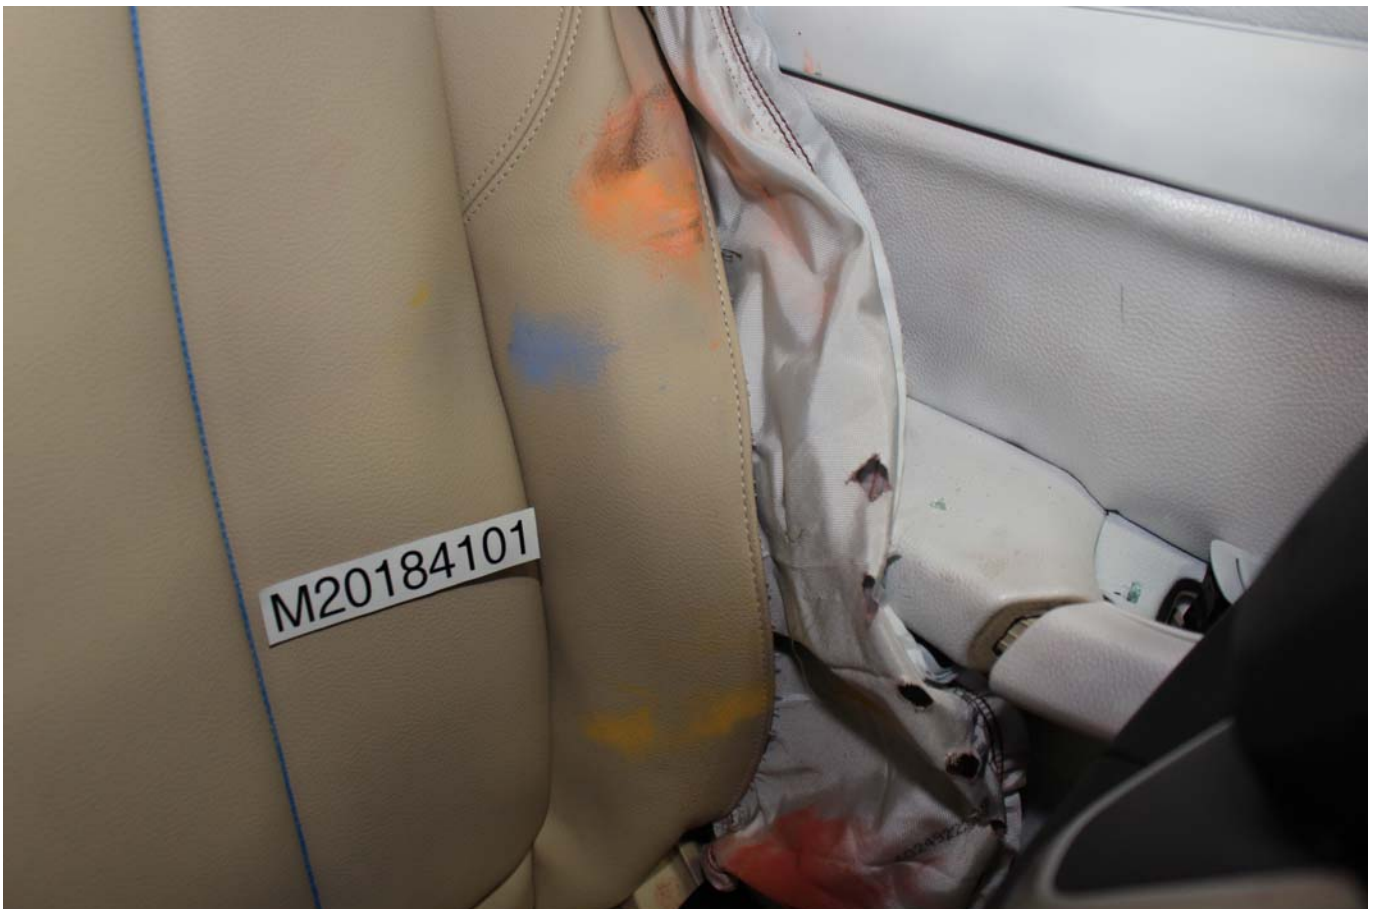
Photo No. 047 - Post-Test Dummy Close-Up Head Contact with Side Air Bag View

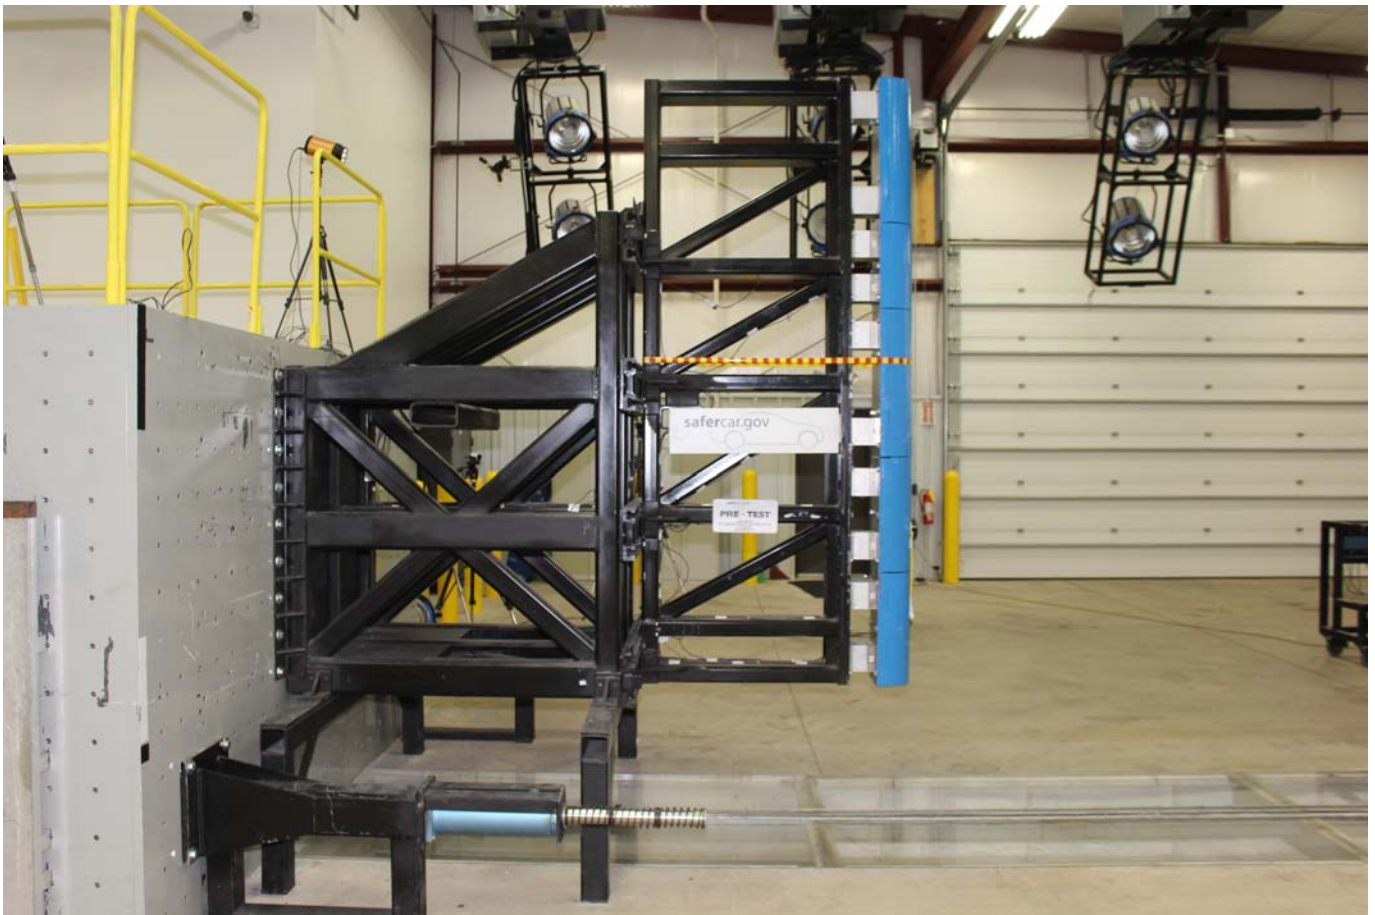
Photo No. 058 - Post-Test Pole Barrier Front View

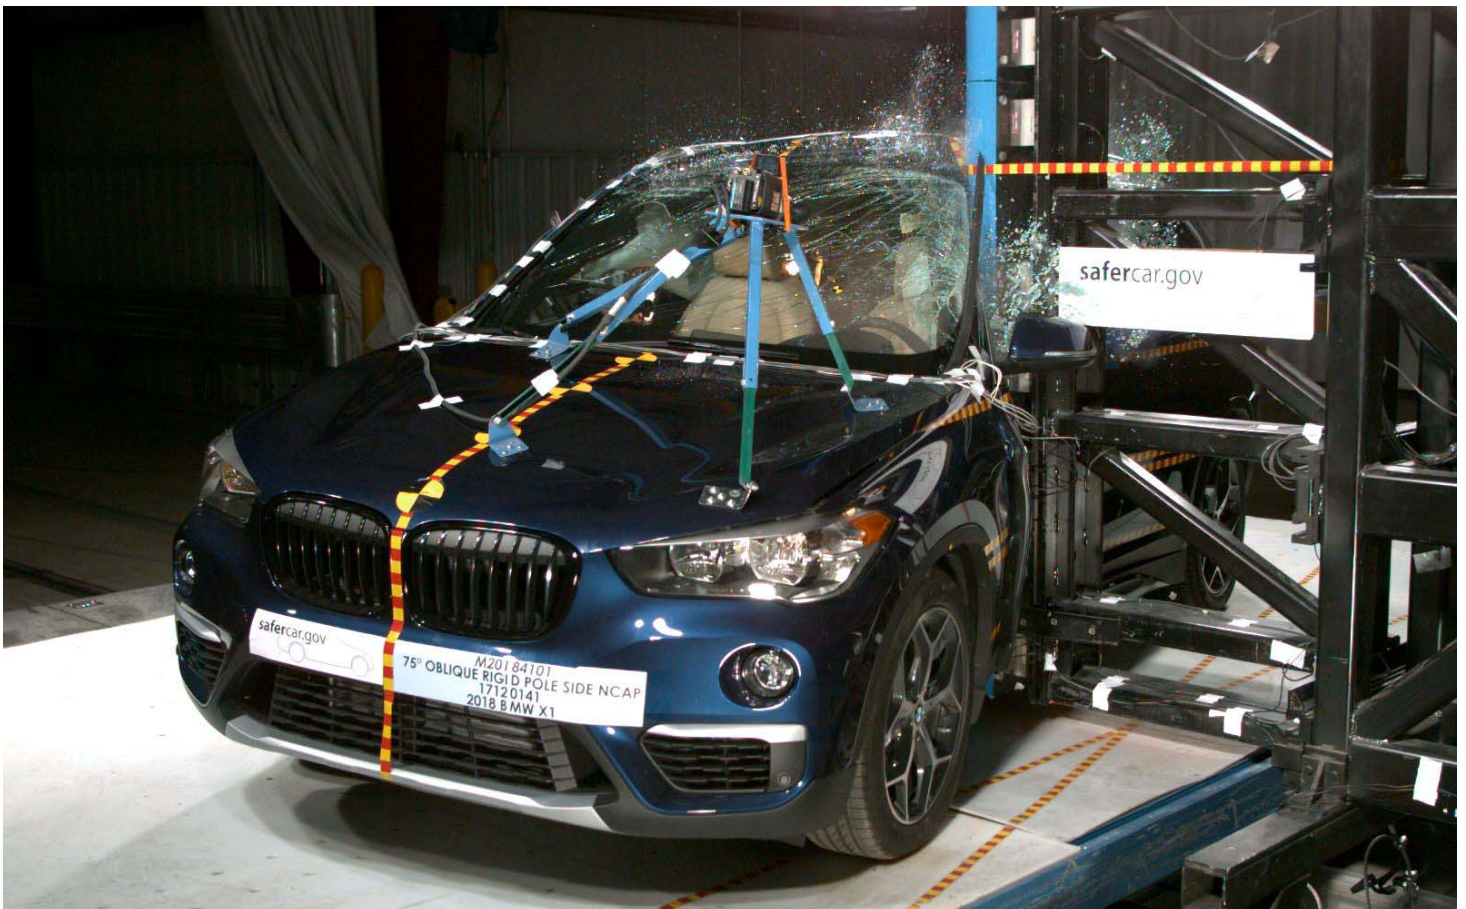
Photo No. 068 - Impact Event

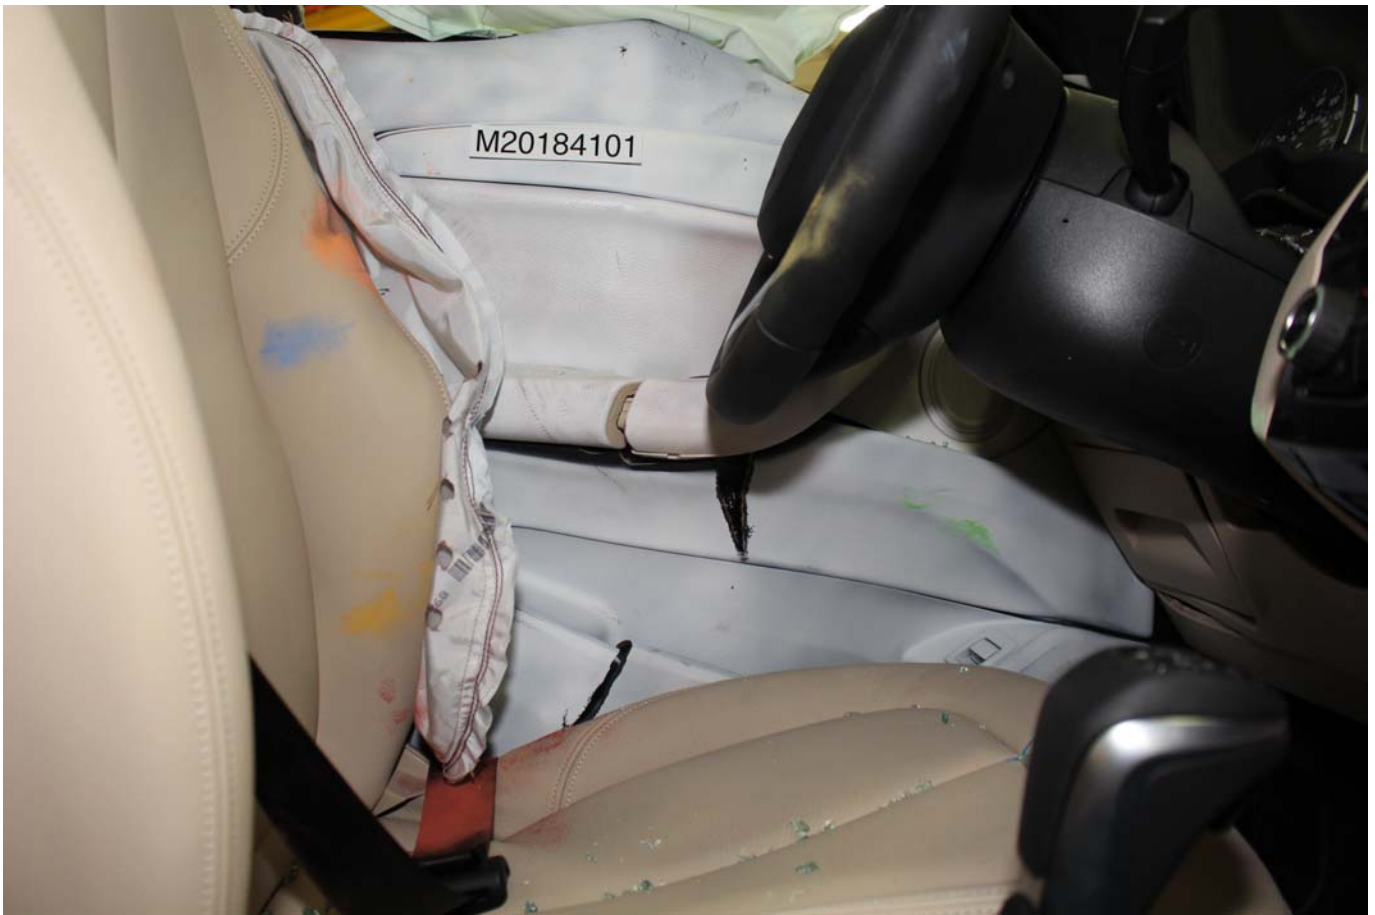
Photo No. 071 - Post-Test View of Shattered Vehicle Inner Door Panel
