REPORT NUMBER: NCAP-MGA-2018-023

**NEW CAR ASSESSMENT PROGRAM (NCAP)
Frontal Barrier Impact Test**

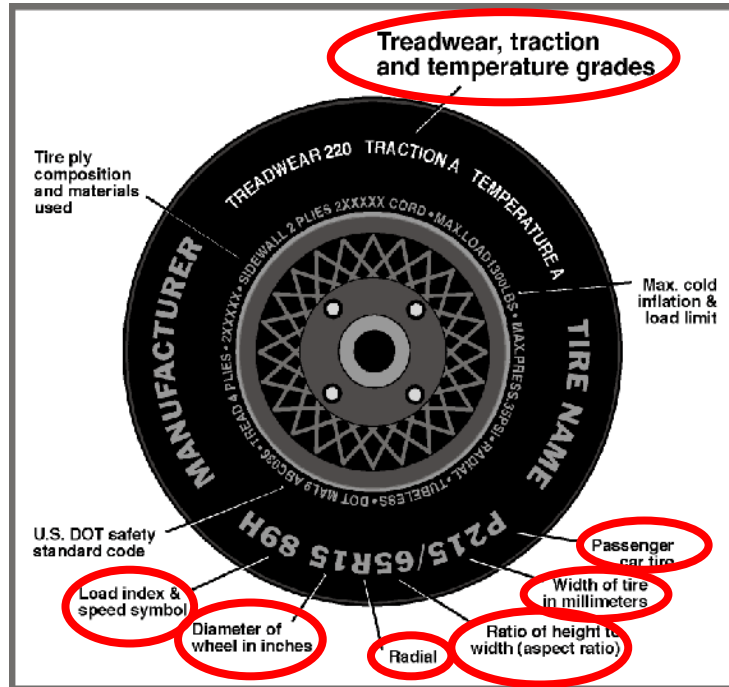
Measured Parameter	Front	Rear
Max. Tire Pressure (kPa)	350	350
Cold Pressure (kPa)	280	280
Recommended Tire Size	215/65R17	215/65R17
Tire Size on Vehicle	215/65R17	215/65R17
Tire Manufacturer	Continental	Continental
Tire Model	ProContact	ProContact
Treadwear	500	500
Traction	A	A
Temperature Grade	A	A
Tire Plies Sidewall	1 Polyester	1 Polyester
Tire Plies Body	1 Polyester, 2 Steel, 1 Polyamide	1 Polyester, 2 Steel, 1 Polyamide
Load Index/Speed Symbol	99H	99H
Tire Material	Rubber	Rubber
DOT Safety Code Left	A33R WD2B 3117	A33R WD2B 3117
DOT Safety Code Right	A33R WD2B 3117	A33R WD2B 3117

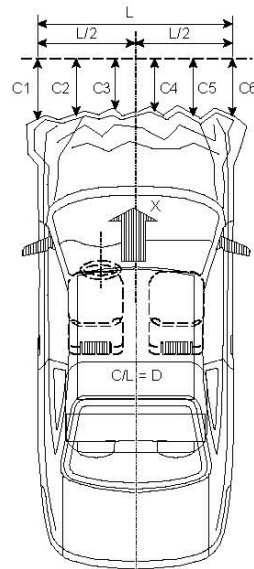
Accelerometer Locations: As per measurements on Page 15
 Cal. Procedure/Interval: MGA procedure / 6 month
 Integration Algorithm: Trapezoidal
 Linearity: > 99%
 Impact Velocity (km/h): 56.26
 Velocity Change (km/h): 63.2
 Time of Separation (msec): 98
