**REPORT NUMBER: SPNCAP-CAL-18-003**

**NEW CAR ASSESSMENT PROGRAM (NCAP)  
SIDE IMPACT POLE TEST**

**Nissan Motor Co., LTD.  
2018 Nissan Armada  
SUV**

**FINAL REPORT**

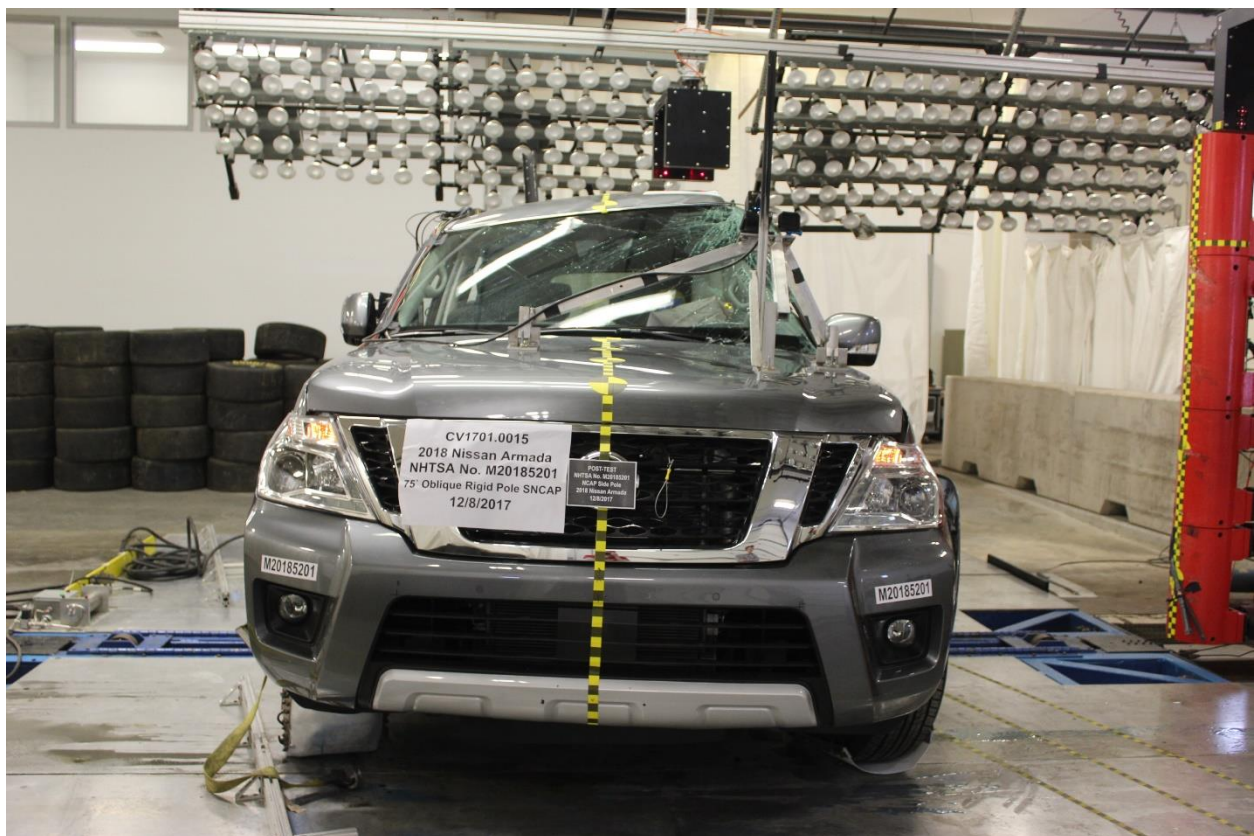
**Figure A-4: Post-Test Frontal View of Test Vehicle**

| Critical Areas of Performance | Observations and Conclusions |
|---|---|
| Windshield Damage | Cracks throughout & separation along A-Pillar |

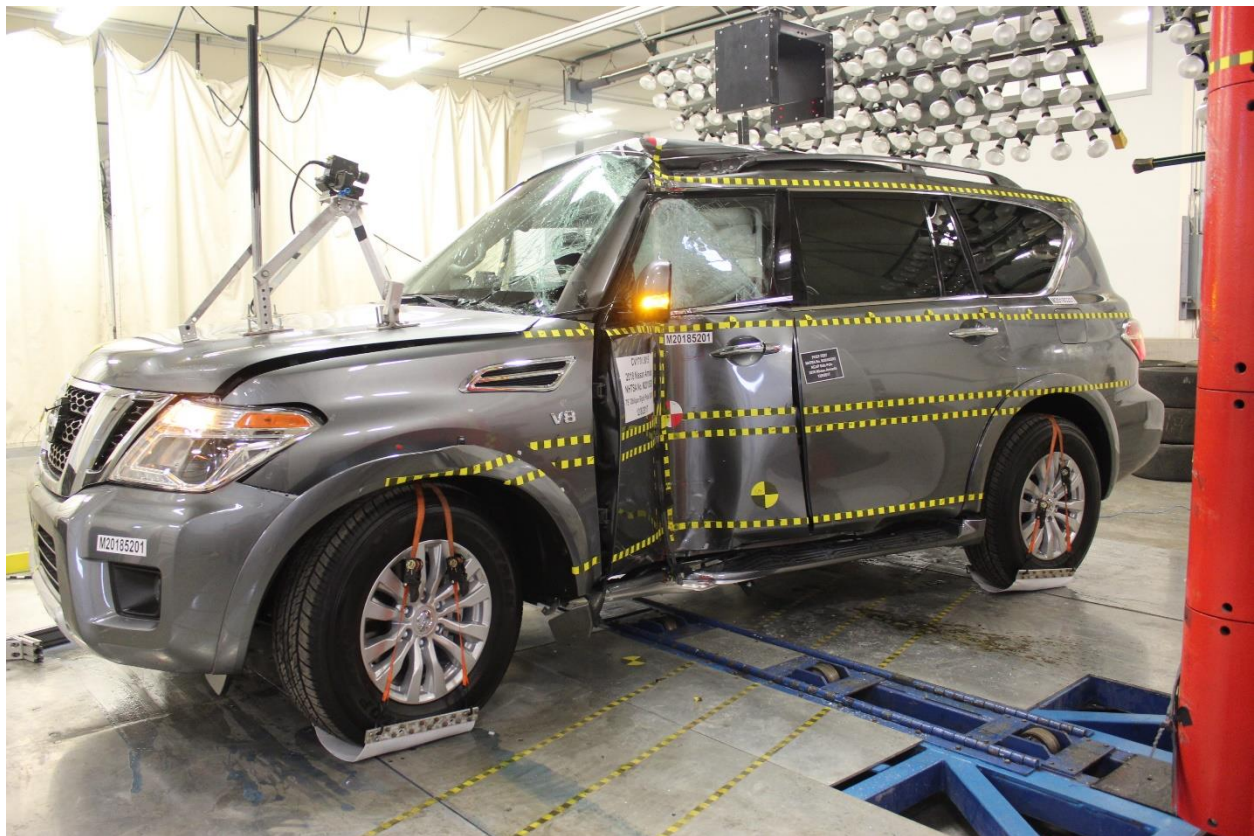
**Figure A-8: Post-Test Left Side View of Test Vehicle**

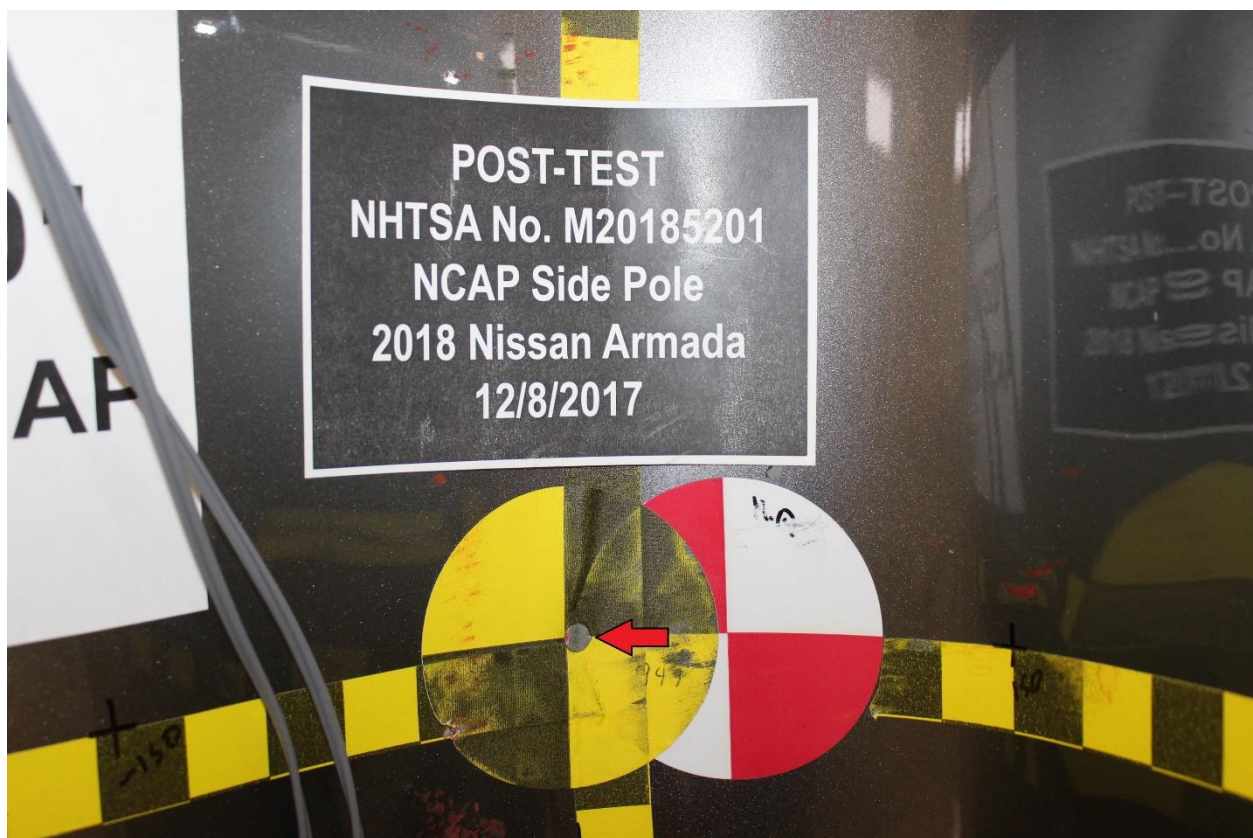
Figure A-20: Post-Test Close-Up View of Impact Point Target Showing Impact Location

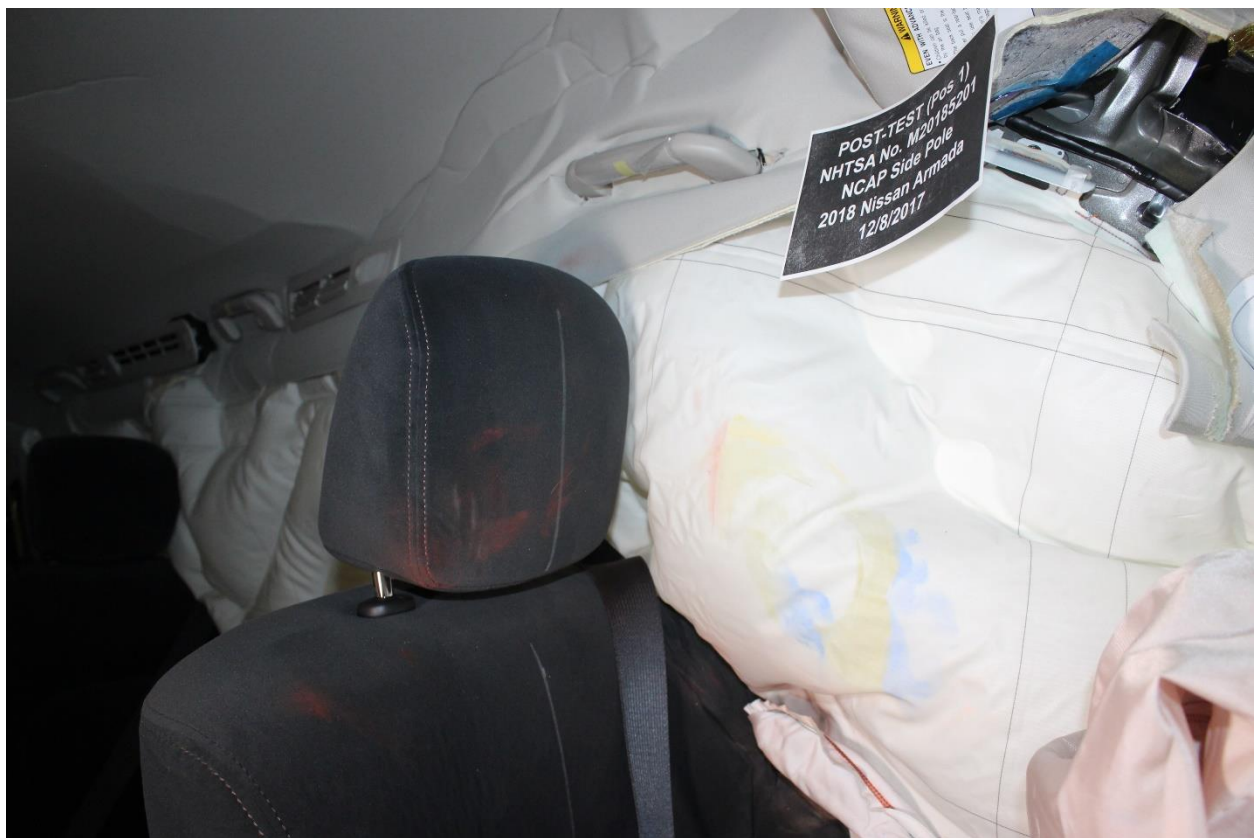
**Figure A-46: Post-Test Dummy Close-Up Head Contact with Vehicle Interior View**

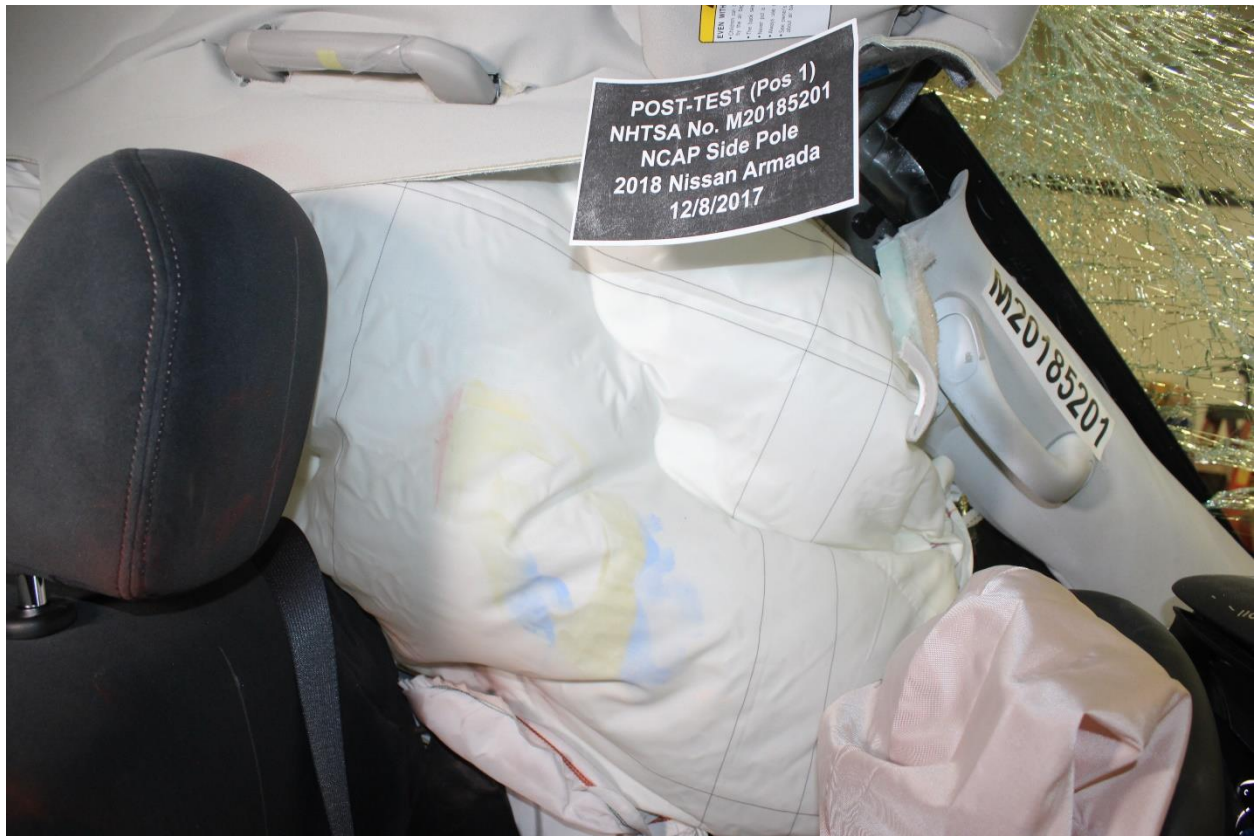
**Figure A-47: Post-Test Dummy Close-Up Head Contact with Side Airbag View**

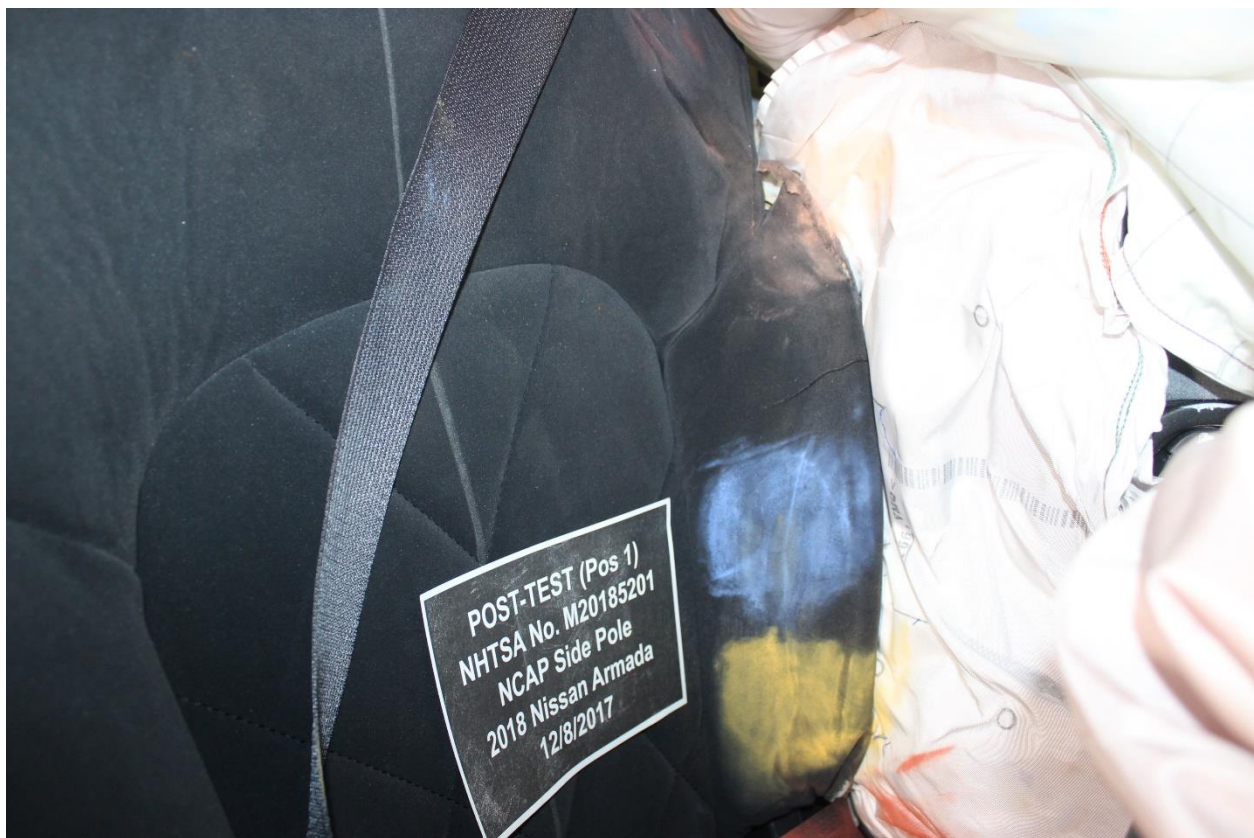
**Figure A-48: Post-Test Dummy Close-Up Torso Contact with Vehicle Interior View**

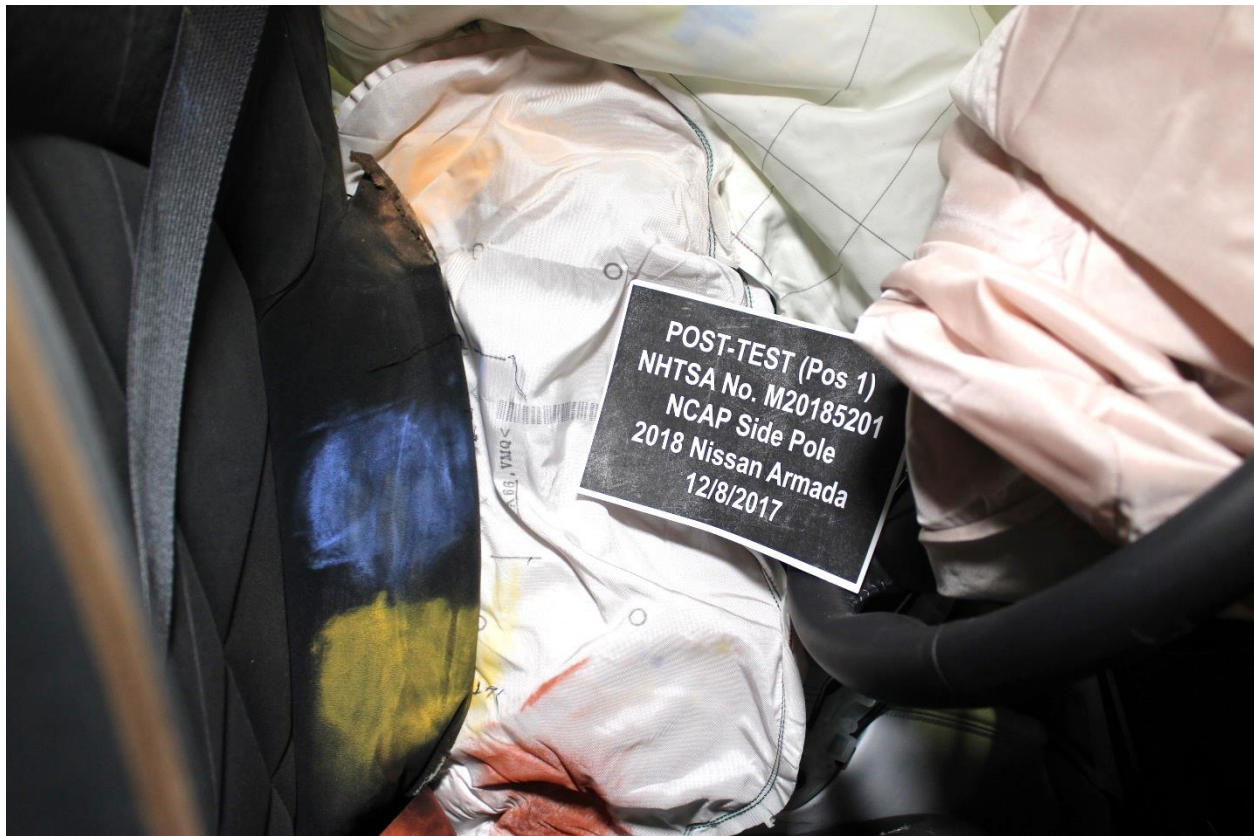
**Figure A-49: Post-Test Dummy Close-Up Torso Contact with Side Airbag View**

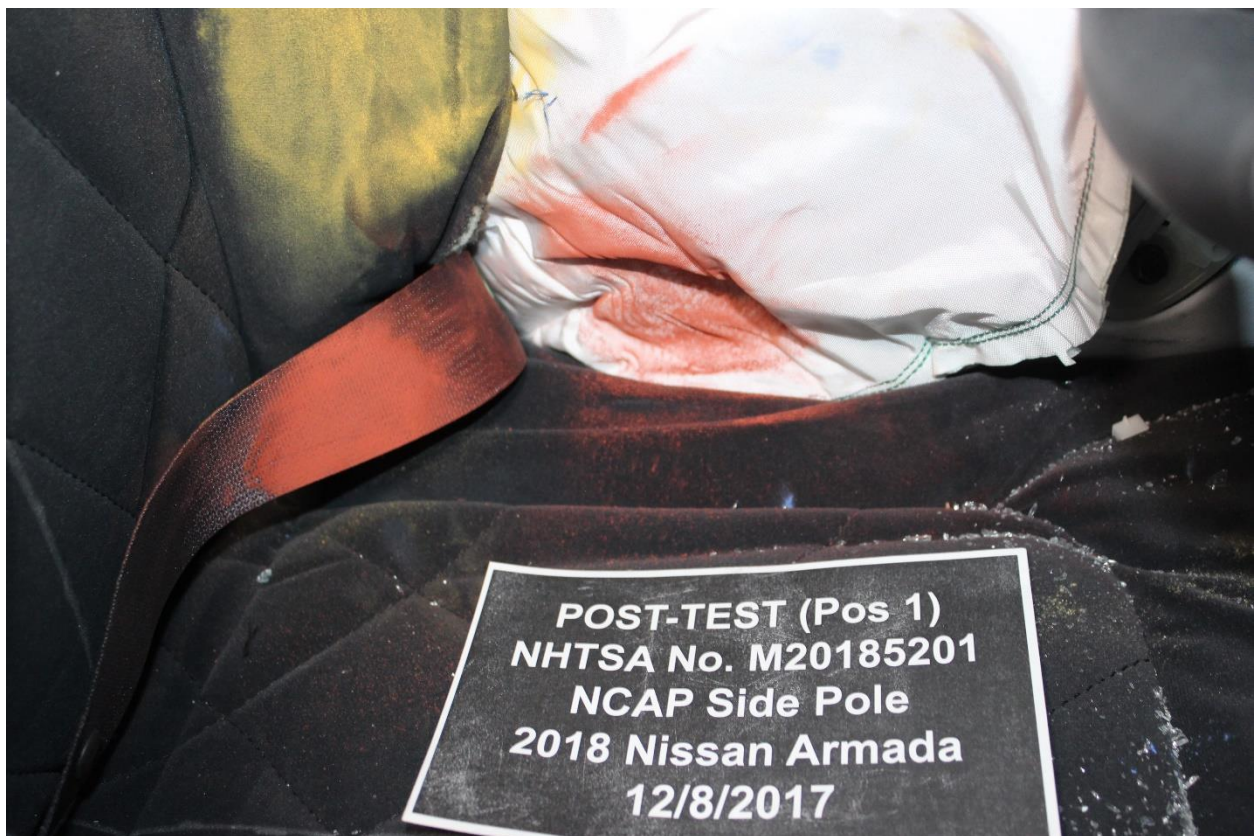
**Figure A-50: Post-Test Dummy Close-Up Pelvis Contact with Vehicle Interior View**
