**REPORT NUMBER: SPNCAP-CAL-18-003**

**NEW CAR ASSESSMENT PROGRAM (NCAP)  
SIDE IMPACT POLE TEST**

**Ford Motor Co  
2018 Ford Mustang  
Two Door Coupe**

**FINAL REPORT**

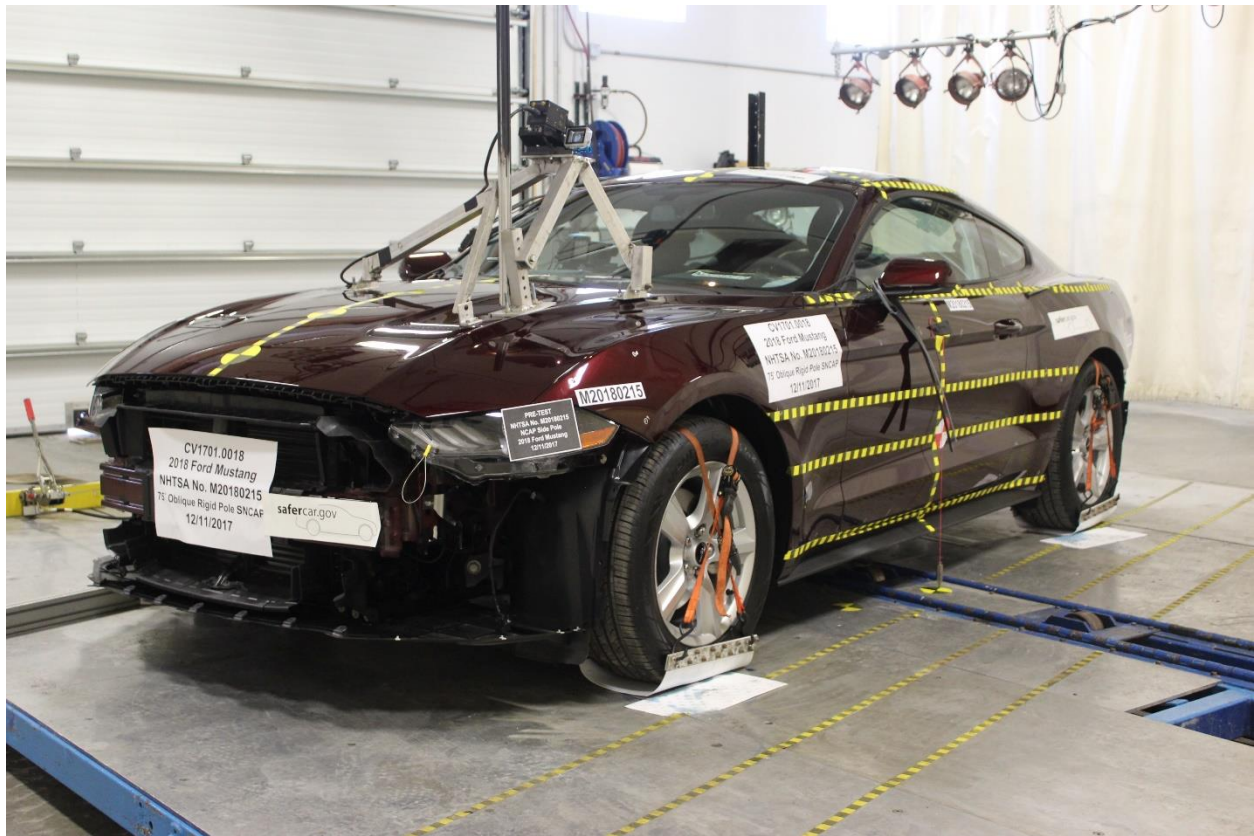
**Figure A-5: Pre-Test Left Front  $\frac{3}{4}$  View of Test Vehicle**

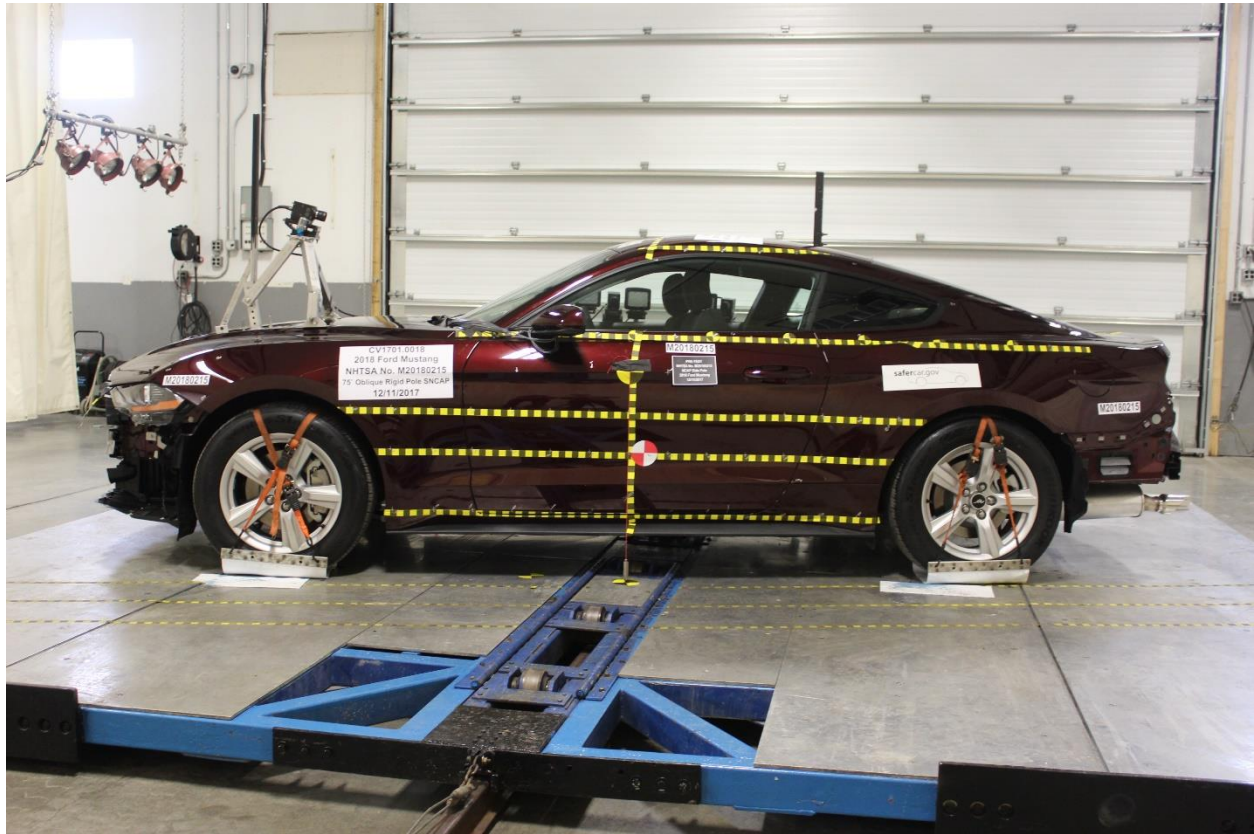
**Figure A-7: Pre-Test Left Side View of Test Vehicle**

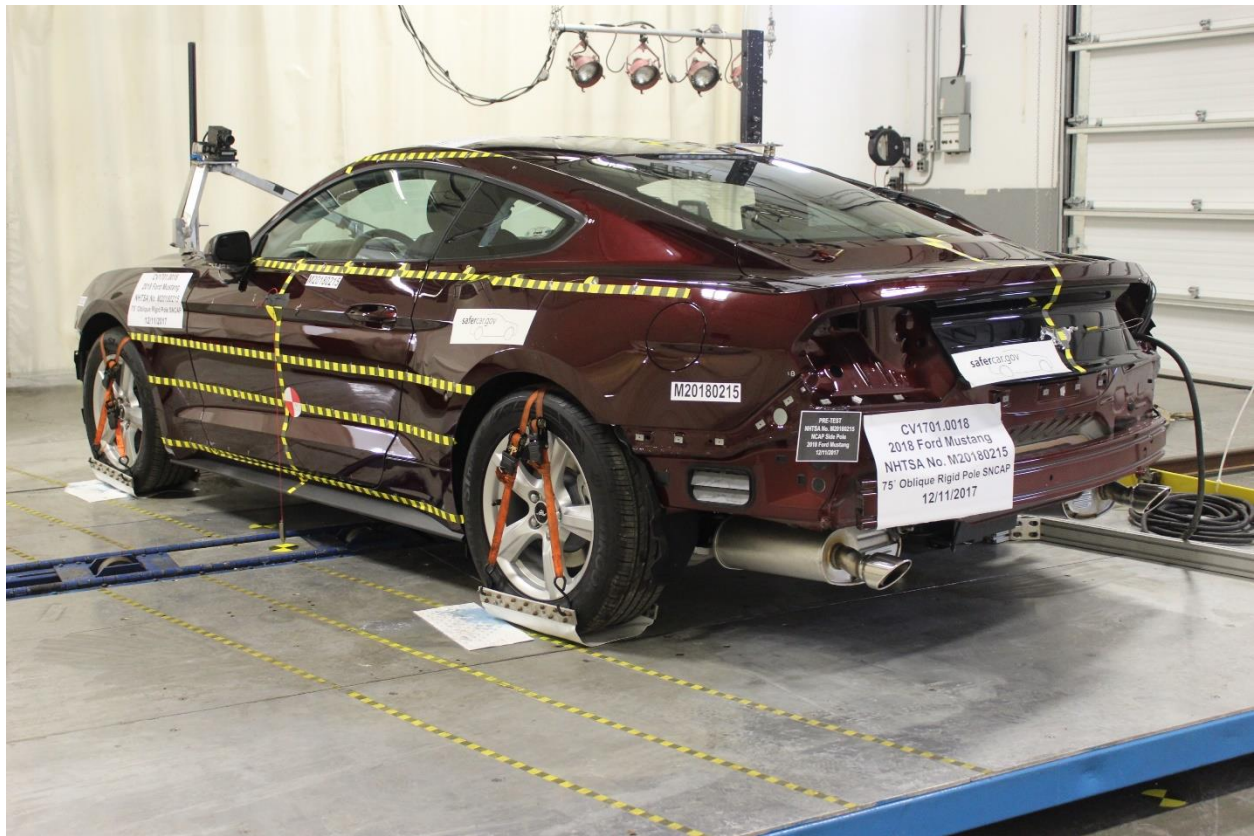
**Figure A-9: Pre-Test Left Rear  $\frac{3}{4}$  View of Test Vehicle**

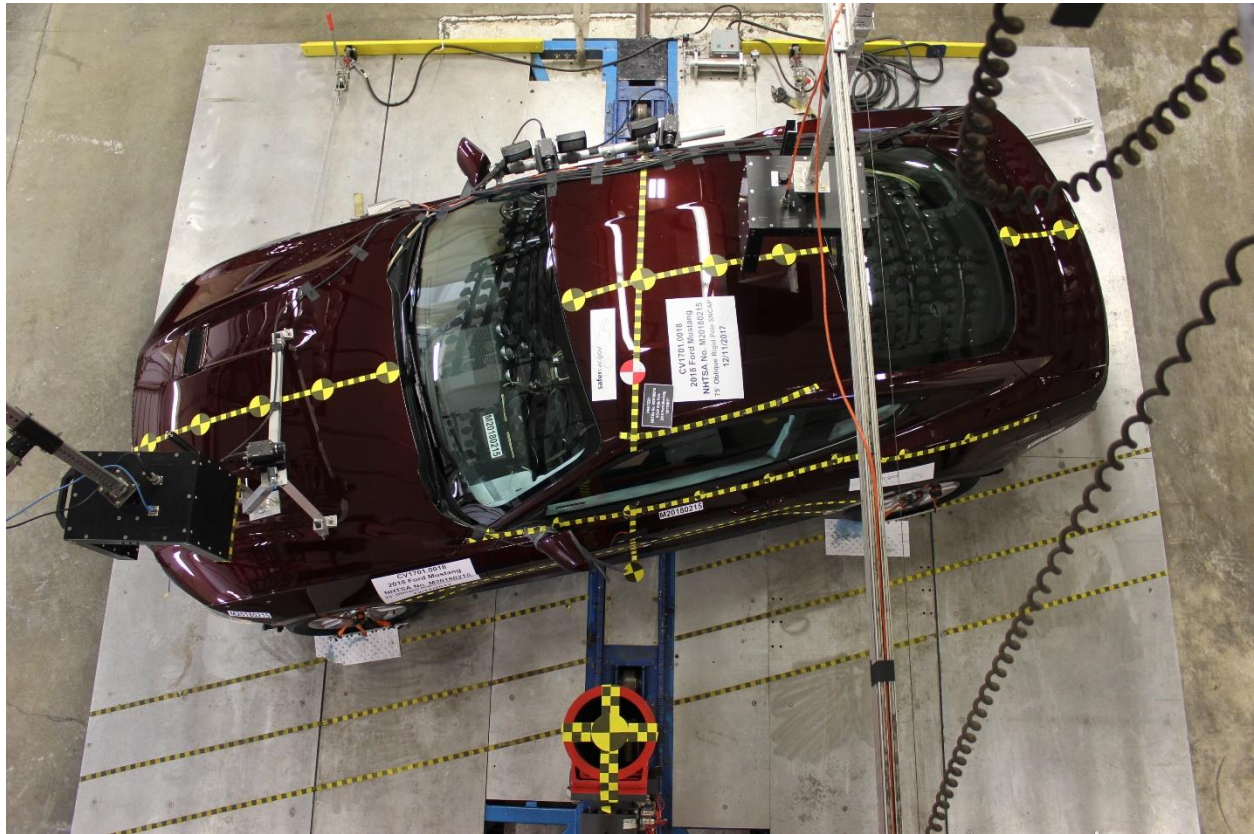
**Figure A-15: Pre-Test Overhead View of Test Area**

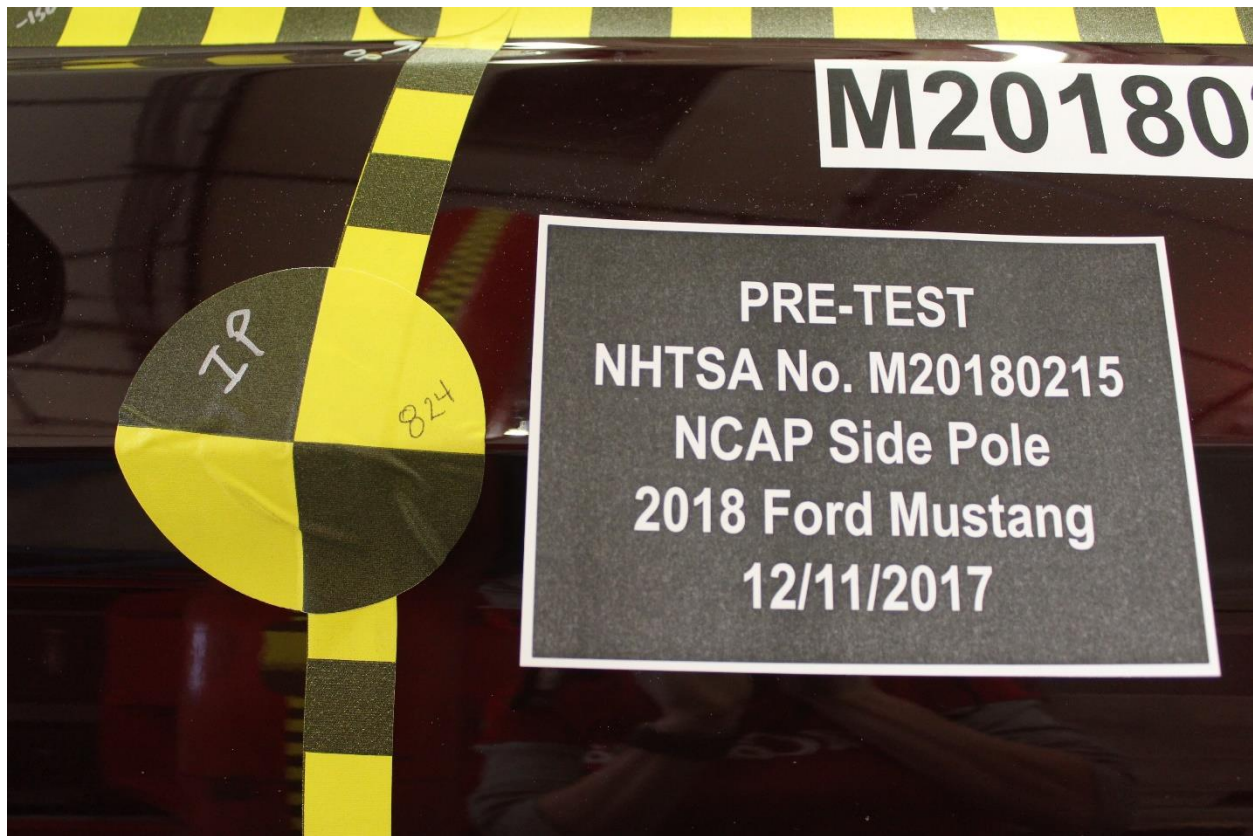
Figure A-19: Pre-Test Close-Up View of Impact Point Target

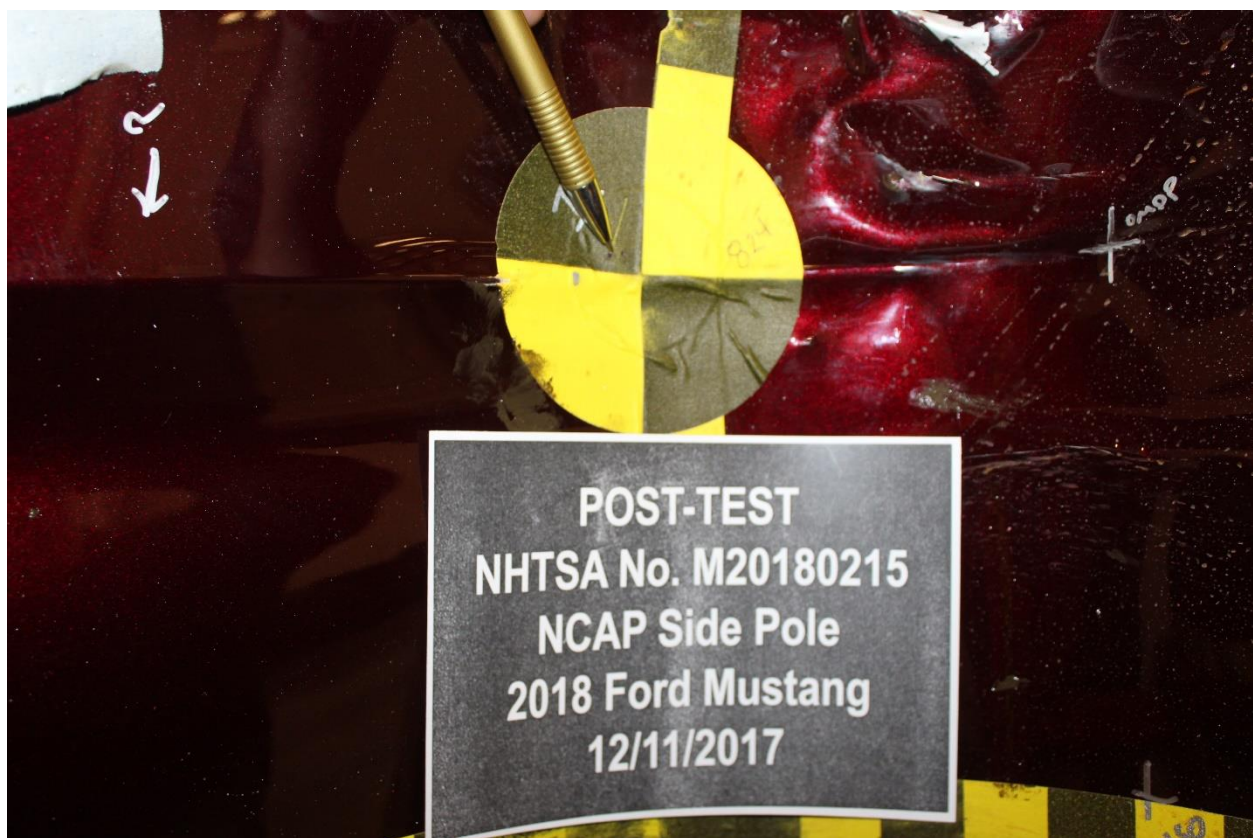
Figure A-20: Post-Test Close-Up View of Impact Point Target Showing Impact Location

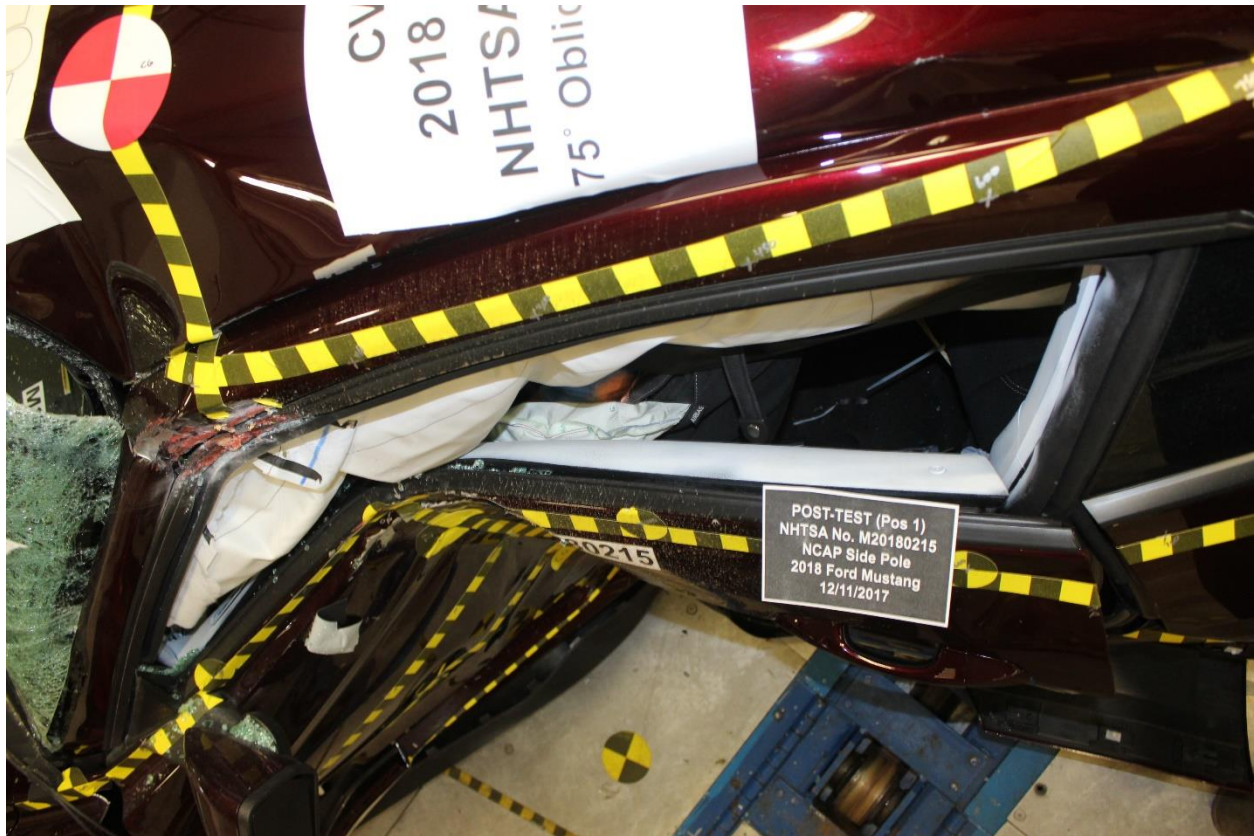
**Figure A-41: Post-Test Dummy and Door Clearance View**

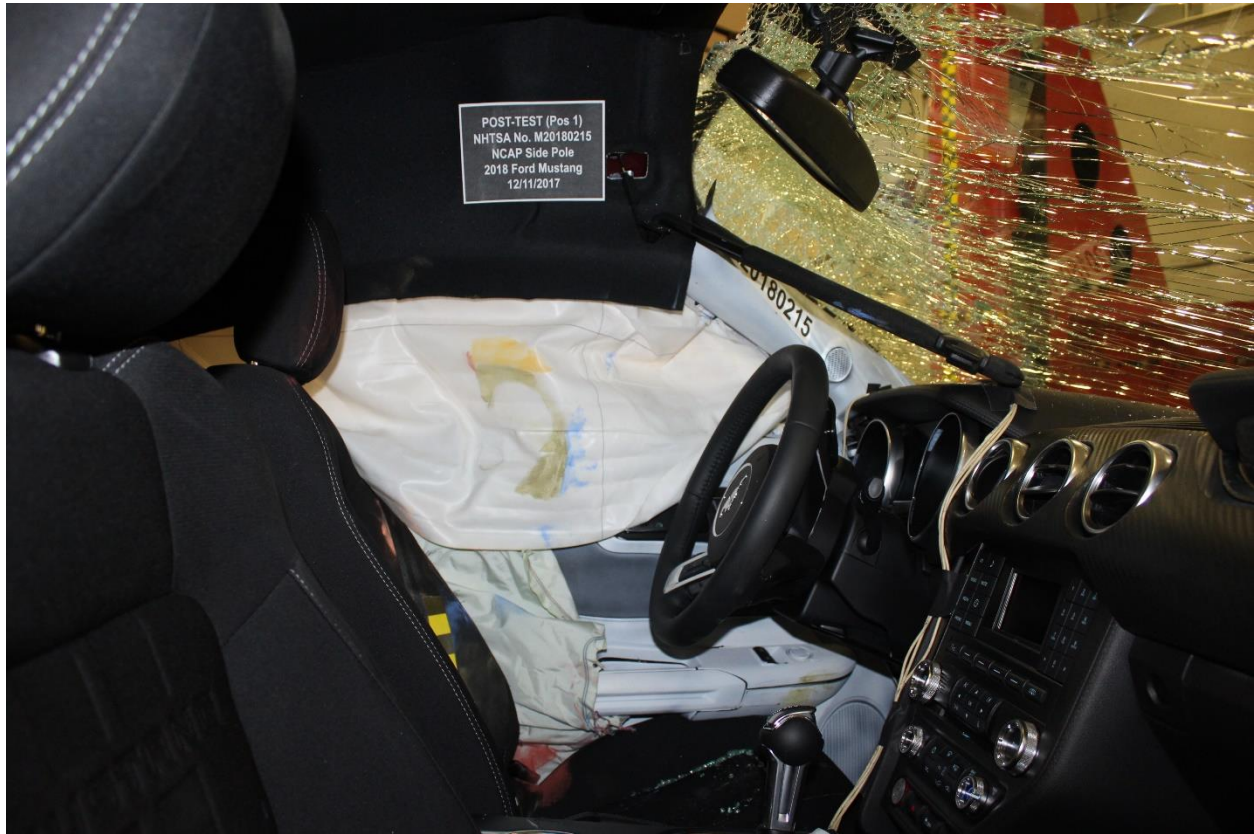
**Figure A-45: Post-Test Inner Door Panel View Showing Dummy Contact Location**

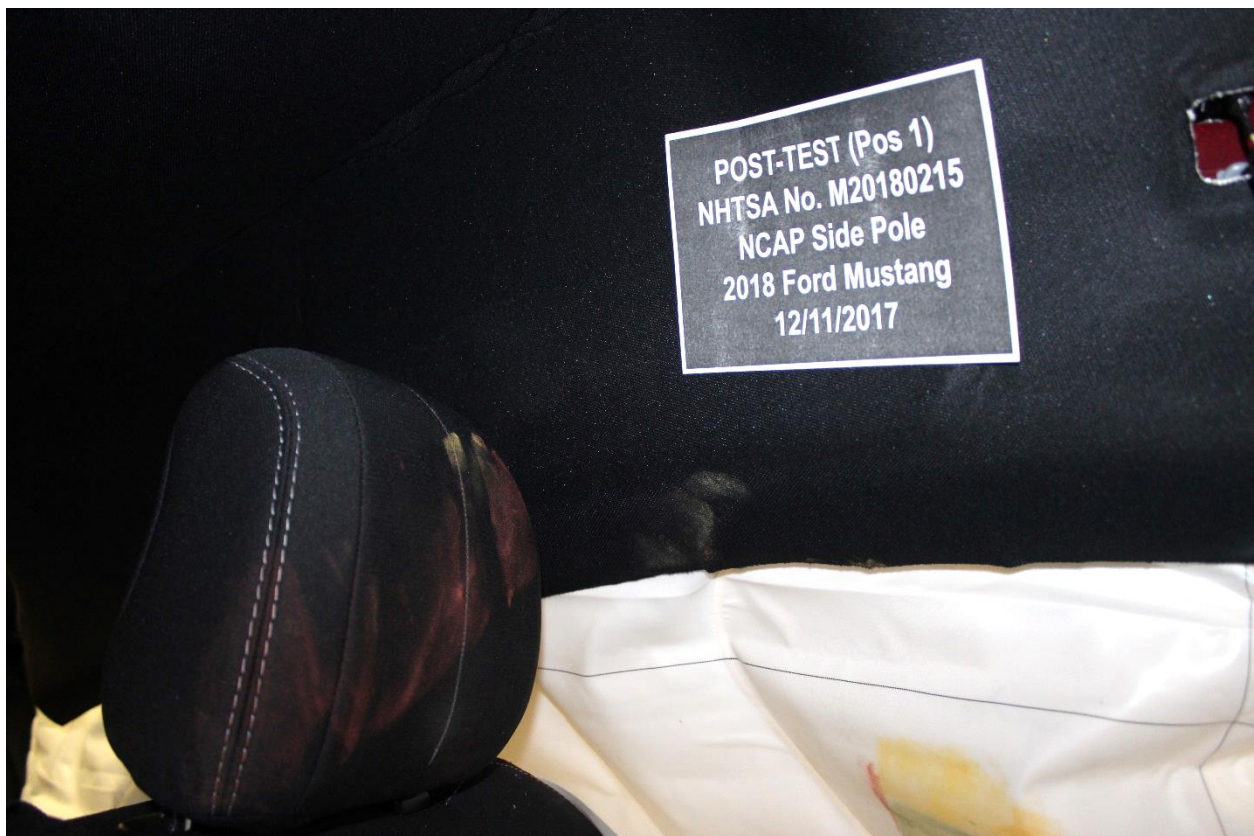
**Figure A-46: Post-Test Dummy Close-Up Head Contact with Vehicle Interior View**

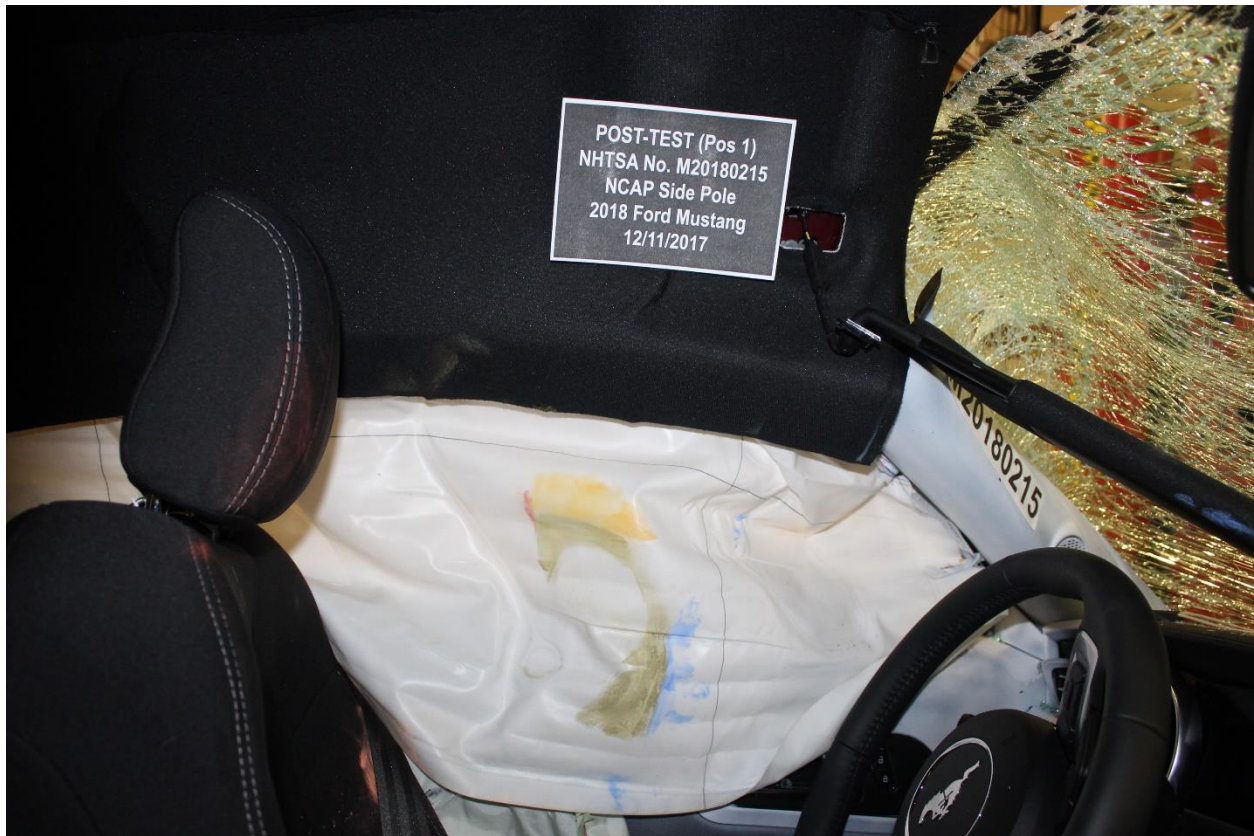
**Figure A-47: Post-Test Dummy Close-Up Head Contact with Side Airbag View**

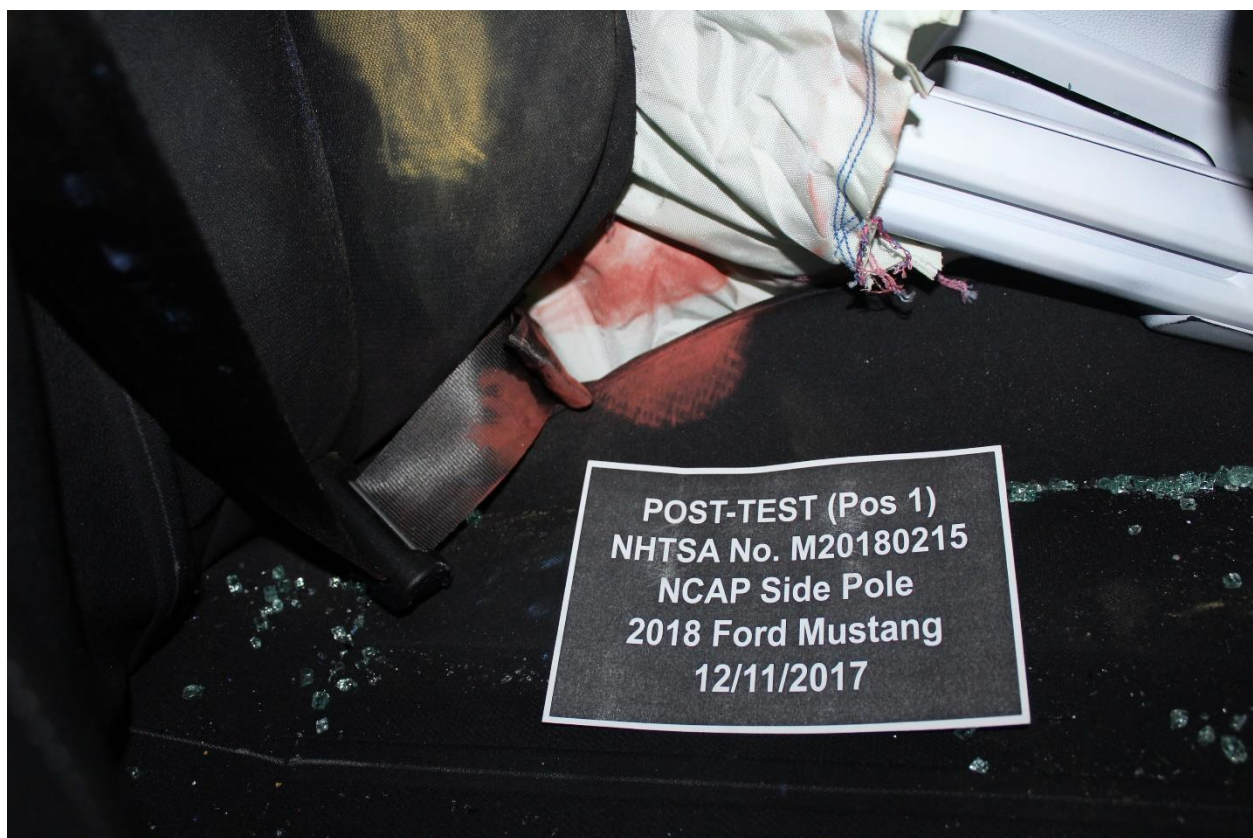
**Figure A-50: Post-Test Dummy Close-Up Pelvis Contact with Vehicle Interior View**

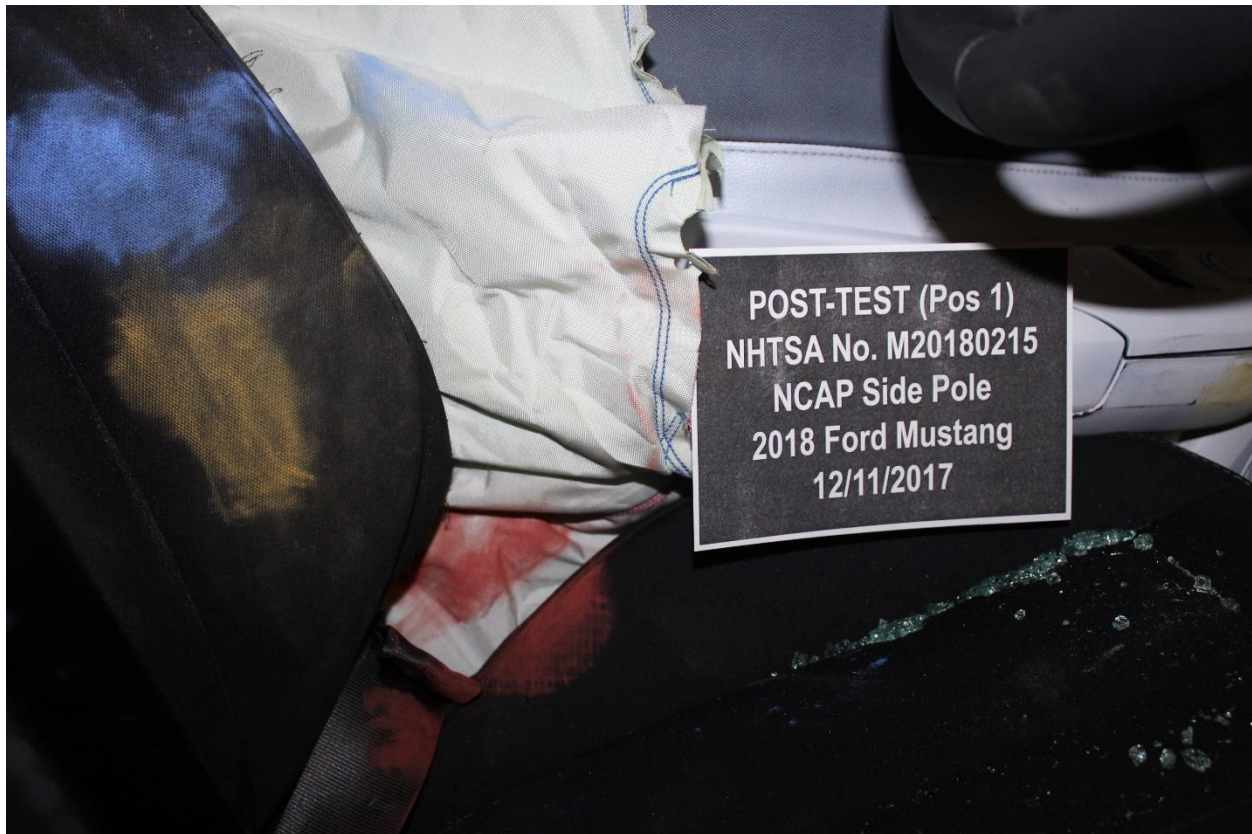
**Figure A-51: Post-Test Dummy Close-Up Pelvis Contact with Side Airbag View**

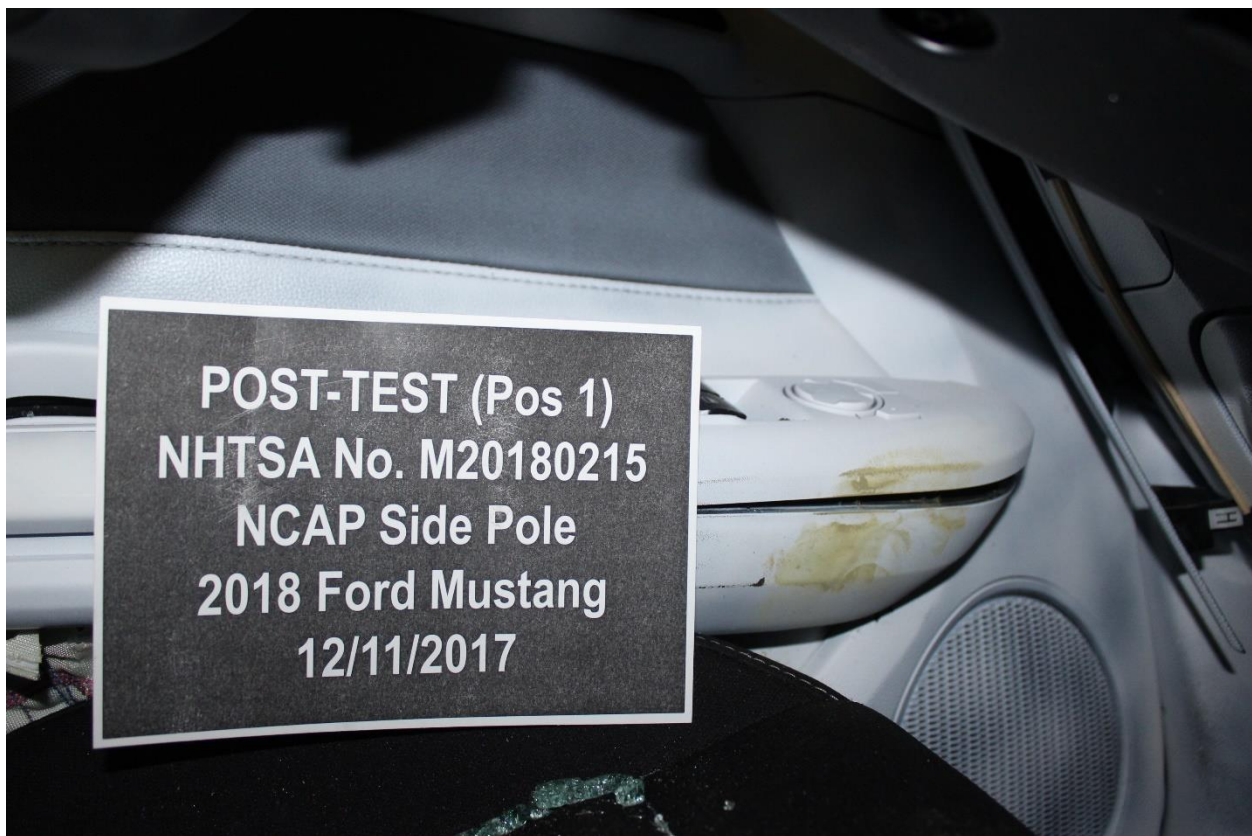
**Figure A-52: Post-Test Dummy Close-Up Knee Contact with Vehicle Interior View**

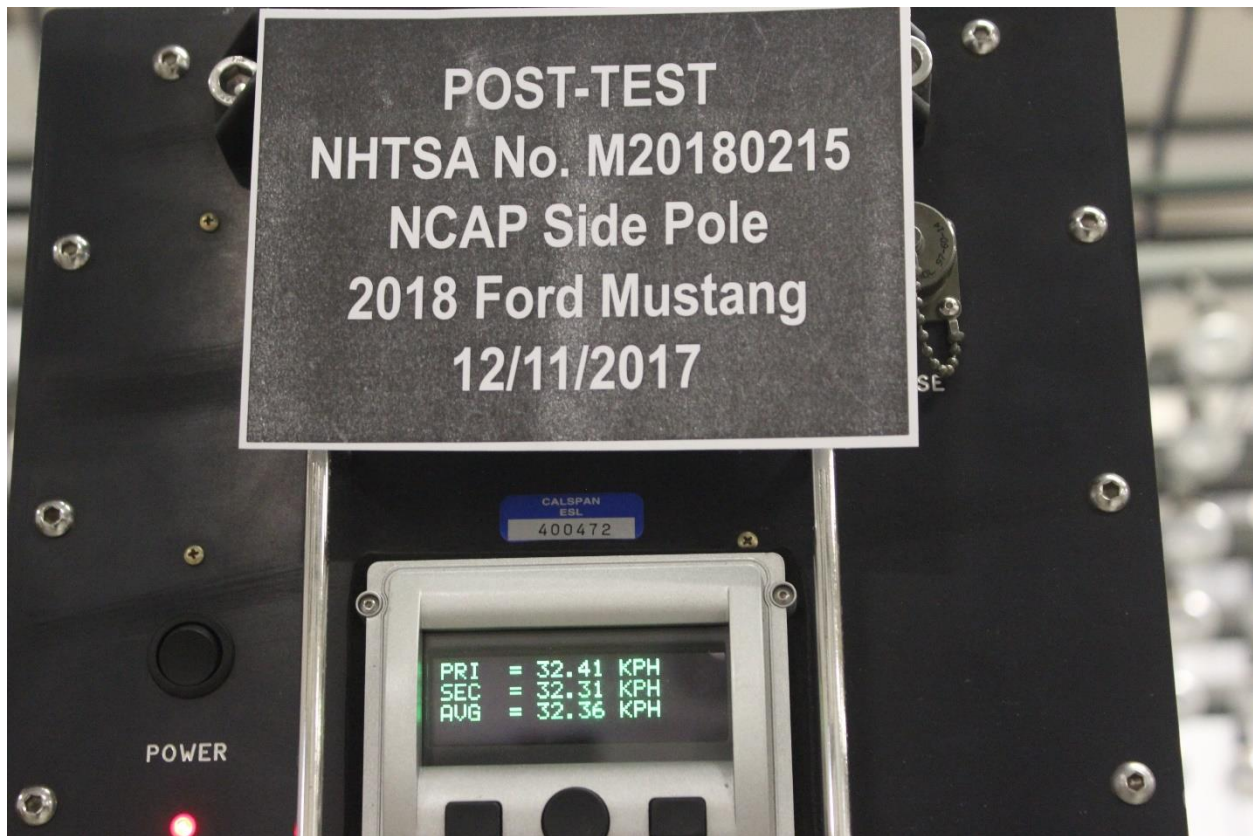
Figure A-62: Post-Test Primary and Redundant Speed Trap Read-Out

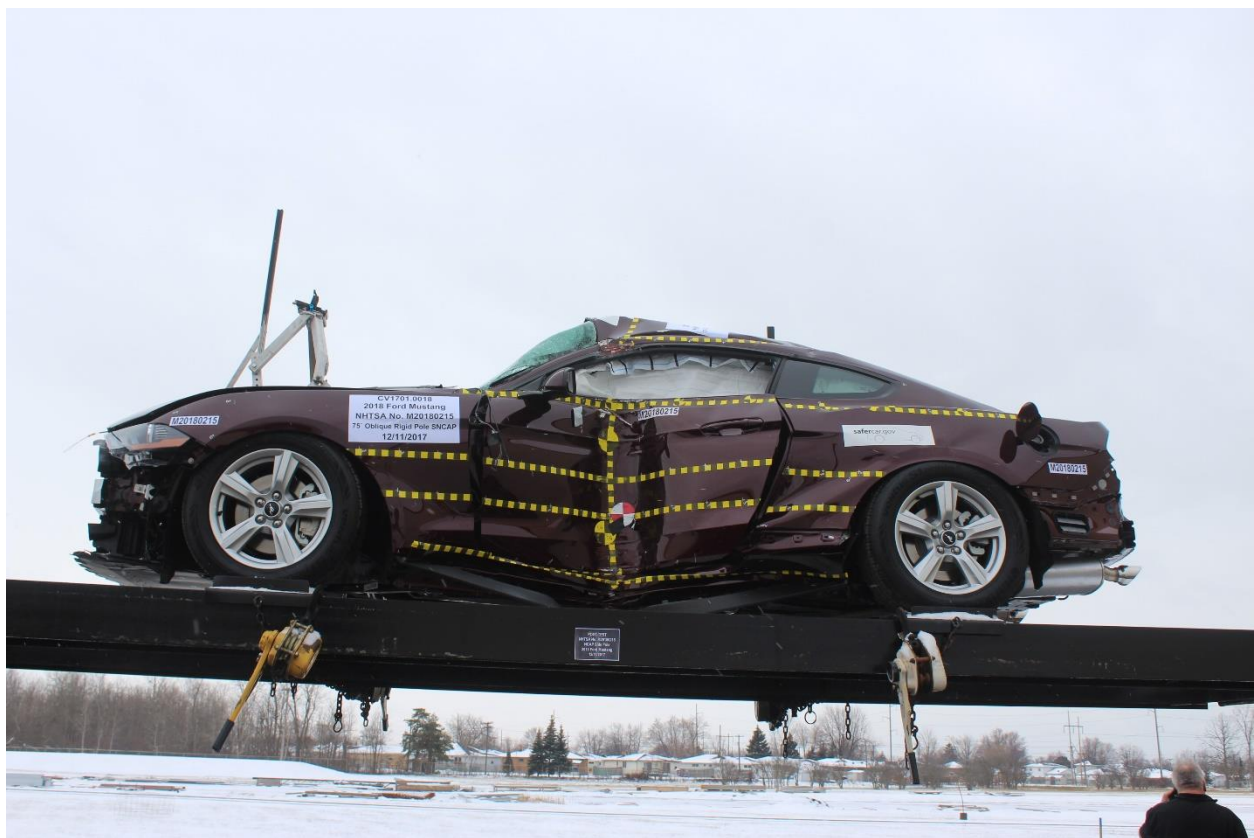
Figure A-63: FMVSS No. 301 Static Rollover 0 Degrees

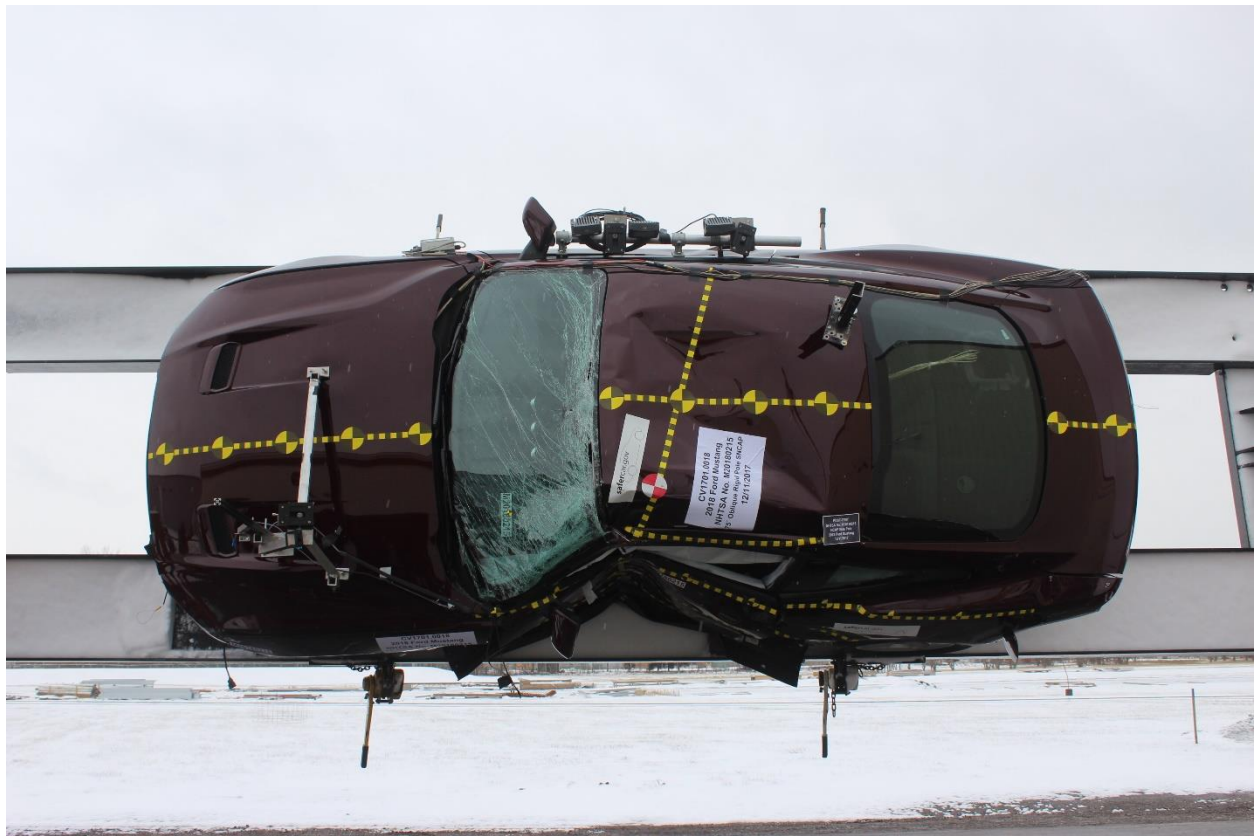
**Figure A-64: FMVSS No. 301 Static Rollover 90 Degrees**

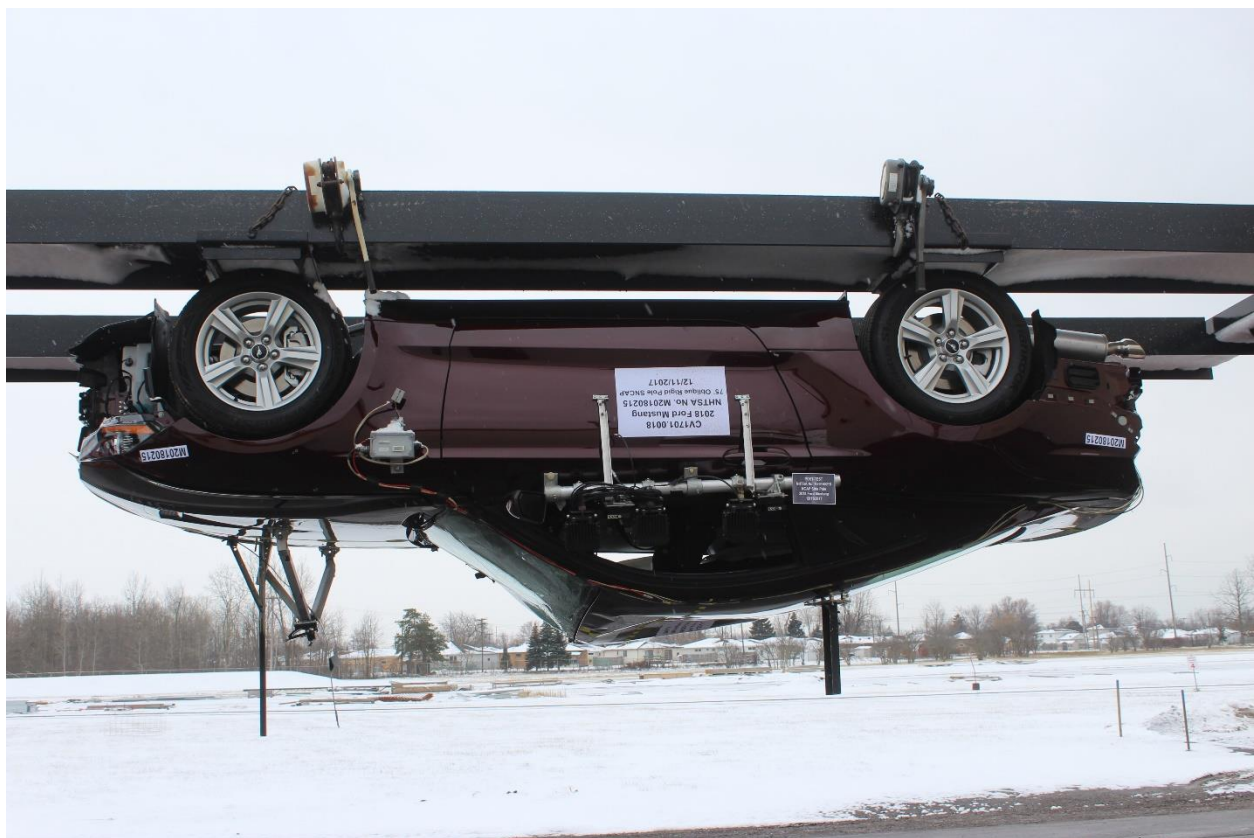
**Figure A-65: FMVSS No. 301 Static Rollover 180 Degrees**

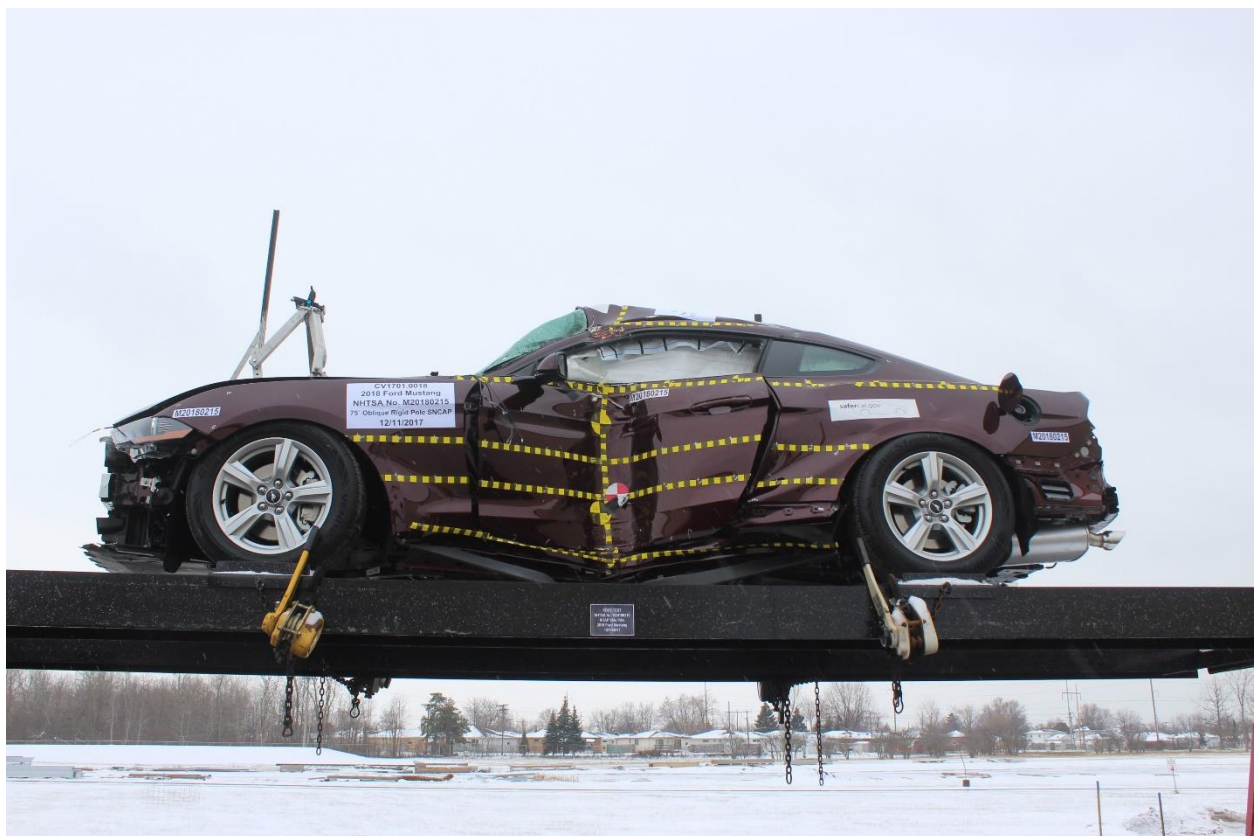
**Figure A-67: FMVSS No. 301 Static Rollover 360 Degrees**
