**Final Report Number: NCAP-TRC-18-003**

**New Car Assessment Program (NCAP)**

**Frontal Barrier Impact Test**

**2018 Volkswagen Tiguan**

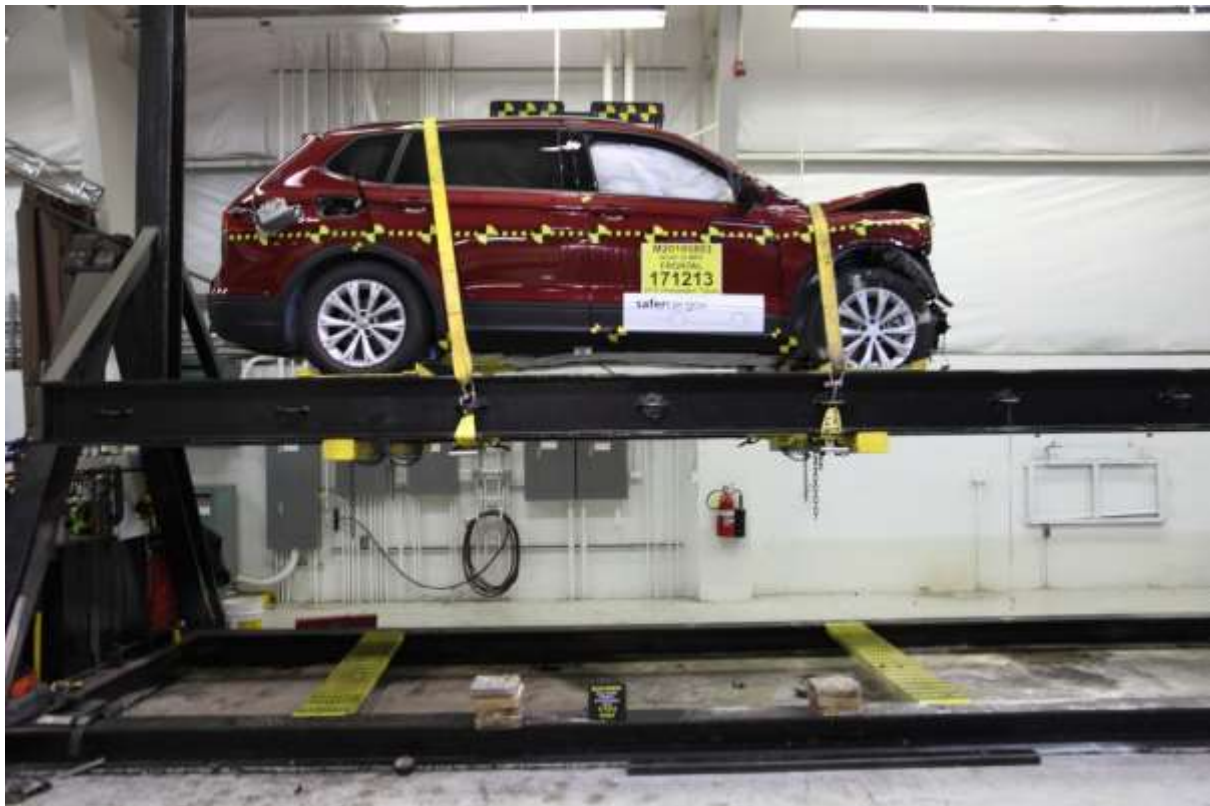
**073 Vehicle at 0° on Static Rollover Device**

There was 100.0 percent windshield retention and no intrusion into the protected zone of the windshield during the event. There was no Stoddard solvent leakage after the event or during any phase of the static rollover.

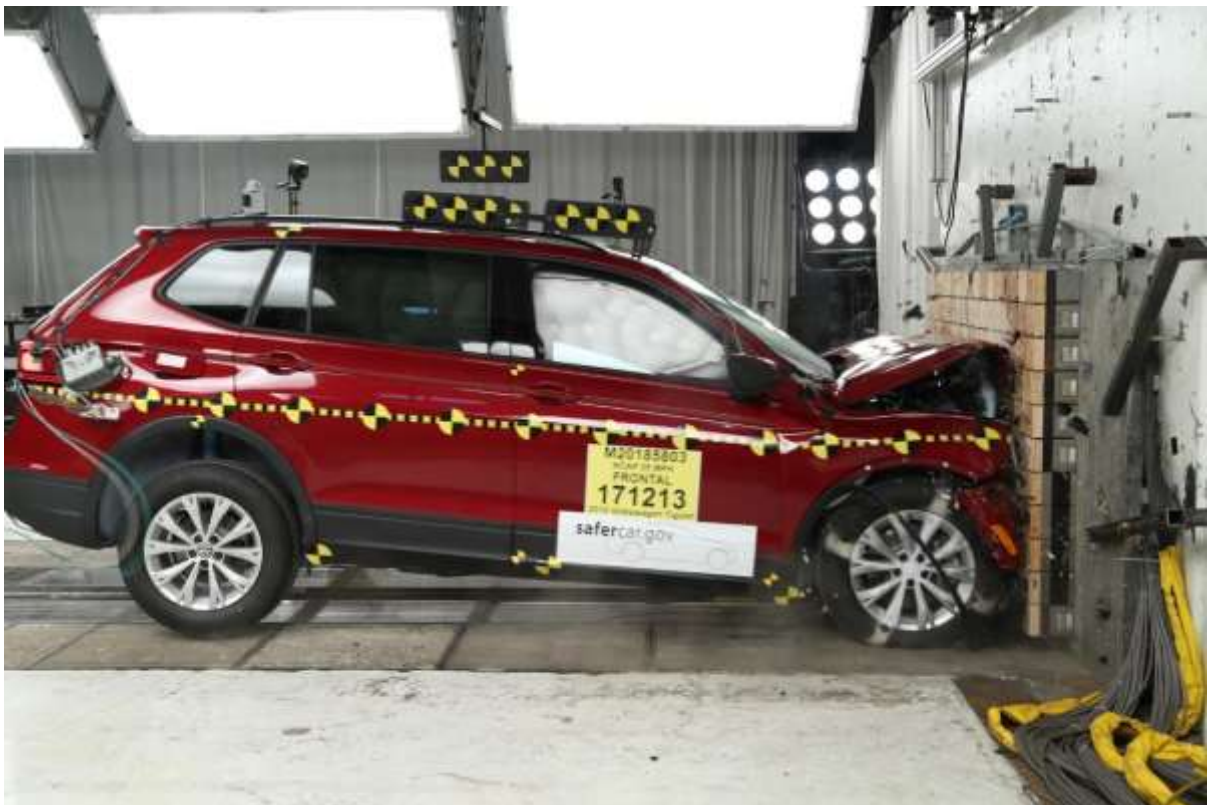
**078 2018 Volkswagen Tiguan Frontal Impact Event**

A 2018 Volkswagen Tiguan impacted the barrier wall at a velocity of 56.64 km/h. The test was performed at Transportation Research Center, Inc. on December 13, 2017. Pre- and post-test photographs of the vehicle and dummies can be found in Appendix A.
